ASBESTOS SURVEY REPORT FOR EAST HERRINGTON ACADEMY, SUNDERLAND

Asbestos Register for EAST HERRINGTON ACADEMY, SUNDERLAND

Date: 30 May 2025

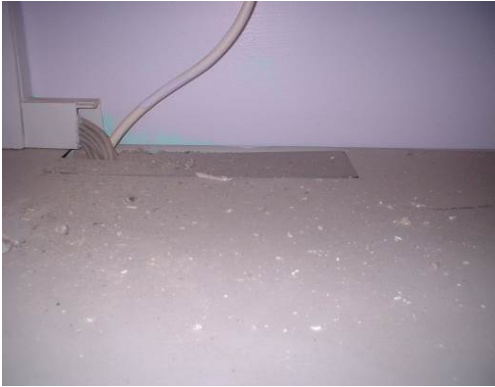
Item 1 Ref: Sample 01

The debris on the computer terminal in the library (Room 0/03) does not contain asbestos.

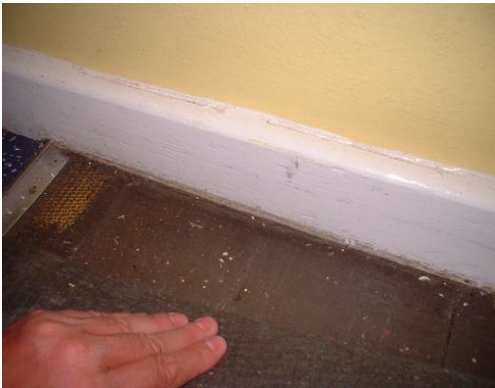
Item 2 - Ref: Sample 02

The vinyl flooring to the infant school corridor (Room 0/04) contains asbestos.

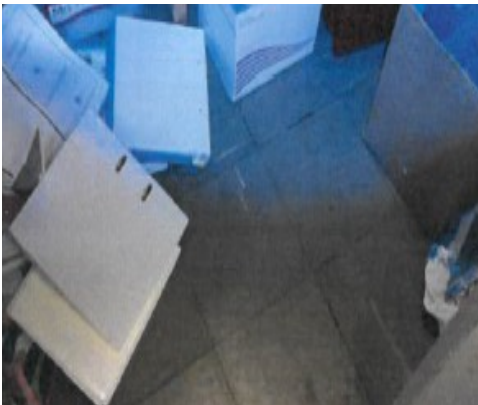
Item 7 – As Sample 08 & AQ000124

The floor covering (vinyl tiles & adhesive) (Room 0/11 Y2 classroom stationary cupboard) contains asbestos.

Any change in its appearance should be recorded and passed to Property Services.

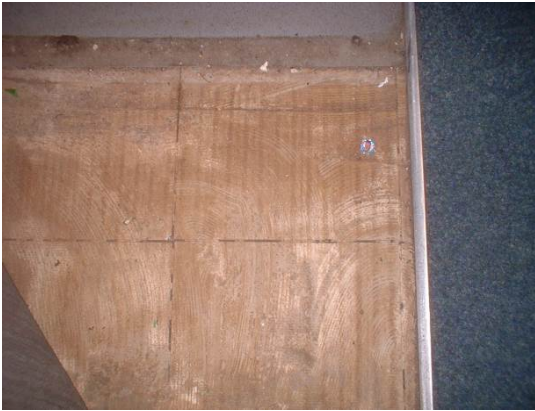
Item 9 - Ref: Sample 10

The vinyl flooring in the infant school cloak room/toilets classroom (Room 0/16) does not contain asbestos.

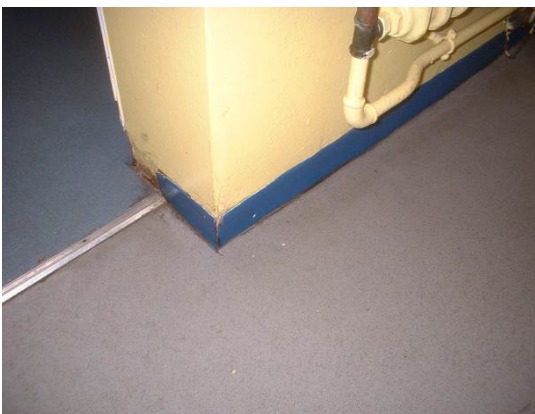
Item 11 - Ref: Sample 11

The skirting in the infant school cloakroom/toilets (Room 0/16) does not contain asbestos.

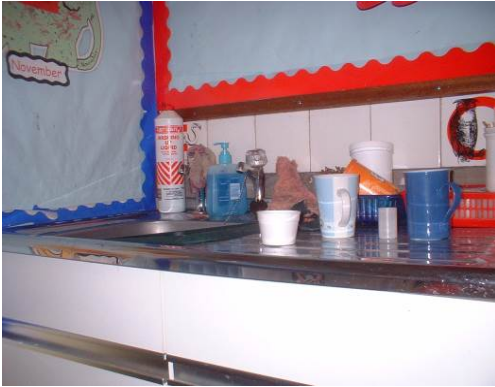
Item 12 - Ref: Sample 12

The sink pad in the infant school classroom (Room 0/17) does not contain asbestos.

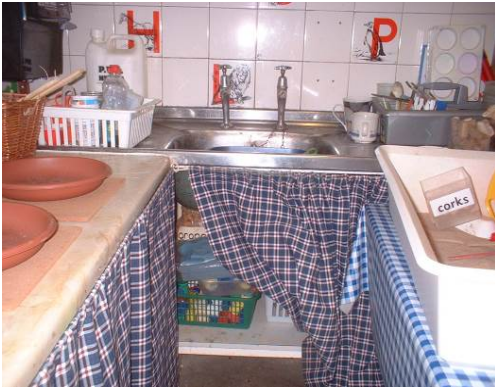
Item 13 – Ref: Sample 13

The sink pad in the infant school classroom (Room 0/19) contains asbestos.

Removed August 2018

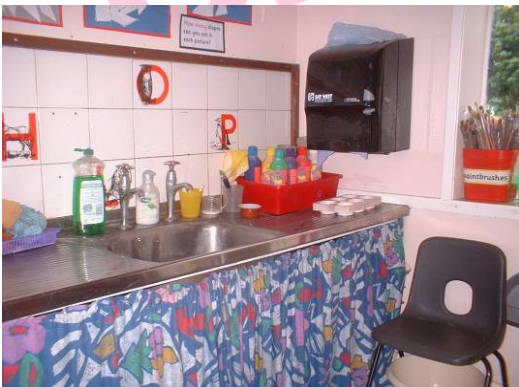
Item 14 - Ref: Sample 14

The sink pad in the infant school classroom (Room 0/21) contains asbestos.

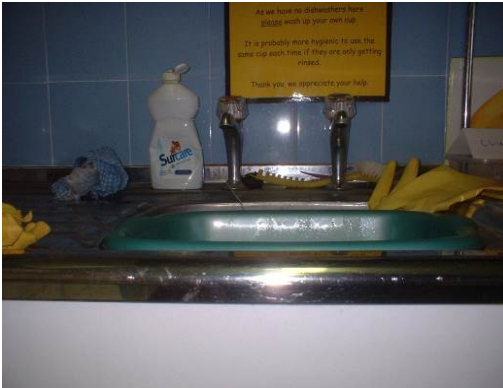
Item 15 - Ref: Sample 15

The sink pad in this infant school classroom (Room 0/23) does not contain asbestos.

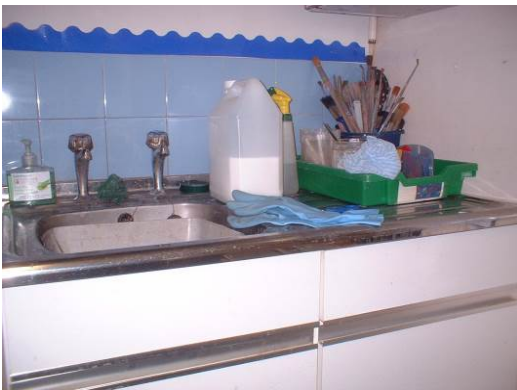
Item 16 – Ref: Sample 16

The sink pad in this infant school classroom (Room 0/23) does not contain asbestos.

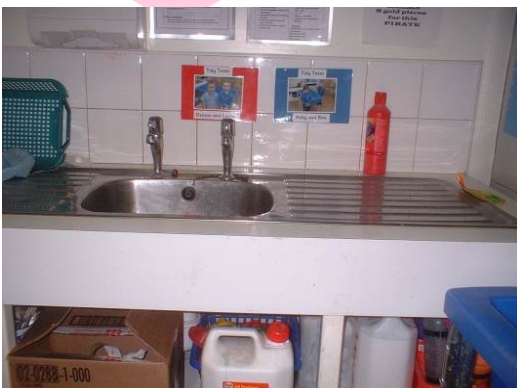
Item 17 - Ref: Sample 17

The sink pad in this infant school classroom (Room 0/26) does not contain asbestos.

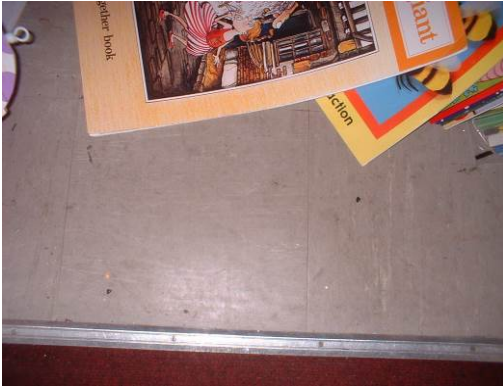
Item 18 - Ref: Sample 18

The vinyl flooring in the infant classroom store (Room 0/27) does not contain asbestos.

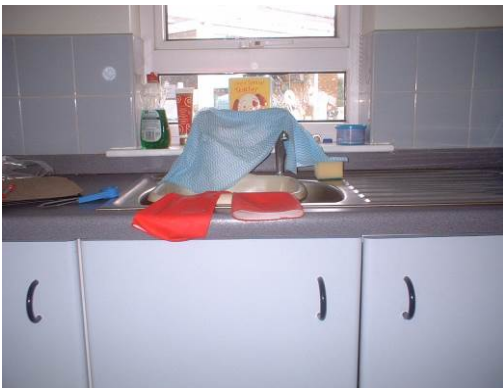
Item 19 – Ref: Sample 19

The sink pad in the infant school classroom kitchen (Room 0/28) does not contain asbestos.

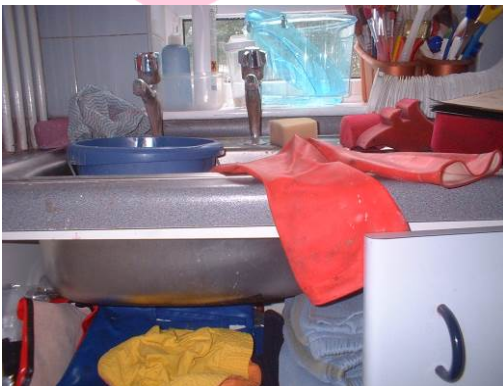
Item 20 - Ref: Sample 20

The sink pad in the infant school classroom washroom (Room 0/29) does not contain asbestos.

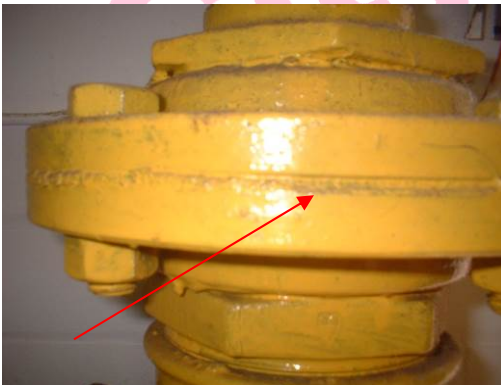
Item 23 – Ref: Sample 22

The pipework gasket in the infant school boiler room (Room 0/33) does not contain asbestos.

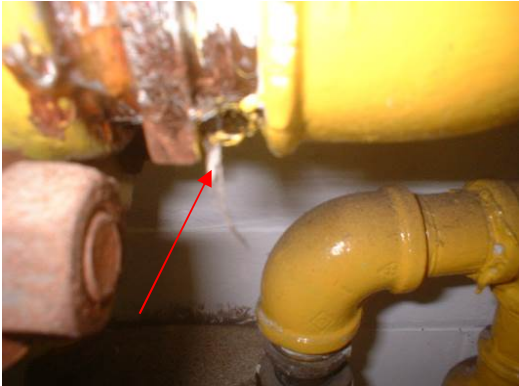
Item 24 - Ref: Sample 23

The redundant rope gasket in the primary school boiler room (Room 0/33) does not contain asbestos.

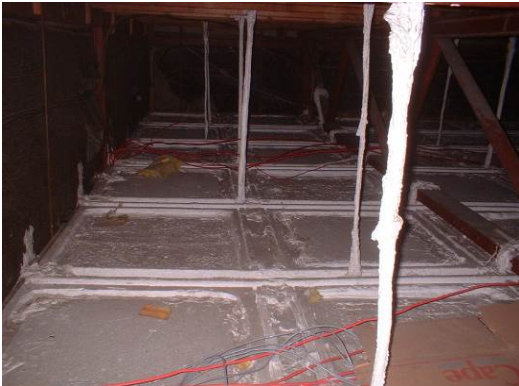
Item 25 - Ref: Sample 24

The main hall ceiling void floor area (Room 1/01) does not contain asbestos.

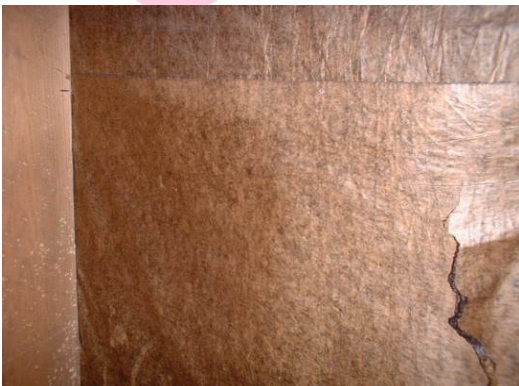
Item 26 – Ref: Sample 25

The infant school main hall roof felt (Room 1/01) does not contain asbestos.

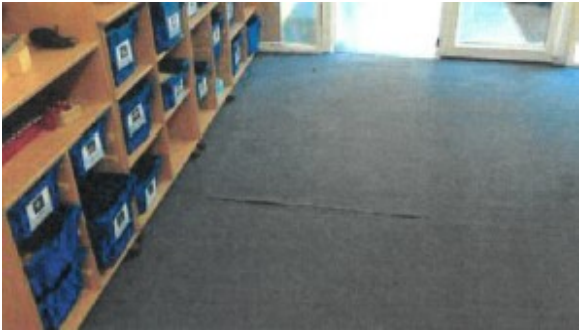
Item 39 - Ref: AQ000125

The Vinyl tile below carpet (Room 0/15 music room lobby) does not contain asbestos.

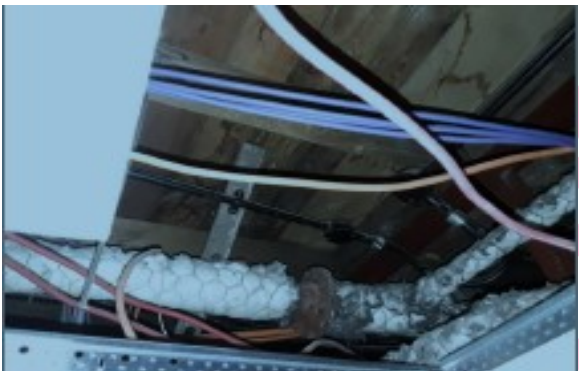
Item 40 - Ref: Presumed

The gasket within pipework flange in the ceiling void above office 1 & 2, Lobby and First Aid is presumed to contain asbestos.

Any change in its appearance should be recorded and passed to Property Services.

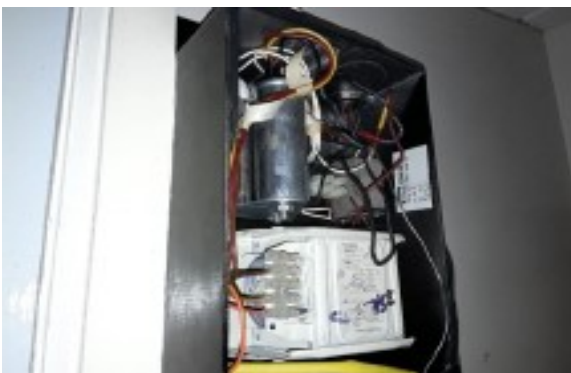
Item 41 - Ref: Presumed

The flashguard within control gear west in Classroom 1 is presumed to contain asbestos.

Removed 2019

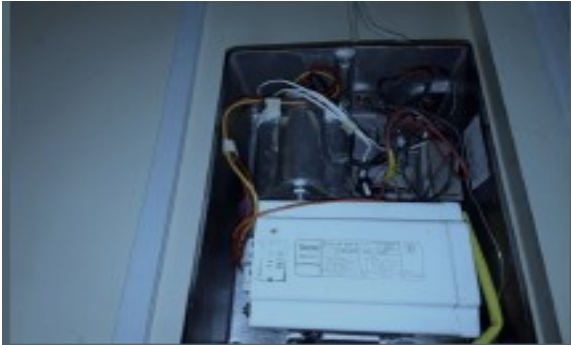
Item 42 - Ref: Presumed

The flashguard within control gear east in Classroom 2 is presumed to contain asbestos.

Removed 2019

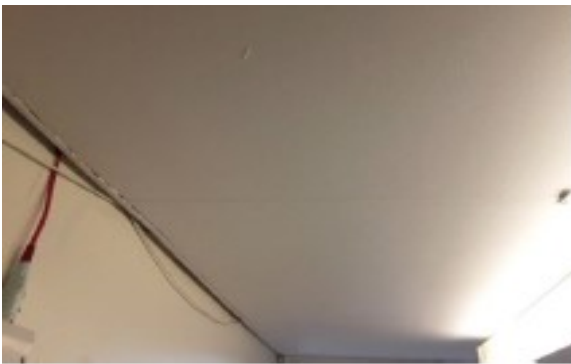
Item 43 - Ref: AL004376

The insulating board ceiling panels in the lobby do not contain asbestos.

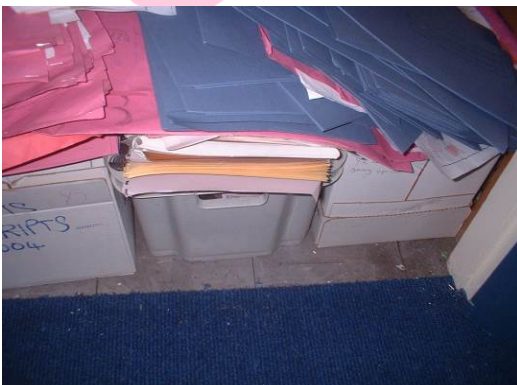
Item 3 - Ref: Sample 29

The vinyl floor tiles in the primary school classroom (Room 0/35) do not contain asbestos.

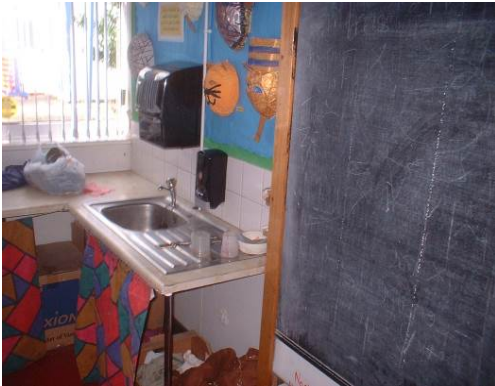
Item 4 - Ref: Sample 30

The sink pad in this primary school classroom (Room 0/36) does not contain asbestos.

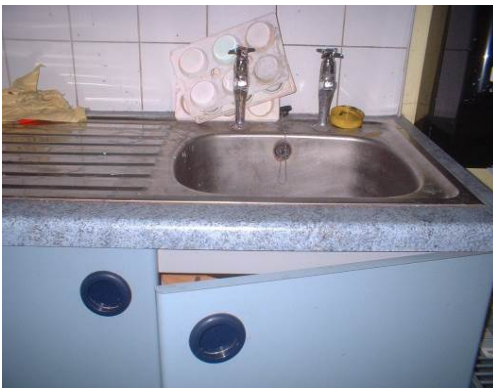
Item 8 - Ref: Sample 33

The sink pad in this primary school classroom (Room 0/38) does not contain asbestos.

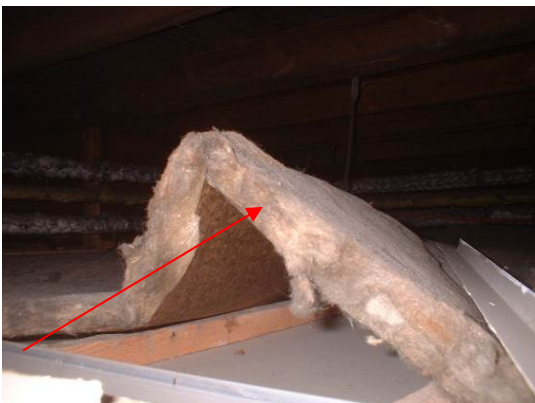
Item 9 – Ref: Sample 34

The ceiling void insulation to the hallway/corridor (Room 0/41) does not contain asbestos.

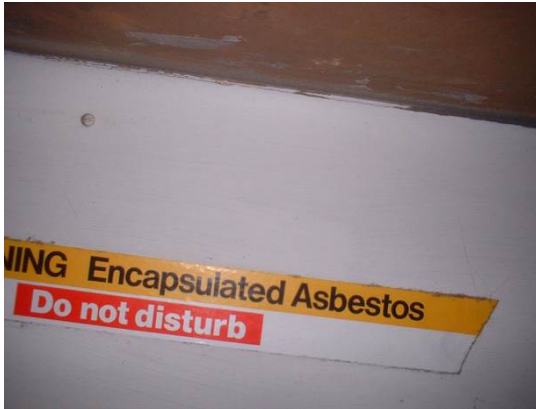
Ref: Sample 35

The insulating board inside the cupboard heaters within the Corridor/hallway (Room 0/41) contained asbestos.

All asbestos linings to the heaters in the school were removed in November 2013.

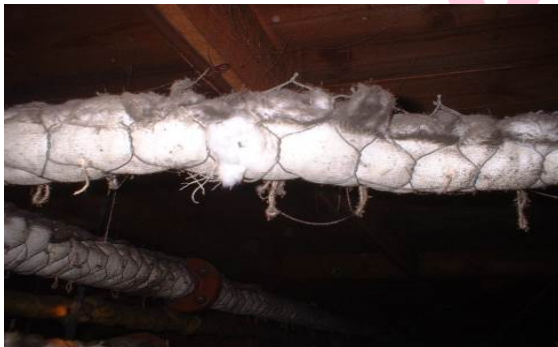
Item 10 - Ref: Sample 36

The lagging insulation to the pipework within the hallway corridor (Room 0/41) does not contain asbestos.

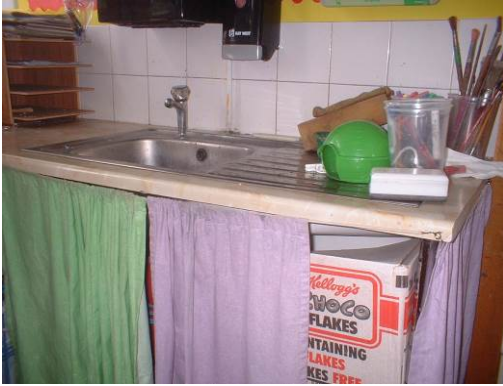
Item 11 - Ref: Sample 38

The sink pad within classroom 8 (Room 0/56) does not contain asbestos.

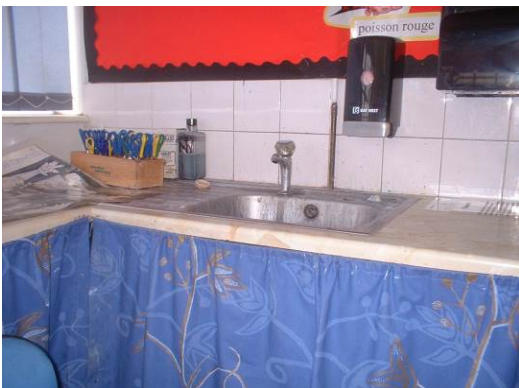
Item 13 – Ref: Sample 40

The sink pad in classroom 7 (Room 0/57) does not contain asbestos.

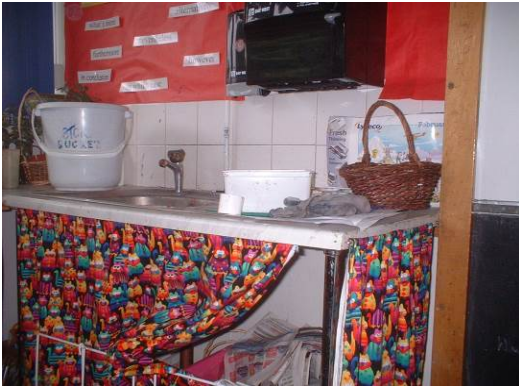
Item 14 - Ref: Sample 41

The sink pad in classroom 6 (Room 0/58) does not contain asbestos.

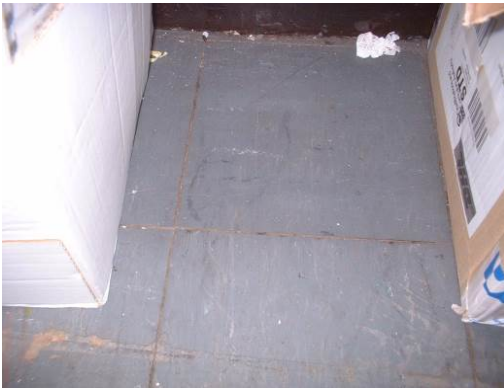
Item 15 - Ref: Sample 42

The vinyl flooring within classroom 6 (Room 0/58) does not contain asbestos.

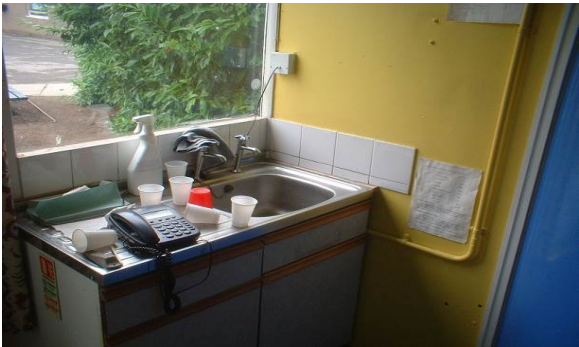
Item 22 – Ref: Sample 49

The sink pad in the library (Room 0/70) does not contain asbestos.

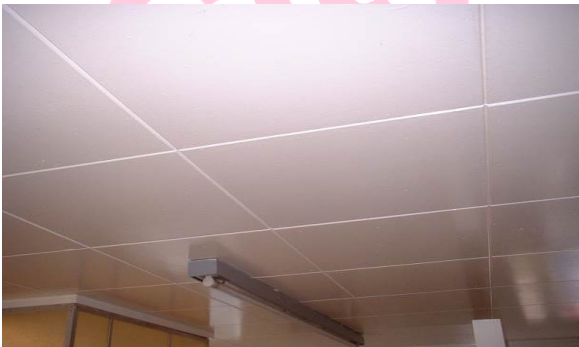
Item 23 - Ref: Sample 50

The ceiling tiles to the kitchen (Room 0/67) contain asbestos.

Any change in its appearance should be recorded and passed to Property Services.

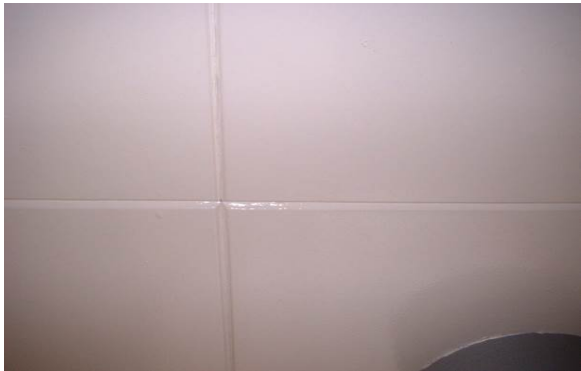
Item 24 – As Sample 50

The ceiling in the kitchen staff wc (Room 0/73) contains asbestos.

Any change in its appearance should be recorded and passed to Property Services.

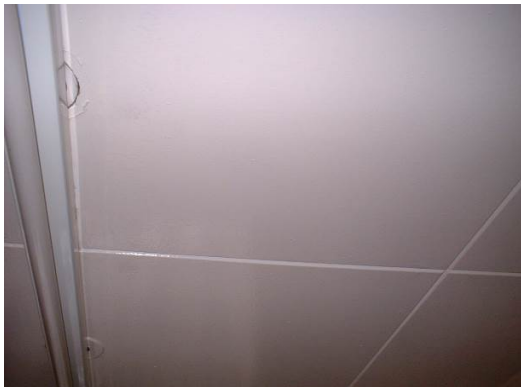
Item 25 – As Sample 50

The ceiling to the kitchen staff room (Room 0/72) contains asbestos.

Any change in its appearance should be recorded and passed to Property Services.

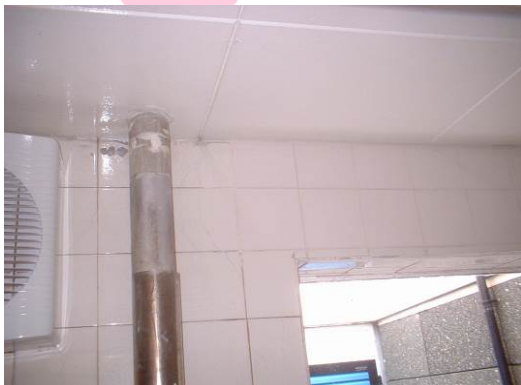
Item 26 - Ref: Sample 51

The flue to the kitchen (Room 0/67) contains asbestos.

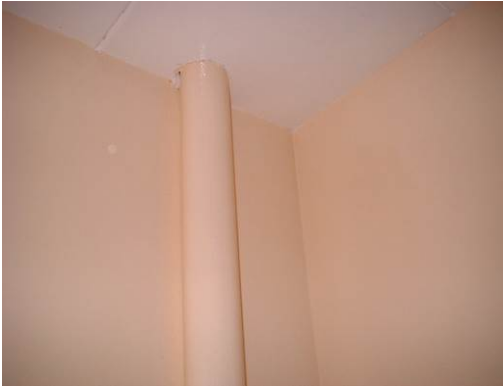
Item 27 – As Sample 51

The flue in the kitchen staff wc (Room 0/73) contains asbestos.

Any change in its appearance should be recorded and passed to Property Services.

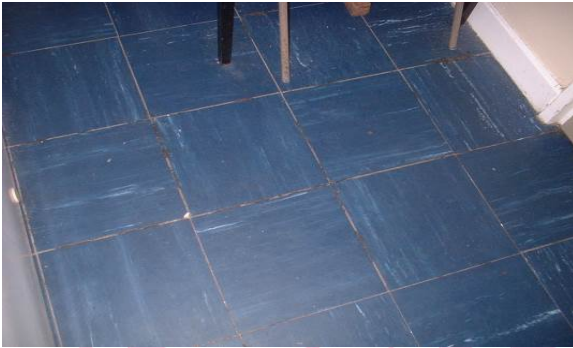
Item 28 –Ref: Sample 52

The vinyl flooring to the kitchen staff room (0/72) does not contain asbestos.

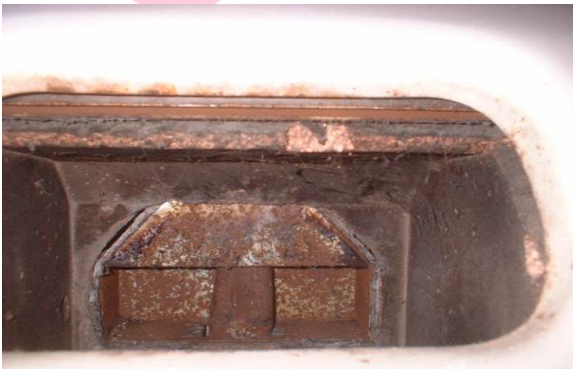
Item 29 - Ref: Sample 53

The panel within the sanitary unit in the kitchen staff wc (Room 0/73) does not contain asbestos.

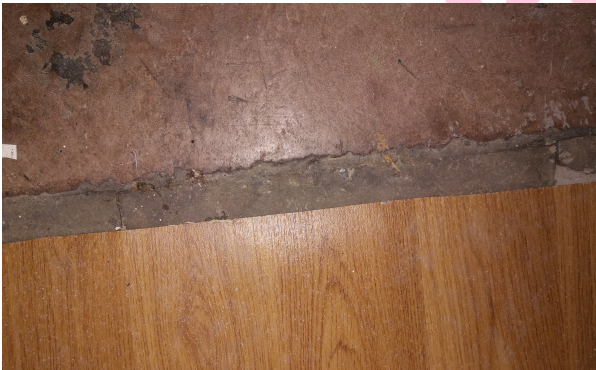
Item 34 - Ref: As 182913-10

The flooring in the corridor (Rm 0/22) contains asbestos.

Any change in its appearance should be recorded and passed to Property Services.

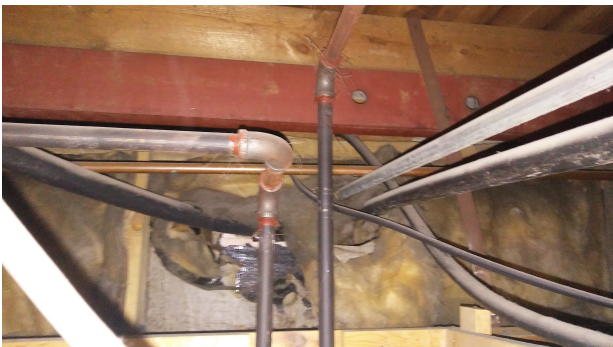
Item 35 - Ref: 182913-9

The felt to the old external wall in the void above rooms 0/21 – 0/24 does not contain asbestos.

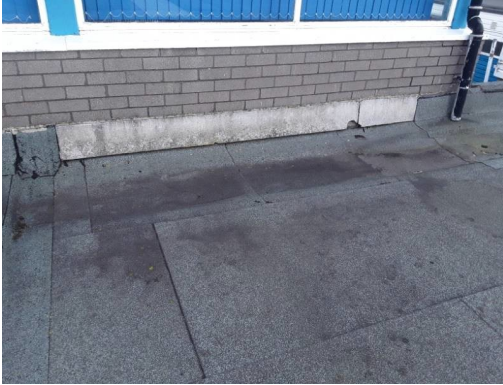
Item 99 Ref: PE001549

The upstanding felt to sports hall (External/Roof 7) contains asbestos.

Removed April 2022 – waiting WCN

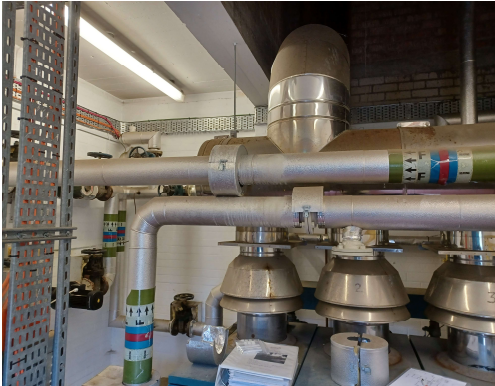
Item 111 Ref: Presumed

The debris to pipework below armer cladding (Rm 0/26 KS1 Boiler Room) is presumed to contain asbestos.

Removed January 2024.

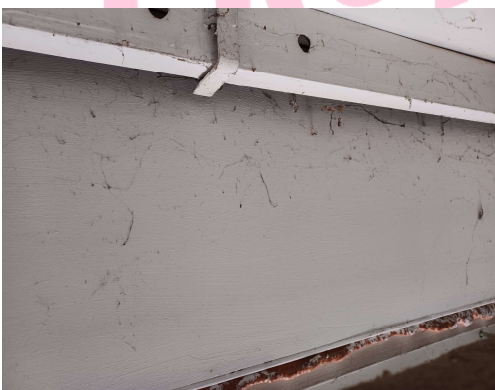
Item 116 Ref: As 581161-11

The panel above door (Rm 0/27 Boiler Room adj Kitchen) contains asbestos.

Removed October 2023.

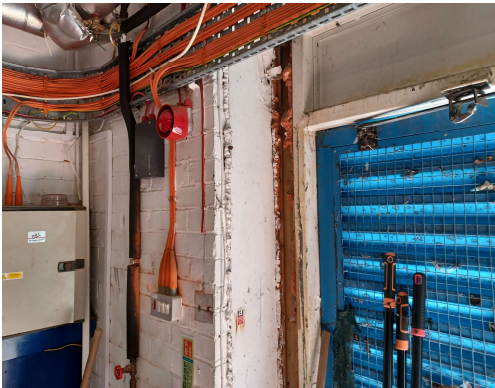
Item 117 Ref: 581161-12

The door surround (Rm 0/27 Boiler Room adj Kitchen) contains asbestos.

Removed October 2023.

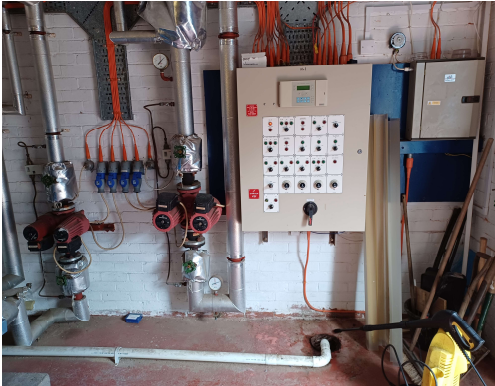
Item 120 Ref: 581161-15

The debris to electric wall
(Rm 0/27 Boiler Room adj
Kitchen) contains asbestos.

Removed October 2023.

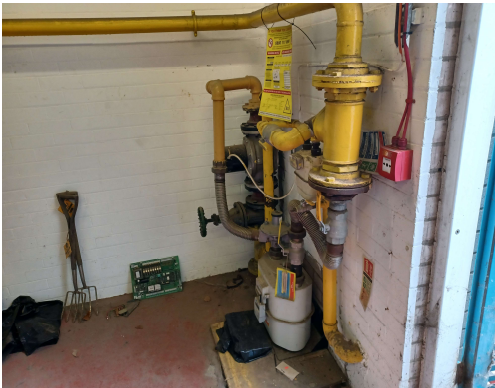
Item 123 Ref: 581161-4

The gasket to main gas pipe (Rm 0/28 Reception Classroom) does not contain asbestos.

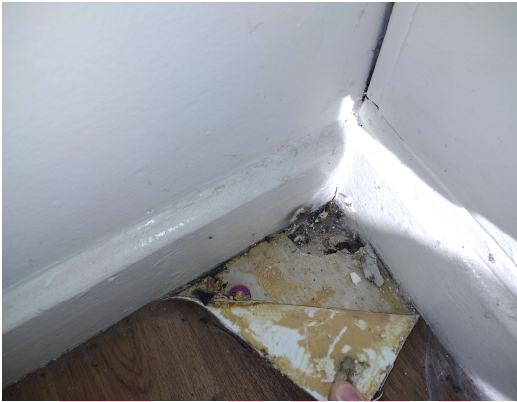
Item 130 Ref: 581161-18

The subfloor – floor tile without bitumen (Rm 0/34 Classroom) contains asbestos.

Any change in its appearance should be recorded and passed to Property Services.

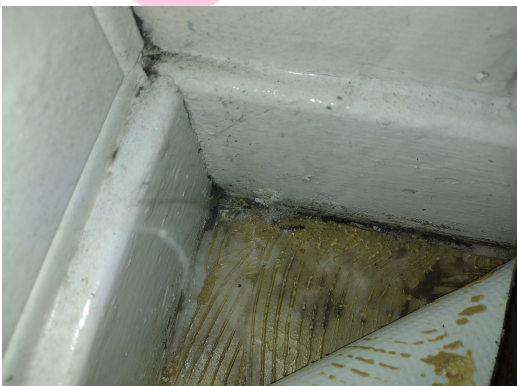
Item 131 Ref: As 581161-18

The subfloor – floor tile without bitumen (Rm 0/35 Classroom) contains asbestos.

Any change in its appearance should be recorded and passed to Property Services.

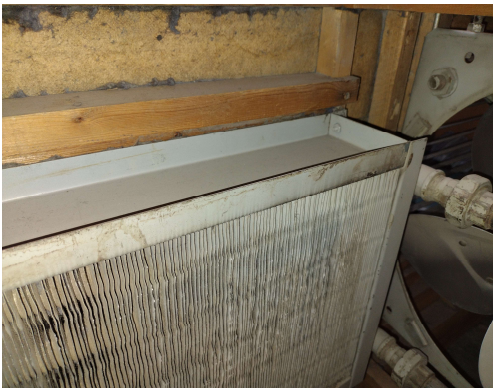
Item 133 Ref: 581161-20

The sealant surrounding convactor (Rm 0/36 Classroom) contains asbestos.

Any change in its appearance should be recorded and passed to Property Services.

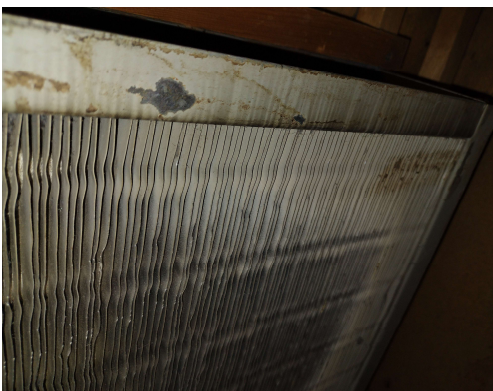
Item 137 Ref: As 581161-20

The sealant surrounding convector (Rm 0/38 Classroom) contains asbestos.

Any change in its appearance should be recorded and passed to Property Services.

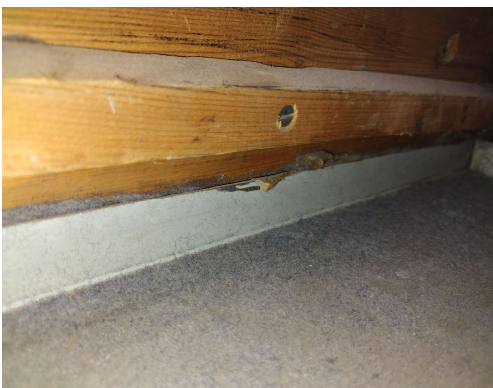
Item 140 Ref: As 581161-20

The sealant surrounding convector (Rm 0/40 Dining Hall) contains asbestos.

Any change in its appearance should be recorded and passed to Property Services.

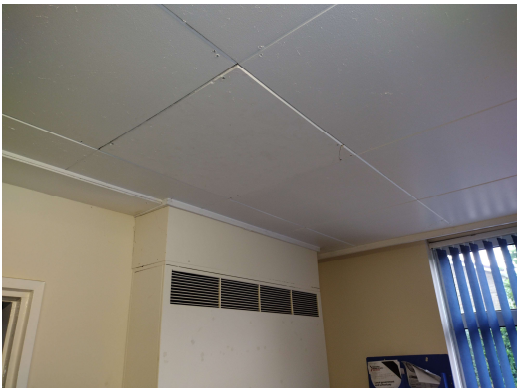
Item 142 Ref: 581161-22

The ceiling (Rm 0/41 Staff Room) does not contain asbestos.

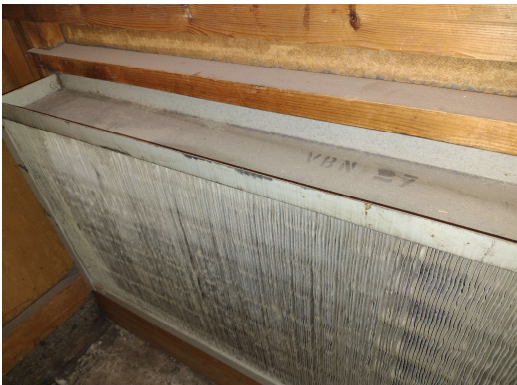
Item 143 Ref: As 581161-20

The sealant surrounding convector (Rm 0/42 Classroom) contains asbestos.

Any change in its appearance should be recorded and passed to Property Services.

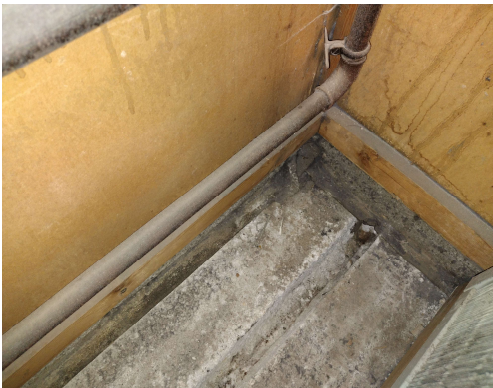
Item 145 Ref: As 581161-19

The damp proof course (Rm 0/42 Classroom) contains asbestos.

Any change in its appearance should be recorded and passed to Property Services.

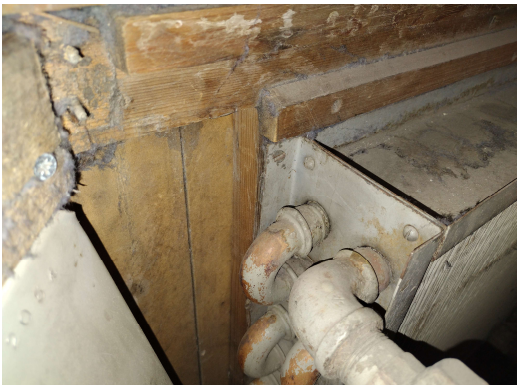
Item 146 Ref: As 581161-20

The sealant surrounding convector (Rm 0/43 Classroom) contains asbestos.

Any change in its appearance should be recorded and passed to Property Services.

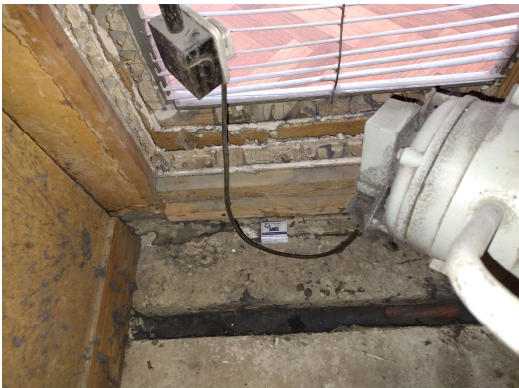
Item 148 Ref: As 581161-19

The damp proof course (Rm 0/43 Classroom) contains asbestos.

Any change in its appearance should be recorded and passed to Property Services.

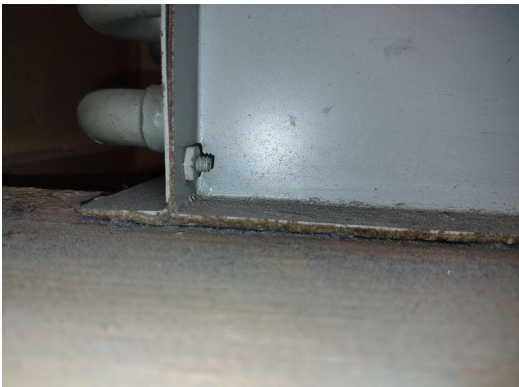
Item 149 Ref: As 581161-20

The sealant surrounding convector (Rm 0/44 Corridor) contains asbestos.

Any change in its appearance should be recorded and passed to Property Services.

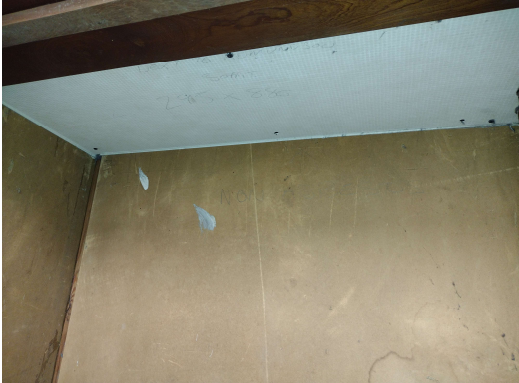
Item 150 Ref: As 581161-21

The ceiling (Rm 0/44 Corridor) does not contain asbestos.

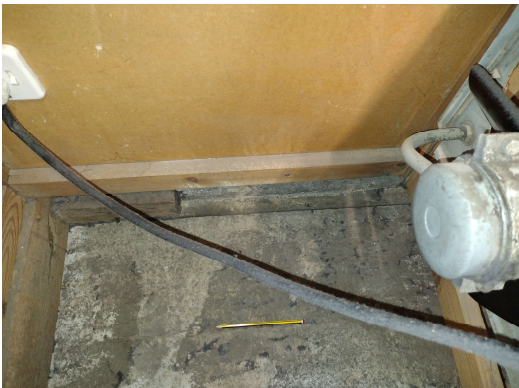
Item 151 Ref: As 581161-19

The damp proof course (Rm 0/45 Classroom) contains asbestos.

Any change in its appearance should be recorded and passed to Property Services.

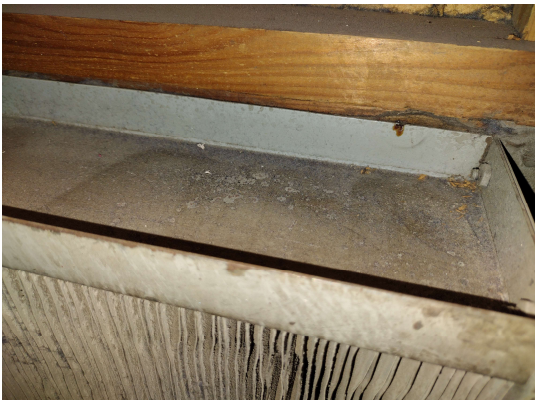
Item 152 Ref: As 581161-20

The sealant surrounding convector (Rm 0/45 Classroom) contains asbestos.

Any change in its appearance should be recorded and passed to Property Services.

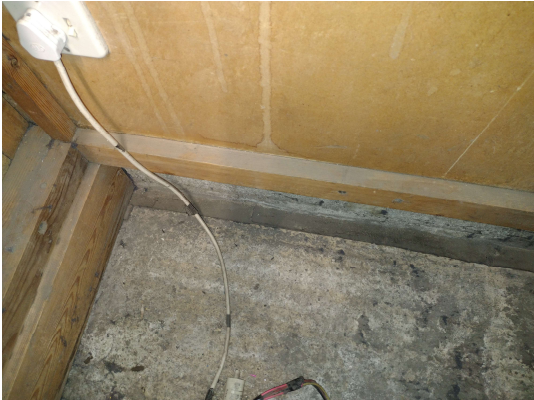
Item 153 Ref: As 581161-19

The damp proof course (Rm 0/46 Classroom) contains asbestos.

Any change in its appearance should be recorded and passed to Property Services.

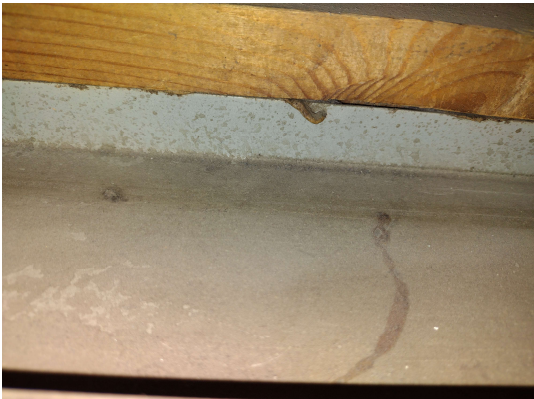
Item 154 Ref: As 581161-20

The sealant surrounding convactor (Rm 0/46 Classroom) contains asbestos.

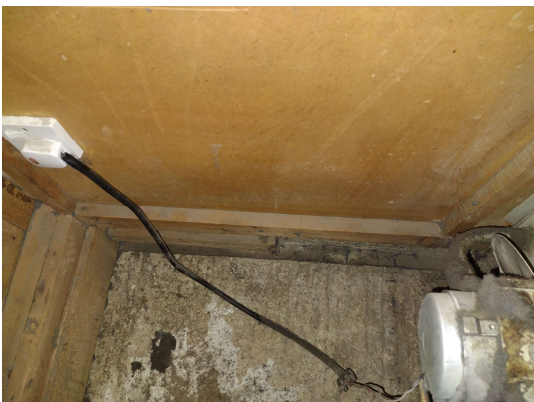
Item 155 Ref: As 581161-19

The damp proof course (Rm 0/47 Classroom) contains asbestos.

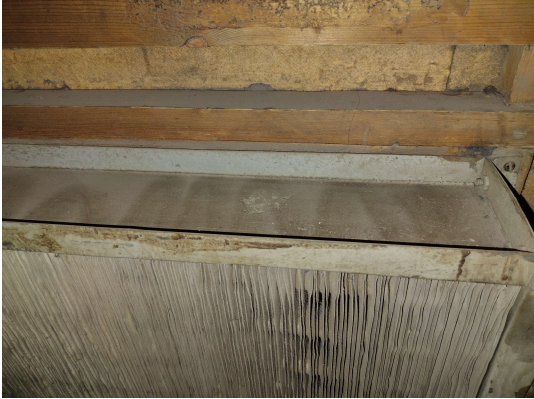
Item 156 Ref: As 581161-20

The sealant surrounding convector (Rm 0/47 Classroom) contains asbestos.

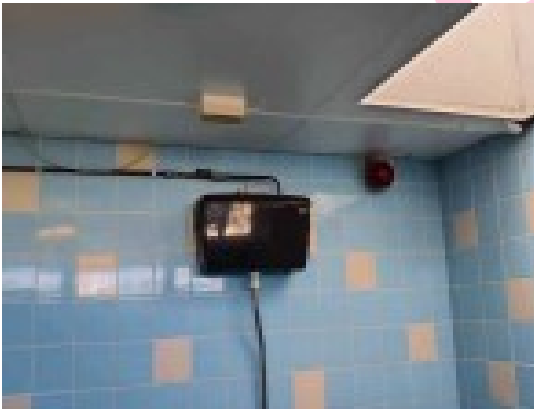
Item 157 Ref: FH0035350

The bakelite cistern in Year 5/6 boys toilet (G/004) does not contain asbestos.
