ASBESTOS SURVEY REPORT FOR EAST HERRINGTON ACADEMY, SUNDERLAND

Asbestos Register for EAST HERRINGTON ACADEMY, SUNDERLAND

Date: 21 July 2025

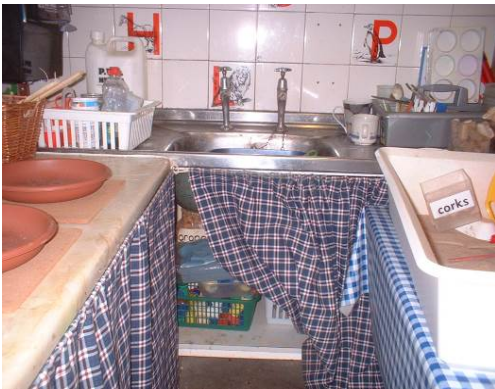
Item 13 – Ref: Sample 13

The sink pad in the infant school classroom (Room 0/19) contains asbestos.

Removed August 2018

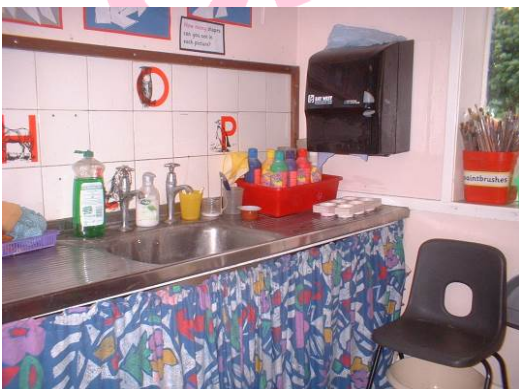
Item 14 - Ref: Sample 14

The sink pad in the infant school classroom (Room 0/21) contains asbestos.

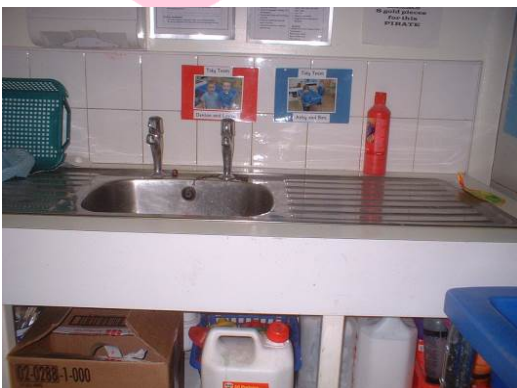
Item 17 - Ref: Sample 17

The sink pad in this infant school classroom (Room 0/26) does not contain asbestos.

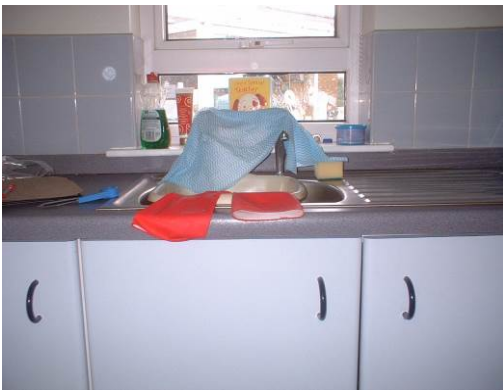
Item 19 – Ref: Sample 19

The sink pad in the infant school classroom kitchen (Room 0/28) does not contain asbestos.

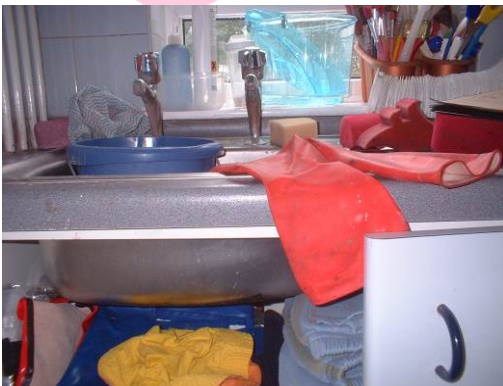
Item 20 - Ref: Sample 20

The sink pad in the infant school classroom washroom (Room 0/29) does not contain asbestos.

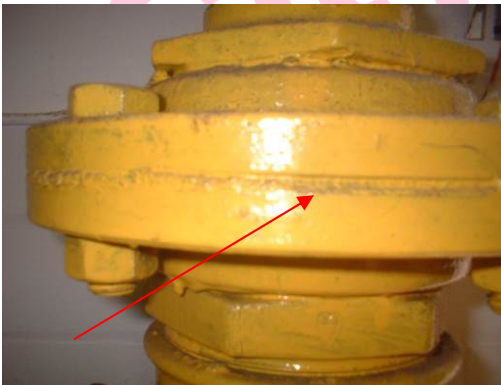
Item 23 – Ref: Sample 22

The pipework gasket in the infant school boiler room (Room 0/33) does not contain asbestos.

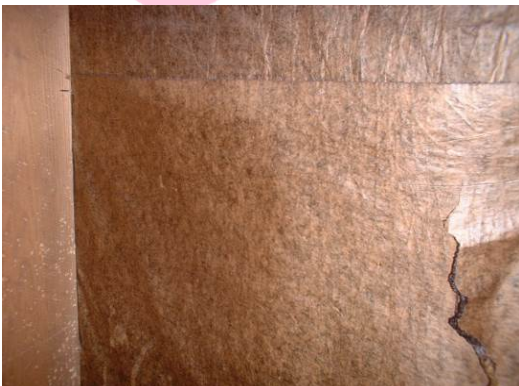
Item 26 – Ref: Sample 25

The infant school main hall roof felt (Room 1/01) does not contain asbestos.

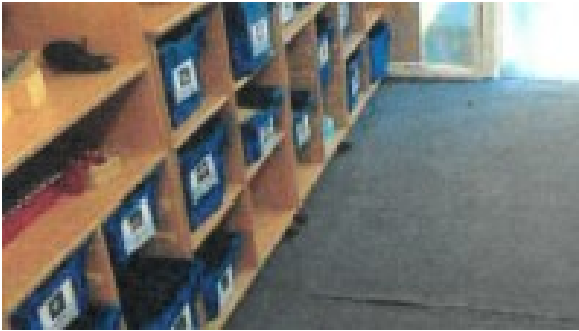
Item 39 - Ref: AQ000125

The Vinyl tile below carpet (Room 0/15 music room lobby) does not contain asbestos.

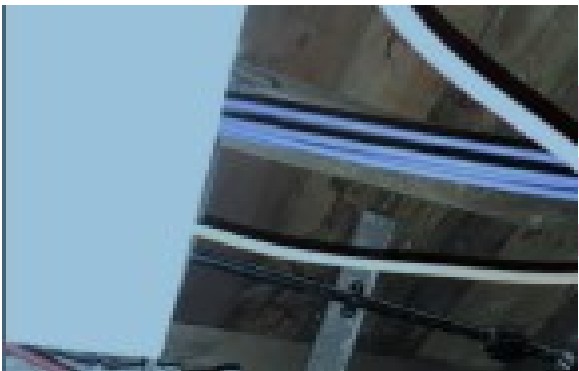
Item 40 - Ref: Presumed

The gasket within pipework flange in the ceiling void above office 1 & 2, Lobby and First Aid is presumed to contain asbestos.

Any change in its appearance should be recorded and passed to Property Services.

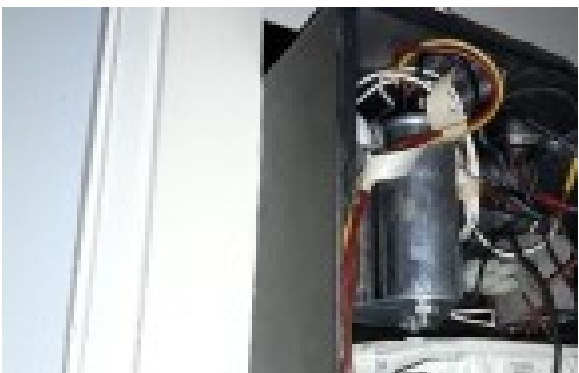
Item 41 - Ref: Presumed

The flashguard within control gear west in Classroom 1 is presumed to contain asbestos.

Removed 2019

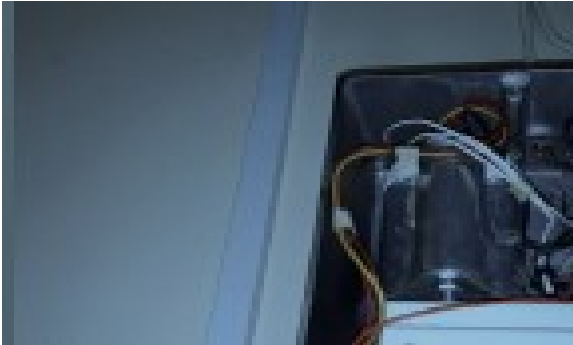
Item 42 - Ref: Presumed

The flashguard within control gear east in Classroom 2 is presumed to contain asbestos.

Removed 2019

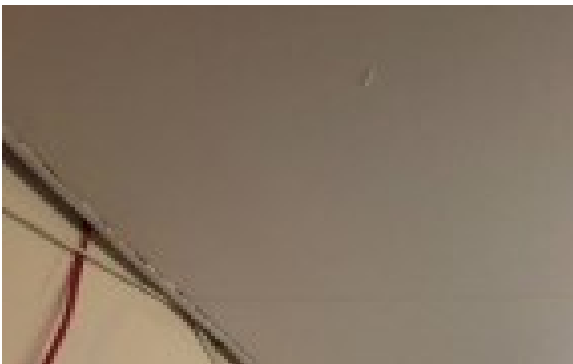
Item 43 - Ref: AL004376

The insulating board ceiling panels in the lobby do not contain asbestos.

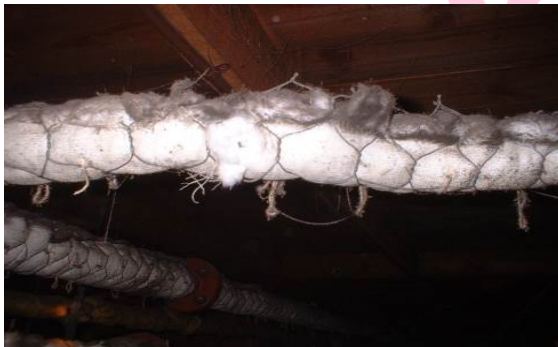
Item 10 - Ref: Sample 36

The lagging insulation to the pipework within the hallway corridor (Room 0/41) does not contain asbestos.

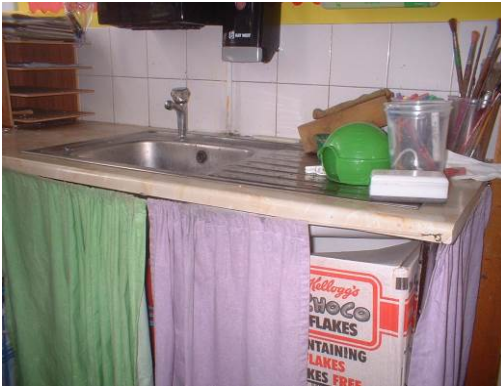
Item 11 - Ref: Sample 38

The sink pad within classroom 8 (Room 0/56) does not contain asbestos.

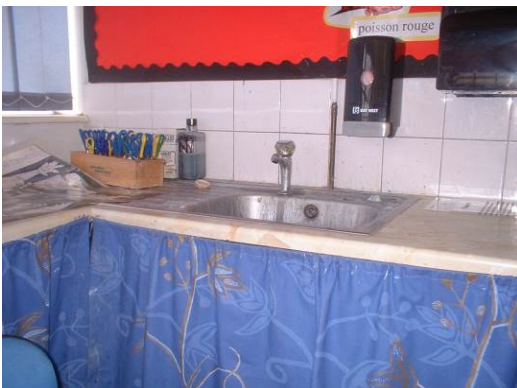
Item 13 – Ref: Sample 40

The sink pad in classroom 7 (Room 0/57) does not contain asbestos.

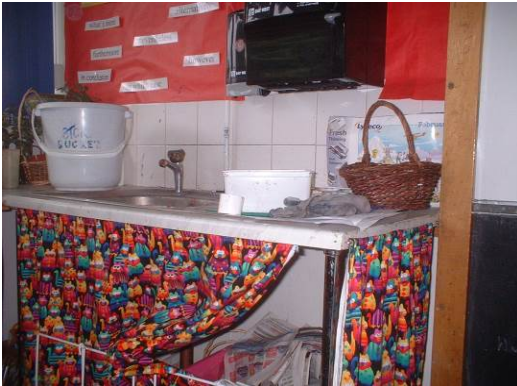
Item 14 - Ref: Sample 41

The sink pad in classroom 6 (Room 0/58) does not contain asbestos.

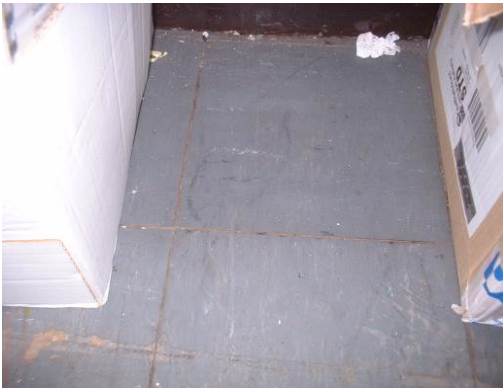
Item 15 - Ref: Sample 42

The vinyl flooring within classroom 6 (Room 0/58) does not contain asbestos.

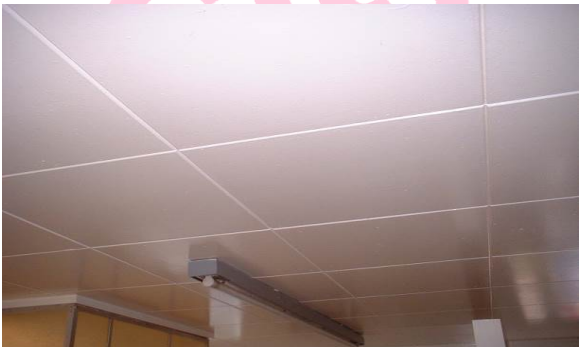
Item 23 - Ref: Sample 50

The ceiling tiles to the kitchen (Room 0/67) contain asbestos.

Any change in its appearance should be recorded and passed to Property Services.

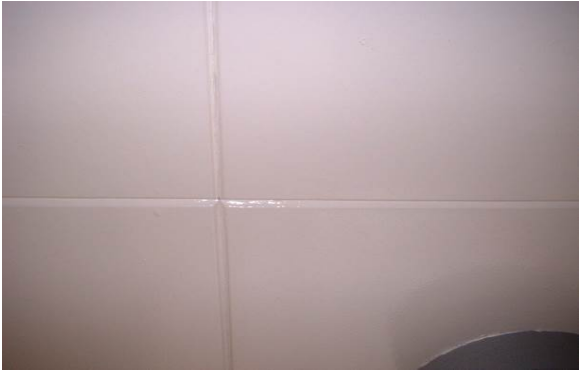
Item 24 – As Sample 50

The ceiling in the kitchen staff wc (Room 0/73) contains asbestos.

Any change in its appearance should be recorded and passed to Property Services.

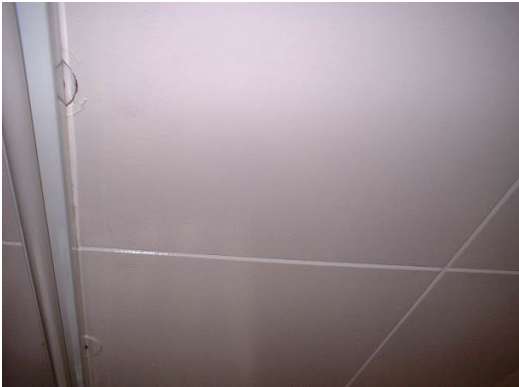
Item 25 – As Sample 50

The ceiling to the kitchen staff room (Room 0/72) contains asbestos.

Any change in its appearance should be recorded and passed to Property Services.

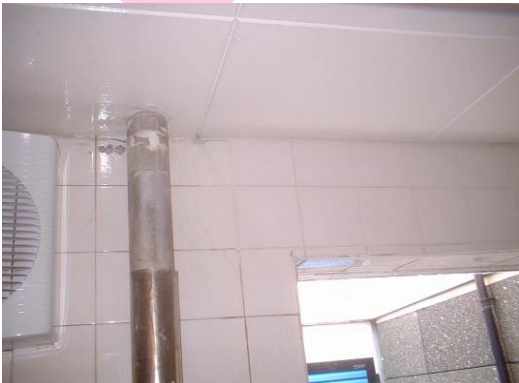
Item 26 - Ref: Sample 51

The flue to the kitchen (Room 0/67) contains asbestos.

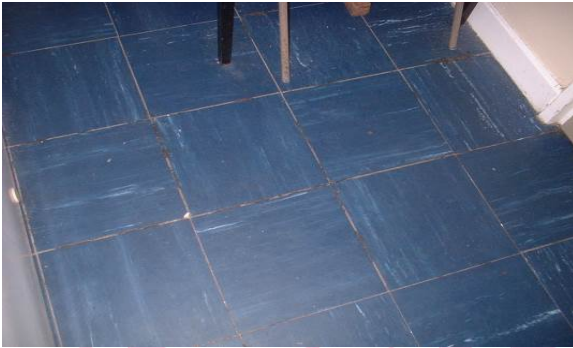
Item 28 –Ref: Sample 52

The vinyl flooring to the kitchen staff room (0/72) does not contain asbestos.

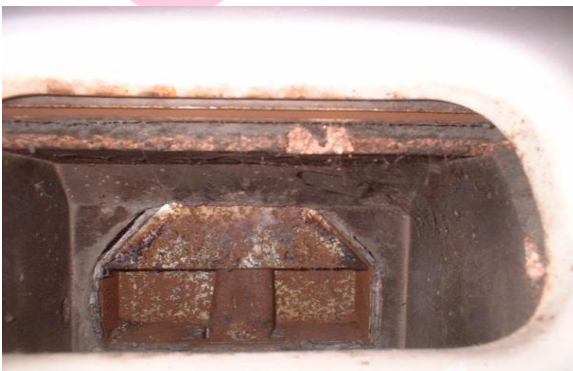
Item 29 - Ref: Sample 53

The panel within the sanitary unit in the kitchen staff wc (Room 0/73) does not contain asbestos.

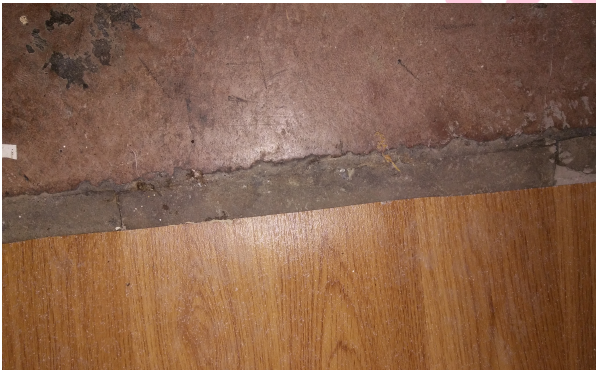
Item 34 - Ref: As 182913-10

The flooring in the corridor (Rm 0/22) contains asbestos.

Any change in its appearance should be recorded and passed to Property Services.

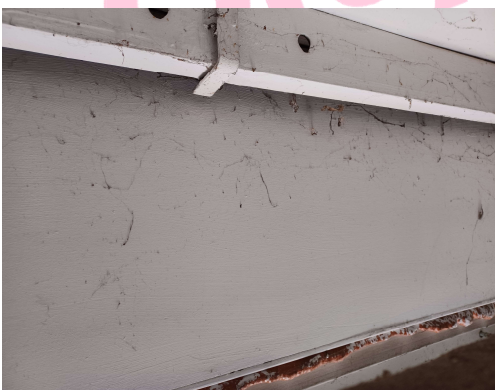
Item 116 Ref: As 581161-11

The panel above door (Rm 0/27 Boiler Room adj Kitchen) contains asbestos.

Removed October 2023.

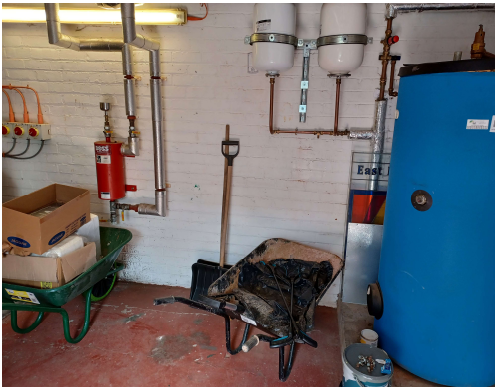
Item 118 Ref: 581161-13

The debris to wall opposite entrance wall (Rm 0/27 Boiler Room adj Kitchen) contains asbestos.

Removed October 2023.

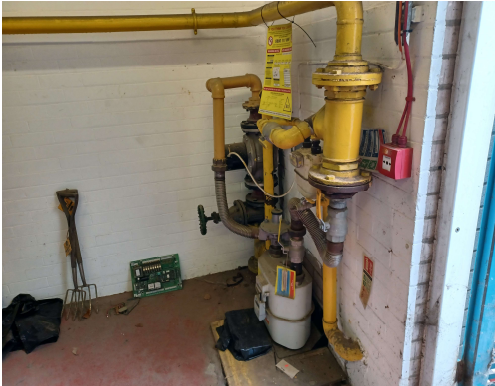
Item 123 Ref: 581161-4

The gasket to main gas pipe (Rm 0/28 Reception Classroom) does not contain asbestos.

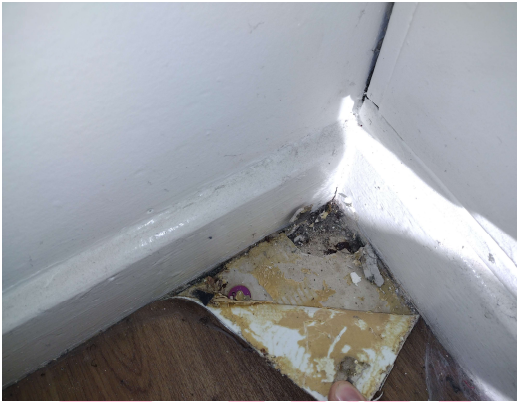
Item 130 Ref: 581161-18

The subfloor – floor tile without bitumen (Rm 0/34 Classroom) contains asbestos.

Any change in its appearance should be recorded and passed to Property Services.

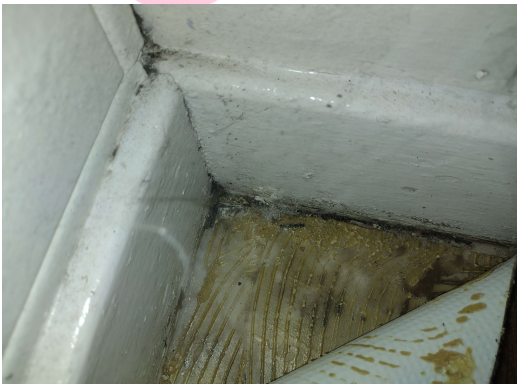
Item 131 Ref: As 581161-18

The subfloor – floor tile without bitumen (Rm 0/35 Classroom) contains asbestos.

Any change in its appearance should be recorded and passed to Property Services.

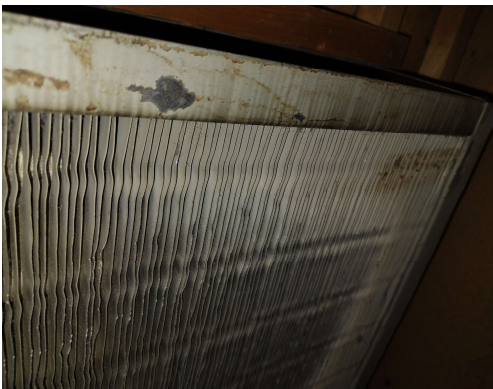
Item 137 Ref: As 581161-20

The sealant surrounding convector (Rm 0/38 Classroom) contains asbestos.

Any change in its appearance should be recorded and passed to Property Services.

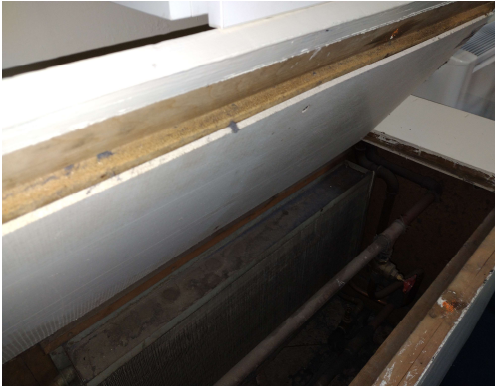
Item 147 Ref: As 581161-21

The cabinet soffit lining (Rm 0/43 Classroom) does not contain asbestos.

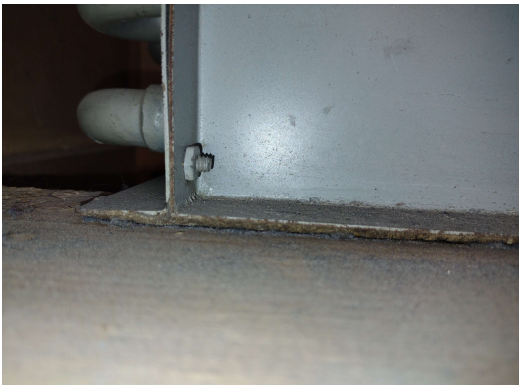
Item 149 Ref: As 581161-20

The sealant surrounding convector (Rm 0/44 Corridor) contains asbestos.

Any change in its appearance should be recorded and passed to Property Services.

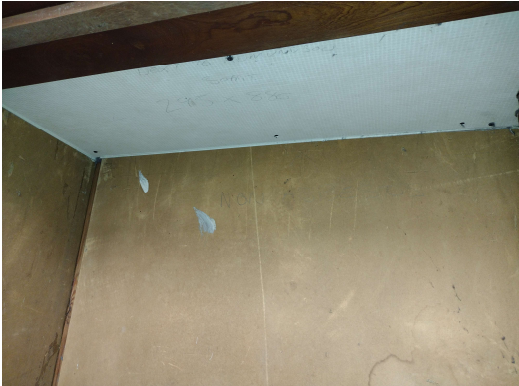
Item 150 Ref: As 581161-21

The ceiling (Rm 0/44 Corridor) does not contain asbestos.

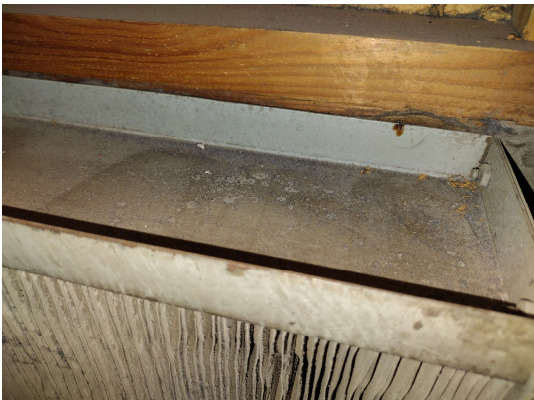
Item 152 Ref: As 581161-20

The sealant surrounding convector (Rm 0/45 Classroom) contains asbestos.

Any change in its appearance should be recorded and passed to Property Services.

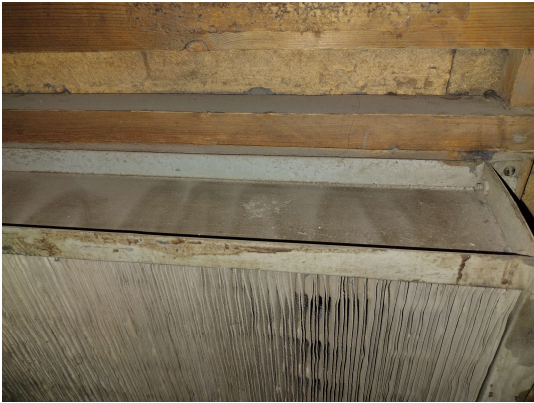
Item 156 Ref: As 581161-20

The sealant surrounding convector (Rm 0/47 Classroom) contains asbestos.

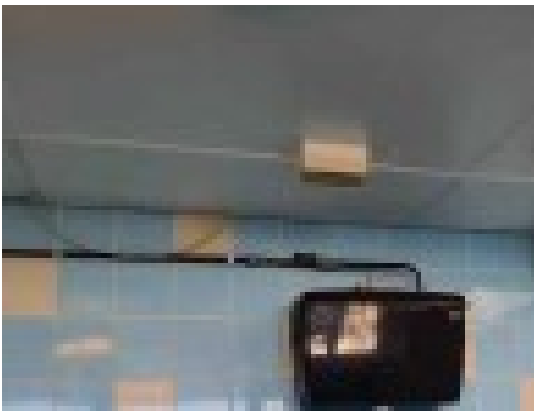
Item 157 Ref: FH0035350

The bakelite cistern in Year 5/6 boys toilet (G/004) does not contain asbestos.
