ASBESTOS SURVEY REPORT FOR EAST HERRINGTON ACADEMY, SUNDERLAND

Asbestos Register for

EAST HERRINGTON ACADEMY, SUNDERLAND

Date: 28 May 2026

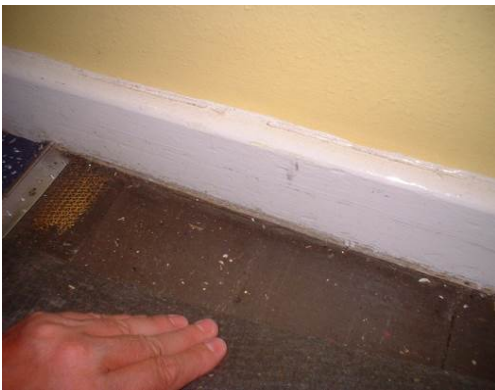
Item 2 - Ref: Sample 02

The vinyl flooring to the infant school corridor (Room 0/04) contains asbestos.

Any change in its appearance should be recorded and passed to Property Services.

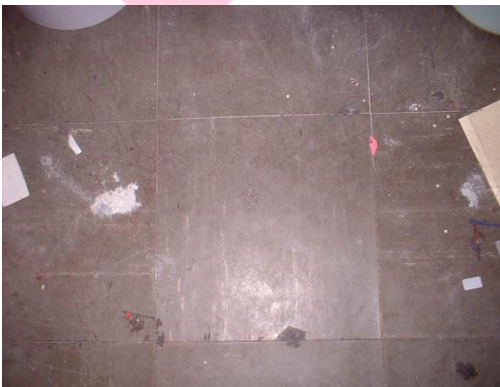
Item 3- As Sample 02

The floor covering to the infant school store room (Room 0/11) contains asbestos.

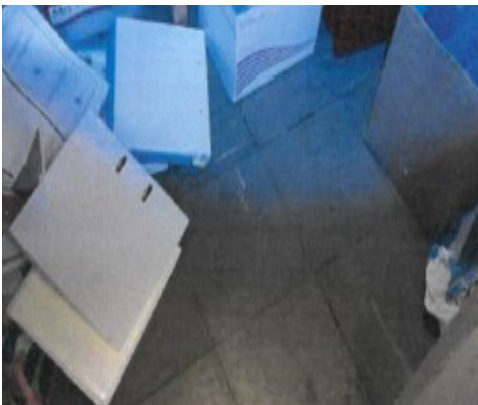
Item 7 – As Sample 08 & AQ000124

The floor covering (vinyl tiles & adhesive) (Room 0/11 Y2 classroom stationary cupboard) contains asbestos.

Any change in its appearance should be recorded and passed to Property Services.

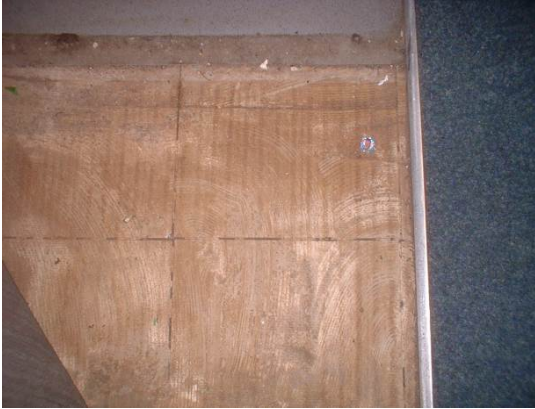
Item 9 - Ref: Sample 10

The vinyl flooring in the infant school cloak room/toilets classroom (Room 0/16) does not contain asbestos.

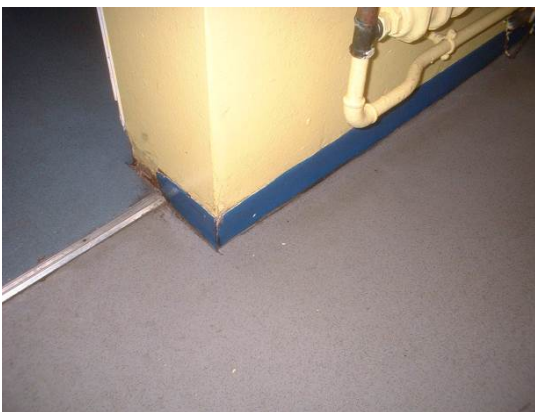
Item 11 - Ref: Sample 11

The skirting in the infant school cloakroom/toilets (Room 0/16) does not contain asbestos.

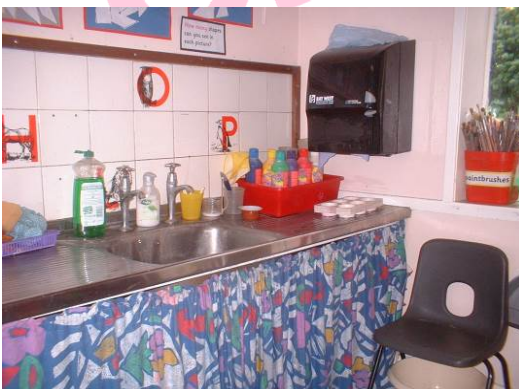
Item 14 - Ref: Sample 14

The sink pad in the infant school classroom (Room 0/21) contains asbestos.

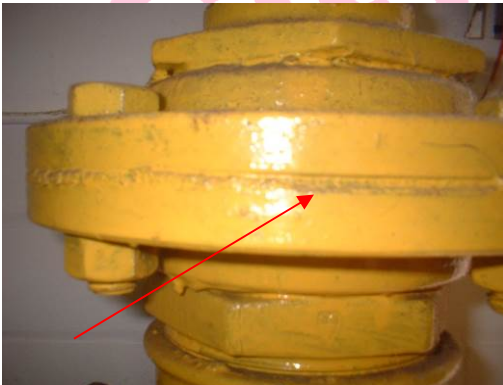
Item 23 – Ref: Sample 22

The pipework gasket in the infant school boiler room (Room 0/33) does not contain asbestos.

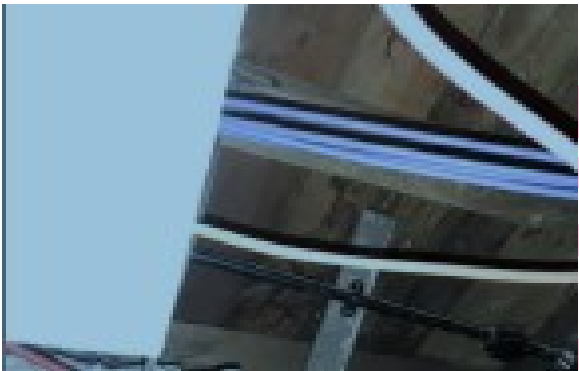
Item 40 - Ref: Presumed

The gasket within pipework flange in the ceiling void above office 1 & 2, Lobby and First Aid is presumed to contain asbestos.

Any change in its appearance should be recorded and passed to Property Services.

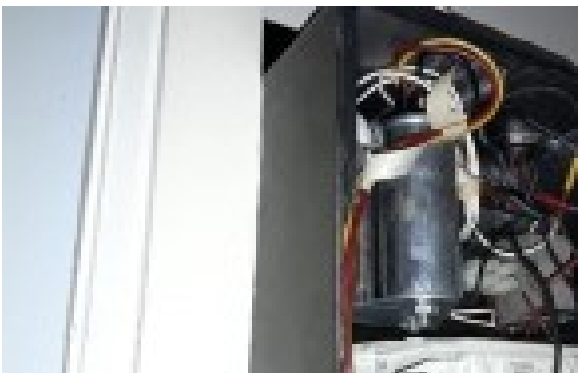
Item 41 - Ref: Presumed

The flashguard within control gear west in Classroom 1 is presumed to contain asbestos.

Removed 2019

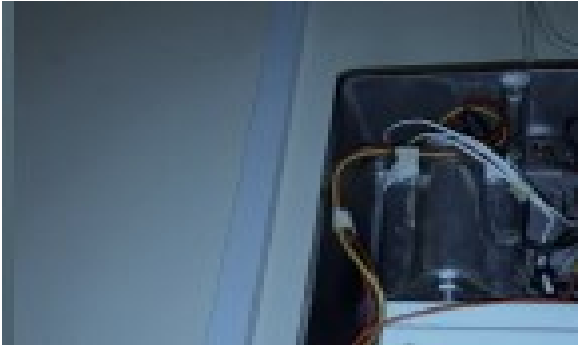
Item 42 - Ref: Presumed

The flashguard within control gear east in Classroom 2 is presumed to contain asbestos.

Removed 2019

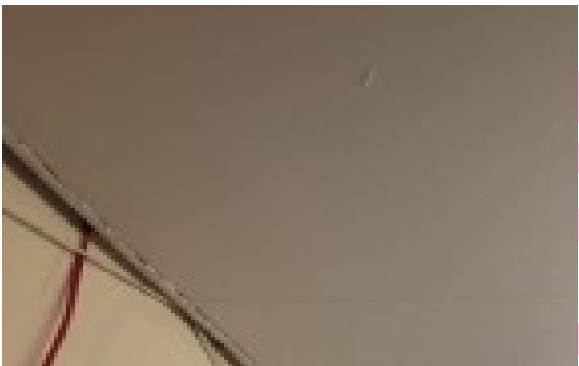
Item 43 - Ref: AL004376

The insulating board ceiling panels in the lobby do not contain asbestos.

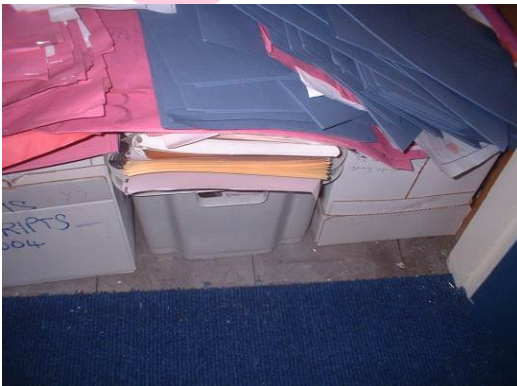
Item 3 - Ref: Sample 29

The vinyl floor tiles in the primary school classroom (Room 0/35) do not contain asbestos.

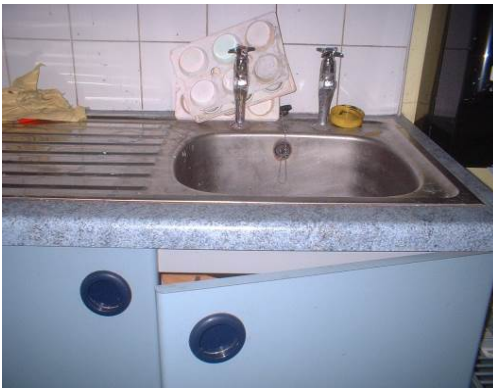
Item 8 - Ref: Sample 33

The sink pad in this primary school classroom (Room 0/38) does not contain asbestos.

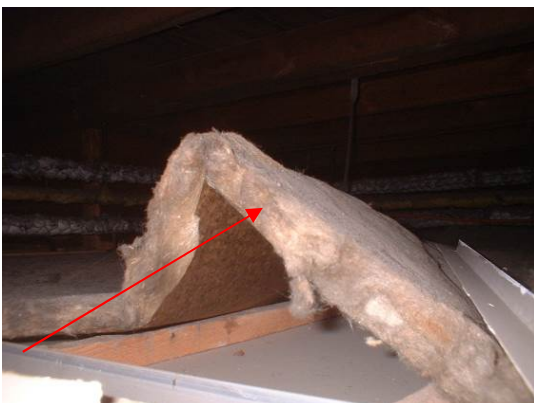
Item 9 - Ref: Sample 34

The ceiling void insulation to the hallway/corridor (Room 0/41) does not contain asbestos.

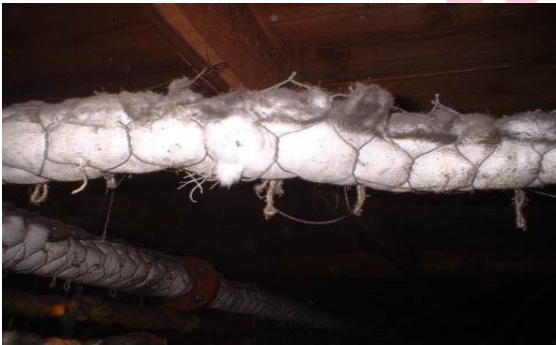
Item 10 - Ref: Sample 36

The lagging insulation to the pipework within the hallway corridor (Room 0/41) does not contain asbestos.

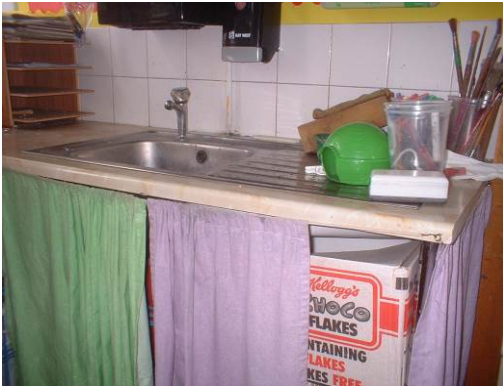
Item 11 - Ref: Sample 38

The sink pad within classroom 8 (Room 0/56) does not contain asbestos.

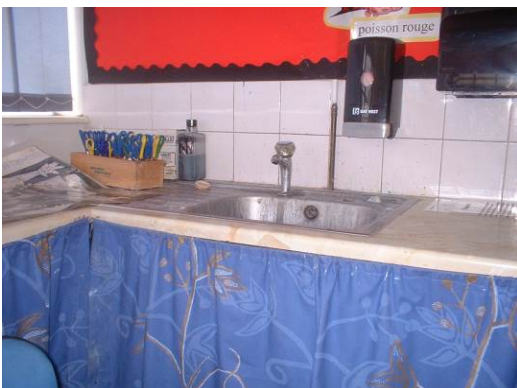
Item 13 – Ref: Sample 40

The sink pad in classroom 7 (Room 0/57) does not contain asbestos.

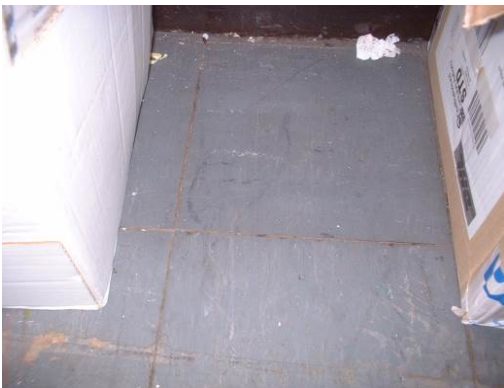
Item 15 - Ref: Sample 42

The vinyl flooring within classroom 6 (Room 0/58) does not contain asbestos.

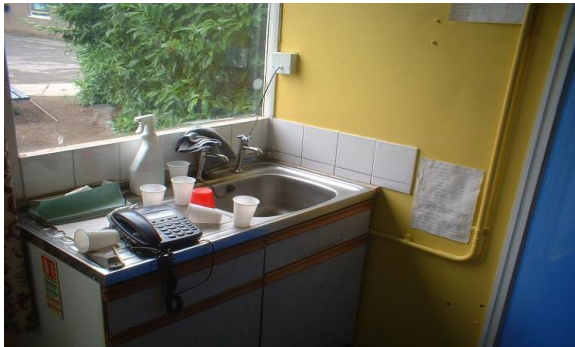
Item 22 – Ref: Sample 49

The sink pad in the library (Room 0/70) does not contain asbestos.

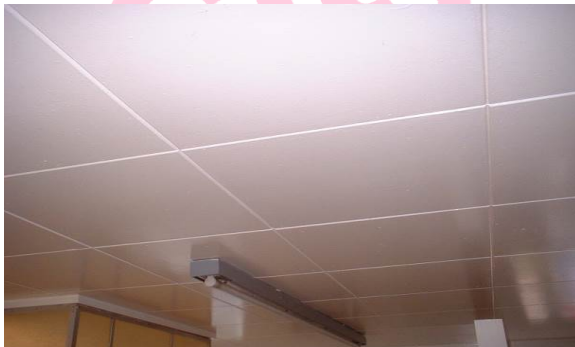
Item 23 - Ref: Sample 50

The ceiling tiles to the kitchen (Room 0/67) contain asbestos.

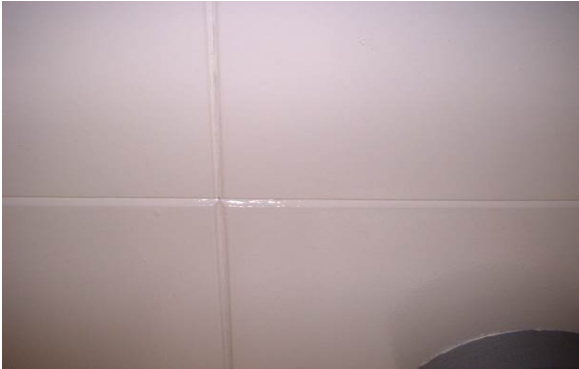
Item 24 – As Sample 50

The ceiling in the kitchen staff wc (Room 0/73) contains asbestos.

Any change in its appearance should be recorded and passed to Property Services.

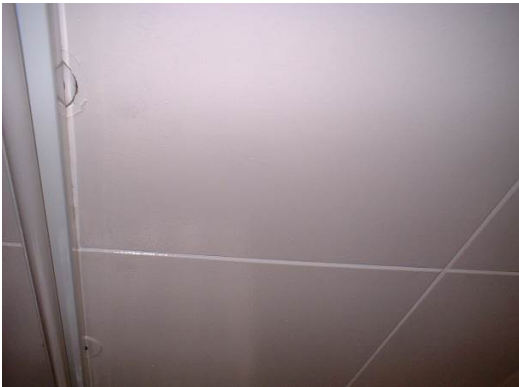
Item 25 – As Sample 50

The ceiling to the kitchen staff room (Room 0/72) contains asbestos.

Any change in its appearance should be recorded and passed to Property Services.

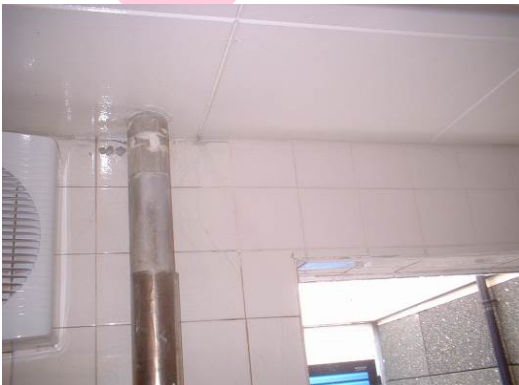
Item 26 - Ref: Sample 51

The flue to the kitchen (Room 0/67) contains asbestos.

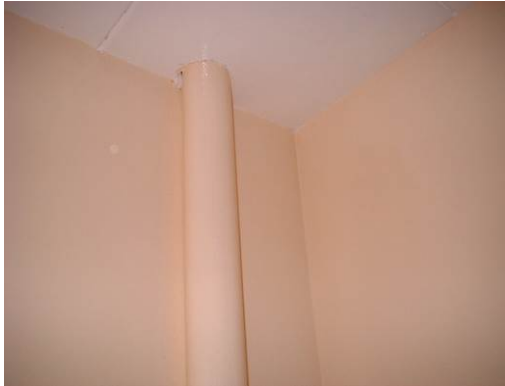
Item 27 – As Sample 51

The flue in the kitchen staff wc (Room 0/73) contains asbestos.

Any change in its appearance should be recorded and passed to Property Services.

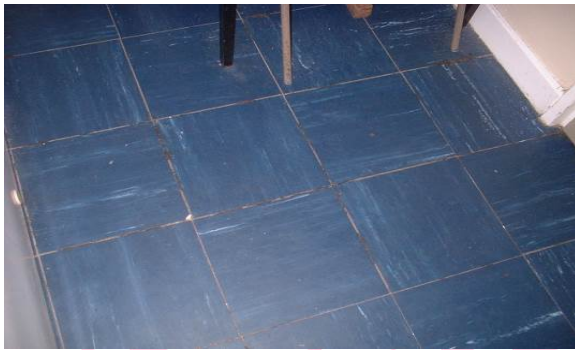
Item 28 –Ref: Sample 52

The vinyl flooring to the kitchen staff room (0/72) does not contain asbestos.

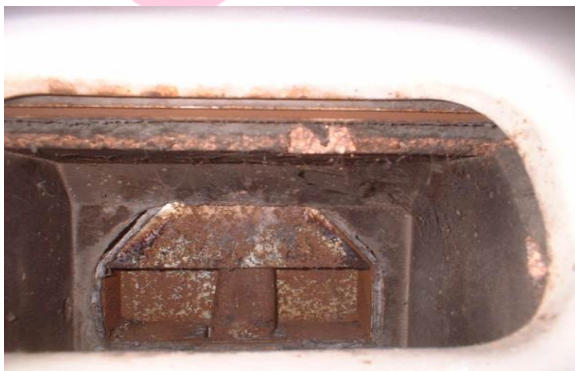
Item 29 - Ref: Sample 53

The panel within the sanitary unit in the kitchen staff wc (Room 0/73) does not contain asbestos.

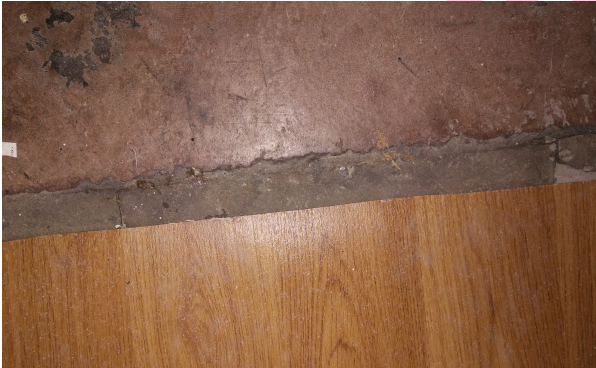
Item 34 - Ref: As 182913-10

The flooring in the corridor (Rm 0/22) contains asbestos.

Any change in its appearance should be recorded and passed to Property Services.

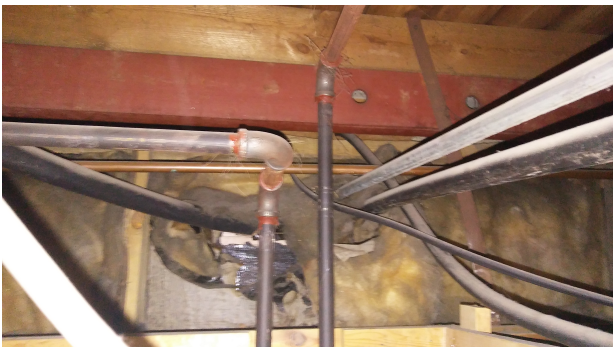
Item 35 - Ref: 182913-9

The felt to the old external wall in the void above rooms 0/21 – 0/24 does not contain asbestos.

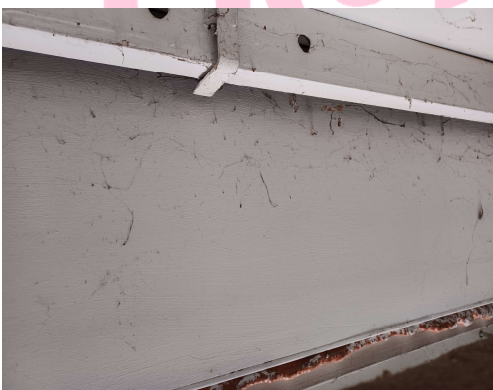
Item 116 Ref: As 581161-11

The panel above door (Rm 0/27 Boiler Room adj Kitchen) contains asbestos.

Removed October 2023.

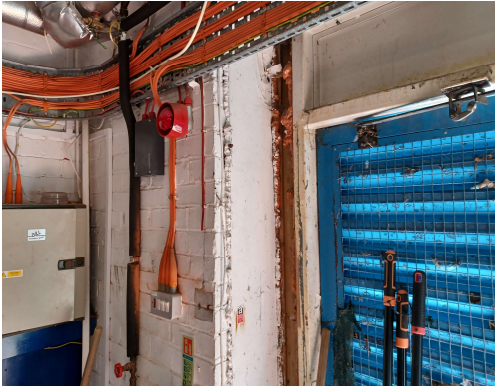
Item 117 Ref: 581161-12

The door surround (Rm 0/27 Boiler Room adj Kitchen) contains asbestos.

Removed October 2023.

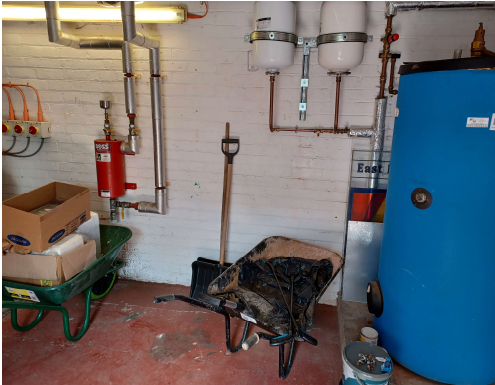
Item 118 Ref: 581161-13

The debris to wall opposite entrance wall (Rm 0/27 Boiler Room adj Kitchen) contains asbestos.

Removed October 2023.

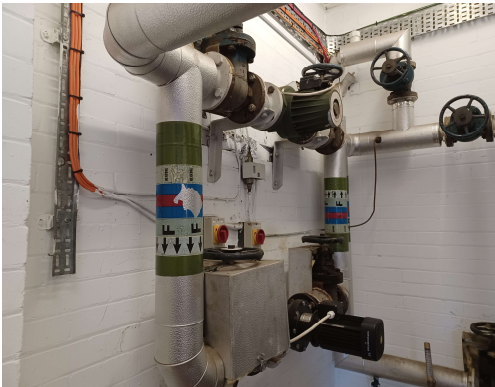
Item 124 Ref: 581161-5

The pipework flange gasket where accessible (Rm 0/28 Reception Classroom) does not contain asbestos.

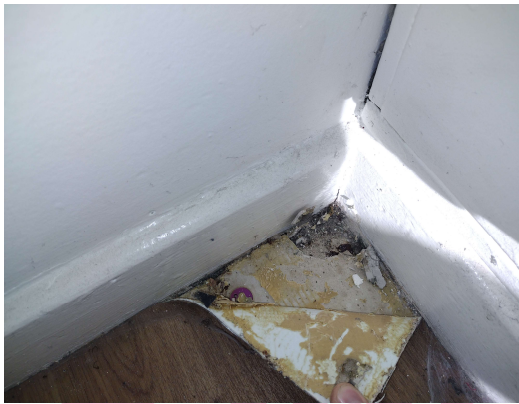
Item 130 Ref: 581161-18

The subfloor – floor tile without bitumen (Rm 0/34 Classroom) contains asbestos.

Any change in its appearance should be recorded and passed to Property Services.

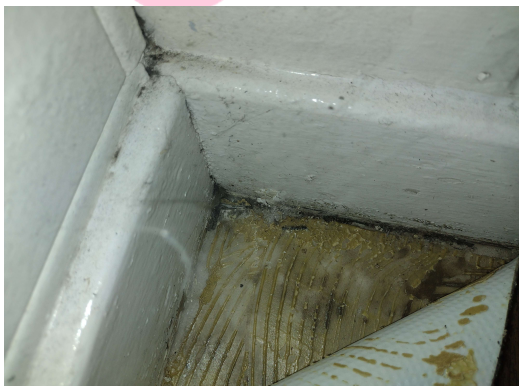
Item 131 Ref: As 581161-18

The subfloor – floor tile without bitumen (Rm 0/35 Classroom) contains asbestos.

Any change in its appearance should be recorded and passed to Property Services.

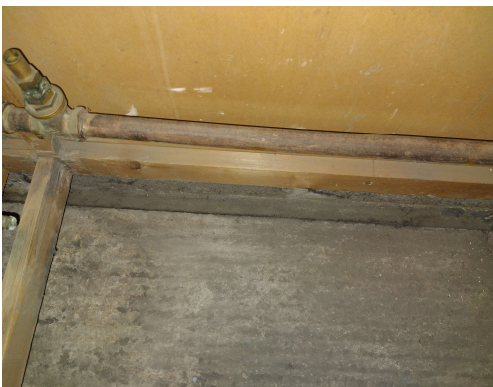
Item 134 Ref: As 581161-19

The damp proof course (Rm 0/37 Classroom) contains asbestos.

Any change in its appearance should be recorded and passed to Property Services.

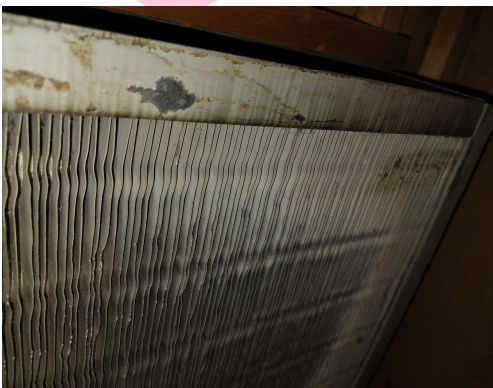
Item 137 Ref: As 581161-20

The sealant surrounding convector (Rm 0/38 Classroom) contains asbestos.

Removed refer to survey J150351.

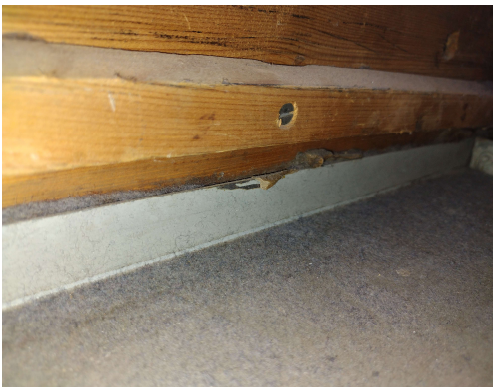
Item 140 Ref: As 581161-20

The sealant surrounding convector (Rm 0/40 Dining Hall) contains asbestos.

Removed refer to survey J150351.

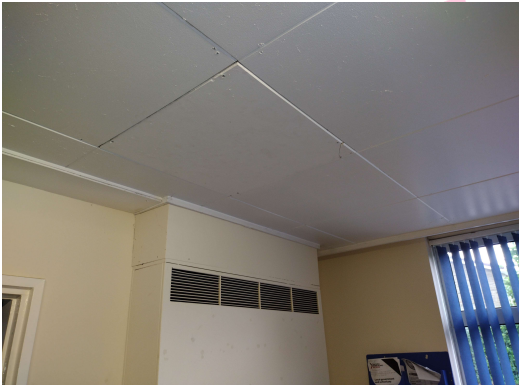
Item 142 Ref: 581161-22

The ceiling (Rm 0/41 Staff Room) does not contain asbestos.

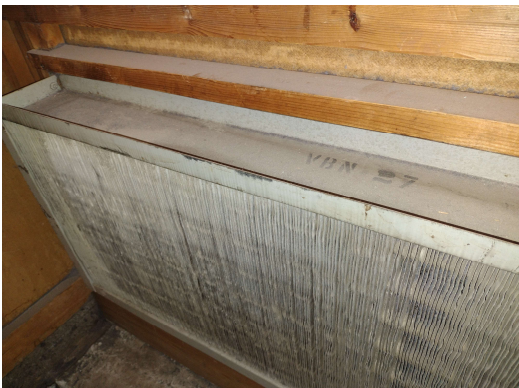
Item 143 Ref: As 581161-20

The sealant surrounding convector (Rm 0/42 Classroom) contains asbestos.

Removed refer to survey J150351.

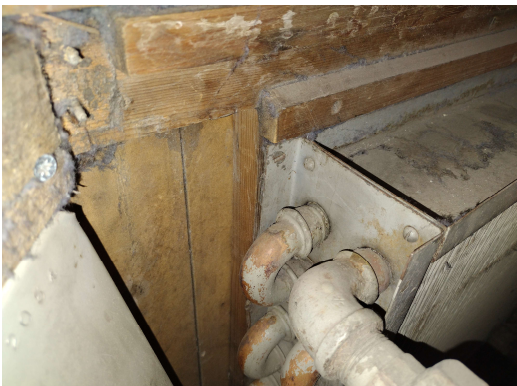
Item 146 Ref: As 581161-20

The sealant surrounding convector (Rm 0/43 Classroom) contains asbestos.

Removed refer to survey J150351.

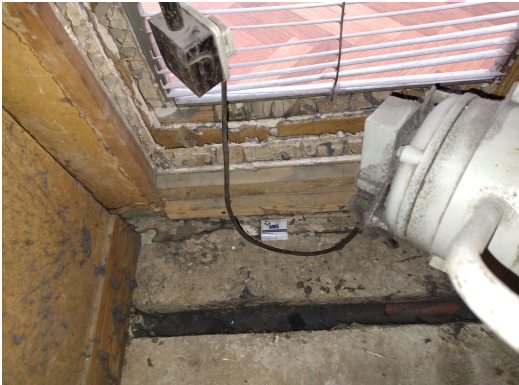
Item 148 Ref: As 581161-19

The damp proof course (Rm 0/43 Classroom) contains asbestos.

Any change in its appearance should be recorded and passed to Property Services.

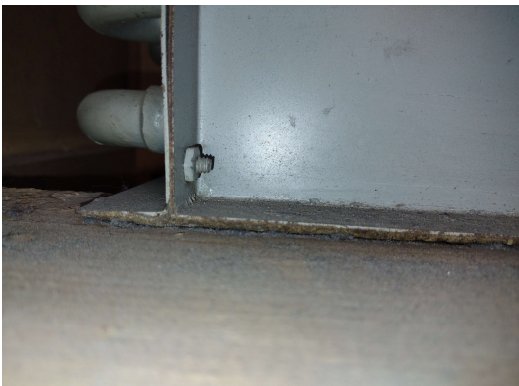
Item 149 Ref: As 581161-20

The sealant surrounding convactor (Rm 0/44 Corridor) contains asbestos.

Removed refer to survey J150351.

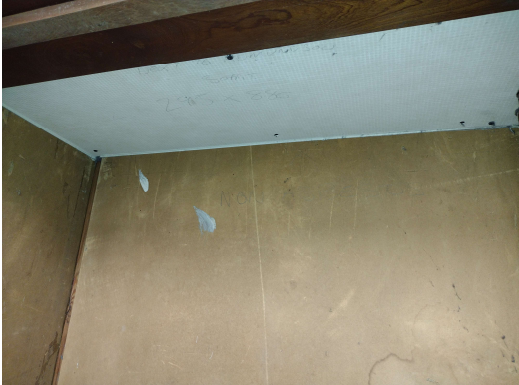
Item 150 Ref: As 581161-21

The ceiling (Rm 0/44 Corridor) does not contain asbestos.

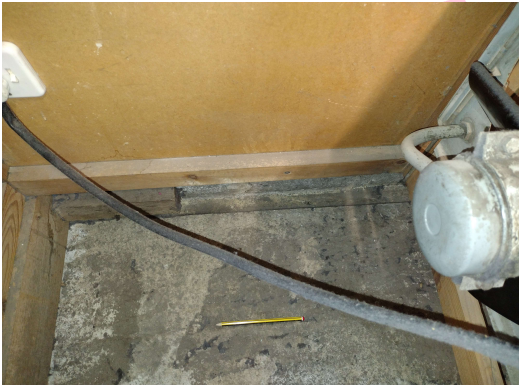
Item 151 Ref: As 581161-19

The damp proof course (Rm 0/45 Classroom) contains asbestos.

Any change in its appearance should be recorded and passed to Property Services.

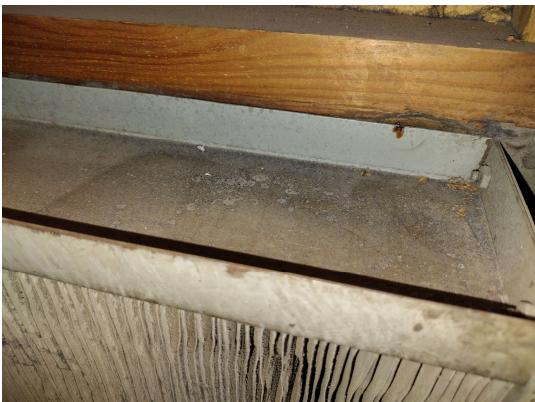
Item 152 Ref: As 581161-20

The sealant surrounding convector (Rm 0/45 Classroom) contains asbestos.

Removed refer to survey J150351.

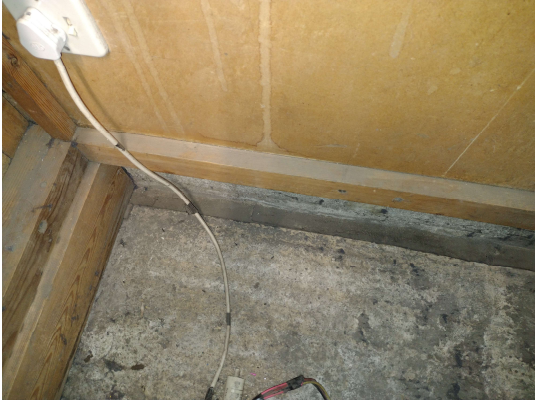
Item 153 Ref: As 581161-19

The damp proof course (Rm 0/46 Classroom) contains asbestos.

Any change in its appearance should be recorded and passed to Property Services.

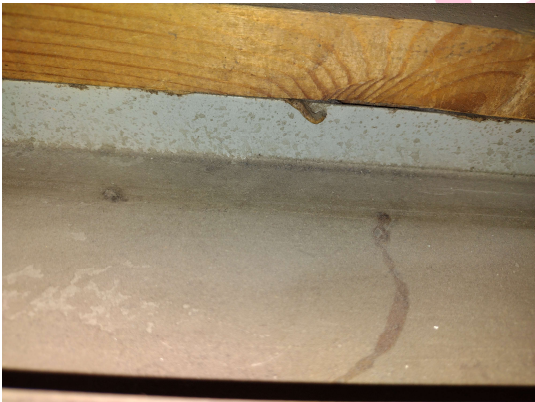
Item 154 Ref: As 581161-20

The sealant surrounding convector (Rm 0/46 Classroom) contains asbestos.

Removed refer to survey J150351.

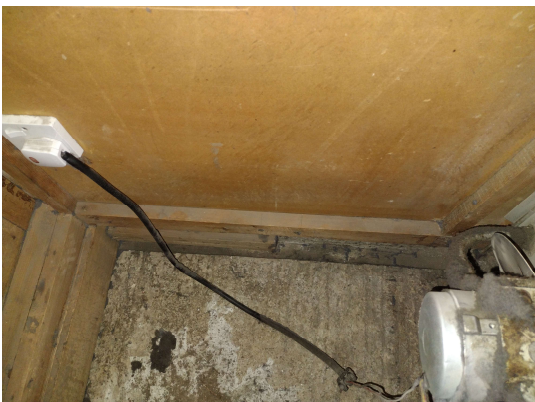
Item 155 Ref: As 581161-19

The damp proof course (Rm 0/47 Classroom) contains asbestos.

Any change in its appearance should be recorded and passed to Property Services.

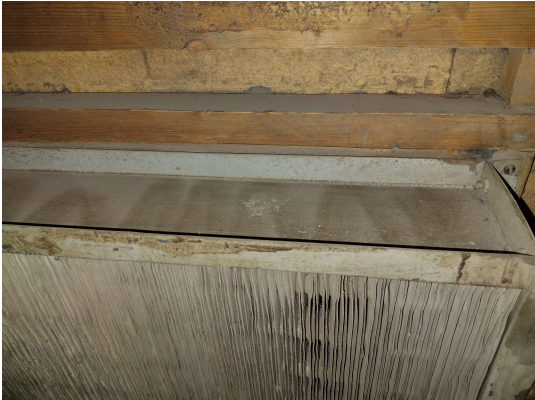
Item 156 Ref: As 581161-20

The sealant surrounding convector (Rm 0/47 Classroom) contains asbestos.

Removed refer to survey J150351.

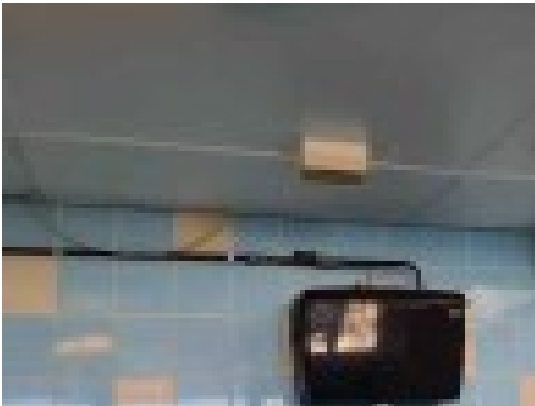
Item 157 Ref: FH0035350

The bakelite cistern in Year 5/6 boys toilet (G/004) does not contain asbestos.
