ASBESTOS SURVEY REPORT FOR EPPLETON ACADEMY PRIMARY SCHOOL, HOUGHTON

Asbestos Register for EPPLETON ACADEMY PRIMARY SCHOOL

Date: 19th May 2025

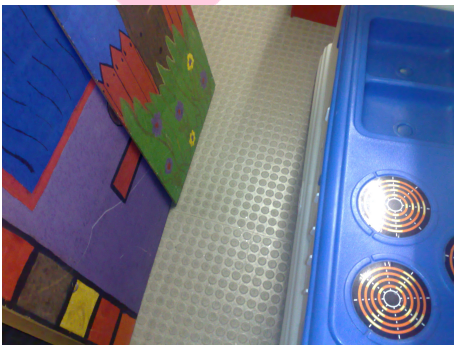
Various - Ref: Sample 08

The flooring to the Changing Room does not contain asbestos.

Similar flooring is located in the Art Store.

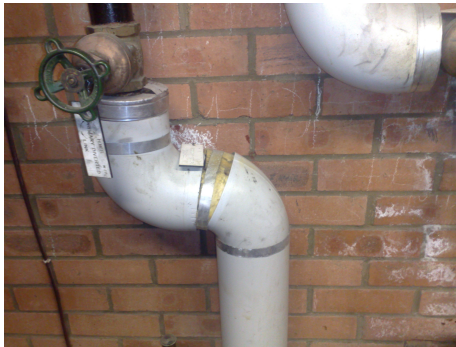
Item 26 - Ref: NO09/214

The pipe insulation to the ground floor boiler house does not contain asbestos.

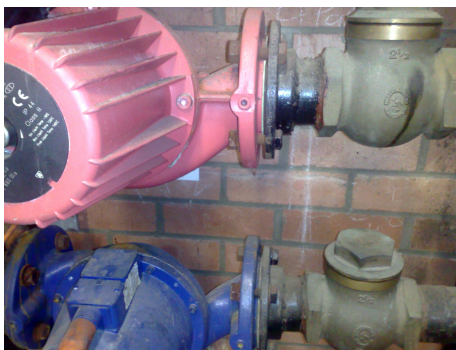
Item 27 - Ref: NO09/215

The gasket material to the ground floor boiler room does not contain asbestos.

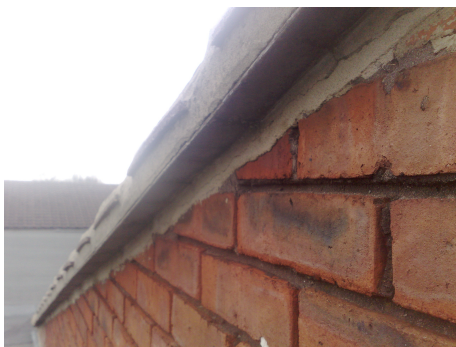
Item 28 - Ref: NO09/216

The fillet boards to the gable of the building do not contain asbestos.

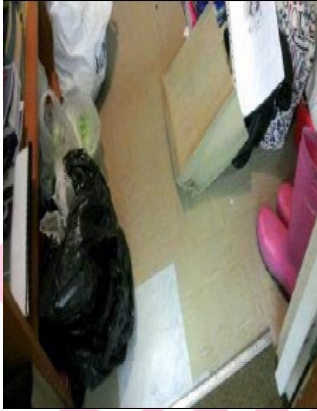
Item 30 - Ref: Presumed

The floor tiles to the Teaching Area 3 Store (Room 14) contain asbestos. Any change in its appearance should be recorded and passed to Property Services.

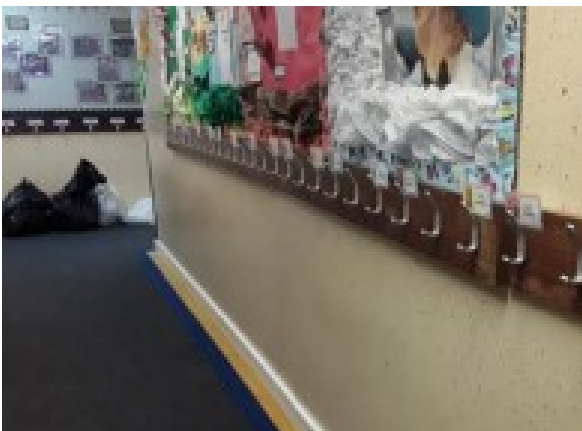
Item 31 - Ref: 21-35987-1

The textured coating to the walls in Area 1 (Hall) does not contain asbestos.

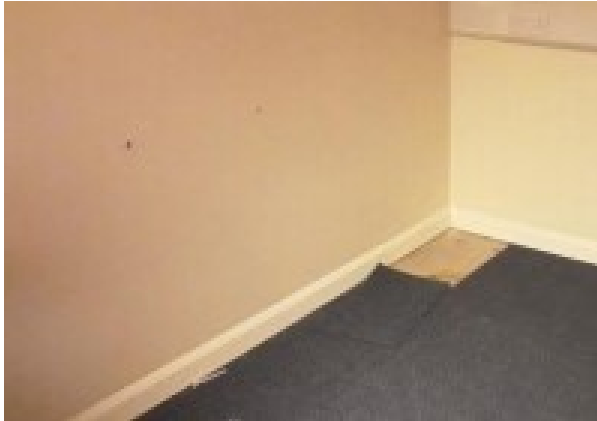
Item 32 - Ref: 21-35987-2

The asphalt floor in Area 2 (Cloakroom) does not contain asbestos.

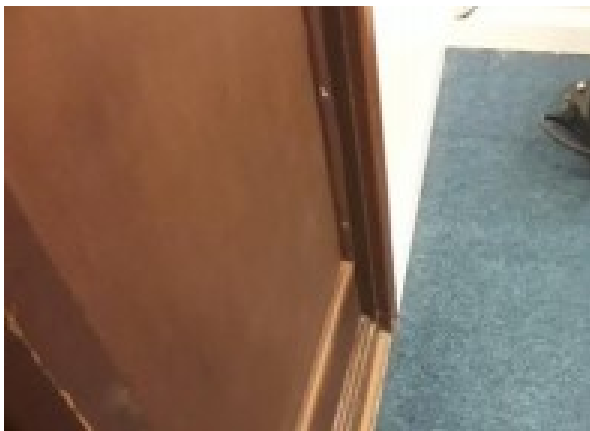
Item 33 - Ref: 21-35987-2

The asphalt floor in Area 3 (Medical Room) does not contain asbestos.

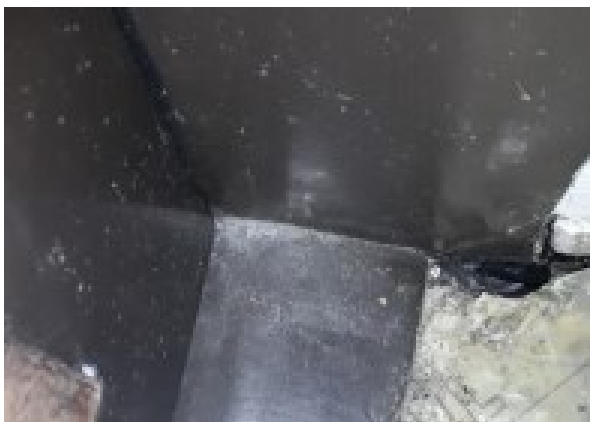
Item 34 - Ref: 21-35987-2

The asphalt floor in Area 4 (Teaching area 2) does not contain asbestos.

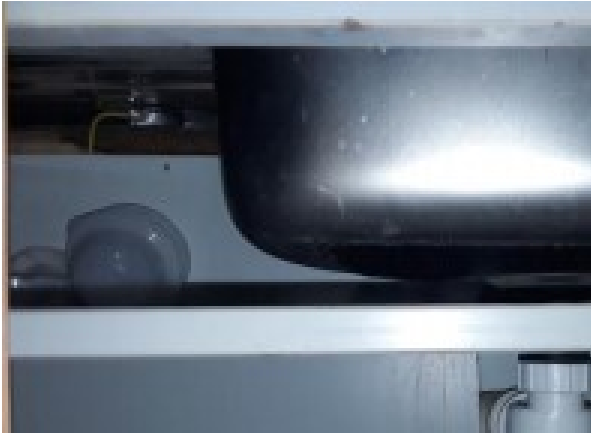
Item 35 - Ref: 21-35987-3

The sink pad in Area 4 (Teaching area 2) does not contain asbestos.

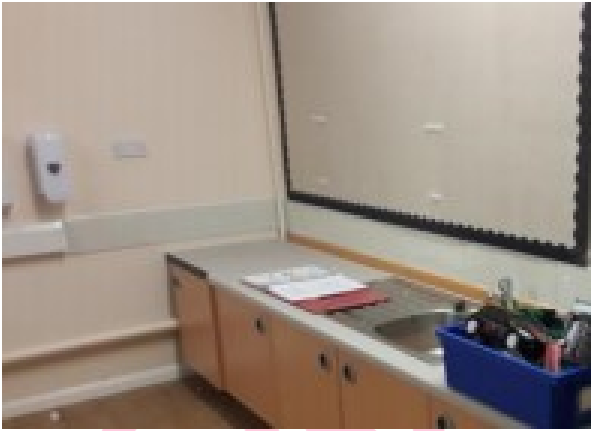
Item 36 - Ref: 21-35987-4

The adhesive to ceramic tiles to wall on area 4 (Teaching area 2) does not contain asbestos.

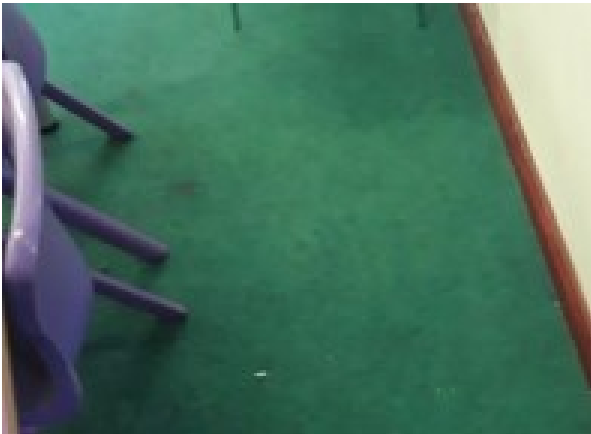
Item 37 - Ref: 21-35987-2

The floor screed beneath the floor in Area 5 (Classroom) does not contain asbestos.

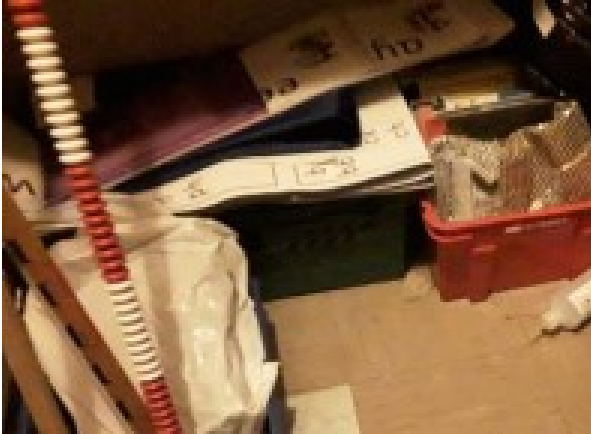
Item 38 - Ref: 21-35987-5

The floor tiles and adhesive in Area 6 (Store Cupboard) contains asbestos.

Any change in appearance should be reported to Property Services.

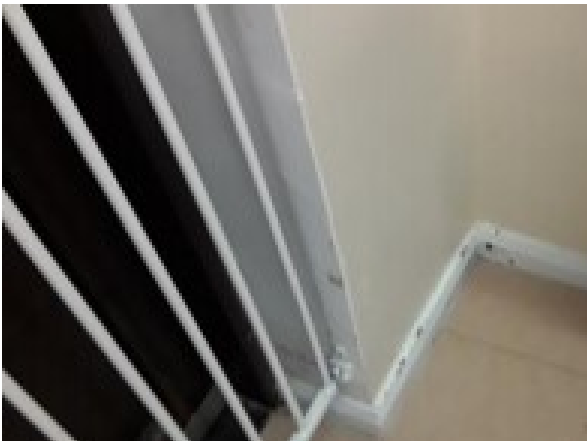
Item 39 - Ref: 21-35987-2

The asphalt floor beneath floor screed in Area 7 (Classroom) does not contain asbestos.

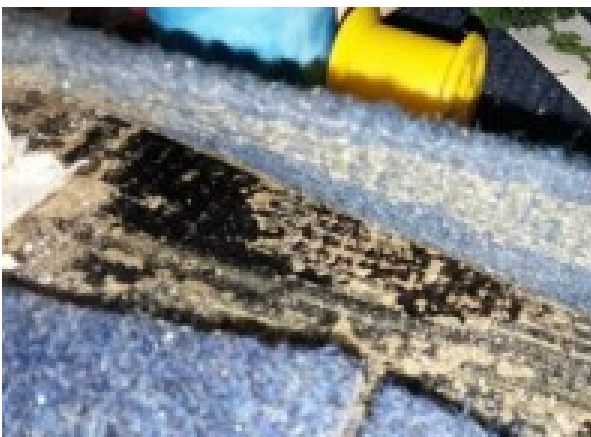
Item 40 - Ref: 21-35987-6

The residual adhesive to the floor in Area 8 (Store Cupboard) contains asbestos.

Any change in appearance should be reported to Property Services.

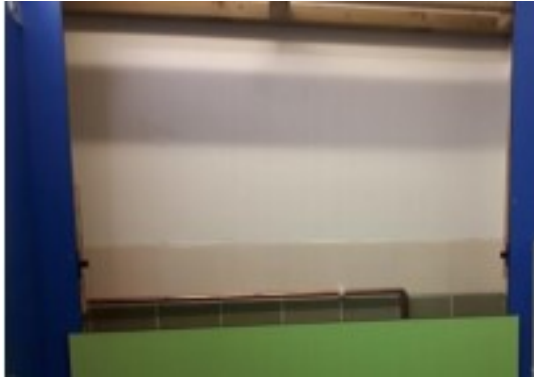
Item 41 - Ref: 21-35987-7

The adhesive to ceramic wall tiles in Area 10 (Boys Toilets) does not contain asbestos.

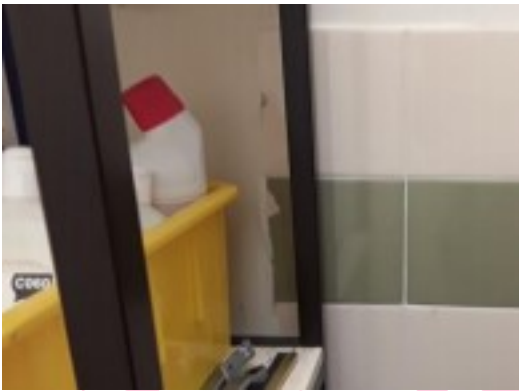
Item 42 - Ref: 21-35987-7

The adhesive to ceramic wall tiles in Area 14 (Cleaners Cupboard) does not contain asbestos.

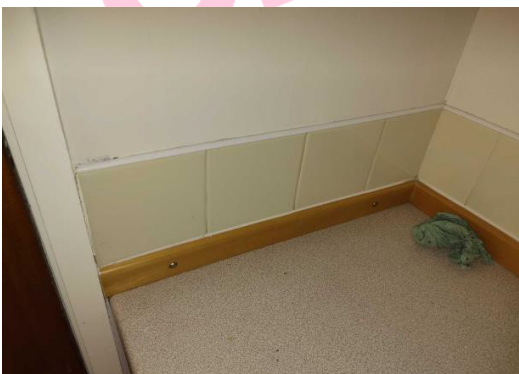
Item 43 Ref: 22-50674-1

The adhesive behind ceramic tiles (Area 1/Upper KS2 Cloakroom) does not contain asbestos.

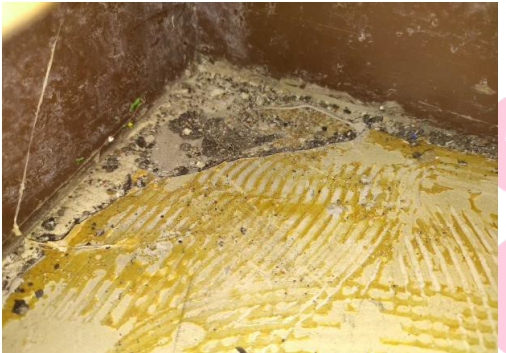
Item 45 Ref: 22-50674-7

The brown adhesive residue below modern screed (Area 1/Upper KS2 Cloakroom) does not contain asbestos.

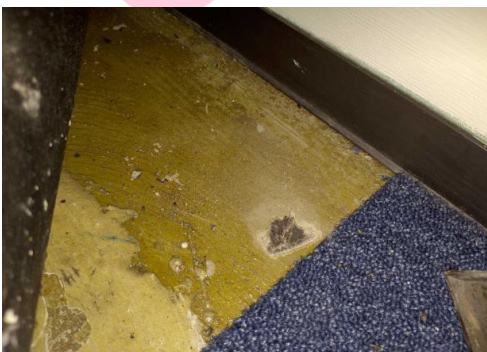
Item 46 Ref: 22-50674-2

The black composite floor (Area 2/Year 6 Classroom) does not contain asbestos.

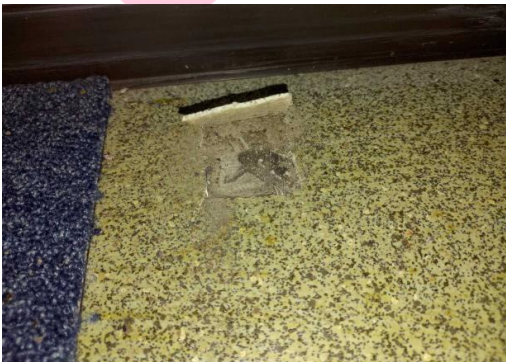
Item 49 Ref: 22-50674-7

The brown adhesive residue below modern screed (Adhesive) (Area 3/Year 5 Classroom) does not contain asbestos.

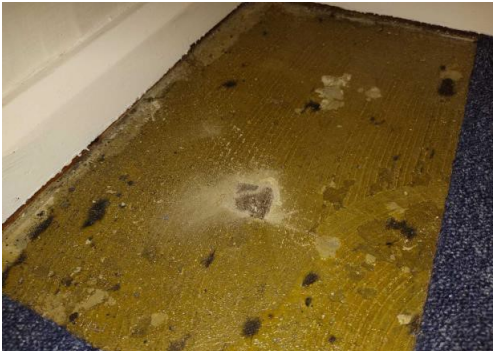
Item 50 Ref: 22-50674-2

The black composite floor (Resin) (Area 4/Year 4 Classroom) does not contain asbestos.

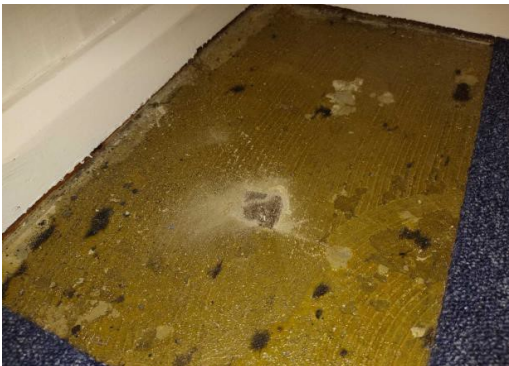
Item 51 Ref: 22-50674-2

The brown adhesive residue below modern screed (Adhesive) (Area 4/Year 4 Classroom) does not contain asbestos.

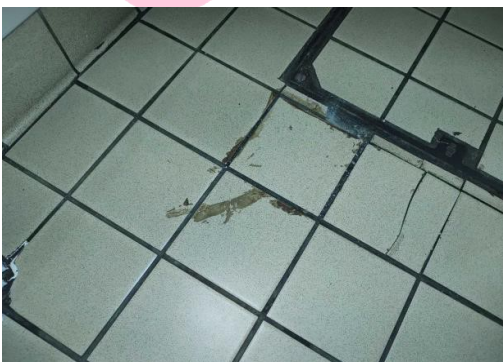
Item 52 Ref: 22-50674-4

The adhesive below ceramic floor tiles (Area 5/Boys Toilet) does not contain asbestos.

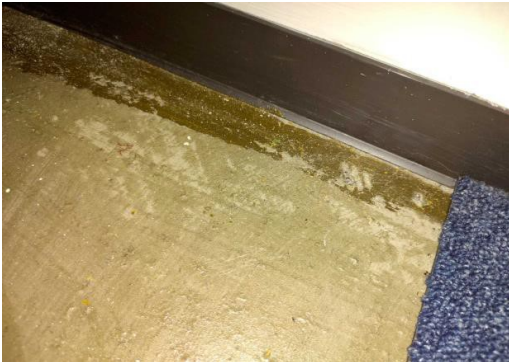
Item 63 Ref: 22-50674-2

The black composite floor (Area 9/Lower KS2 Classroom 2) does not contain asbestos.

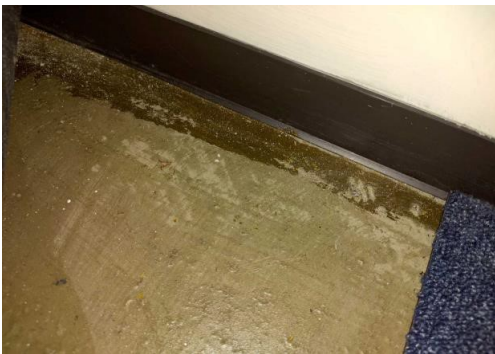
Item 64 Ref: 22-50674-7

The brown adhesive residue below modern screed (Area 9/Lower KS2 Classroom 2) does not contain asbestos.

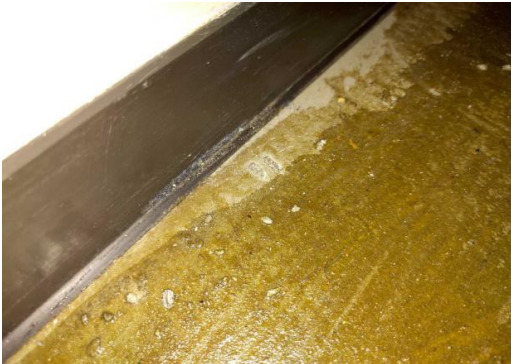
Item 65 Ref: 22-50674-2

The black composite floor (Area 10/Lower KS2 Classroom 3) does not contain asbestos.

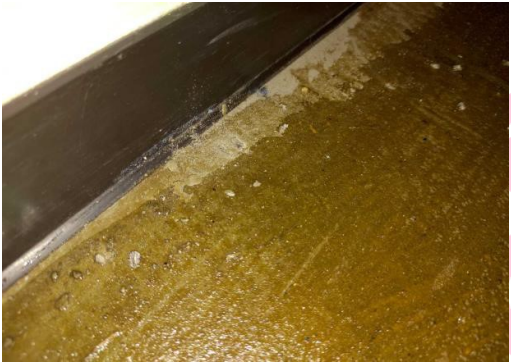
Item 66 Ref: 22-50674-7

The brown adhesive residue below modern screed (Area 10/Lower KS2 Classroom 3) does not contain asbestos.

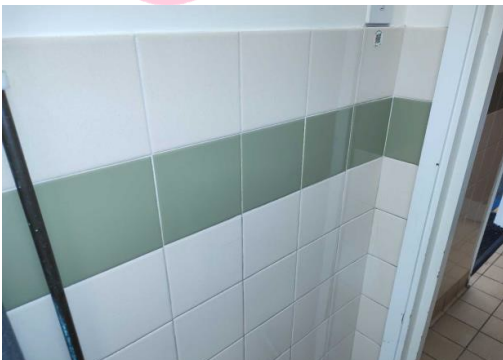
Item 67 Ref: 22-50674-3

The adhesive behind ceramic tiles (Area 11/Shared Toilet) does not contain asbestos.

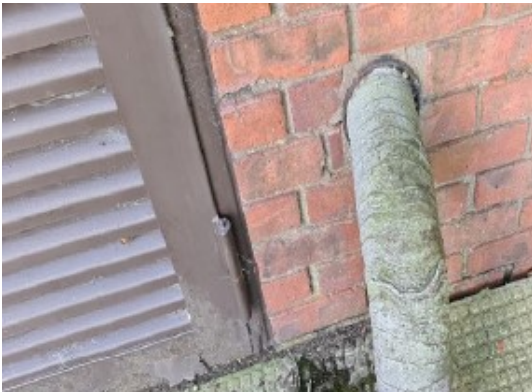
Item 69 Ref: 23/8/B/11/JGS7

The Tape wrapping to gas inlet pipe (External) does not contain asbestos.

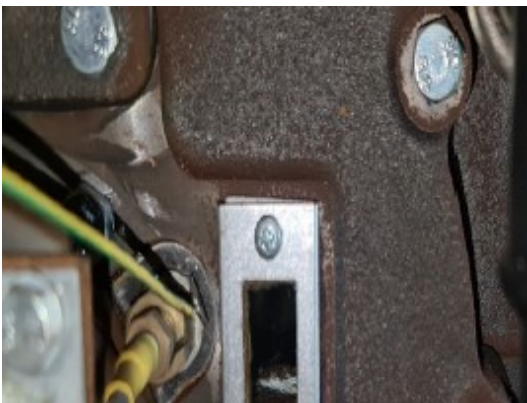
Item 70 Ref: 23/8/B/11/JGS1

The Internal boiler pilot light sight glass gasket (Boiler Room) does not contain asbestos.

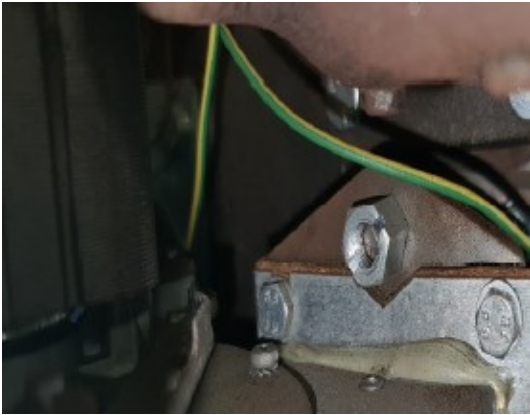
Item 71 Ref: 23/8/B/11/JGS2

The Internal boiler pump gasket (Boiler Room) does not contain asbestos.

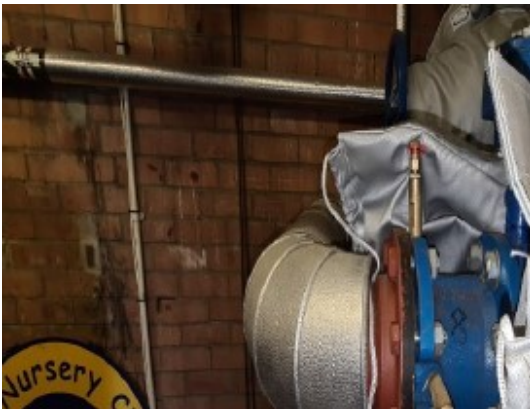
Item 72 Ref: 23/8/B/11/JGS3

The Pipework flange gaskets (Boiler Room) does not contain asbestos.

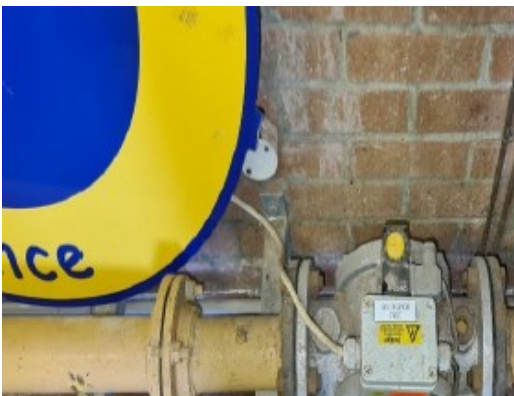
Item 73 Ref: 23/8/B/11/JGS4

The Gas pipework flange joints gaskets (Boiler Room) does not contain asbestos.

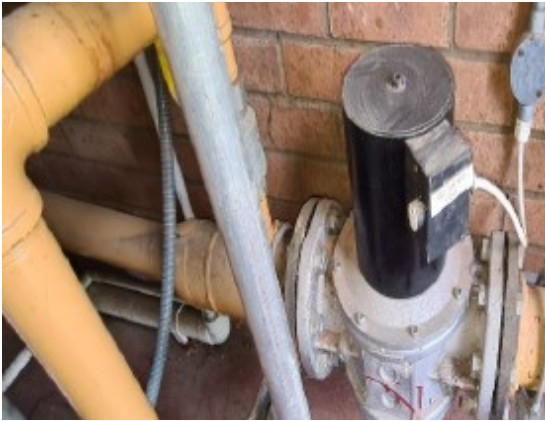
Item 74 Ref: 23/8/B/11/JGS5

The Insulation valve joints putty (Boiler Room) does not contain asbestos.

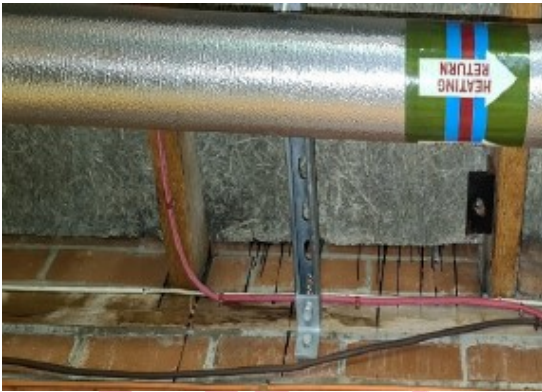
Item 75 Ref: 23/8/B/11/JGS6

The High level walls/roof bitumen pitch residuals (Boiler Room) does not contain asbestos.

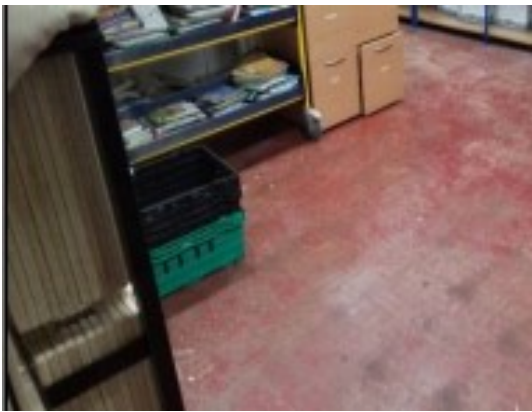
Item 89 Ref: OQ000238

The floor screed (Store Room G/001) does not contain asbestos.

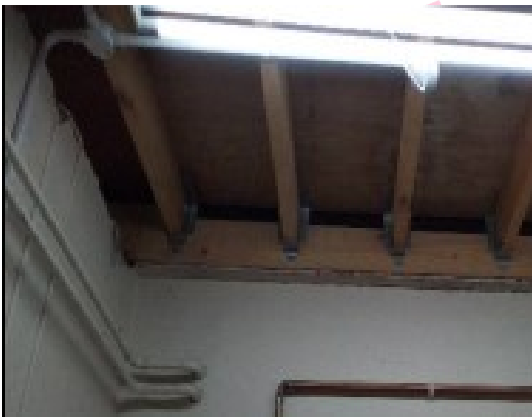
Item 90 Ref: OQ000241

The roof felt from external roof (Store Room G/001) does not contain asbestos.

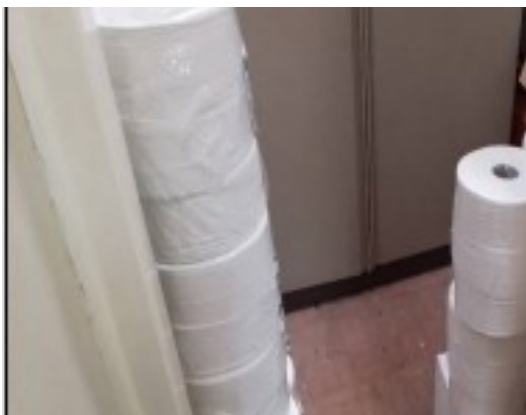
Item 91 Ref: OQ000240

The floor screed (Cupboard former shower G/002) does not contain asbestos.

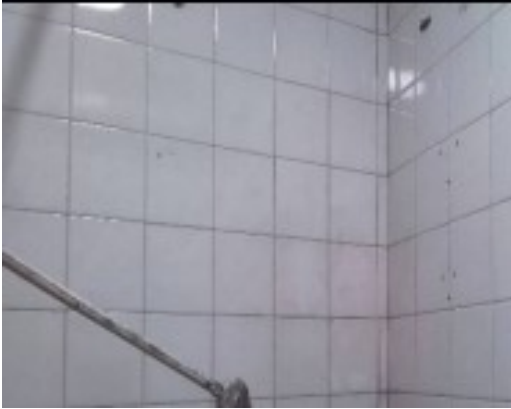
Item 92 Ref: OQ000239

The wall tile adhesive (Cupboard former shower G/002) does not contain asbestos.

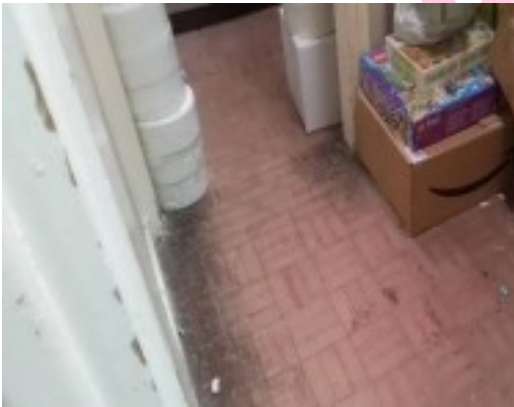
Item 93 Ref: As OQ000240

The floor screed (Cupboard G/003) does not contain asbestos.

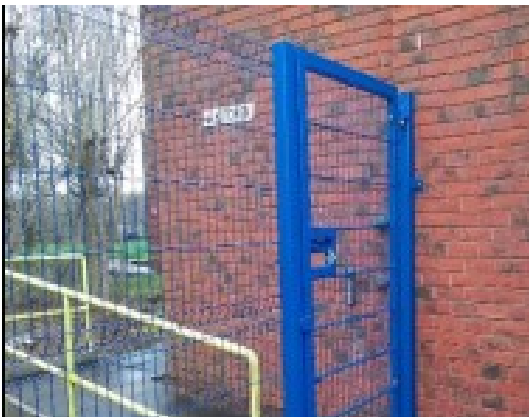
Item 94 Ref: OQ000242

The damp proof course (External E/001) does not contain asbestos.
