### ASBESTOS SURVEY REPORT FOR FULWELL INFANT ACADEMY SCHOOL, SUNDERLAND

**Asbestos Register for**

**FULWELL INFANT ACADEMY**

**Date: 11 February 2026**

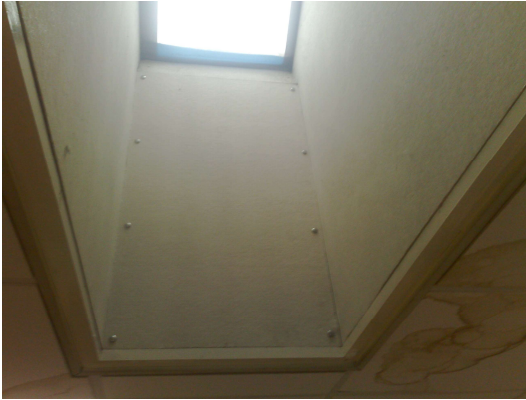
### **Various - Ref: NO09/175**

The skylight upstands to the waiting area do not contain asbestos.

Similar upstands are located in reception 2.

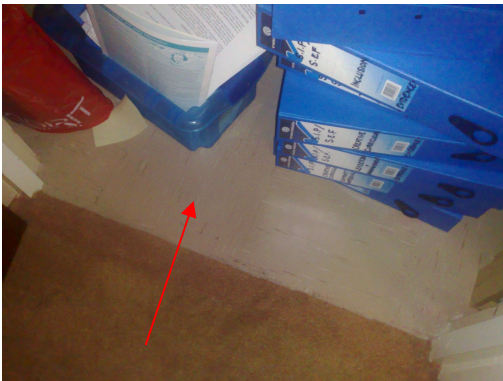
### **Various - Ref: NO09/176**

The floor tiles to the Deputy Heads office do not contain asbestos.

Similar flooring is located in: HT office, Elec intake, Emerg battery room, Stationary store, Gents WC, Ladies WC, Middle Inf store, Teaching area 2021, Mixed hazard store, Disabled WC, Recep Area 1, Chemical store, Top infants store, Hall store, Kitchen WC, Kitchen office, Dry store and cleaners store.

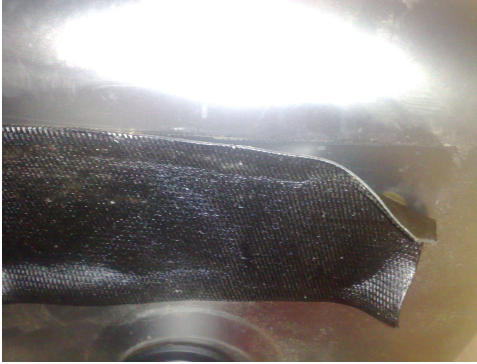
**Item 4 - Ref: NO09/177**

The sink pad to the staff room does not contain asbestos.

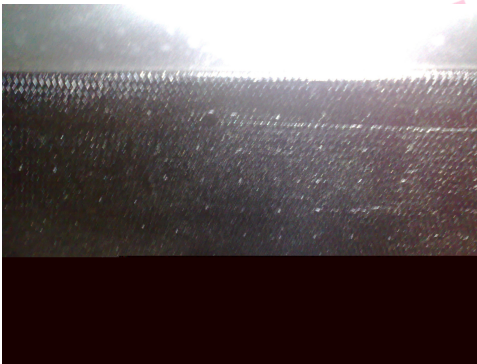
**Item 10 - Ref: NO09/179**

The sink pad to reception 2 does not contain asbestos.

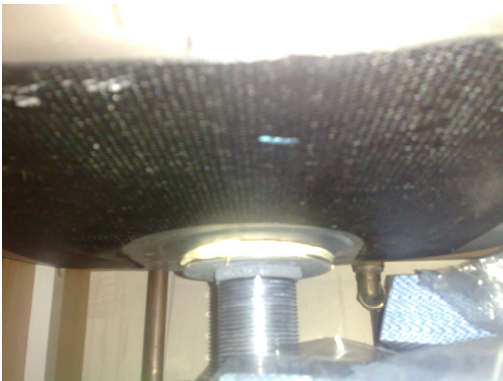
**Item 12 - Ref: NO09/180**

The sink pad in the middle infants does not contain asbestos.

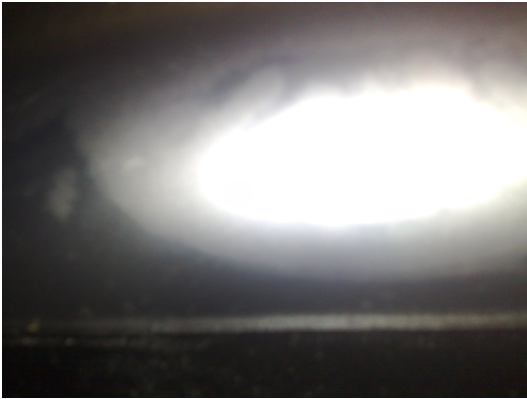
**Item 18 - Ref: NO09/178**

The sink pad to reception area 1 does not contain asbestos.

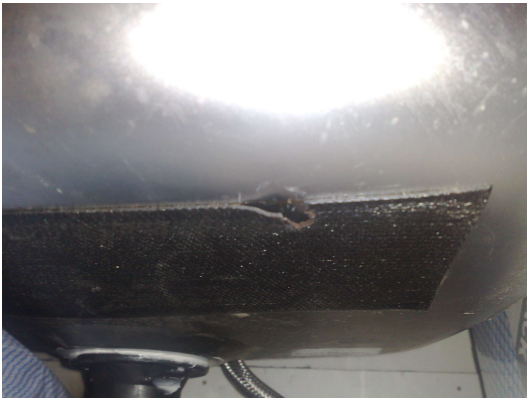
**Item 21 - Ref: NO09/181**

The sink pad to the top infants does not contain asbestos.

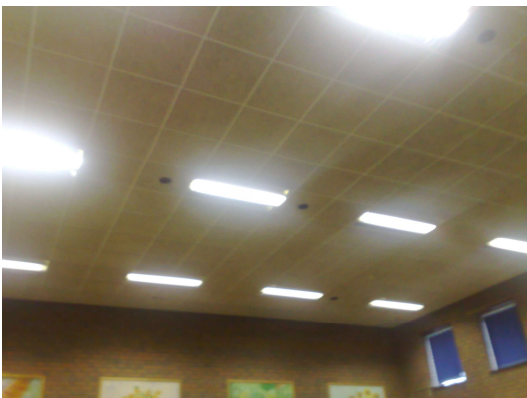
**Item 23 - Ref: NO09/182**

The ceiling tiles to the hall do not contain asbestos.

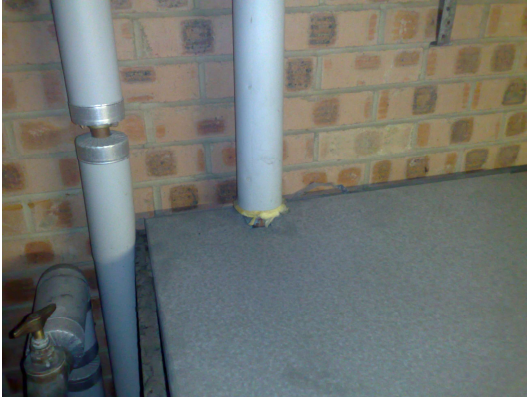
**Item 29 - Ref: NO09/183**

The pipe insulation in the boiler house on the first floor does not contain asbestos.

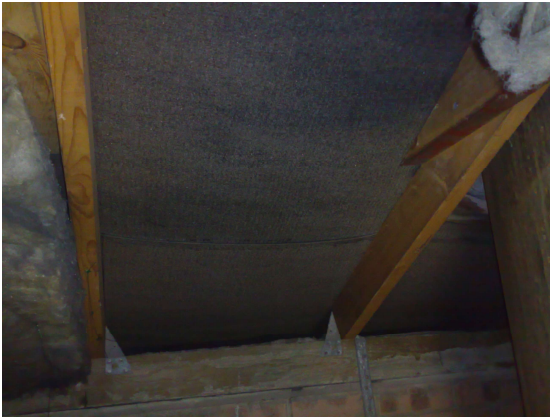
**Item 30 - Ref: NO09/184**

The felt to the roof of the first floor boiler room does not contain asbestos.

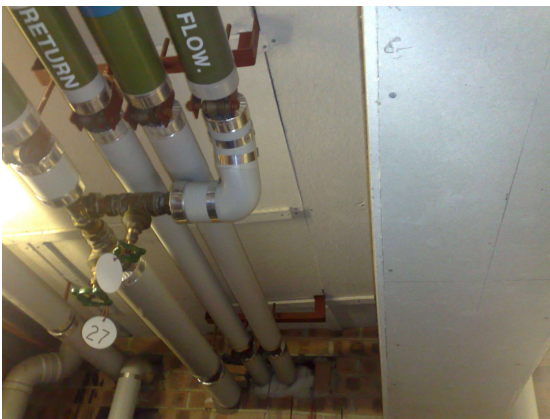
**Item 31 - Ref: NO09/185**

The ceiling boards to the boiler house on the ground floor do not contain asbestos.

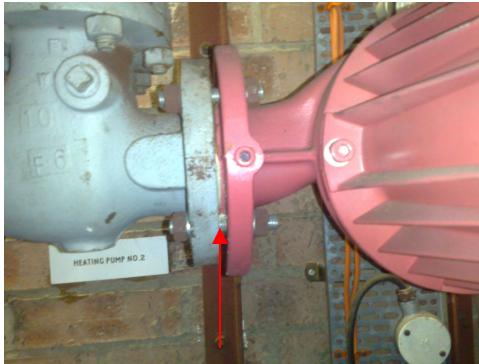
### **Item 32 - Ref: NO09/186**

The gasket material in the boiler house on the ground floor contained asbestos.

*This was removed in July 2015.*

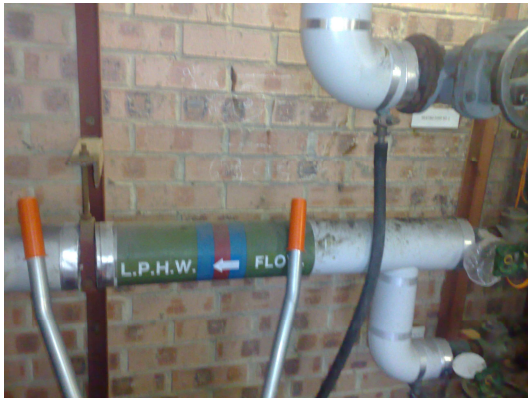
### **Various - Ref: NO09/187**

The pipe insulation to the boiler house on the ground floor does not contain asbestos.

Similar insulation is located in the ceiling void.

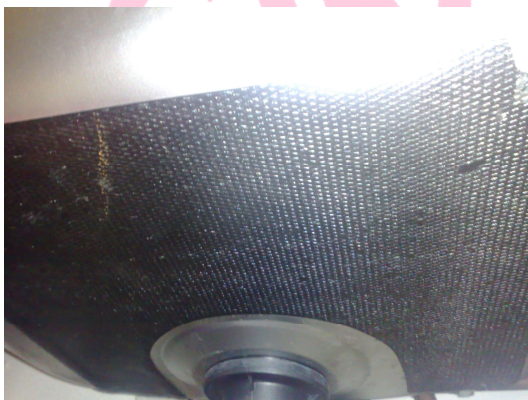
### **Item 34 - Ref: NO09/188**

The sink pad to the nursery does not contain asbestos.

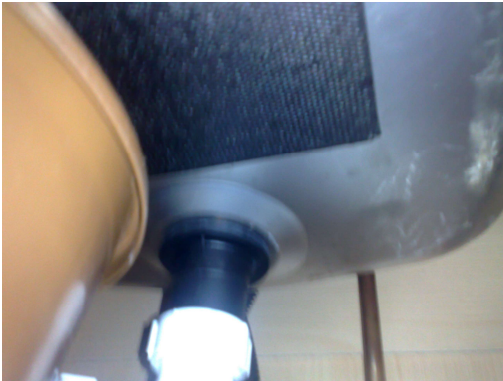
**Item 35 - Ref: NO09/191**

The sink pad to the circular sink in the nursery does not contain asbestos.

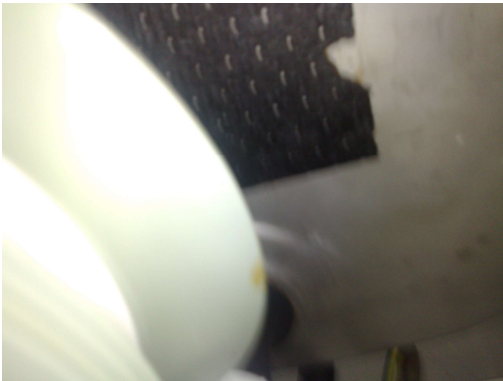
**Item 36 - Ref: NO09/189**

The sink pad to the sink in the nursery boiler room does not contain asbestos.

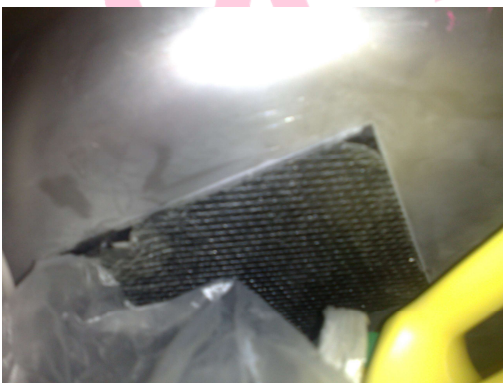
**Item 37 - Ref: NO09/190**

The sink pad to the nursery kitchen does not contain asbestos.

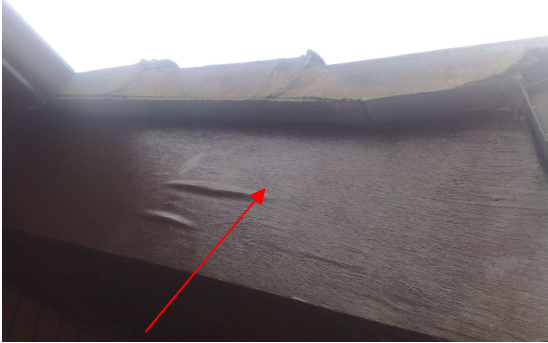
### Item 38 - Ref: NO09/192

The fillet board to the external of the building does not contain asbestos.

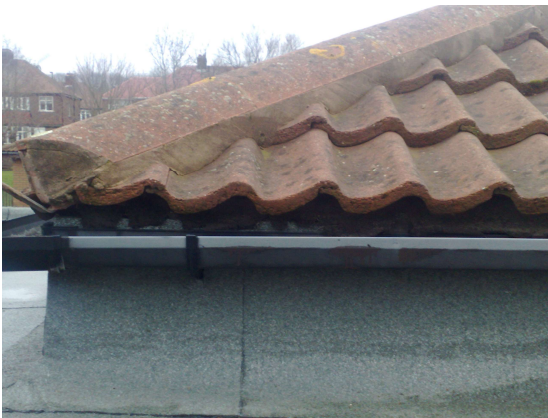
### Item 39 - Ref: NO09/193

The roof felt to the external does not contain asbestos.

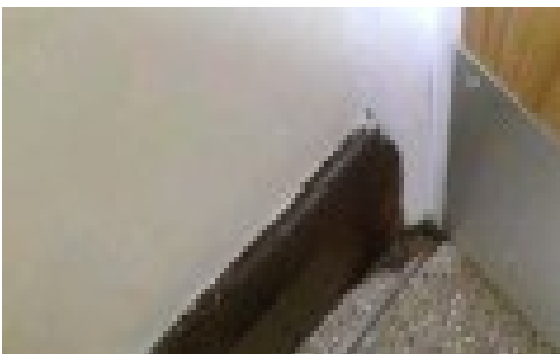
The floor beneath the lino in the kitchen was accessed and no suspect materials were found.

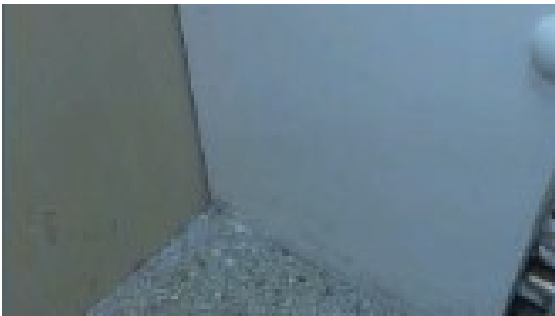
The boxing void in the kitchen was accessed. No suspect materials were found.

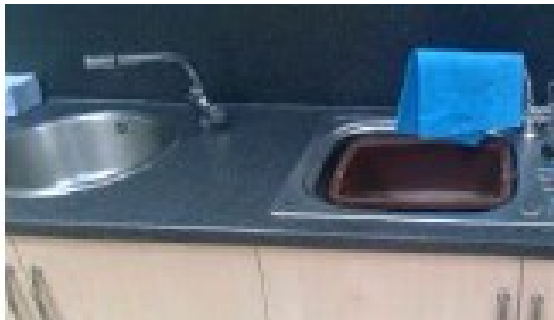
### Item 41 - Ref: AK000133

The sink pad in the kitchen does not contain asbestos.

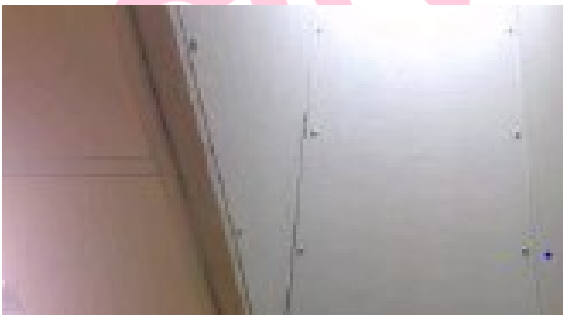
### Item 42 – Ref: AK000134

The insulation board to the sky light window in the kitchen does not contain asbestos.

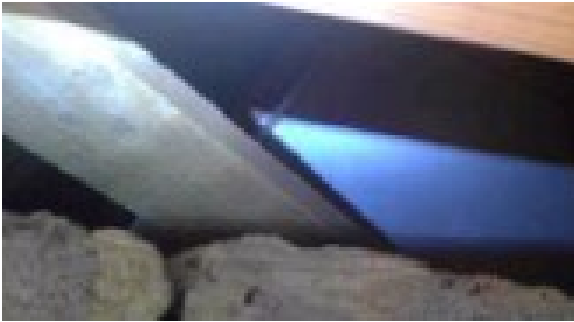
### **Item 43 – Ref: As AK000134**

The insulation board above the ceiling tiles in the kitchen does not contain asbestos.

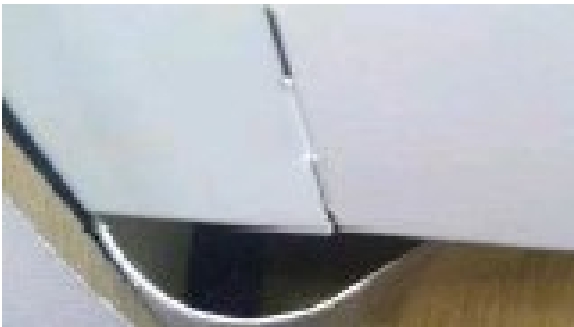
The lino below the floor in the link room was accessed and no suspect materials were found.

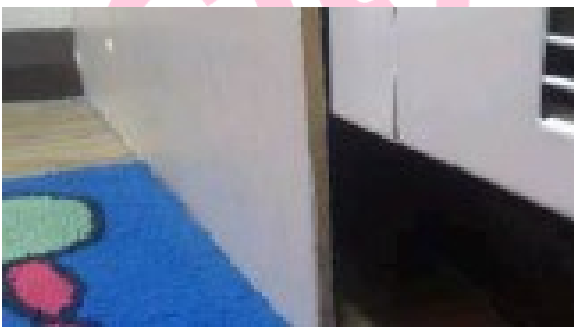
The boxing void in the link room was accessed and no suspect materials were found.

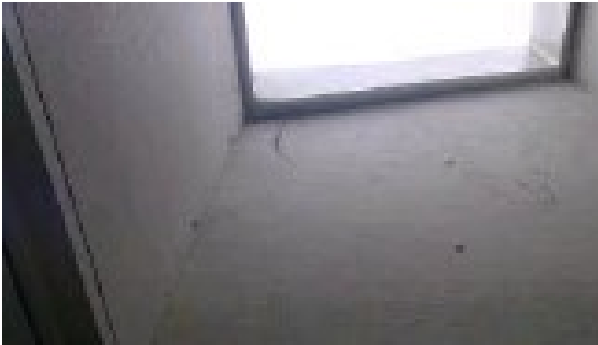
### **Item 44 – Ref: As AK000134**

The insulation board to the sky light window in the link room does not contain asbestos.

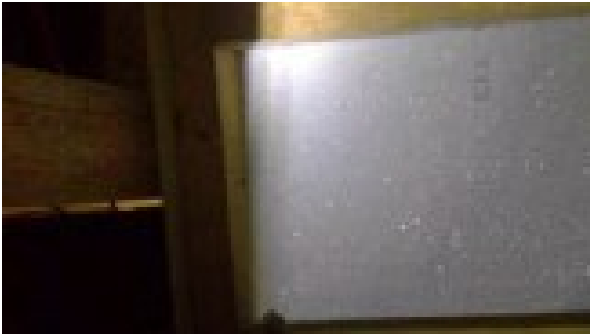
### **Item 45 - Ref: As AK000134**

The insulation board above the ceiling tiles in the link room does not contain asbestos.

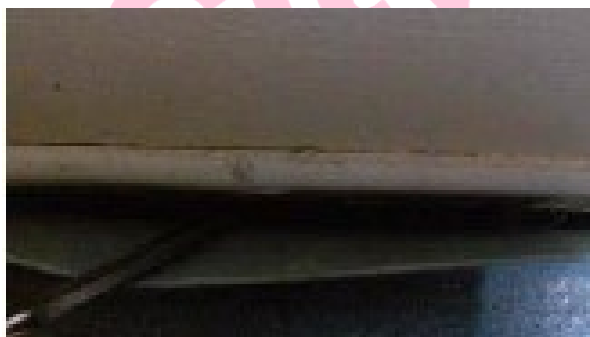
The floor below the lino in the medical room was accessed and no suspect materials were found.

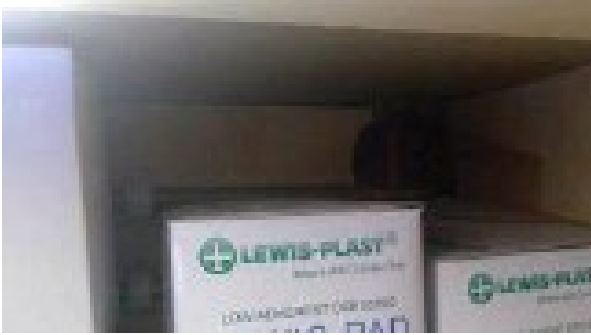
The boxing void in the medical room was accessed and no suspect materials were found.

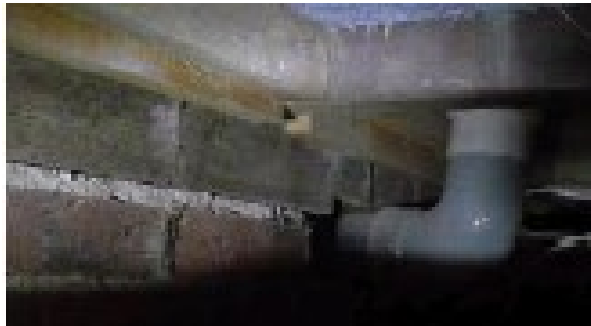
The ceiling void in the medical room was accessed and no suspect materials were found.

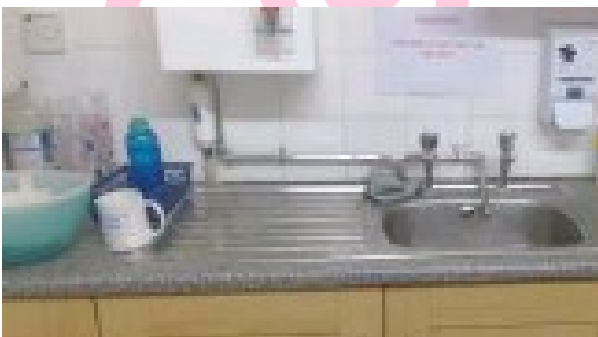
### **Item 46 – Ref: AK000135**

The sink pad in the medical room does not contain asbestos.

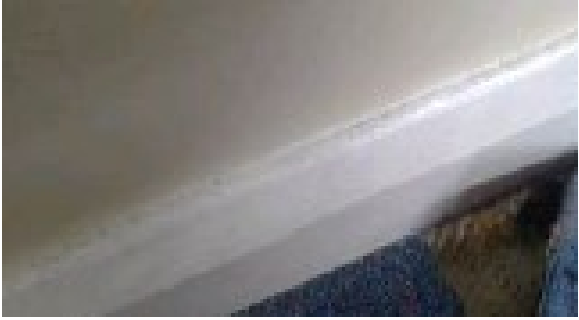
The floor below the carpet tiles in the staff room was accessed and no suspect materials were found.

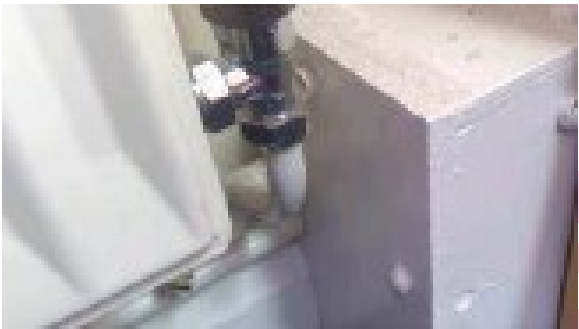
The boxing void in the staff room was accessed and no suspect materials were found.

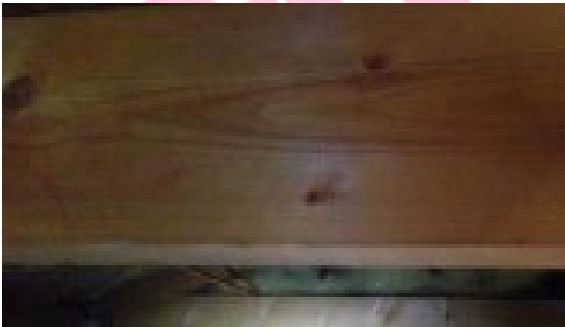
The ceiling void in the staff room was accessed and no suspect materials were found.

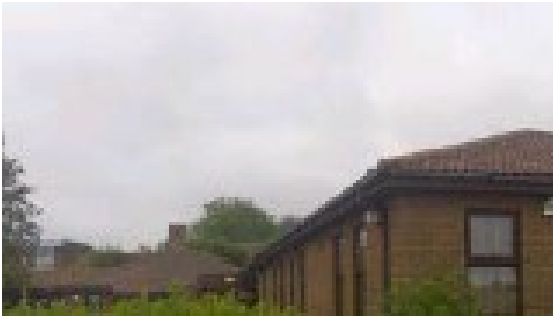
The external area to the school was accessed and no suspect materials were found.

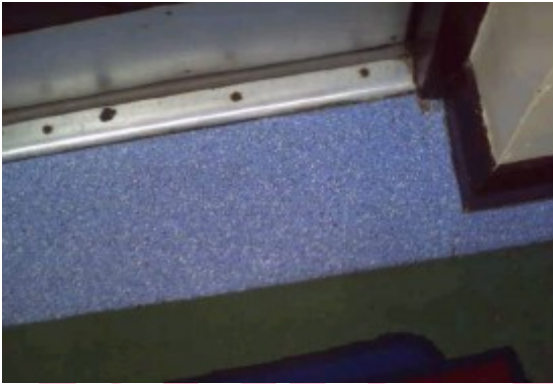
### **Item 47 – Ref: BB000343**

The Lino on concrete in the Reception area 1 does not contain asbestos.

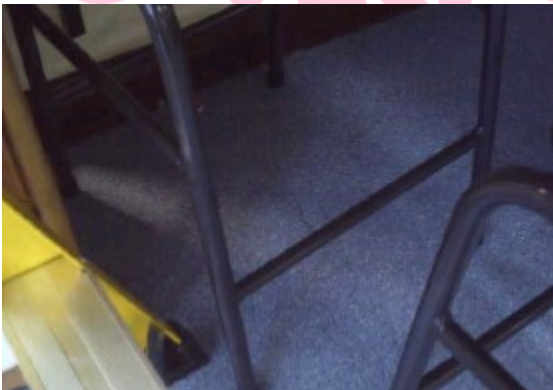
### **Item 48 – Ref: As BB000343**

The Lino on concrete in the Quiet Room 2 does not contain asbestos.

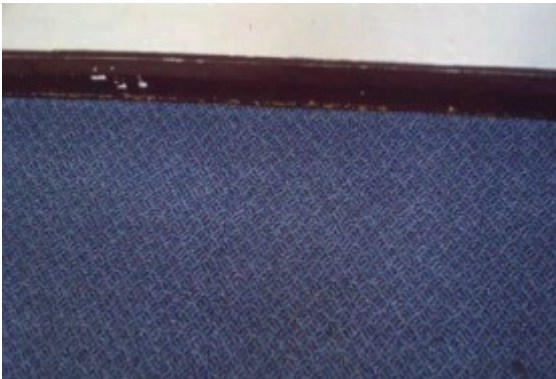
**Item 50 – Ref: As BB000343**

The Lino under carpet in Reception area 2 does not contain asbestos.

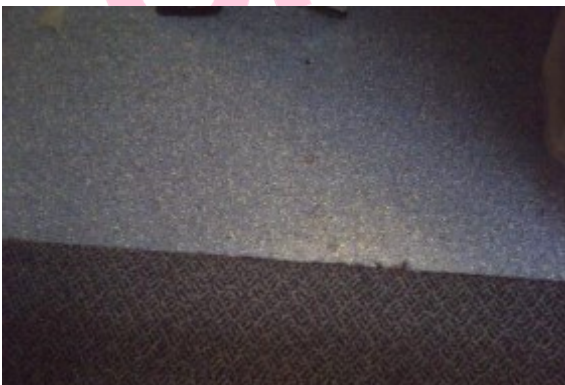
**Item 51 – Ref: As BB000343**

The Lino on concrete in the Store does not contain asbestos.

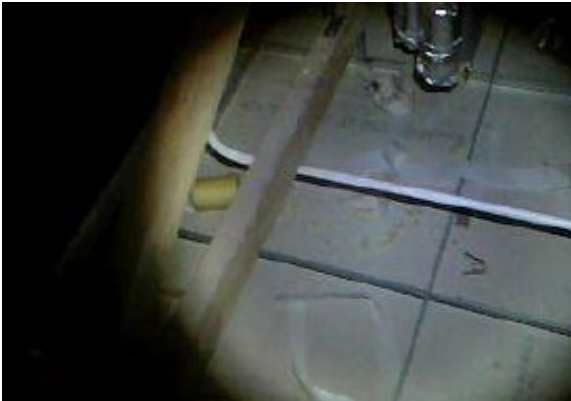
**Item 52 – Ref: AD001191**

The Debris to ceiling in the Nursery Roof Void does not contain asbestos.

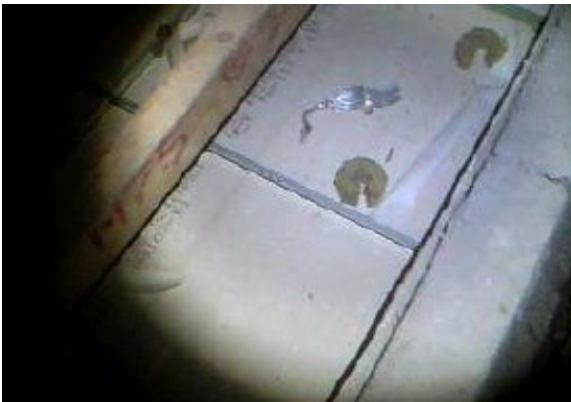
**Item 53 – Ref: AD001192**

The Debris to ceiling top in the Nursery Roof Void does not contain asbestos.

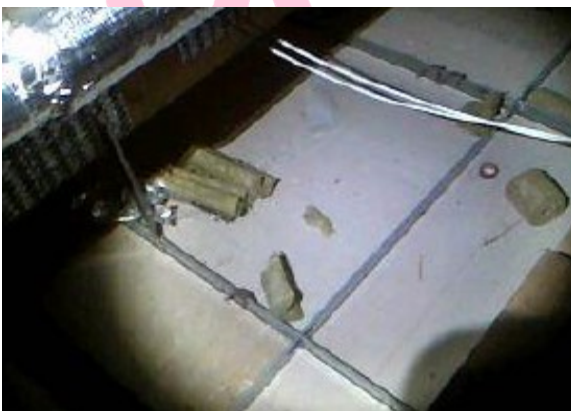
**Item 54 – Ref: AD001193**

The Debris to ceiling top in the Nursery Roof Void does not contain asbestos.

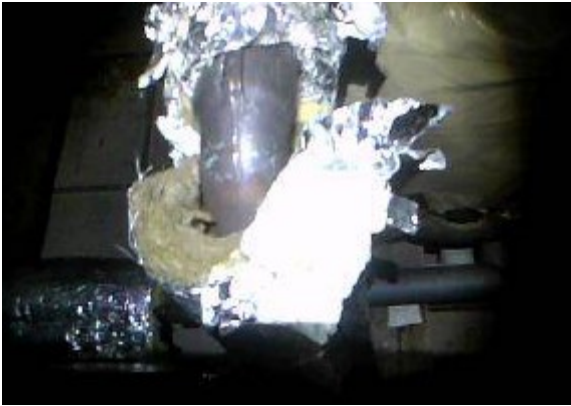
**Item 55 – Ref: AD001194**

The residue to pipework in the Nursery Roof Void does not contain asbestos.

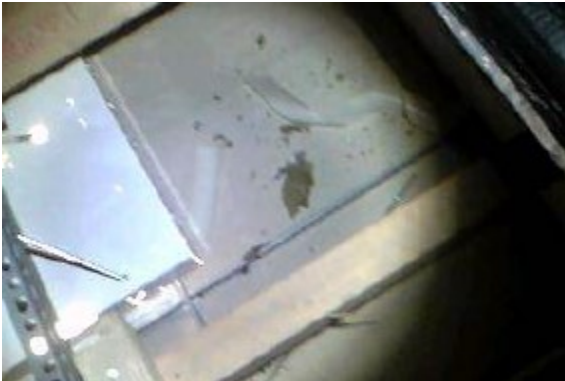
**Item 56 – Ref: AD001195**

The debris to ceiling top in the Nursery Roof Void does not contain asbestos.

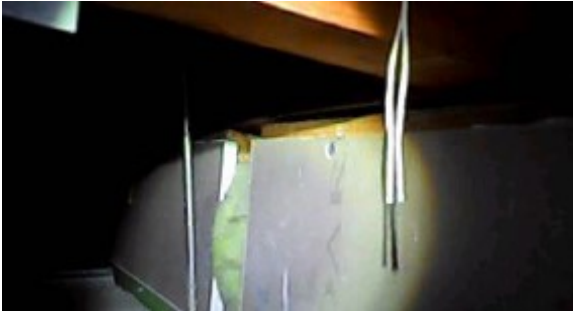
### **Item 58 – Ref: EB000310**

The partition wall in the Practical area & Class 6 does not contain asbestos.

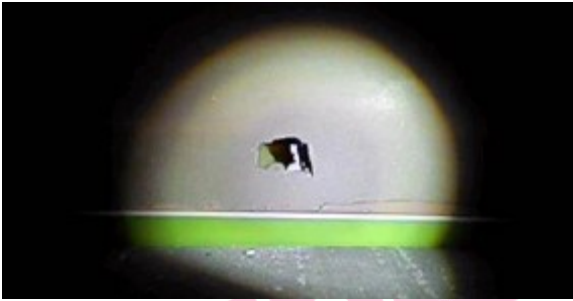
### **Item 59 – Ref: As EB000310**

The partition wall in Class 6 & Class 5 does not contain asbestos.

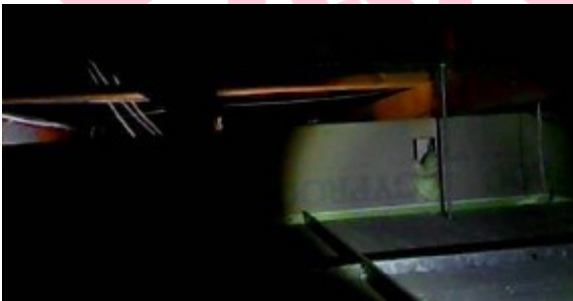
### **Item 60 – Ref: As EB000310**

The partition wall in the Practical area & Class 5 does not contain asbestos.

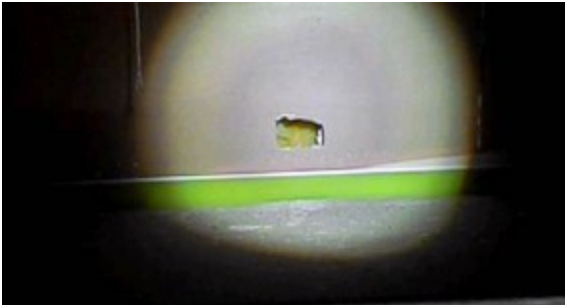
### **Item 61 – Ref: As EB000310**

The partition wall in the Practical area & Class 4 does not contain asbestos.

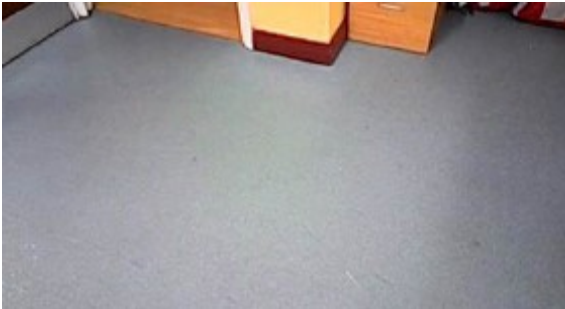
### **Item 62 – Ref: EB000311**

The blue vinyl floor covering in Room 1 does not contain asbestos.

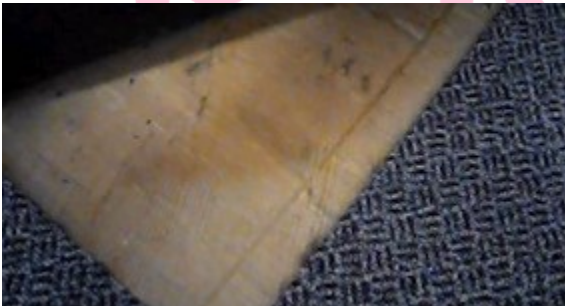
### **Item 63 – Ref: EB000313**

The beige vinyl tiles in Class 6/Room 1 does not contain asbestos.

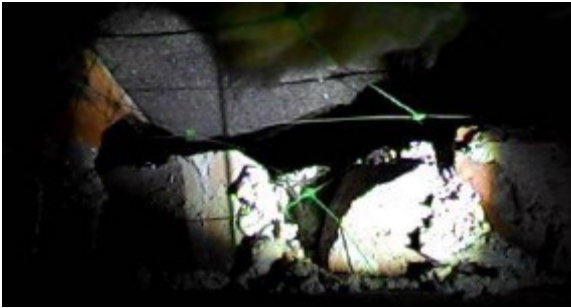
### **Item 64 – Ref: EB000314**

The sarking to felt roof in Room 2 roof void does not contain asbestos.

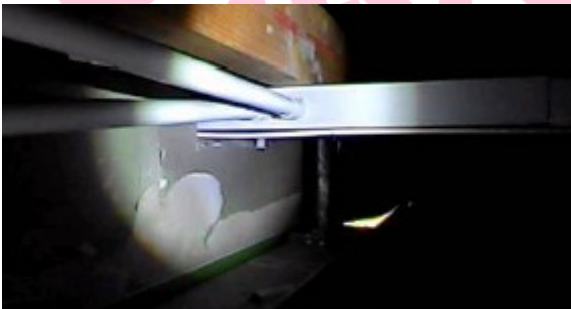
### **Item 66 – Ref: As EB000310**

The Partition wall between Practical area & class 3 in Room 3 does not contain asbestos.

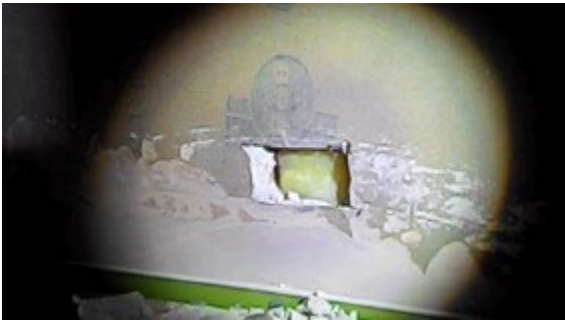
### **Item 67 – Ref: As EB000310**

The Partition wall between Practical area & class 2 & 1 in Room 3 does not contain asbestos.

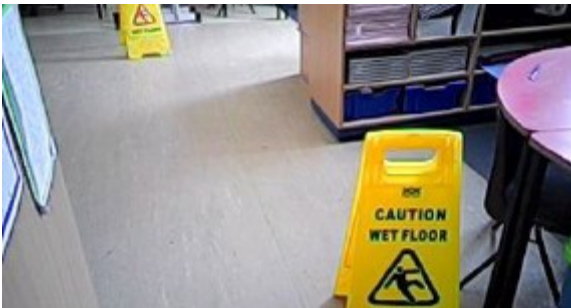
### **Item 68 – Ref: As EB000313**

The Beige vinyl tiles in Room 3 do not contain asbestos.

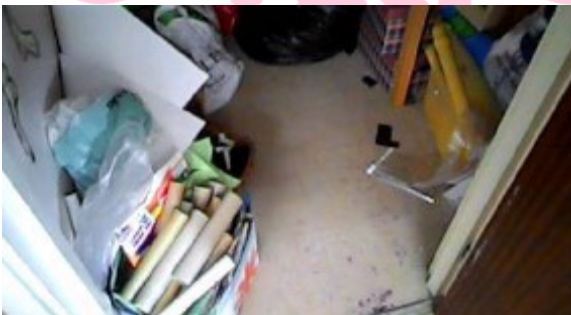
### **Item 69 – Ref: As EB000312**

The Beige vinyl tiles in Room 3 do not contain asbestos.

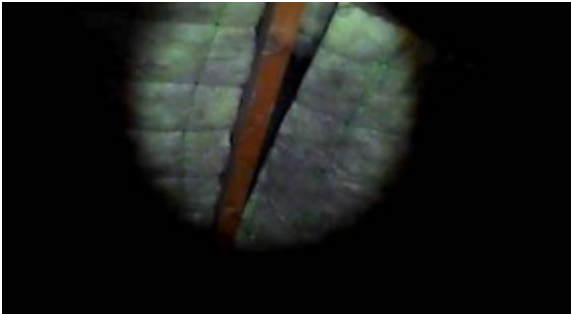
### **Item 71 – Ref: As EB000314**

The Sarking to felt roof in Room 4 roof void does not contain asbestos.

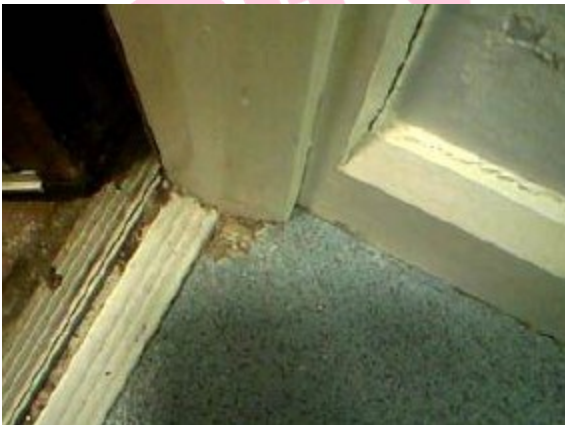
### **Item 72 – Ref: BB004336**

The Lino and bitumen in Nursery Staff Room does not contain asbestos.

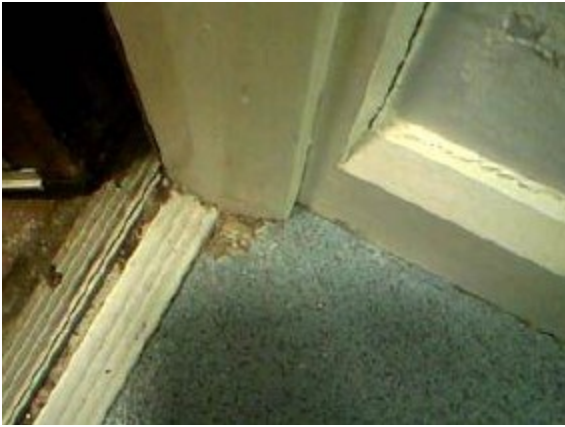
### **Item 72 – Ref: BB004336**

The Lino and bitumen in Nursery Staff Room does not contain asbestos.

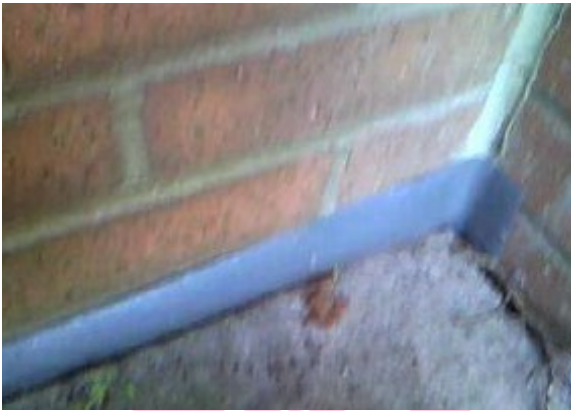
### **Item 73 – Ref: BB004337**

The Damp proof course (external) does not contain asbestos.

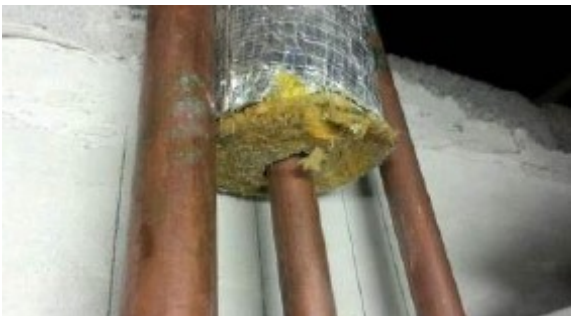
### **Item 74 – Ref: EY001751**

The Pipe lagging in the Nursery Chemical Cupboard ceiling void does not contain asbestos.

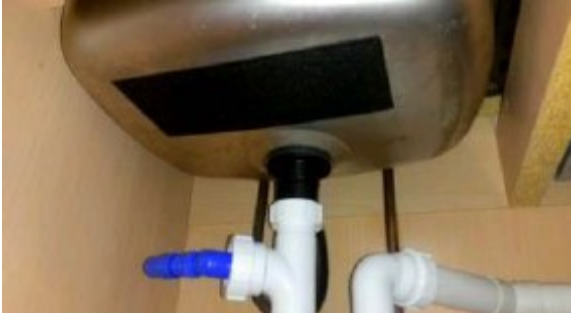
**Item 75 – Ref: EY001752**

The Sink pad in the Nursery Chemical Cupboard does not contain asbestos.

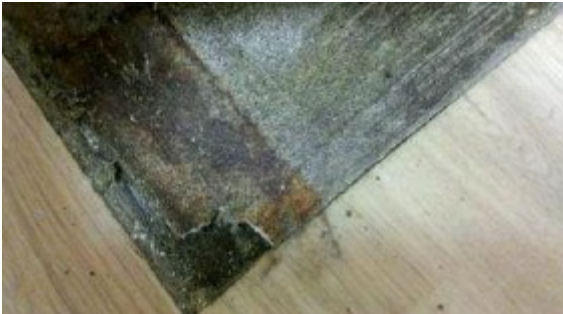
**Item 76 – Ref: EY001753**

The Old Lino in the Nursery Chemical Cupboard does not contain asbestos.

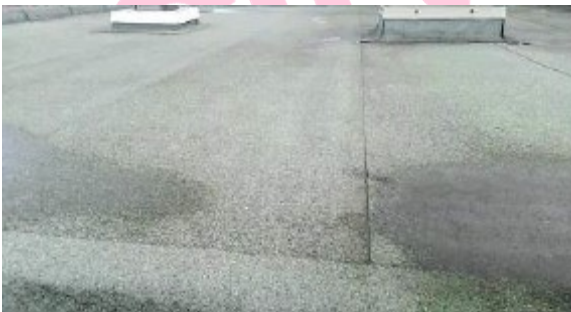
**Item 77 – Ref: EO005428**

The Flat roof over kitchen (external) does not contain asbestos.

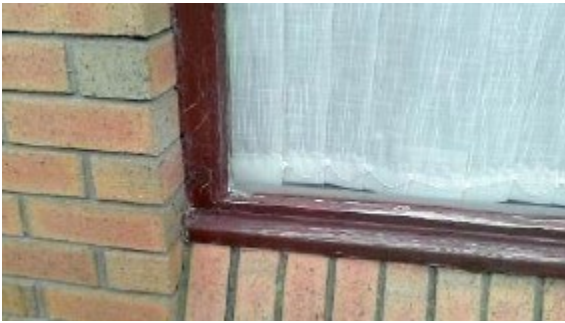
**Item 78 – Ref: EO005429**

The Putty to window frames (external) does not contain asbestos.

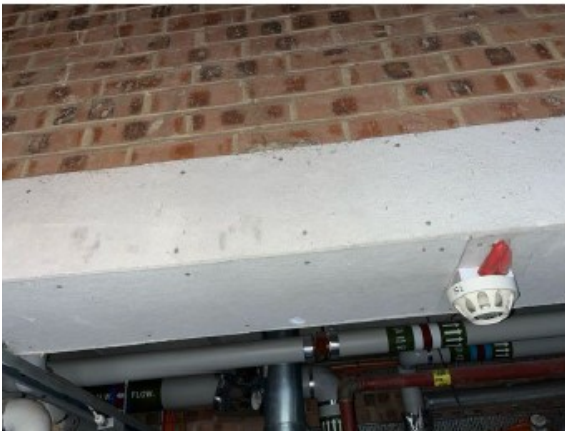
**Item 80 – Ref: S001**

The insulating board boxing in the boiler house does not contain asbestos.

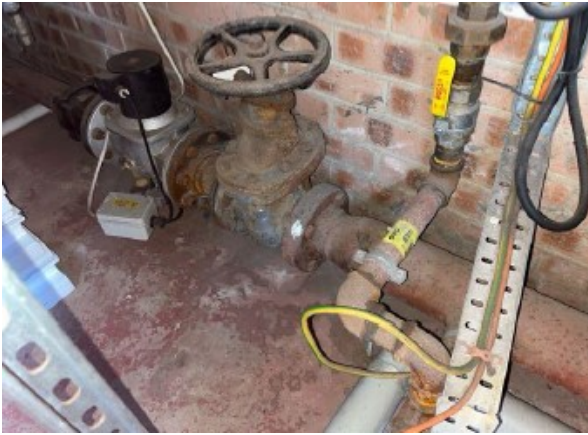
**Item 81 – Ref: S002**

The gaskets to the pipe flanges in the boiler house does contain asbestos.

Any change in appearance should be reported to Property Services.
