ASBESTOS SURVEY REPORT FOR EAST RAINTON PRIMARY SCHOOL,
SCHOOL ROAD, EAST RAINTON, DH5 9RA.

**East Rainton Primary School, School Road, East
Rainton, Houghton, DH5 9RA**

Date: 22 May 2026

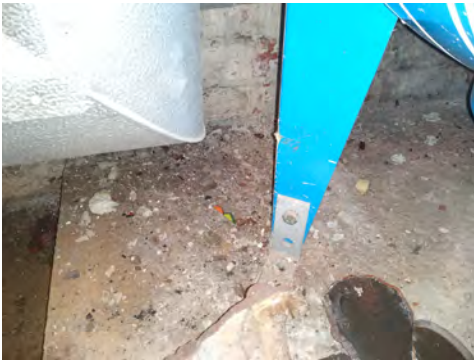
Item 2 Ref: 427459-16

The general debris to floor in -1/013 Plant Room does not contain asbestos.

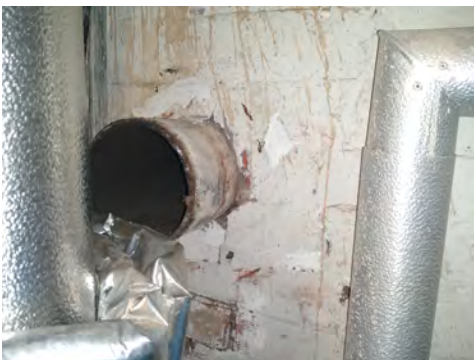
Item 3 Ref: 427459-17

The debris to wall around pipe penetration in -1/013 Plant Room contains asbestos.

Removed October 2020

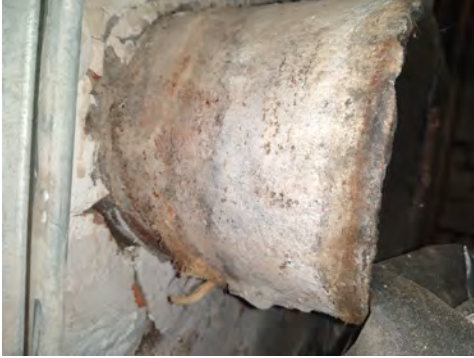
Item 4 Ref: 427459-18

The pipework residue in -1/013 Plant Room does not contain asbestos.

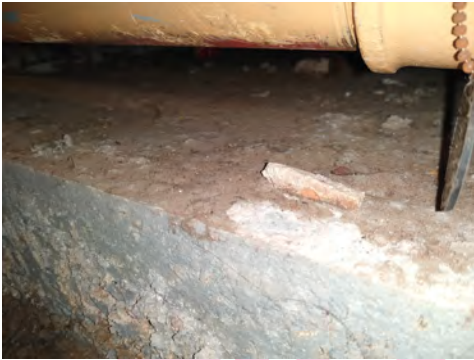
Item 5 Ref: 427459-19

The plinth in -1/013 Plant Room does not contain asbestos.

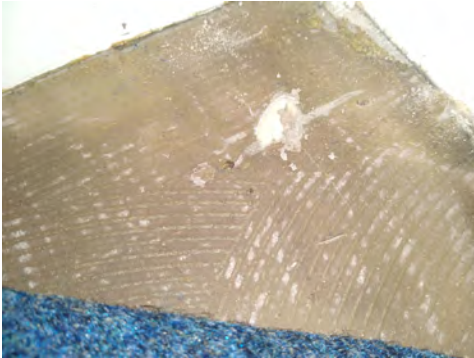
Item 7 Ref: 427459-1

The floor covering in 0/005 Store does not contain asbestos.

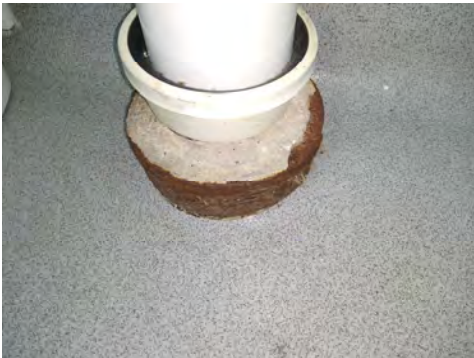
Item 8 Ref: Presumed

The mastic in 0/008 Girls WC is presumed to contain asbestos.

Any change in its appearance should be recorded and passed to Property Services.

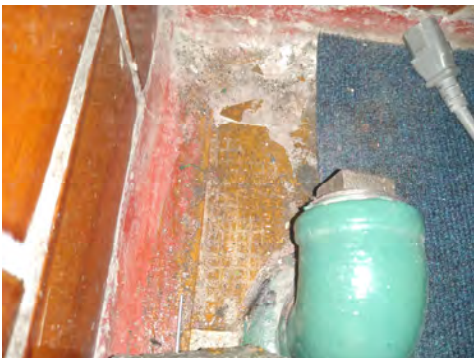
Item 9 Ref: 427459-2

The floor covering in 0/009 Computer Room contains asbestos.

Any change in its appearance should be recorded and passed to Property Services.

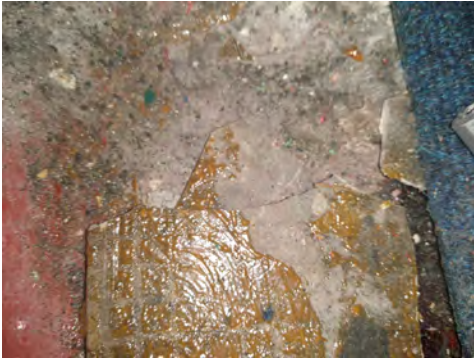
Item 10 Ref: 427459-5

The floor in 0/009 Computer Room contains asbestos.

Any change in its appearance should be recorded and passed to Property Services.

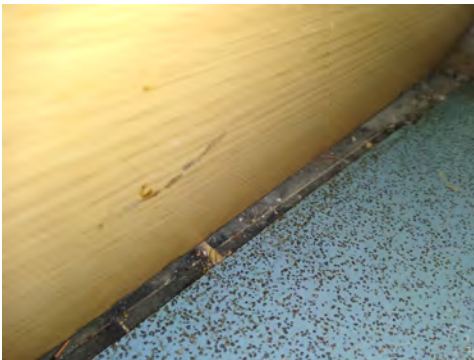
Item 11 Ref: 427459-3

The floor in 0/010 Kitchenette contains asbestos.

Any change in its appearance should be recorded and passed to Property Services.

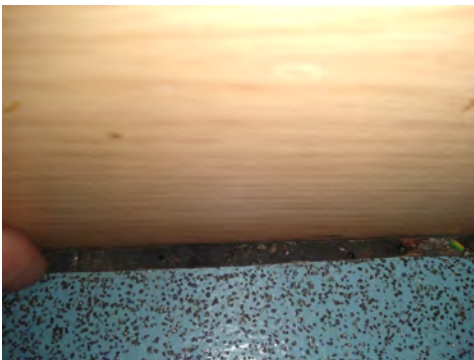
Item 12 Ref: 427459-4

The floor in 0/010 Kitchenette contains asbestos.

Any change in its appearance should be recorded and passed to Property Services.

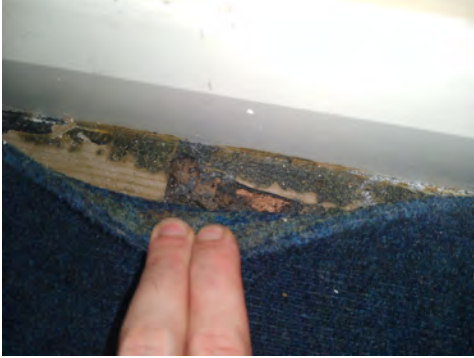
Item 13 Ref: As 427459-3

The floor covering in 0/011 Staff Room contains asbestos.

Any change in its appearance should be recorded and passed to Property Services.

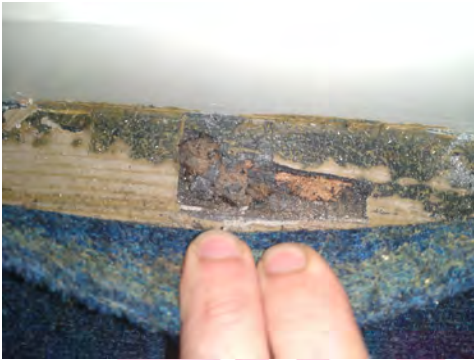
Item 14 Ref: As 427459-4

The floor in 0/011 Staff Room contains asbestos.

Any change in its appearance should be recorded and passed to Property Services.

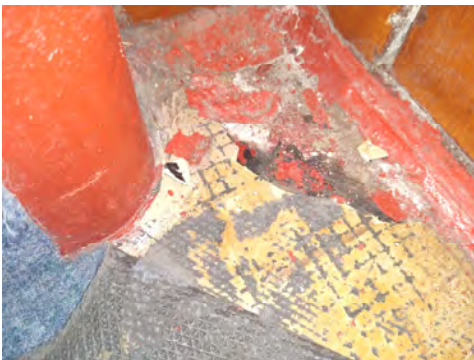
Item 15 Ref: As 427459-2

The floor covering in 0/012 Corridor contains asbestos.

Any change in its appearance should be recorded and passed to Property Services.

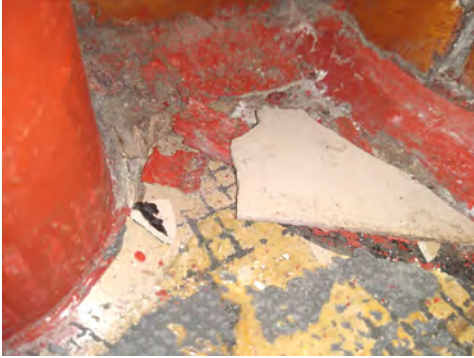
Item 16 Ref: As 427459-2

The floor in 0/012 Corridor contains asbestos.

Any change in its appearance should be recorded and passed to Property Services.

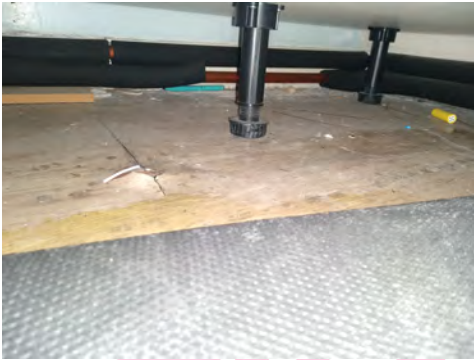
Item 17 Ref: 427459-6

The floor covering in 0/014 Class 5 does not contain asbestos.

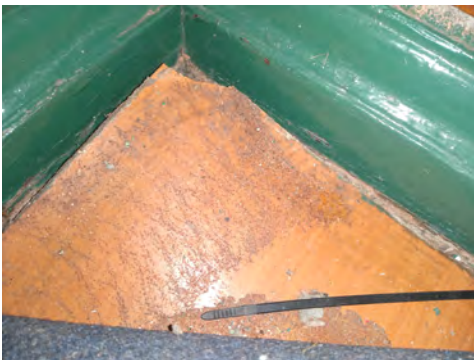
Item 18 Ref: 427459-7

The floor covering in 0/015 Corridor does not contain asbestos.

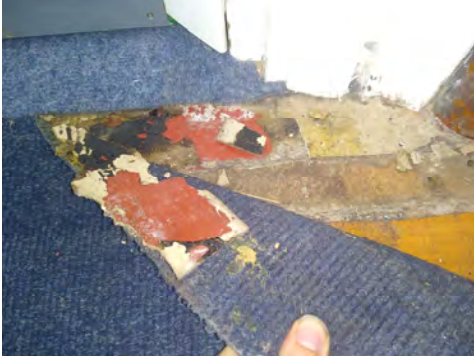
Item 19 Ref: As 427459-6

The floor in 0/015 Corridor does not contain asbestos.

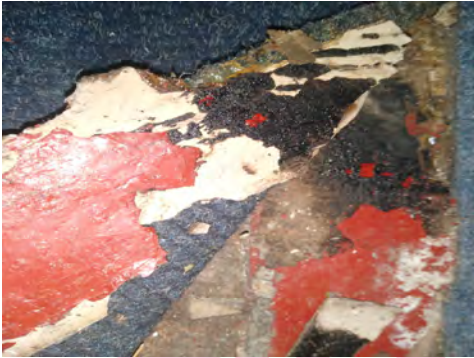
Item 20 Ref: As 427459-5

The floor in 0/015 Corridor contains asbestos.

Any change in its appearance should be recorded and passed to Property Services.

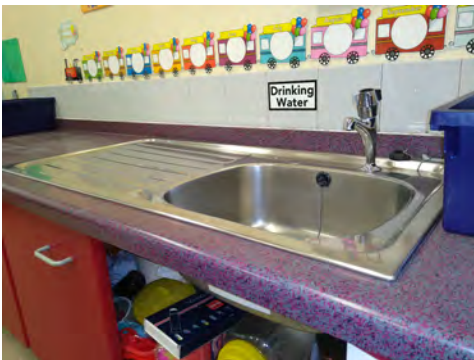
Item 21 Ref: 427459-8

The sink pad in 0/021 Class 1 does not contain asbestos.

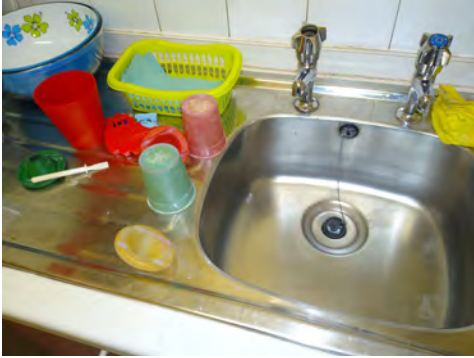
Item 22 Ref: 427459-9

The sink pad in 0/022 Kitchen classroom 1 does not contain asbestos.

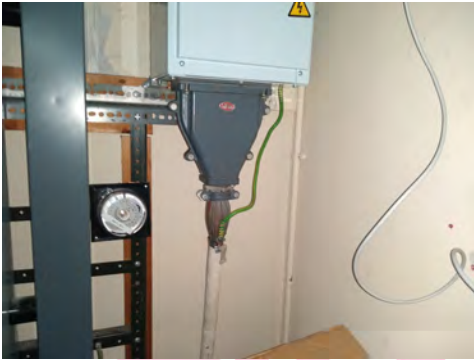
Item 23 Ref: Presumed

The electrics in 0/023 Switch Room is presumed to contain asbestos.

Any change in its appearance should be recorded and passed to Property Services.

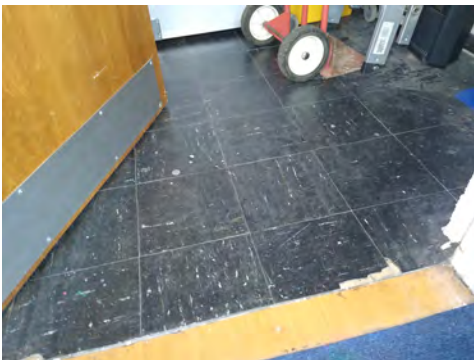
Item 24 Ref: 427459-10

The floor covering in 0/023 Switch Room contains asbestos.

Any change in its appearance should be recorded and passed to Property Services.

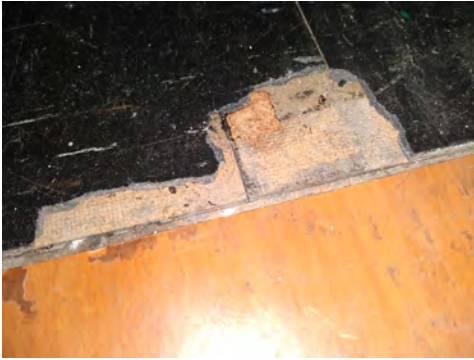
Item 25 Ref: 427459-11

The floor in 0/023 Switch Room contains asbestos.

Any change in its appearance should be recorded and passed to Property Services.

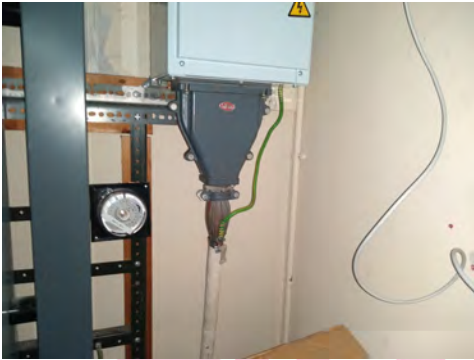
Item 26 Ref: Presumed

The pipe lagging in 0/023 Switch Room is presumed to contain asbestos.

Any change in its appearance should be recorded and passed to Property Services.

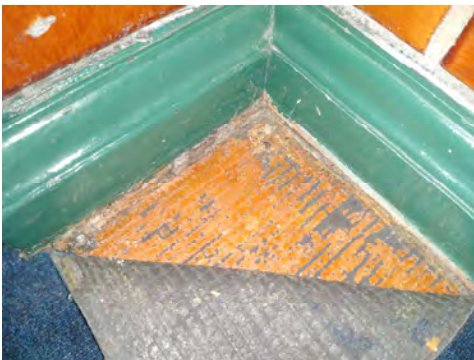
Item 27 Ref: As 427459-7

The floor covering in 0/024 Corridor does not contain asbestos.

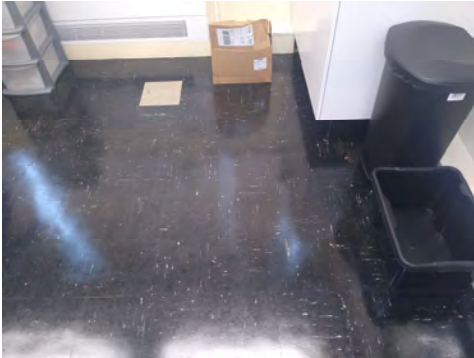
Item 28 Ref: As 427459-10

The floor covering in 0/025 Class 2 contains asbestos.

Any change in its appearance should be recorded and passed to Property Services.

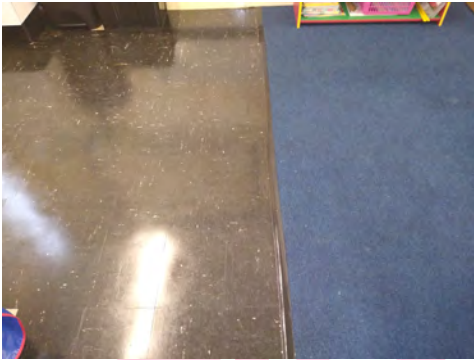
Item 29 Ref: As 427459-11

The floor in 0/025 Class 2 contains asbestos.

Any change in its appearance should be recorded and passed to Property Services.

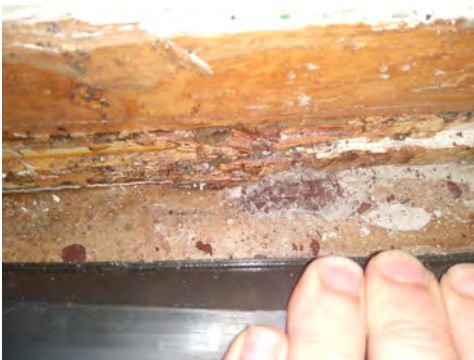
Item 30 Ref: 427459-12

The floor covering in 0/026 Boys WC does not contain asbestos.

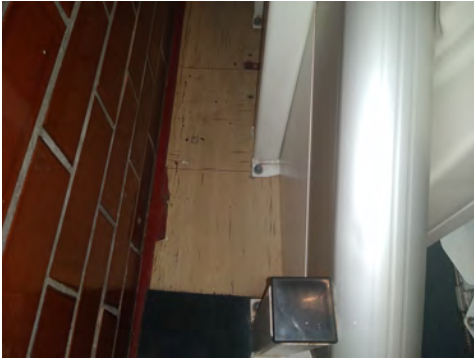
Item 31 Ref: 427459-13

The floor covering in 0/030 Corridor contains asbestos.

Any change in its appearance should be recorded and passed to Property Services.

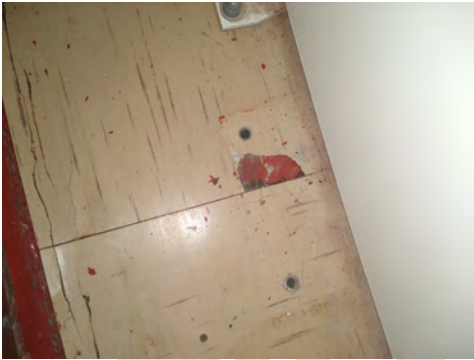
Item 32 Ref: 427459-14

The floor in 0/030 Corridor contains asbestos.

Any change in its appearance should be recorded and passed to Property Services.

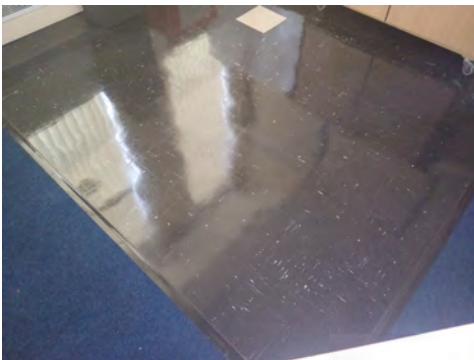
Item 33 Ref: As 427459-10

The floor covering in 0/031 Class 3 contains asbestos.

Any change in its appearance should be recorded and passed to Property Services.

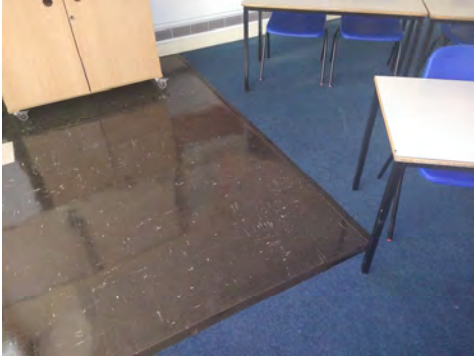
Item 34 Ref: As 427459-11

The floor in 0/031 Class 3 contains asbestos.

Any change in its appearance should be recorded and passed to Property Services.

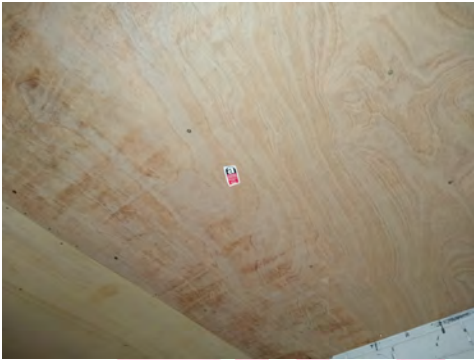
Item 35 Ref: Presumed

The ceiling in 0/032 External Store is presumed to contain asbestos.

Any change in its appearance should be recorded and passed to Property Services.

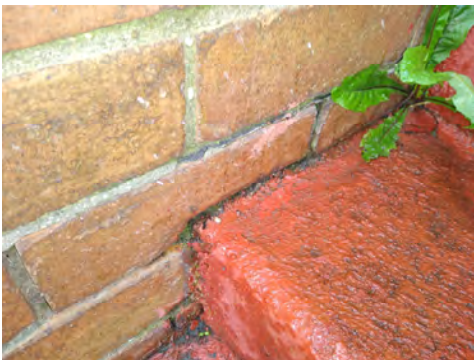
Item 36 Ref: 427459-21

The damp proof course (External) does not contain asbestos.

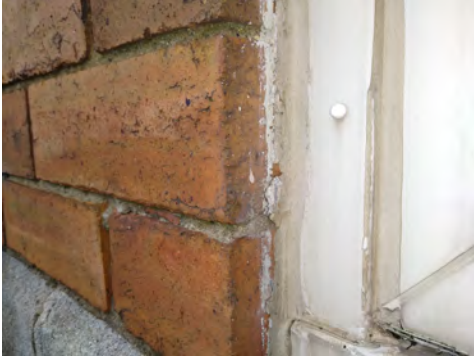
Item 37 Ref: 427459-22

The window frame (External) does not contain asbestos.

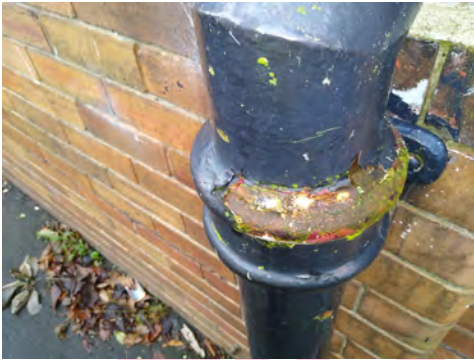
Item 38 Ref: 427459-23

The metal soil pipe frame (External) does not contain asbestos.

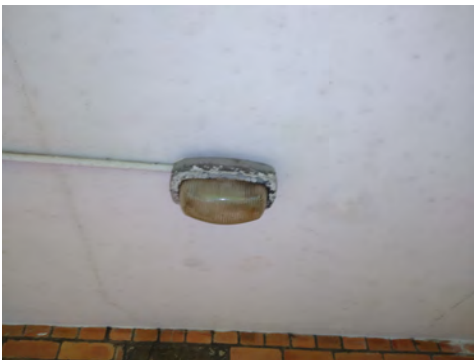
Item 39 Ref: 427459-24

The security lights (External) contain asbestos.

Any change in its appearance should be recorded and passed to Property Services.

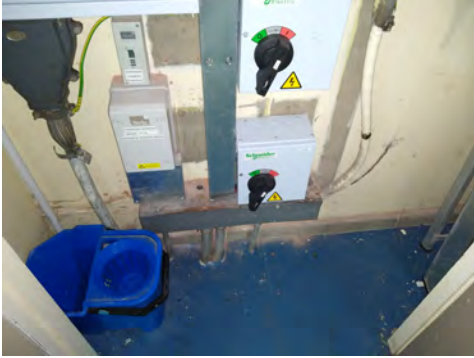
Item 40 Ref: Presumed

The pipe lagging in 0/001 Kitchen electric cupboard - Canteen is presumed to contain asbestos.

Any change in its appearance should be recorded and passed to Property Services.

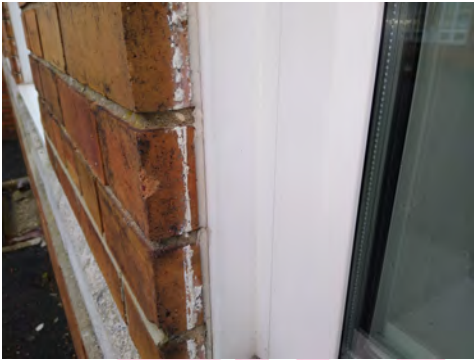
Item 41 Ref: 427459-25

The window and door frame (External Canteen) do not contain asbestos.

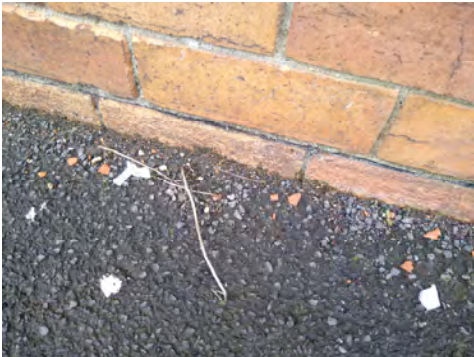
Item 42 Ref: 427459-26

The damp proof course (External Canteen) does not contain asbestos.

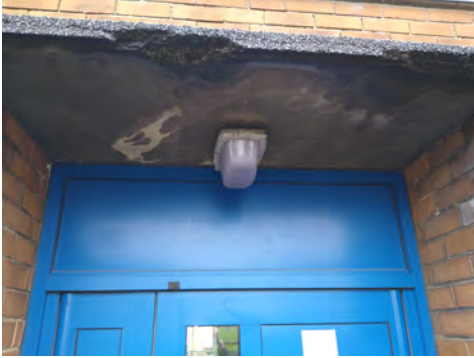
Item 43 Ref: 427459-27

The security light (External Canteen) contains asbestos.

Any change in its appearance should be recorded and passed to Property Services.

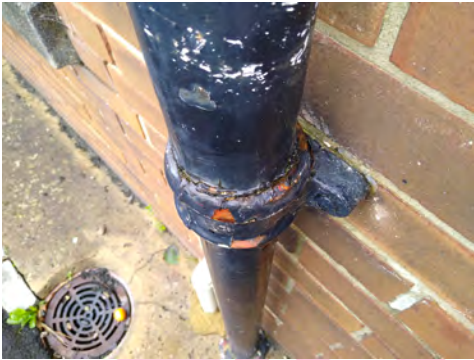
Item 44 Ref: 427459-28

The metal soil pipe flange (External Canteen) does not contain asbestos.

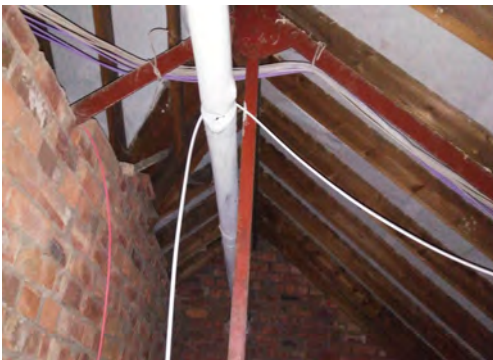
Item 45 Ref: 427459-6

The pipe lagging in Loft Main Building contains asbestos.

Any change in its appearance should be recorded and passed to Property Services.

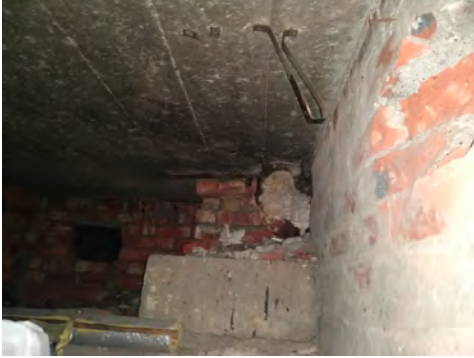
Item 46 Ref: Presumed

The pipe lagging in Main service duct is presumed to contain asbestos.

Any change in its appearance should be recorded and passed to Property Services.

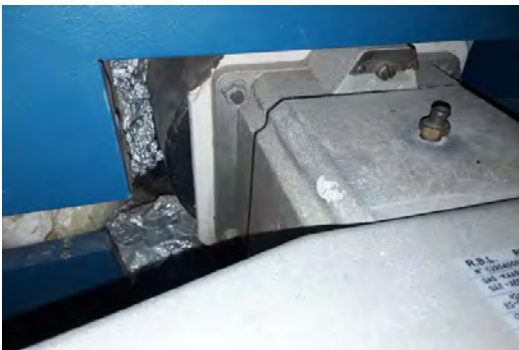
Item 48 Ref: 23-63275-3

The insulation boards inside boilers in Main Boiler Room so not contain asbestos.

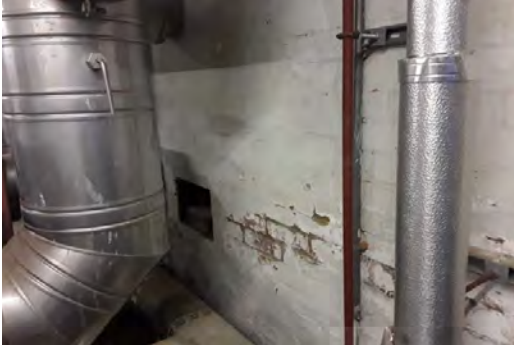
Item 49 Ref: 23-63275-4

The residual insulation to walls in Main Boiler Room contains asbestos.

Any change in its appearance should be recorded and passed to Property Services.

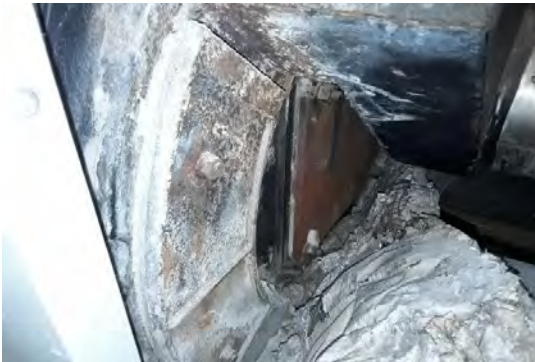
Item 50 Ref: 23-63275-5

The gaskets inside boilers in Main Boiler Room does not contain asbestos.

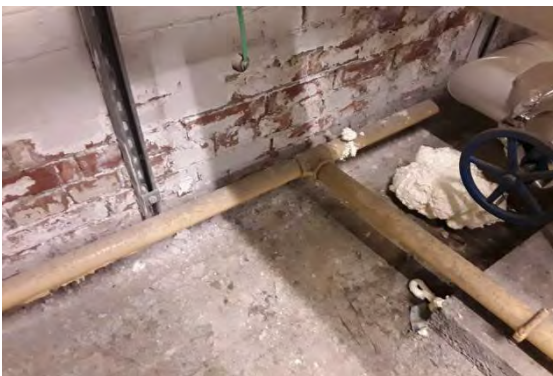
Item 51 Ref: 23-63275-6

The debris to floor in Main Boiler Room contains asbestos.

This was removed August 2023

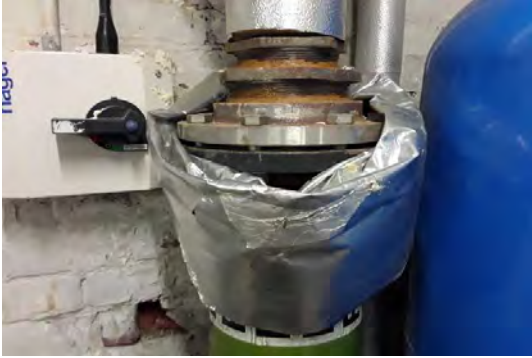
Item 52 Ref: 23-63275-7

The pipe flange gaskets in Main Boiler Room does not contains asbestos.

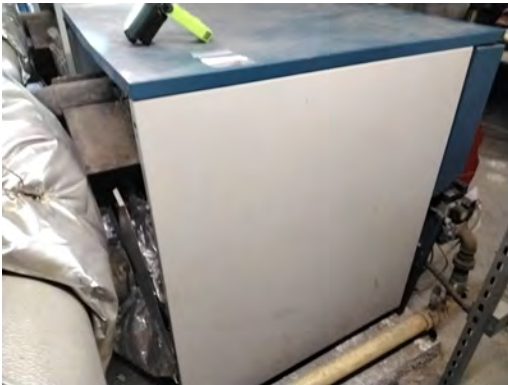
Item 53 Ref: KX001946/01

The putty between boiler segments in Boiler Room does not contain asbestos.

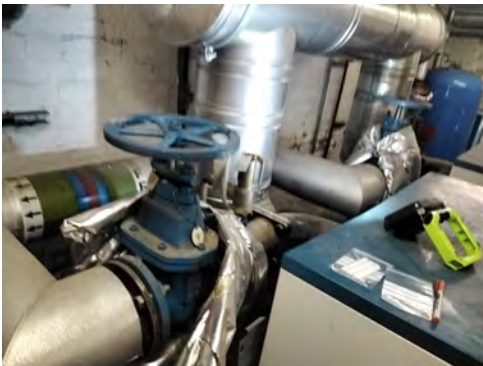
Item 54 Ref: KX001947/02

The gaskets in Main Boiler Room does not contains asbestos.

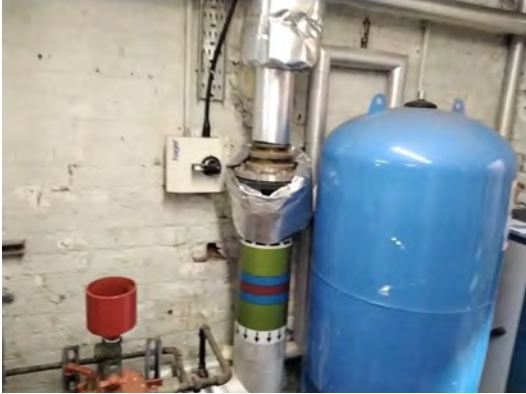
Item 55 Ref: KX001948/03

The pipe flange gaskets in Main Boiler Room does not contains asbestos.

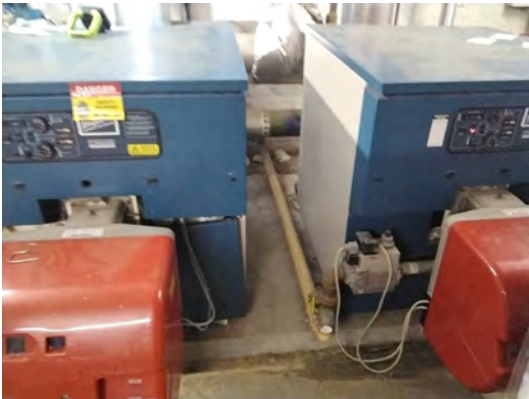
Item 56 Ref: KX001949/04

The seal to pumps on front of boilers in Boiler Room does not contain asbestos.

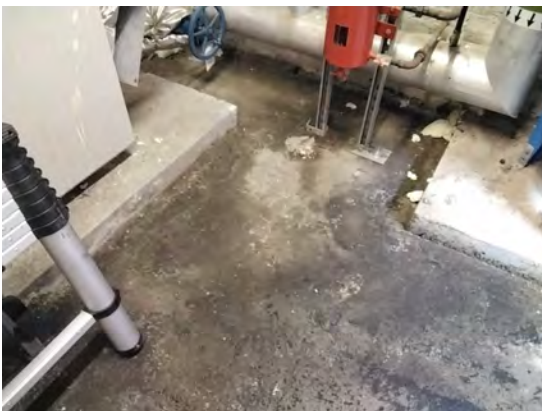
Item 57 Ref: KX001950/05

The debris to floor between door and front boiler in Main Boiler Room does not contains asbestos.

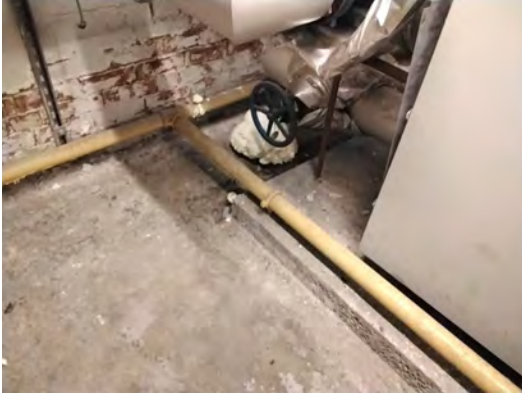
Item 58 Ref: KX001951/06

The debris to floor behind rear boiler in Main Boiler Room contains asbestos.

This was removed August 2023

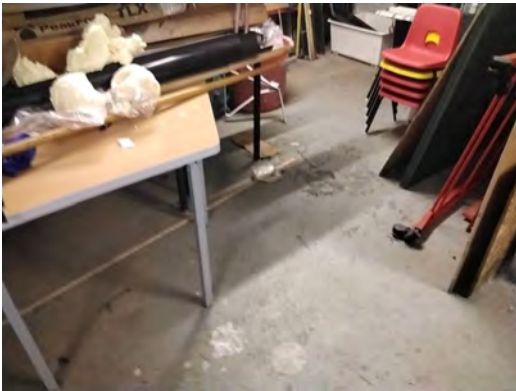
Item 59 Ref: KX001952/07

The debris to floor in gas inlet room in Boiler Room does not contain asbestos.

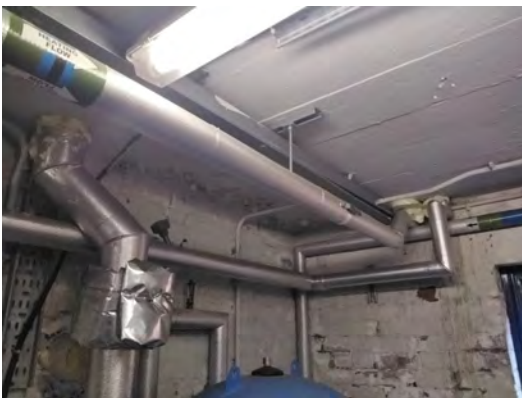
Item 60 Ref: KX001955/10

The debris to ceiling penetrations in Main Boiler Room contains asbestos.

Any change in its appearance should be recorded and passed to Property Services.

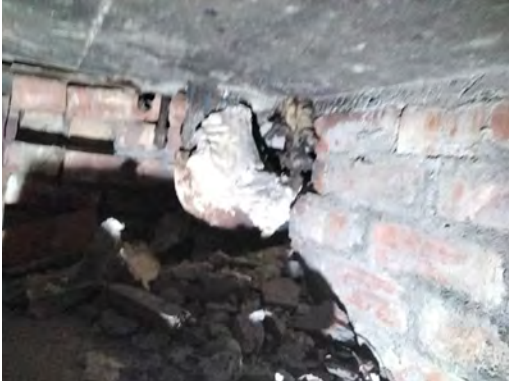
Item 61 Ref: KX001956/11

The pipework insulation in Main Boiler Room contains asbestos.

Any change in its appearance should be recorded and passed to Property Services.

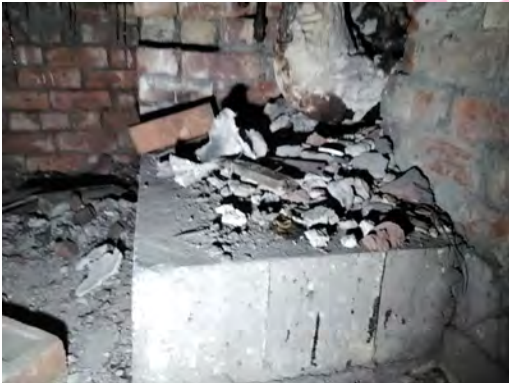
Item 62 Ref: KX001957/12

The debris in Main Boiler Room contains asbestos.

Any change in its appearance should be recorded and passed to Property Services.

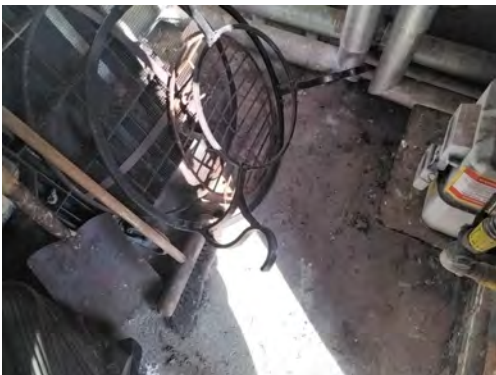
Item 63 Ref: KX001958/13

The debris in Plant Room does not contain asbestos.

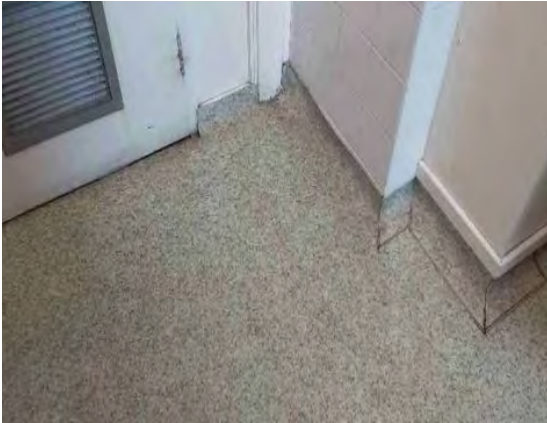
Item 64 Ref: OQ000499

The floor tiles in the Male Toilet (G/001) does not contain asbestos.

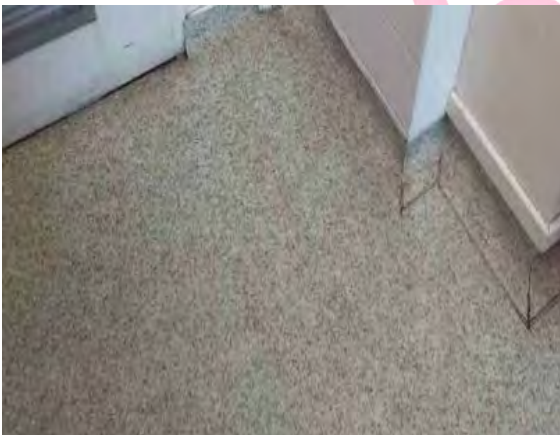
Item 65 Ref: As OQ000499

The floor tiles in the Female toilet (G/002) does not contain asbestos.

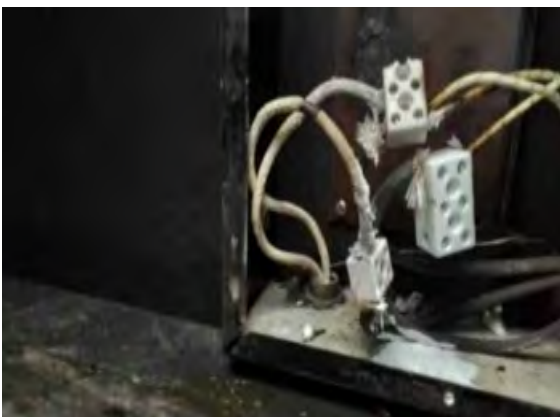
Item 66 Ref: OQ000506

The electrical services cable/braiding insulation in the Kitchen (G/003) does contain asbestos.

Removed September 2024

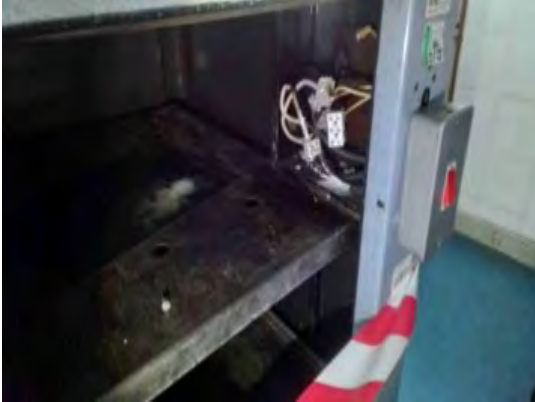
Item 67 Ref: OQ000507

The lining to the bottom of the electrical box in the Kitchen (G/003) does contain asbestos.

Removed September 2024

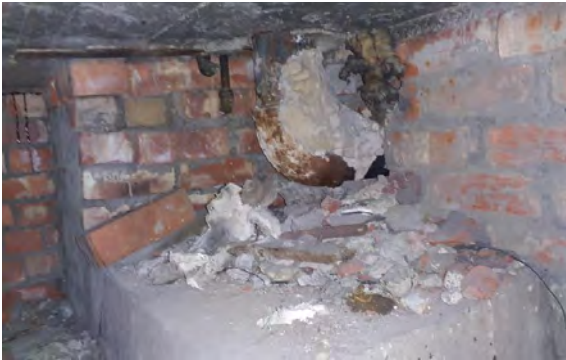
Item 68 Ref: Presumed

The insulation debris to floor and to pipe in the Undercroft (Z1/01) does contain asbestos.

Any change in its appearance should be recorded and passed to Property Services.

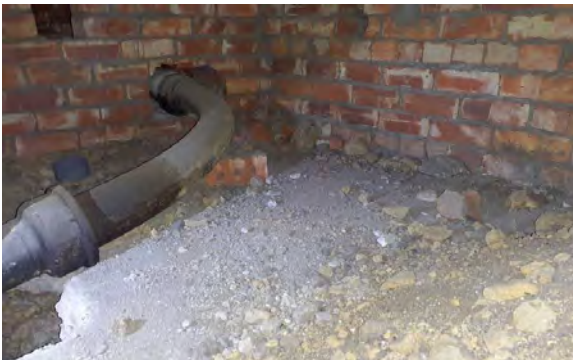
Item 69 Ref: Presumed

The insulation debris to floor in the Undercroft (Z1/02) does contain asbestos.

Any change in its appearance should be recorded and passed to Property Services.

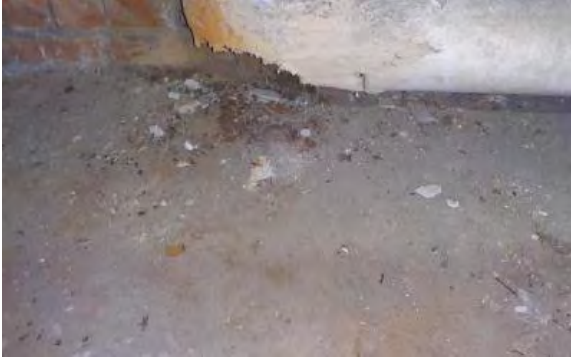
Item 70 Ref: Presumed

The insulation debris to floor in the Undercroft (Z1/05) does contain asbestos.

Any change in its appearance should be recorded and passed to Property Services.

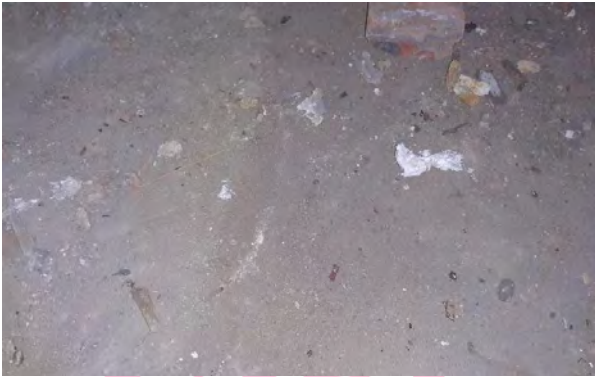
Item 71 Ref: Presumed

The insulation debris to floor and to pipe in the Undercroft (Z1/07) does contain asbestos.

Any change in its appearance should be recorded and passed to Property Services.
