ASBESTOS SURVEY REPORT FOR FUWELL JUNIOR SCHOOL, FULWELL, SUNDERLAND, SR6 9EE.

**Asbestos Register for**

**Fulwell Junior School**

**Date: 16 April 2026**

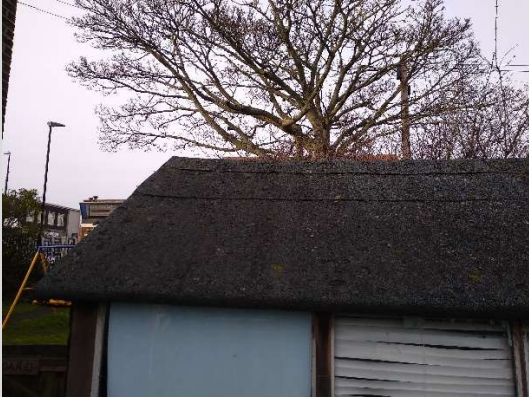
12	392632-34	Roof felt to timber shed	External/ Caretakers House	No Risk

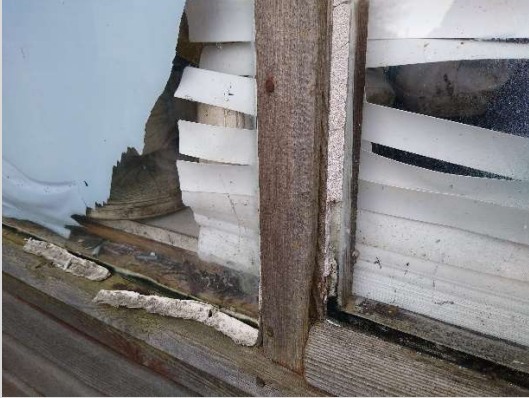
13	392632-35	Putty to glazing	External/ Caretakers House	No Risk
