ASBESTOS SURVEY REPORT FOR GRINDON INFANTS SCHOOL,
GLENEAGLES ROAD, SUNDERLAND, SR4 9QN

Asbestos Register for Grindon Infants School

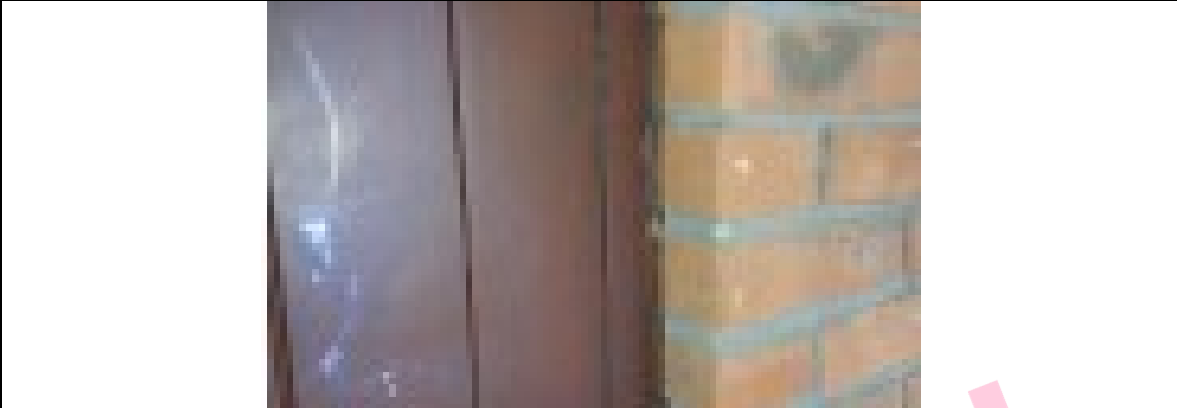
16	PK004398	Mastic – wood door frame	External E/001	Very Low Risk - inspect annually
