ASBESTOS SURVEY REPORT FOR THE HARRATON CENTRE, FIRTREE AVENUE, WASHINGTON, TYNE & WEAR, NE38 9BA

**The Harraton Centre, Washington. NE38 9BA**

**Date: 08 July 2025**

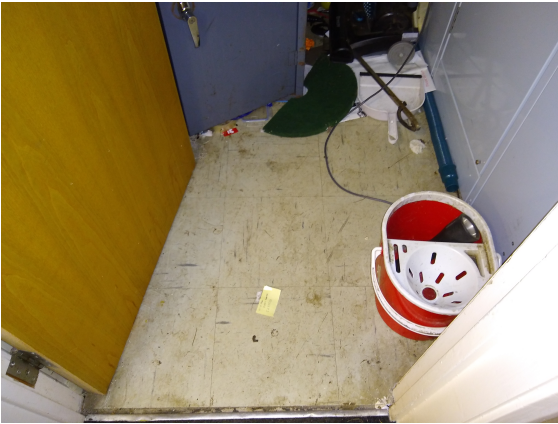
### **Item 4 Ref: 365647-2**

- (Item 3) Ref: As 365647-1 – Remnant adhesive to floor (003/store) – Very Low Risk
- (Item 4) Ref: 365647-2 – Floor covering (004/meter cupboard) – Very Low Risk

The floor covering in room 004/meter cupboard contains asbestos.

Any change in its appearance should be recorded and passed to Property Services.

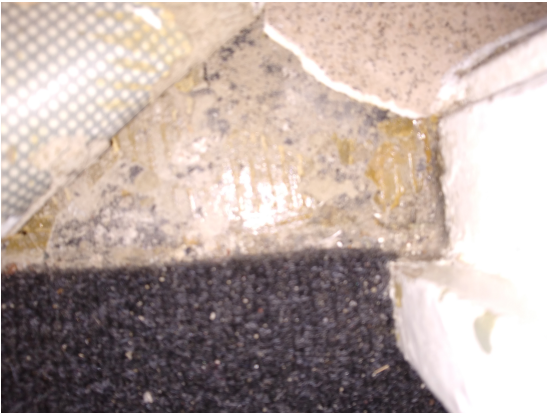
### **Item 5 Ref: 365647-3**

The adhesive to floor in room 005/female wc contains asbestos.

Any change in its appearance should be recorded and passed to Property Services.

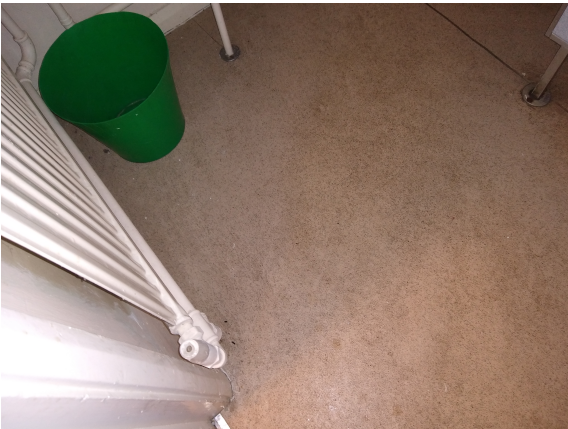
### **Item 6 Ref: As 365647-3**

The remnant adhesive to floor in room 006/male wc contains asbestos.

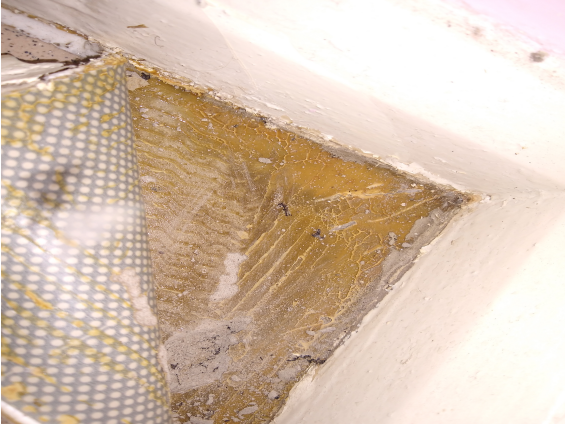
### **Item 7 Ref: As 365647-3**

The adhesive to floor in room 007/disabled wc contains asbestos.

Any change in its appearance should be recorded and passed to Property Services.

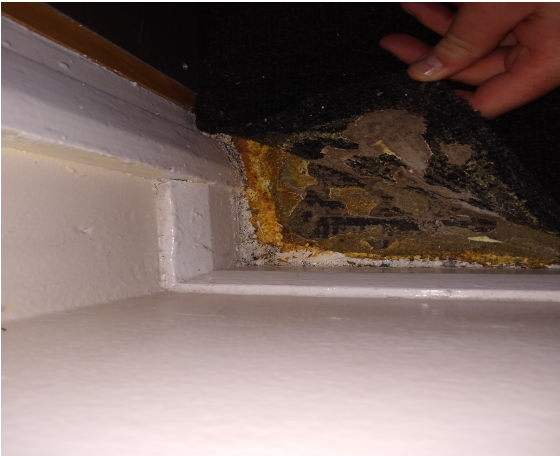
### **Item 8 Ref: As 365647-3**

The remnant adhesive to floor in room 008/entrance lobby contains asbestos.

Any change in its appearance should be recorded and passed to Property Services.

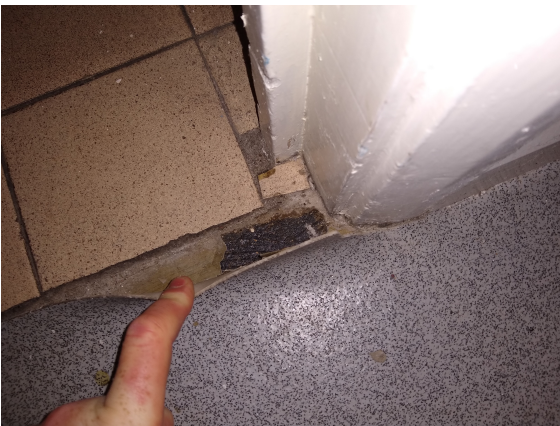
### **Item 9 Ref: As 365647-3**

The remnant adhesive to floor in room 008A/lobby contains asbestos.

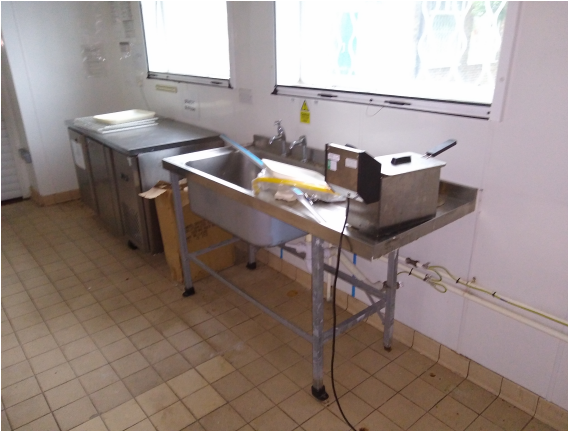
### **Item 10 Ref: 365647-4**

The acoustic paint to metal sinks in room 013/kitchen does not contain asbestos.

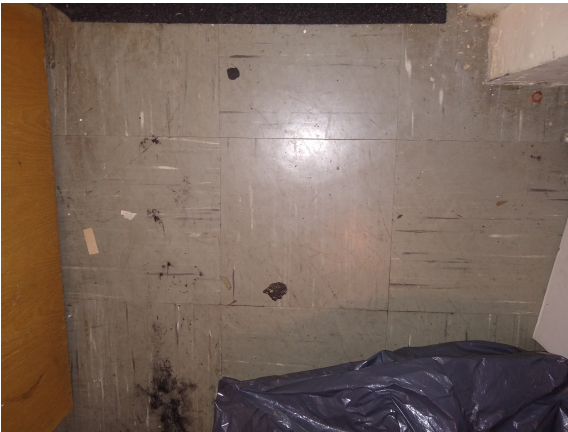
### **Item 11 Ref: 365647-5**

The floor covering in room 014/store contains asbestos.

Any change in its appearance should be recorded and passed to Property Services.

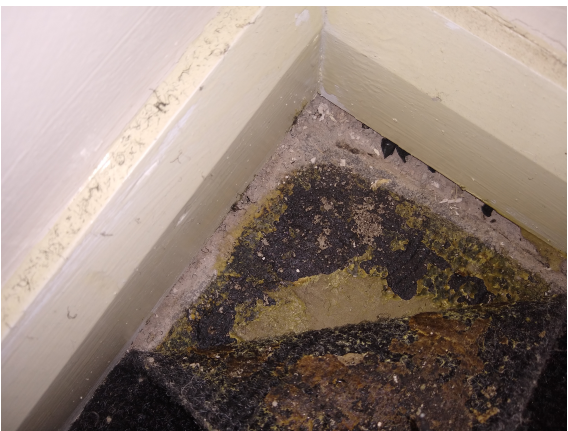
### **Item 12 Ref: As 365647-3**

The remnant adhesive to floor in room 015/office contains asbestos.

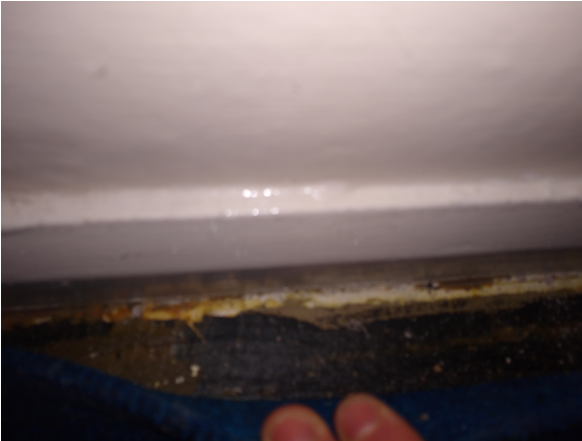
### **Item 13 Ref: As 365647-3**

The remnant adhesive to floor in room 016/office contains asbestos.

Any change in its appearance should be recorded and passed to Property Services.

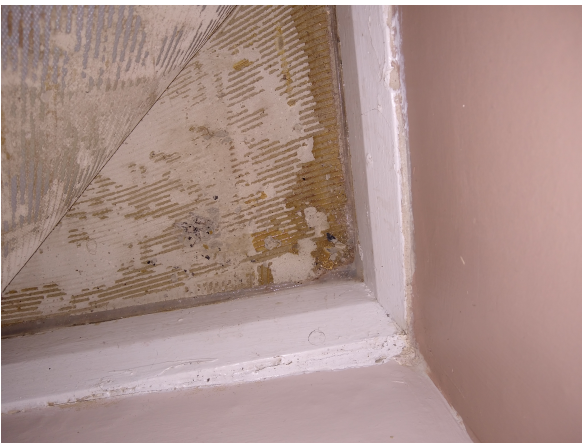
### **Item 14 Ref: As 365647-3**

The remnant adhesive to floor in room 017/office contains asbestos.

Any change in its appearance should be recorded and passed to Property Services.

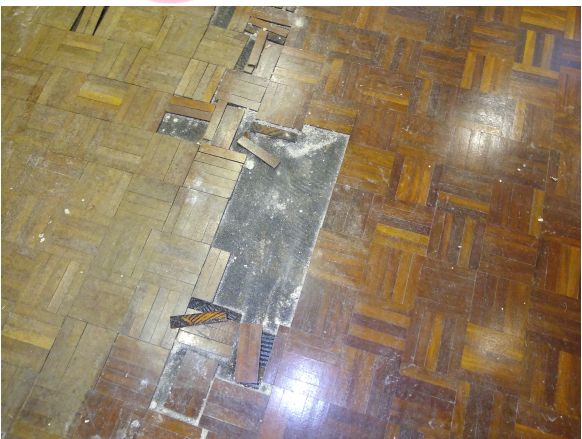
### **Item 15 Ref: 365647-6**

The adhesive backing to parquet flooring in room 019/hall does not contain asbestos.

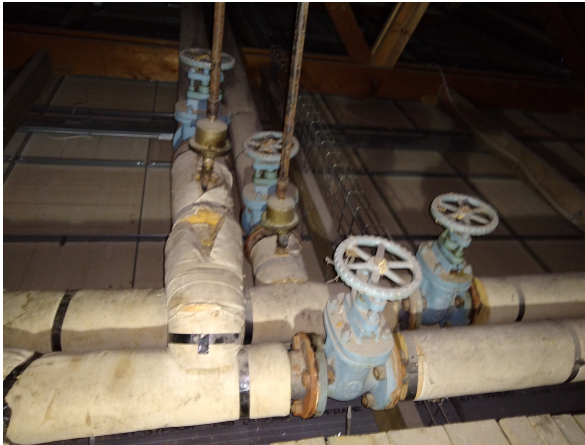
### **Item 16 Ref: 365647-15**

The pipework flange gaskets in room 019/hall void above contains asbestos.

Any change in its appearance should be recorded and passed to Property Services.

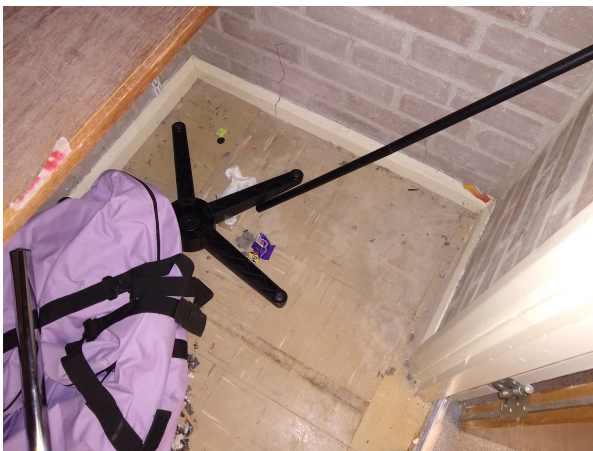
### **Item 18 Ref: 365647-7**

The floor covering in room 021a/store cupboard contains asbestos.

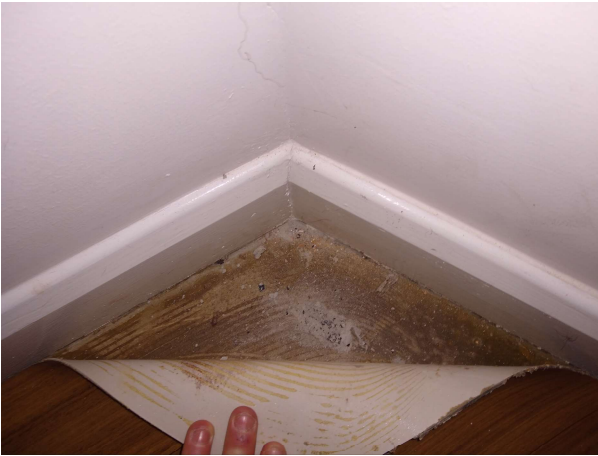
### **Item 19 Ref: 365647-8**

The adhesive to floor below linoleum in room 023/salon contains asbestos.

Any change in its appearance should be recorded and passed to Property Services.

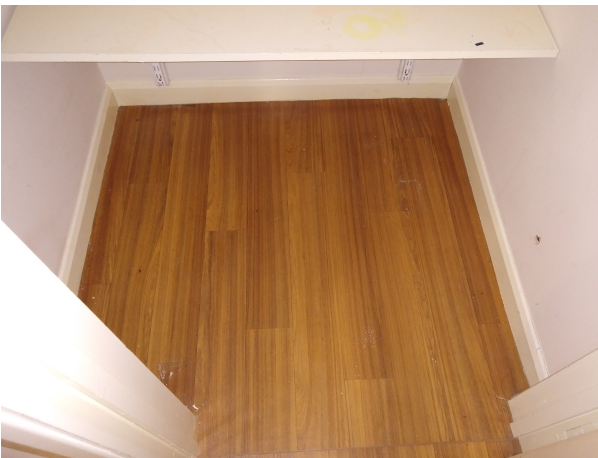
### **Item 20 Ref: As 365647-8**

The adhesive to floor in room 23a/salon cupboard contains asbestos.

Any change in its appearance should be recorded and passed to Property Services.

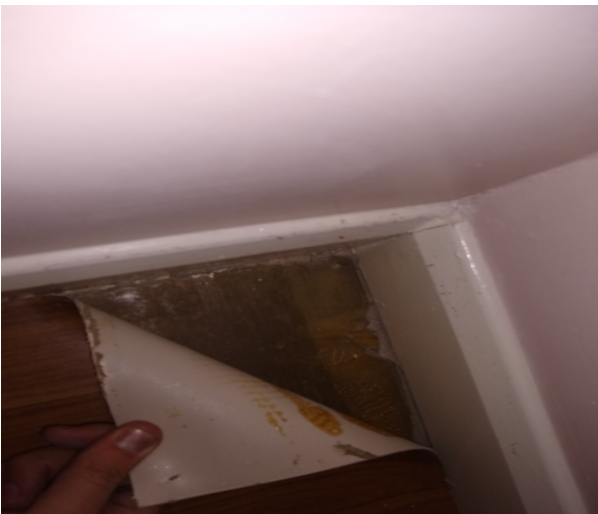
### **Item 21 Ref: As 365647-8**

The adhesive to floor in room 24/salon kitchen contains asbestos.

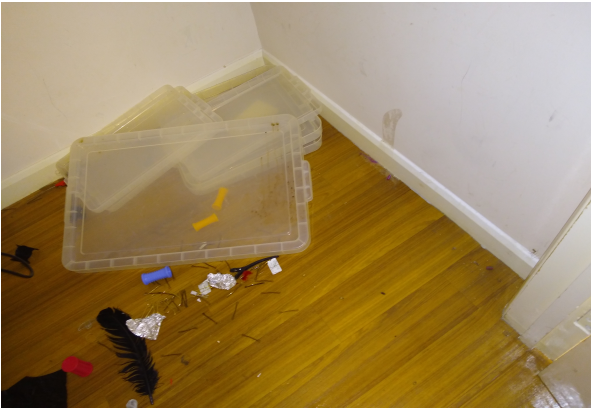
### **Item 22 Ref: As 365647-8**

The adhesive to floor in room 024a/salon kitchen cupboard contains asbestos.

Any change in its appearance should be recorded and passed to Property Services.

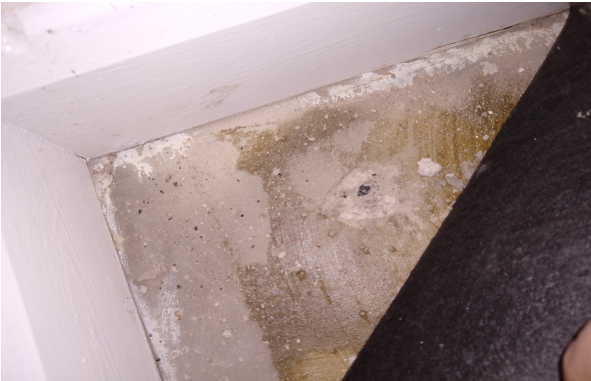
### **Item 23 Ref: As 365647-8**

The remnant adhesive to floor in room 28/reception contains asbestos.

Any change in its appearance should be recorded and passed to Property Services.

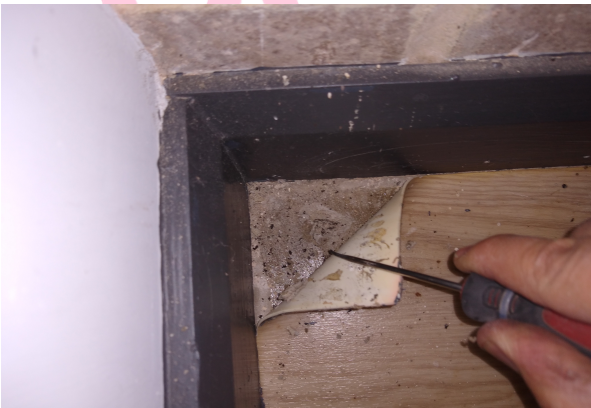
### **Item 24 Ref: As 365647-8**

The adhesive to floor in room 30/room contains asbestos.

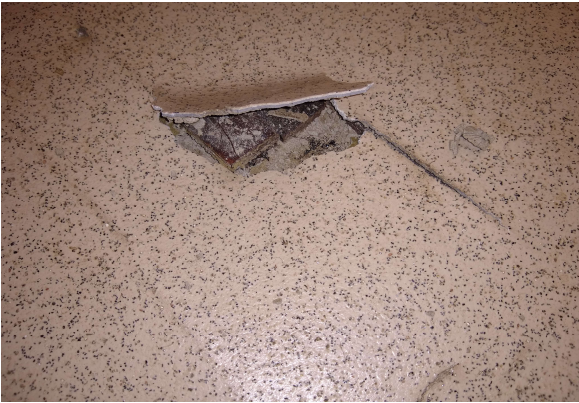
### **Item 25 Ref: As 365647-6**

The adhesive backing to parquet floor and concrete floor in room 032/kitchen does not contain asbestos.

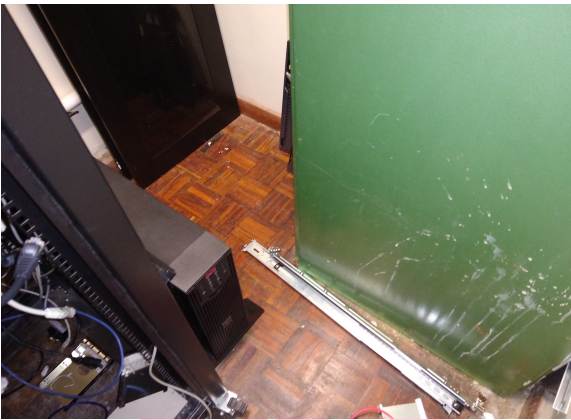
### **Item 26 Ref: As 365647-6**

The adhesive backing to parquet floor and concrete floor in room 033/server room does not contain asbestos.

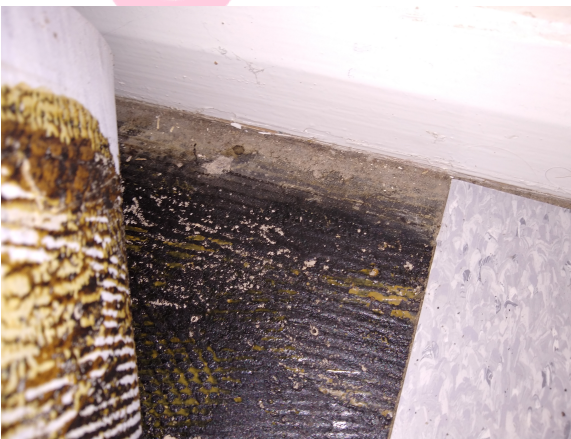
### **Item 27 Ref: 365647-9**

The adhesive to floor in room 38/classroom contains asbestos.

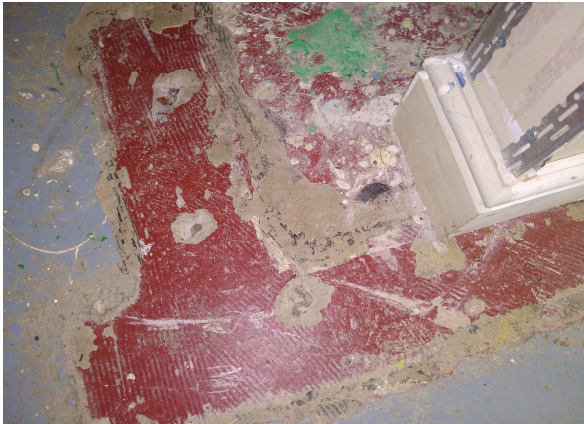
### **Item 28 Ref: 365647-10**

The remnant adhesive to floor in room 045/workshop contains asbestos.

Any change in its appearance should be recorded and passed to Property Services.

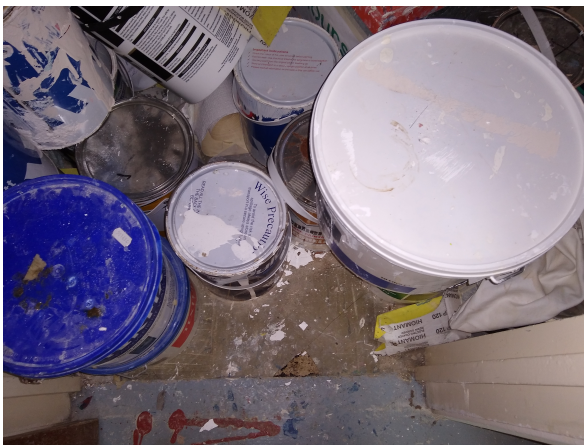
### **Item 29 Ref: 365647-11**

The floor covering in room 045a/cupboard contains asbestos.

Any change in its appearance should be recorded and passed to Property Services.

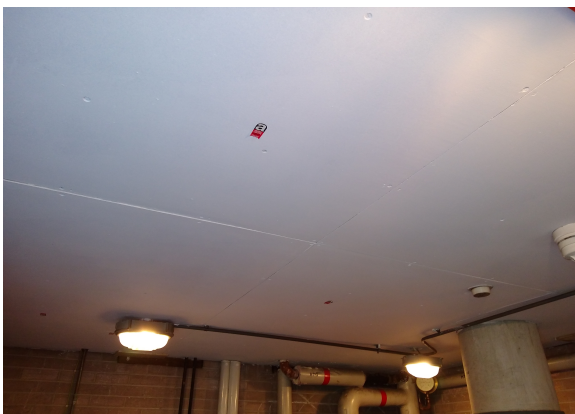
### **Item 30 Ref: 365647-22**

The ceiling panels in room 47/boiler room contains asbestos.

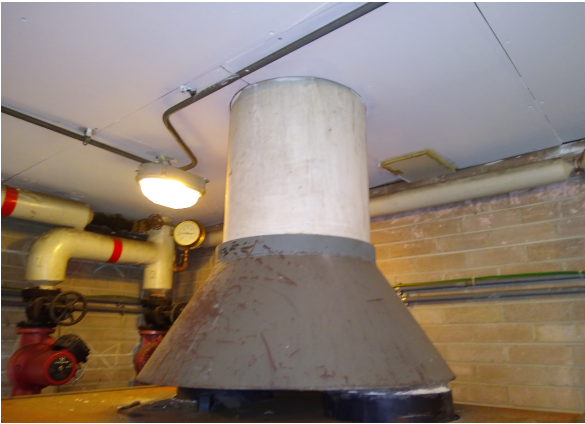
### **Item 31 Ref: As 365647-12**

The boiler flue in room 47/boiler room contains asbestos.

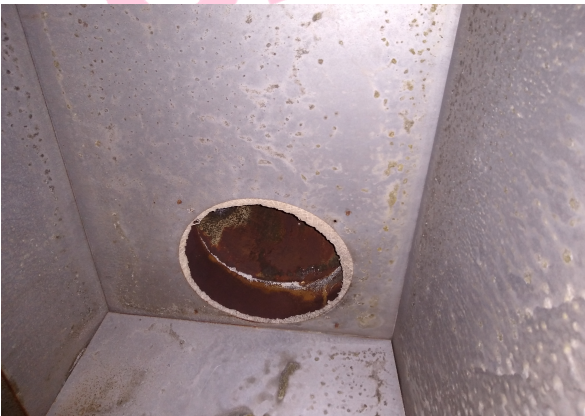
### **Item 33 Ref: 365647-24**

The seal to flue exhausts (boiler internals) in room 47/boiler room contains asbestos.

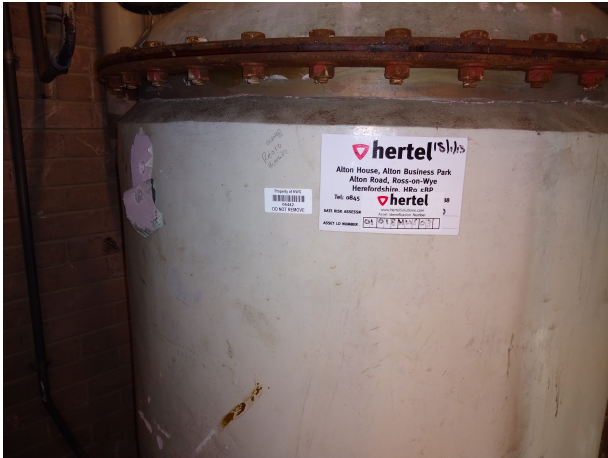
### **Item 34 Ref: 365647-25**

The hertel tank insulation in room 47/boiler room does not contain asbestos.

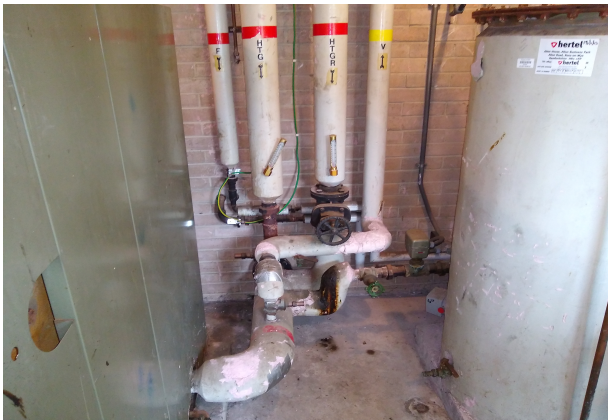
### **Item 35 Ref: 365647-26**

The pipe lagging medium bore pipework in room 47/boiler room does not contain asbestos.

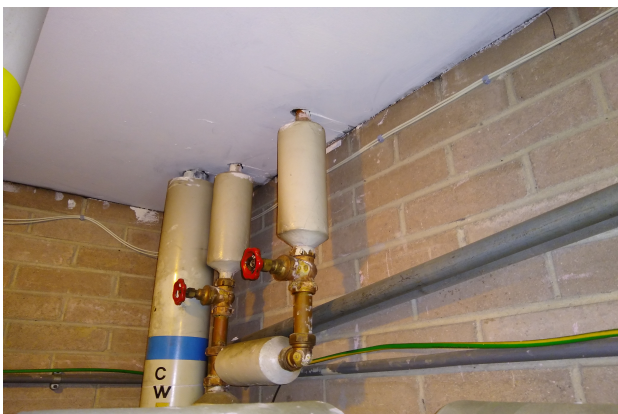
### **Item 36 Ref: 365647-27**

The pipe lagging small bore in room 47/boiler room does not contain asbestos.

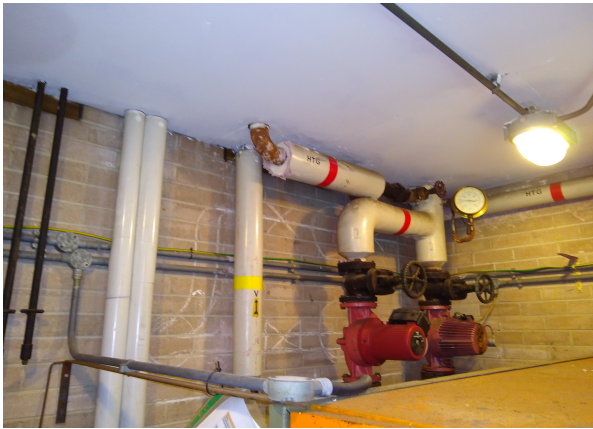
### **Item 37 Ref: 365647-28**

The pipe lagging medium bore pipework in room 47/boiler room does not contain asbestos.

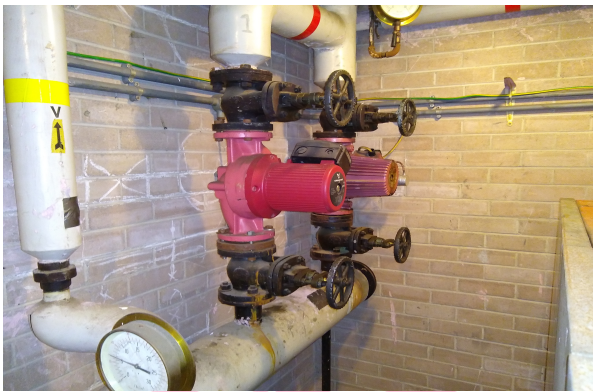
### **Item 38 Ref: 365647-29**

The pipework flange gaskets in room 47/boiler room contain asbestos.

Any change in appearance should be reported to Property Services.

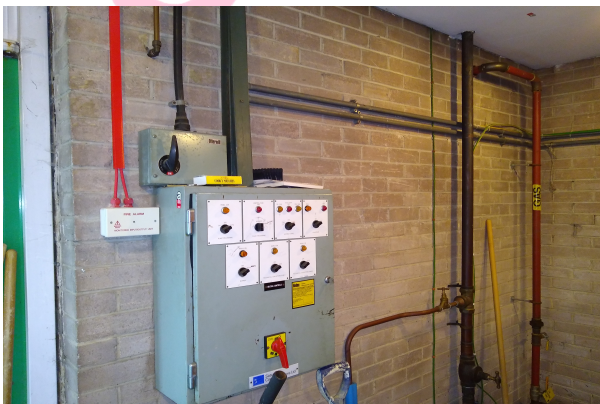
### **Item 39 Ref: 365647-30**

The debris to wall in room 47/boiler room does not contain asbestos.

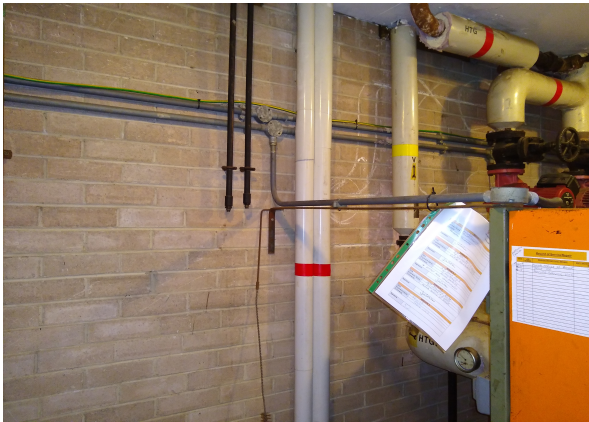
**Item 40 Ref: 365647-31**

The debris to wall in room 47/boiler room does not contain asbestos.

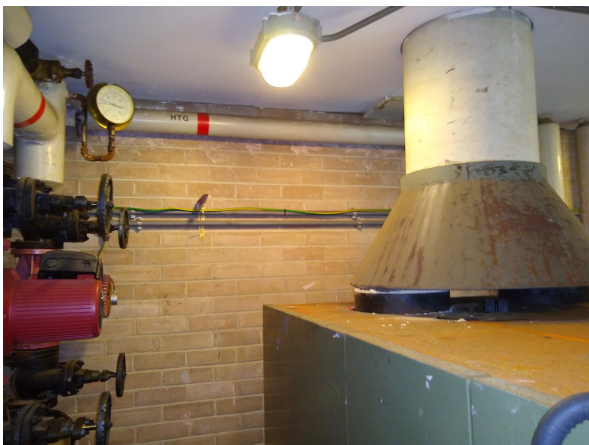
**Item 41 Ref: 365647-32**

The debris to wall in room 47/boiler room does not contain asbestos.

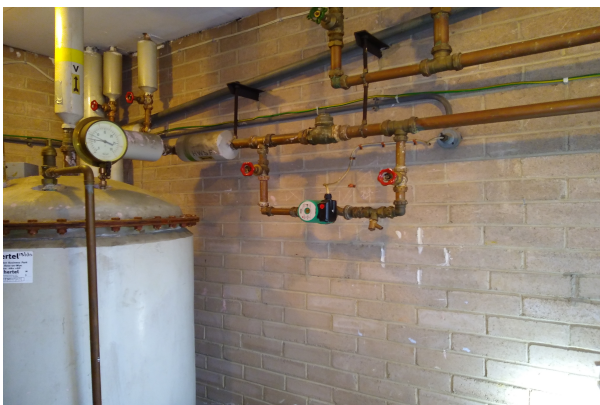
**Item 42 Ref: 365647-33**

The debris to wall in room 47/boiler room does not contain asbestos.

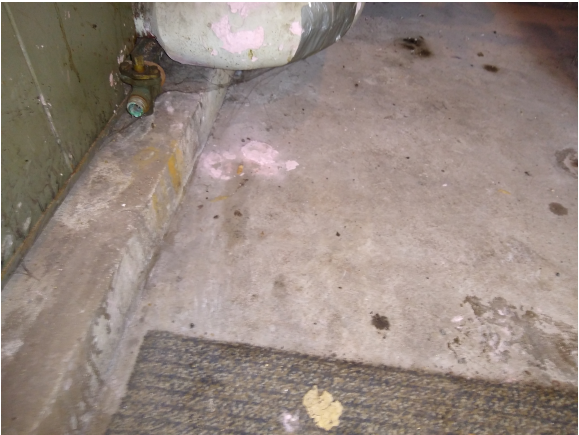
### **Item 43 Ref: 365647-34**

The debris to floor and plinth in room 47/boiler room does not contain asbestos.

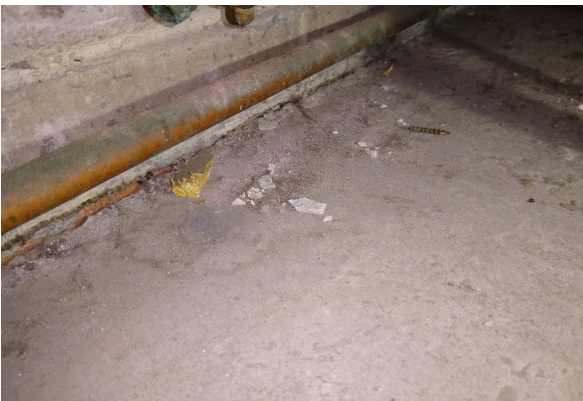
### **Item 44 Ref: 365647-35**

The debris to floor below pipework adjacent to the boiler in room 47/boiler room does contain asbestos.

Removed December 2019

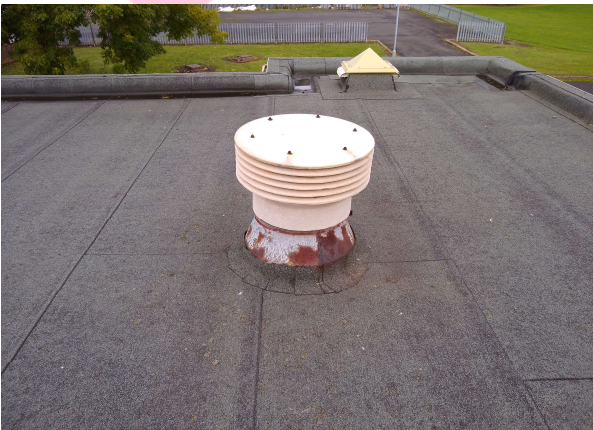
### **Item 45 Ref: 365647-33**

The flue cowl above boiler room (external) does contain asbestos.

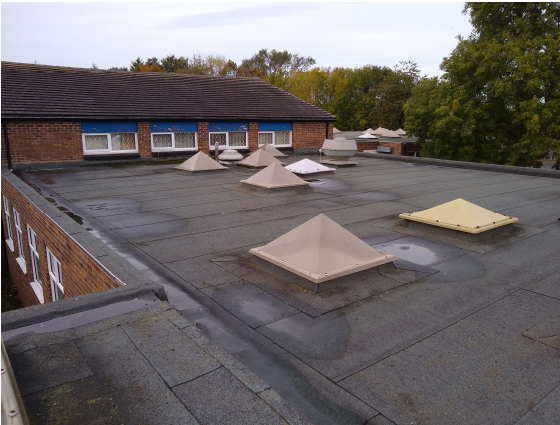
### **Item 47 Ref: 365647-14**

The flat roof covering (external) does not contain asbestos.

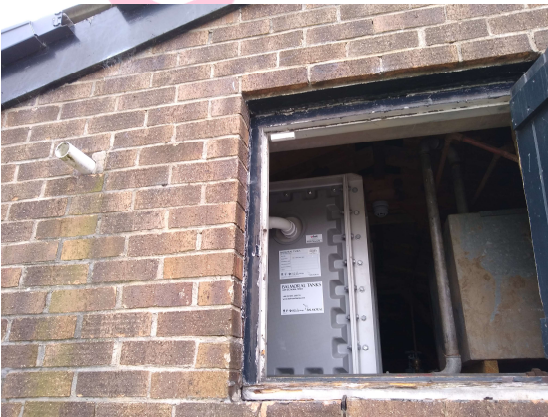
### **Item 48 Ref: 365647-16**

The seal to tank stand door (external) does not contain asbestos.

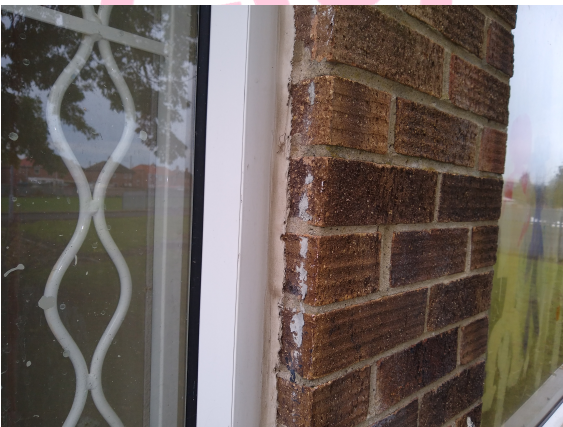
### **Item 51 Ref: 365647-18**

The remnant seal to window frames (external) does contain asbestos.

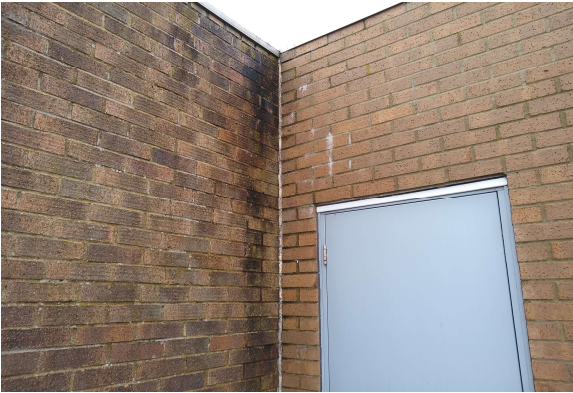
**Item 52 Ref: 365647-19**

The expansion gap seal (external) does not contain asbestos.

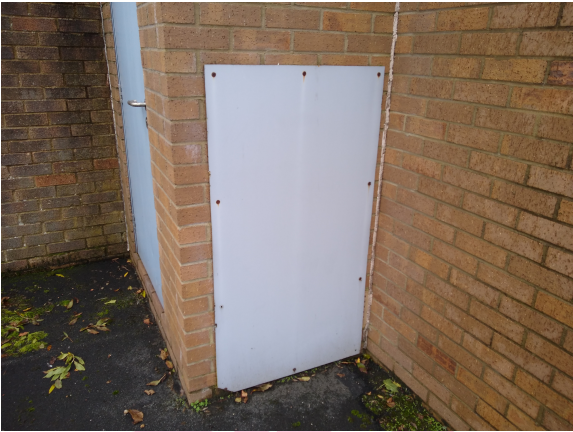
**Item 53 Ref: 365647-20**

The panel to wall (external) does not contain asbestos.

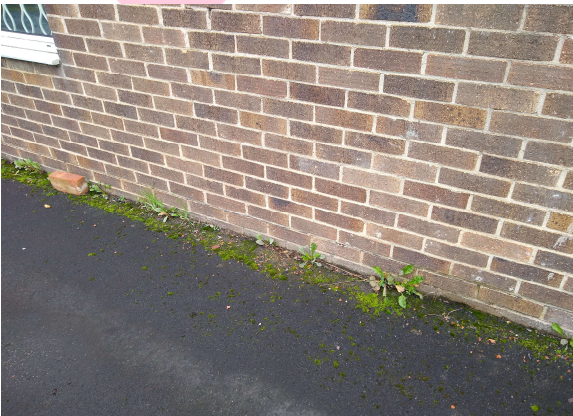
**Item 54 Ref: 365647-21**

The damp proof course (external) does not contain asbestos.

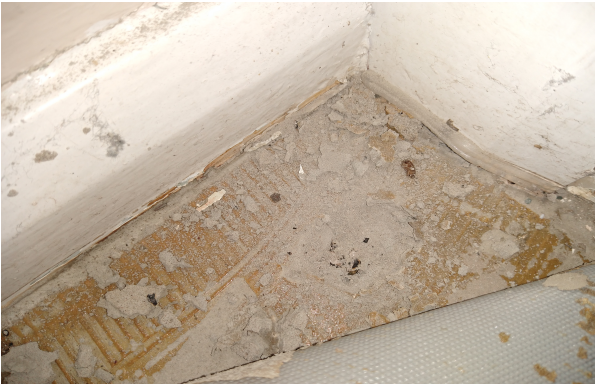
### **Item 55 Ref: 412164-9**

The remnant bitumen adhesive below modern linoleum in corridor (Rm 0/18) does contain asbestos.

Any change in appearance should be reported to Property Services.

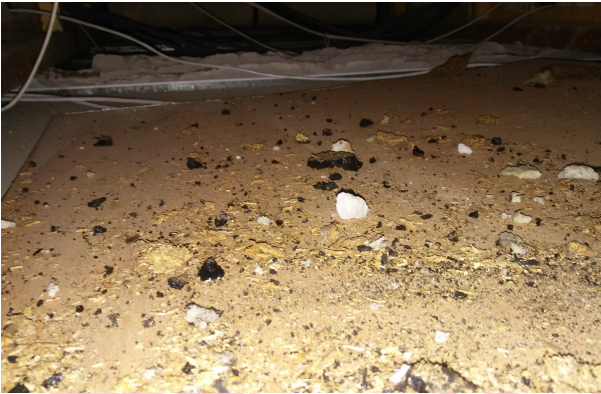
### **Item 56 Ref: 412164-8**

The debris to top of suspended ceiling in corridor – void above (Rm 0/18) does not contain asbestos.

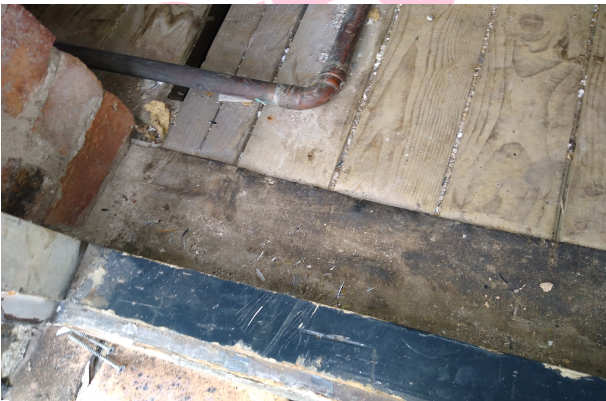
### **Item 57 Ref: 412164-7**

The bituminous felt adj door from roof in hall - void above (Rm 0/19) does not contain asbestos.

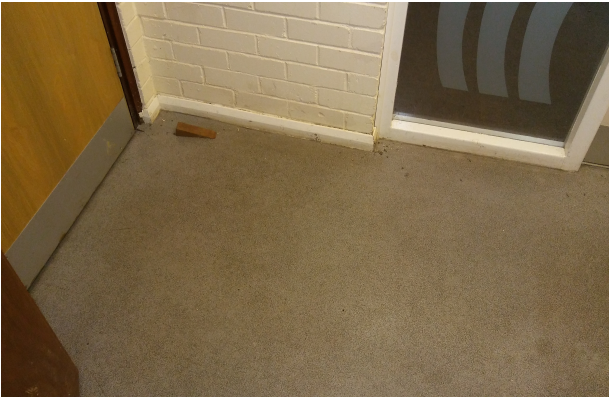
### **Item 58 Ref: As 412164-4**

The adhesive to floor beneath screed in the lobby (Rm 0/21) does contain asbestos.

Any change in appearance should be reported to Property Services.

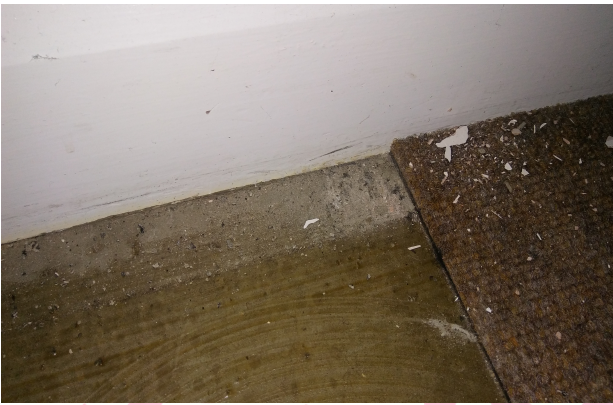
### **Item 59 Ref: 412164-5**

The adhesive to floor beneath screed in the classroom (Rm 0/22) does contain asbestos.

Any change in appearance should be reported to Property Services.

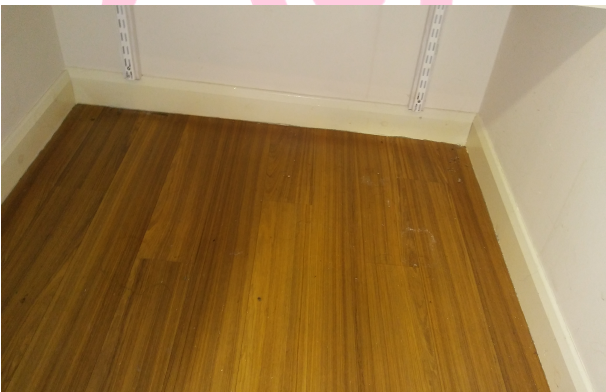
### **Item 60 Ref: As 412164-5**

The adhesive to floor beneath linoleum in the store (Rm 0/23a) does contain asbestos.

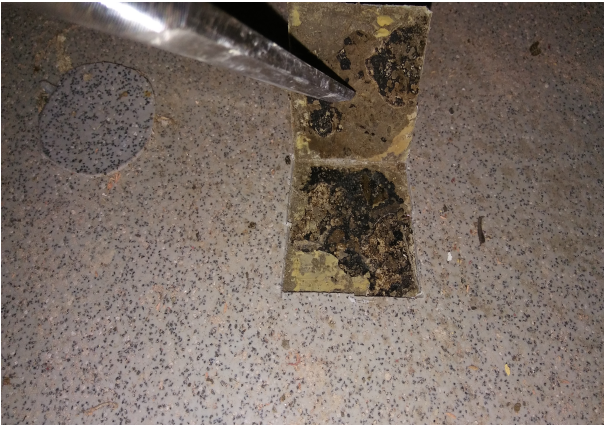
### **Item 62 Ref: As 412164-6**

The adhesive to floor beneath screed in the female WC (Rm 0/25) does contain asbestos.

Any change in appearance should be reported to Property Services.

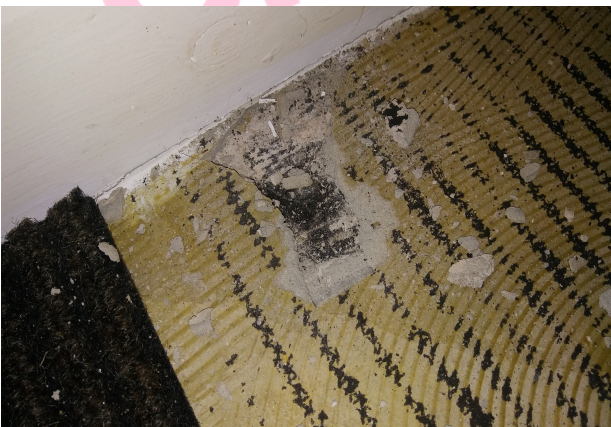
### **Item 63 Ref: 412164-6**

The adhesive to floor beneath screed in the lobby (Rm 0/26) does contain asbestos.

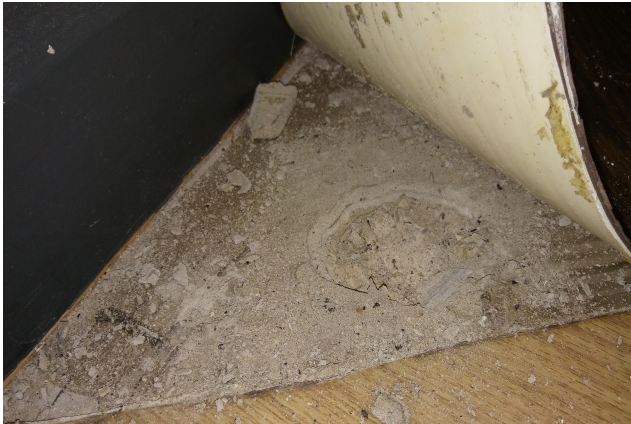
### **Item 64 Ref: 412164-4**

The adhesive to floor beneath screed in the studio (Rm 0/29) does contain asbestos.

Any change in appearance should be reported to Property Services.

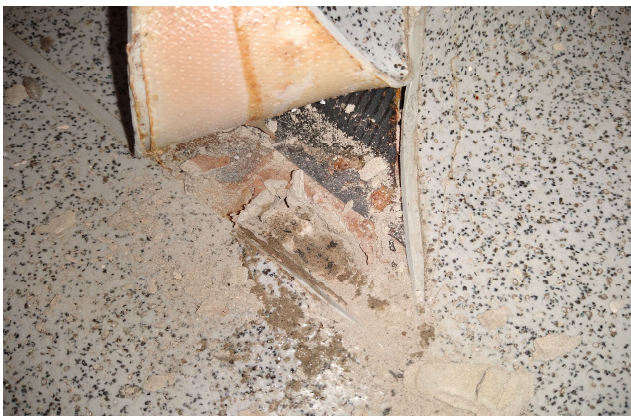
### **Item 65 Ref: As 412164-3**

The remnant bitumen adhesive below modern linoleum in the female wc lobby (Rm 0/34) does contain asbestos.

Any change in appearance should be reported to Property Services.

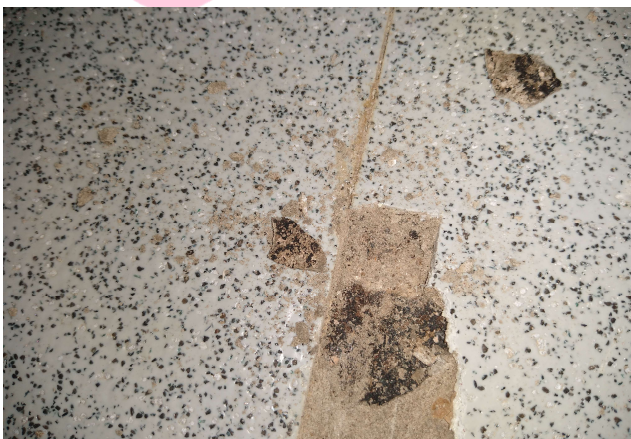
### **Item 66 Ref: As 412164-3**

The remnant bitumen adhesive below modern linoleum in the female wc (Rm 0/35) does contain asbestos.

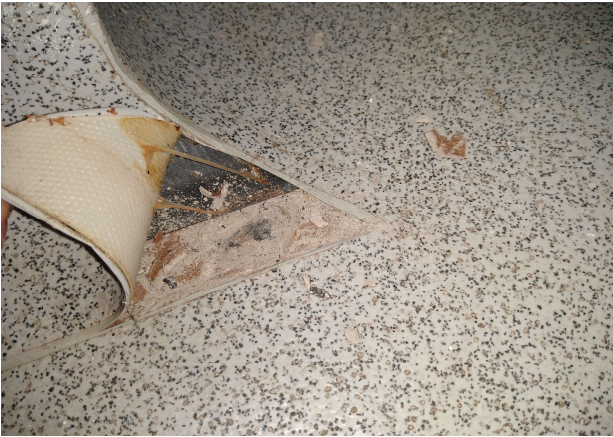
### **Item 67 Ref: As 412164-3**

The remnant bitumen adhesive below modern linoleum in the male wc lobby (Rm 0/36) does contain asbestos.

Any change in appearance should be reported to Property Services.

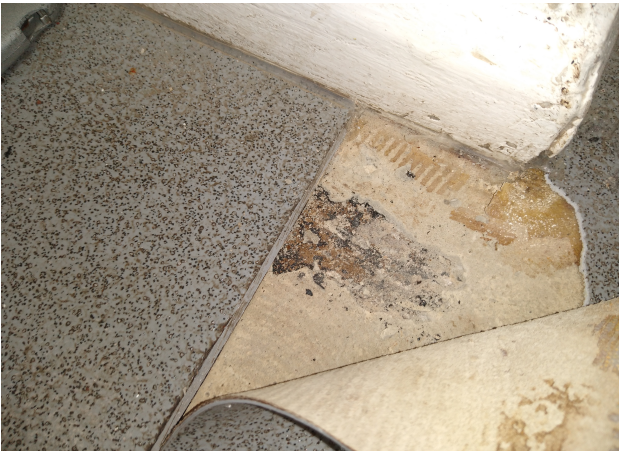
### **Item 68 Ref: 412164-3**

The remnant bitumen adhesive below modern linoleum in corridor (Rm 0/40) does contain asbestos.

Any change in appearance should be reported to Property Services.

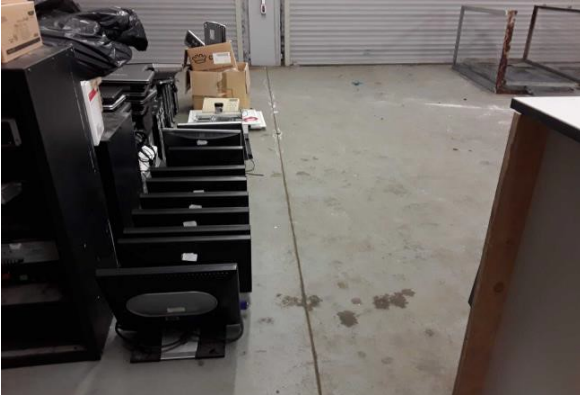
### **Item 82 Ref: 22-43761-3**

The putty between floor slabs (Area 1/Garage) does not contain asbestos.

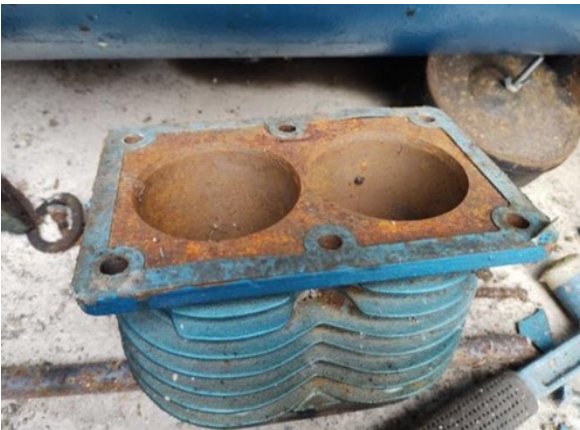
### **Item 83 Ref: 22-52616-1**

- (Item 83) Ref: 22-52616-1 – Gasket to loose compressor parts (Area 1: External Store) – Low Risk – removed Jan 2023 waiting removal paperwork
- (Item 84) Ref: 22-52616-2 – Gasket to loose compressor parts (Area 1: External Store) – Low Risk – removed Jan 2023 waiting removal paperwork

The gasket to loose compressor parts in the External Store (Area 1) does contain asbestos.

Removed Jan 2023 – waiting removal paperwork

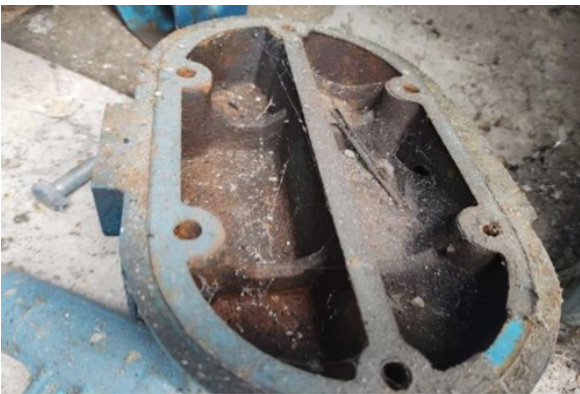
### **Item 84 Ref: 22-52616-2**

The gasket to loose compressor parts in the External Store (Area 1) does contain asbestos.

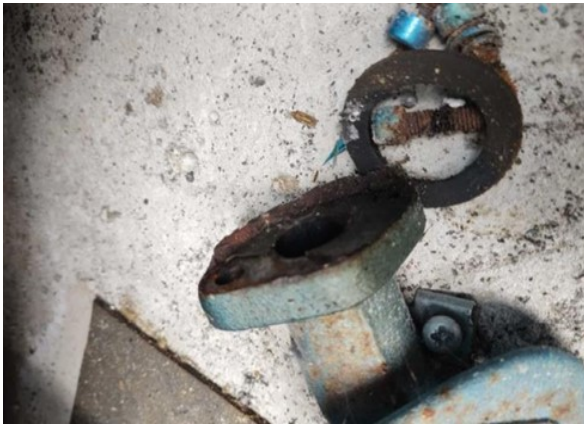
### **Item 85 Ref: 22-52616-3**

The gasket to loose compressor parts in the External Store (Area 1) does contain asbestos.

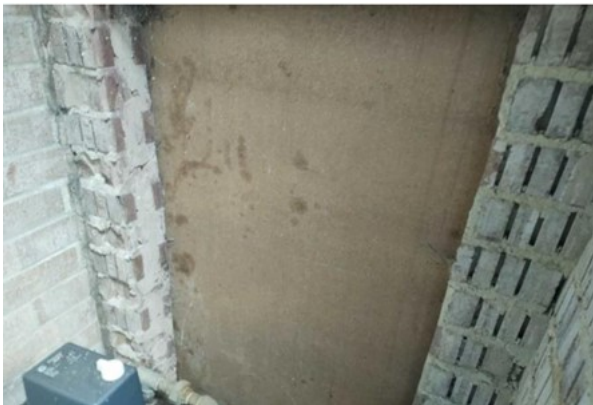
### **Item 86 Ref: 22-52616-4**

The cement infill panels in the external store (Area 1) does not contain asbestos.
