### ASBESTOS SURVEY REPORT FOR HILL VIEW INFANT SCHOOL, SUNDERLAND

**Asbestos Register for**

**HILL VIEW INFANT SCHOOL, SUNDERLAND**

**Date: 23 March 2026**

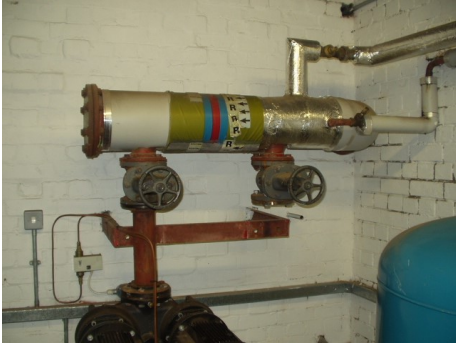
### **Item 1 Ref: Presumed**

The pipework flange gaskets to the boiler room are strongly presumed to contain asbestos.

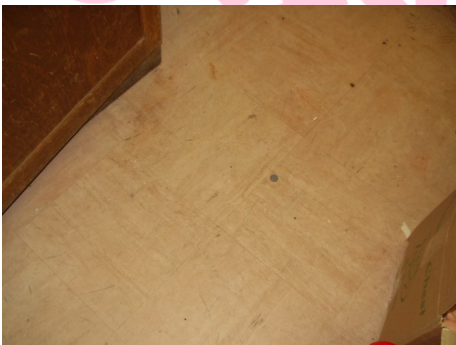
### **Item 3 - Ref: AW0834/08**

The beige floor tiles to the store cupboard (Rm 0/16) do not contain asbestos.

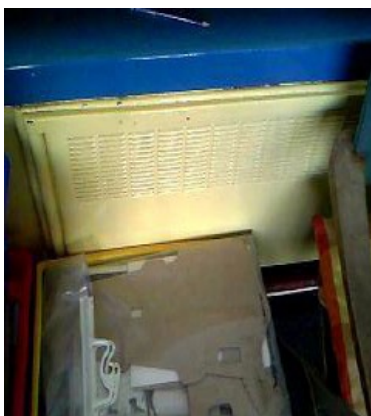
### **Item 15 – As BB000791**

The insulation panel between the heater and the brickwork to the wall in room 0/49 does not contain asbestos.

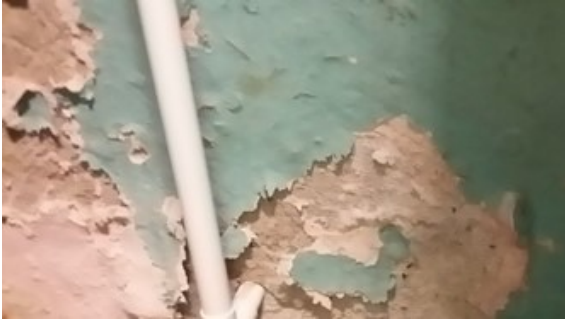
### **Item 25 - Ref: 102516-1**

The plaster to wall (Rm 086/store) does not contain asbestos.

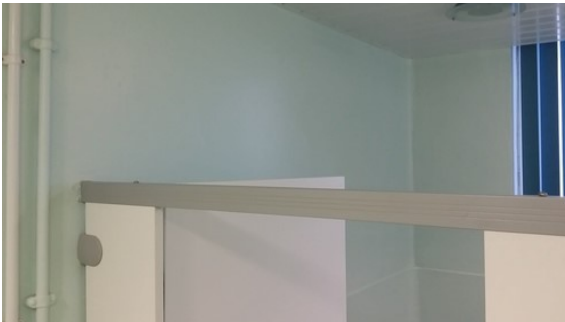
### **Item 26 - Ref: As 102516-**

The plaster to wall (Rm 087/Female WC) does not contain asbestos.

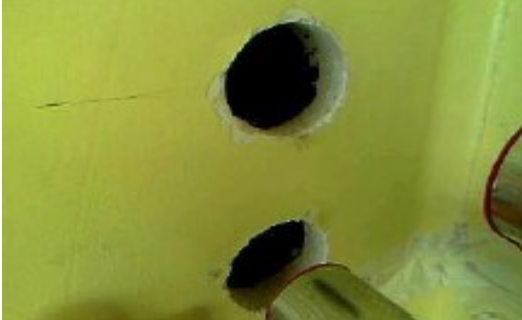
**Item 28 - Ref: BB001184**

The wall material (concrete & mesh) (Rm 01) does not contain asbestos.

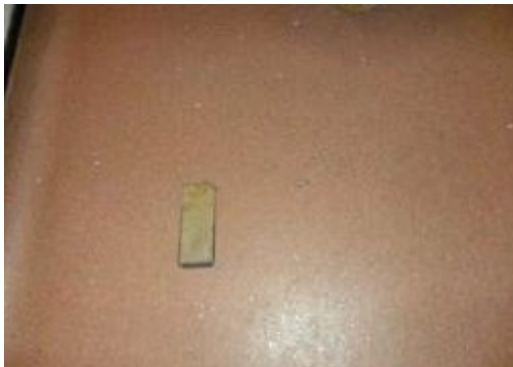
**Item 29 - Ref: VP003141**

The Pink vinyl floor covering (Rm 01/Female WC vestibule) does not contain asbestos.

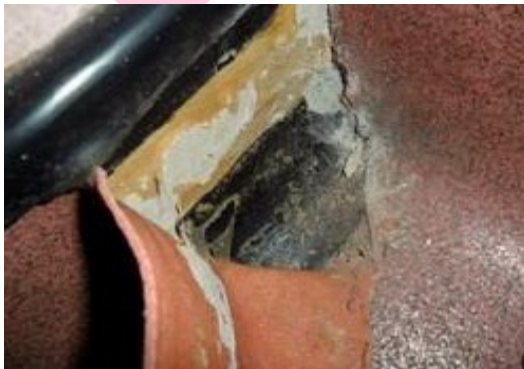
**Item 30 - Ref: VP003142**

The Skirting to base of wall (Rm 01/Female WC vestibule) does not contain asbestos.

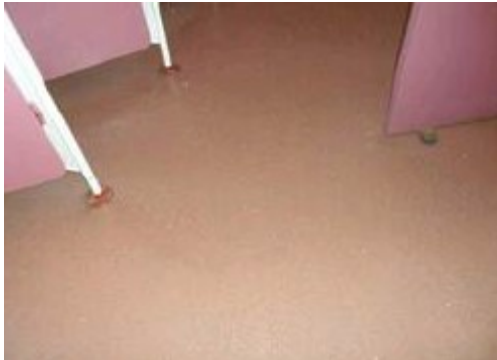
**Item 31 - Ref: As**

The Pink vinyl floor covering (Rm 02/Female WC) does not contain asbestos.

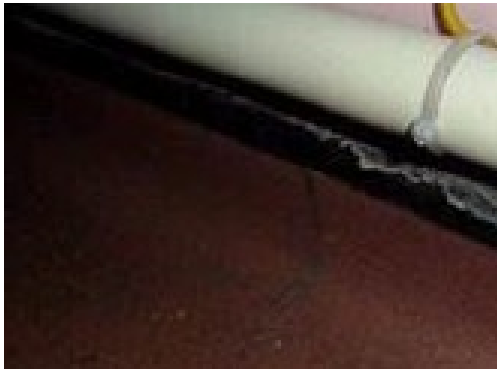
**Item 32 - Ref: As**

The Skirting to base of wall (Rm 02/Female WC) does not contain asbestos.

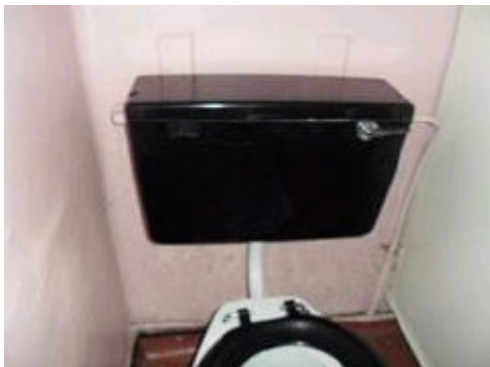
**Item 33 - Ref: VP003143**

The Toilet Cistern (Rm 02/Female WC) contains asbestos.

***Removed***

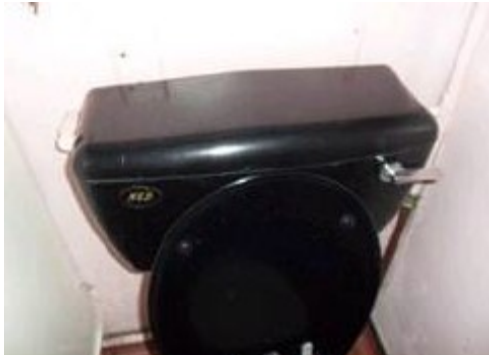
**Item 34 - Ref: VP003144**

The Toilet Cistern (Rm 02/Female WC) contains asbestos.

***Removed***

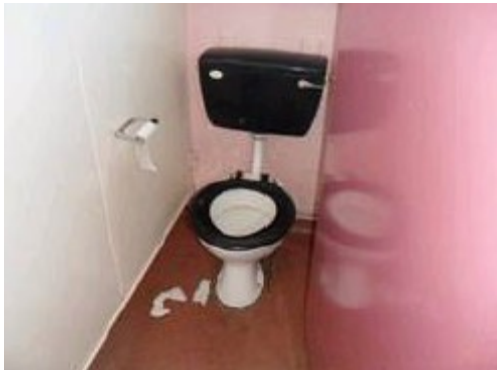
**Item 35 - Ref: VP003145**

The Toilet seats (Rm 02/Female WC) contains asbestos.

***Removed***

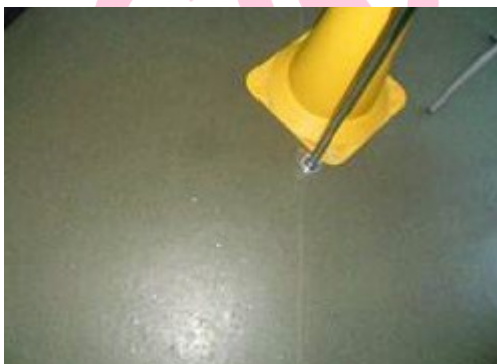
**Item 36 - Ref: VP003146**

The Green vinyl floor covering (Rm 03/Children's kitchen) does not contain asbestos.

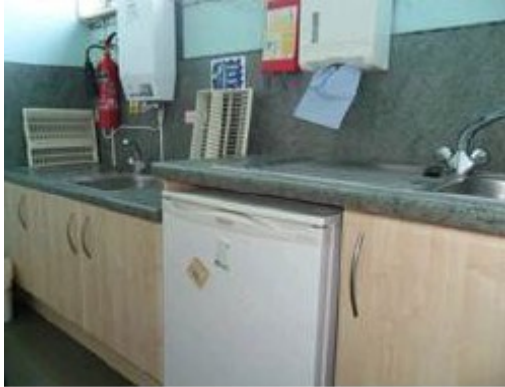
### **Item 37 - Ref: VP003146**

The Bitumen pads to underside of sink and drainer (Rm 03/Children's kitchen) does not contain asbestos.

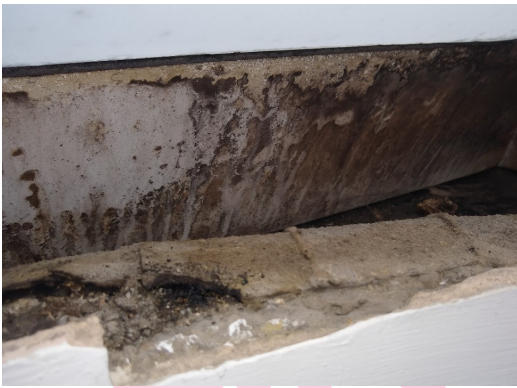
### **Item 38 Ref: 437902-1**

The felt to top of skylights surrounding (0/030 Corridor) does not contain asbestos.

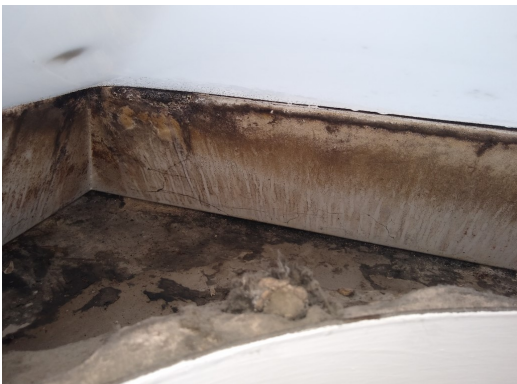
### **Item 39 Ref: 437902-2**

437902-2 – Rope packers to skylight adjacent year 2 cloakroom (0/030 Corridor) (Item 39) – Low Risk

The rope packers to skylight adjacent year 2 cloakroom (0/030 Corridor) contain asbestos.

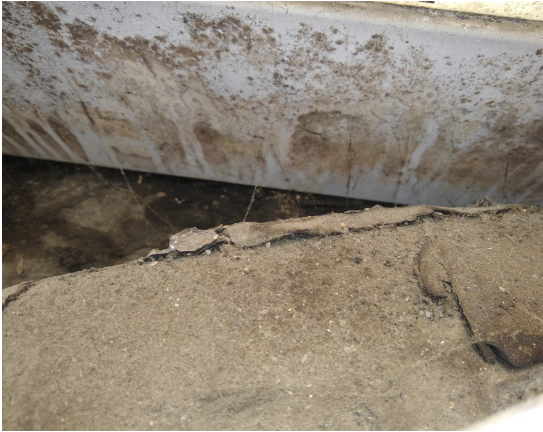
**Item 40 Ref: 437902-4**

The felt to top of skylights surrounding (0/050 Corridor) does not contain asbestos.

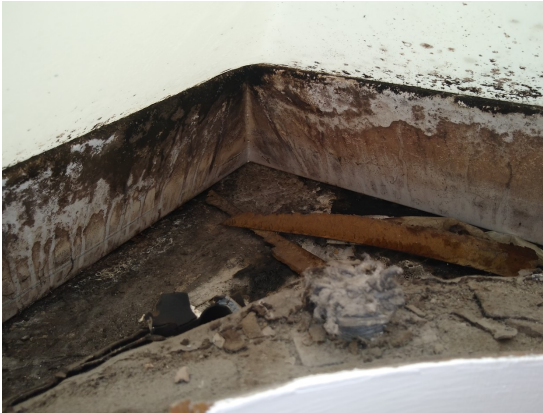
**Item 41 Ref: 437902-3**

437902-3 – Rope packers to skylight brackets (0/050 Corridor) (Item 41) – Low Risk

The rope packers to skylight brackets (0/050 Corridor) contain asbestos.

Any change in its appearance should be recorded, and passed to Property Services.

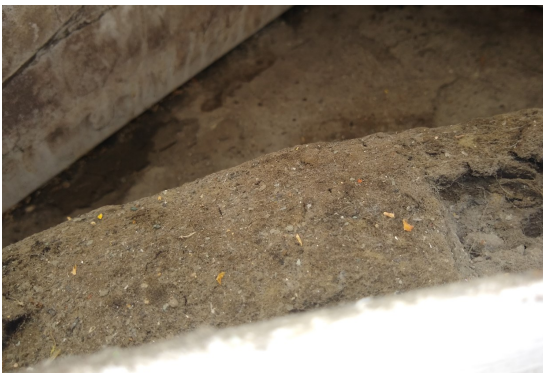
**Item 42 Ref: As 437902-4**

The felt to top of skylights surrounding (0/050a Lobby) does not contain asbestos.

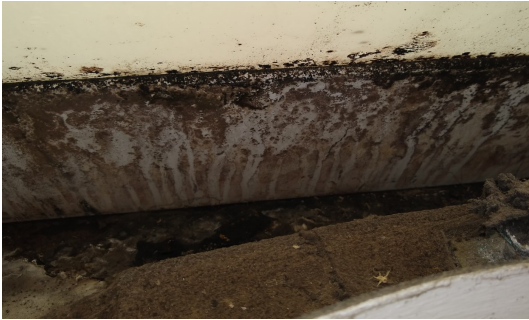
### **Item 43 Ref: As 437902-4**

The felt to top of skylights surrounding (0/050b Lobby) does not contain asbestos.

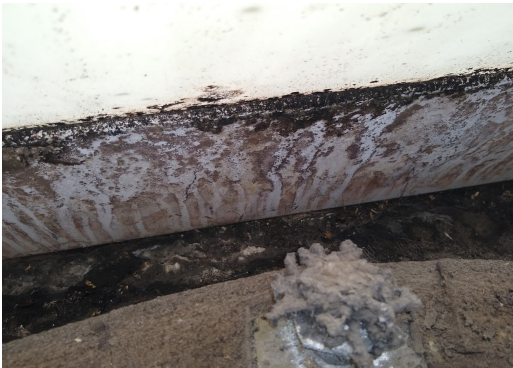
### **Item 44 Ref: As 437902-3**

As 437902-3 – Rope packers to skylight brackets (0/050b Lobby) (Item 44) – Very Low Risk

The rope packers to skylight brackets (0/050b Lobby) contain asbestos.

Any change in its appearance should be recorded, and passed to Property Services.

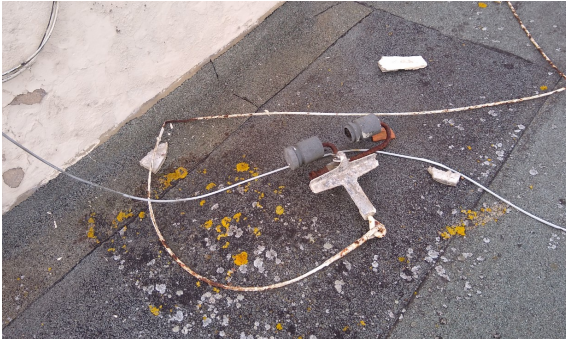
**Item 49 Ref: 437902-9**

The telephone insulation (External Roof 3) contains asbestos.

*Removed March 2021*

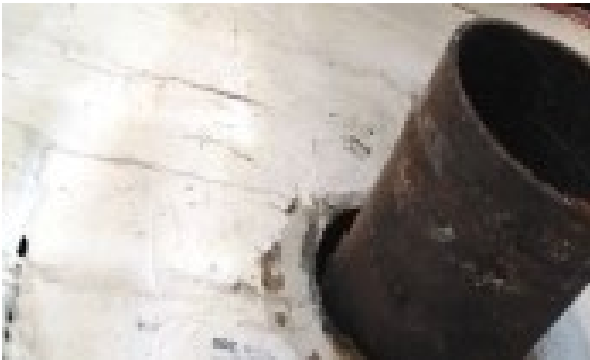
**Item 77 Ref: NO000536**

The debris/residue to wall redundant pipe area in the Boiler Room Z/001 does contain asbestos.

Environmental clean carried out August 2023. Any change in appearance notify Property Services.

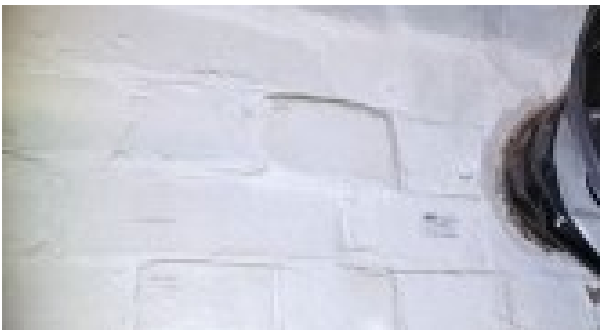
**Item 78 Ref: NO000537**

The debris/residue to wall adjacent to redundant pipe area in the Boiler Room Z/001 does contain asbestos.

Environmental clean carried out August 2023. Any change in appearance notify Property Services.

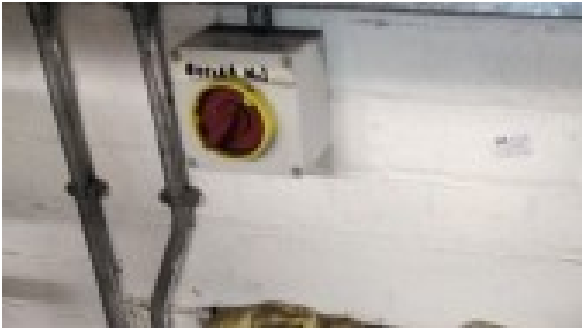
**Item 79 Ref: NO000538**

The debris/residue to flue chimney in the Boiler Room Z/001 does contain asbestos.

Environmental clean carried out August 2023. Any change in appearance notify Property Services.

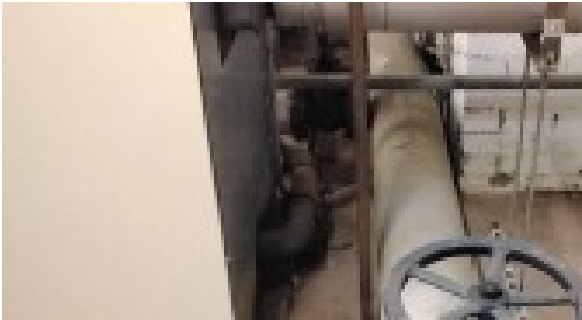
**Item 80 Ref: NO000539**

The debris/residue to floor behind boilers in the Boiler Room Z/001 does contain asbestos.

Environmental clean carried out August 2023. Any change in appearance notify Property Services.

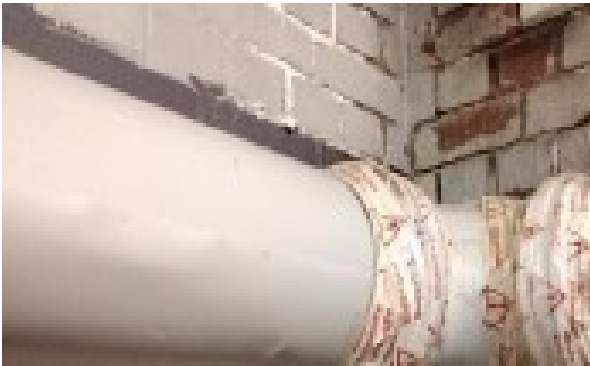
### **Item 86 Ref: Presumed**

The pipework gaskets in the switch room Z/002 are presumed to contain asbestos.

Removed August 2023

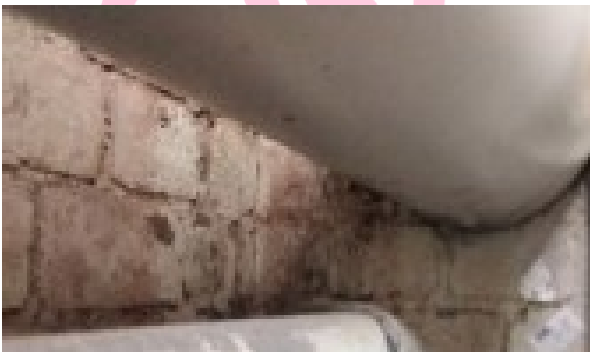
### **Item 87 Ref: NO00545**

The debris/residue to walls behind redundant pipes in the switch room Z/002 does contain asbestos.

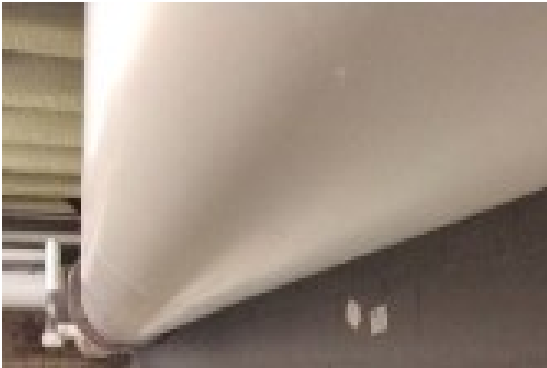
**Item 88 Ref: NO000546**

The debris/residue to walls behind redundant pipes partially sealed showing signs of deterioration in the switch room Z/002 does contain asbestos.

Environmental clean carried out August 2023. Any change in appearance notify Property Services.

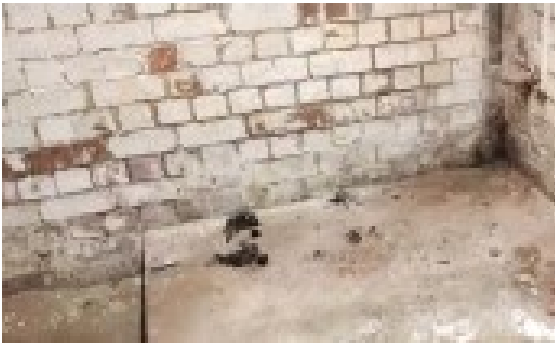
**Item 89 Ref: NO000547**

The debris/residue floor in the switch room Z/002 does contain asbestos.

Environmental clean carried out August 2023. Any change in appearance notify Property Services.

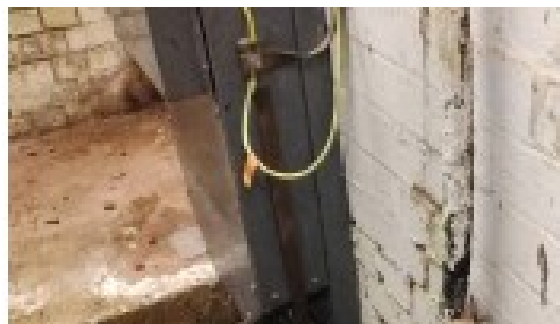
**Item 90 Ref: Presumed**

The electrical services cable braiding/insulation in the switch room Z/002 is presumed to contain asbestos.

Removed August 2023

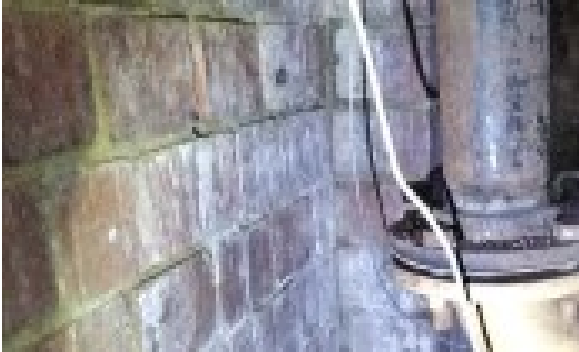
**Item 91 Ref: NO000548**

The pipework gaskets valve over boiler in the form coal bunker Z/004 does contain asbestos.

Removed August 2023
