ASBESTOS SURVEY REPORT FOR HILL VIEW JUNIOR SCHOOL ACADEMY,
QUEEN ALEXANDRA ROAD, SUNDERLAND, TYNE AND WEAR, SR2 9HE.

**Hill View Junior School Academy, Queen Alexandra
Road, Sunderland, SR2 9HE**

Date: 16 April 2026

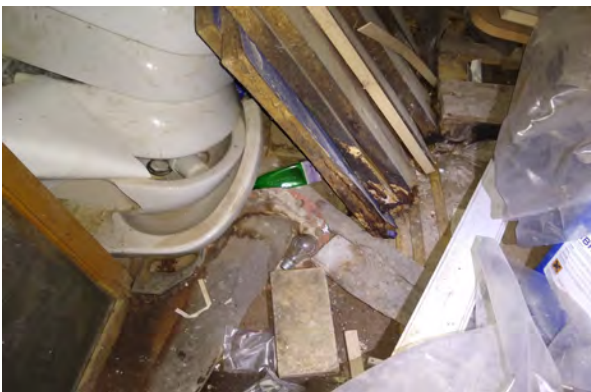
Item 12 Ref: 422644-9

The loose lying gasket to floor in the Former Coal Bunker (Rm -1/02) contains asbestos.

Any change in its appearance should be recorded and passed to Property Services.

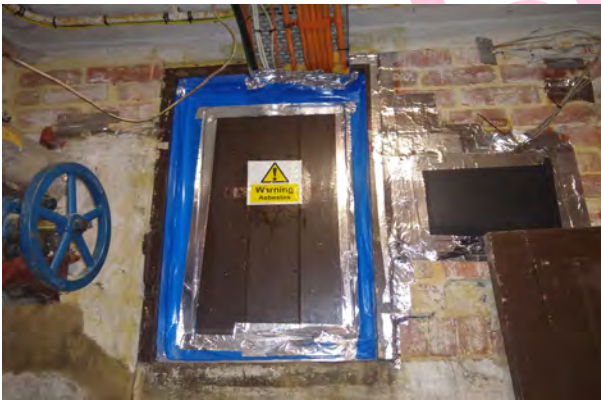
Item 17 Ref: 243272-1

The lagging debris to floor in the Pipe Duct (Rm -1/04) does contain asbestos.

Any change in its appearance should be recorded and passed to Property Services.

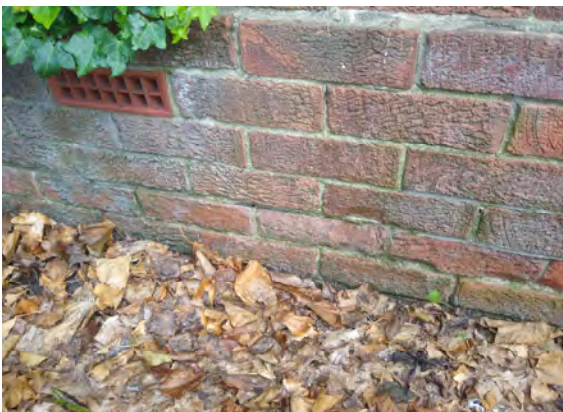
Item 150 Ref: 422644-64

The damp proof course (External) does not contain asbestos.

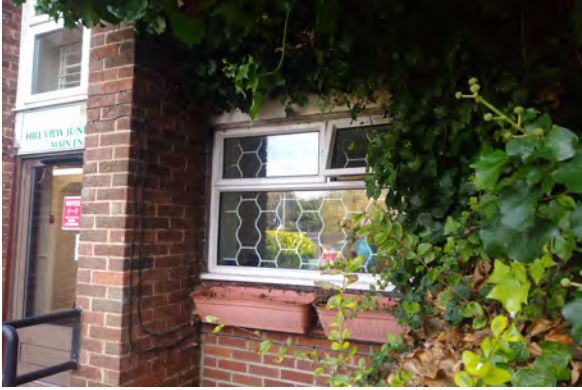
Item 151 Ref: 422644-65

The remnant sealant to window frames either side of main entrance (External) contains asbestos.

Any change in its appearance should be recorded and passed to Property Services.

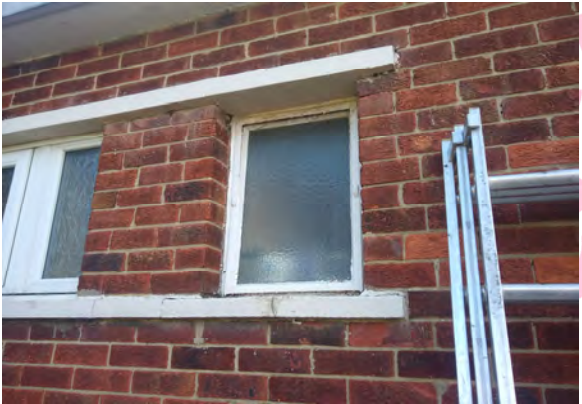
Item 152 Ref: 422644-66

The sealant to original metal window frames (External) contains asbestos.

Any change in its appearance should be recorded and passed to Property Services.

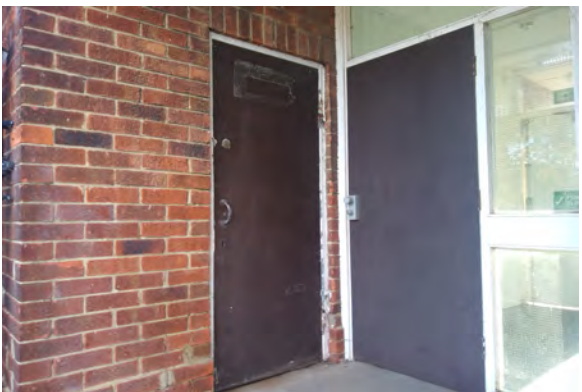
Item 153 Ref: 422644-67

The sealant to original metal door frames (External) contains asbestos.

Any change in its appearance should be recorded and passed to Property Services.
