ASBESTOS SURVEY REPORT FOR HILL VIEW JUNIOR SCHOOL ACADEMY,  
QUEEN ALEXANDRA ROAD, SUNDERLAND, TYNE AND WEAR, SR2 9HE.

**Hill View Junior School Academy, Queen Alexandra Road, Sunderland, SR2 9HE**

**Date: 24 April 2025**

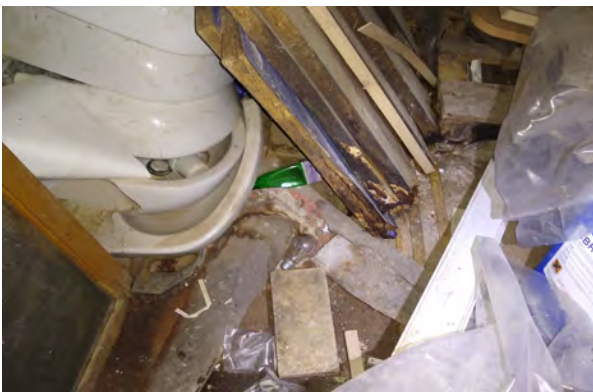
### **Item 12 Ref: 422644-9**

The loose lying gasket to floor in the Former Coal Bunker (Rm -1/02) contains asbestos.

| Picture | Location | Risk | Inspection Frequency | Date of return |
|---|--|---|---|--|
| <b>Item 12</b> | <b>Loose lying gasket to floor</b> | <b>Low Risk</b> | <b>6 monthly</b> | <b>13/10/2025</b><br><b>– noted as</b> |

Any change in its appearance should be recorded and passed to Property Services.

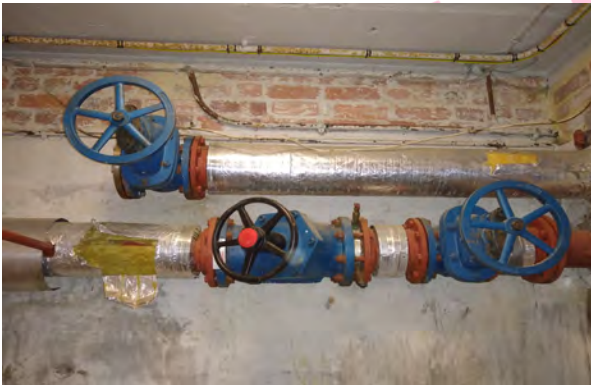
### **Item 14 Ref: 422644-11**

The pipework flange gaskets in the Switch Room (Rm -1/03) does not contain asbestos.

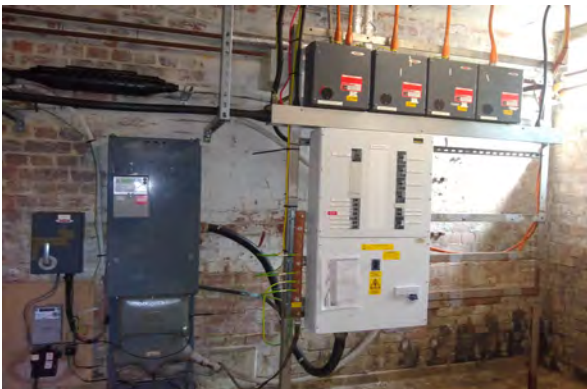
### **Item 15 Ref: Presumed**

The MEM / Lucy Oxford electrics in the Switch Room (Rm -1/03) is presumed to contain asbestos.

Any change in its appearance should be recorded and passed to Property Services.

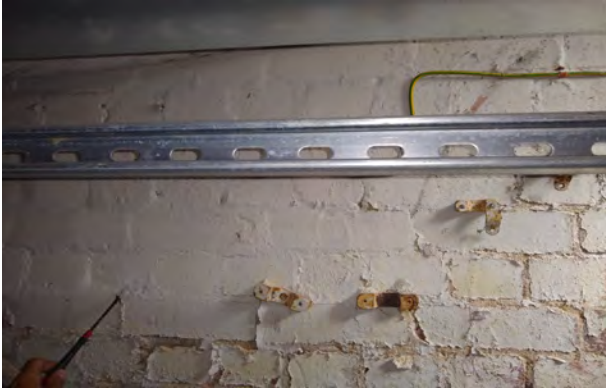
### **Item 16 Ref: 422644-12**

The residue to walls at low level in the Switch Room (Rm -1/03) contains asbestos.

Any change in its appearance should be recorded and passed to Property Services.

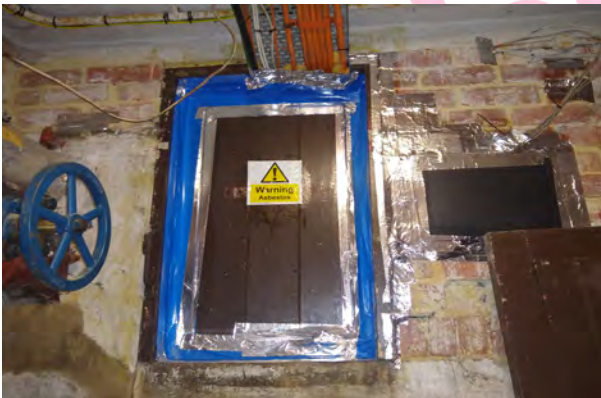
### **Item 17 Ref: 243272-1**

The lagging debris to floor in the Pipe Duct (Rm -1/04) does contain asbestos.

Any change in its appearance should be recorded and passed to Property Services.

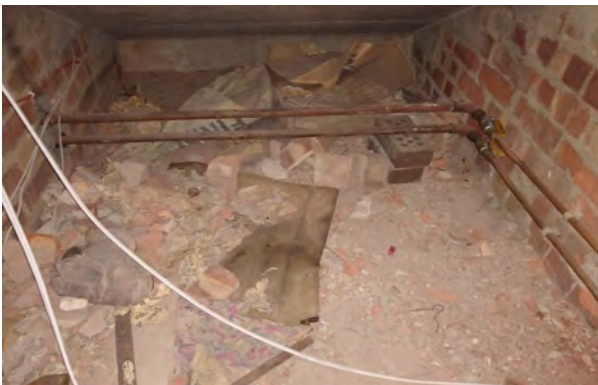
### **Item 18 Ref: 422644-15**

The loose lying felt to floor in the Main Entrance Lobby – void below stairs (Rm 0/01) does not contain asbestos.

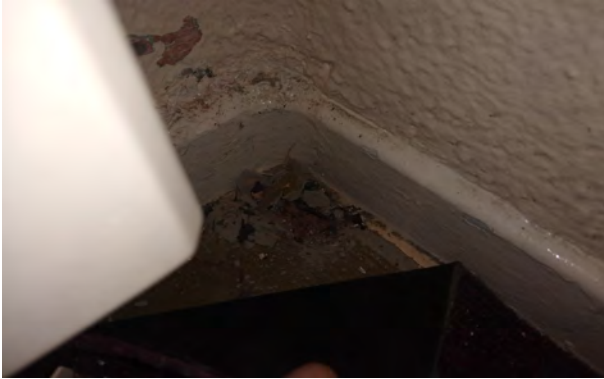
### **Item 19 Ref: 422644-16**

The subfloor and skirting in the Foyer (Rm 0/02) do not contain asbestos.

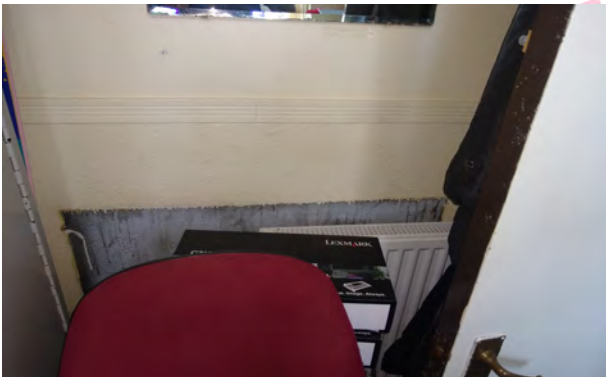
### **Item 23 Ref: As 422644-17**

The decorative finish to low level walls in the Office (Rm 0/06) does not contain asbestos.

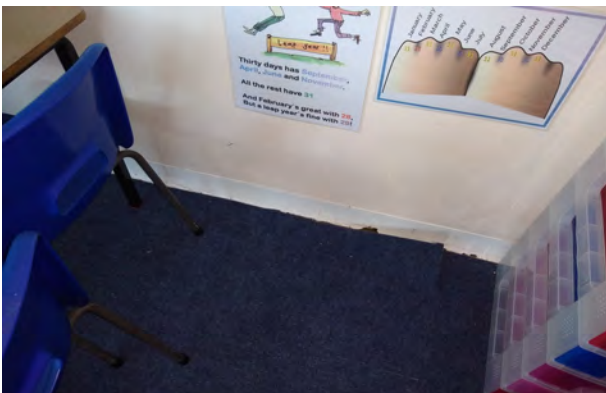
### **Item 24 Ref: 422644-19**

The skirting in the Classroom (Rm 0/08) does not contain asbestos.

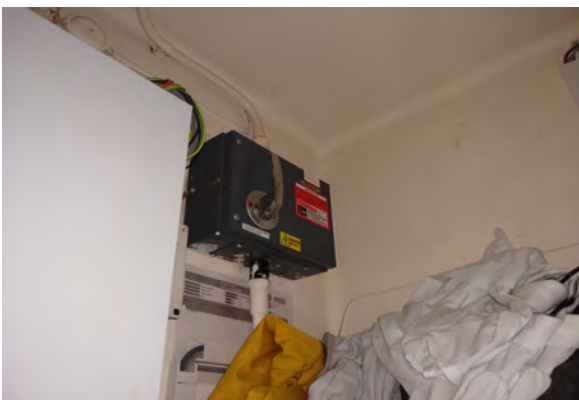
### **Item 36 Ref: Presumed**

The MEM & alarm electrics in the Store (Rm 0/19) contain asbestos.

Any change in its appearance should be recorded and passed to Property Services.

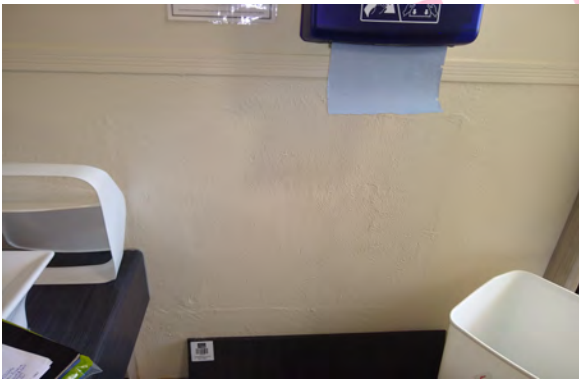
### **Item 38 Ref: 422644-27**

The patch repair to decorative finish to low level walls in the Male Staff WC & Lobby (Rm 0/20) does not contain asbestos.

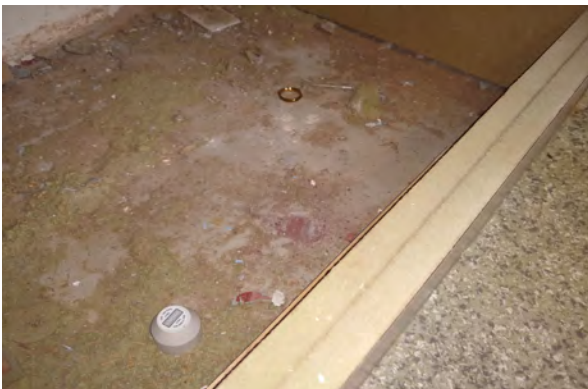
### **Item 39 Ref: 422644-28**

The red floor screed beneath modern screed in the Male Staff WC & Lobby (Rm 0/20) contains asbestos.

Any change in its appearance should be recorded and passed to Property Services.

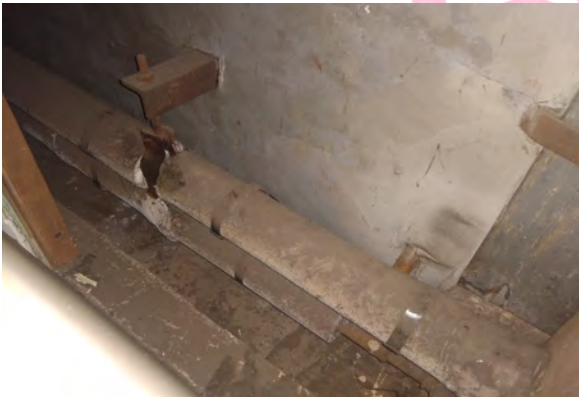
### **Item 68 Ref: 422644-41**

The pipe lagging in Classroom 4 – void within pipework boxing between redundant heaters (Rm 0/52) contains asbestos.

Any change in its appearance should be recorded and passed to Property Services.

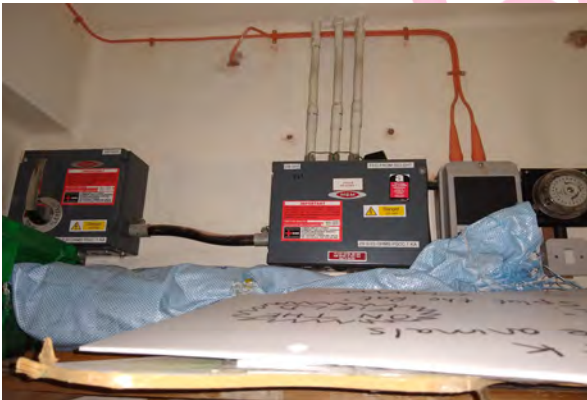
### **Item 119 Ref: Presumed**

The electrics in the Store (Rm 0/95) are presumed to contain asbestos.

Any change in its appearance should be recorded and passed to Property Services.

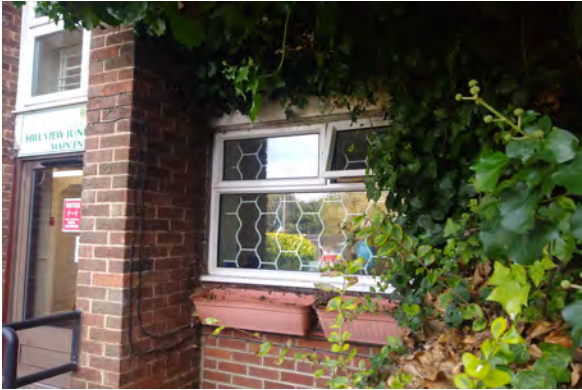
### **Item 151 Ref: 422644-65**

The remnant sealant to window frames either side of main entrance (External) contains asbestos.

Any change in its appearance should be recorded and passed to Property Services.

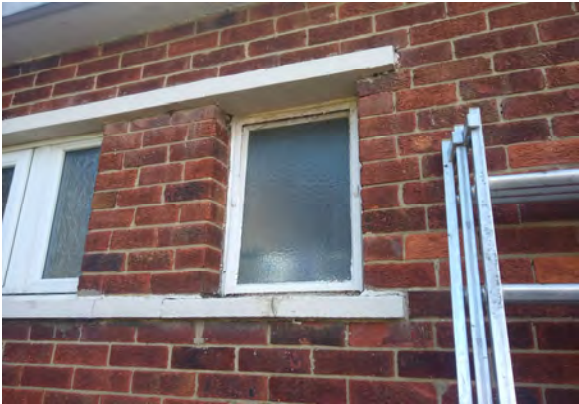
### **Item 152 Ref: 422644-66**

The sealant to original metal window frames (External) contains asbestos.

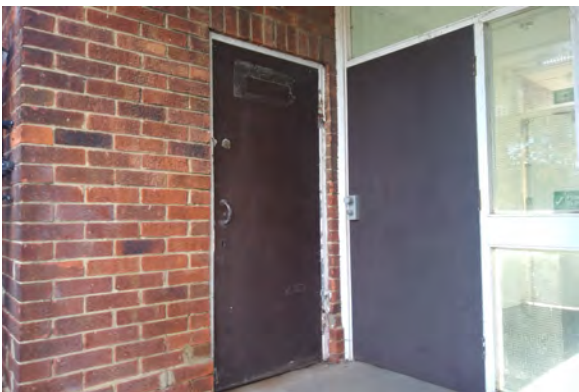
### **Item 153 Ref: 422644-67**

The sealant to original metal door frames (External) contains asbestos.

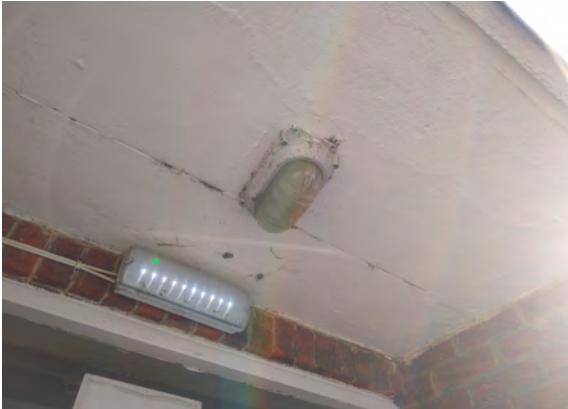
### **Item 154 Ref: 422644-68**

The sealant to diffuser of bulkhead light fittings (External) contains asbestos.

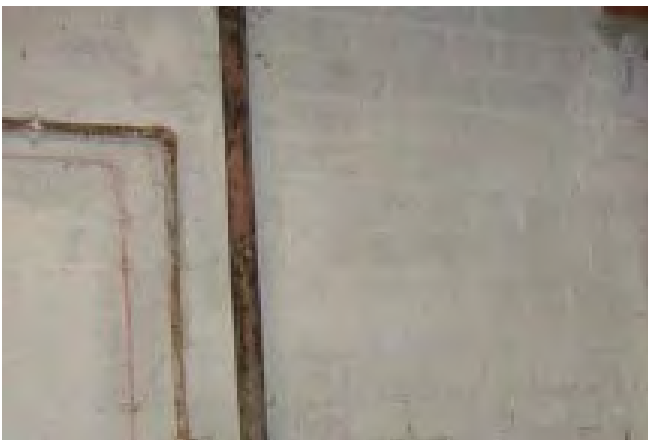
### **Item 156 Ref: SC17524**

The insulation residue in the Plant Room (Basement) does not contain asbestos.

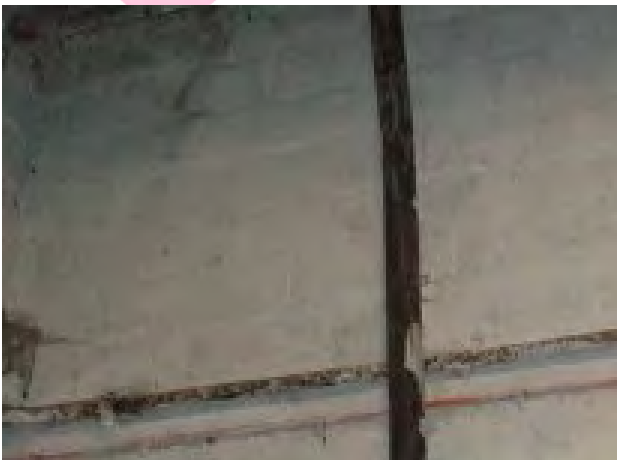
#### **Item 159 Ref: SC17527**

The insulation residue in the Plant Room (Basement) does not contain asbestos.

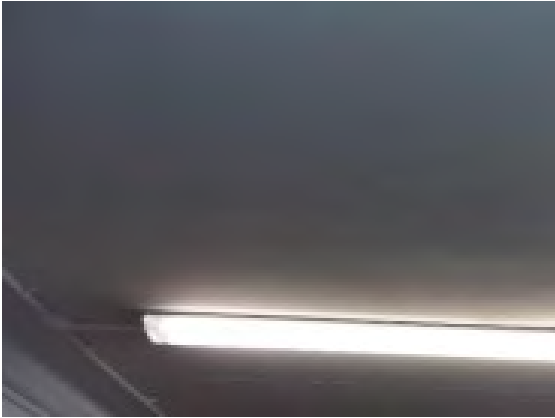
### **Item 160 Ref: VK001497**

The concrete and plaster finishes to ceilings (Ground Floor / 01 / Area 1) do not contain asbestos.
