ASBESTOS SURVEY REPORT FOR HOLLEY PARK ACADEMY, WASHINGTON

**HOLLEY PARK ACADEMY SCHOOL,
WASHINGTON**

Date: 23rd June 2025

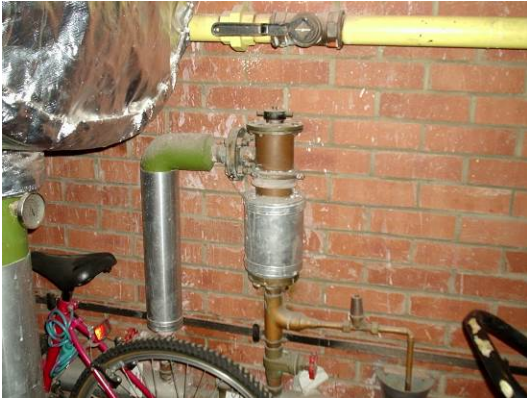
Item 1 Ref: JP0543/07

The gasket to the pipe work in the boiler room (Rm 0/1) does not contain asbestos.

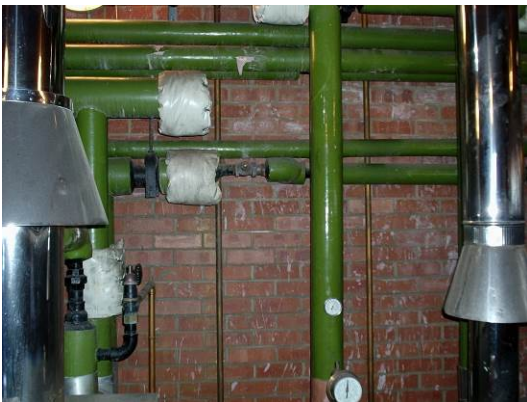
Item 2 - Ref: JP0542/07

The insulation to the pipework in the boiler room does not contain asbestos.

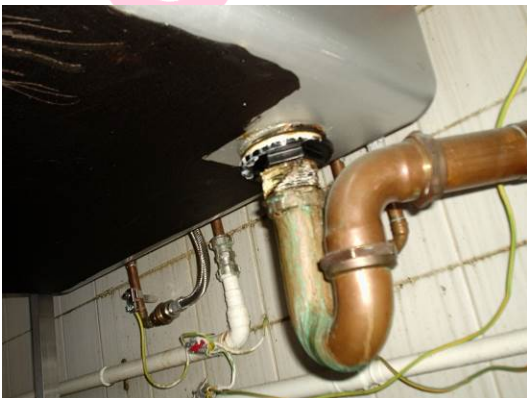
Item 3 - Ref: JP0545/07

The sink pad in the kitchen (Rm 0/8) does not contain asbestos.

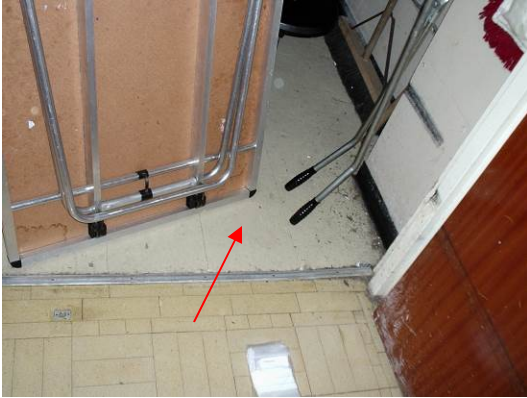
Item 4 - Ref: JP0546/07

The cream vinyl floor tiles to the store (Rm 0/11) contain asbestos.

Item 4	Floor tile - 0/11	Very Low	12 monthly	03.02.27
<i>Item 5</i>	<i>No asbestos</i>	<i>Is present</i>		
Item 6	Floor tile – 0/16	Very Low	12 monthly	03.02.27
<i>Item 7</i>	<i>No asbestos</i>	<i>Is present</i>		
<i>Item 8</i>	<i>No asbestos</i>	<i>Is present</i>		
<i>Item 9</i>	<i>No asbestos</i>	<i>Is present</i>		
<i>Item 10</i>	<i>No asbestos</i>	<i>Is present</i>

Any change in its appearance should be recorded and passed to Property Services.

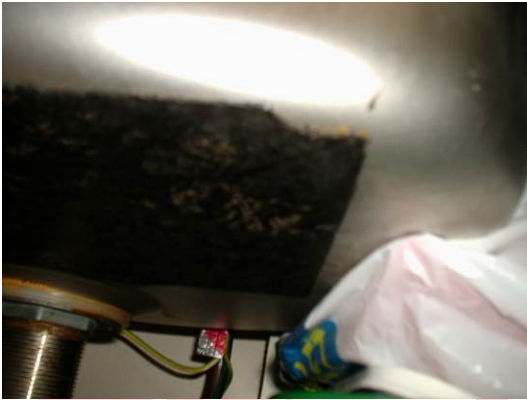
Item 5 - Ref: JP0547/07

The sink pad to classroom year 3 (Rm 0/12) does not contain asbestos.

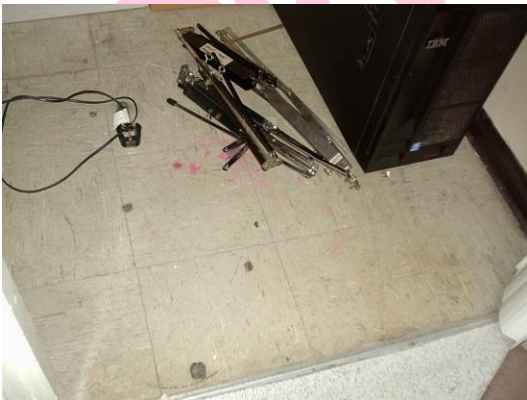
Item 6 – As JP0546/07

The vinyl floor tiles to the cleaners cupboard (Rm 0/16) contain asbestos.

Any change in its appearance should be recorded and passed to Property Services.

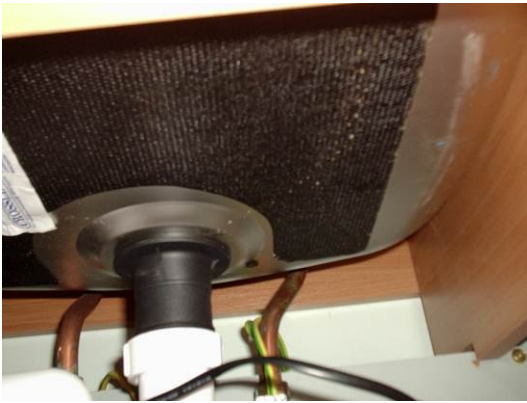
Item 7 - Ref: JP0548/07

The sink pad to classroom year 4 (Rm 0/20) does not contain asbestos.

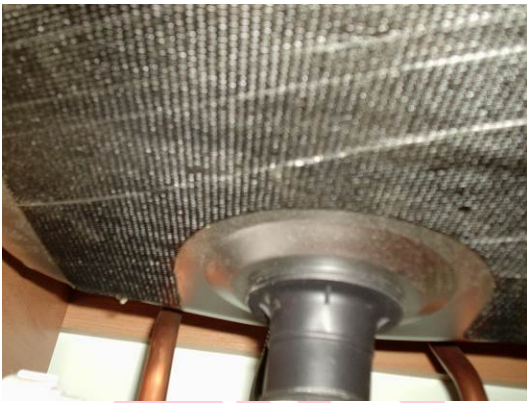
Item 8 - Ref: JP0549/07

The sink pad to classroom year 5 (Rm 0/21) does not contain asbestos.

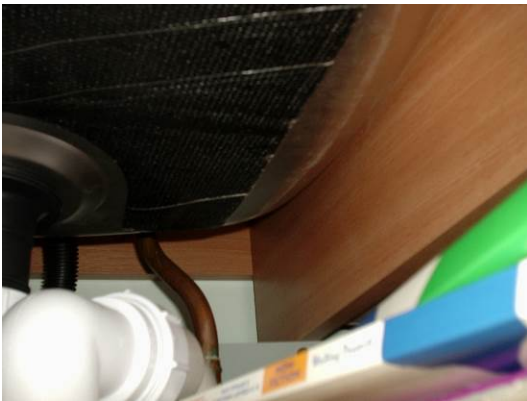
Item 9 - Ref: JP0550/07

The sink pad to classroom year 6 (Rm 0/24) does not contain asbestos.

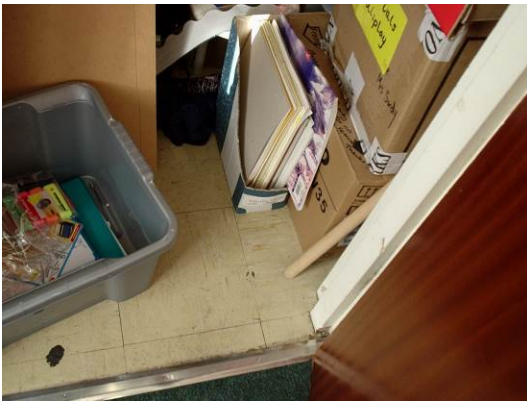
Item 11 – As JP0546/07

The cream floor tiles to the store cupboard (rm 0/27) contain asbestos.

Item 11	Floor tile - 0/27	Very Low	12 monthly	03.02.27
<i>Item 12</i>	<i>No asbestos</i>	<i>Is present</i>		
<i>Item 13</i>	<i>No asbestos</i>	<i>Is present</i>		
<i>Item 14</i>	<i>No asbestos</i>	<i>Is present</i>

Any change in its appearance should be recorded and passed to Property Services.

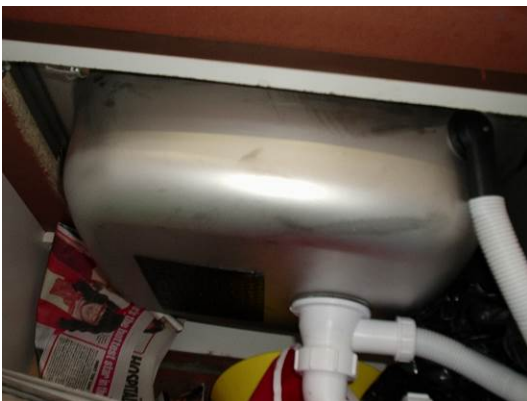
Item 12 – Ref: JP0552/07

The sink pad to classroom practical (Rm 0/29) does not contain asbestos.

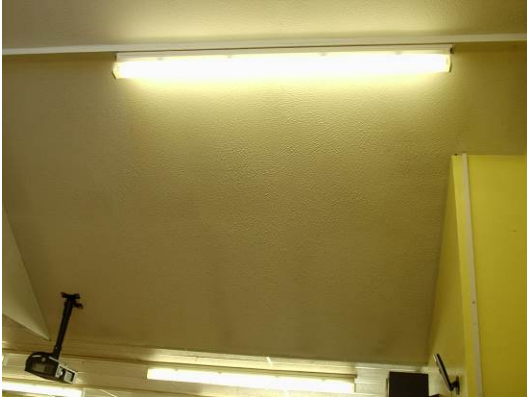
Item 13 - Ref: JP0553/07

The decorative coating to the ceiling in classroom reception 1 (Rm 0/31) does not contain asbestos.

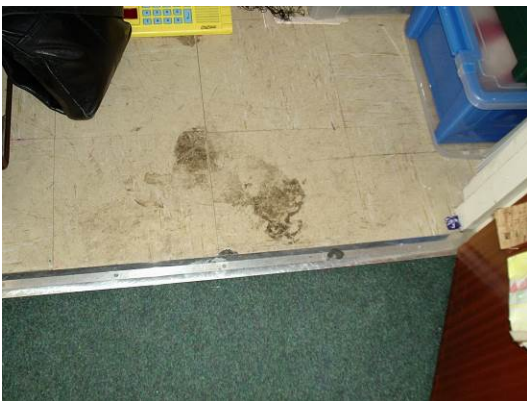
Item 15 – As JP0546/07

The cream floor tiles to the store (Rm 0/32) contain asbestos.

Any change in its appearance should be recorded, and passed to Property Services.

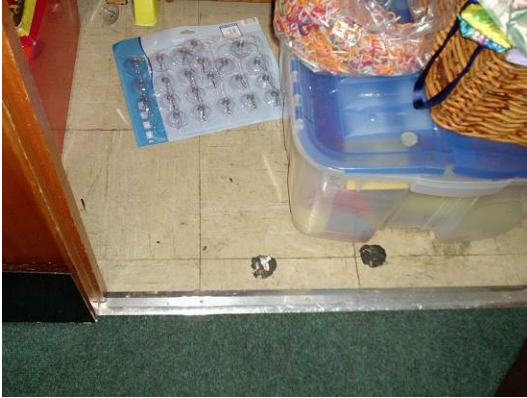
Item 16 – As JP0546/07

The cream floor tiles to the store (Rm 0/33) contain asbestos.

Any change in its appearance should be recorded and passed to Property Services.

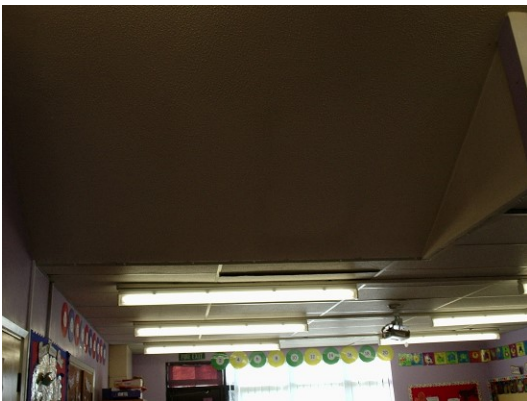
Item 18 – Ref: JP0554/07

The decorative coating to the ceiling in classroom reception 2 (Rm 0/35) does not contain asbestos.

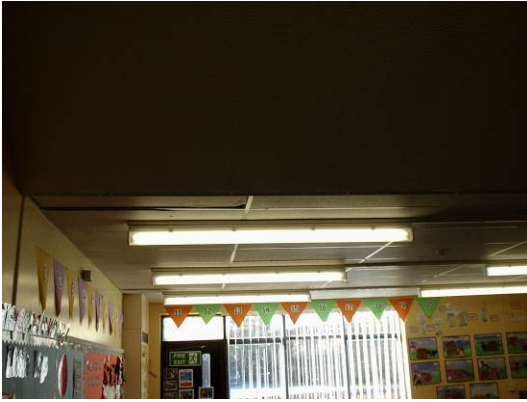
Item 19 Ref: JP0555/07

The decorative finish to the ceiling of Classroom Reception 3 (Rm 0/36) does not contain asbestos.

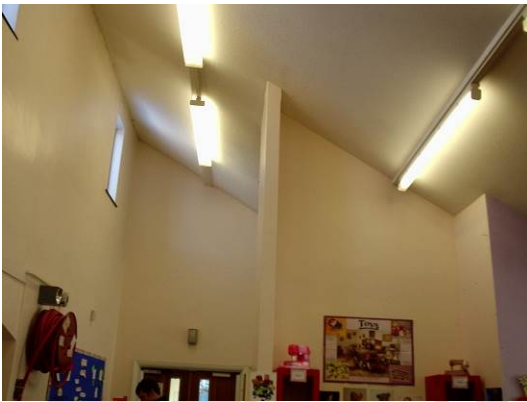
Item 20 - Ref: JP0556/07

The decorative finish to the ceiling of the corridor and practical area (Rm 0/37) does not contain asbestos.

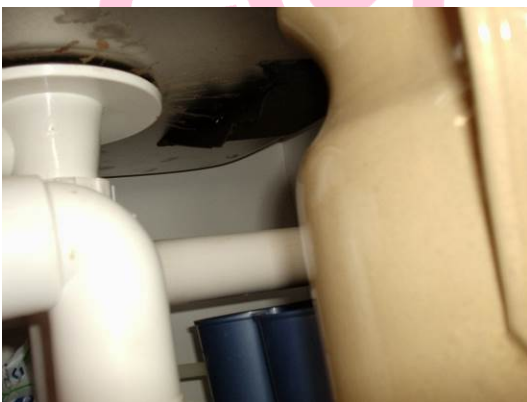
Item 21 - Ref: JP0558/07

The sink pad to the staff room (Rm 0/42) does not contain asbestos.

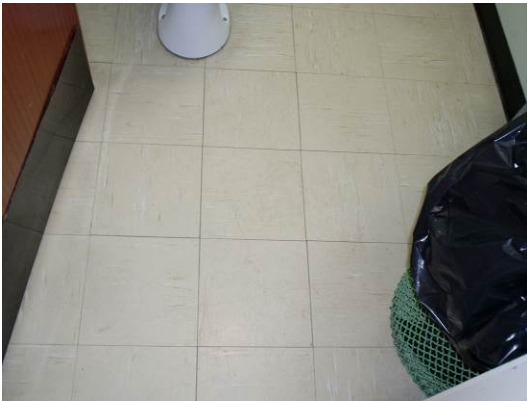
Item 22 – As JP0546/07

The cream floor tiles to the male staff toilets (Rm 0/43) contained asbestos.

These have now been removed.

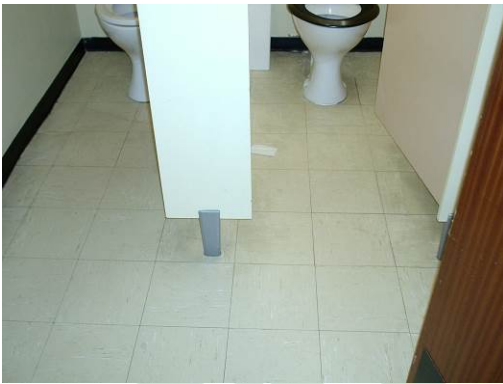
Item 23 – As JP0546/07

The cream floor tiles to the female toilets (Rm 0/44) contained asbestos.

These have now been removed.

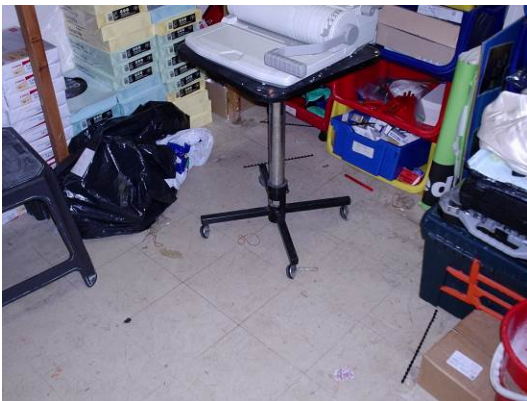
Item 24 – As JP0546/07

The cream floor tiles to the store room (Rm 0/48) contain asbestos.

Item 24	Floor tile – 0/48	Very Low	12 monthly	03.02.27
<i>Item 25</i>	<i>No asbestos</i>	<i>Is present</i>		
Item 26	Floor tile – 0/51	Very Low	12 monthly	03.02.27

Any change in its appearance should be recorded and passed to Property Services.

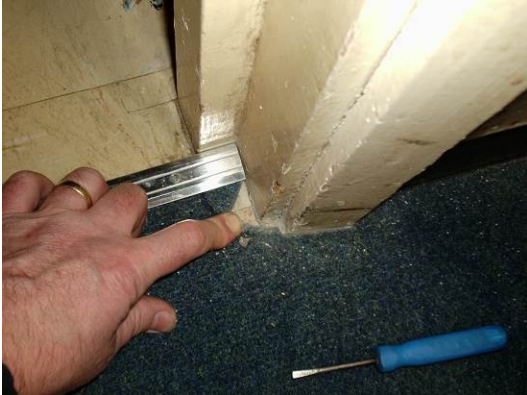
Item 25 - Ref: JP0559/07

The lino beneath the carpet in the corridor (Rm 0/50) does not contain asbestos.

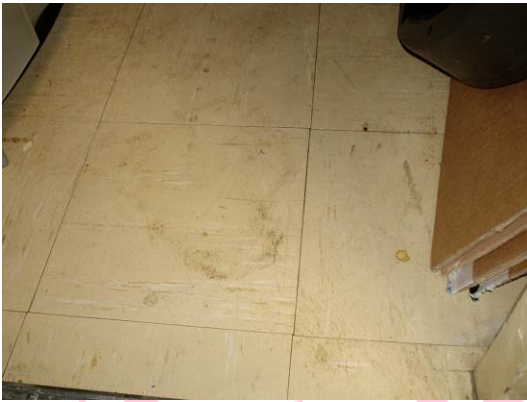
Item 26 – As JP0546/07

The cream floor tiles to the store room (Rm 0/51) contain asbestos.

Any change in its appearance should be recorded and passed to Property Services.

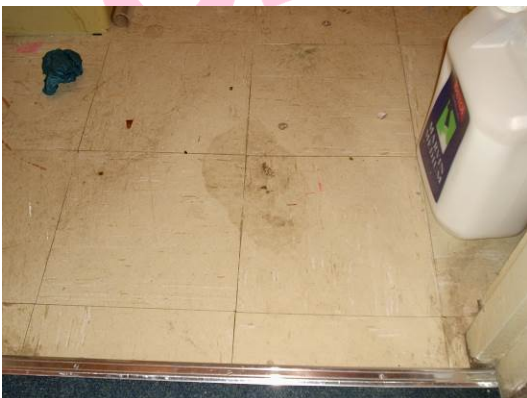
Item 27 – As JP0546/07

The cream floor tiles to the store room (Rm 0/52) contain asbestos.

Any change in its appearance should be recorded and passed to Property Services.

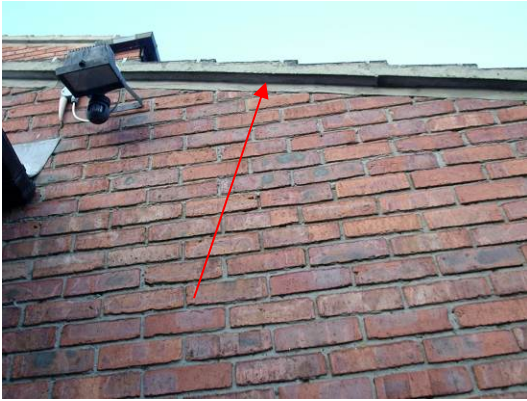
Item 28 - Ref: JP0544/07

The undercloaking to the external of the school contains asbestos.

Item 27	Floor tile -0/52	Very Low	12 monthly	03.02.27
Item 28	Undercloaking - External	Very Low	12 monthly	03.02.27
<i>Item 29</i>	<i>No asbestos</i>	<i>Is present</i>		
<i>Item 30</i>	<i>No asbestos</i>	<i>Is present</i>		
<i>Item 31</i>	<i>No asbestos</i>	<i>Is present</i>

Any change in its appearance should be recorded and passed to Property Services.

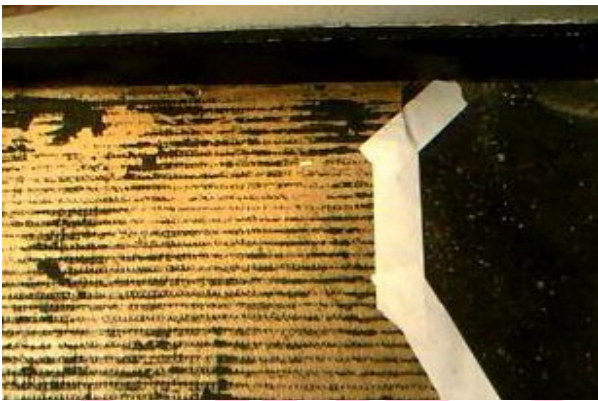
Item 32 - Ref: BB002525

The lino and screed below in the Key Stage 1 Cloaks does not contain asbestos.

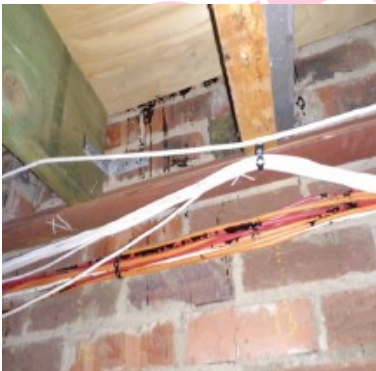
Item 36 Ref: As RT000255

The bitumen overspill - to walls/cabling in void (Nursery G/13) does not contain asbestos.
