ASBESTOS SURVEY REPORT FOR HOUGHTON NURSERY, NEASHAM PLACE, HOUGHTON LE SPRING, DH5 8AE.

Asbestos Register for

Houghton Nursery, Neasham Place, Houghton le Spring

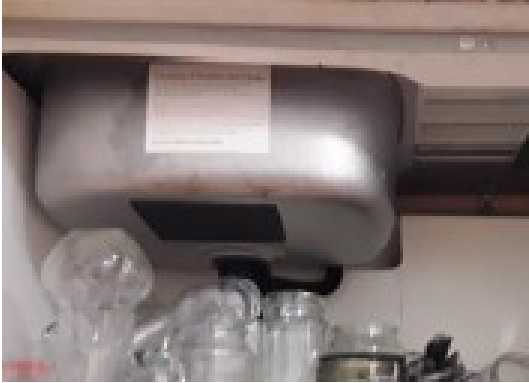
Item 1 Ref: 21-35335-1

The sink pad in Room 5 (Playrooms) does not contain asbestos.

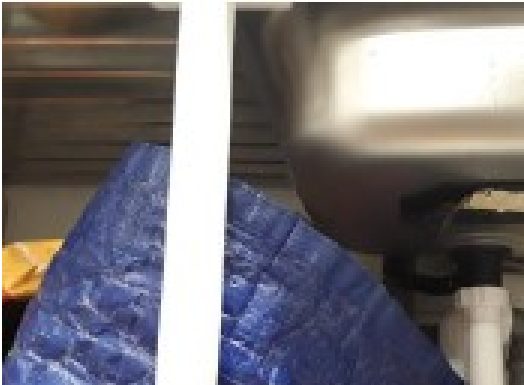
Item 2 Ref: 21-35335-2

The sink pad in Room 8 (Kitchen) does not contain asbestos.

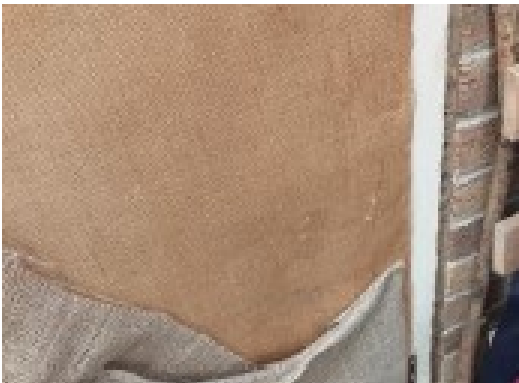
Item 3 Ref: 21-35335-3

The frame sealant to the brickwork to toy storage room (Room 12) does not contain asbestos.

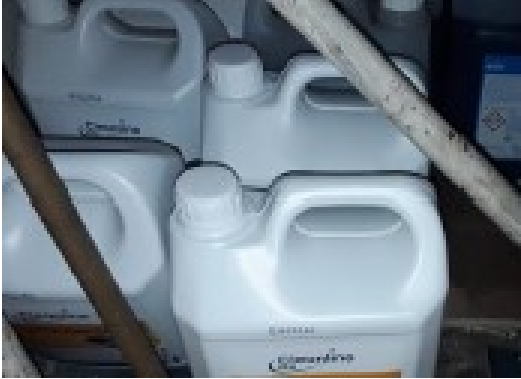
Item 4 Ref: 21-35335-4

The floor tiles and adhesive in the cleaners cupboard (Room 18) do not contain asbestos.

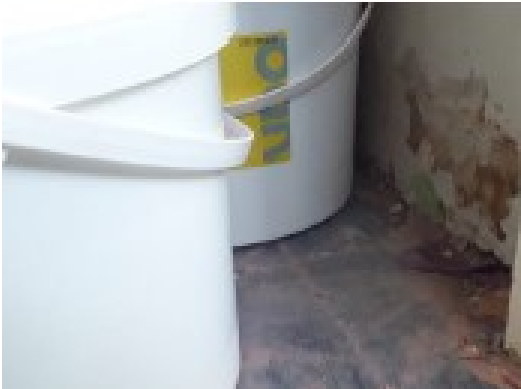
Item 5 Ref: 21-35335-4

The floor tiles and adhesive in the store cupboard (Room 22) do not contain asbestos.

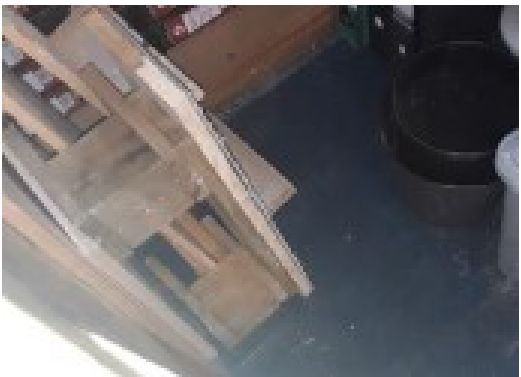
Item 6 Ref: 21-35335-4

The floor tiles and adhesive in the store cupboard (Room 23) do not contain asbestos.

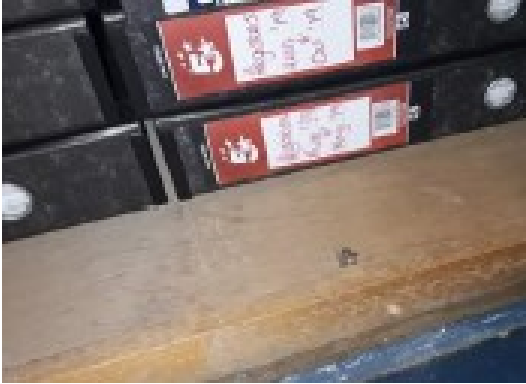
Item 7 Ref: 21-35335-5

The floor tiles and adhesive in the store cupboard (Room 23) does contain asbestos.

Item 7	Floor tiles and adhesive (Floor G/Room 23 Store Cupboard)	Low Risk	6 monthly	30/03/2025
Item 8	Floor tiles and adhesive (Floor G/Room 24 Cleaners Cupboard)	Low Risk	6 monthly	30/03/2025
<i>Item 9</i>	<i>No asbestos</i>	<i>Is present</i>		
<i>Item 10</i>	<i>No asbestos</i>	<i>Is present</i>		
<i>Item 11</i>	<i>No asbestos</i>	<i>Is present</i>

Any change in appearance should be reported to Property Services.

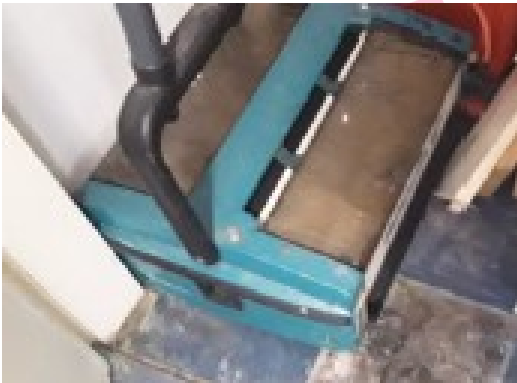
Item 8 Ref: 21-35335-5

The floor tiles and adhesive in the cleaners cupboard (Room 24) does contain asbestos.

Any change in appearance should be reported to Property Services.

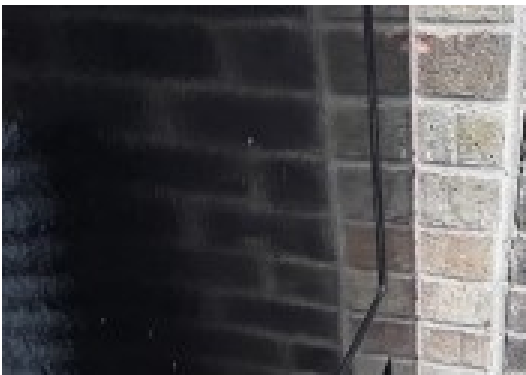
Item 9 Ref: 21-35335-6

The frame sealant to the door in the Boiler Room (Room 37) does not contain asbestos.

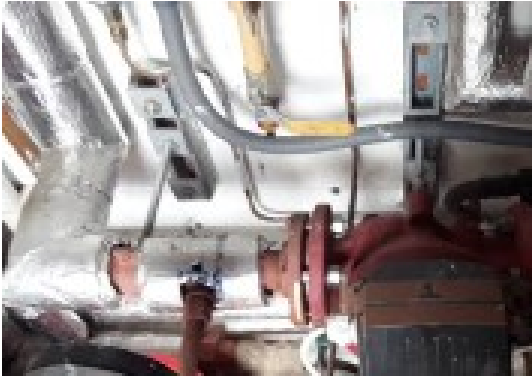
Item 10 Ref: 21-35335-7

The pipe flanges (Gaskets) in the Boiler Room (Room 37) do not contain asbestos.

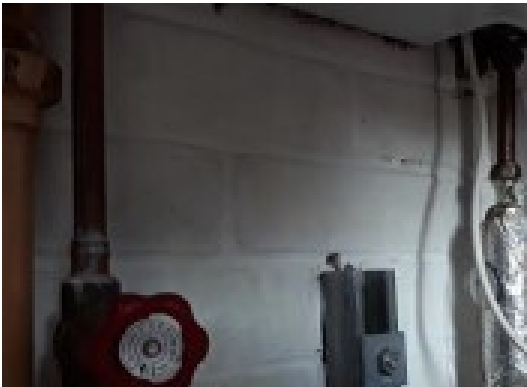
Item 11 Ref: 21-35335-9

The debris to the encapsulated walls in the Boiler Room (Room 37) does not contain asbestos.

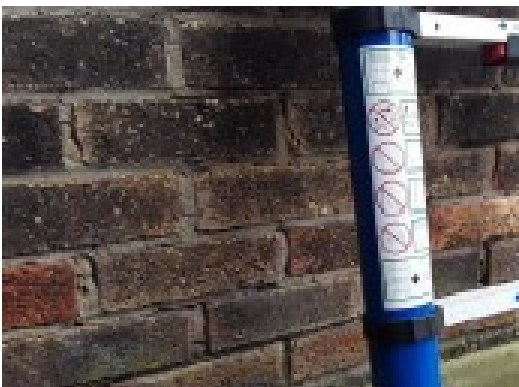
Item 12 Ref: 21-35335-8

The damp proof course (Externally) does contain asbestos.

Item 12	Damp proof course (External/Area 38)	Very Low Risk	12 monthly	30/09/2025
Item 13	Damp proof course (External/Area 38)	Very Low Risk	12 monthly	30/09/2025
<i>Item 14</i>	<i>No asbestos</i>	<i>Is present</i>

Any change in appearance should be reported to Property Services.

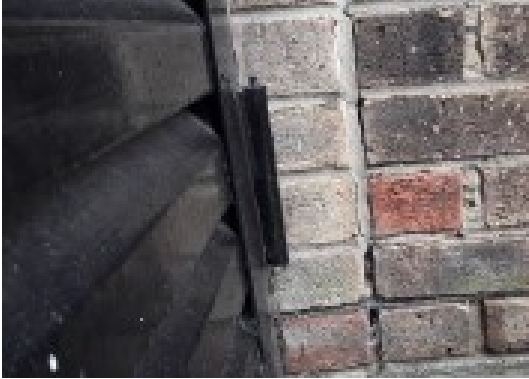
Item 13 Ref: 21-35335-8

The damp proof course (Externally) does contain asbestos.

Any change in appearance should be reported to Property Services.

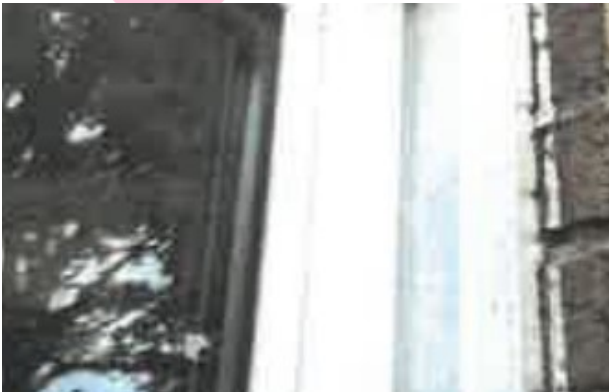
Item 15 Ref: VA008071

The mastic to the frame of the exterior exit door does contain asbestos.

Item 15	Mastic to the frame of the exterior exit door	Very Low Risk	12 monthly	30/09/2025

Any change in appearance should be reported to Property Services.
