ASBESTOS SURVEY REPORT FOR HYLTON REDHOUSE NURSERY,
ROTHERHAM ROAD, SUNDERLAND, SR5 5QL

Asbestos Register for

**Hylton Redhouse Nursery, Rotherham Road,
Sunderland, SR5 5QL**

Date: 03 February 2026

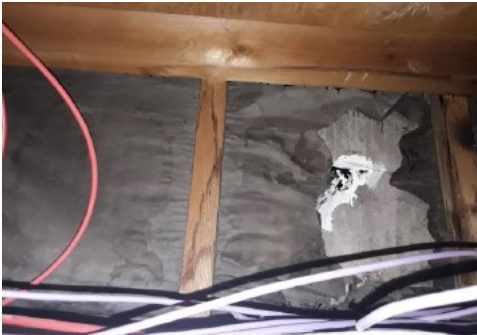
Item 2 Ref: Presumed

The cement fascia (Area 2/Play Area) is presumed to contain asbestos.

Confirmed as positive see item 23

Any change in its appearance should be recorded and passed to Property Services.

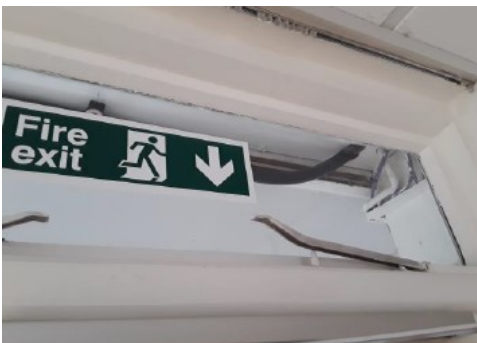
Item 3 Ref: 21-35336-2

The original cement fascia boards (Area 3/Corridor & Staffroom) contain asbestos.

Duplicate item see item 40

Any change in its appearance should be recorded and passed to Property Services.

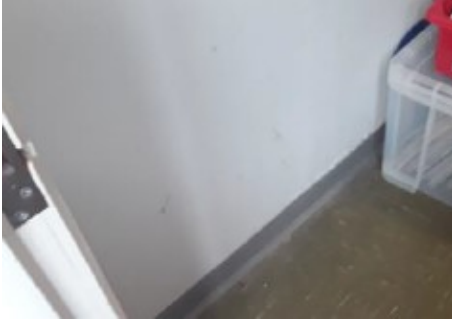
Item 10 Ref: 21-35336-3

The floor tiles and adhesive (Area 12/Store Room) contain asbestos.

Any change in its appearance should be recorded and passed to Property Services.

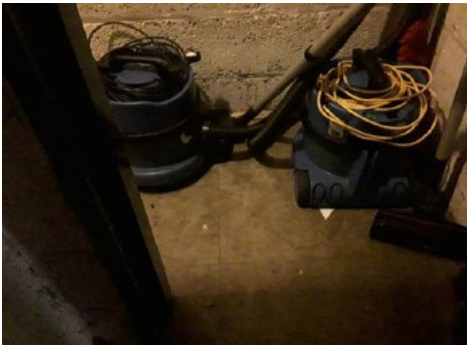
Item 11 Ref: 21-35336-3

The floor tiles and adhesive (Area 24/Boiler Room) contain asbestos.

Any change in its appearance should be recorded and passed to Property Services.

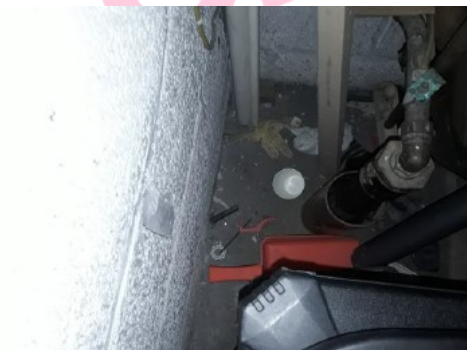
Item 12 Ref: 21-35336-5

The debris to floor (Area 24/Boiler Room) does not contain asbestos.

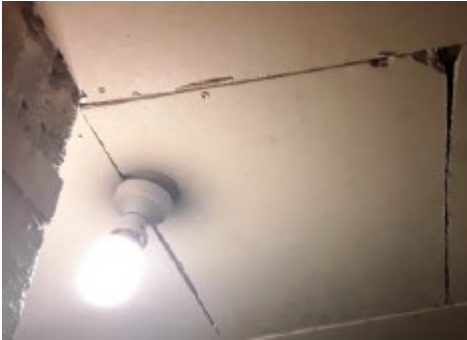
Item 13 Ref: 21-35336-6

The ceiling (Area 24/Boiler Room) does not contain asbestos.

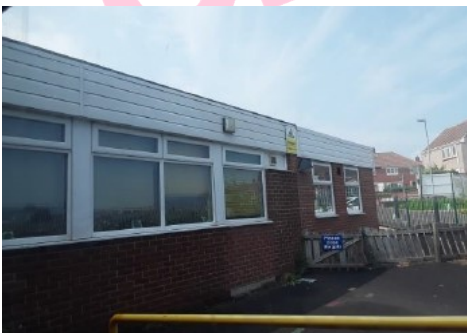
Item 15 Ref: Presumed

The fascia behind new PVC fascia boards (Area 25/External) is presumed to contain asbestos.

Any change in its appearance should be recorded and passed to Property Services.

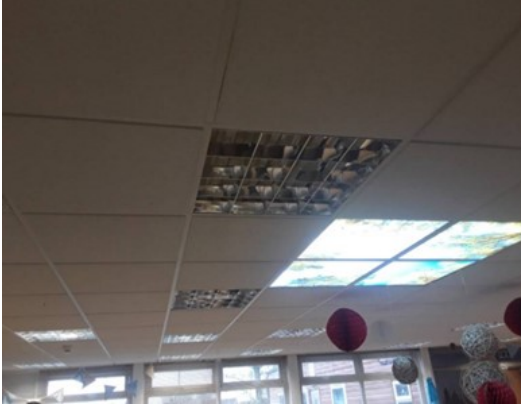
Item 22 Ref: NZ000214

The felt debris to beams from over spill from roof in the Classroom (G002) does not contain asbestos.

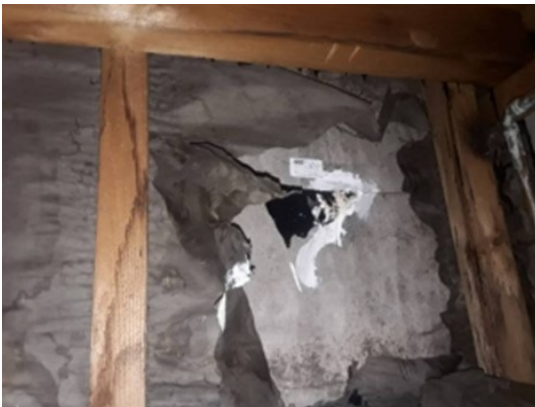
Item 23 Ref: NZ000216

- (Item 23)** *NZ000216 – Fascias above door to new extension (Classroom/G002) – Very Low Risk*
- (Item 24)** *NZ000217 – Debris from damaged fascias above door (Classroom/G002) – Removed June 2023*

The fascias above door to new extension in Classroom (G002) do contain asbestos.

Any change in its appearance should be recorded and passed to Property Services.

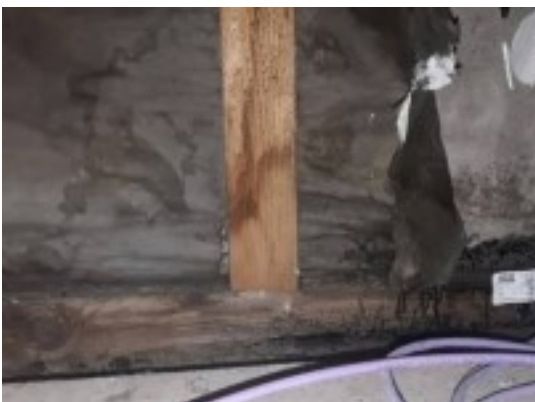
Item 24 Ref: NZ000217

The debris from the damaged fascias above door in Classroom (G002) do contain asbestos.

Removed June 2023.

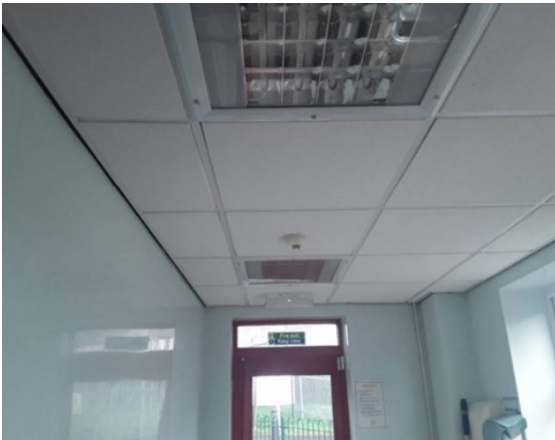
Item 26 Ref: NZ000214

The felt debris to beams from over spill from roof in Kitchen Room 005) does not contain asbestos.

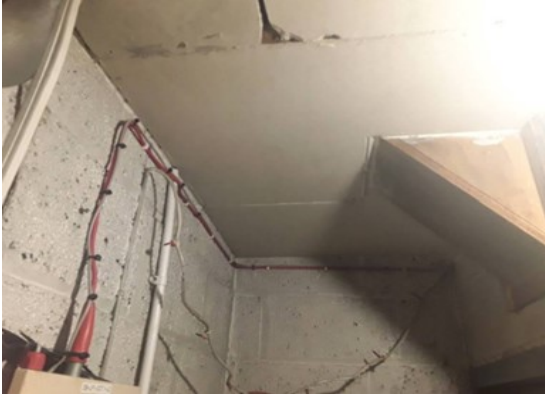
Item 39 Ref: NZ000220

The ceiling in the Entrance Boiler Room to Boiler Room (G020) does not contain asbestos.

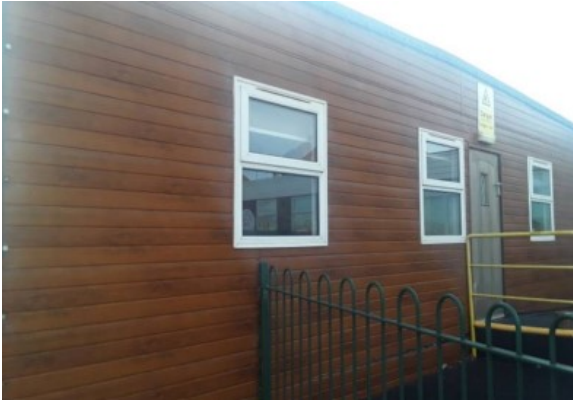
Item 51 Ref: NZ002354

The wall coating timber behind wall sheet cladding to demountable unit (External E/001) does not contain asbestos.

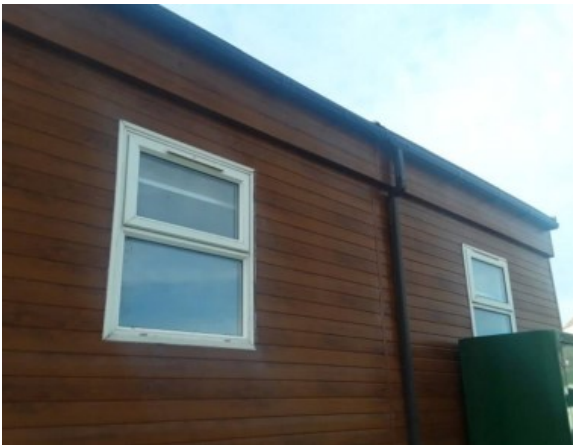
Item 52 Ref: NZ002355

The window putty/seal to frame (External E/001) does not contain asbestos.
