### **ASBESTOS SURVEY REPORT FOR JOHN F KENNEDY PRIMARY SCHOOL, WASHINGTON**

### **JOHN F KENNEDY PRIMARY SCHOOL, WASHINGTON**

**Date: 02 July 2025**

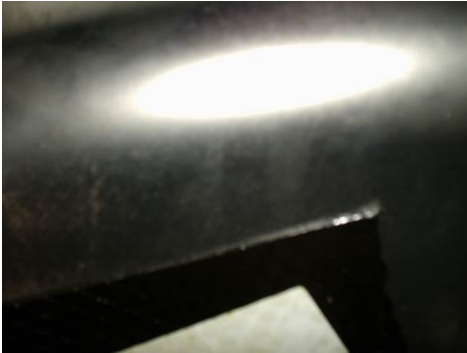
### **Item 4 - Ref: JP0652/07**

The sink pad to the classroom (Room 0/21) does not contain asbestos.

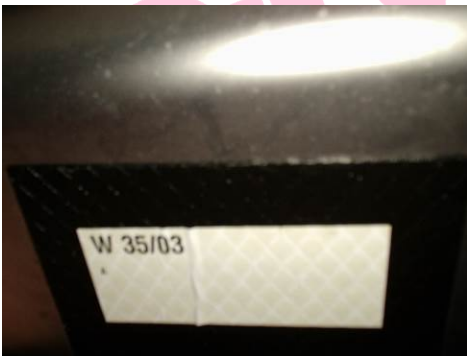
### **Item 6 - Ref: JP0654/07**

The sink pad to the classroom (Room 0/27) does not contain asbestos.

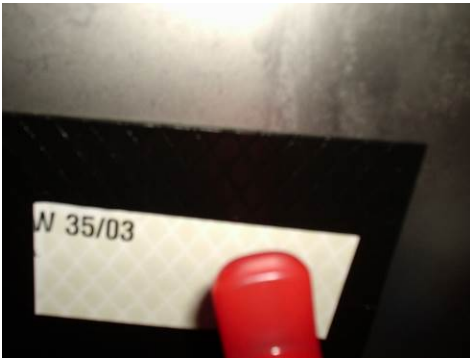
### **Item 7 - Ref: JP0655/07**

The sink pad to the classroom (Room 0/28) does not contain asbestos.

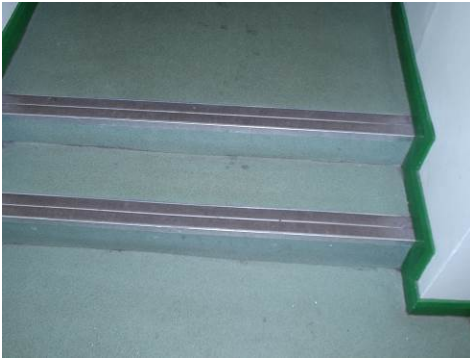
### **Item 8 - Ref: JP0656/07**

The nosing to the stairs in the corridor (Room 0/33) does not contain asbestos.

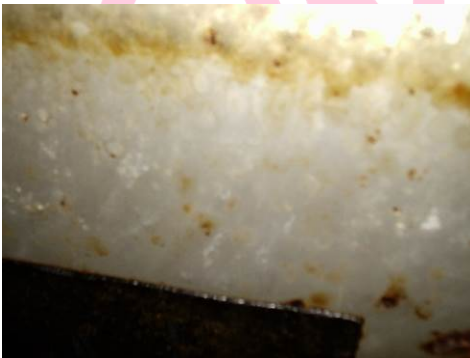
### **Item 9 - Ref: JP0657/07**

The sink pad to the kitchen (Room 0/36) does not contain asbestos

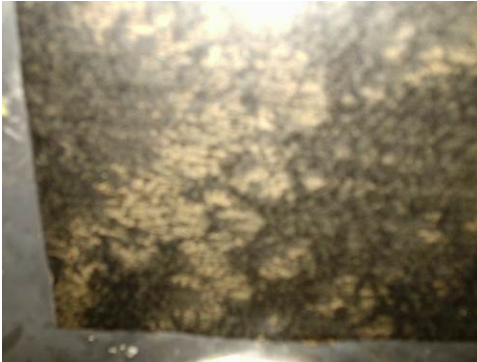
### **Item 13 - Ref:JP0661/07**

The sink pad to the classroom  
(Room 0/59) does not contain  
asbestos

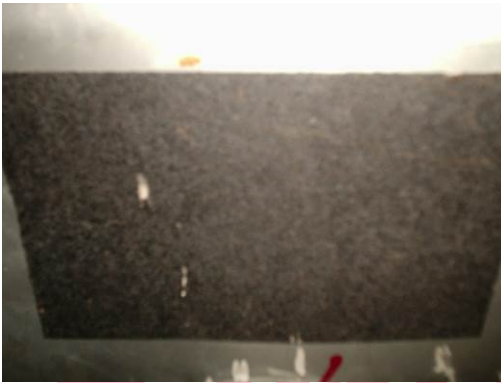
### **Item 14 - Ref:JP0662/07**

The sink pad to the classroom  
(Room 0/61) does not contain  
asbestos

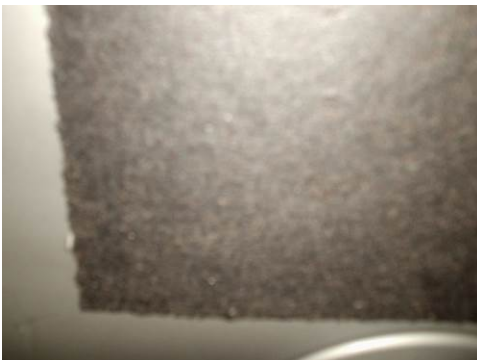
### **Item 15 - Ref:JP0663/07**

The sink pad to the classroom  
(Room 0/62) does not contain  
asbestos

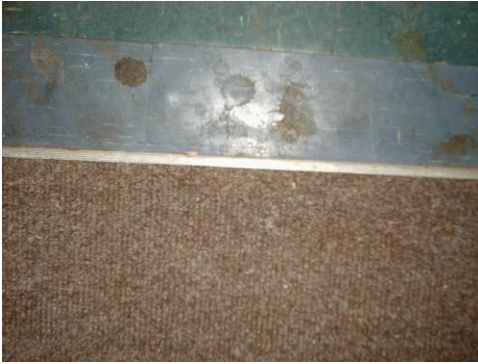
### **Item 19 - Ref:JP0667/07**

The blue floor tiles to the caretakers office (Room 0/74) contains asbestos.

Any change in its appearance should be recorded, and passed to Property Services.

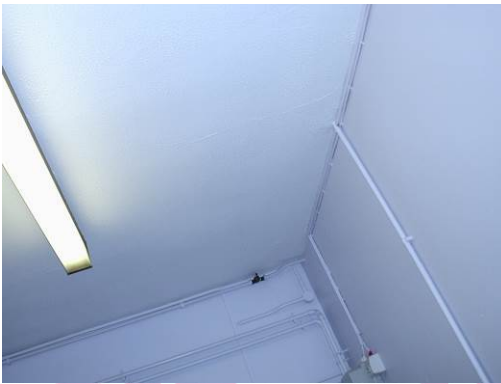
### **Item 20 - Ref:JP0668/07**

The textured coating to the ceiling in the corridor (Room 0/76) does not contain asbestos.

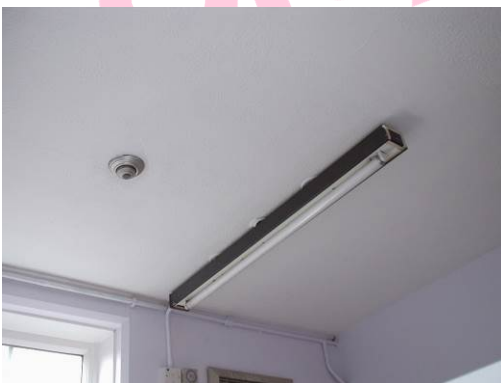
### **Item 21 - Ref:JP0669/07**

The textured coating to the ceiling in the female WC (Room 0/77) does not contain asbestos.

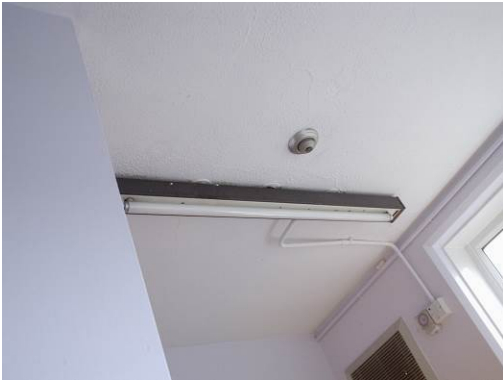
### **Item 22 - Ref:JP0670/07**

The textured coating to the ceiling in the male WC (Room 0/78) does not contain asbestos.

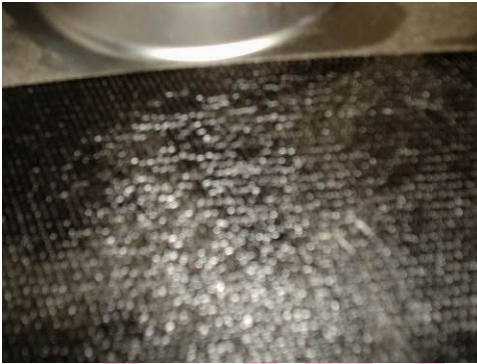
### **Item 23 - Ref:JP0671/07**

The sink pad in the classroom (Room 0/79) does not contain asbestos.

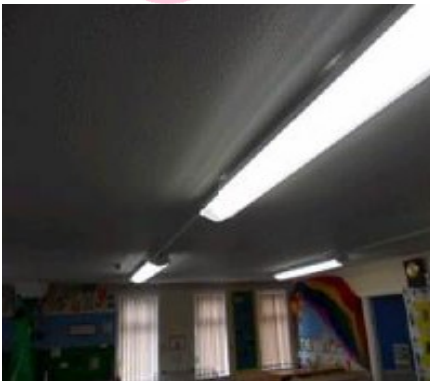
### **Item 24: Ref: VP003646**

*The textured coating to the ceiling within the nursery contains asbestos.*

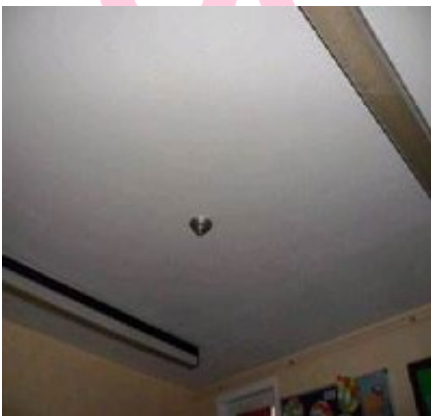
### **Item 27: As VP003646**

*The textured coating to the ceiling within the adjacent room within the nursery contains asbestos.*

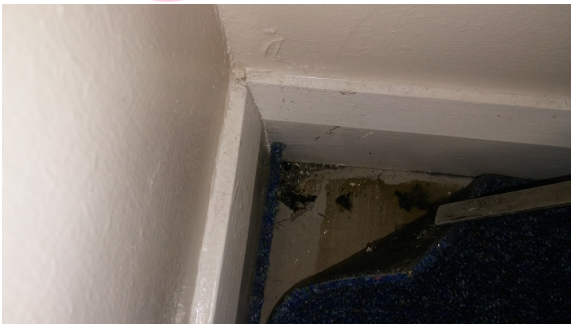
### **Item 36 Ref: As 415279-2**

The remnant floor adhesive  
beneath screed in Rm 0/033  
Classroom contains asbestos.

Any change in its appearance  
should be recorded and  
passed to Property Services.

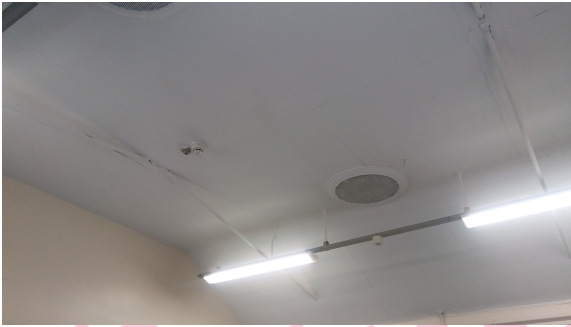
### **Item 38 Ref: As 415279-1**

The ceiling in Rm 0/033 Classroom does not contain asbestos.

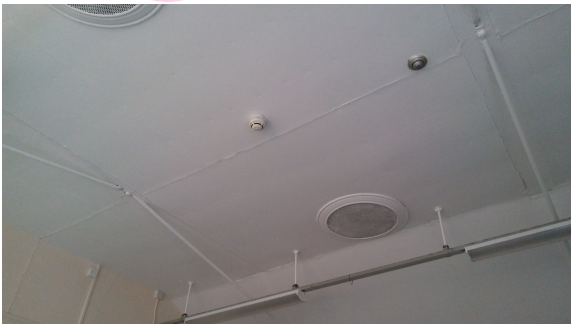
### **Item 39 Ref: 415279-1**

The ceiling in Rm 0/034 Classroom does not contain asbestos.

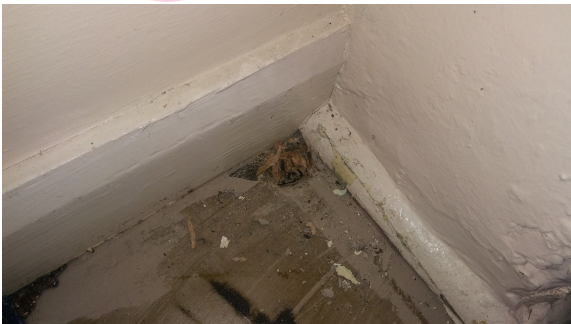
### **Item 42 Ref: 415279-3**

The remnant floor adhesive in Rm 0/035 Classroom does not contain asbestos.

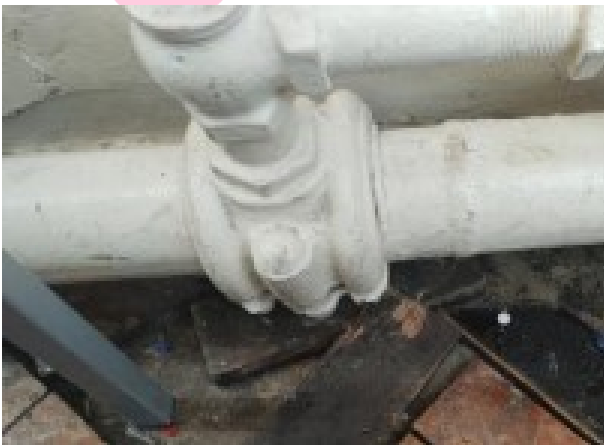
### **Item 141 Ref: 21-32784-1**

The bitumen to the floor in Year 6 Classroom (Area 1) does not contain asbestos.

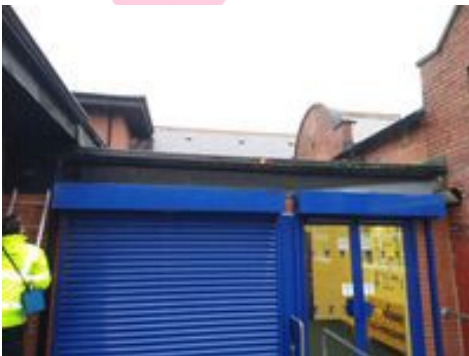
### **Item 144 Ref: 451175-4**

The roof covering (External  
Roof 6) does not contain  
asbestos.

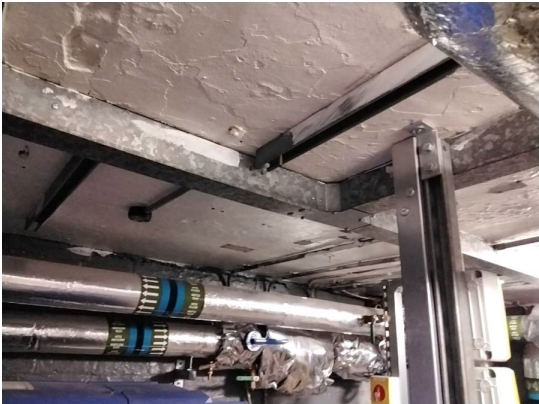
### **Item 151 Ref: Presumed**

The Debris/Residue to ceiling (Boiler Room Plant Room 2 Z1/001) is presumed to contain asbestos.

Any change in its appearance should be recorded and passed to Property Services.

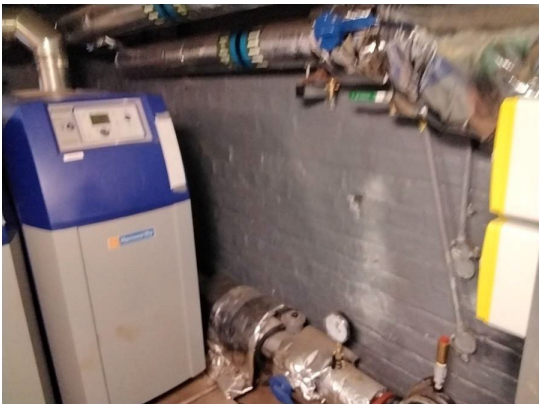
### **Item 152 Ref: Presumed**

The Debris/Residue to walls (Boiler Room Plant Room 2 Z1/001) is presumed to contain asbestos.

Item 152	Debris/Residue to walls (Boiler Room Plant Room 2 Z1/001)	Medium Risk		03.09.2025
Item 153	Debris/Residue to wall opposite door, paint degraded (Boiler Room Plant Room 2 Z1/001)	Medium Risk		03.09.2025

Any change in its appearance should be recorded and passed to Property Services.

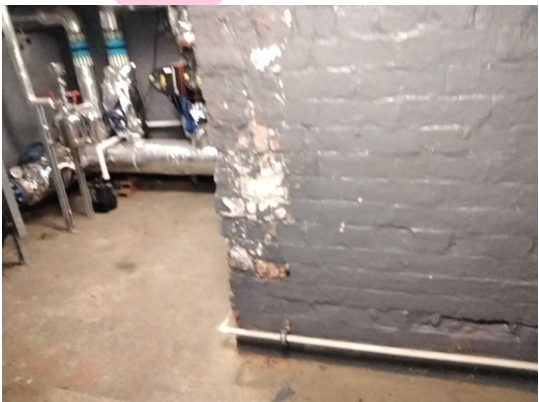
### **Item 153 Ref: Presumed**

The Debris/Residue to wall opposite door, paint degraded (Boiler Room Plant Room 2 Z1/001) is presumed to contain asbestos.

Any change in its appearance should be recorded and passed to Property Services.

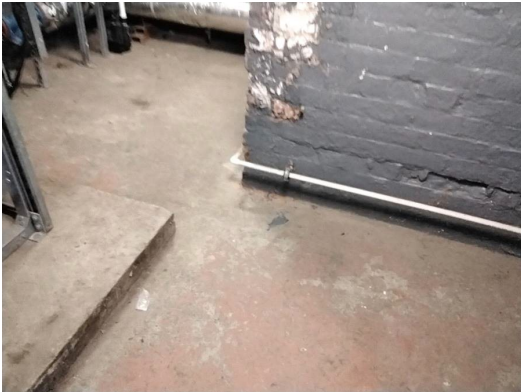
### **Item 154 Ref: KX001875**

The Debris/Residue to floor (Boiler Room Plant Room 2 Z1/001) does not contain asbestos.

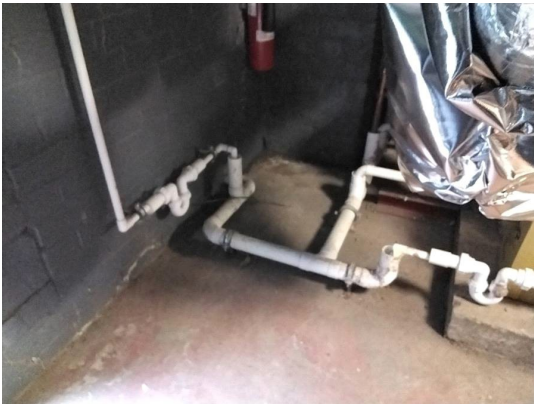
### **Item 155 Ref: KX001876**

The Debris/Residue to floor (Boiler Room Plant Room 2 Z1/001) contains asbestos.

Any change in its appearance should be recorded and passed to Property Services.

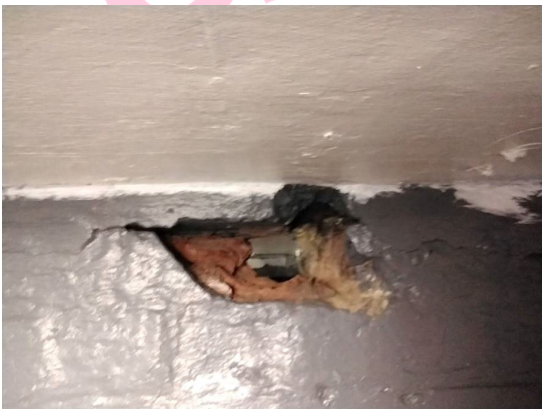
### **Item 156 Ref: KX001877**

The Debris/Residue within pipe penetration (Boiler Room Plant Room 2 Z1/001) does not contain asbestos.

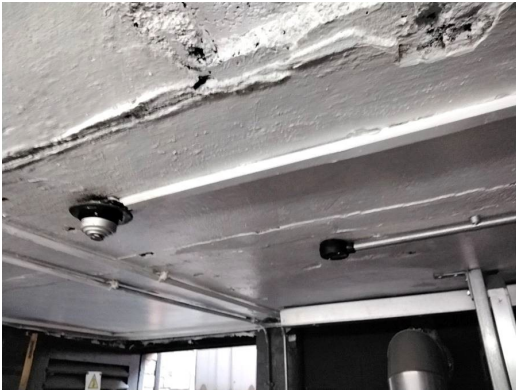
### **Item 157 Ref: Presumed**

The Debris/Residue to ceiling (Boiler Room Plant Room 3 Z1/002) is presumed to contain asbestos.

Any change in its appearance should be recorded and passed to Property Services.

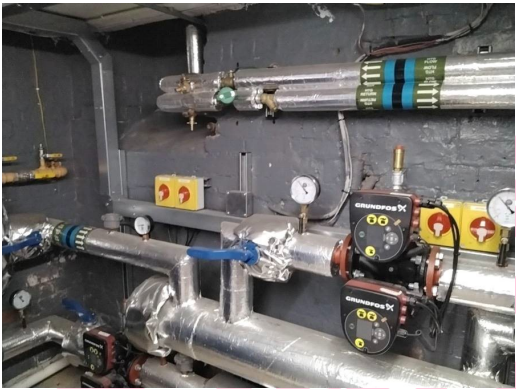
### **Item 158 Ref: Presumed**

The Debris/Residue to walls (Boiler Room Plant Room 3 Z1/002) is presumed to contain asbestos.

Any change in its appearance should be recorded and passed to Property Services.

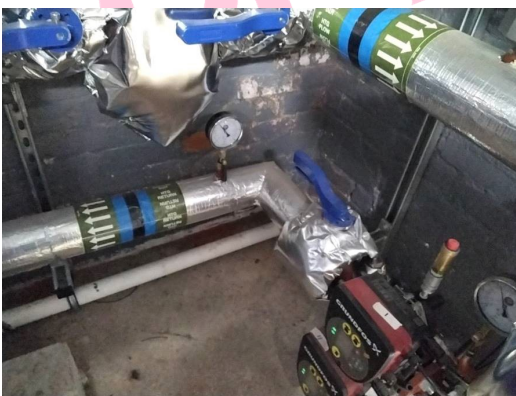
### **Item 159 Ref: Presumed**

The Debris/Residue to wall in corner, paint degraded (Boiler Room Plant Room 3 Z1/002) is presumed to contain asbestos.

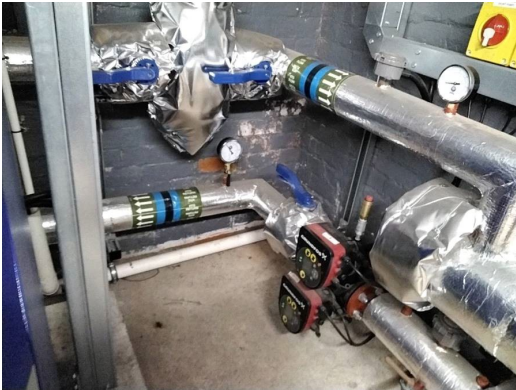
### **Item 160 Ref: KX001878**

The Debris/Residue to floor (Boiler Room Plant Room 3 Z1/002) does not contain asbestos.

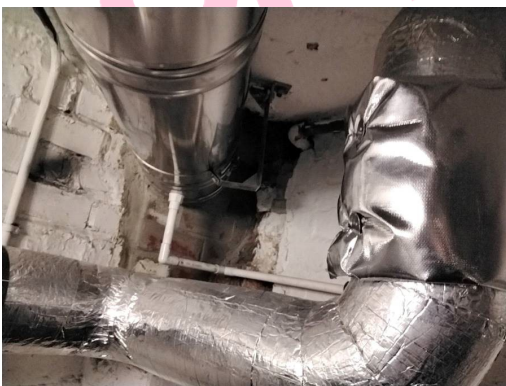
### **Item 162 Ref: KX001883**

The Debris/Residue to corner penetration (Boiler Room Plant Room 1 Z1/003) does not contain asbestos.

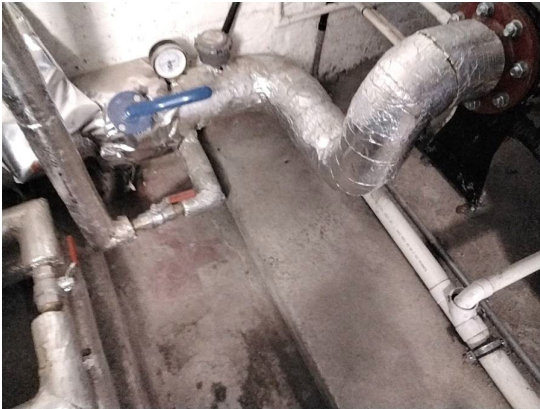
### **Item 163 Ref: KX001882**

The Debris/Residue to floor (Boiler Room Plant Room 1 Z1/003) does not contain asbestos.

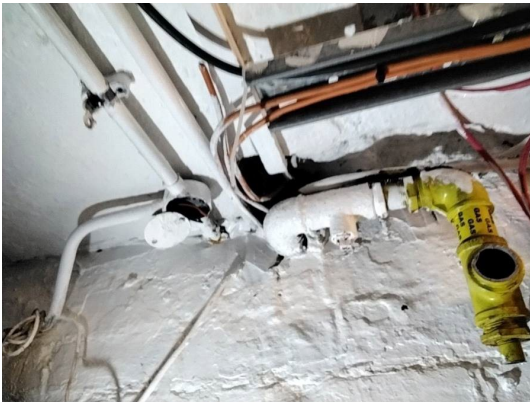
### **Item 164 Ref: KX001880**

The Debris/Residue to ceiling penetrations (Boiler Room Plant Room 1 Z1/003) does not contain asbestos.

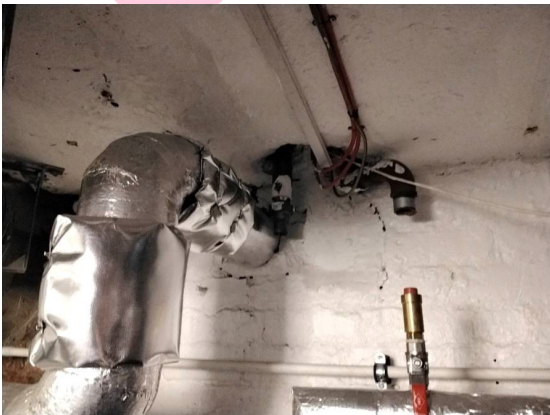
### **Item 165 Ref: KX001881**

The Debris/Residue within pipe penetrations to rear wall (Boiler Room Plant Room 1 Z1/003) does not contain asbestos.

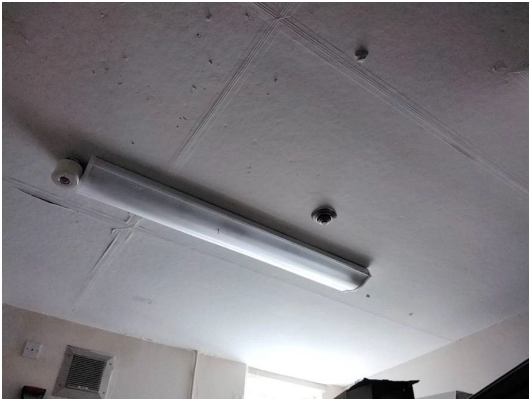
### **Item 166 Ref: KX001872**

The Ceiling (Male Toilets G/002) does not contain asbestos.

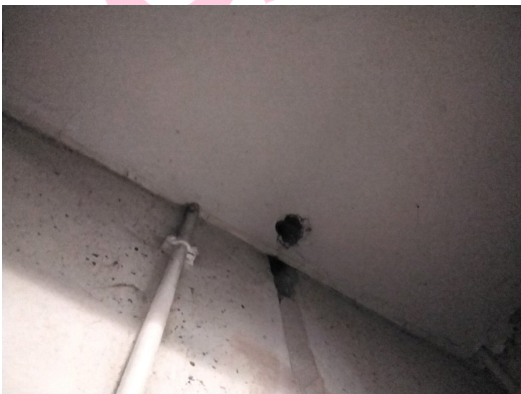
### **Item 168 Ref: As KX001872**

The Ceiling (Corridor G/004) does not contain asbestos.

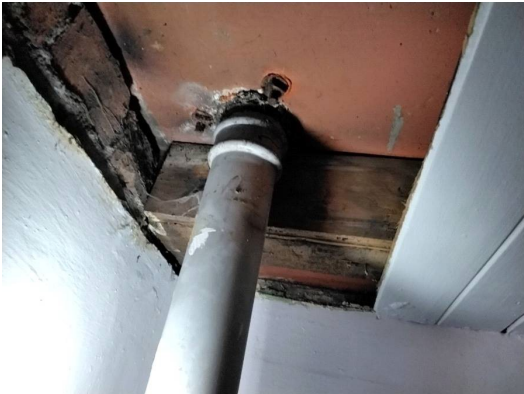
### **Item 169 Ref: KX001873**

The Pipe joints  
Caulking/packing drainpipe  
joint to tank (Cupboard G/007)  
does not contain asbestos.

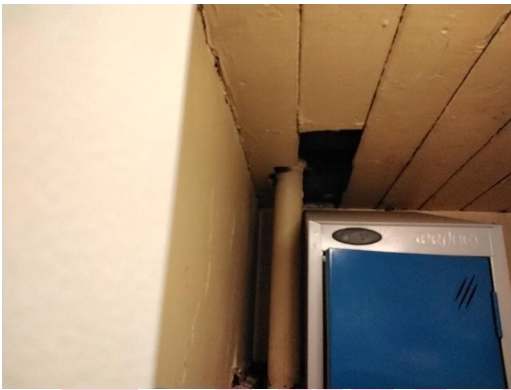
### **Item 170 Ref: As KX001873**

The Pipe joints  
Caulking/packing drainpipe  
joint to tank (Cupboard G/016)  
does not contain asbestos.

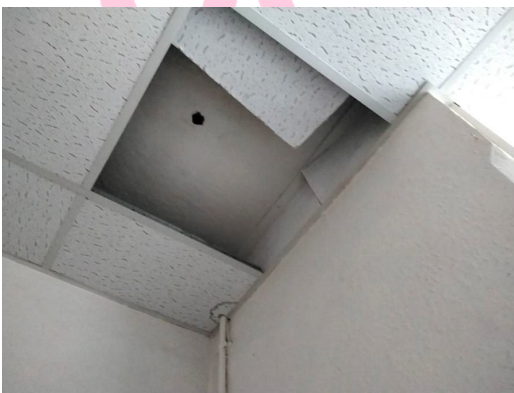
### **Item 171 Ref: KX001874**

The Ceiling (Store Room  
G/017) does not contain  
asbestos.

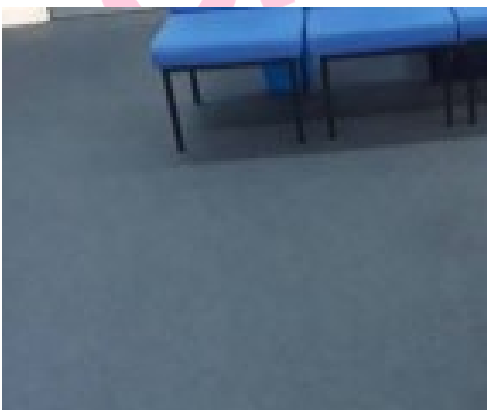
### **Item 174 Ref: NZ001550**

The Floor screed (Staff Room G/004) does not contain asbestos.

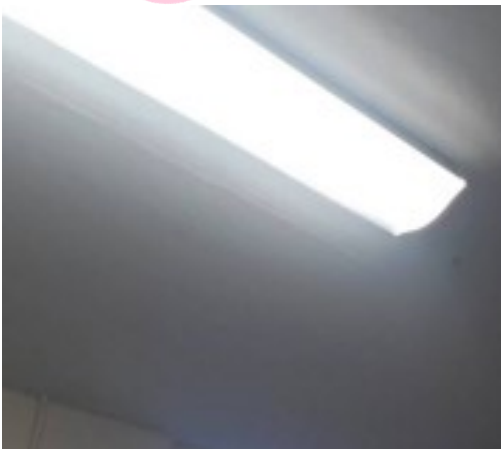
### **Item 177 Ref: As NZ001551**

The Ceiling (Caretakes room adjacent staff toilet G/007) does not contain asbestos.
