### ASBESTOS SURVEY REPORT FOR JOHN F KENNEDY PRIMARY SCHOOL, WASHINGTON

*Control of Asbestos  
Regulations 2012*

### JOHN F KENNEDY PRIMARY SCHOOL, WASHINGTON

**Date: 03 March 2026**

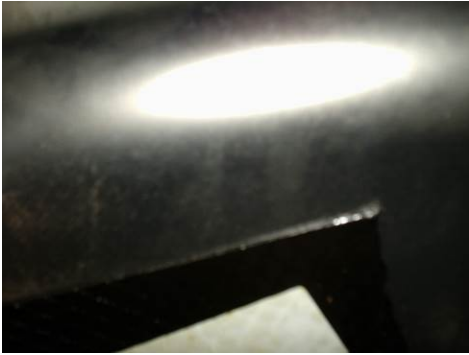
### **Item 4 - Ref: JP0652/07**

The sink pad to the classroom (Room 0/21) does not contain asbestos.

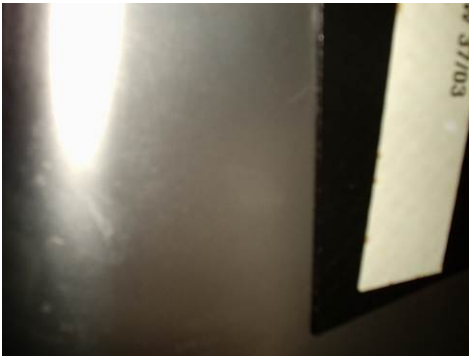
### **Item 5 - Ref: JP0653/07**

The sink pad to the classroom (Room 0/22) does not contain asbestos.

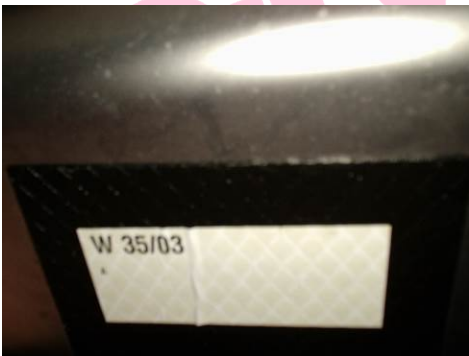
### **Item 6 - Ref: JP0654/07**

The sink pad to the classroom (Room 0/27) does not contain asbestos.

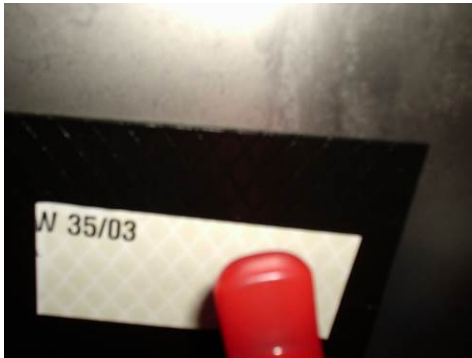
### **Item 7 - Ref: JP0655/07**

The sink pad to the classroom (Room 0/28) does not contain asbestos.

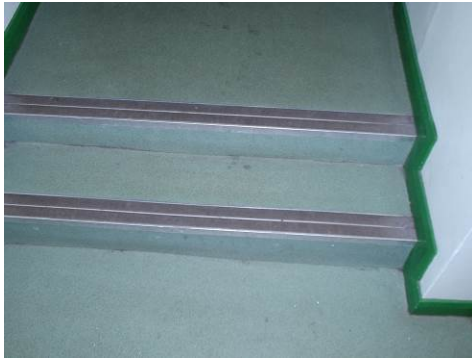
### **Item 8 - Ref: JP0656/07**

The nosing to the stairs in the corridor (Room 0/33) does not contain asbestos.

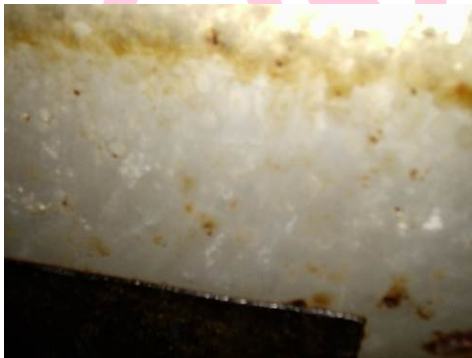
### **Item 9 - Ref: JP0657/07**

The sink pad to the kitchen (Room 0/36) does not contain asbestos.

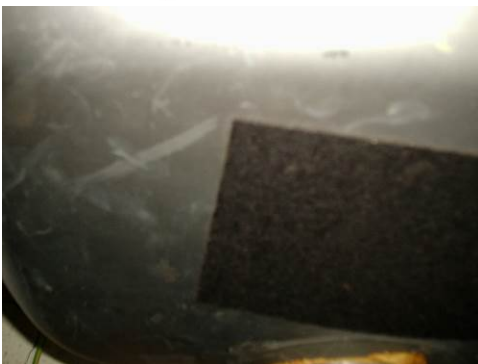
**Item 12 - Ref: JP0660/07**

The sink pad to the classroom (Room 0/58) does not contain asbestos

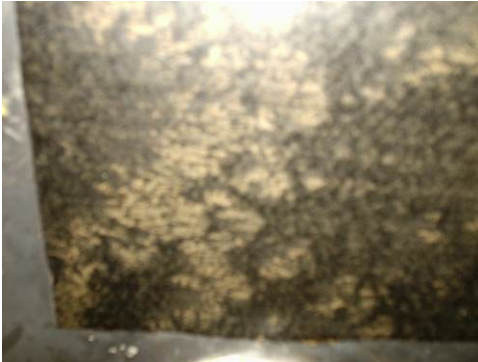
### **Item 13 - Ref:JP0661/07**

The sink pad to the classroom (Room 0/59) does not contain asbestos

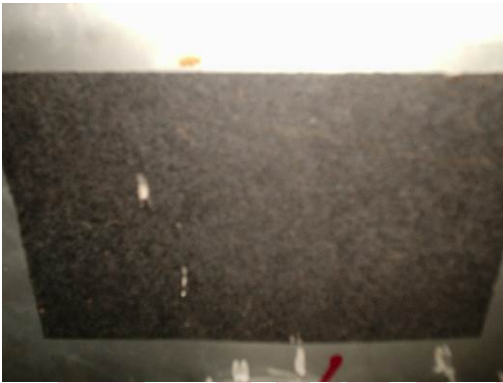
### **Item 14 - Ref:JP0662/07**

The sink pad to the classroom (Room 0/61) does not contain asbestos

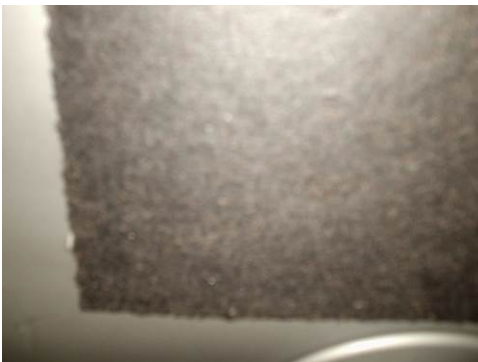
### **Item 15 - Ref:JP0663/07**

The sink pad to the classroom (Room 0/62) does not contain asbestos

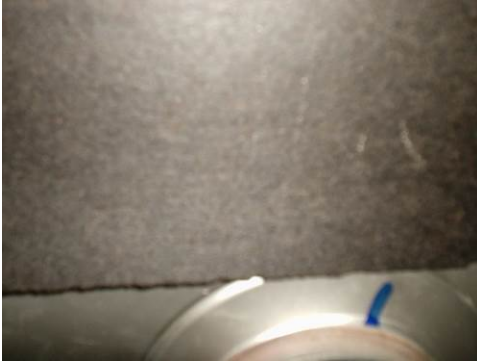
**Item 16 - Ref: JP0664/07**

The sink pad to the classroom (Room 0/63) does not contain asbestos

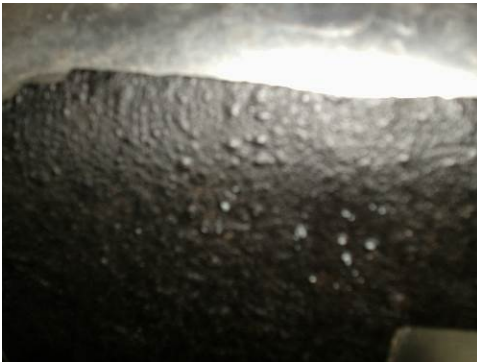
**Item 17 - Ref: JP0665/07**

The sink pad to the classroom (Room 0/65) contained asbestos.

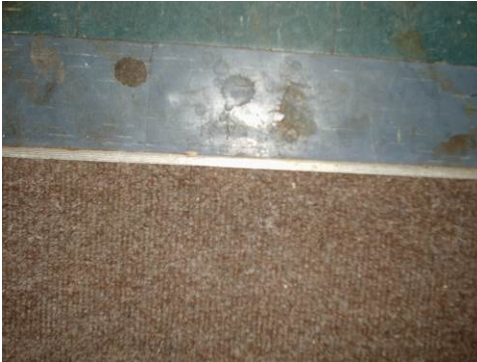
### **Item 19 - Ref:JP0667/07**

The blue floor tiles to the caretakers office (Room 0/74) contains asbestos.

Any change in its appearance should be recorded, and passed to Property Services.

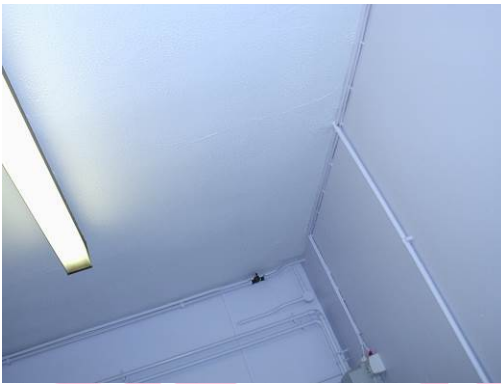
### **Item 20 - Ref:JP0668/07**

The textured coating to the ceiling in the corridor (Room 0/76) does not contain asbestos.

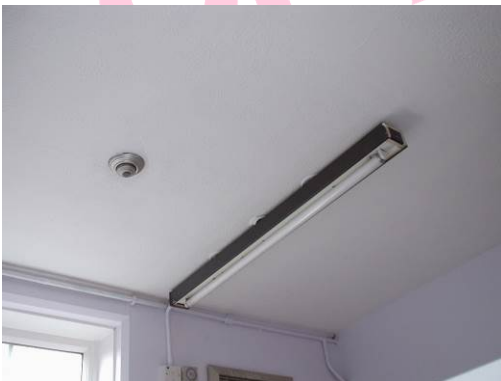
### **Item 21 - Ref:JP0669/07**

The textured coating to the ceiling in the female WC (Room 0/77) does not contain asbestos.

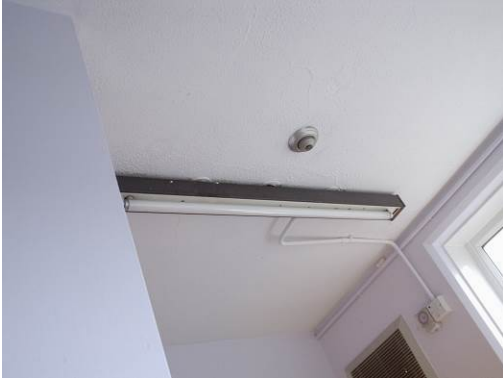
### **Item 22 - Ref:JP0670/07**

The textured coating to the ceiling in the male WC (Room 0/78) does not contain asbestos.

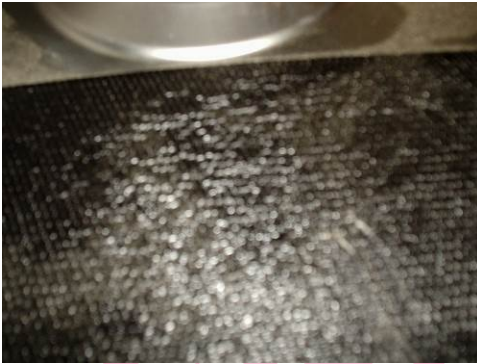
### **Item 23 - Ref:JP0671/07**

The sink pad in the classroom (Room 0/79) does not contain asbestos.

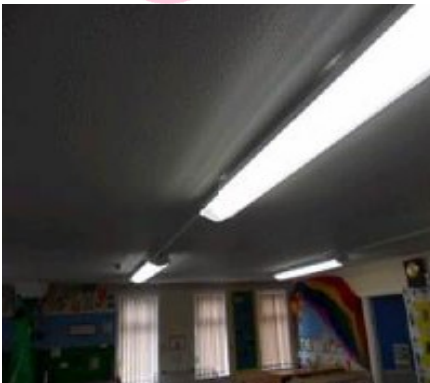
### **Item 24: Ref: VP003646**

*The textured coating to the ceiling within the nursery contains asbestos.*

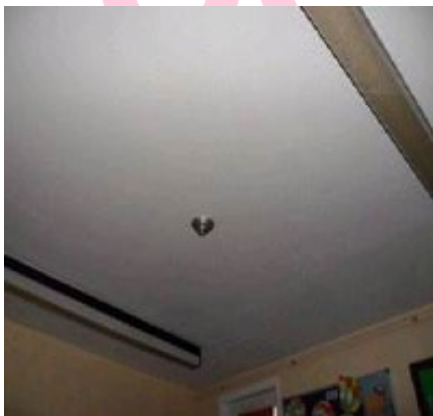
**Item 27: As VP003646**

*The textured coating to the ceiling within the adjacent room within the nursery contains asbestos.*

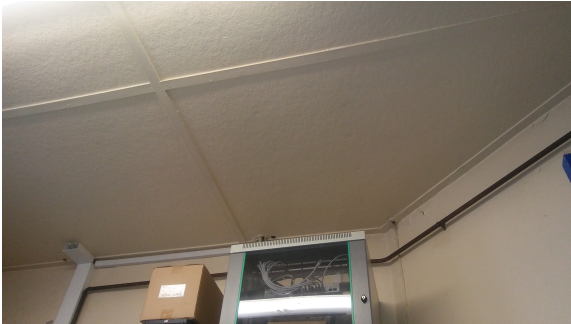
### **Item 34 Ref: As 415279-5**

The ceiling in Rm 0/031  
Caretakers Room does not  
contain asbestos.

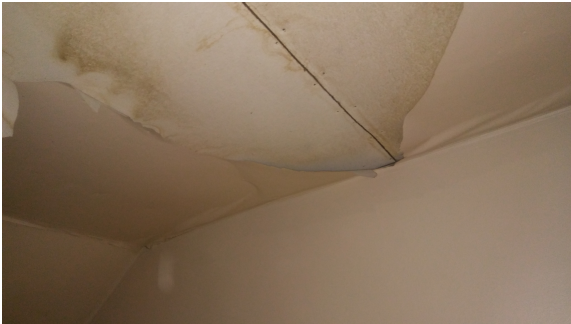
### **Item 35 Ref: As 415279-1**

The ceiling in Rm 0/032  
Classroom void above does  
not contain asbestos.

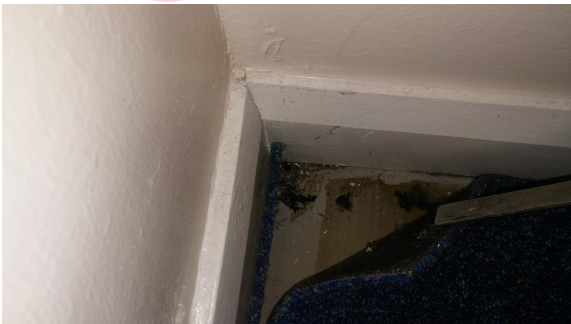
### **Item 36 Ref: As 415279-2**

The remnant floor adhesive  
beneath screed in Rm 0/033  
Classroom contains asbestos.

Any change in its appearance  
should be recorded and  
passed to Property Services.

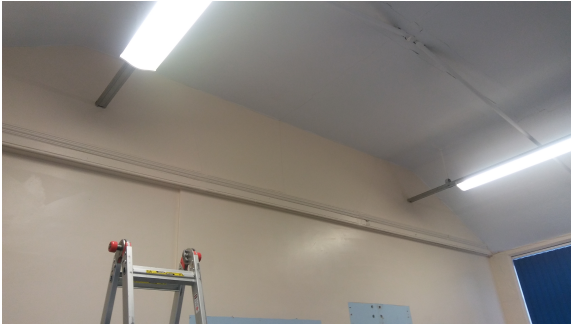
**Item 37 Ref: As 415279-1**

The high level panels in Rm 0/033 Classroom do not contain asbestos.

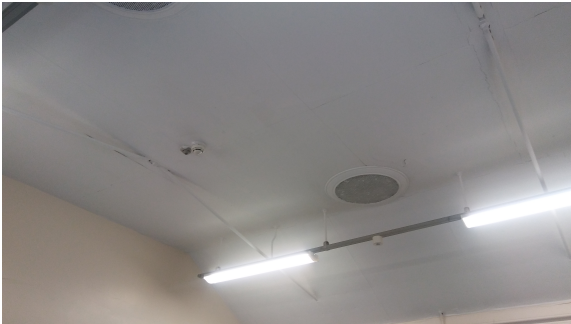
**Item 38 Ref: As 415279-1**

The ceiling in Rm 0/033 Classroom does not contain asbestos.

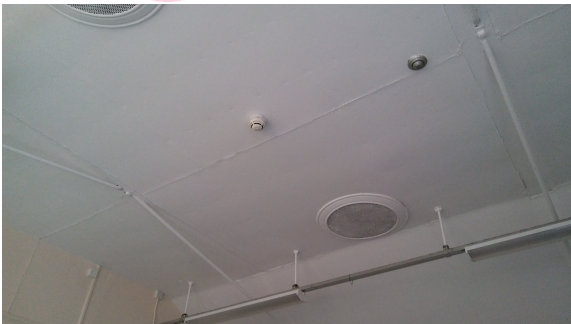
**Item 39 Ref: 415279-1**

The ceiling in Rm 0/034 Classroom does not contain asbestos.

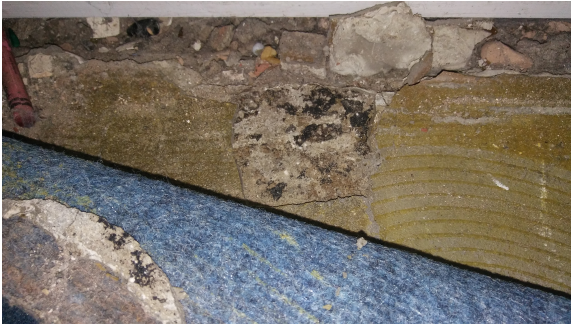
### **Item 40 Ref: 415279-2**

The remnant floor adhesive beneath screed in Rm 0/034 Classroom contains asbestos.

Any change in its appearance should be recorded and passed to Property Services.

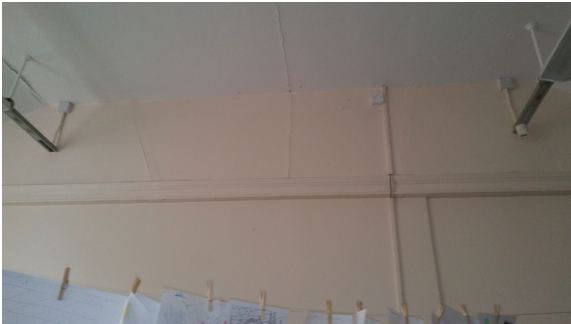
### **Item 41 Ref: As 415279-1**

The high level panels in Rm 0/034 Classroom do not contain asbestos.

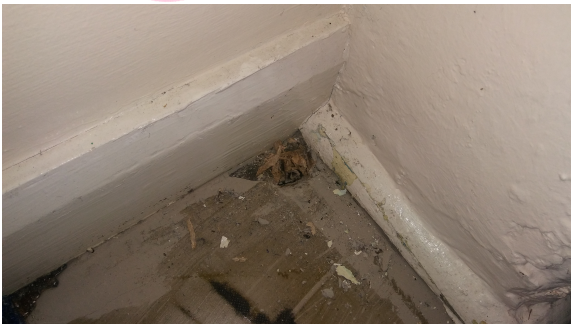
### **Item 42 Ref: 415279-3**

The remnant floor adhesive in Rm 0/035 Classroom does not contain asbestos.

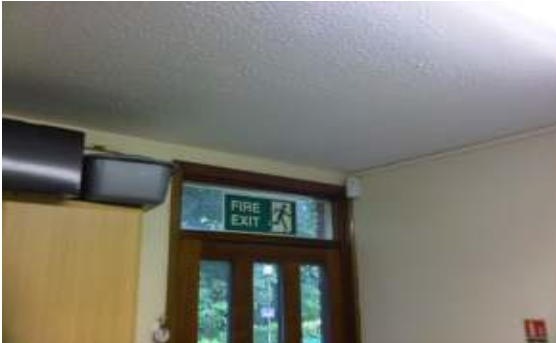
**Item 46 Ref: IC11-493**

The textured coating to ceiling above door (Door A) does not contain asbestos.

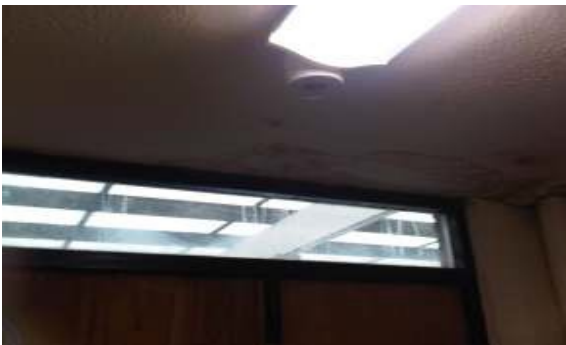
**Item 47 Ref: As IC11-493**

The textured coating to ceiling above door (Door B) does not contain asbestos.

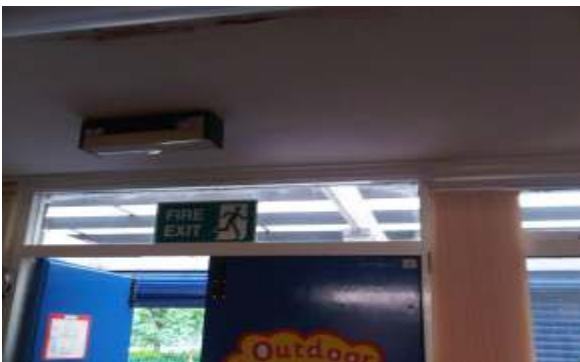
**Item 48 Ref: As IC11-493**

The textured coating to ceiling above door (Door C) does not contain asbestos.

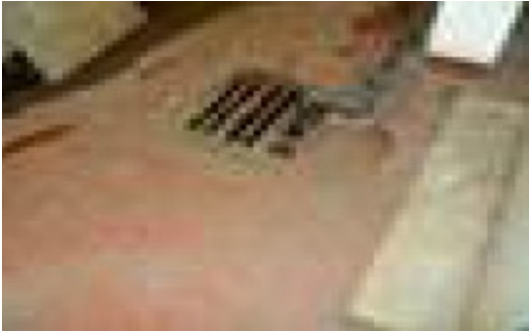
**Item 55 Ref: BS004221**

The Debris to floor (Boiler Room 1) does not contain asbestos.

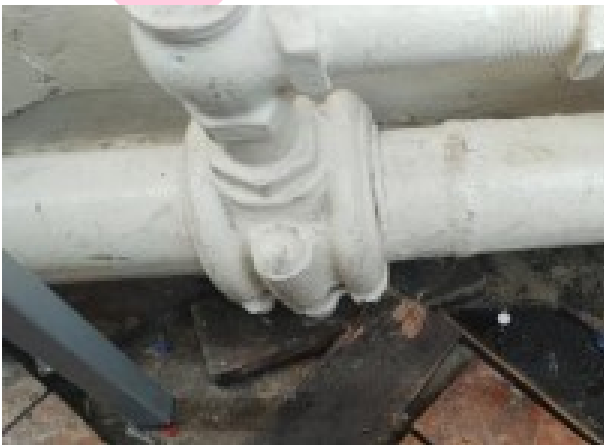
**Item 141 Ref: 21-32784-1**

The bitumen to the floor in Year 6 Classroom (Area 1) does not contain asbestos.

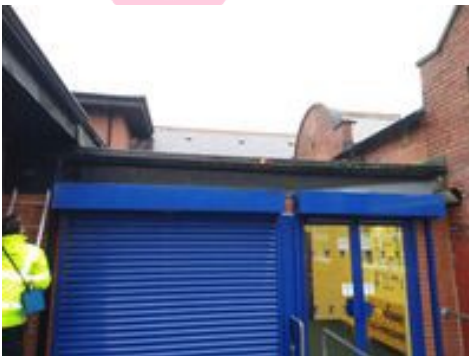
**Item 144 Ref: 451175-4**

The roof covering (External Roof 6) does not contain asbestos.

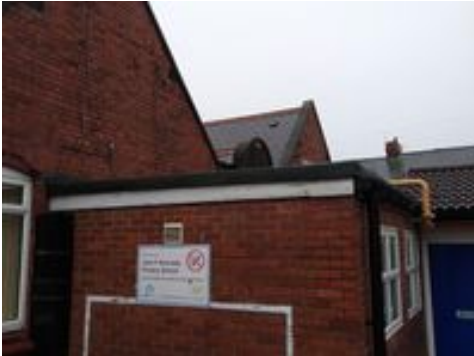
**Item 145 Ref: 451175-2**

The roof covering (External Roof 7) does not contain asbestos.

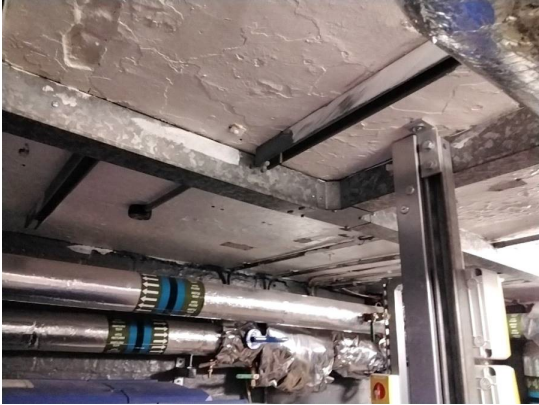
### **Item 151 Ref: Presumed**

The Debris/Residue to ceiling (Boiler Room Plant Room 2 Z1/001) is presumed to contain asbestos.

Any change in its appearance should be recorded and passed to Property Services.

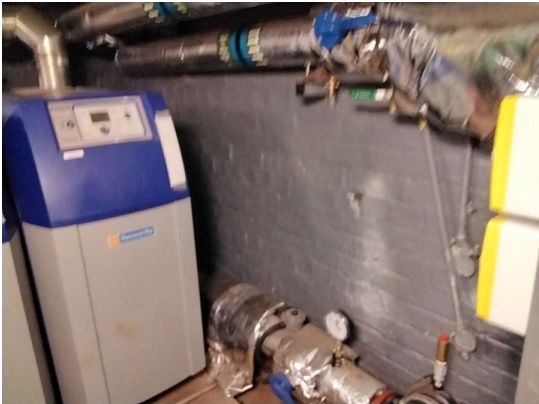
### **Item 152 Ref: Presumed**

The Debris/Residue to walls (Boiler Room Plant Room 2 Z1/001) is presumed to contain asbestos.

Any change in its appearance should be recorded and passed to Property Services.

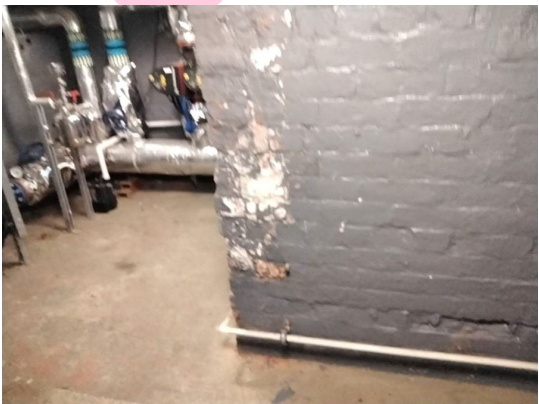
### **Item 153 Ref: Presumed**

The Debris/Residue to wall opposite door, paint degraded (Boiler Room Plant Room 2 Z1/001) is presumed to contain asbestos.

Any change in its appearance should be recorded and passed to Property Services.

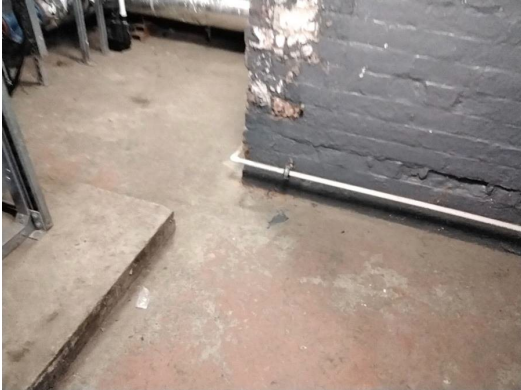
**Item 154 Ref: KX001875**

The Debris/Residue to floor (Boiler Room Plant Room 2 Z1/001) does not contain asbestos.

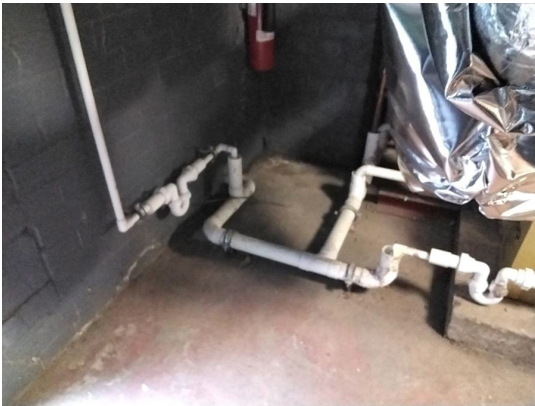
**Item 155 Ref: KX001876**

The Debris/Residue to floor (Boiler Room Plant Room 2 Z1/001) contains asbestos.

Any change in its appearance should be recorded and passed to Property Services.

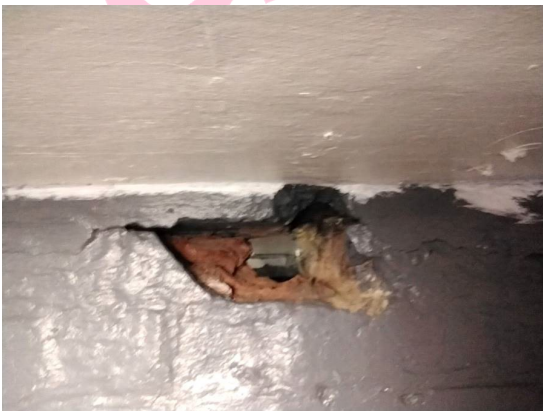
**Item 156 Ref: KX001877**

The Debris/Residue within pipe penetration (Boiler Room Plant Room 2 Z1/001) does not contain asbestos.

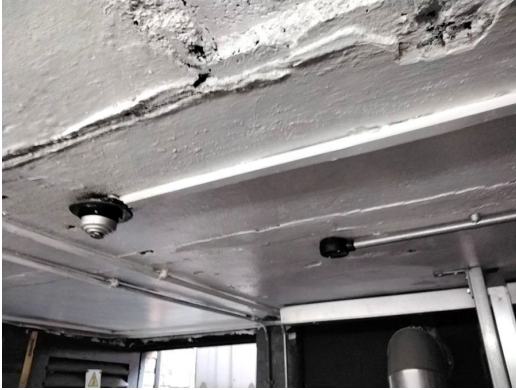
### **Item 157 Ref: Presumed**

The Debris/Residue to ceiling (Boiler Room Plant Room 3 Z1/002) is presumed to contain asbestos.

Any change in its appearance should be recorded and passed to Property Services.

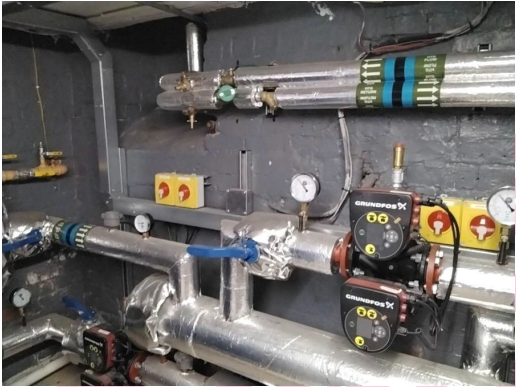
### **Item 158 Ref: Presumed**

The Debris/Residue to walls (Boiler Room Plant Room 3 Z1/002) is presumed to contain asbestos.

Any change in its appearance should be recorded and passed to Property Services.

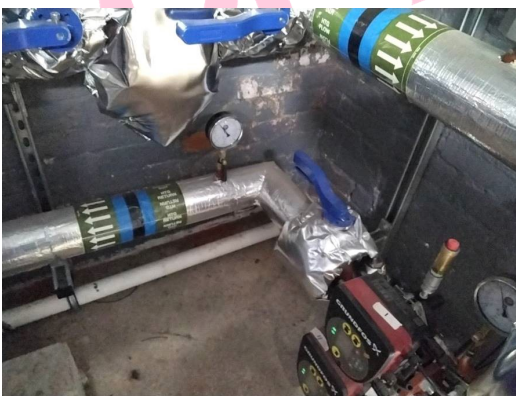
### **Item 159 Ref: Presumed**

The Debris/Residue to wall in corner, paint degraded (Boiler Room Plant Room 3 Z1/002) is presumed to contain asbestos.

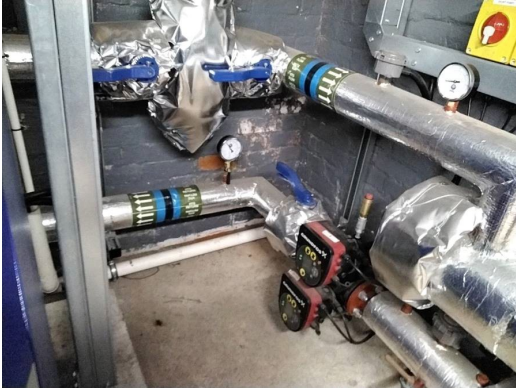
**Item 160 Ref: KX001878**

The Debris/Residue to floor (Boiler Room Plant Room 3 Z1/002) does not contain asbestos.

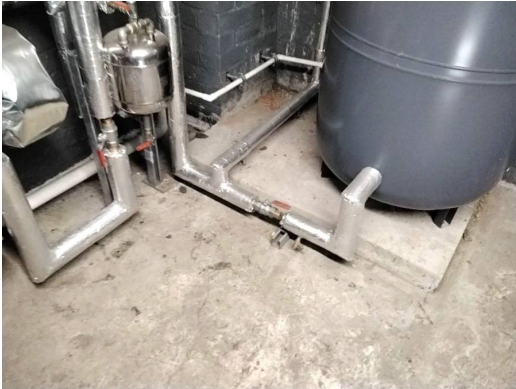
**Item 161 Ref: KX001879**

The Debris/Residue to floor (Boiler Room Plant Room 3 Z1/002) does not contain asbestos.

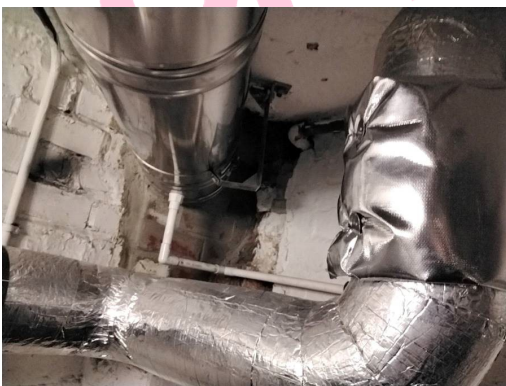
**Item 162 Ref: KX001883**

The Debris/Residue to corner penetration (Boiler Room Plant Room 1 Z1/003) does not contain asbestos.

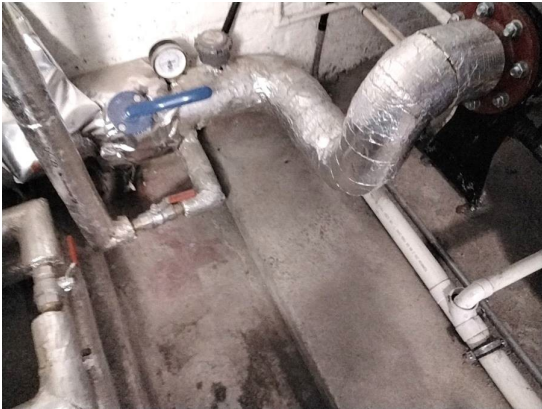
**Item 163 Ref: KX001882**

The Debris/Residue to floor (Boiler Room Plant Room 1 Z1/003) does not contain asbestos.

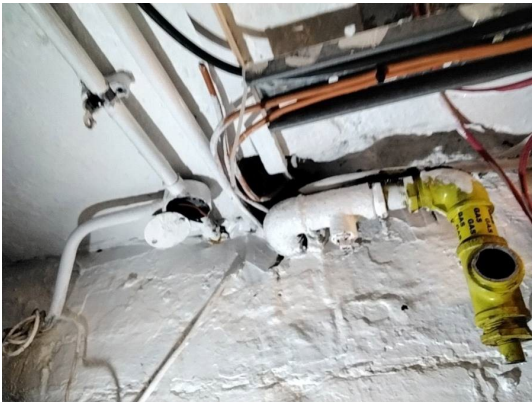
**Item 164 Ref: KX001880**

The Debris/Residue to ceiling penetrations (Boiler Room Plant Room 1 Z1/003) does not contain asbestos.

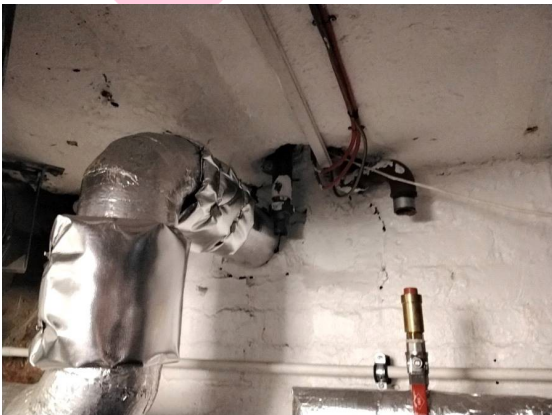
**Item 165 Ref: KX001881**

The Debris/Residue within pipe penetrations to rear wall (Boiler Room Plant Room 1 Z1/003) does not contain asbestos.

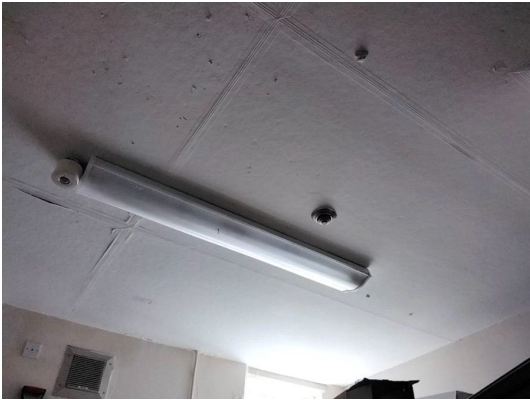
**Item 166 Ref: KX001872**

The Ceiling (Male Toilets G/002) does not contain asbestos.

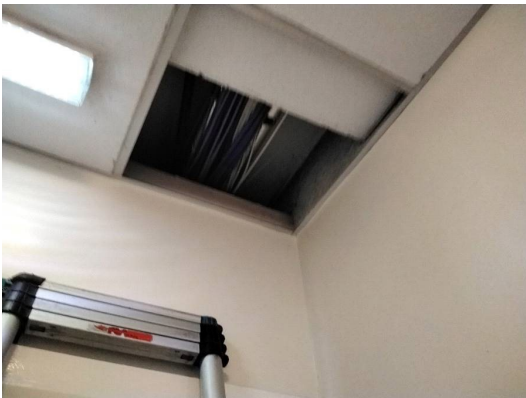
**Item 167 Ref: As KX001872**

The Ceiling (Corridor G/003) does not contain asbestos.

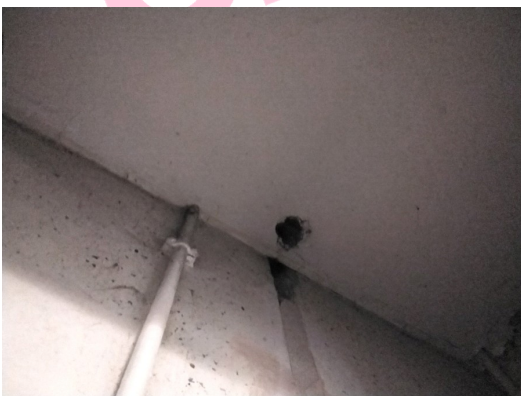
**Item 168 Ref: As KX001872**

The Ceiling (Corridor G/004) does not contain asbestos.

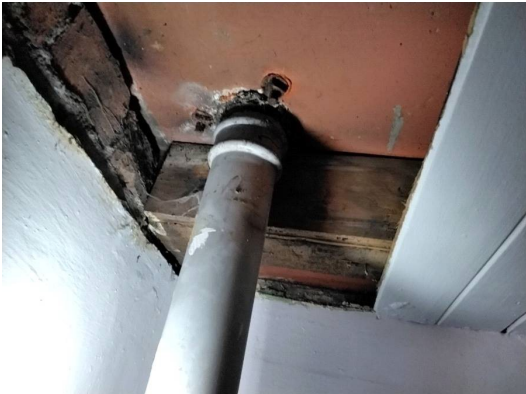
**Item 169 Ref: KX001873**

The Pipe joints  
Caulking/packing drainpipe  
joint to tank (Cupboard G/007)  
does not contain asbestos.

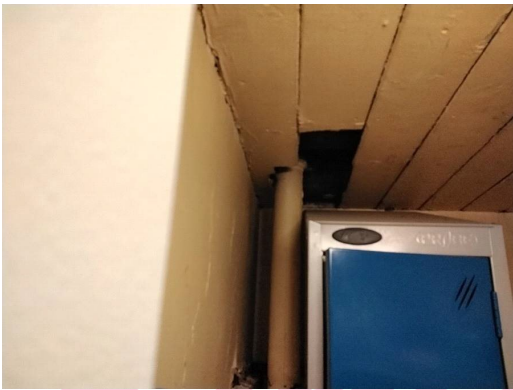
**Item 170 Ref: As KX001873**

The Pipe joints  
Caulking/packing drainpipe  
joint to tank (Cupboard G/016)  
does not contain asbestos.

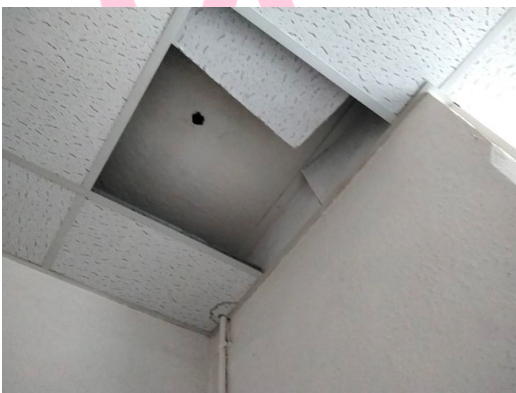
**Item 171 Ref: KX001874**

The Ceiling (Store Room  
G/017) does not contain  
asbestos.

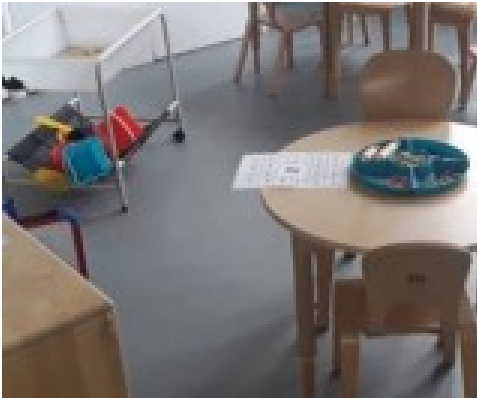
### **Item 172 Ref: NZ001548**

The Floor parquet tiles (Classroom Hedgehog Room G/001) does not contain asbestos.

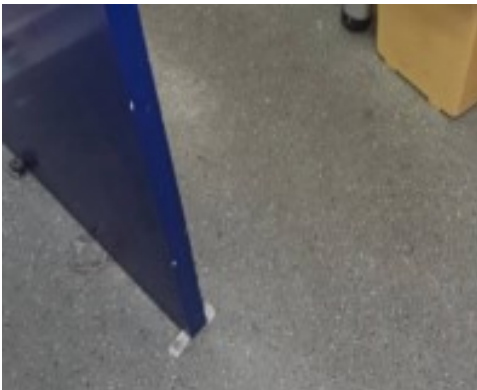
### **Item 173 Ref: NZ001549**

The Floor tile with adhesive (Kitchen G/003) does not contain asbestos.

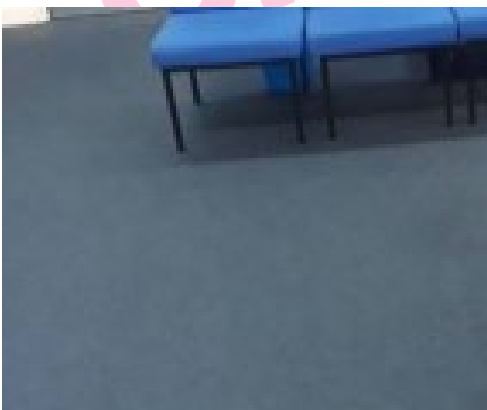
### **Item 174 Ref: NZ001550**

The Floor screed (Staff Room G/004) does not contain asbestos.

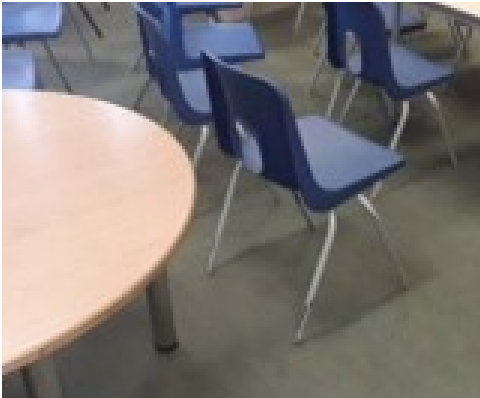
### **Item 175 Ref: As NZ001550**

The Floor screed (Classroom proposed after school club G/005) does not contain asbestos.

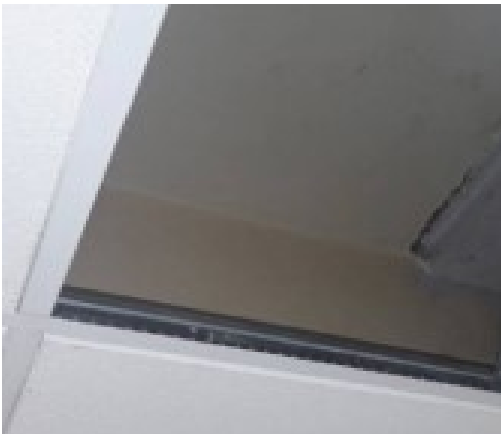
### **Item 176 Ref: NZ001551**

The Ceiling void ceiling above (Toilets staff adjacent caretakes room G/006) does not contain asbestos.

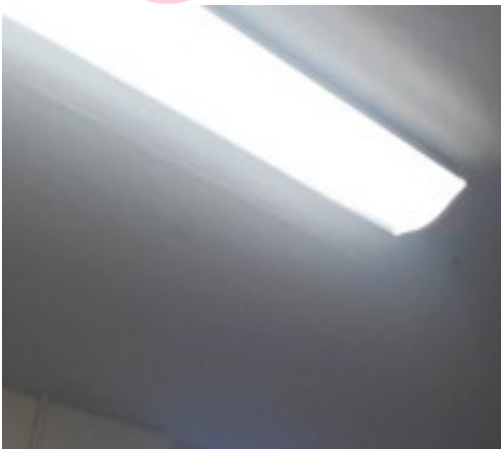
### **Item 177 Ref: As NZ001551**

The Ceiling (Caretakes room adjacent staff toilet G/007) does not contain asbestos.

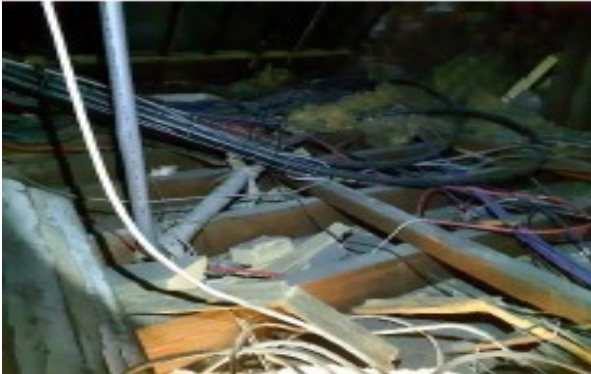
**Item 178 Ref: RO001518**

The insulation debris in the roof void (PPA Room G/01) does not contain asbestos.

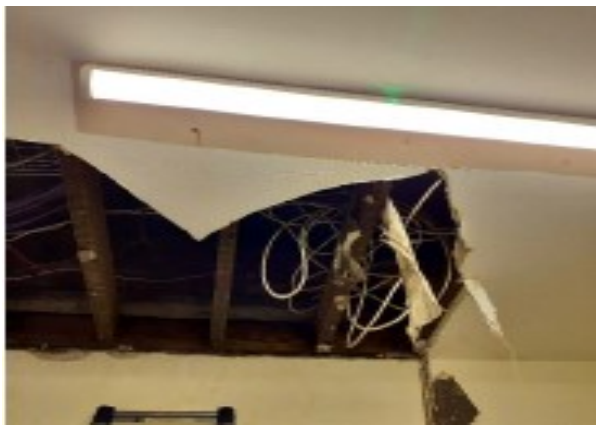
**Item 179 Ref: RO001519**

The plasterboard ceiling in (PPA Room G/01) does not contain asbestos.

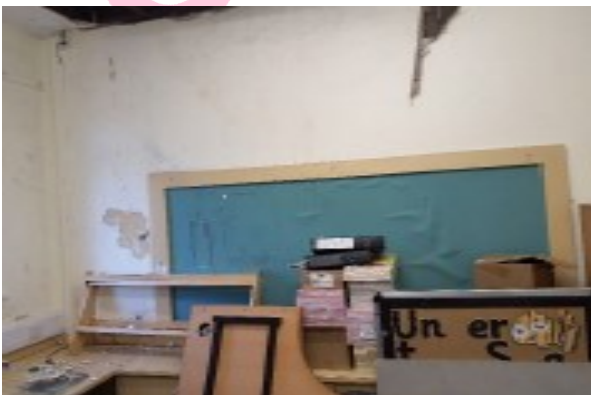
**Item 180 Ref: RO001520**

The plastered masonry wall in (PPA Room G/01) does not contain asbestos.

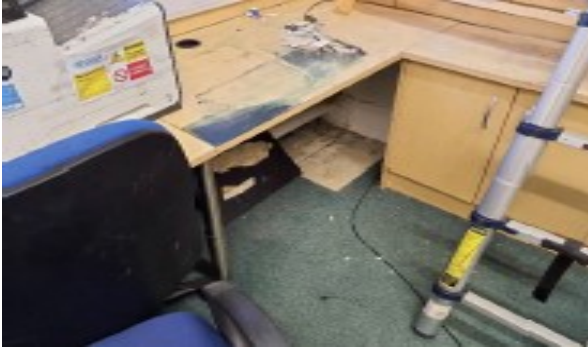
**Item 181 Ref: RO001520**

The bitumen adhesive to floor in (PPA Room G/01) does not contain asbestos.
