ASBESTOS SURVEY REPORT FOR MILL HILL NURSERY SCHOOL,  
TORPHIN HILL DRIVE, SUNDERLAND, SR3 2LE.

## **Asbestos Register for MILL HILL NURSERY SCHOOL**

**Date: 27<sup>th</sup> January 2025**

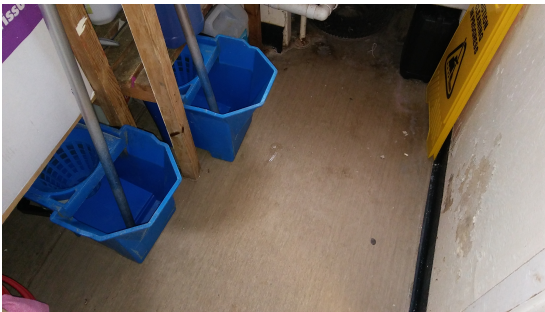
### **Item 1 Ref: 254938-4**

The Floor covering in 010/Cleaners contains asbestos.

Removed August 2024

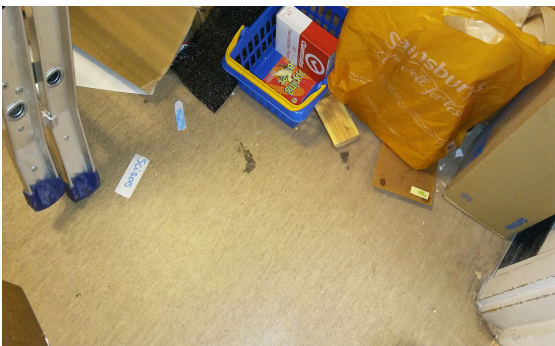
### **Item 2 Ref: As 254938-4**

The Floor covering in 012/Store void above contains asbestos.

Any change in its appearance should be noted and reported to Property Services.

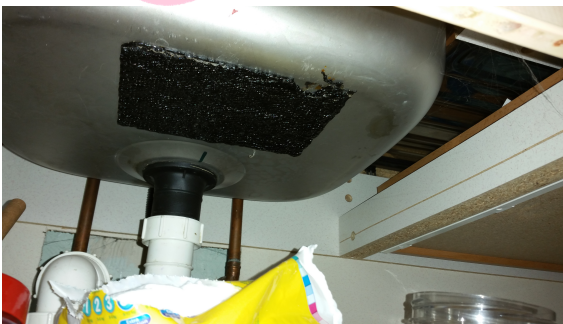
### **Item 3 Ref: 254938-5**

The Sink Pad in 014/Nursery does not contain asbestos.

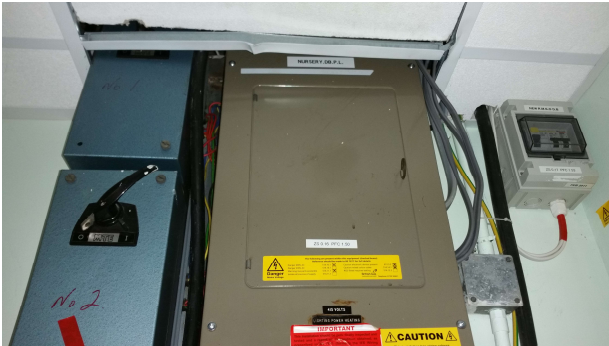
### **Item 4 Ref: Presumed**

The Electrics  
NURSERY.DB.P.L. woven  
product in 014A/Electric  
Cupboard contains asbestos.

Any change in its appearance  
should be noted and reported  
to Property Services.

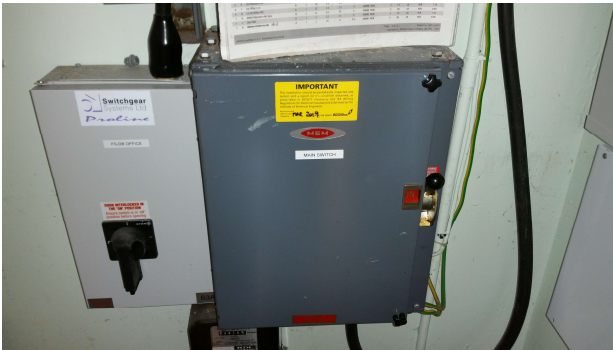
### **Item 5 Ref: Presumed**

The Electrics MAIN SWITCH  
woven product in 014A/Electric  
Cupboard contains asbestos.

Any change in its appearance  
should be noted and reported  
to Property Services.

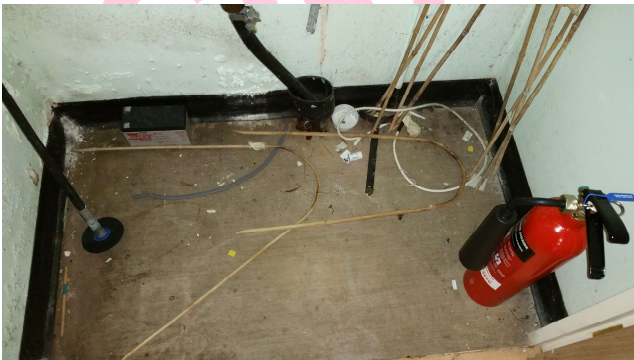
### **Item 6 Ref: As 254938-4**

The Floor covering in  
014A/Electric Cupboard  
contains asbestos.

Any change in its appearance  
should be noted and reported  
to Property Services.

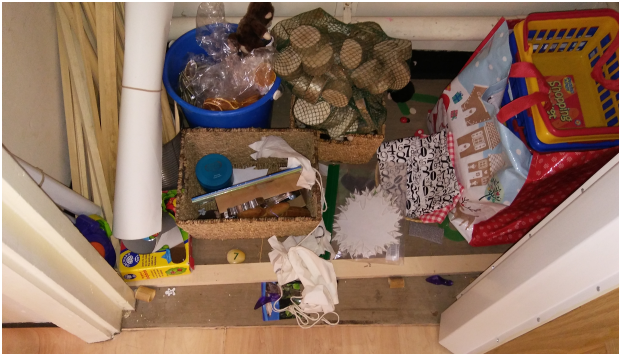
### **Item 7 Ref: As 254938-4**

The Floor covering in 014B/Cupboard contains asbestos.

Any change in its appearance should be noted and reported to Property Services.

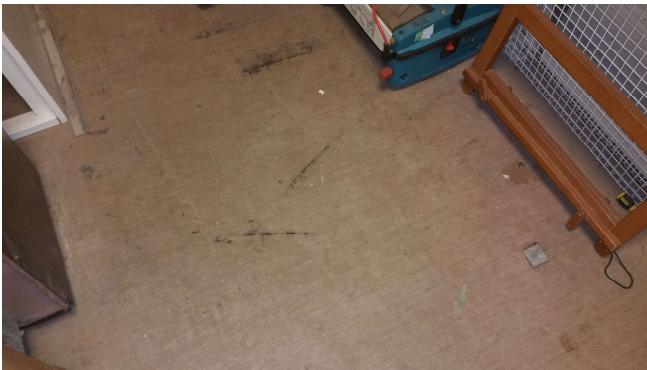
### **Item 8 Ref: As 254938-4**

The Floor covering in 015/Plant Room contains asbestos.

Any change in its appearance should be noted and reported to Property Services.

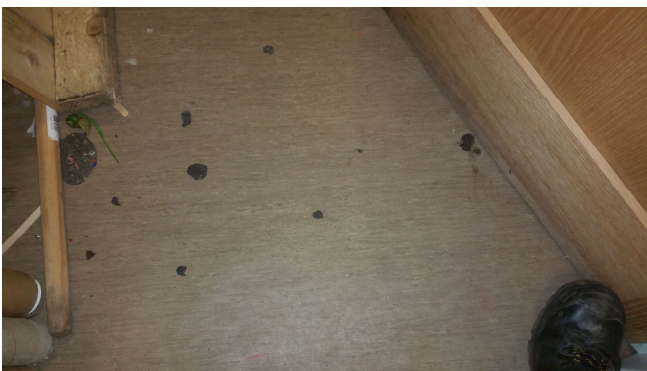
### **Item 9 Ref: As 254938-4**

The Floor covering in 016/Store Room contains asbestos.

Any change in its appearance should be noted and reported to Property Services.

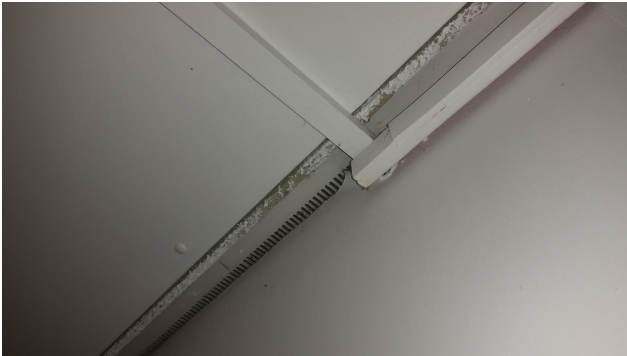
### **Item 10 Ref: 254938-3**

The Textured Coating in 023/Entrance Lobby does not contain asbestos.

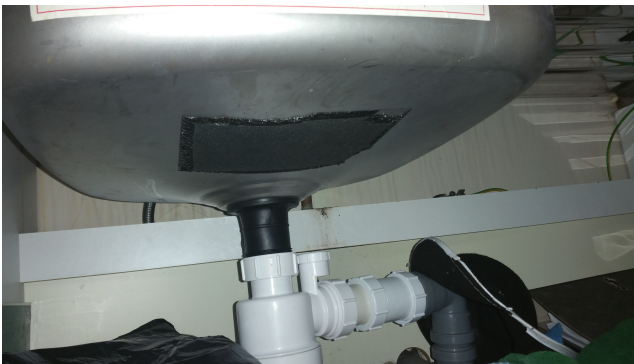
### **Item 11 Ref: 254938-2**

The Sink Pad in 025/Staff area does not contain asbestos.

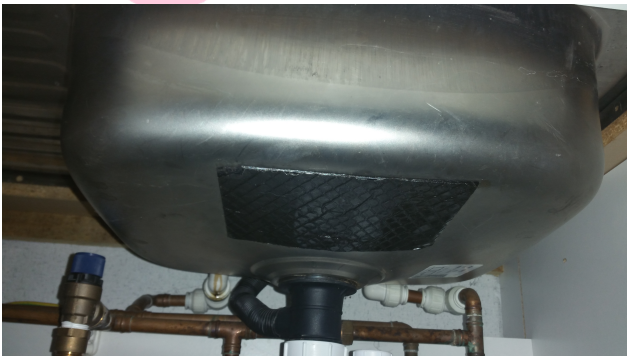
### **Item 12 Ref: 254938-1**

The Sink Pad in 028/Nursery does not contain asbestos.

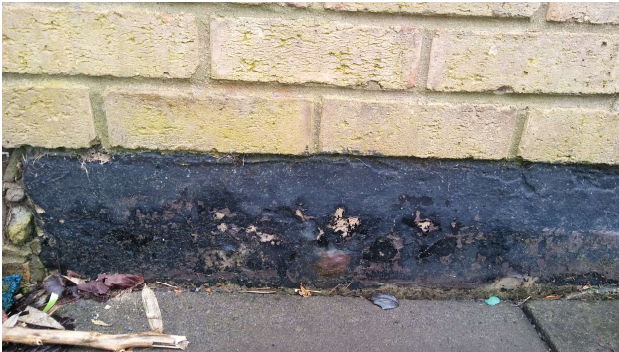
**Item 13 Ref: 254938-5**

The Damp Proof Course -  
External does not contain  
asbestos.

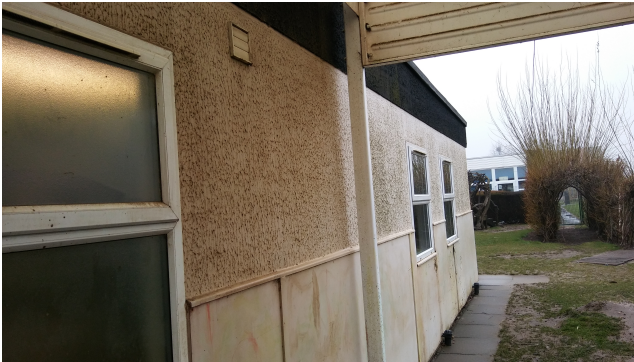
**Item 14 Ref: As 254938-3**

The Textured Coating -External  
does not contain asbestos.

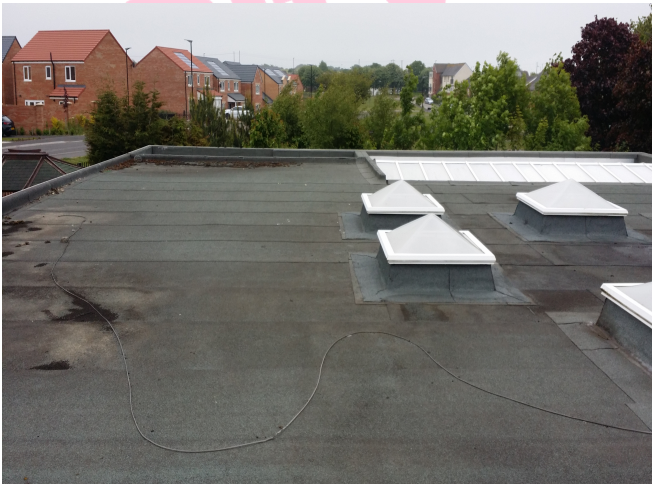
**Item 15 Ref: 266111-1**

The roof area 2 covering  
does not contain asbestos.

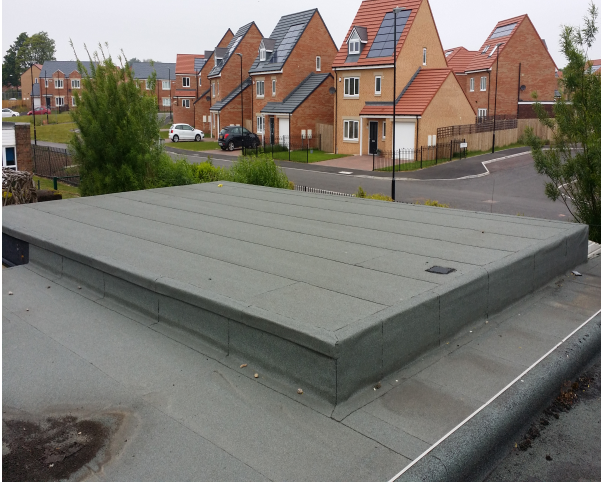
**Item 16 Ref: 266111-3**

The roof area 1 covering  
does not contain asbestos.

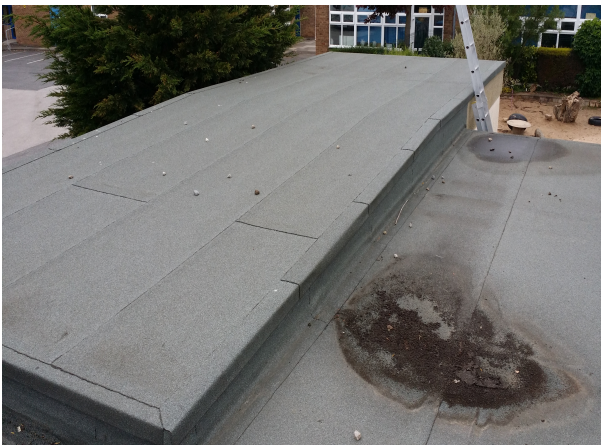
**Item 17 Ref: 266111-4**

The roof area 1 covering  
does not contain asbestos

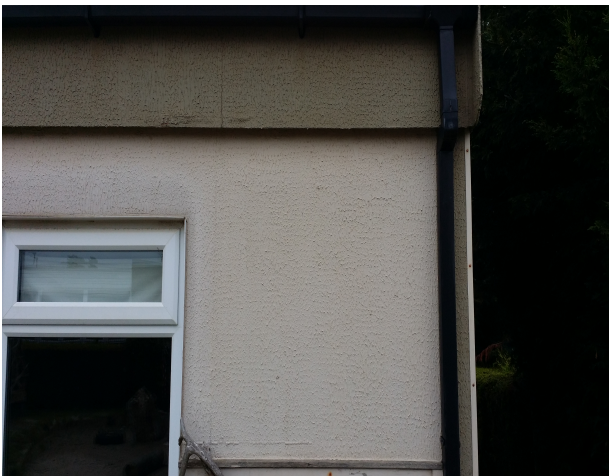
**Item 18 Ref: 266111-5**

The covering to wood pre-fab  
walls does not contain  
asbestos

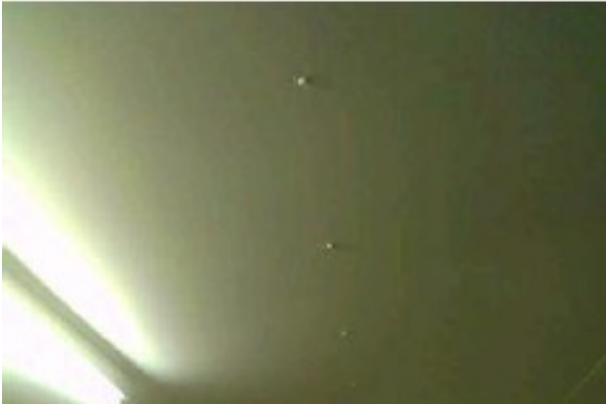
**Item 19 Ref: AD001983**

The ceiling in Room 1 Meeting Room does not contain asbestos.

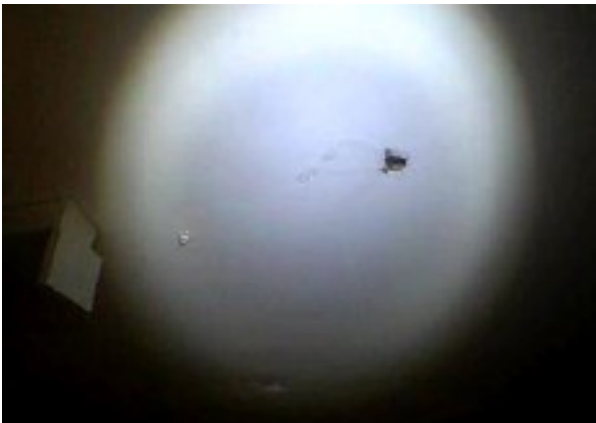
**Item 20 Ref: AD001984**

The ceiling in Room 2 Lunch Room does not contain asbestos.
