ASBESTOS SURVEY REPORT FOR OXCLOSE NURSERY, BRANCEPETH ROAD, WASHINGTON, TYNE AND WEAR, NE38 0LA

Asbestos Register for

Oxclose Nursery, Brancepeth Road, Washington

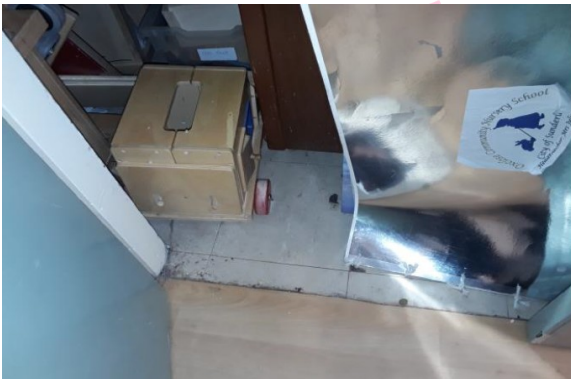
Item 8 Ref: 21-35338-7

The tiles and adhesive to floor (Area 9 / Store Cupboard) does not contain asbestos.

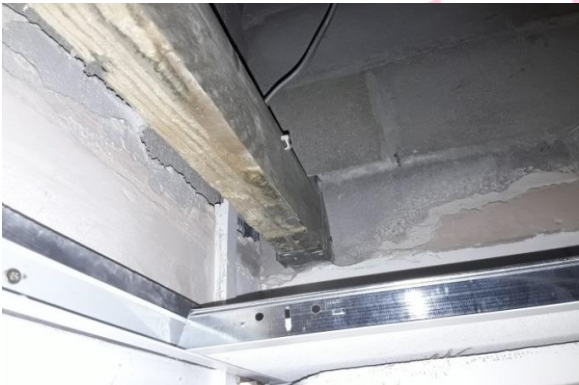
Item 11 Ref: 21-35338-10

The residual insulation debris to nails in wood joists (Area 11 / Ceiling void above area 10 office and area 11 disabled toilets / shower) does not contain asbestos.

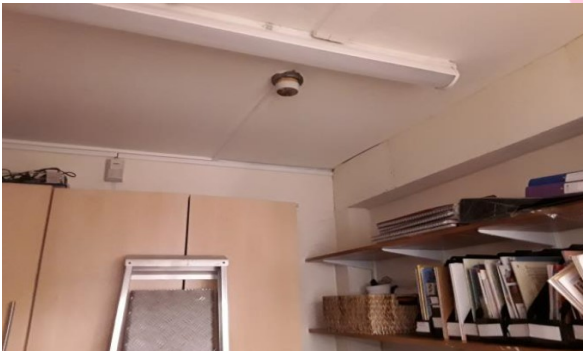
Item 14 Ref: 21-35338-13

The insulating board ceiling (Area 17 / Store room) does contain asbestos.

Any change in its appearance should be recorded and passed to property services.

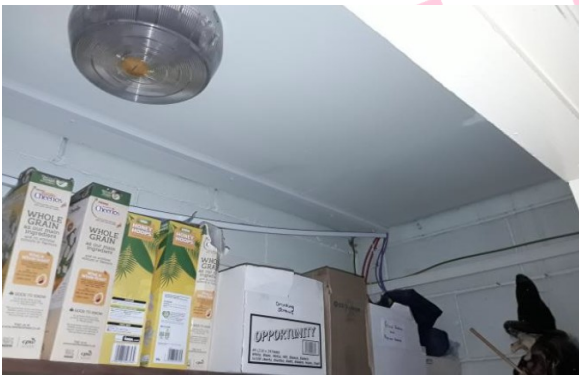
Item 17 Ref: 21-35338-14

The insulating board ceiling (Area 19 / Store cupboard) does contain asbestos.

Any change in its appearance should be recorded and passed to property services.

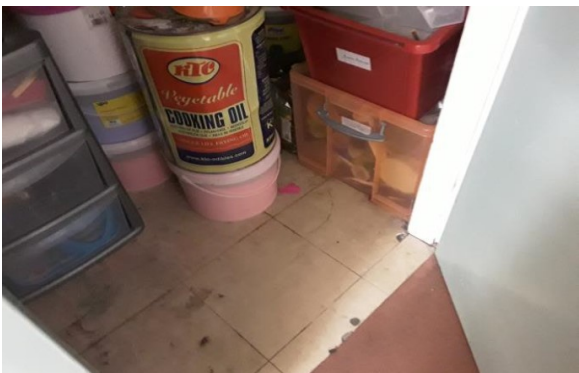
Item 18 Ref: 21-35338-15

The tiles and adhesive to floor (Area 19 / Store cupboard) does not contain asbestos.

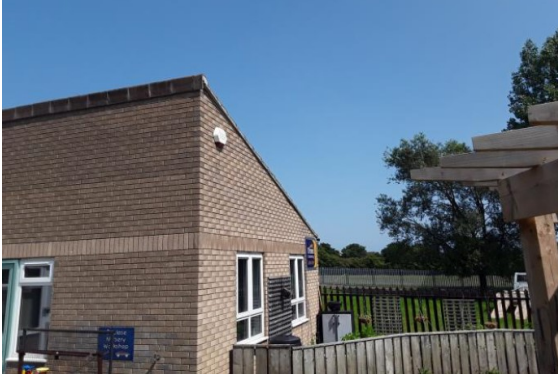
Item 19 Ref: 21-35338-18

The cement undercloaks to roof (Area 25 / External) does not contain asbestos.

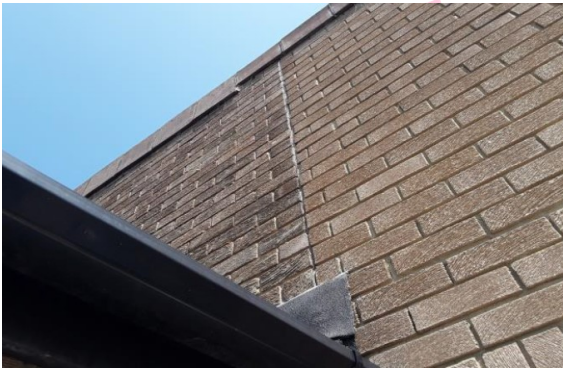
Item 20 Ref: 21-35338-19

The putty to expansion joints (Area 25 / External) does not contain asbestos.

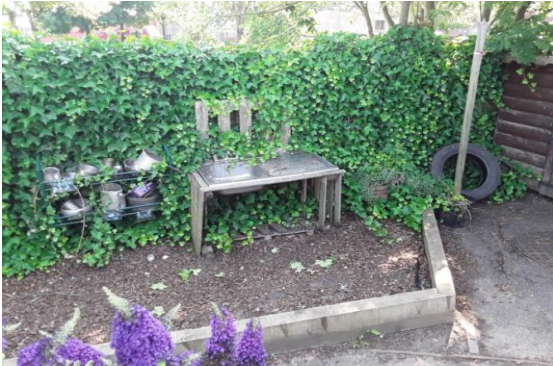
Item 22 Ref: 21-35338-21

The sink pad to external garden sink (Area 25 / External) does not contain asbestos.

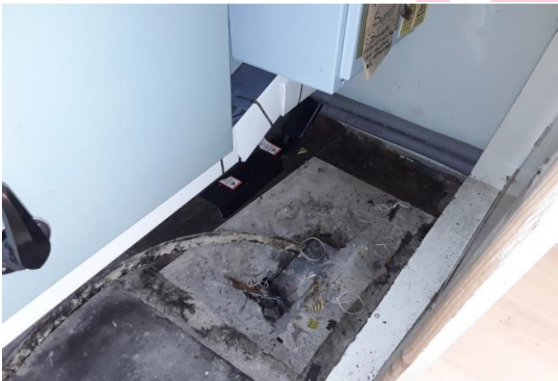
Item 23 Ref: 21-35338-17

The damp proof course (Area 30 / Photocopy room and cupboard) does not contain asbestos.
