ASBESTOS SURVEY REPORT FOR ST ANNES RC PRIMARY, SUNDERLAND

Asbestos Register for ST ANNES RC PRIMARY, SUNDERLAND

Date: 04 March 2026

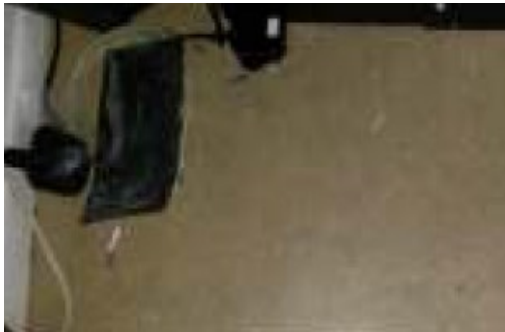
Item 2 Ref: 15-19198/2
cross ref: 25-88025-6

The floor (Tiles & adhesive)
(Room 1/ ICT Suite and
cupboard/Area: 048) contain
asbestos.

Any change in its appearance
should be noted and passed to
Property Services.

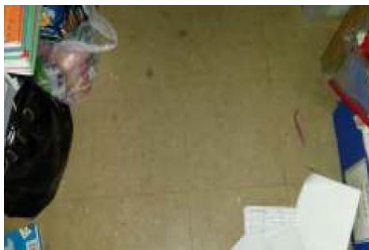
Item 3 As: 15-19198/2

The floor tiles and the
adhesive to the year 6
classroom store (Room 4) do
not contain asbestos.

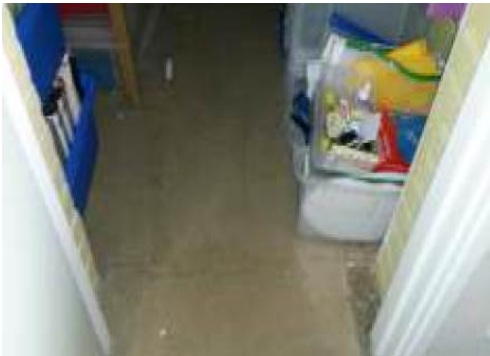
Item 4 As: 15-19198/2

The floor tiles and the adhesive to the year 6 classroom store (Room 6) does not contain asbestos.

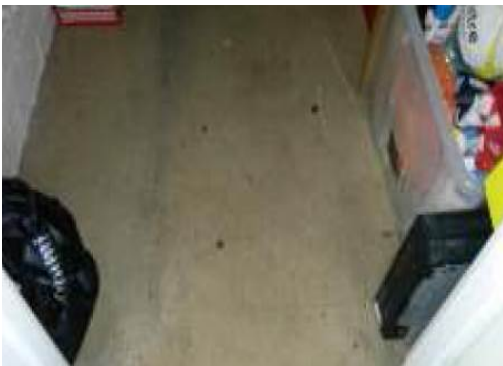
Item 5 Ref: 15-19198/2

The floor tiles and the adhesive to the year 4 classroom store (Room 8) do not contain asbestos.

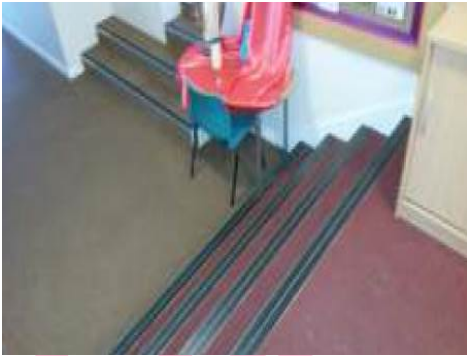
Item 8 Ref: 15-19198/9

The stair nosing to the corridor (Room 22) does not contain asbestos.

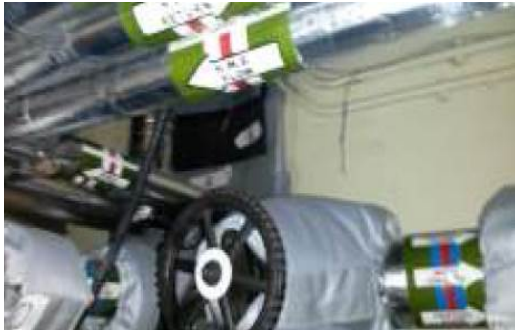
Item 10 Ref: Presumed

The pipe insulation in the sealed duct within the boiler room (Room 23) is presumed to contain asbestos.

Prior to entering the duct, further investigation is required.

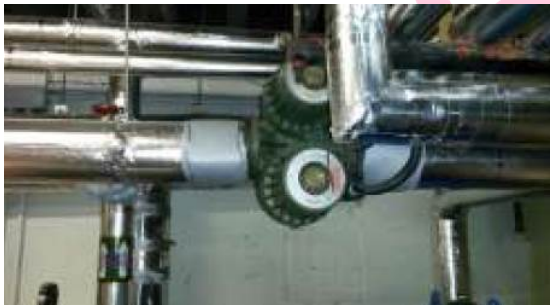
Item 11 Ref: 15-19198/4

The flange gaskets to the boiler room (Room 23) contain asbestos.

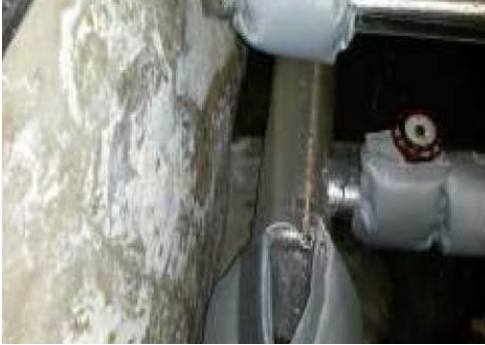
Item 13 Ref: 15-19198/7

The debris to the floor removed and floor encapsulated in the boiler room (Room 23) - August 2024 - waiting WCN's.

Encapsulated - Environmental clean carried out in April 2019 and Aug 2024

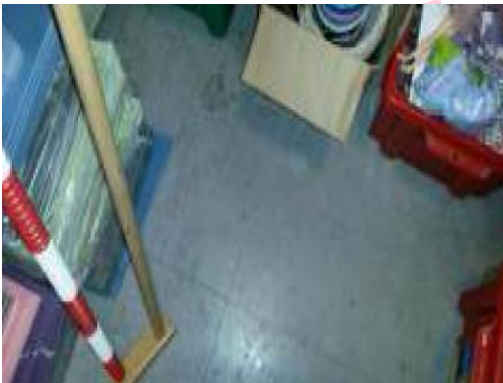
Item 14 Ref: 15-19198/10

The floor tiles and adhesive to the year 3 classroom store (Room 27) contain asbestos.

Any change in its appearance should be noted and passed to Property Services.

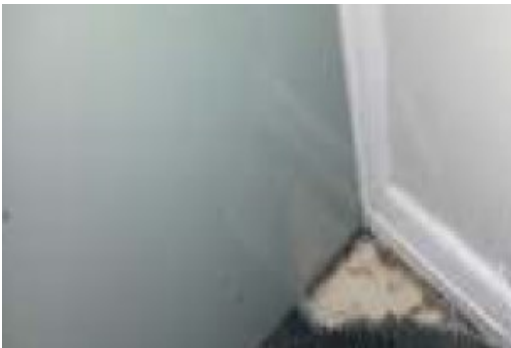
Item 15 Ref: 15-19198/11

The floor tiles and adhesive to the IR Room (Room 28) do not contain asbestos.

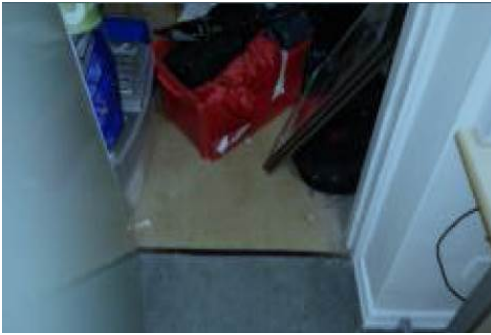
Item 16 Ref: 15-19198/12

The floor tiles and adhesive to the IR Room store (Room 30) do not contain asbestos.

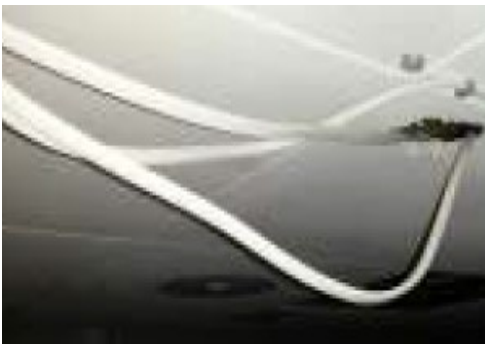
Item 17 Ref: 15-19198/13

The insulation board to the void above the ceiling in the nurture room (Room 31) does not contain asbestos.

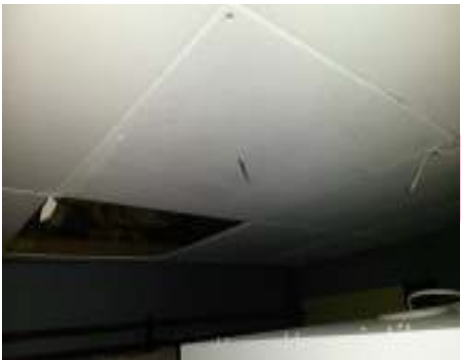
Item 23 Ref: 15-19198/19

The insulation board ceiling to the cleaners' cupboard (Room 48) does not contain asbestos.

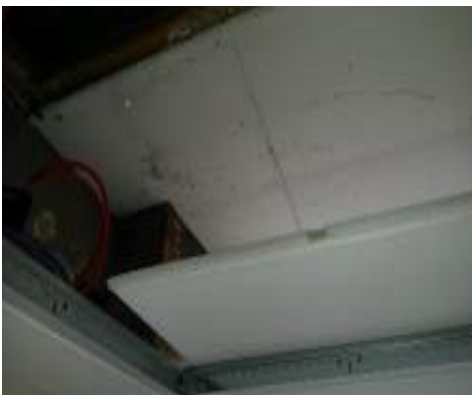
Item 24 Ref: 15-19198/20

The insulation board ceiling to the cleaners' cupboard (Room 51) does not contain asbestos.

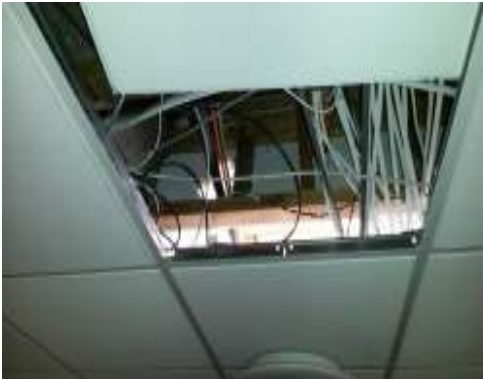
Item 25 Ref: 15-19198/20

The insulation board upstands to the redundant skylight in the void above Room 61 (Room 62) do not contain asbestos.

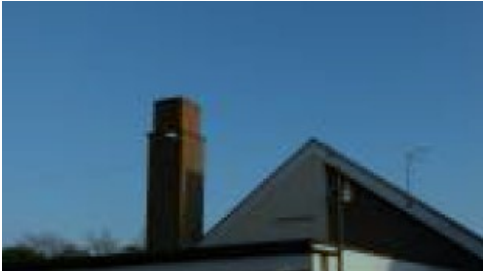
Item 29 Ref: 15-19198/29

The external cement under cloaking contains asbestos.

Any change in its appearance should be noted and passed to Property Services.

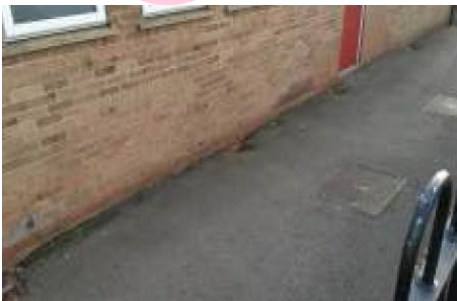
Item 30 Ref: 15-19198/30

The damp proof course to the external contains asbestos.

Any change in its appearance should be noted and passed to Property Services.

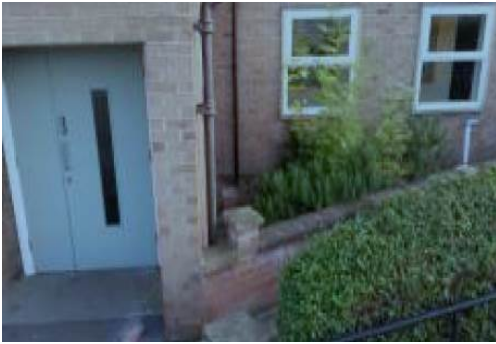
Item 31 Ref: 15-19198/32

The jointing compound to the soil pipe (External) contains asbestos.

Any change in its appearance should be noted and passed to Property Services.

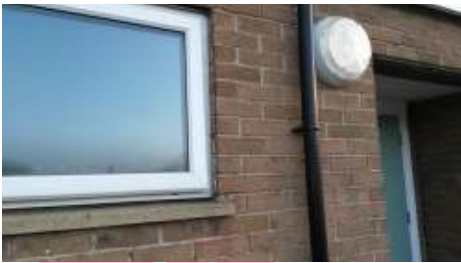
Item 32 Ref: 15-19198/31

The putty to the brickwork (External) does not contain asbestos.

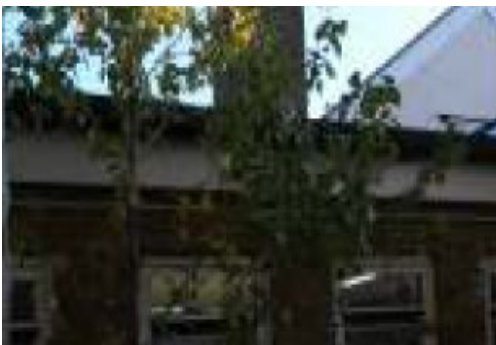
Item 33 Ref: 15-19198/28

The putty to the wood frame (External) does not contain asbestos.

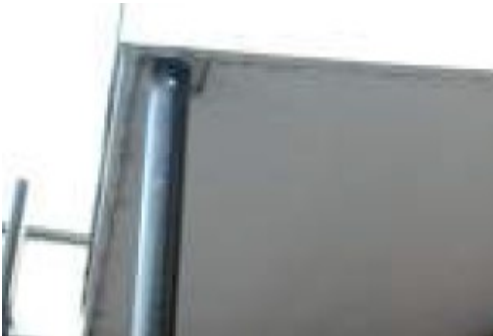
Item 35 Ref: 15-19198/25

The insulation board to the rear canopy outside the kitchen (external) does not contain asbestos.

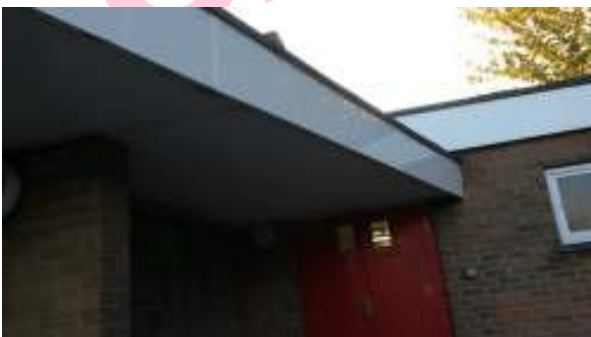
Item 36 Ref: 15-19198/26

The insulation board soffits to the rear canopy outside the kitchen (External) do not contain asbestos.

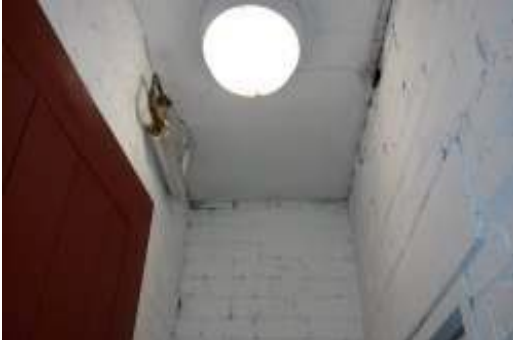
Item 37 Ref: 15-19198/33

The insulation board to the ceiling in the external wc does not contain asbestos.

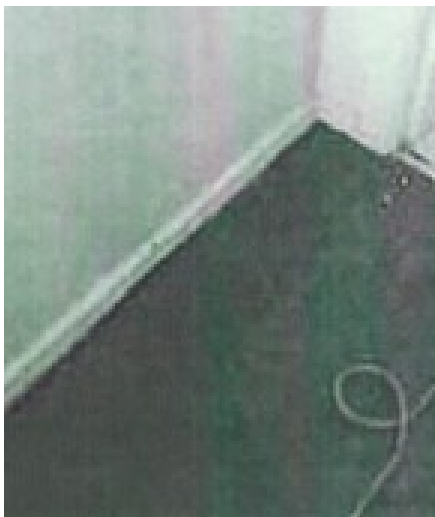
Item 46 Ref: SARCS/001

The vinyl floor covering in the Community Room does contain asbestos.

Any change in appearance should be reported to Property Services.

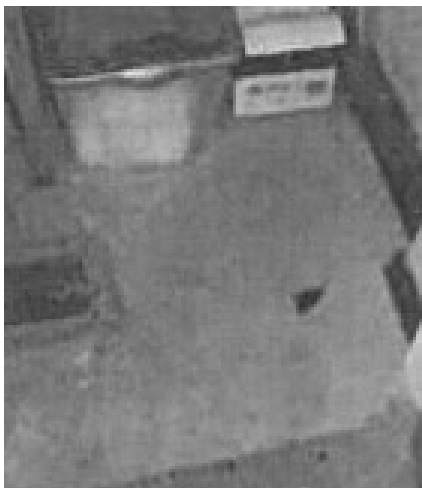
Item 47 Ref: SARCS/003

The vinyl floor tiles in the Community Room cupboard does contain asbestos.

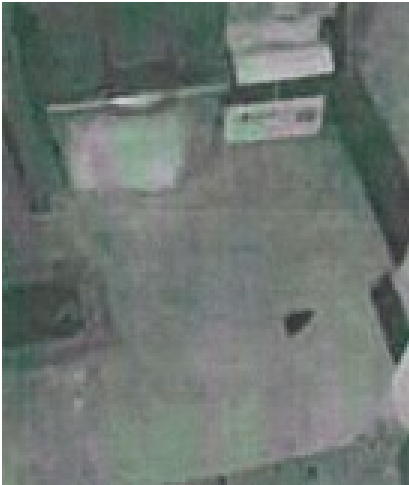
Item 48 Ref: SARCS/004

The vinyl floor tile adhesive in the Community Room cupboard does contain asbestos.

Any change in appearance should be reported to Property Services.

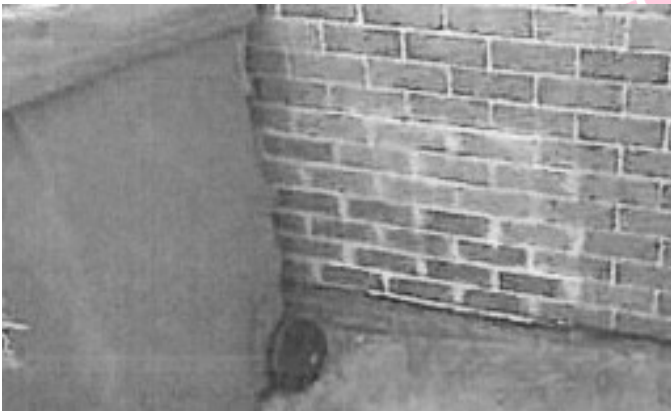
Item 49 Ref: SAS/002

The damp proof course to the external area of the Community Room cupboard does contain asbestos.

Any change in appearance should be reported to Property Services.

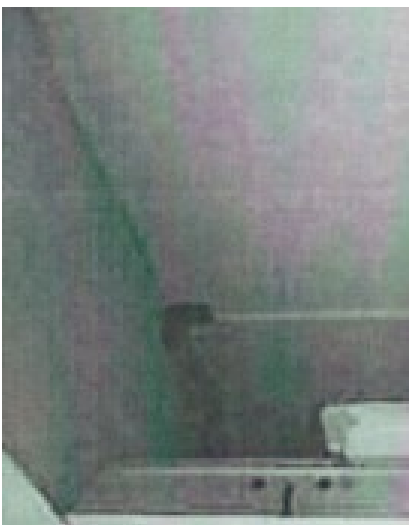
Item 50 Ref: SAS/003

The panels above the windows in the Community Room does not contain asbestos.

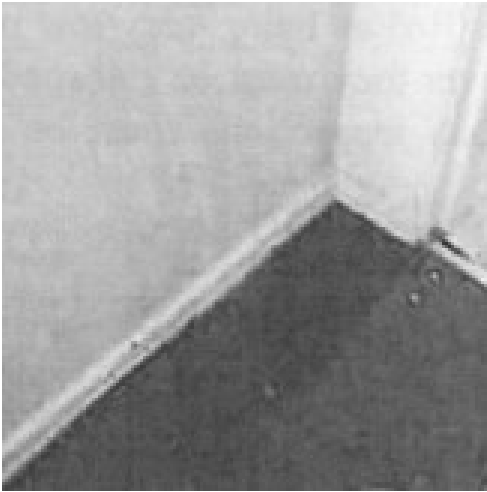
Item 51 Ref: SARCS/002

The floor screed in the Community Room does not contain asbestos.

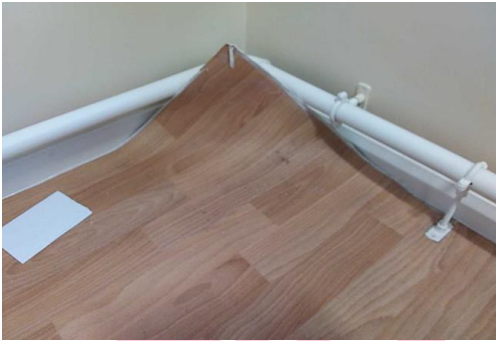
Item 52 Ref: 22-44268-1

The floor (Community Room and Cupboards/Area 1) does not contain asbestos.

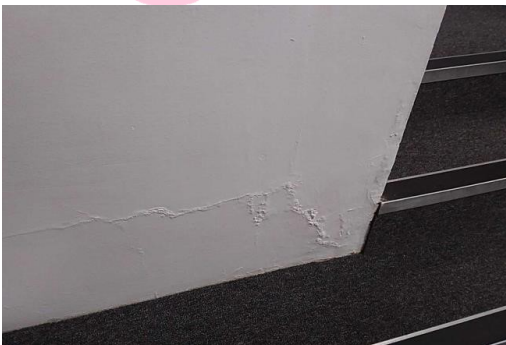
Item 53 Ref: 22-44268-2

The left side of walls (Corridor opposite main hall/Area 2) does not contain asbestos.

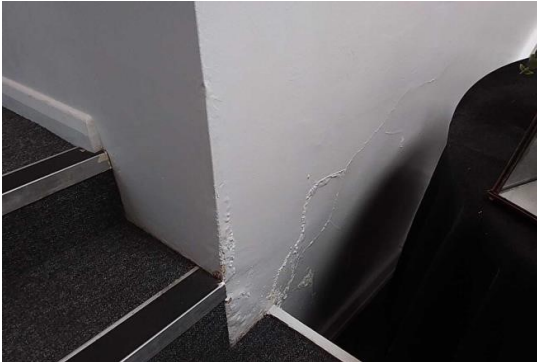
Item 54 Ref: 22-44268-3

The right side of walls (Corridor opposite main hall/Area 2) does not contain asbestos.

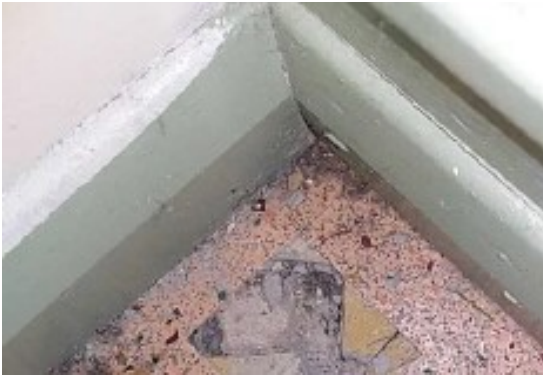
Item 55 Ref: 22-49421-1

The residual adhesive beneath modern vinyl and screed (Early Years WC 2 /Area 2) does contain asbestos.

Removed July 2022

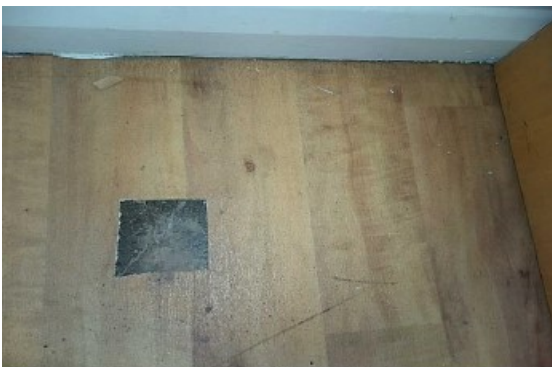
Item 56 Ref: 22-49421-1

The residual adhesive beneath modern vinyl and screed (Nursery /Area 3) does contain asbestos.

Any change in appearance should be reported to Property Services.

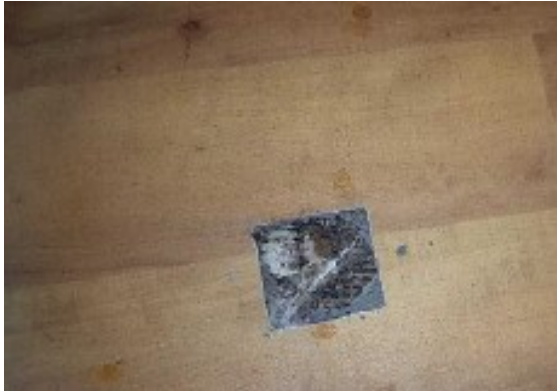
Item 57 Ref: 22-49421-1

The residual adhesive beneath modern vinyl and screed (Fs Unit /Area 4) does contain asbestos.

Any change in appearance should be reported to Property Services.

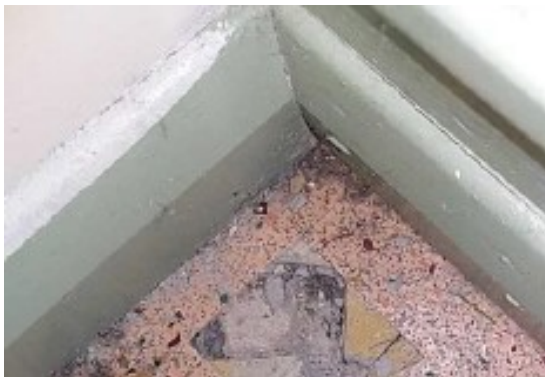
Item 58 Ref: 22-49421-1

The residual adhesive beneath modern vinyl and screed (Reception Class /Area 5) does contain asbestos.

Any change in appearance should be reported to Property Services.

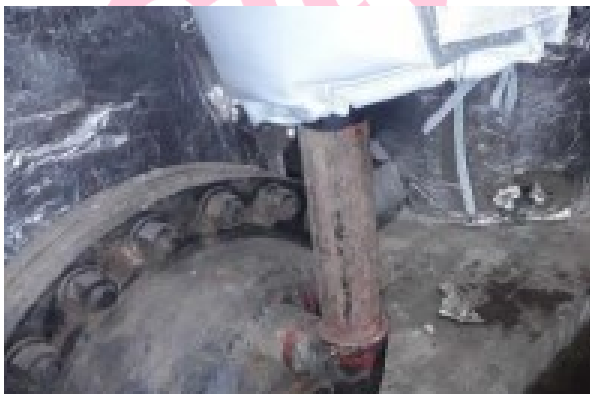
Item 59 Ref: 24-76425-1

The residual insulation to copper tank front flanges x 2 (Boiler Room/Area 001) does contain asbestos.

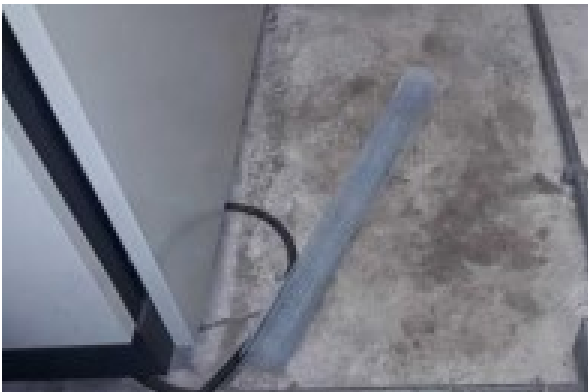
Item 61 Ref: 24-76425-4

The walls residual insulation to boiler plinth (Boiler Room/Area 001) does not contain asbestos.

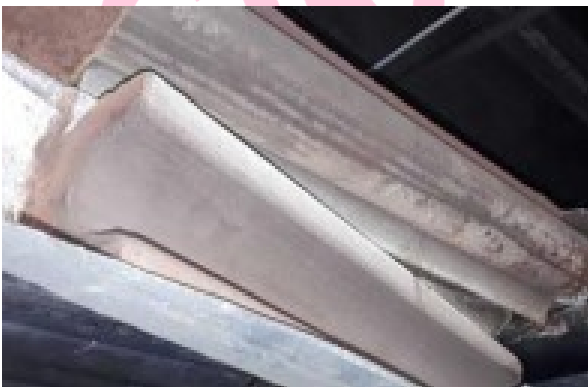
Item 62 Ref: 24-76425-6

The residual insulation to old pipework and hangers beneath foam insulation (Boiler Room/Area 001) contains asbestos.

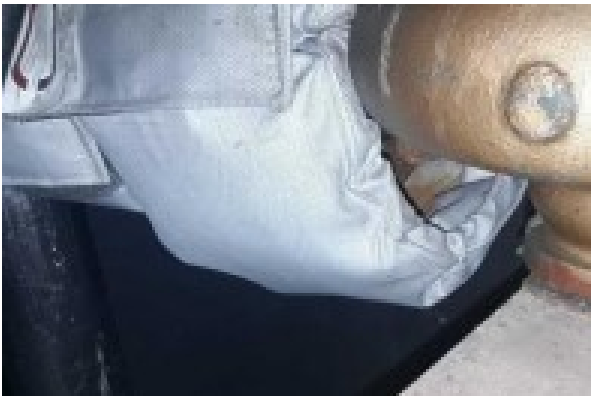
Item 64 Ref: 24-76425-8

The acoustic pads beneath 2 x pumps (Boiler Room/Area 001) do not contain asbestos.

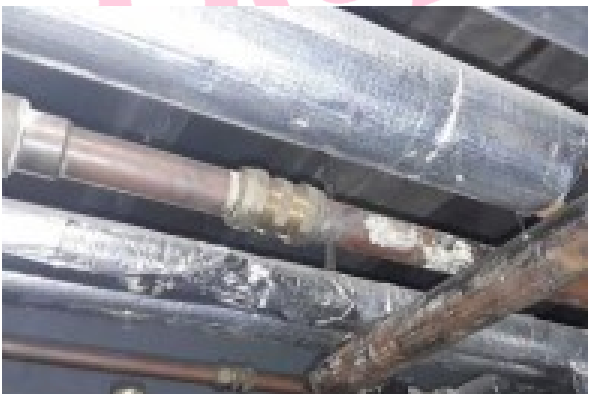
Item 65 Ref: 24-76425-9

The residual insulation to old pipework and hangers beneath foam insulation (Boiler Room/Area 001) contains asbestos.

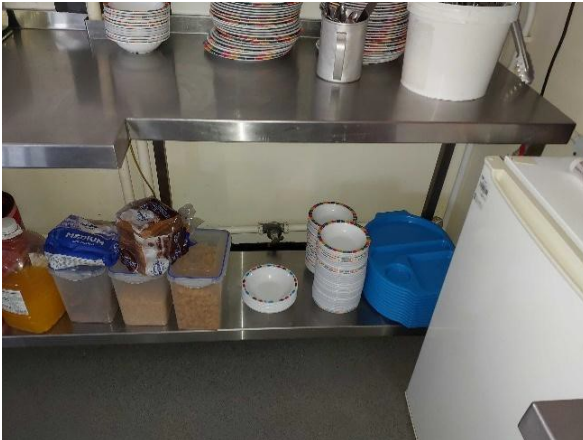
Item 67 Ref: Presumed

The Pipes - stop tap gasket (Gasket) (Kitchen/Area: 002) are presumed to contain asbestos.

Any change in appearance should be reported to Property Services.

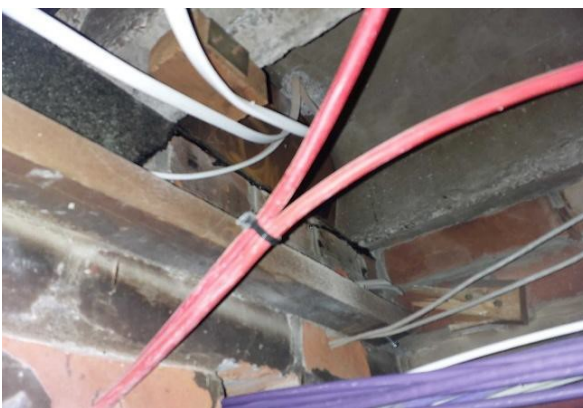
Item 68 Ref: 25-88025-3

The ceiling - felt to brickwork near pipework (Bitumen) (Electric Cupboard/Area: 019) does not contain asbestos.

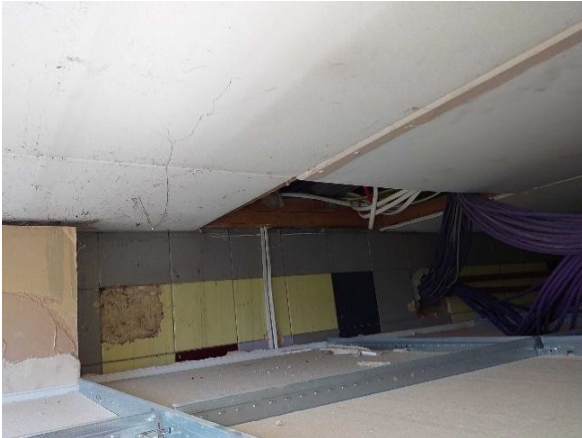
Item 69 Ref: 25-88025-4

The ceiling - ceiling tiles above new suspended ceiling tiles (Insulating board) (PPA Room/Area: 021) does not contain asbestos.

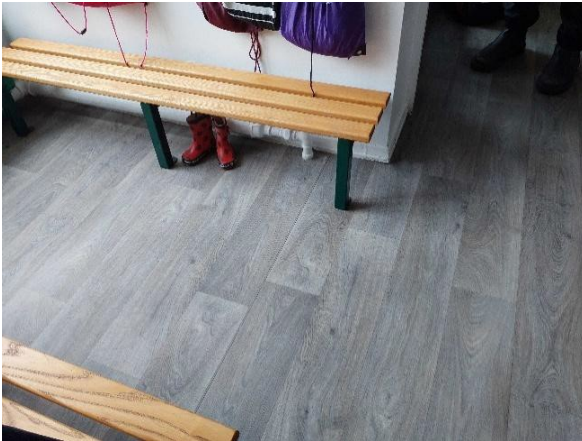
Item 70 Ref: 25-88025-5

The floor - residual adhesive beneath screed (Bitumen) (Cloakroom/Area: 033) contains asbestos.

Any change in appearance should be reported to Property Services.

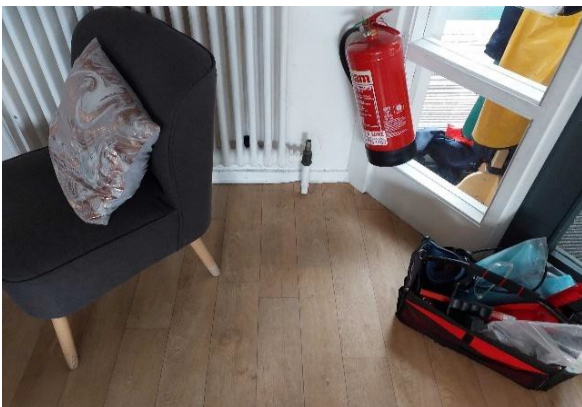
Item 71 Ref: 25-88025-5

The floor - residual adhesive beneath screed (Bitumen) (Reception class/ Area: 034) contains asbestos.

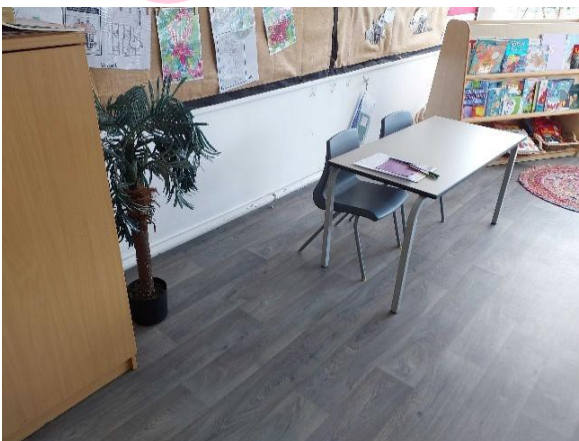
Item 74 Ref: 25-88025-5

The floor - residual adhesive beneath screed (Bitumen) (Year 2 and cupboards/ Area: 041) contains asbestos.

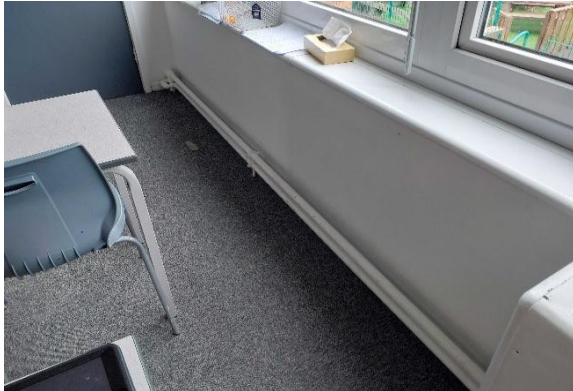
Item 75 Ref: 25-88025-7

The floor - residual adhesive beneath screed (Bitumen) (Year 5 Classroom/Area: 050) does not contain asbestos.

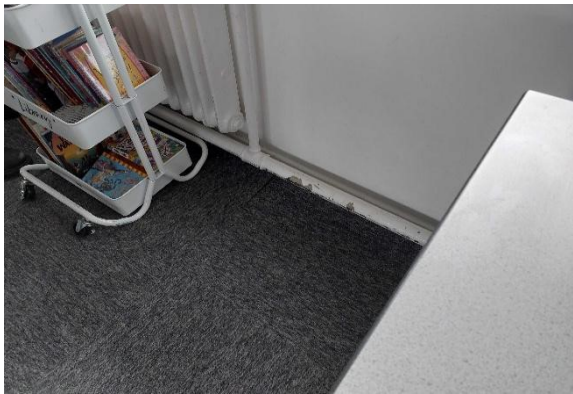
Item 76 Ref: 25-88025-7

The floor - residual adhesive beneath screed (Bitumen) (Year 4 Classroom/Area: 051) does not contain asbestos.

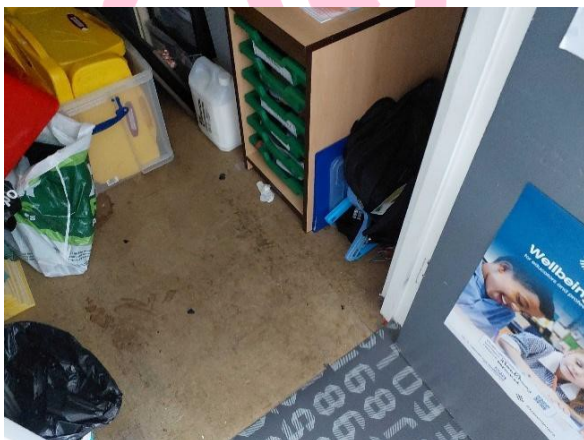
Item 77 Ref: 25-88025-6

The floor (Tiles & adhesive) (Year 4 Classroom cupboard/Area: 052) contains asbestos.

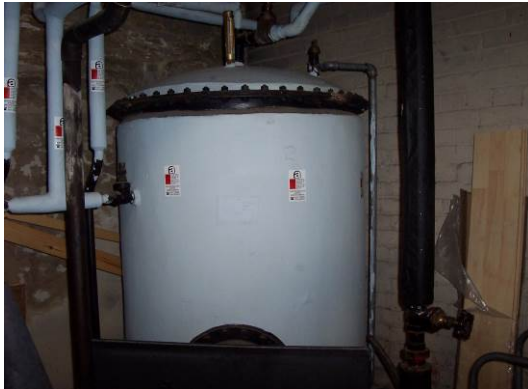
Ref:037SW2

The calorifier insulation in the plant room (Room 23) contained asbestos.

This was removed in February 2014.

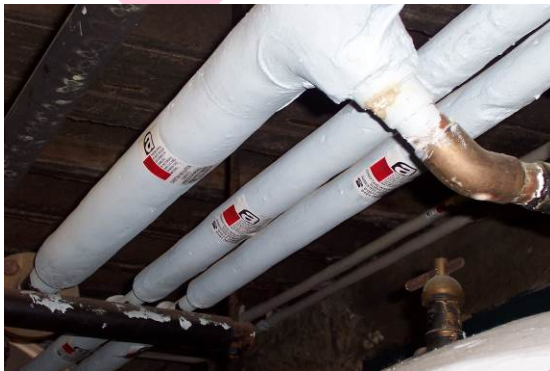
Ref:037SW3

The pipe insulation in the plant room (Room 23) contained asbestos.

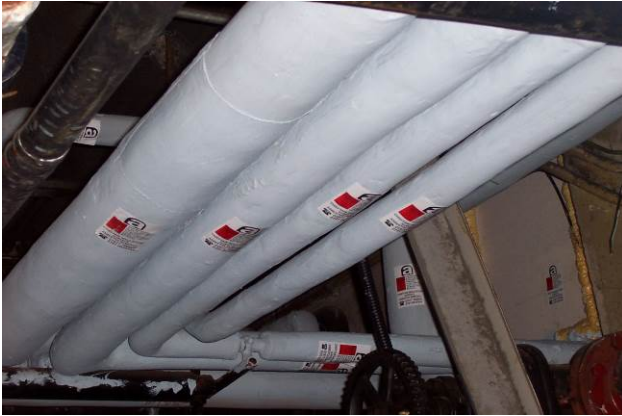
Ref:037SW3 and 037SW6

The pipe insulation in the plant room (Room 23) contained asbestos.

This was removed in February 2014.
