ASBESTOS SURVEY REPORT FOR USWORTH COLLIERY NURSERY,  
MANOR ROAD, WASHINGTON, TYNE AND WEAR, NE37 3BL

## **Asbestos Register for**

**Usworth Collier Nursery, Manor Road,  
Washington, NE37 3BL**

**Date: 25 July 2025**

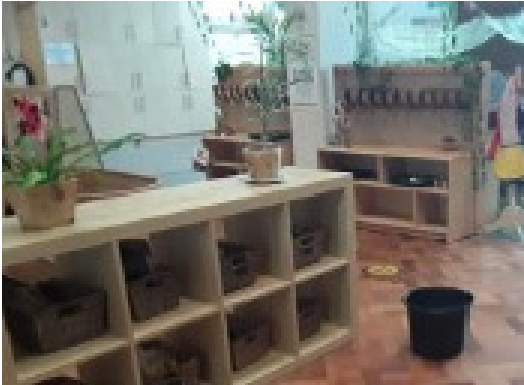
### **Item 1 Ref: Presumed**

- (Item 1) Ref: Presumed – Adhesive beneath fitted parquet flooring (Area 3/Main nursery playroom) – Low Risk
- (Item 2) Ref: 21-35337-2 – Textured coating to walls (Area 10/Cloakroom) – No Risk

The adhesive beneath fitted parquet flooring to the main nursery playroom (Area 3) contains asbestos.

Any change in its appearance should be recorded and passed to Property Services.

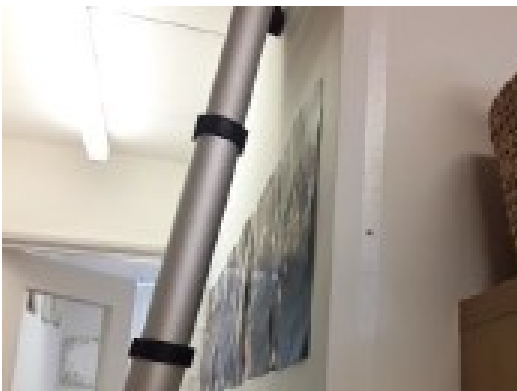
### **Item 3 Ref: 21-35337-2**

The textured coating to the walls in the hallway (Area 12) does not contain asbestos.

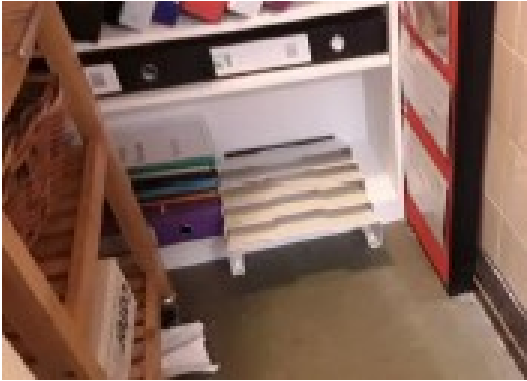
### **Item 4 Ref: 21-35337-3**

- (Item 3) Ref: 21-35337-2 – Textured coating to walls (Area 12/Hallway) – No Risk
- (Item 4) Ref: 21-35337-3 – Floor tiles and adhesive (Area 17/Server Cupboard) – Very Low Risk

The floor tiles and adhesive in the server cupboard (Area 17) contains asbestos.

Any change in its appearance should be recorded and passed to Property Services.

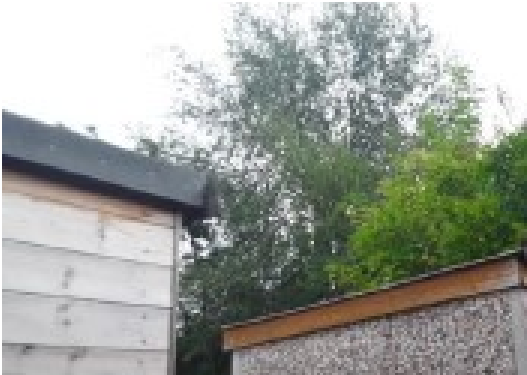
### **Item 5 Ref: 21-35337-6**

The roof to the outhouse (Area 32) does not contain asbestos.

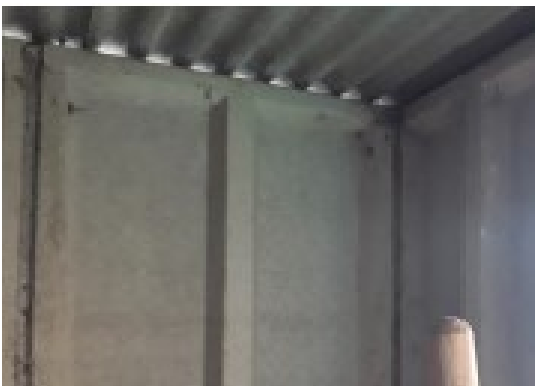
### **Item 6 Ref: 21-35337-11**

The expansion joints to the Garage (Area 33) does not contain asbestos.

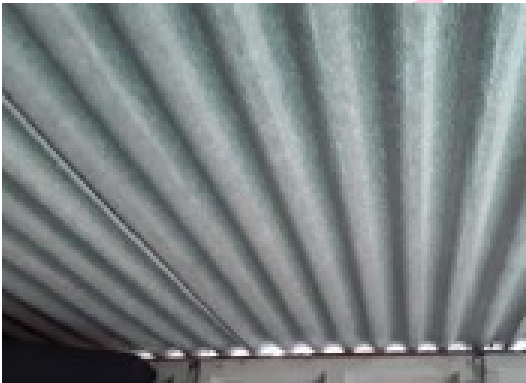
### **Item 8 Ref: 21-35337-7**

The ceiling to the Garage (Area 33) does not contain asbestos.

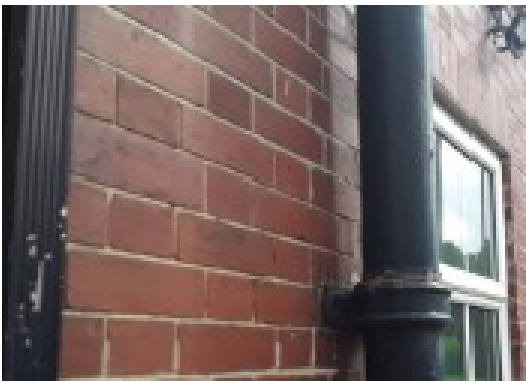
### **Item 9 Ref: 21-35337-4**

The capping compound around the soil pipe externally (Area 34) does not contain asbestos.

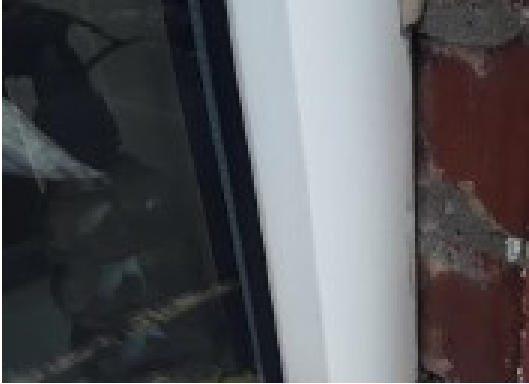
### **Item 10 Ref: 21-35337-5**

The frame sealant to the brickwork externally (Area 34) does not contain asbestos.

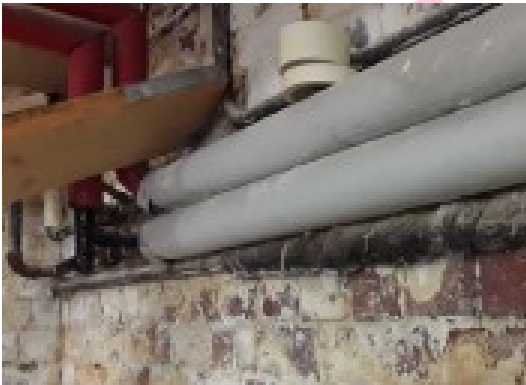
### **Item 11 Ref: 21-35337-10**

The string to hessian lagged metal pipes in the Boiler Room (Area 35) does not contain asbestos.

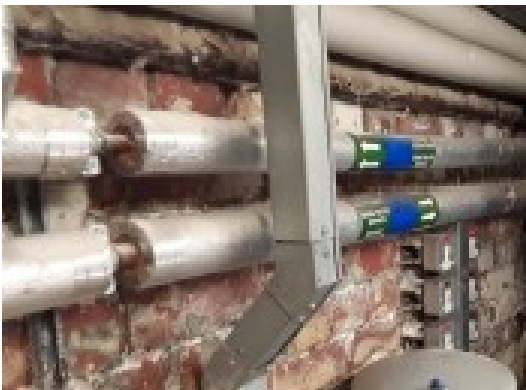
### **Item 12 Ref: 21-35337-8**

The debris to the walls in the Boiler Room (Area 35) does not contain asbestos.

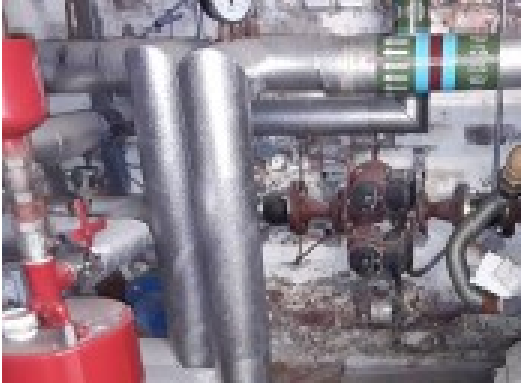
### **Item 13 Ref: 21-35337-9**

The pipe flanges (Gaskets) in the Boiler Room (Area 35) do not contain asbestos.

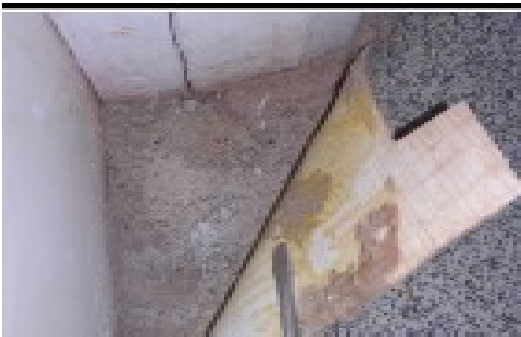
### **Item 14 Ref: OU001937**

The residual adhesive beneath modern vinyl and screed in the reception lobby (G/01) does not contain asbestos.

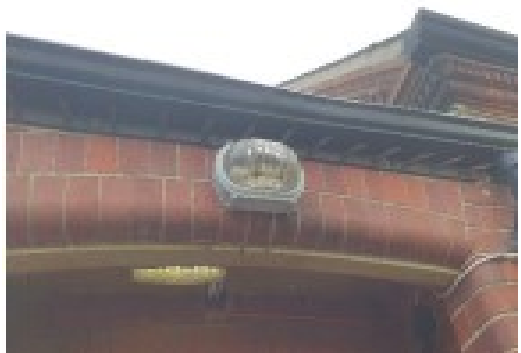
### **Item 15 Ref: OU001938**

The sealant around glass in oval spotlight (External E/01) does not contain asbestos.

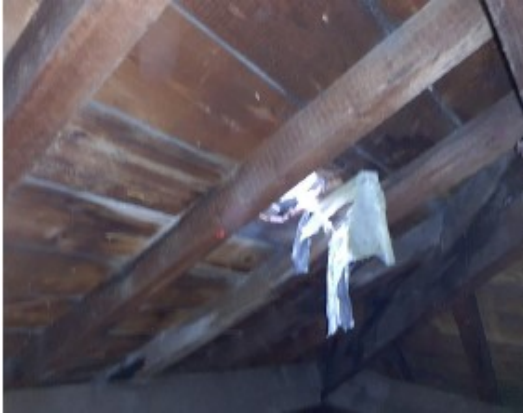
### **Item 16 Ref: Presumed**

- (Item 15) Ref: OU001938 – Sealant around glass in oval spotlight (External E/01) – No Risk
- (Item 16) Ref: Presumed – Cowl Roof (Loft 6 R/01) – Very Low Risk

The roof cowl in the loft (R/01) is presumed to contain asbestos.

Any change in appearance should be reported to Property Services.
