ASBESTOS SURVEY REPORT FOR USWORTH COLLIERY NURSERY,
MANOR ROAD, WASHINGTON, TYNE AND WEAR, NE37 3BL

**Usworth Collier Nursery, Manor Road,
Washington, NE37 3BL**

Date: 18 May 2026

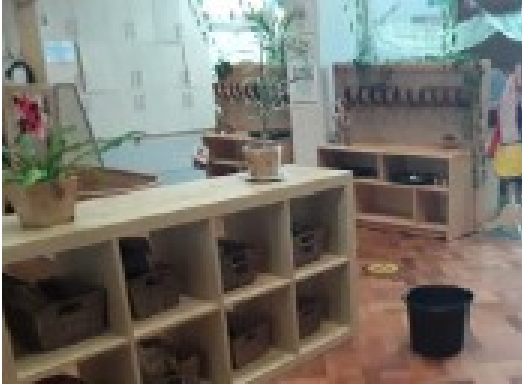
Item 1 Ref: Presumed

- (Item 1) Ref: Presumed – Adhesive beneath fitted parquet flooring (Area 3/Main nursery playroom) – Low Risk
- (Item 2) Ref: 21-35337-2 – Textured coating to walls (Area 10/Cloakroom) – No Risk

The adhesive beneath fitted parquet flooring to the main nursery playroom (Area 3) contains asbestos.

Any change in its appearance should be recorded and passed to Property Services.

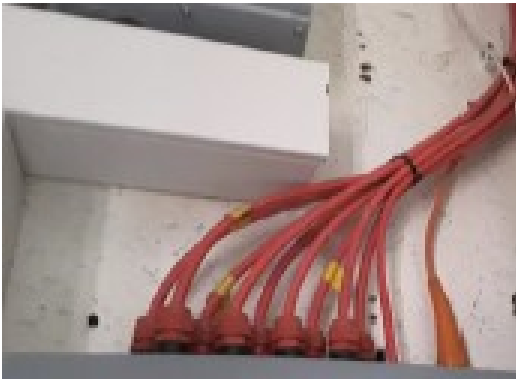
Item 2 Ref: 21-35337-2

The textured coating to the walls in the cloakroom (Area 10) does not contain asbestos.

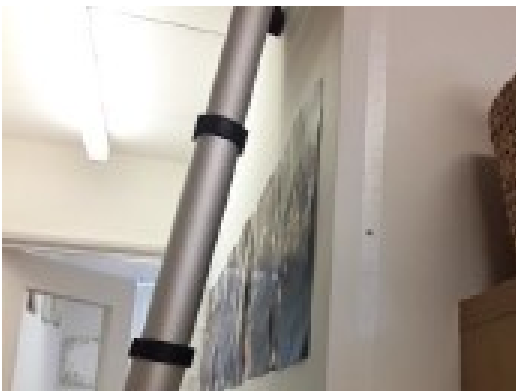
Item 3 Ref: 21-35337-2

The textured coating to the walls in the hallway (Area 12) does not contain asbestos.

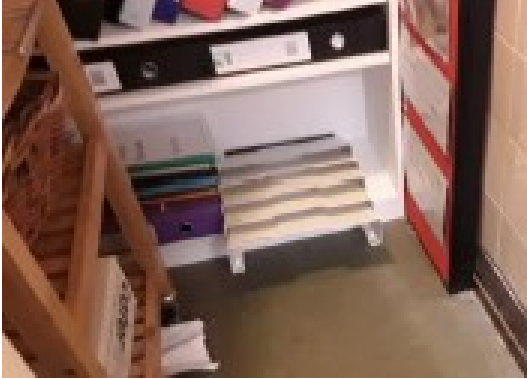
Item 4 Ref: 21-35337-3

- (Item 3) Ref: 21-35337-2 – Textured coating to walls (Area 12/Hallway) – No Risk
- (Item 4) Ref: 21-35337-3 – Floor tiles and adhesive (Area 17/Server Cupboard) – Very Low Risk

The floor tiles and adhesive in the server cupboard (Area 17) contains asbestos.

Any change in its appearance should be recorded and passed to Property Services.

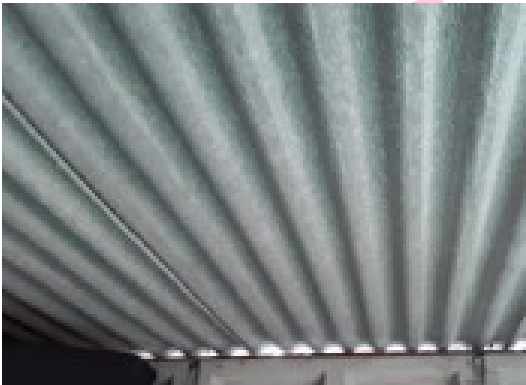
Item 8 Ref: 21-35337-7

The ceiling to the Garage (Area 33) does not contain asbestos.

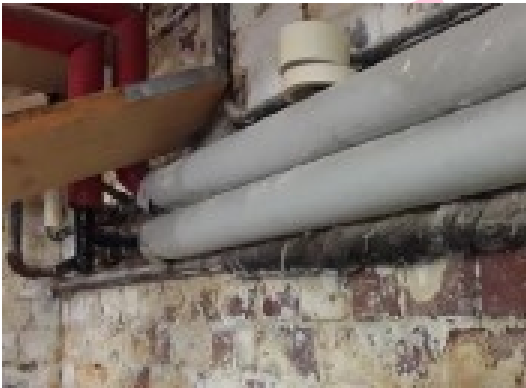
Item 11 Ref: 21-35337-10

The string to hessian lagged metal pipes in the Boiler Room (Area 35) does not contain asbestos.

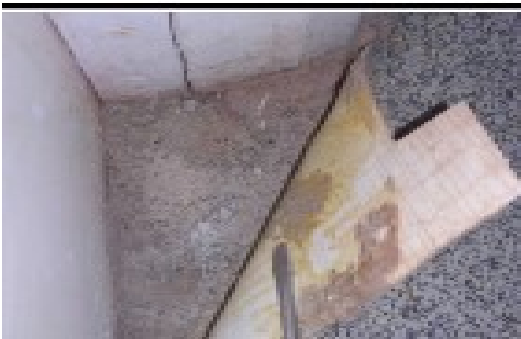
Item 14 Ref: OU001937

The residual adhesive beneath modern vinyl and screed in the reception lobby (G/01) does not contain asbestos.

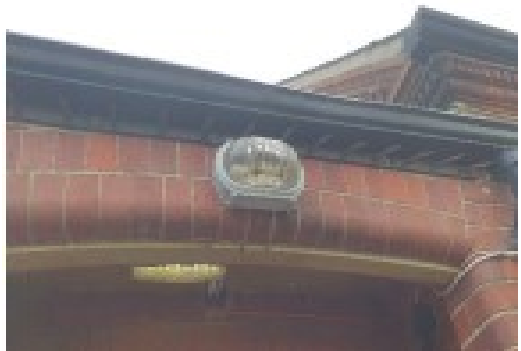
Item 15 Ref: OU001938

The sealant around glass in oval spotlight (External E/01) does not contain asbestos.

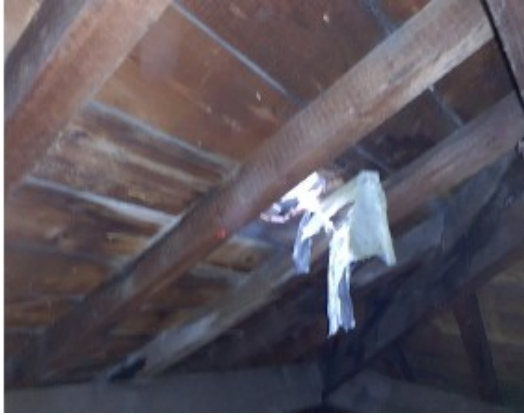
Item 16 Ref: Presumed

- (Item 15) Ref: OU001938 – Sealant around glass in oval spotlight (External E/01) – No Risk
- (Item 16) Ref: Presumed – Cowl Roof (Loft 6 R/01) – Very Low Risk

The roof cowl in the loft (R/01) is presumed to contain asbestos.

Any change in appearance should be reported to Property Services.

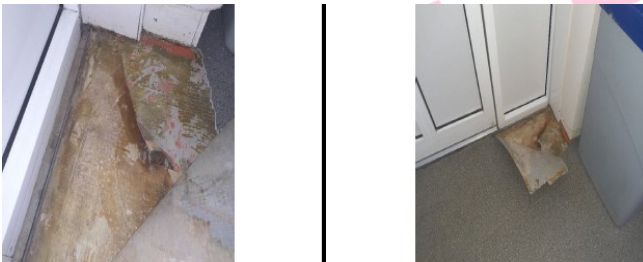
Item 17 Ref: SE000117

The vinyl - floor surrounding CP5 (below modern vinyl) (Big Nursery 001) does not contain asbestos.

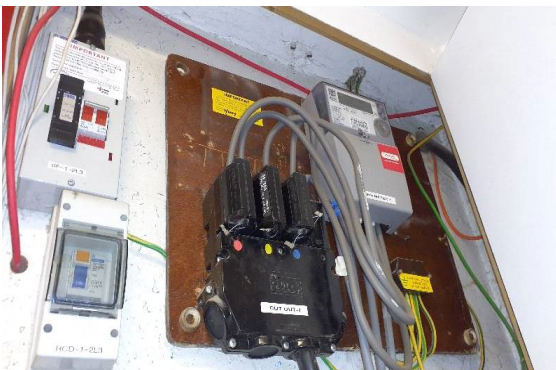
Item 18 Ref: Presumed

- (Item 17) Ref: SE000117 - Vinyl - Floor surrounding CP5 (below modern vinyl) (Big Nursery 001) – No Risk
- (Item 18) Ref: Presumed – Flash Guards (Entrance G/11) – Very Low Risk

The Flash Guards – Fuse Box (Entrance G/11) is presumed to contain asbestos.

Any change in appearance should be reported to Property Services.

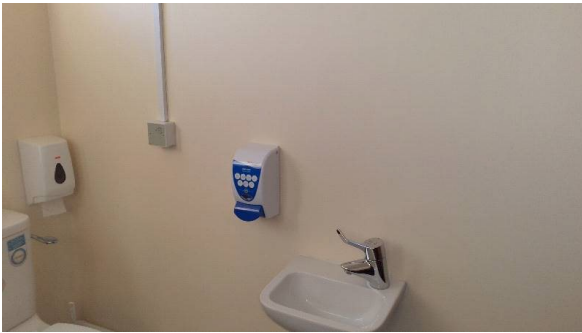
Item 19 Ref: OU004055

The Insulating Board –
Wall (Disabled Toilet
G/12) does not contain
asbestos.
