ASBESTOS SURVEY REPORT FOR WESSINGTON PRIMARY SCHOOL
LANERCOST, WASHINGTON, TYNE AND WEAR, NE38 7QA.

Asbestos Register for

**Wessington Primary School, Washington,
NE38 7QA**

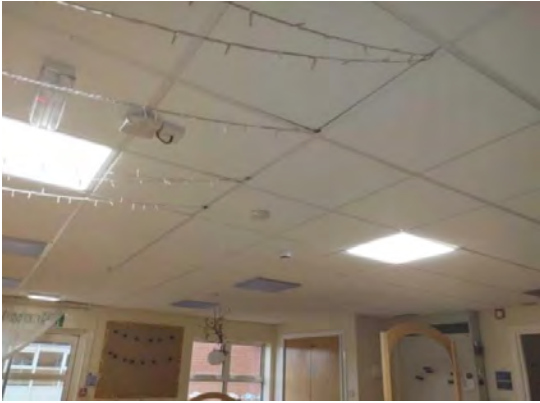
Item 1 Ref: 20-28462-2

The ceiling (Area 1/Nursery Classroom) does not contain asbestos.

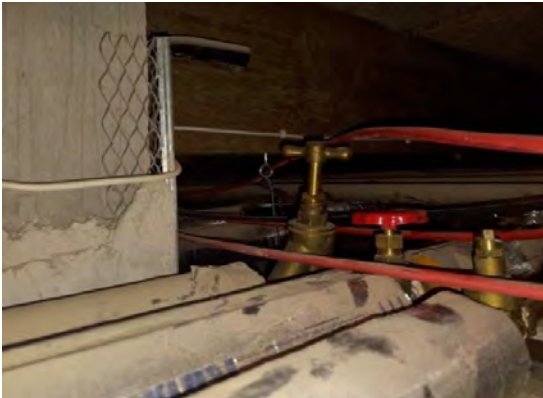
Item 2 Ref: 20-28462-3

The gaskets (Area 1/Nursery Classroom) do not contain asbestos.

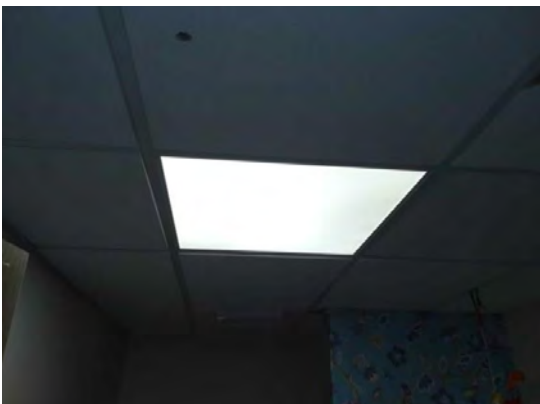
Item 3 Ref: 20-28462-2

The ceiling (Area 7/Shower) does not contain asbestos.

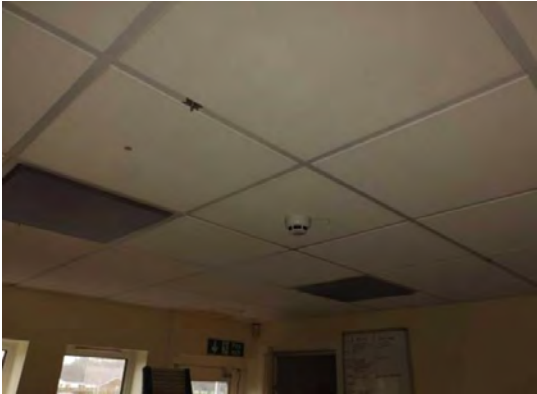
Item 4 Ref: 20-28462-2

The ceiling (Area 8/Kitchen and Cupboard) does not contain asbestos.

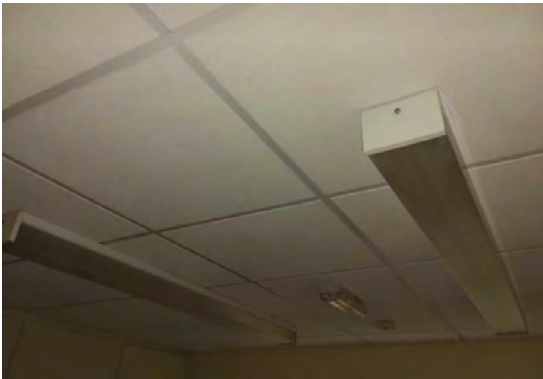
Item 5 Ref: 20-28462-2

The ceiling (Area 9/Toilet) does not contain asbestos.

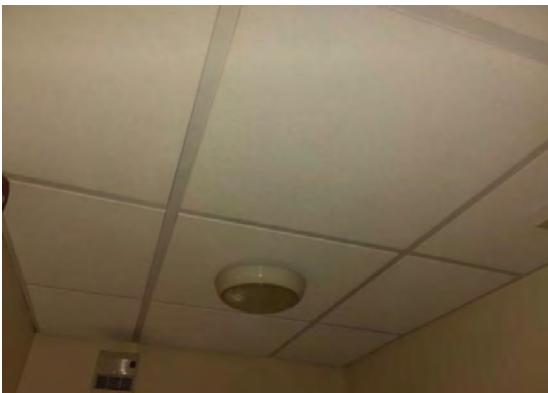
Item 6 Ref: 20-28462-2

The ceiling (Area 10/Staff Toilet) does not contain asbestos.

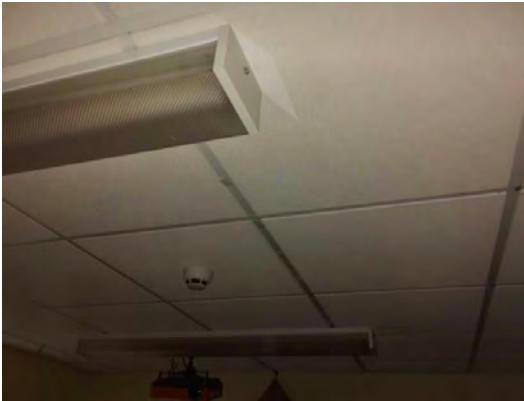
Item 7 Ref: 20-28462-2

The ceiling (Area 11/Quiet Room) does not contain asbestos.

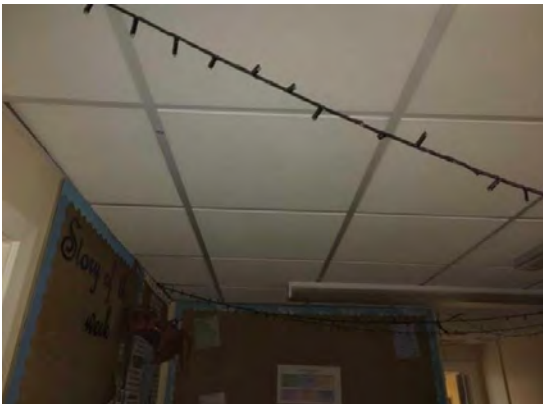
Item 8 Ref: 20-28462-2

The ceiling (Area 12/Corridor) does not contain asbestos.

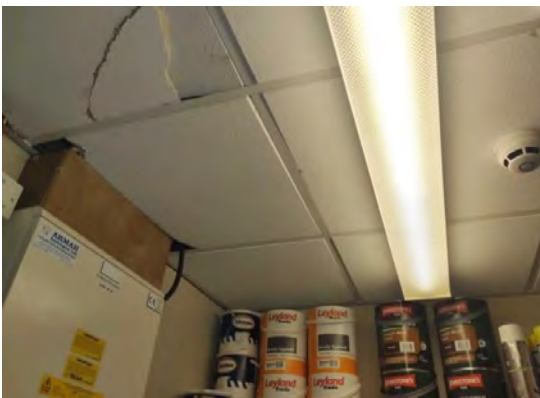
Item 9 Ref: 20-28462-2

The ceiling (Area 13/Store) does not contain asbestos.

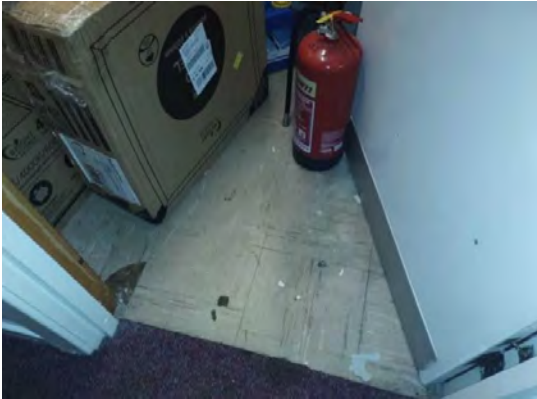
Item 10 Ref: 20-28462-4

The floor tiles and adhesive (Area13/Store) does not contain asbestos.

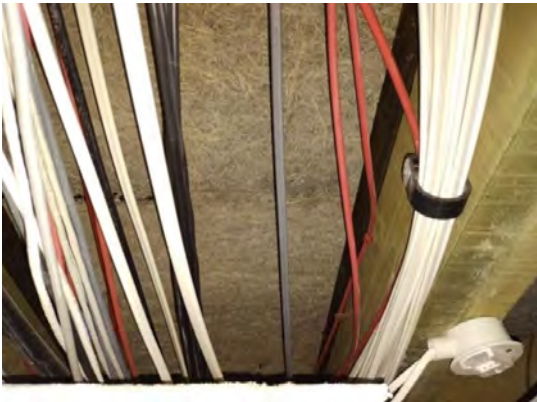
Item 11 Ref: 20-28462-2

The ceiling (Area 14/Corridor) does not contain asbestos.

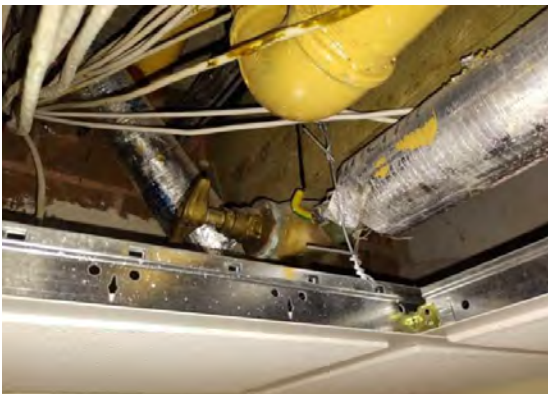
Item 12 Ref: 20-28462-5

The gasket (Area 14/Corridor ceiling void) does not contain asbestos.

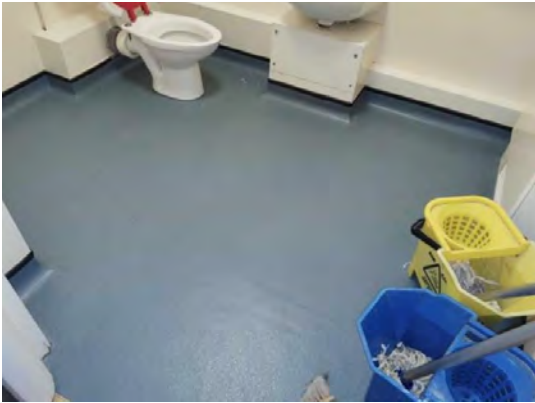
Item 13 Ref: 20-28462-6

The floor (Area 18/Disabled toilet) does not contain asbestos.

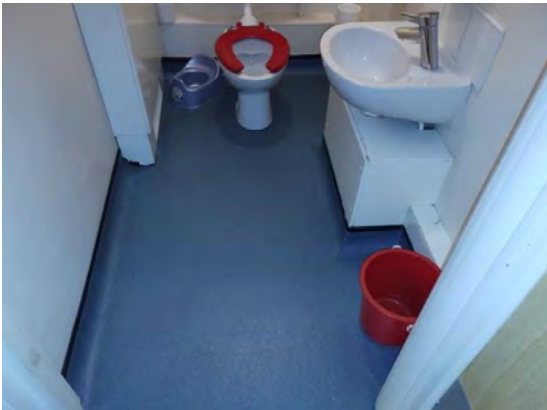
Item 14 Ref: 20-28462-6

The floor (Area 19/Toilet) does not contain asbestos.

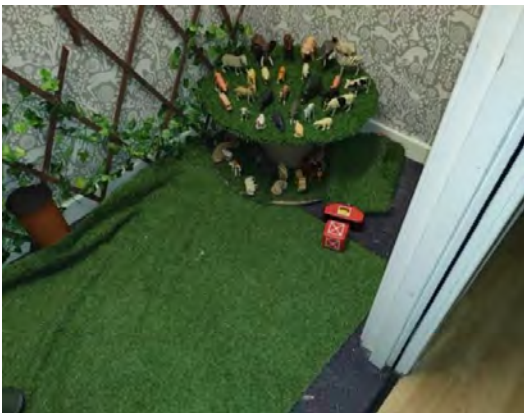
Item 15 Ref: 20-28462-1

- (Item 13) Ref: 20-28462-6 – Floor (Area 18/Disabled toilet) – No Risk
- (Item 14) Ref: 20-28462-6 – Floor (Area 19/Toilet) – No Risk
- (Item 15) Ref: 20-28462-1 – Floor (Area 1b/Cupboard) – Very Low Risk

The floor (Area 1b/Cupboard) contains asbestos.

Any change in its appearance should be recorded and passed to Property Services.

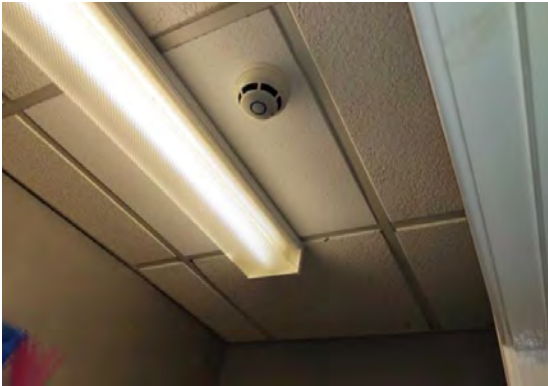
Item 16 Ref: 20-28462-2

The ceiling (Area 1b/Cupboard) does not contain asbestos.

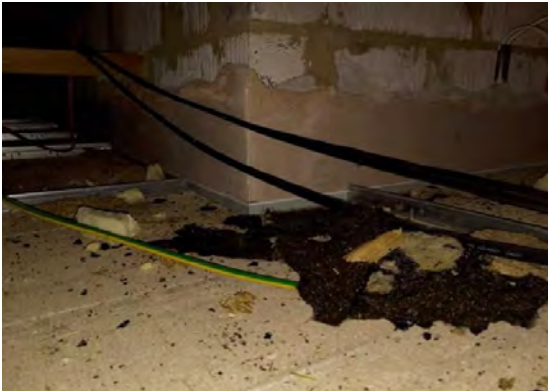
Item 17 Ref: 20-28462-7

The ceiling (Area 28/Corridor) does not contain asbestos.

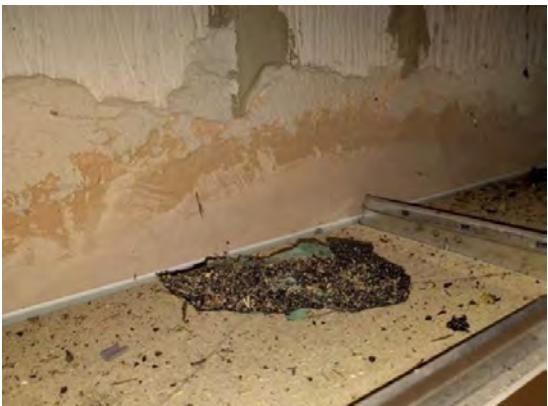
Item 18 Ref: 20-28462-7

The ceiling (Area 29/Toilet) does not contain asbestos.

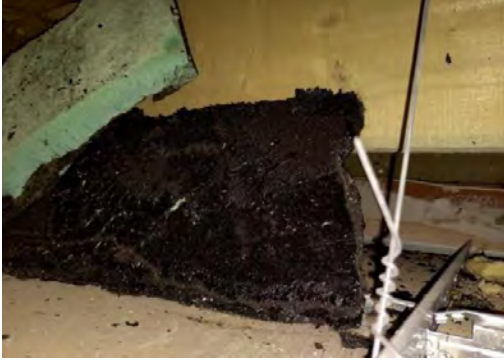
Item 19 Ref: 20-28462-7

The ceiling (Area 30/Toilet) does not contain asbestos.

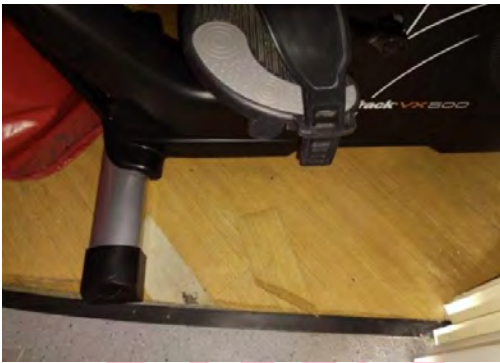
Item 20 Ref: 20-28462-6

The floor (Area 35/Cupboard) does not contain asbestos.

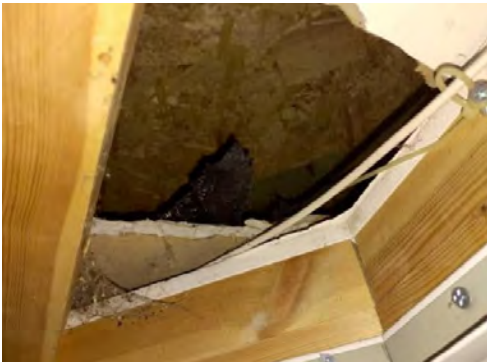
Item 21 Ref: 20-28462-7

The ceiling (Area 36/Corridor) does not contain asbestos.

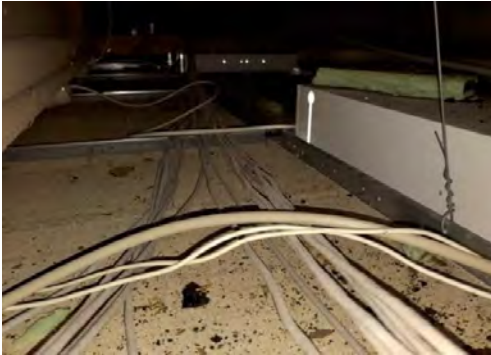
Item 22 Ref: 20-28462-7

The ceiling (Area 42/Classroom and cupboard) does not contain asbestos.

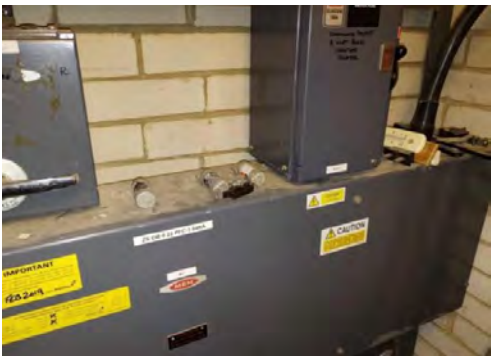
Item 23 Ref: 20-28462-8

The electrical equipment (Area 46/Electric meter cupboard) does not contain asbestos.

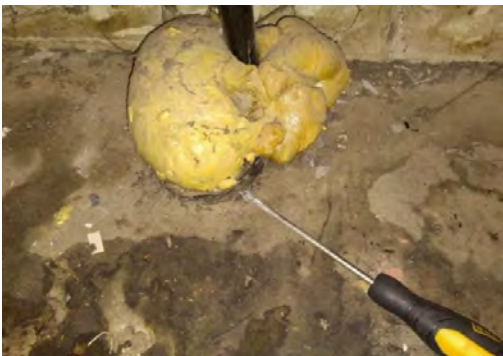
Item 24 Ref: 20-28462-9

The cable intrusion sleeve (Area 46/Electric meter cupboard) does not contain asbestos.

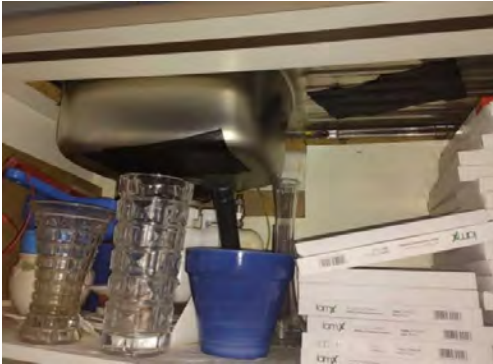
Item 25 Ref: 20-28462-10

The sink pad (Area 60/Reprographic Room) does not contain asbestos.

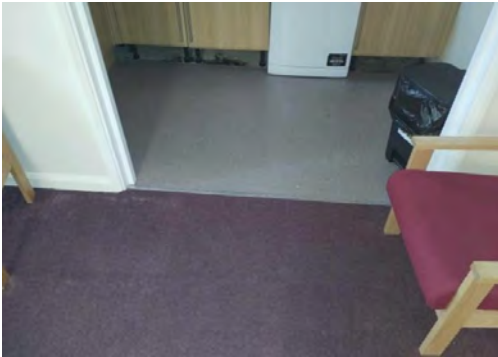
Item 26 Ref: 20-28462-11

The floor (Area 70/Staff room and kitchen) does not contain asbestos.

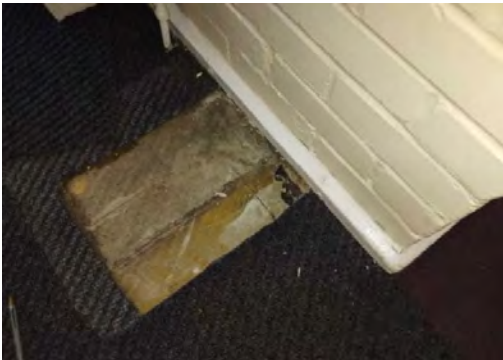
Item 27 Ref: 20-28462-12

The floor (Area 72/Corridor) does not contain asbestos.

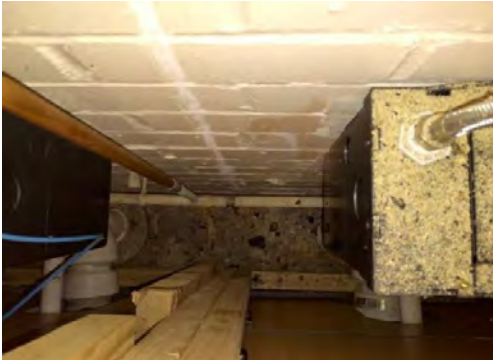
Item 28 Ref: 20-28462-7

The ceiling (Area 73/Toilet) does not contain asbestos.

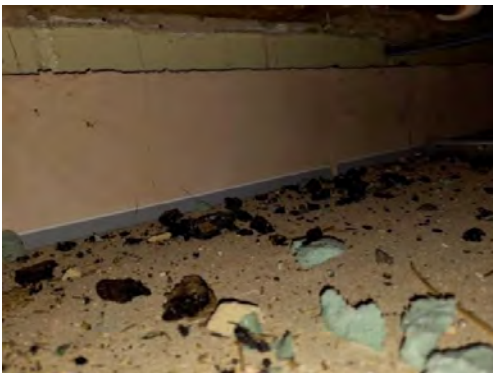
Item 29 Ref: 20-28462-7

The ceiling (Area 79/Toilet) does not contain asbestos.

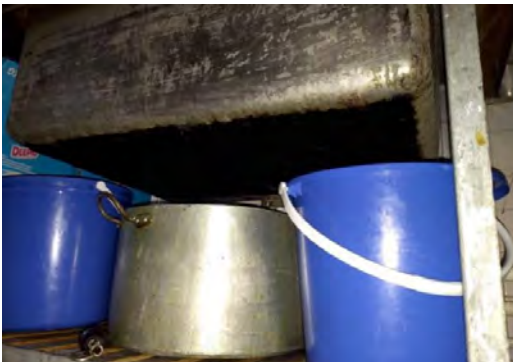
Item 30 Ref: 20-28462-14

The sink pad (Area 83/Kitchen) does not contain asbestos.

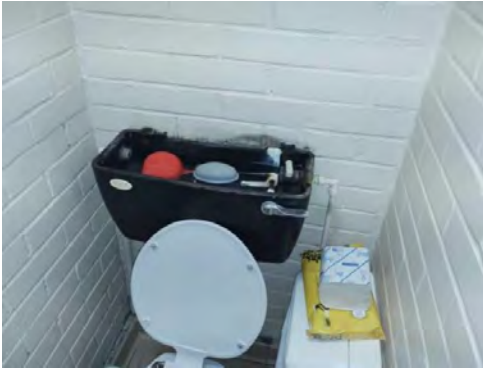
Item 31 Ref: 20-28462-15

- (Item 29) Ref: 20-28462-7 – Ceiling (Area 79/Toilet) – No Risk
- (Item 30) Ref: 20-28462-14 – Sink pad (Area 83/Kitchen) – No Risk
- (Item 31) Ref: 20-28462-15 – Toilet Cistern (Area 86/WC) – Low Risk

The toilet cistern (Area 86/WC) contains asbestos.

Any change in its appearance should be recorded and passed to Property Services.

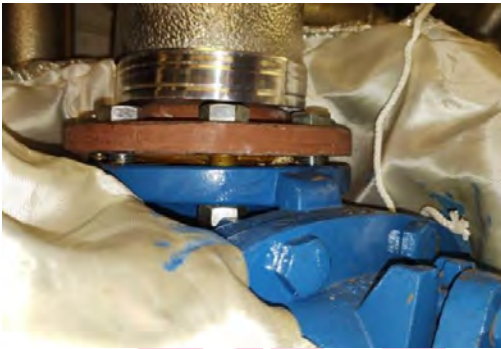
Item 32 Ref: 20-28462-16

The flanges throughout gaskets (Area 103/Boiler Room) do not contain asbestos.

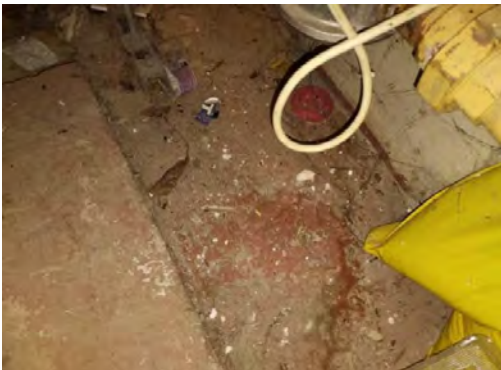
Item 33 Ref: 20-28462-17

The debris to floor (Area 103/Boiler Room) does not contain asbestos.

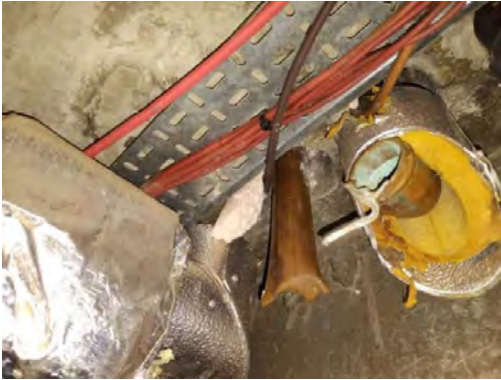
Item 34 Ref: 20-28462-17

The ceiling (Area 103/Boiler Room) does not contain asbestos.

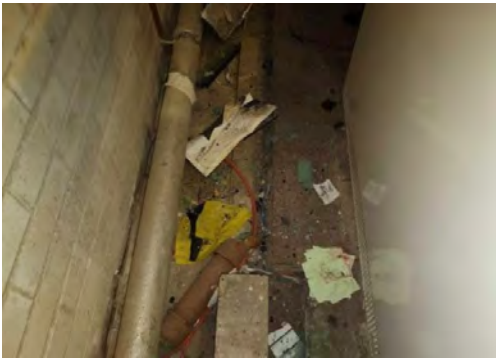
Item 35 Ref: 20-28462-7

The felt debris (Area 103/Boiler Room) does not contain asbestos.

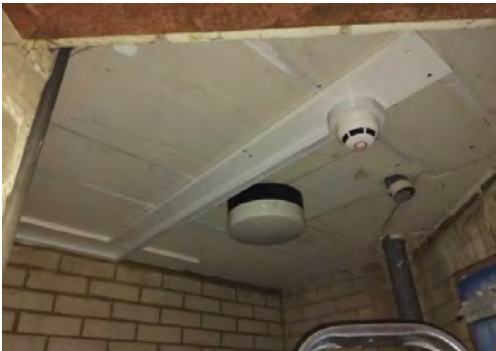
Item 36 Ref: 20-28462-18

The ceiling (Area 104/External Store) does not contain asbestos.

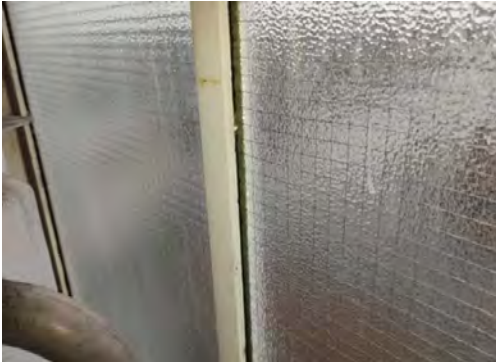
Item 37 Ref: 20-28462-19

- (Item 37) Ref: 20-28462-19 – Sealant to glass panes (Area 105/Tank Room) – Very Low Risk
- (Item 38) Ref: 20-28462-20 – Gaskets (Area 105/Tank Room) – No Risk

The sealant to glass panes (Area 105/Tank Room) contains asbestos.

Any change in its appearance should be recorded and passed to Property Services.

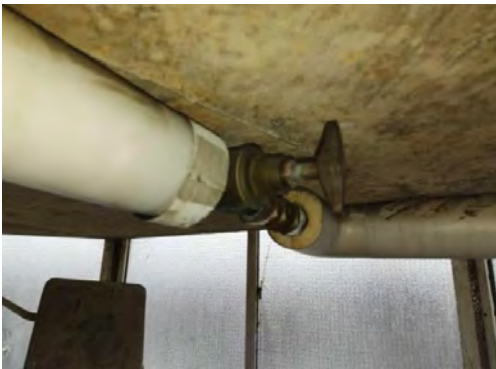
Item 38 Ref: 20-28462-20

The gaskets (Area 105/Tank Room) do not contain asbestos.

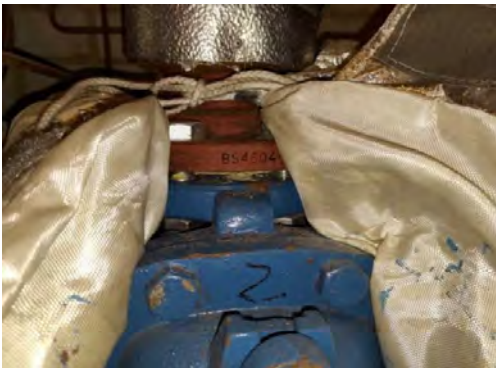
Item 39 Ref: 20-28462-22

The gaskets (Area 105/Tank Room) do not contain asbestos.

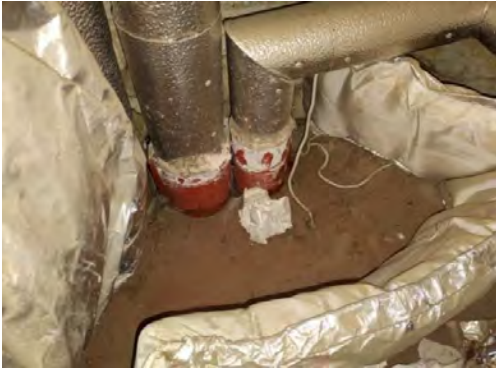
Item 40 Ref: 20-28462-23

The pipes (Area 106/Boiler Room) do not contain asbestos.

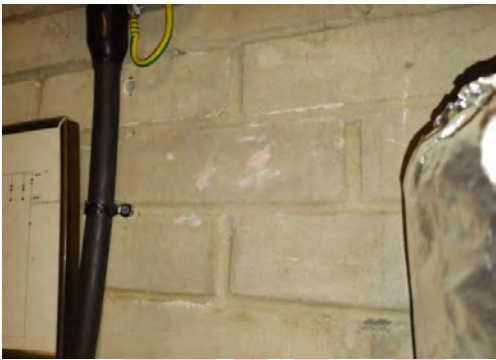
Item 41 Ref: 20-28462-23

The debris to walls (Area 106/Boiler Room) does not contain asbestos.

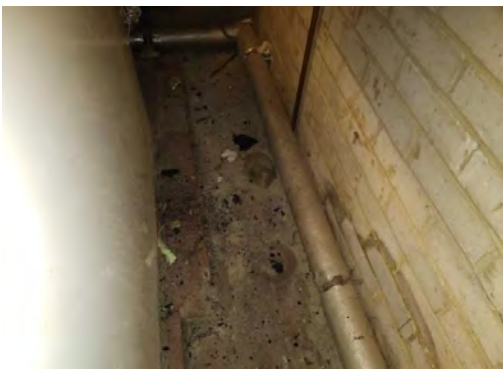
Item 42 Ref: 20-28462-7

The felt debris (Area 106/Boiler Room) does not contain asbestos.

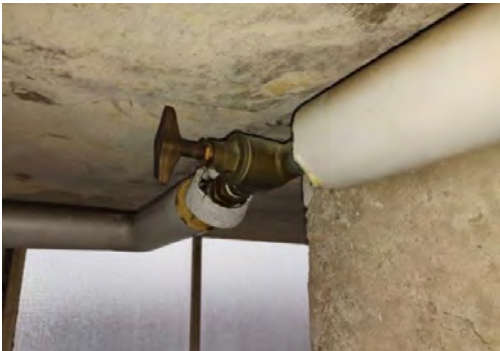
Item 44 Ref: 20-28462-20

The gaskets (Area 107/Tank Room) do not contain asbestos.

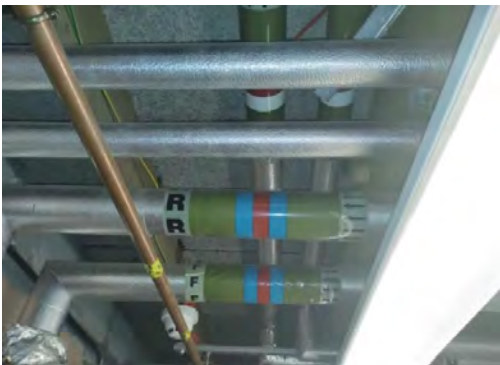
Item 45 Ref: 20-28462-2

The ceiling (Area 108/Boiler Room) does not contain asbestos.

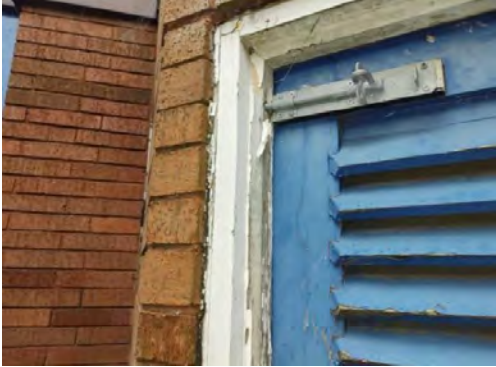
Item 46 Ref: 20-28462-21

- (Item 45) Ref: 20-28462-2 – Ceiling (Area 108/Boiler Room) – No Risk
- (Item 46) Ref: 20-28462-21 – Sealant to door frame (Store area 104) (Area 109/External) – **Very Low Risk**

The sealant to door frame (Store area 104) (Area 109/External) contains asbestos.

Any change in its appearance should be recorded and passed to Property Services.

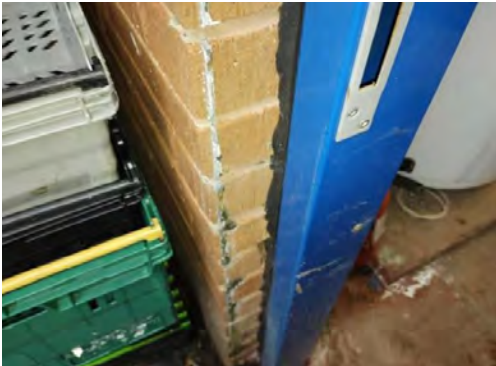
Item 47 Ref: 20-28462-21

The sealant to brickwork (Area 109/External) contains asbestos.

Any change in its appearance should be recorded and passed to Property Services.

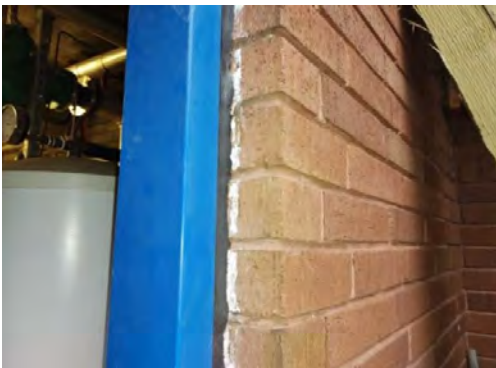
Item 48 Ref: 20-28462-21

The sealant to brickwork (Area 109/External) contains asbestos.

Any change in its appearance should be recorded and passed to Property Services.

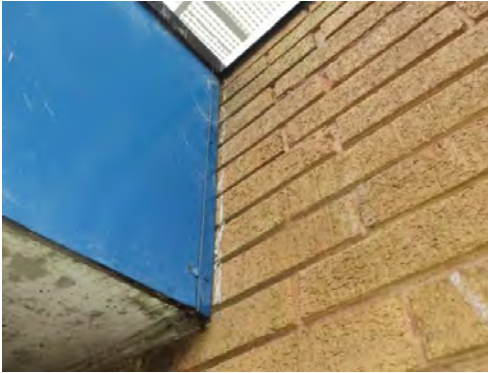
Item 49 Ref: 20-28462-21

- (Item 49) Ref: 20-28462-21 – Sealant to Wooden cladding (Area 109/External) – **Very Low Risk**
- (Item 50) Ref: 20-28462-21 – Sealant to Walls (CAMHS Entrance) (Area 109/External) – **Very Low Risk**

The sealant to wooden cladding (Area 109/External) contains asbestos.

Any change in its appearance should be recorded and passed to Property Services.

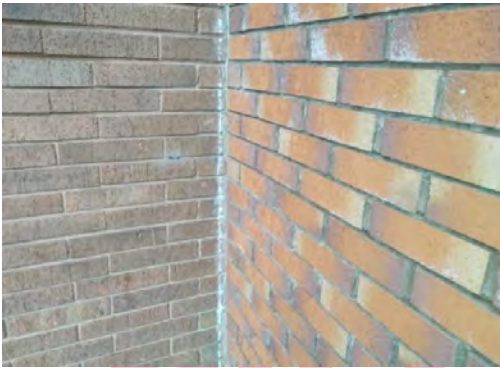
Item 50 Ref: 20-28462-21

The sealant to walls (CAMHS Entrance) (Area 109/External) contains asbestos.

Any change in its appearance should be recorded and passed to Property Services.

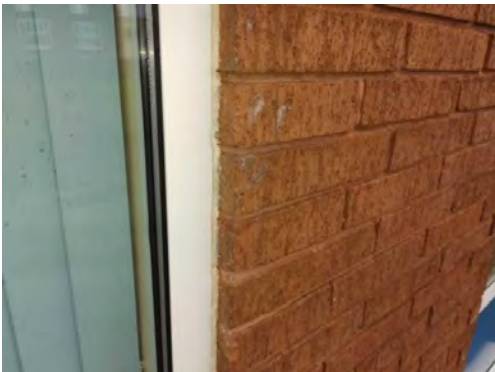
Item 51 Ref: 20-28462-21

- (Item 51) Ref: 20-28462-21 – Sealant to Walls (Area 109/External) – **Very Low Risk**
- (Item 52) Ref: 20-28462-24 – Damp proof course (Area 109/External) – No Risk

The sealant to walls (Area 109/External) contains asbestos.

Any change in its appearance should be recorded and passed to Property Services.

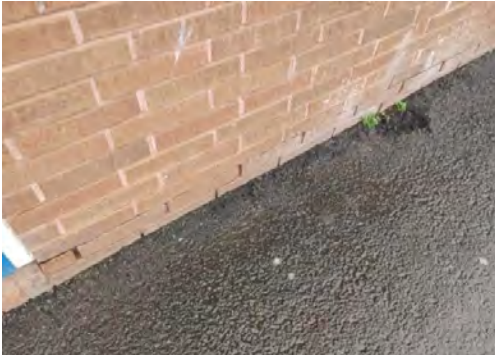
Item 52 Ref: 20-28462-24

The damp proof course (Area 109/External) does not contain asbestos.

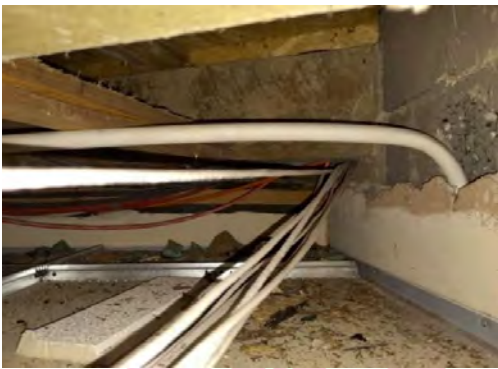
Item 53 Ref: 20-28462-7

The ceiling (Area 71a/Corridor) does not contain asbestos.

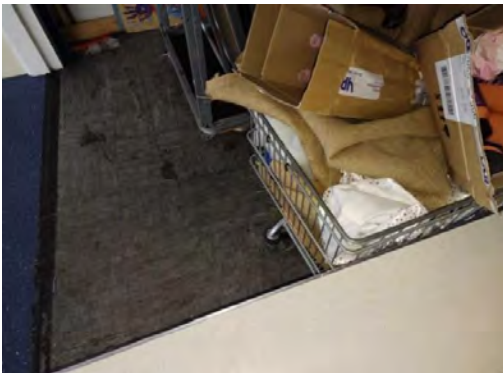
Item 54 Ref: 20-28462-13

The floor (Area 82a/Store Cupboards) contains asbestos.

Removed July 2025

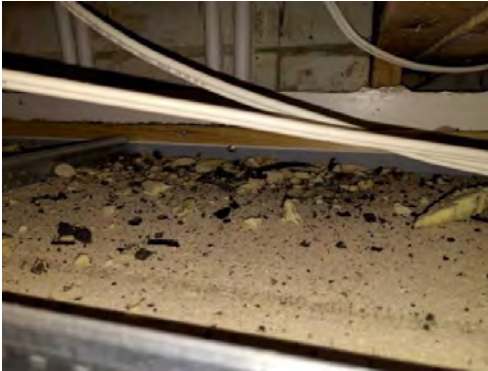
Item 55 Ref: 20-28462-7

The ceiling (Area 95a/Kitchen) does not contain asbestos.

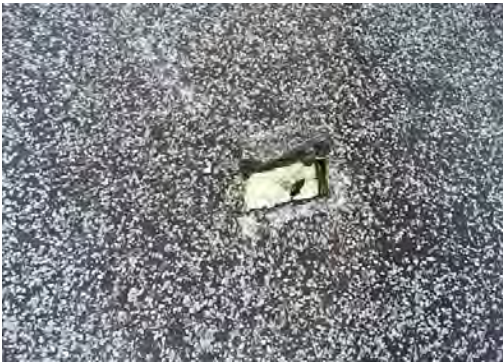
Item 56 Ref: 22-47238-1

The bitumen roof felt (Area 1/External) does not contain asbestos.

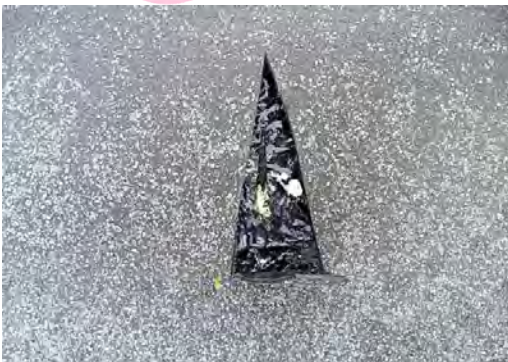
Item 57 Ref: 22-47238-10

The bitumen roof felt (Area 1/External) does not contain asbestos.

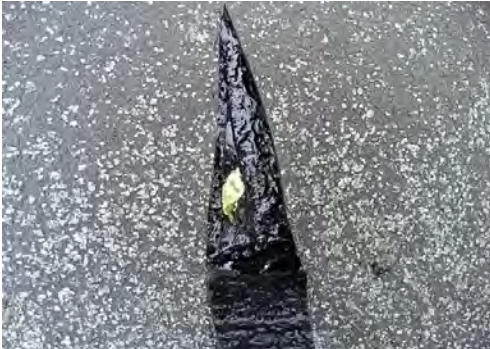
Item 58 Ref: 22-47238-11

The bitumen roof felt (Area 1/External) does not contain asbestos.

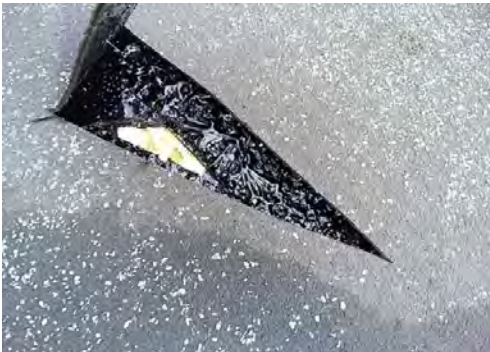
Item 59 Ref: 22-47238-12

The bitumen roof felt (Area 1/External) does not contain asbestos.

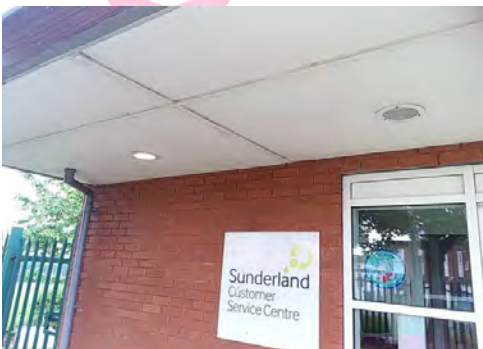
Item 60 Ref: 22-47238-13

The ceiling canopy above front entrance (Area 1/External) does not contain asbestos.

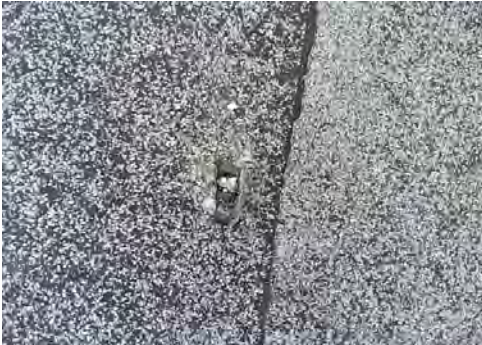
Item 62 Ref: 22-47238-3

The bitumen roof felt (Area 1/External) does not contain asbestos.

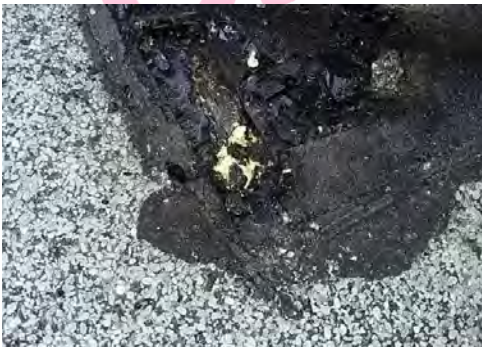
Item 63 Ref: 22-47238-4

The bitumen roof felt (Area 1/External) does not contain asbestos.

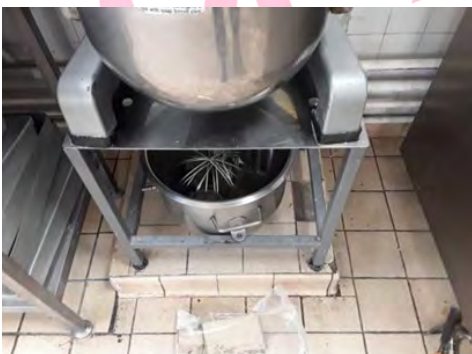
Item 69 Ref: 22-53635-1

The floor beneath the ceramic tiles to concrete floor plinth (Area 1: Kitchen) does not contain asbestos.

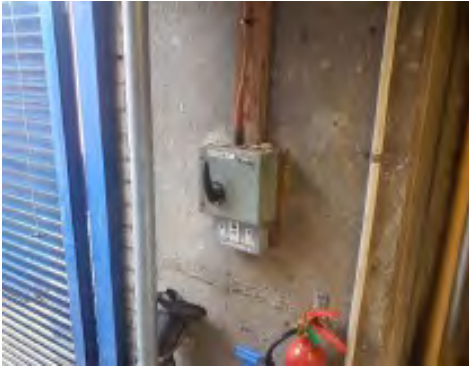
Item 70 Ref: Presumed

- (Item 70) Ref: Presumed – Textiles within ottermill fuse box (Keystage 1 Plant Room G/01) – **Very Low Risk**
- (Item 71) Ref: RC000278 – Lagging pipework (Keystage 1 Plant Room G/01) – No Risk

The Textiles within ottermill fuse box (Keystage 1 Plant Room G/01) are presumed to contain asbestos.

Any change in appearance should be reported to Property Services.

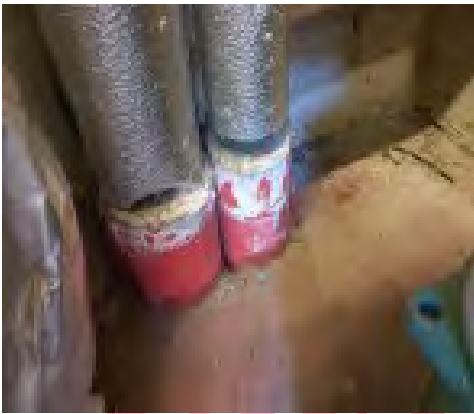
Item 71 Ref: RC000278

The lagging pipework (Keystage 1 Plant Room G/01) does not contain asbestos.

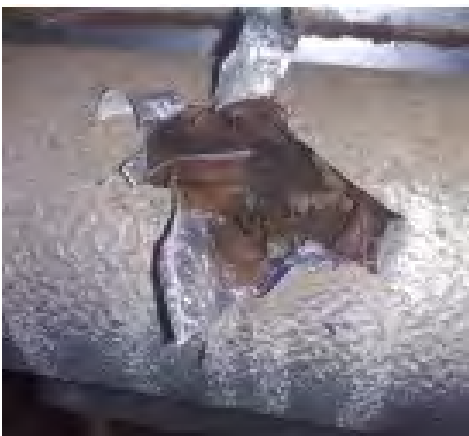
Item 72 Ref: RC000279

The Paper lining – plant pipework behind metal casing (Keystage 1 Plant Room G/01) does not contain asbestos.

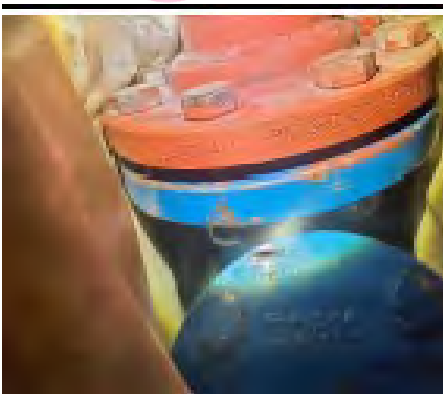
Item 75 Ref: RC000282

The - Gaskets pipework at high level and behind plant RHS side (Keystage 1 Plant Room G/01) does not contain asbestos.

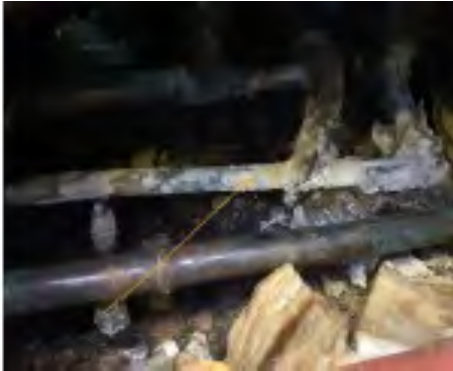
Item 76 Ref: RC000562

The Lagging residue pipework (Floor duct G/01 Hall KS2) does not contain asbestos.

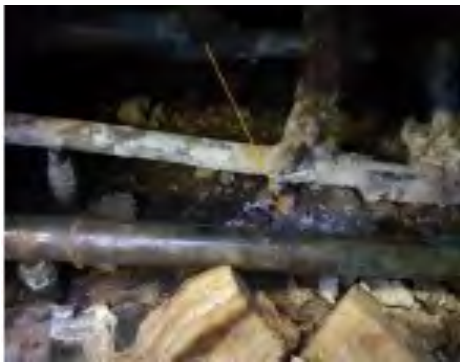
Item 77 Ref: RC000563

The Debris residue from pipework (Floor duct G/01 Hall KS2) does not contain asbestos.
