ASBESTOS SURVEY REPORT FOR WESSINGTON PRIMARY SCHOOL LANERCOST, WASHINGTON, TYNE AND WEAR, NE38 7QA.

Asbestos Register for

**Wessington Primary School, Washington,
NE38 7QA**

Date: 03 July 2025

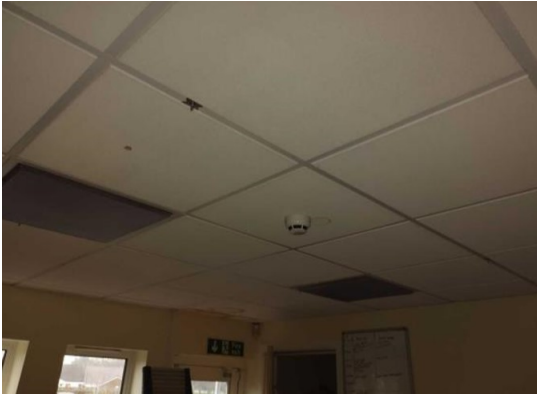
Item 4 Ref: 20-28462-2

The ceiling (Area 8/Kitchen and Cupboard) does not contain asbestos.

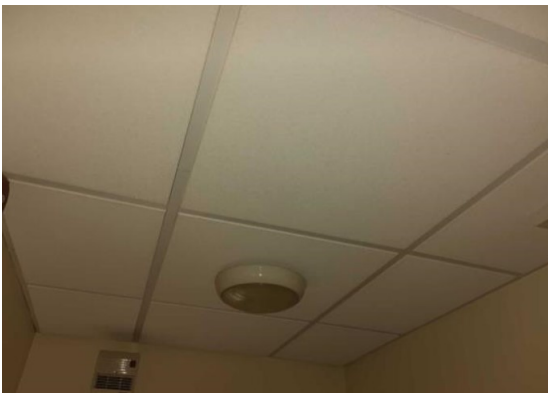
Item 6 Ref: 20-28462-2

The ceiling (Area 10/Staff Toilet) does not contain asbestos.

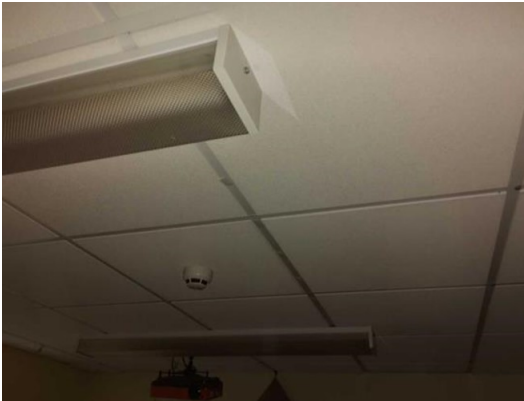
Item 7 Ref: 20-28462-2

The ceiling (Area 11/Quiet Room) does not contain asbestos.

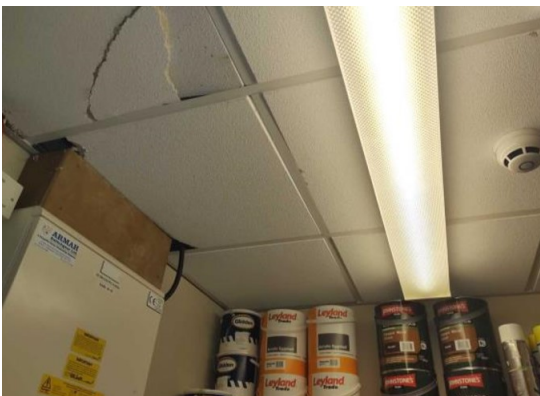
Item 9 Ref: 20-28462-2

The ceiling (Area 13/Store) does not contain asbestos.

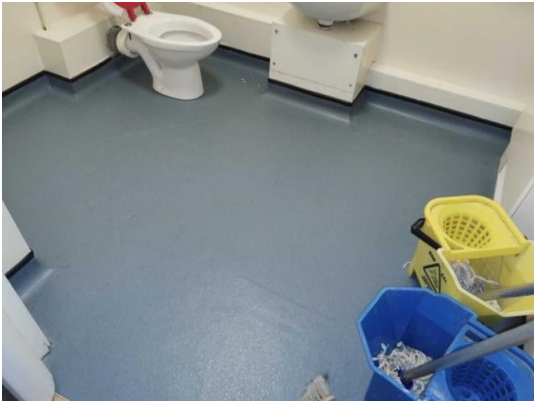
Item 13 Ref: 20-28462-6

The floor (Area 18/Disabled toilet) does not contain asbestos.

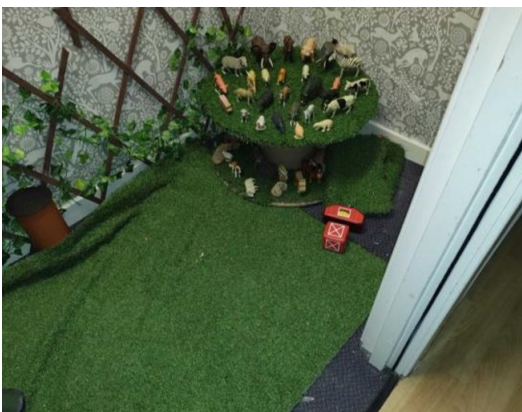
Item 15 Ref: 20-28462-1

- (Item 13) Ref: 20-28462-6 – Floor (Area 18/Disabled toilet) – No Risk
- (Item 14) Ref: 20-28462-6 – Floor (Area 19/Toilet) – No Risk
- (Item 15) Ref: 20-28462-1 – Floor (Area 1b/Cupboard) – Very Low Risk

The floor (Area 1b/Cupboard) contains asbestos.

Any change in its appearance should be recorded and passed to Property Services.

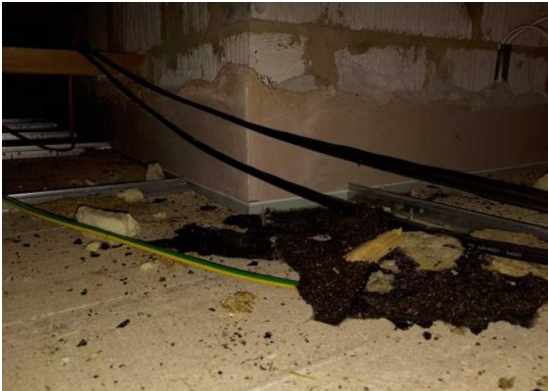
Item 17 Ref: 20-28462-7

The ceiling (Area 28/Corridor) does not contain asbestos.

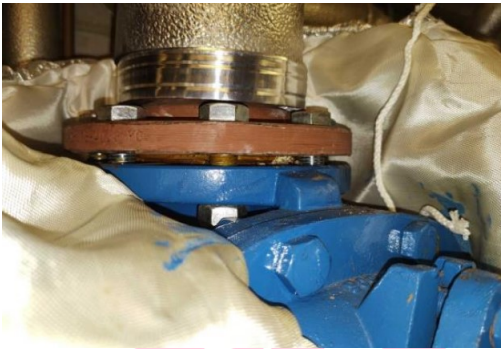
Item 32 Ref: 20-28462-16

The flanges throughout gaskets (Area 103/Boiler Room) do not contain asbestos.

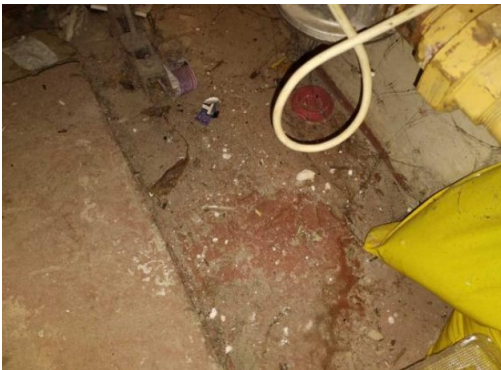
Item 33 Ref: 20-28462-17

The debris to floor (Area 103/Boiler Room) does not contain asbestos.

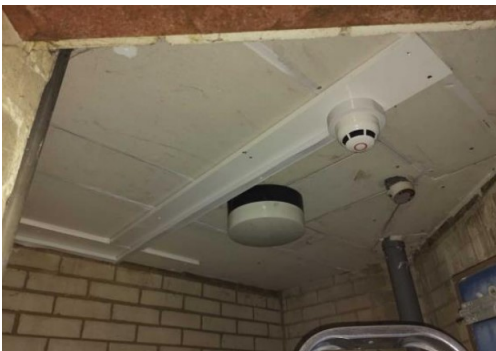
Item 36 Ref: 20-28462-18

The ceiling (Area 104/External Store) does not contain asbestos.

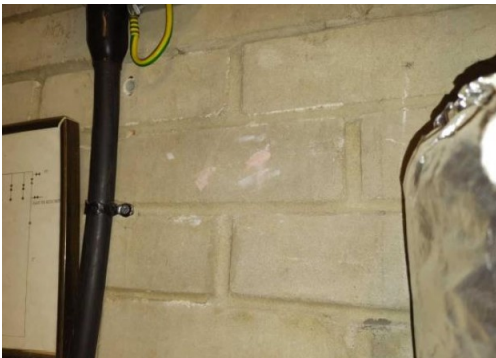
Item 41 Ref: 20-28462-23

The debris to walls (Area 106/Boiler Room) does not contain asbestos.

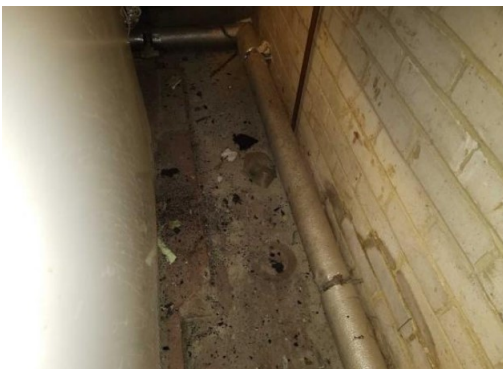
Item 42 Ref: 20-28462-7

The felt debris (Area 106/Boiler Room) does not contain asbestos.

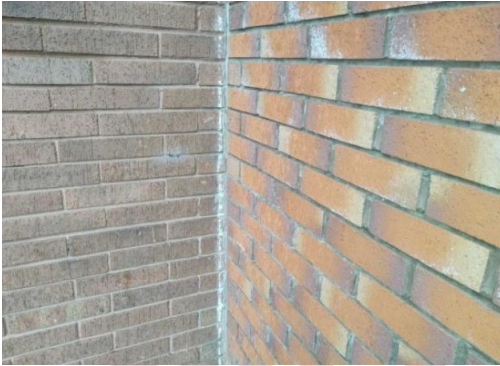
Item 50 Ref: 20-28462-21

The sealant to walls (CAMHS Entrance) (Area 109/External) contains asbestos.

Any change in its appearance should be recorded and passed to Property Services.

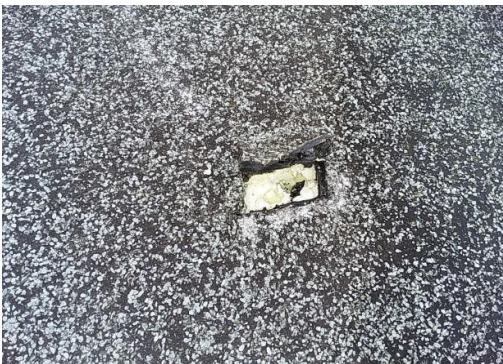
Item 56 Ref: 22-47238-1

The bitumen roof felt (Area 1/External) does not contain asbestos.

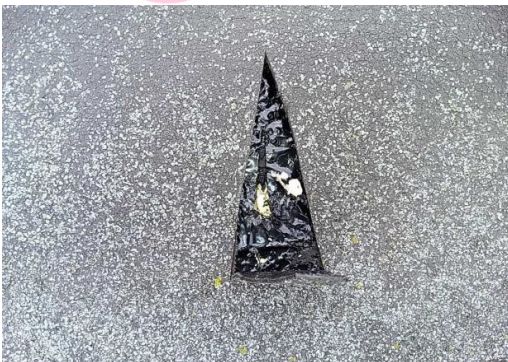
Item 57 Ref: 22-47238-10

The bitumen roof felt (Area 1/External) does not contain asbestos.

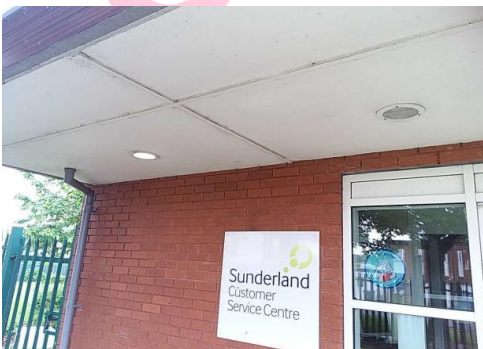
Item 60 Ref: 22-47238-13

The ceiling canopy above front entrance (Area 1/External) does not contain asbestos.

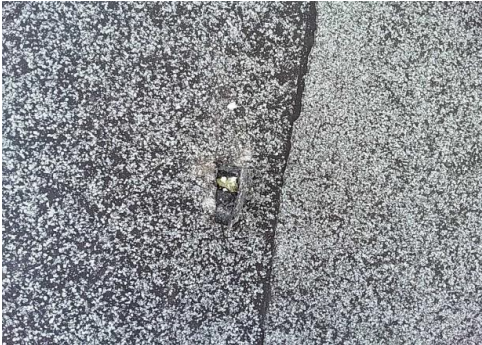
Item 62 Ref: 22-47238-3

The bitumen roof felt (Area 1/External) does not contain asbestos.

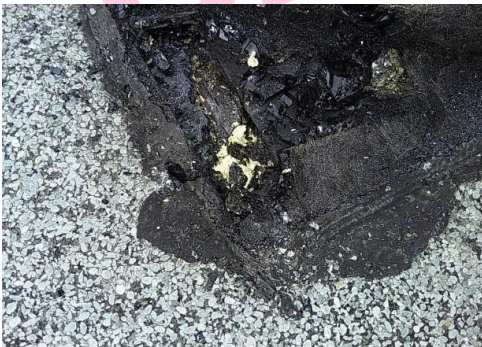
Item 63 Ref: 22-47238-4

The bitumen roof felt (Area 1/External) does not contain asbestos.

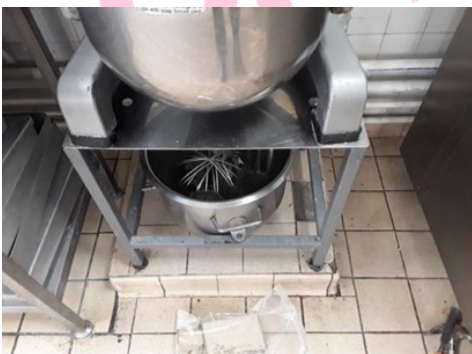
Item 69 Ref: 22-53635-1

The floor beneath the ceramic tiles to concrete floor plinth (Area 1: Kitchen) does not contain asbestos.

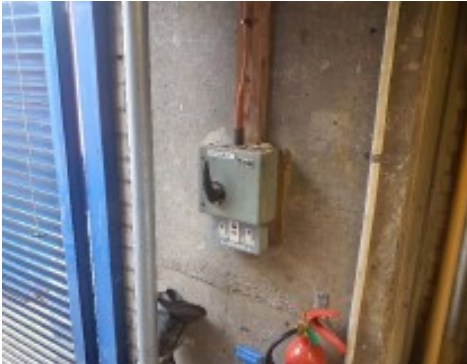
Item 70 Ref: Presumed

The Textiles within ottermill fuse box (Keystage 1 Plant Room G/01) are presumed to contain asbestos.

Any change in appearance should be reported to Property Services.

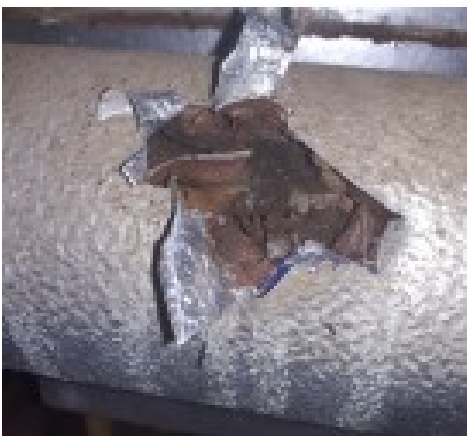
Item 72 Ref: RC000279

The Paper lining – plant pipework behind metal casing (Keystage 1 Plant Room G/01) does not contain asbestos.

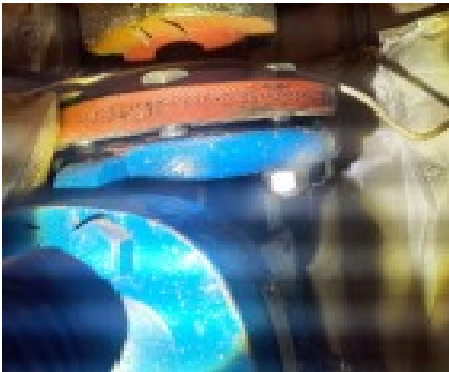
Item 74 Ref: RC000281

The Gaskets pipework RHS side (Keystage 1 Plant Room G/01) does not contain asbestos.

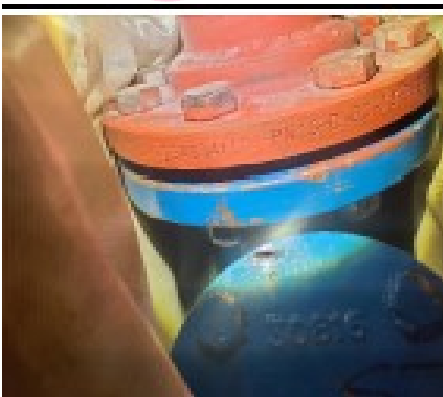
Item 75 Ref: RC000282

The - Gaskets pipework at high level and behind plant RHS side (Keystage 1 Plant Room G/01) does not contain asbestos.

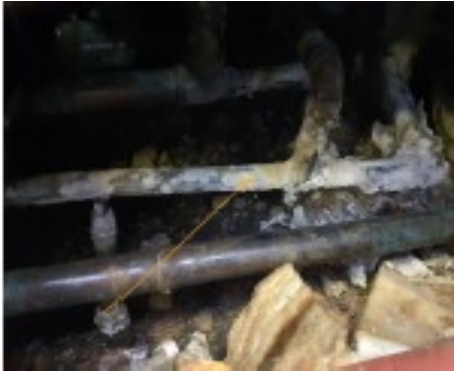
Item 76 Ref: RC000562

The Lagging residue pipework (Floor duct G/01 Hall KS2) does not contain asbestos.

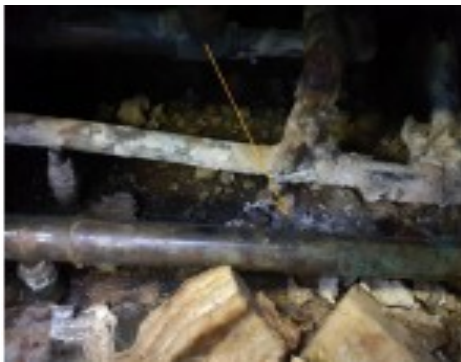
Item 77 Ref: RC000563

The Debris residue from pipework (Floor duct G/01 Hall KS2) does not contain asbestos.
