ASBESTOS SURVEY REPORT FOR BARNES JUNIOR SCHOOL, MOUNT ROAD, SUNDERLAND, SR4 7QF.

**Barnes Junior School, Mount Road, Sunderland,
SR4 7QF**

UPRN: - 428662

Date: 01 May 2026

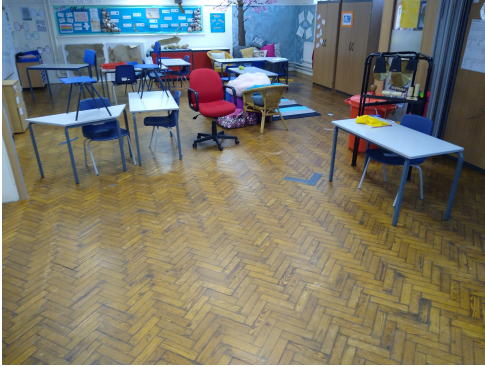
Item 1 Ref: 428662-15

- (Item 1) Ref: 428662-15 – Bitumen adhesive below parquet flooring (-1/006 Classroom) – No Risk
- (Item 2) 22-45856-15 (428662-16) – Panel to ceiling (-1/006 Classroom void above) – No Risk

The bitumen adhesive below parquet flooring in -1/006 Classroom does not contain asbestos.

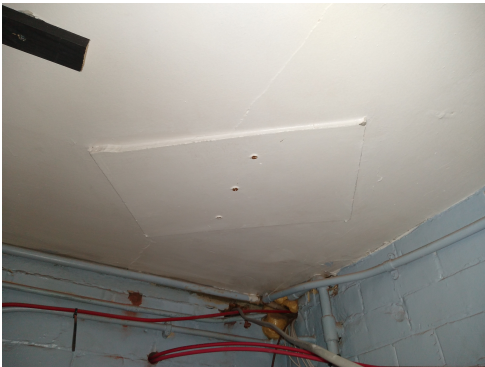
Item 2 Ref: 22-45856-15

The panel to ceiling in -1/006 Classroom – wraparound care was tested by Pattinsons and found to not contain asbestos.

(Previously tested by Lucion ref: 428662-16)

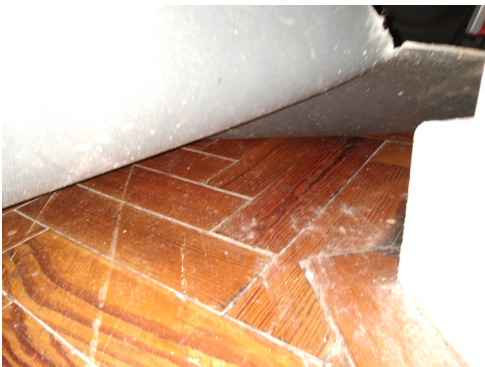
Item 3 Ref: As 428662-15

The bitumen adhesive below parquet flooring in -1/008 Toilet does not contain asbestos.

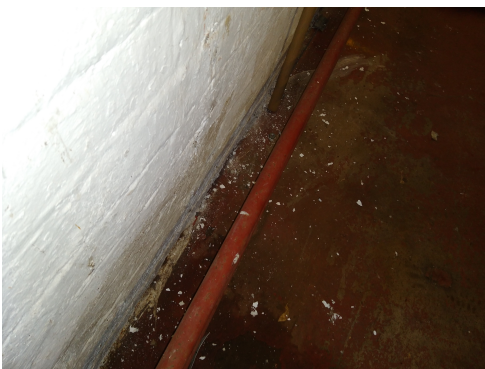
Item 6 Ref: 428662-13

The debris to floor in -1/012 Boiler Room does not contain asbestos.

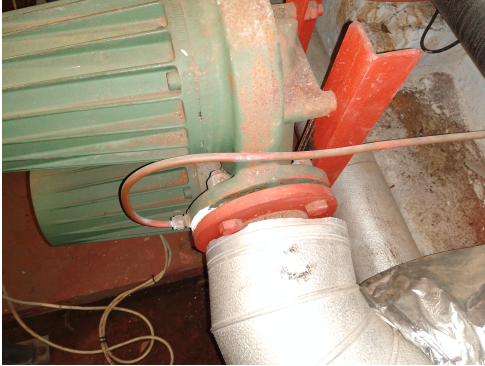
Item 7 Ref: 428662-14

The pipework flange gasket in -1/012 Boiler Room does not contain asbestos.

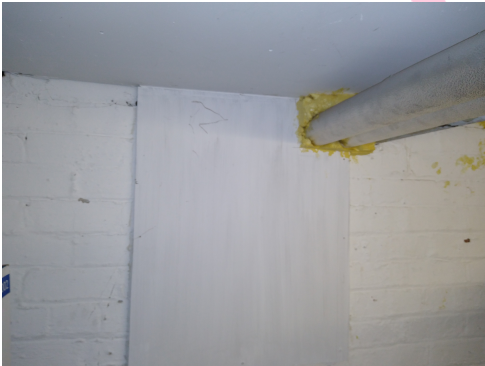
Item 8 Ref: Presumed

- (Item 7) Ref: 428662-14 – Pipework flange gasket (-1/012 Boiler Room) – No Risk
- (Item 8) **Ref: Presumed – Undercroft (-1/013 Store) – Medium Risk**

The undercroft in -1/013 Store is presumed to contain asbestos.

Any change in its appearance should be recorded and passed to Property Services

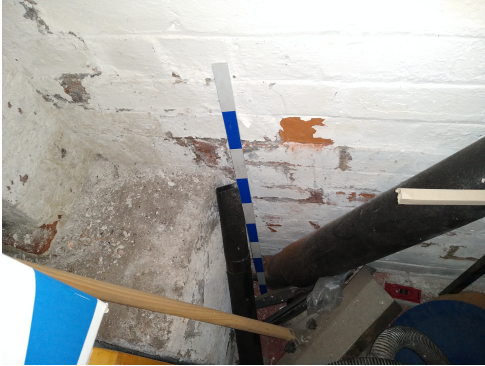
Item 10 Ref: 428662-8

The general debris to floor in -
1/013 Store does not contain
asbestos.

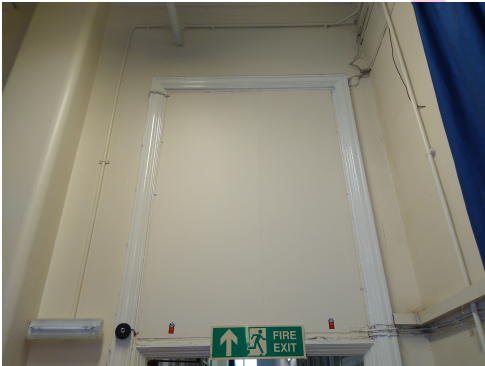
Item 11 Ref: As 428662-2

The panel above door in 0/006
Hall contains asbestos.

Removed December 2022

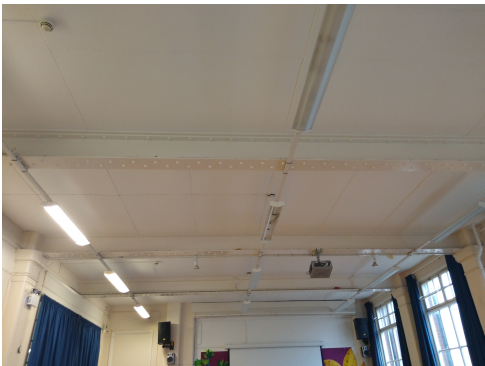
Item 12 Ref: 428662-3

The ceiling in 0/006 Hall does
not contain asbestos.

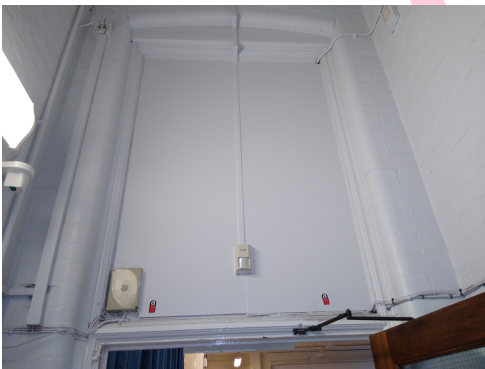
Item 14 Ref: 428662-2

The panel above door in 0/012 Corridor contains asbestos.

Removed December 2022

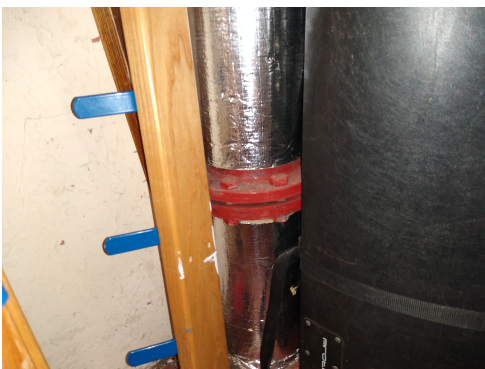
Item 15 Ref: 428662-4

The pipework flange gasket in 0/017 Hall store does not contain asbestos.

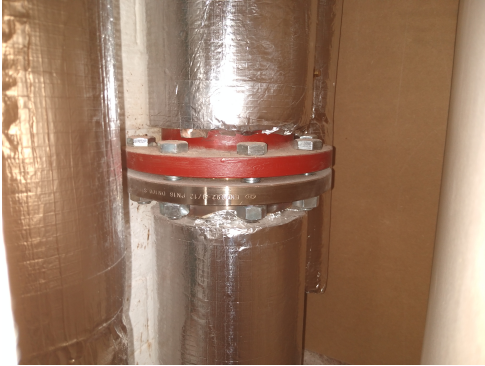
Item 16 Ref: As 428662-4

The pipework flange gasket within boxing in 0/018 Corridor and Stairs does not contain asbestos.

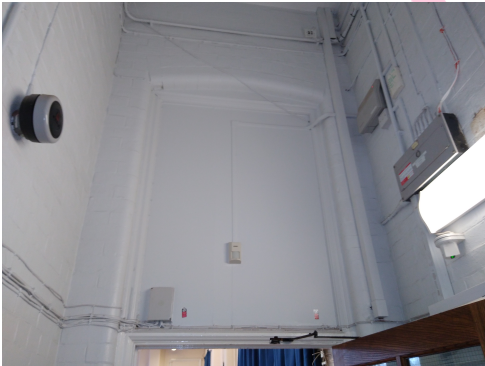
Item 17 Ref: As 428662-2

The panel above door in 0/023 Corridor contains asbestos.

Removed December 2022

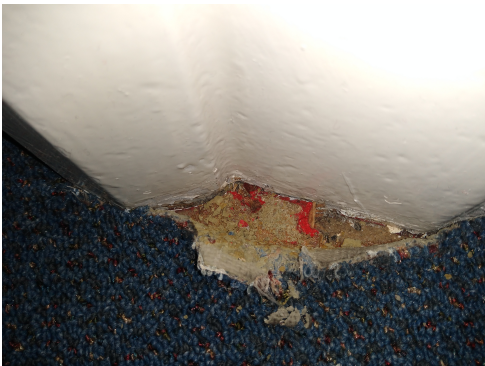
Item 18 Ref: 428662-5

The sub floor covering below carpet adjacent fireplace in 0.5/002 Deputy headteachers office does not contain asbestos.

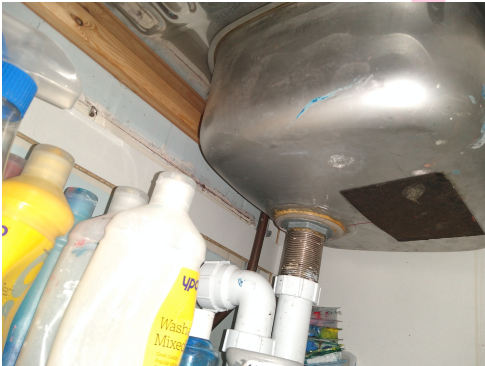
Item 20 Ref: As 428662-11

The sink pad in 1/003 cloakroom does not contain asbestos.

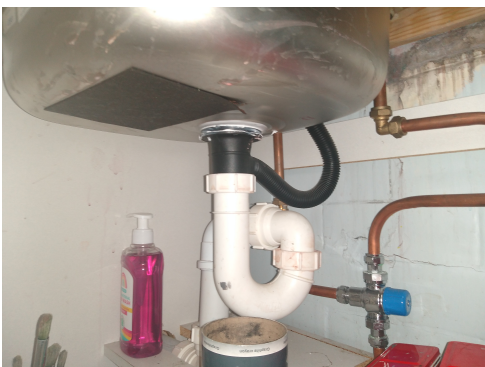
Item 21 Ref: As 428662-11

The sink pad in 1/005 cloakroom does not contain asbestos.

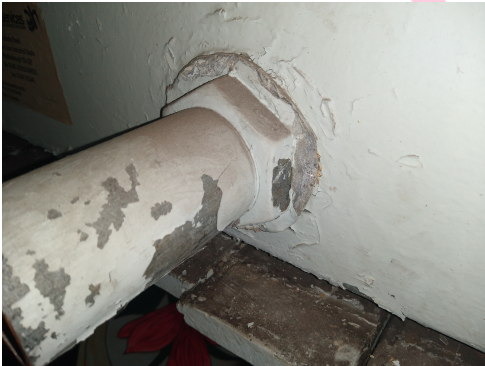
Item 23 Ref: 428662-12

The gasket to redundant water tanks in 1/006 toilet and cloakroom void above does not contain asbestos.

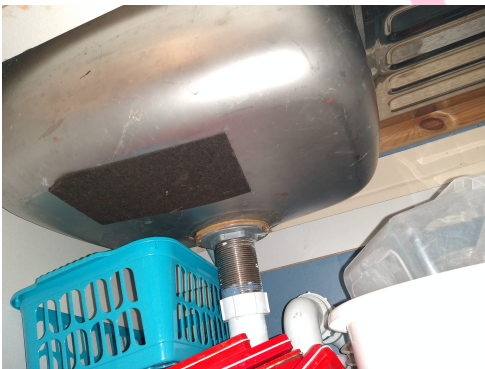
Item 26 Ref: As 428662-11

The sink pad in 1/017 classroom does not contain asbestos.

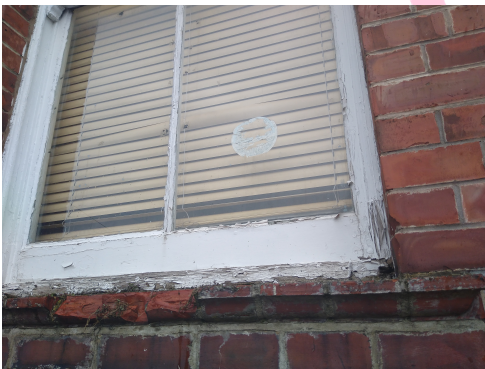
Item 29 Ref: 428662-18

The putty to window frames (External) does not contain asbestos.

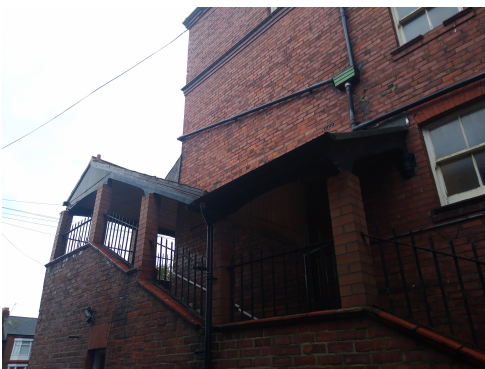
Item 30 Ref: 428662-19

The roof tile to low level roof to external stairs (External) does not contain asbestos.

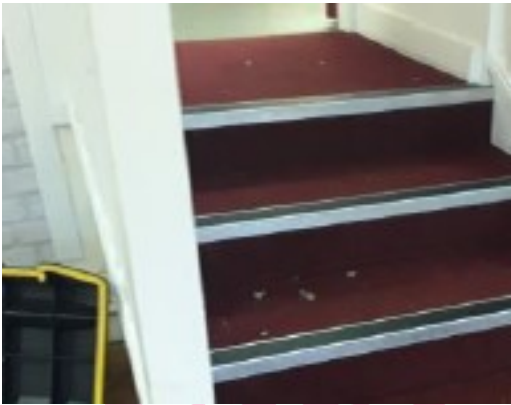
Item 32 Ref: 21-37468-2

The Floor – stair nosing (bitumen) in Area 1 (Classroom) does not contain asbestos.

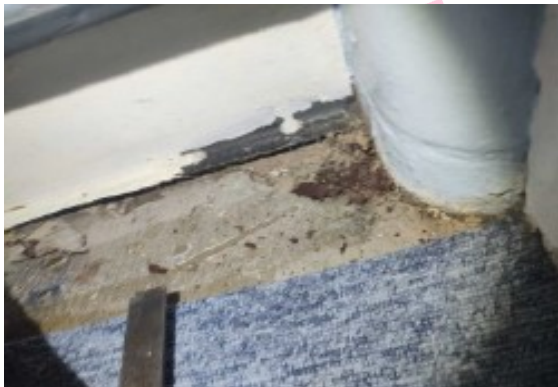
Item 35 Ref: 22-45856-8

The floor – asphalt in Area 0/0.004 Reception Store does not contain asbestos.

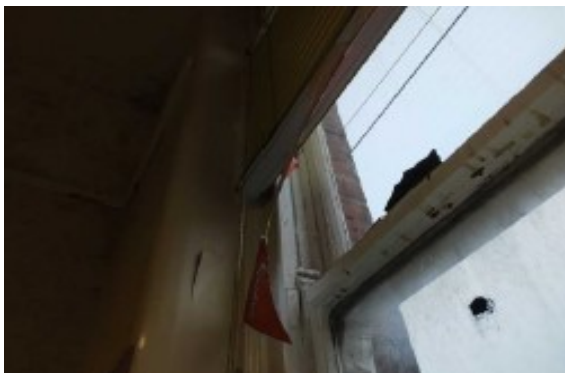
Item 36 Ref: 22-45856-10

The sash window cords in Area 0/0.007 Classroom 4CS does not contain asbestos.

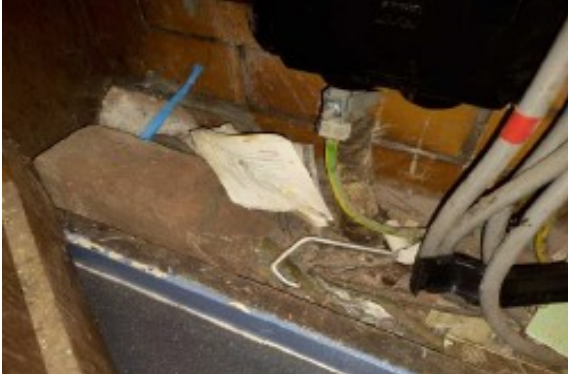
Item 37 Ref: 22-45856-12P

- (Item 37) **Presumed – Cable wrap within mains cupboard (Area 0/0.012 Circulation) – Very Low Risk**
- (Item 38) 22-45856-10 – Window, Sash window cords (Area 0/0.015 Classroom 4RH) – No Risk

The cable wrap within mains cupboard in Area 0/0.012 Circulation is presumed to contain asbestos.

Any change in its appearance should be recorded and passed to Property Services

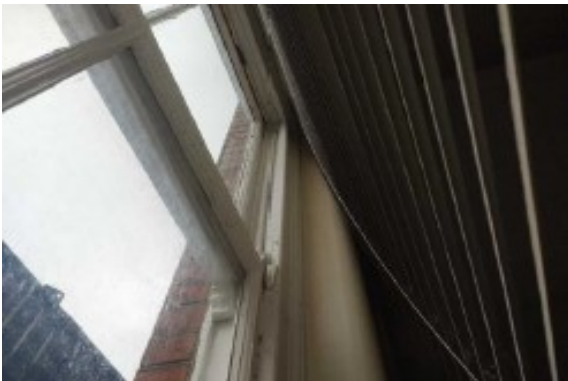
Item 38 Ref: 22-45856-10

The sash window cords in Area 0/0.015 Classroom 4RH does not contain asbestos.

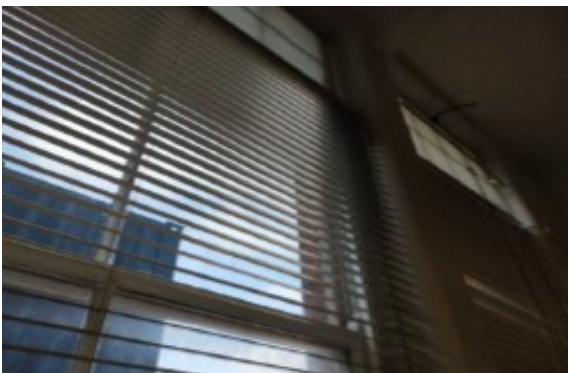
Item 39 Ref: 22-45856-10

The sash window cords in Area 0/0.016 Temporary catering room does not contain asbestos.

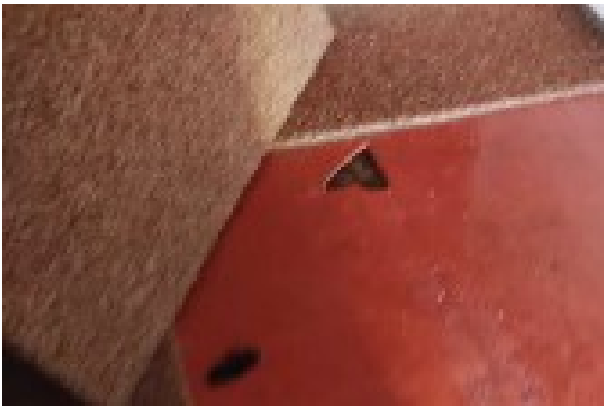
Item 45 Ref: 22-45856-14

The tiles & adhesive to the floor in Area 0/0.023 Circulation 2 does not contain asbestos.

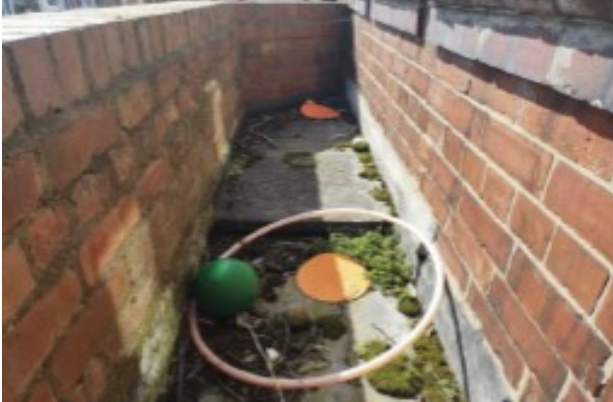
Item 46 Ref: 22-45856-23

The bitumen covering to flat roof by parapet wall to mezzanines (External) contains asbestos.

Removed January 2023

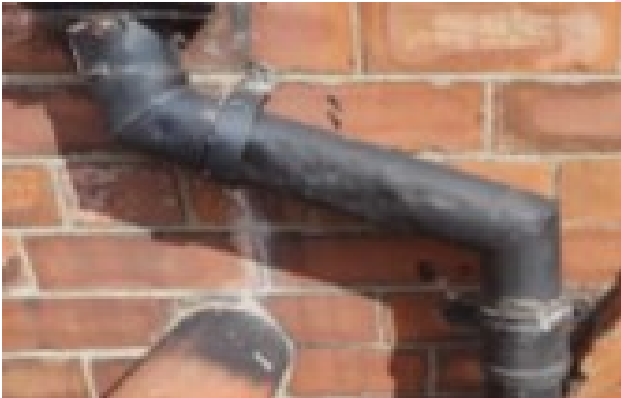
Item 47 Ref: 22-45856-29

The mastic infill to knuckles on metal down pipes (External) does not contain asbestos.

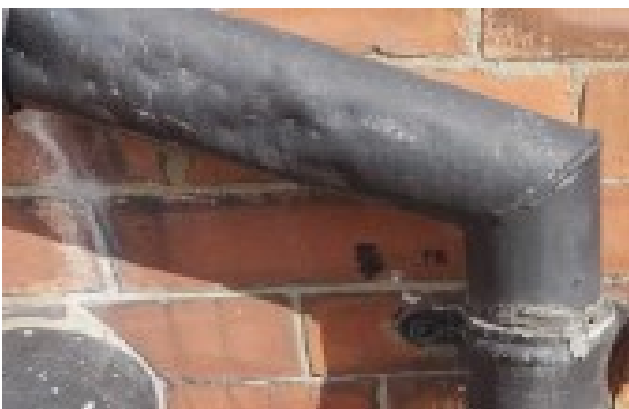
Item 48 Ref: 22-45856-29

The mastic infill to knuckles on metal down pipes (External) does not contain asbestos.

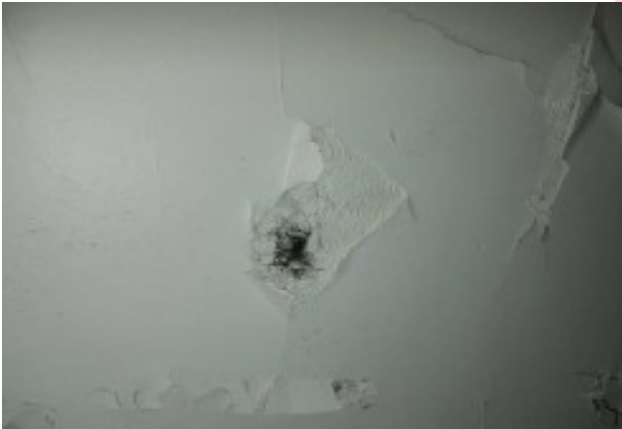
Item 50 Ref: 22-45856-2

The possible textured coating to lath and plaster ceiling in Area 1/1.002 WC does not contain asbestos.

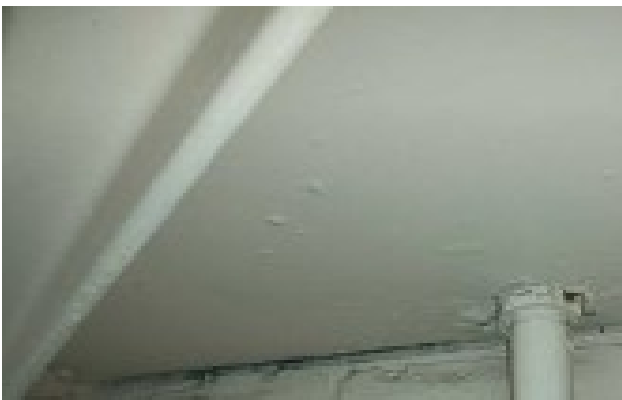
Item 51 Ref: 22-45856-3

The gaskets to redundant water tank in Area 1/1.002 WC contains asbestos.

Removed 2024

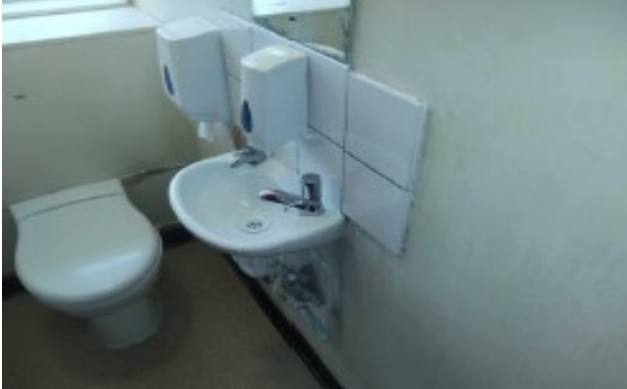
Item 52 Ref: 22-45856-7

The ceramic wall tiles adhesive in Area 1/1.002 WC does not contain asbestos.

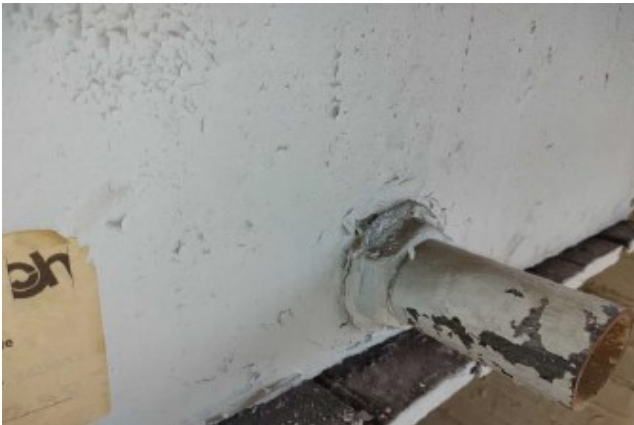
Item 53 Ref: 22-45856-5

The sealant to hex nuts on redundant water tanks in Area 1/1.006 WC does not contain asbestos.

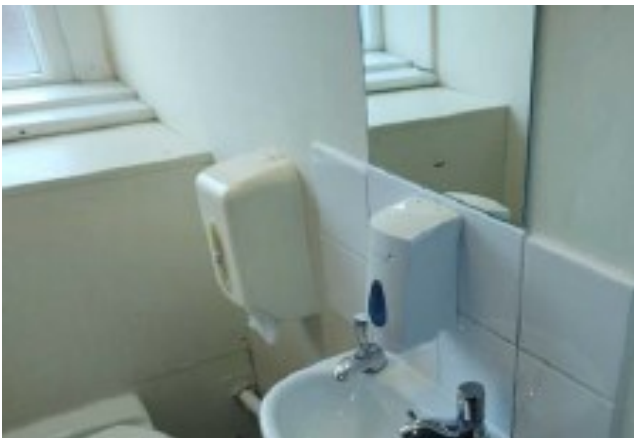
Item 54 Ref: 22-45856-7

The ceramic wall tiles adhesive in Area 1/1.006 WC does not contain asbestos.

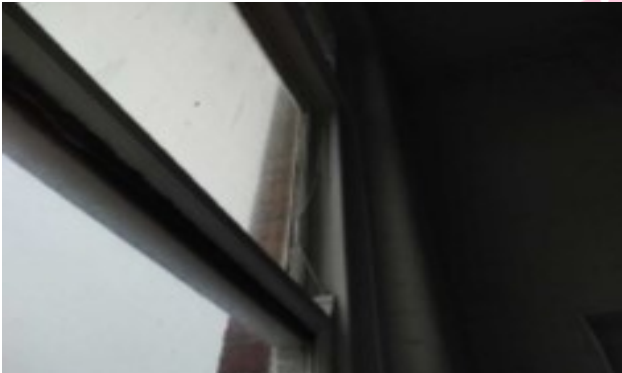
Item 56 Ref: 22-45856-10

The sash window cords in Area 1/1.012 Landing and Stairs does not contain asbestos.

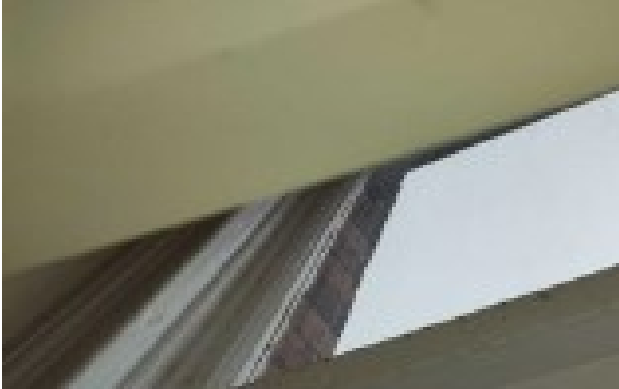
Item 58 Ref: 22-45856-10

The sash window cords in Area 1/1.015 Classroom 5CQ does not contain asbestos.

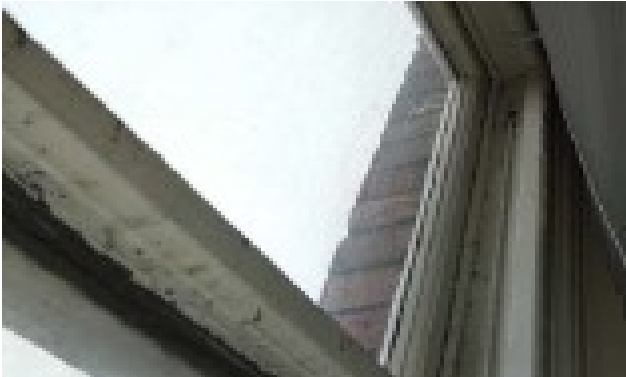
Item 59 Ref: 22-45856-10

The sash window cords in Area 1/1.017 Classroom 5TA does not contain asbestos.

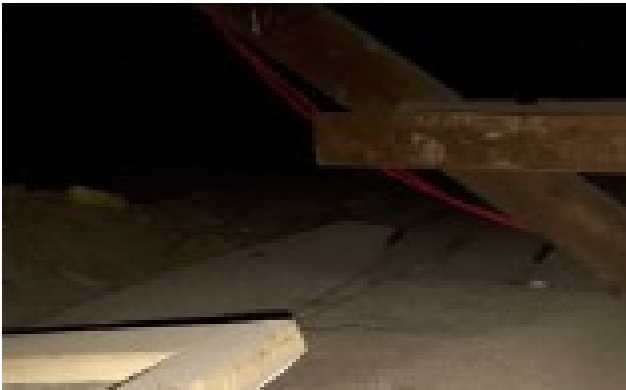
Item 60 Ref: 22-45856-30

The loose lying felt in Area 2/2.009 Loft 9 does not contain asbestos.

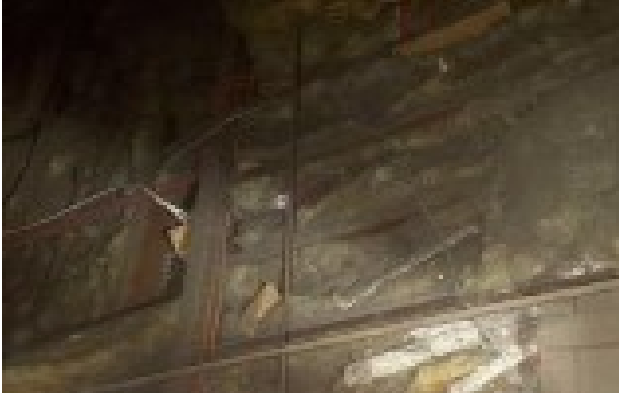
Item 61 Ref: 22-45856-6

The loose lying plaster and possible textured coating in Area 2/2.014 Loft 14 does not contain asbestos.

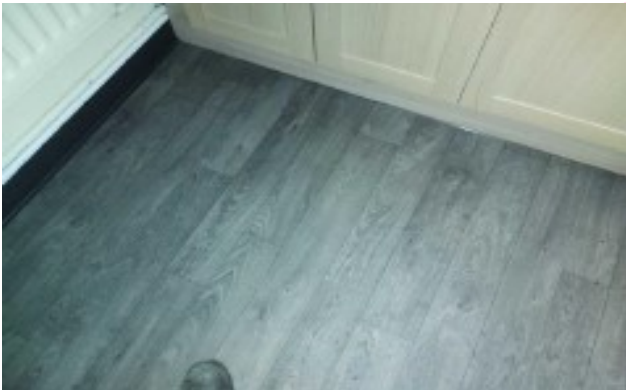
Item 62 Ref: 22-45856-16

The bitumen adhesive beneath modern vinyl flooring and screed in Area -1/-1.007 Kitchen does not contain asbestos.

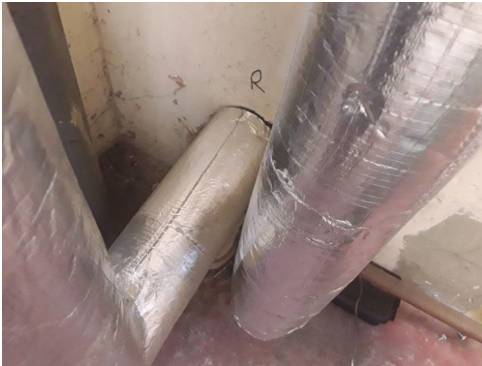
Item 65 Ref: NZ000385/004

The debris/residue to floor and unlagged pipes Ground Floor, Cupboard, G.001 contains asbestos.

Removed August 2023
