ASBESTOS SURVEY REPORT FOR NEW SILKSWORTH INFANTS SCHOOL, SUNDERLAND

Asbestos Register for

NEW SILKSWORTH INFANTS SCHOOL, SUNDERLAND

Date: 14th January 2025

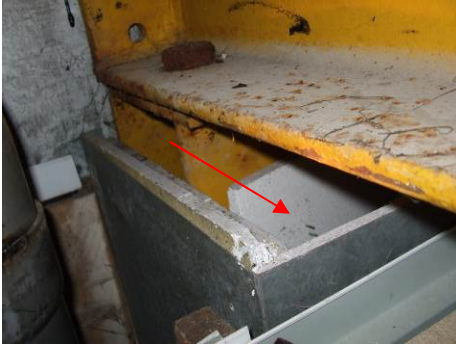
Item 1 Ref: Sample 01

The column cladding to the children's WC (Room 0/01) contains asbestos.

Any change in its appearance should be recorded and passed to Property Services.

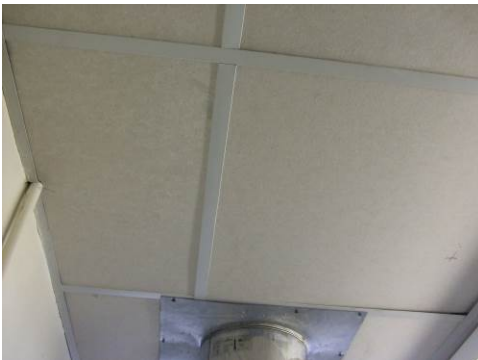
Item 2 - Ref: Sample 02

The ceiling to the boiler room (Rm 0/03) does not contain asbestos.

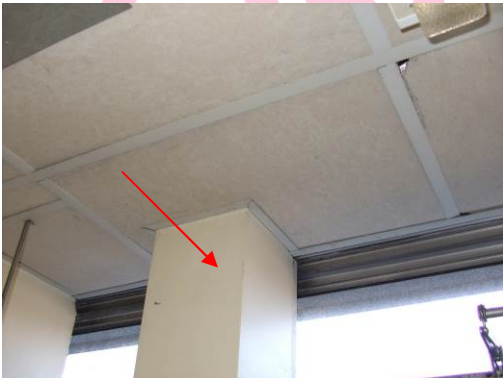
Item 3 – As Sample 01

The column cladding to the boiler room (Room 0/03) contains asbestos.

Any change in its appearance should be recorded and passed to Property Services.

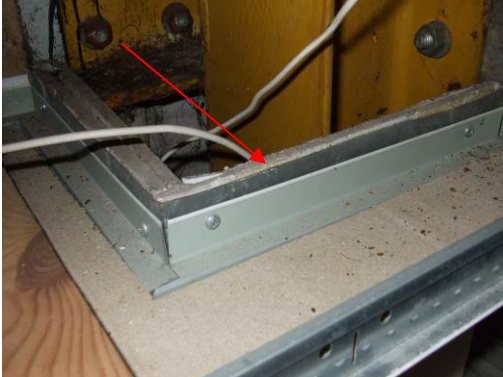
Item 4 – As Sample 01

The column cladding to the disabled WC (Room 0/04) contains asbestos.

Any change in its appearance should be recorded and passed to Property Services.

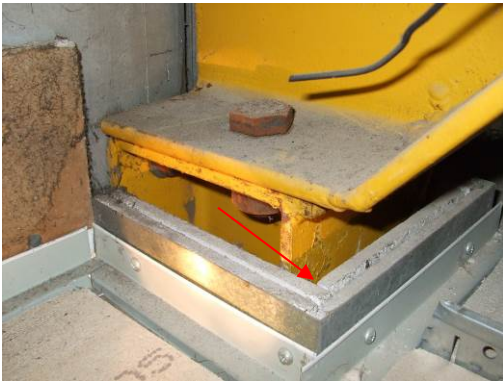
Item 5 - Ref: Sample 05

The column cladding to the kitchen area (Room 0/05) contains asbestos.

Any change in its appearance should be recorded and passed to Property Services.

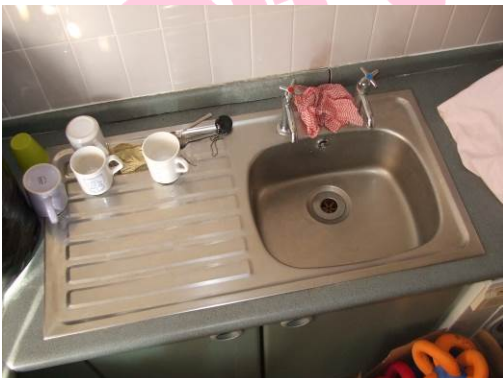
Item 6 - Ref: Sample 03

The sink pad to the kitchen area (Rm 0/05) does not contain asbestos.

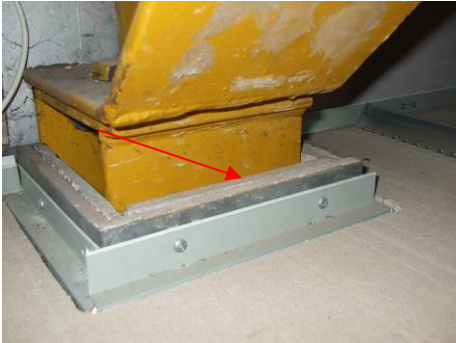
Item 7 – As Sample 01

The column cladding to the entrance lobby (Room 0/07) contains asbestos.

Any change in its appearance should be recorded and passed to Property Services.

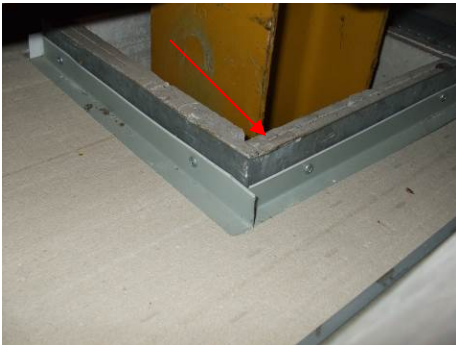
Item 8 – As Sample 01

The column cladding to the classroom (Room 0/08) contains asbestos.

Any change in its appearance should be recorded and passed to Property Services.

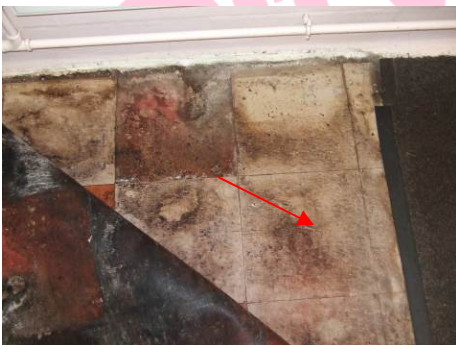
Item 9 - Ref: Sample 04

The floor covering to the WC/Office/Corridor (Rm 0/09) contained asbestos.

These were removed in April 2014.

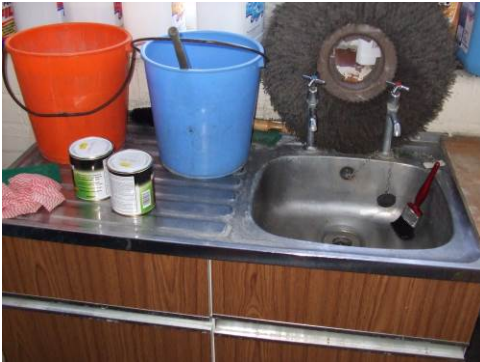
Item 10 - Ref: Sample 05

The sink pad to the WC/Office/Corridor (Rm 0/09) does not contain asbestos.

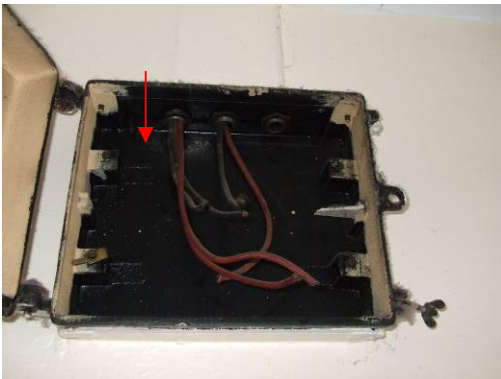
Item 11 - Ref: Sample 06

The panel inside the electrical box in the cloak room and WC (Rm 0/14) contains asbestos.

Any change in its appearance should be recorded and passed to Property Services.

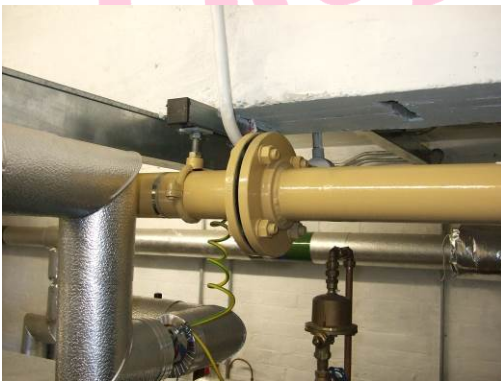
Item 12 - Ref: Sample 07

The gaskets to the pipework in the boiler room (Rm -1/01) do not contain asbestos.

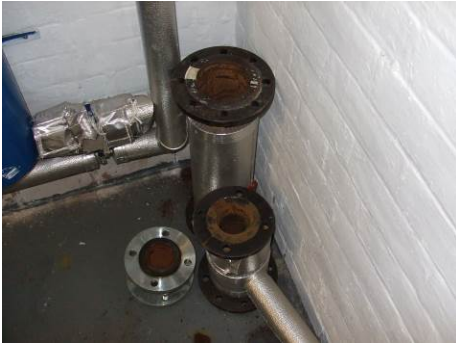
Item 13 - Ref: Sample 08

The gasket debris to the boiler room (Rm –1/01) does not contain asbestos.

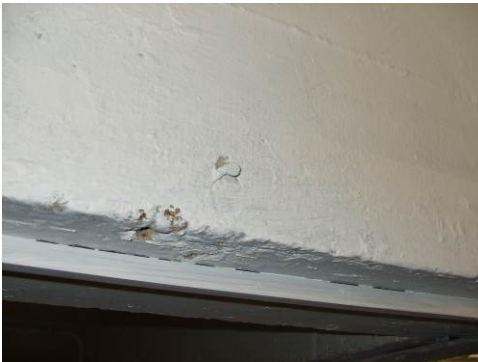
Item 14 - Ref: Sample 09

The debris to the walls and ceilings to the boiler room (Rm –1/01) does not contain asbestos.

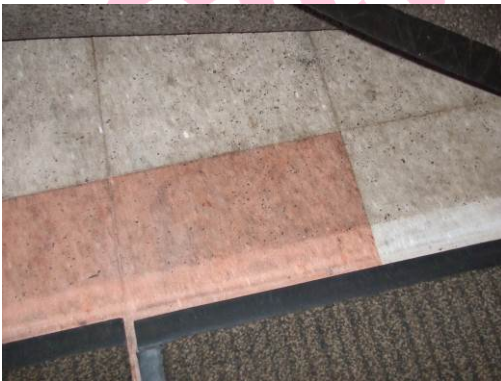
Item 15 - As Sample 04

The floor covering to the WC/Medical Room/Store (Rm 0/21) contained asbestos.

This was removed in April 2014.

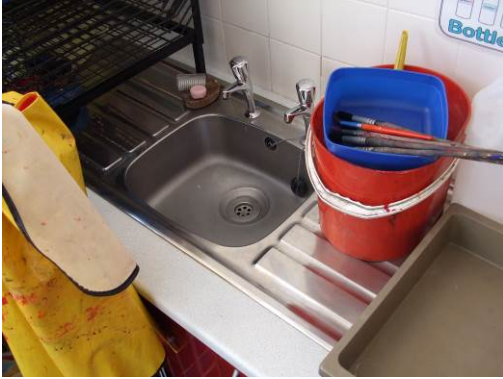
Item 16 – As Sample 03

The sink pad to class 3 (Rm 0/25) does not contain asbestos.

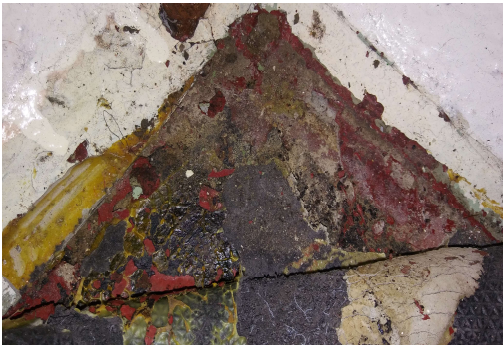
Item 17- 345159-8

The subfloor beneath chemical store and classroom in the corridor (Room 001) contains asbestos.

Any change in appearance should be reported to Property Services.

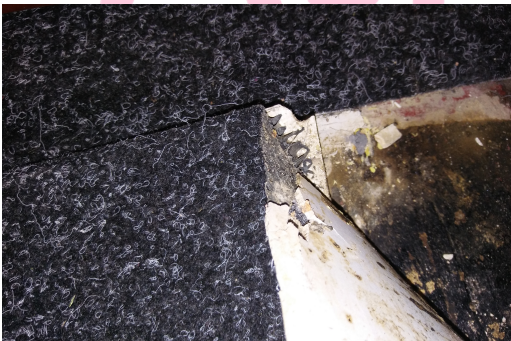
Item 18 – As 345159-7

The subfloor in the corridor (Room 010) does not contain asbestos.

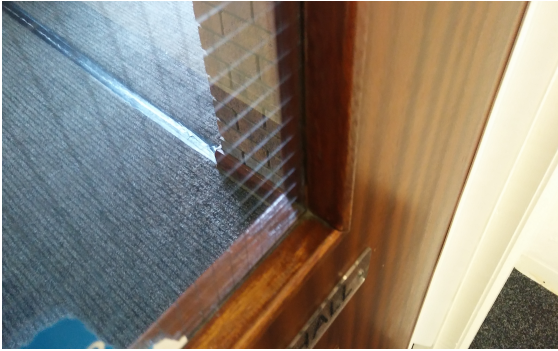
Item 19 – 345159-6

The brown sealant to the glazed panels within the door in the corridor (Room 010) does not contain asbestos.

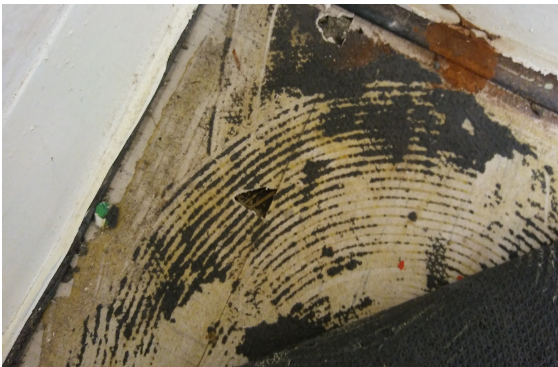
Item 20 - 345159-7

The subfloor in the corridor (Room 010) does not contain asbestos.

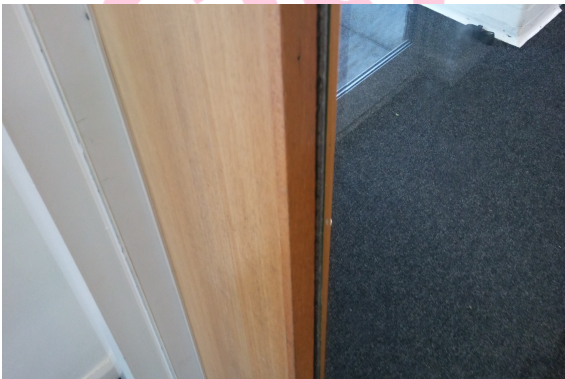
Item 21 – As 345159-1

The grey sealant to glazed panes within the door in the corridor (Room 023) does not contain asbestos.

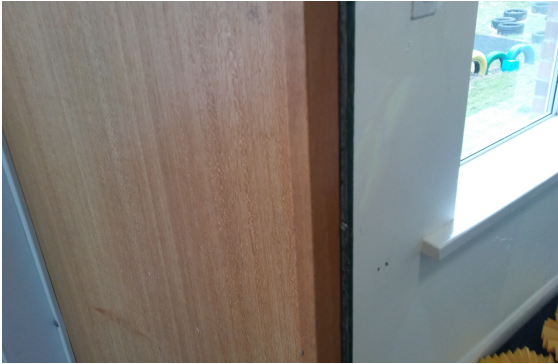
Item 22 – As 345159-1

The grey sealant to glazed panes within the door in the corridor (Room 026) does not contain asbestos.

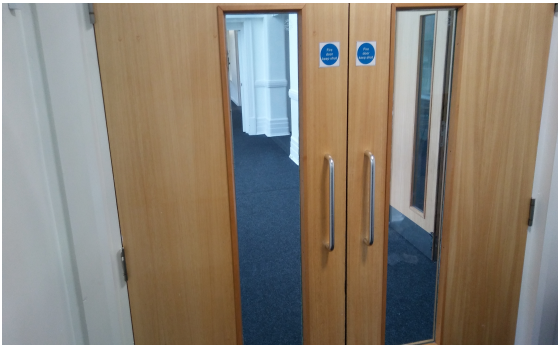
Item 23 – As 345159-1

The grey sealant to glazed panes within the door in the corridor (Room 029) does not contain asbestos.

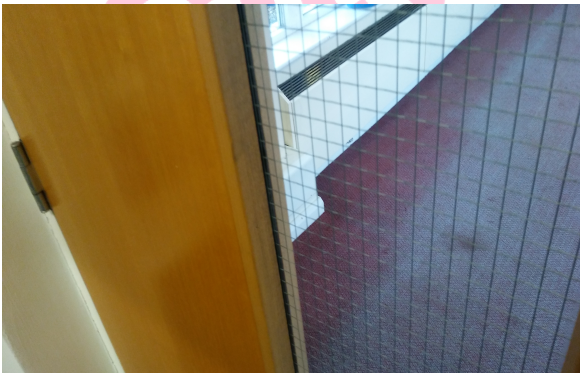
Item 24 – 345159-3

The black sealant to glazed panes within the door in the corridor (Room 029) does not contain asbestos.

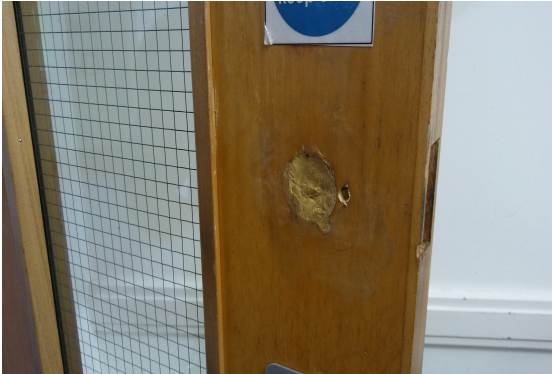
Item 25 – 345159-4

The packing to the door in the corridor (Room 029) does not contain asbestos.

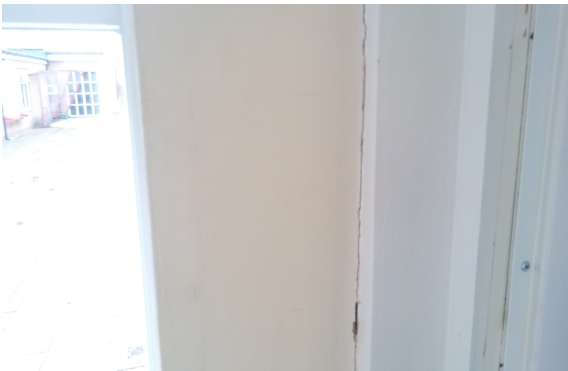
Item 26 – 345159-5

The sealant to the door frame in the corridor (Room 029) does not contain asbestos.

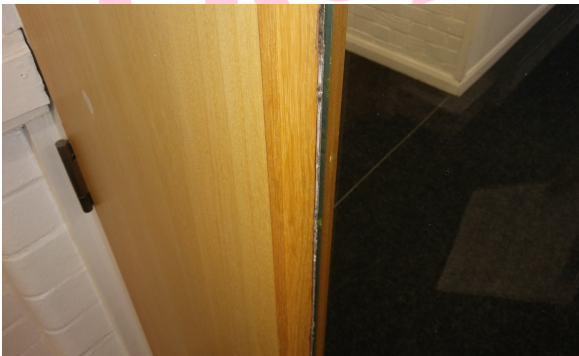
Item 27 – 345159-1

The grey sealant to glazed panes within the door in the corridor (Room 037) does not contain asbestos.

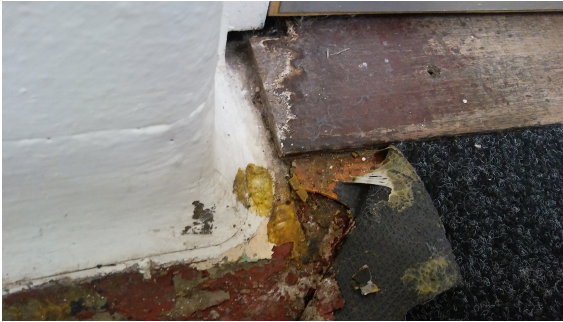
Item 28 – 345159-2

The remnant floor tile beneath wood sole plate to base of door in the corridor (Room 37) does contain asbestos.

Any change in appearance should be reported to Property Services.

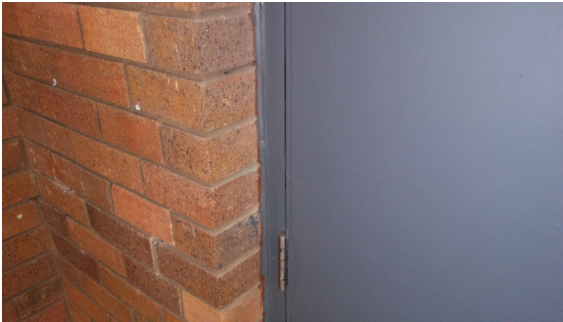
Item 29 – 345159-11

The sealant to the door frame in the link corridor (Room 049) does not contain asbestos.

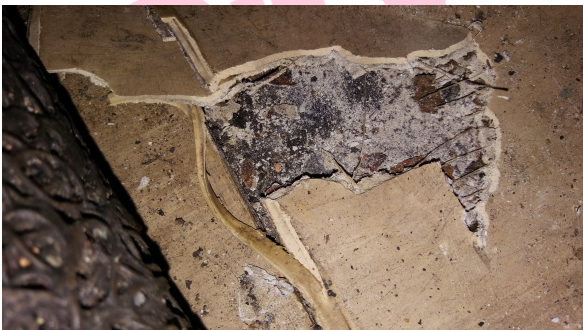
Item 30 – 345159-12

The black screed beneath modern linoleum in the link corridor (Room 047) does not contain asbestos.

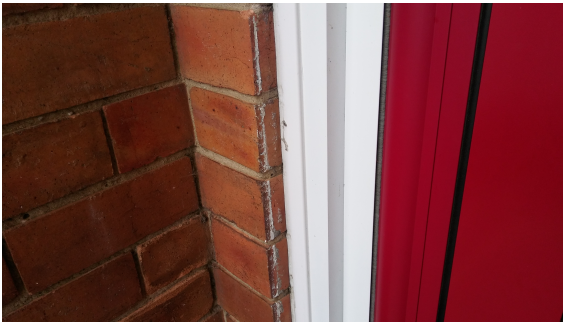
Item 31 – 345159-10

The remnant sealant to the walls externally does not contain asbestos.

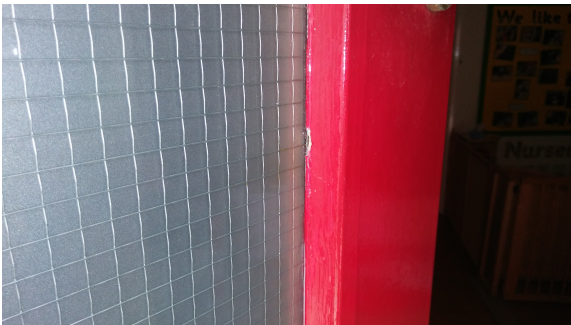
Item 32 – 345159-9

The sealant to the glazed panels within door to externals in the Classroom (Room 004) does not contain asbestos.

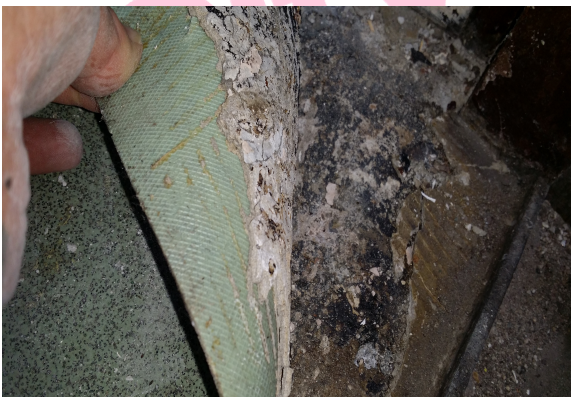
Item 33 – 118815-2

The screed to floor in the kitchen (Rm 0/05) does contain asbestos.

Any change in appearance should be reported to Property Services.

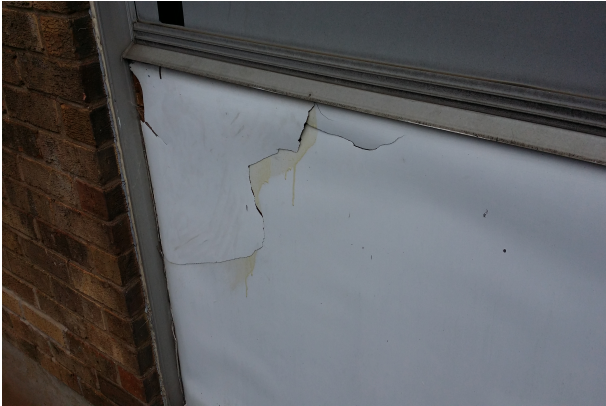
Item 34 – 118815-3

The covering board to wood panel (External) does not contain asbestos.

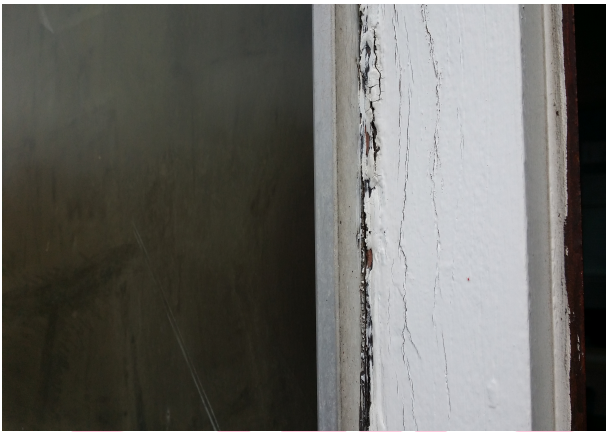
Item 35 – 118815-4

The sealant to framework (External) does not contain asbestos.

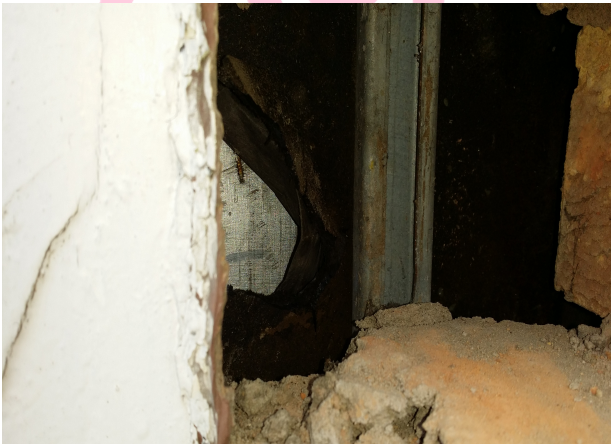
Item 36 – 118815-5

The damp proof course to wall cavity (External) does contain asbestos.

Any change in appearance should be reported to Property Services.

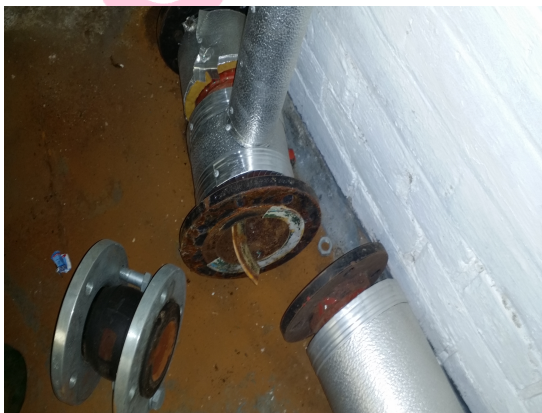
Item 39 – 106221-21

The loose lying gasket to redundant pipework (01/01 Boiler Room) does not contain asbestos.

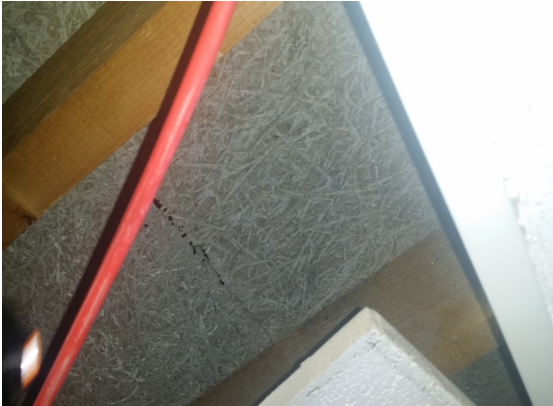
Item 40 – 106221-1

The underside of roof (0/01 Corridor – void above) does not contain asbestos.

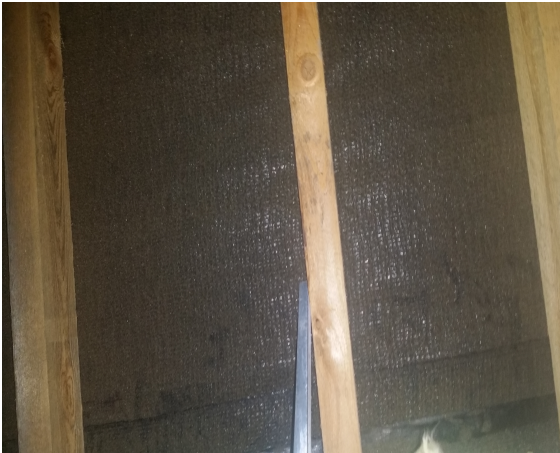
Item 41 – 106221-2

The underside of roof (0/03 Corridor – void above) does not contain asbestos.

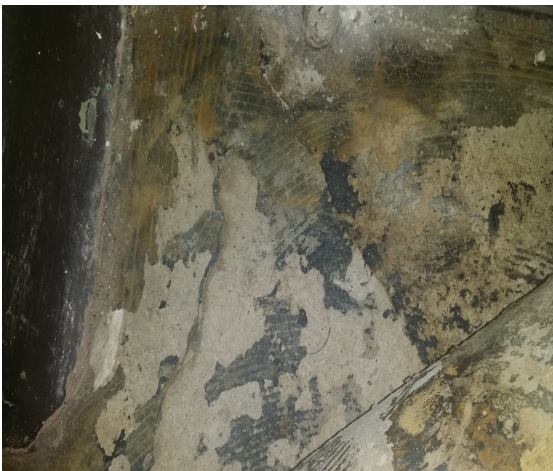
Item 42 – 106221-3

The adhesive backing to linoleum (0/04 Toilets) does contain asbestos.

This was removed 2018

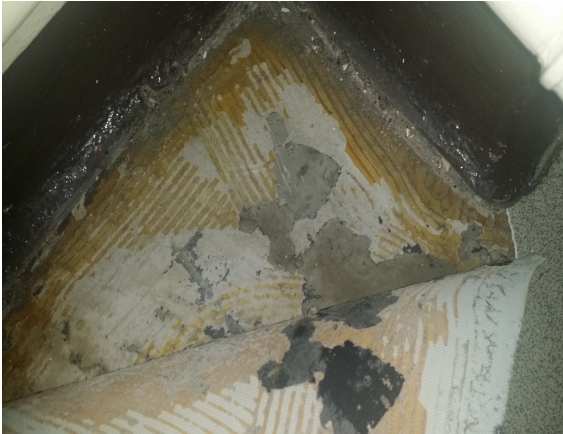
Item 43 – As 106221-3

The adhesive backing to linoleum (0/06 Toilets) does contain asbestos.

This was removed 2018

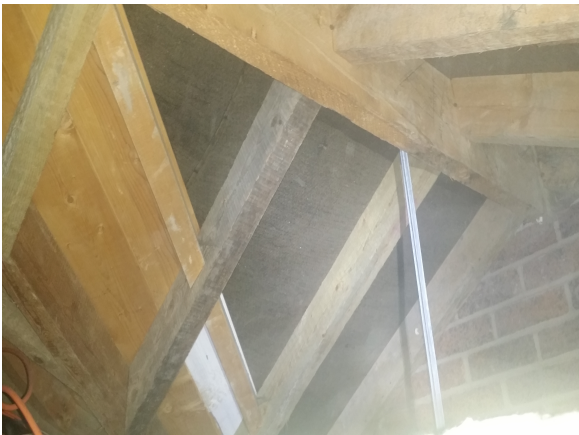
Item 44 – As 106221-2

The underside of roof (0/07 Corridor – void above) does not contain asbestos.

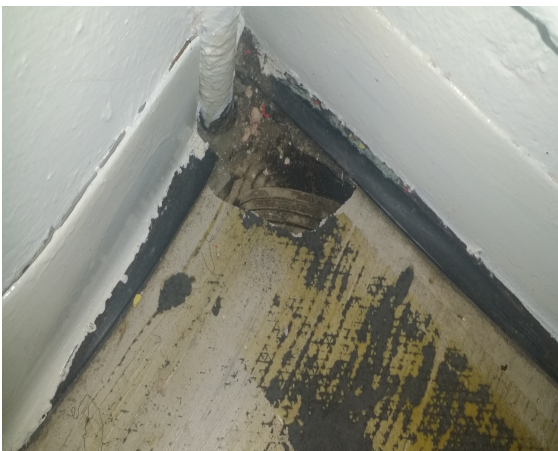
Item 45 – 106221-5

The adhesive backing to floor tiles (0/10 Corridor) does not contain asbestos.

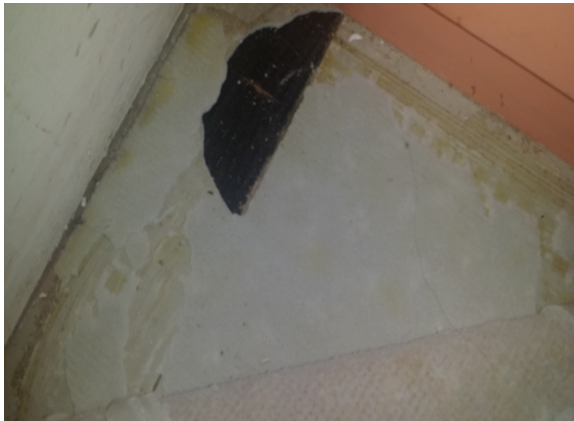
Item 46 – 106221-6

The subfloor (0/11 Female Toilets) does contain asbestos.

Any change in appearance should be reported to Property Services.

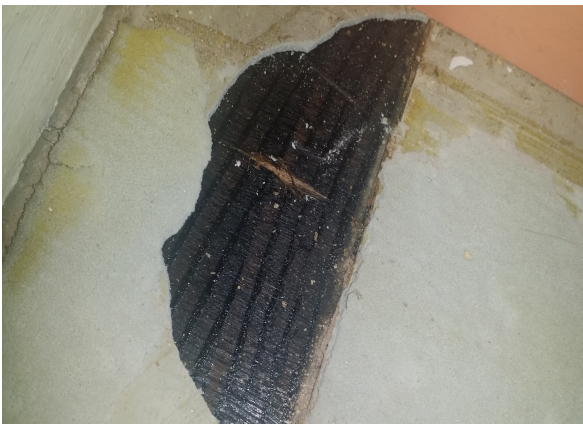
Item 47 – 106221-7

The adhesive backing to floor tiles (0/11 Female Toilets) does contain asbestos.

Any change in appearance should be reported to Property Services.

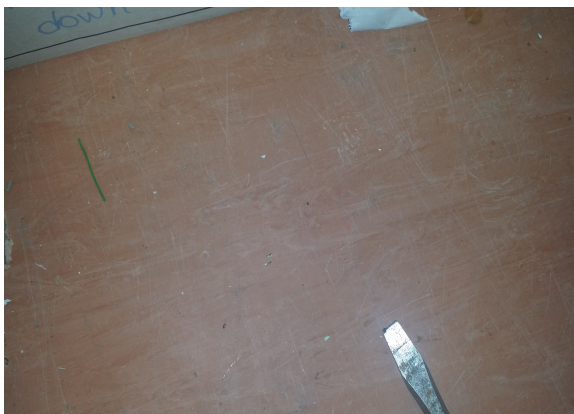
Item 48 – 106221-8

The floor covering (0/12 Store) does not contain asbestos.

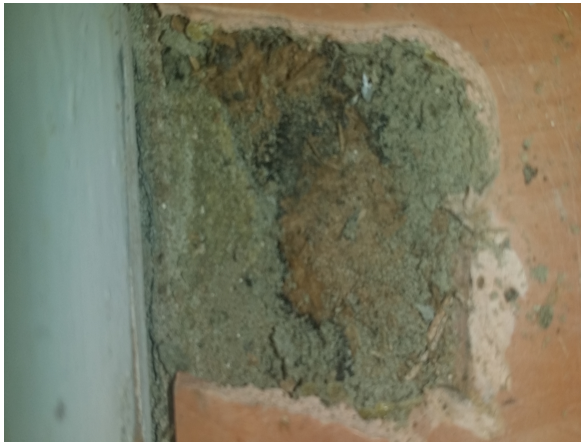
Item 49 – 106221-9

The adhesive backing to linoleum (0/12 Store) does not contain asbestos.

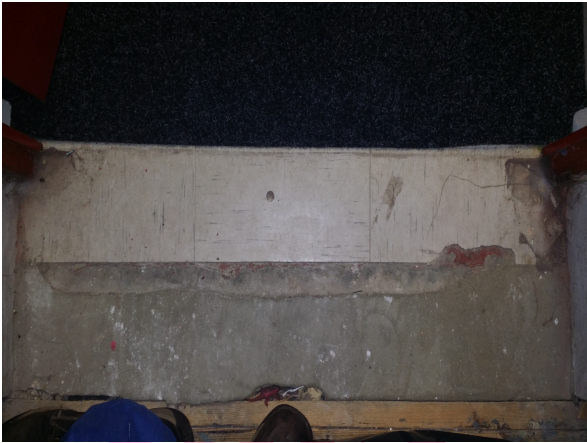
Item 50 – As 106221-6

The floor covering (0/13 Store) does contain asbestos.

Any change in appearance should be reported to Property Services.

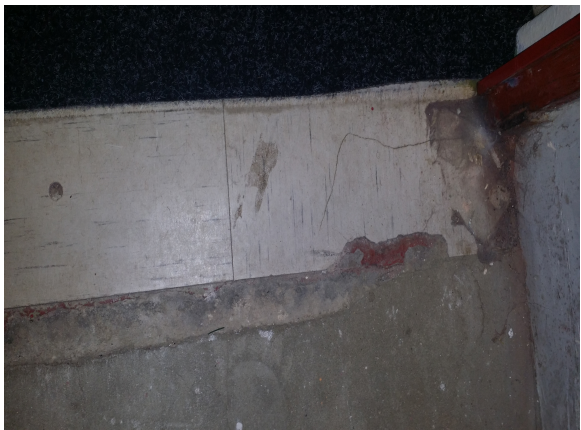
Item 51 – As 106221-9

The adhesive backing to linoleum (0/13 Store) does not contain asbestos.

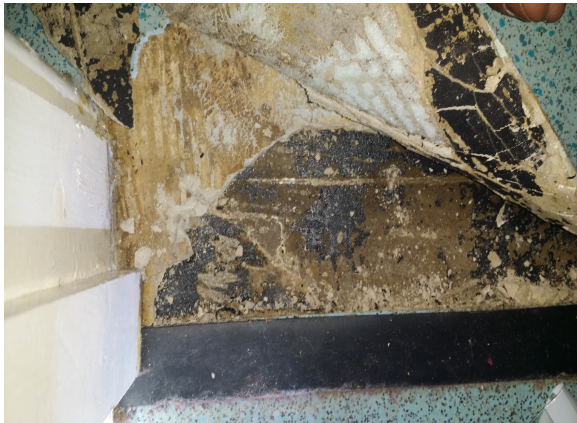
Item 52 – 106221-19

The subfloor (0/17 Disabled Toilet) does contain asbestos.

Any change in appearance should be reported to Property Services.

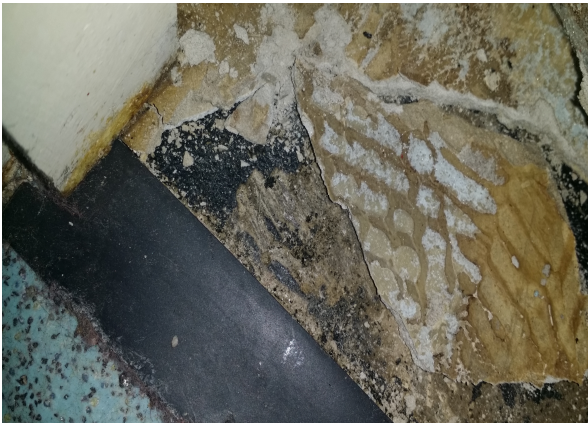
Item 53 – 106221-20

The adhesive backing to floor tiles (0/17 Disabled Toilet) does not contain asbestos.

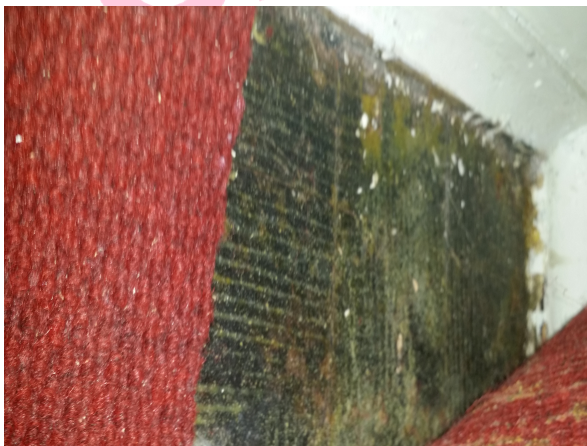
Item 54 – 106221-18

The adhesive backing to floor covering (0/21 Office) does not contain asbestos.

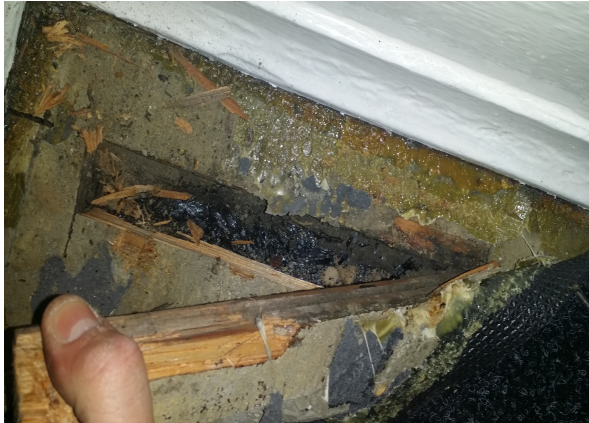
Item 55 – 106221-17

The adhesive backing to
parquet floor (0/26 Corridor)
does not contain asbestos.

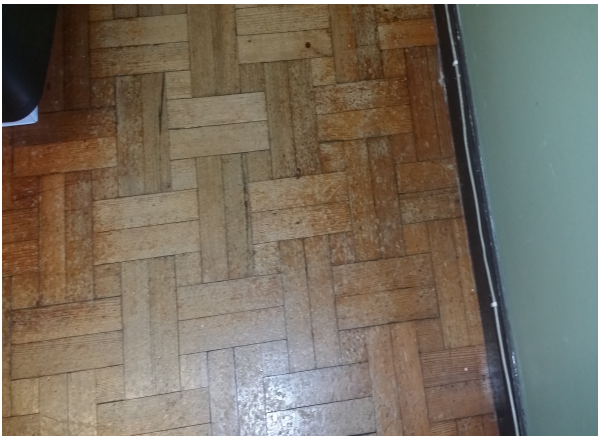
Item 56 – As 106221-17

The adhesive backing to
parquet floor (0/27
Photocopy Room) does not
contain asbestos.

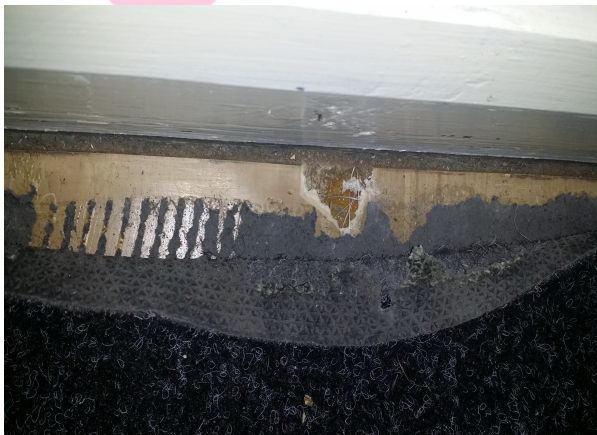
Item 57 – 106221-15

The subfloor (0/29 Corridor)
does not contain asbestos.

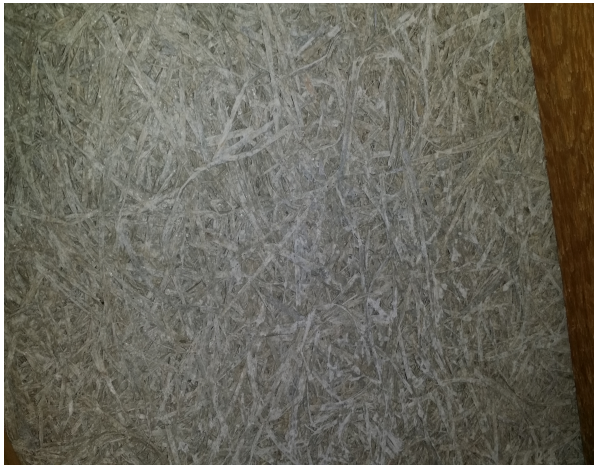
Item 58 – As 106221-1

The underside of roof (0/29 Corridor – void above) does not contain asbestos.

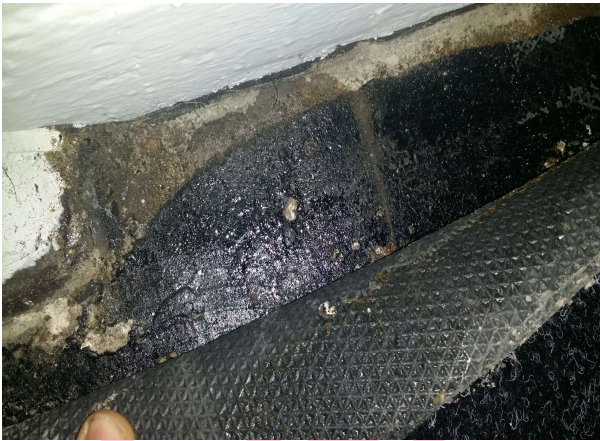
Item 59 – As 106221-16

The remnant adhesive backing to floor covering (0/32 Toilets) does contain asbestos.

Any change in appearance should be reported to Property Services.

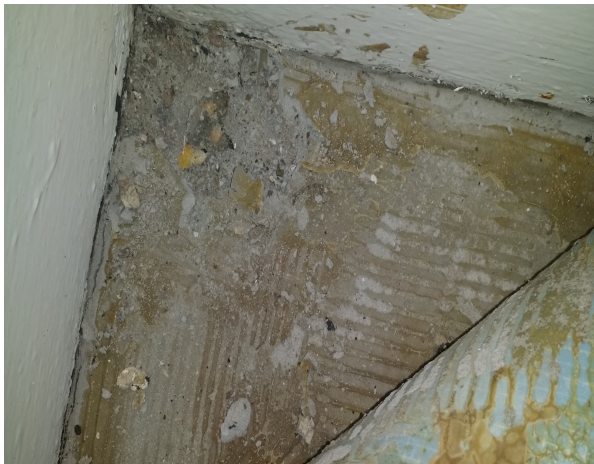
Item 60 – As 106221-16

The remnant adhesive backing to floor covering (0/35 Toilet lobby) does contain asbestos.

Any change in appearance should be reported to Property Services.

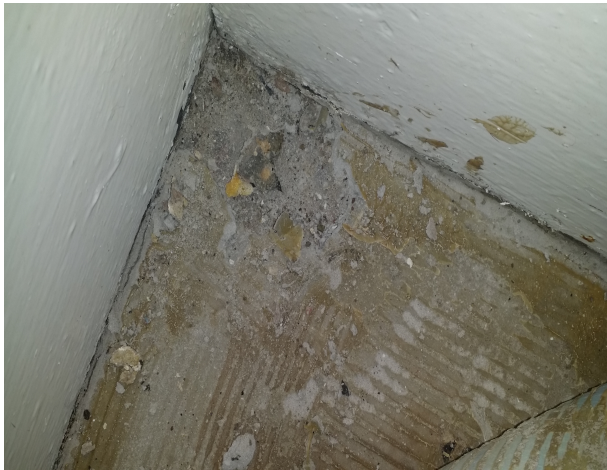
Item 61 – As 106221-16

The remnant adhesive backing to floor covering (0/36 Toilets) does contain asbestos.

Any change in appearance should be reported to Property Services.

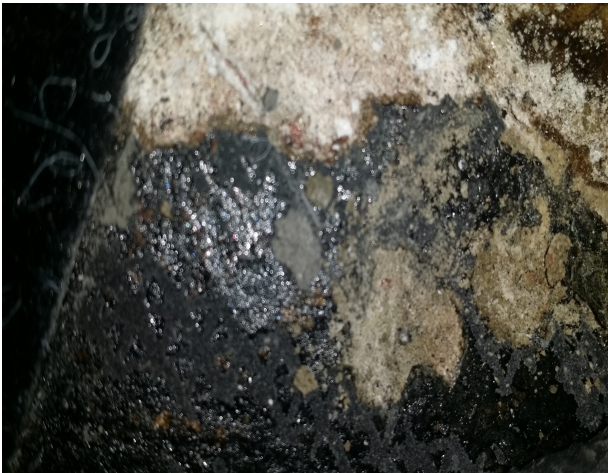
Item 62 – 106221-16

The remnant adhesive backing to floor covering (0/37 Corridor) does contain asbestos.

Any change in appearance should be reported to Property Services.

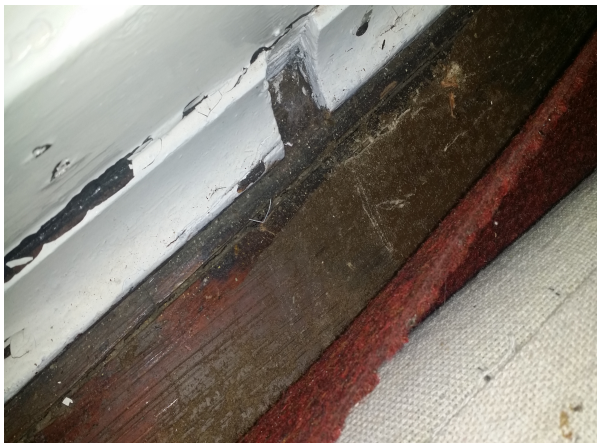
Item 63 – As 106221-14

The adhesive to back of parquet flooring (0/38 Creche) does not contain asbestos.

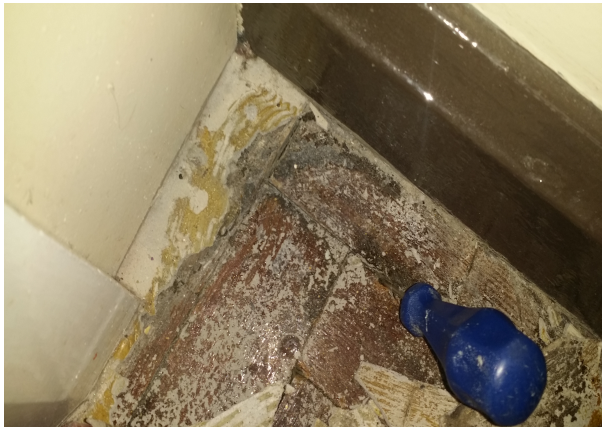
Item 64 – 106221-14

The adhesive to back of
parquet flooring (0/39 Soft
Play) does not contain
asbestos.

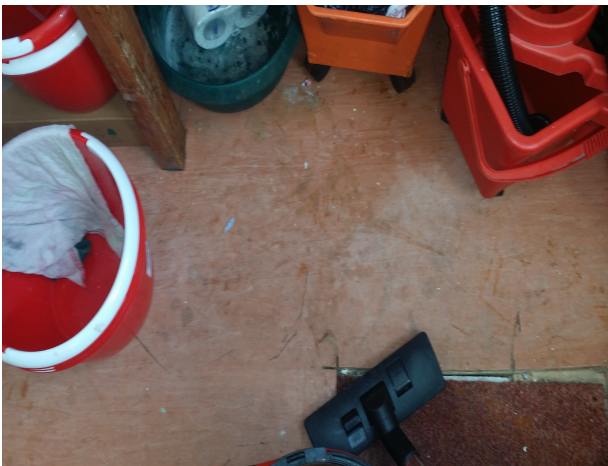
Item 65 – As 106221-8

The floor covering (0/40
Store) does not contain
asbestos.

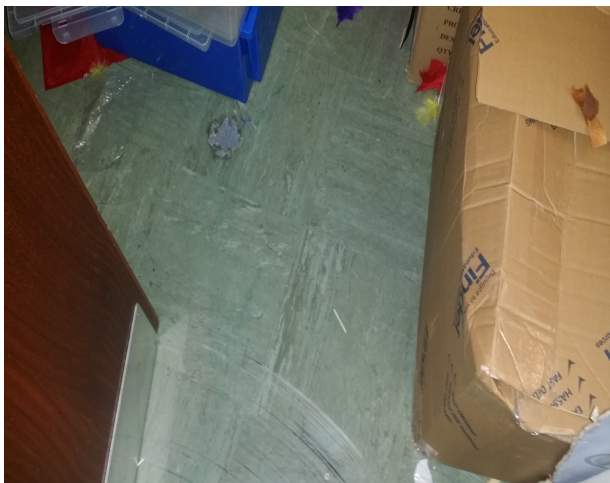
Item 66 – 106221-12

The floor covering (0/41
Store) does not contain
asbestos.

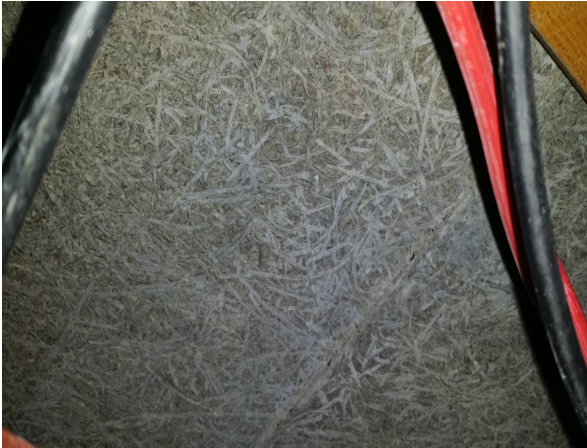
Item 67 – As 106221-1

The underside of roof (0/48 Corridor – void above) does not contain asbestos.
