ASBESTOS SURVEY REPORT FOR NEW SILKSWORTH INFANTS SCHOOL, SUNDERLAND

*Control of Asbestos
Regulations 2012*

NEW SILKSWORTH INFANTS SCHOOL, SUNDERLAND

Date: 25th September 2025

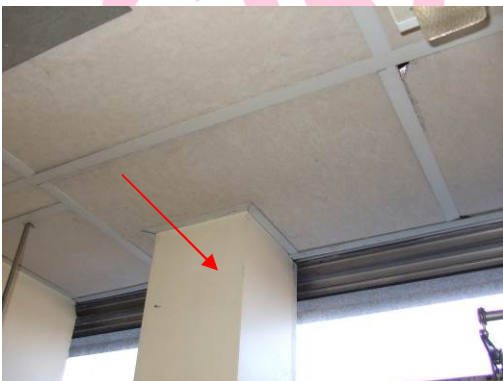
Item 3 – As Sample 01

The column cladding to the boiler room (Room 0/03) contains asbestos.

Any change in its appearance should be recorded and passed to Property Services.

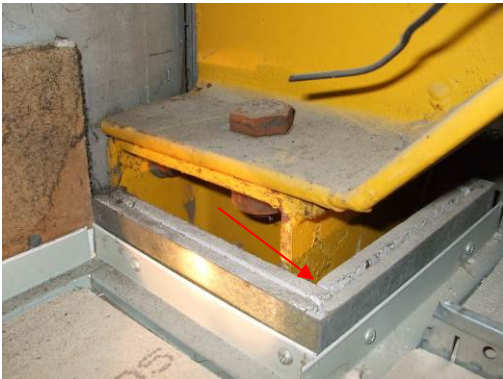
Item 5 - Ref: Sample 05

The column cladding to the kitchen area (Room 0/05) contains asbestos.

Any change in its appearance should be recorded and passed to Property Services.

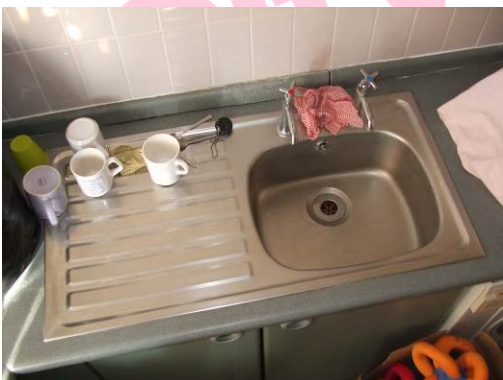
Item 6 - Ref: Sample 03

The sink pad to the kitchen area (Rm 0/05) does not contain asbestos.

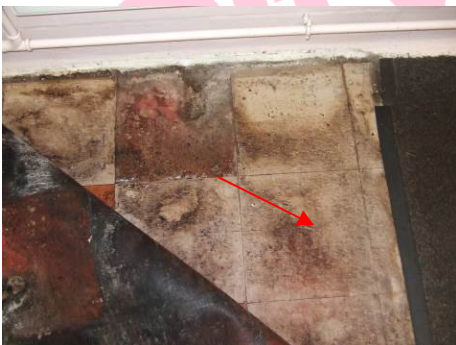
Item 9 - Ref: Sample 04

The floor covering to the WC/Office/Corridor (Rm 0/09) contained asbestos.

These were removed in April 2014.

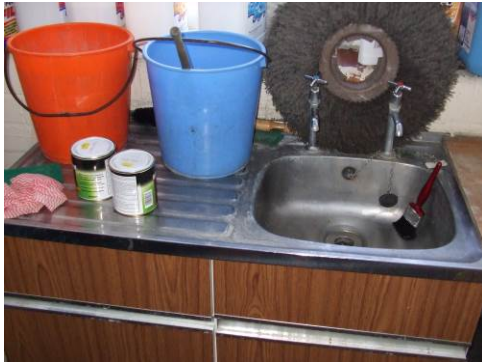
Item 10 - Ref: Sample 05

The sink pad to the WC/Office/Corridor (Rm 0/09) does not contain asbestos.

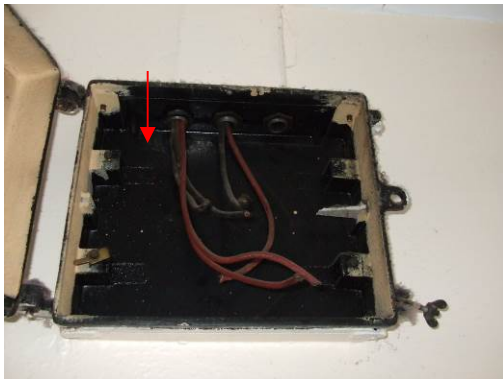
Item 11 - Ref: Sample 06

The panel inside the electrical box in the cloak room and WC (Rm 0/14) contains asbestos.

Any change in its appearance should be recorded and passed to Property Services.

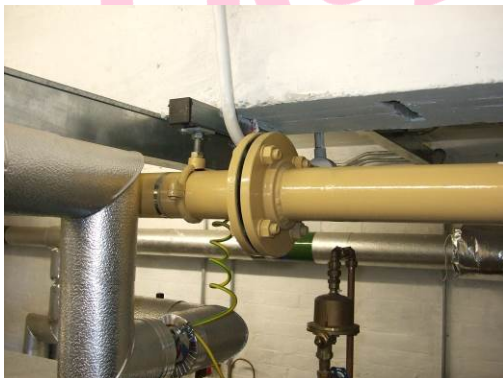
Item 12 - Ref: Sample 07

The gaskets to the pipework in the boiler room (Rm -1/01) do not contain asbestos.

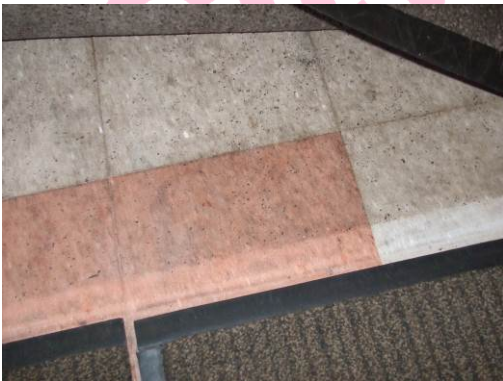
Item 15 - As Sample 04

The floor covering to the WC/Medical Room/Store (Rm 0/21) contained asbestos.

This was removed in April 2014.

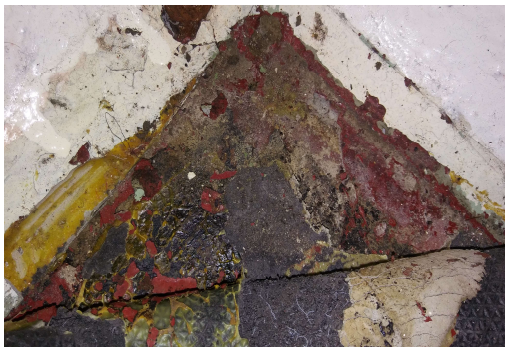
Item 17- 345159-8

The subfloor beneath chemical store and classroom in the corridor (Room 001) contains asbestos.

Any change in appearance should be reported to Property Services.

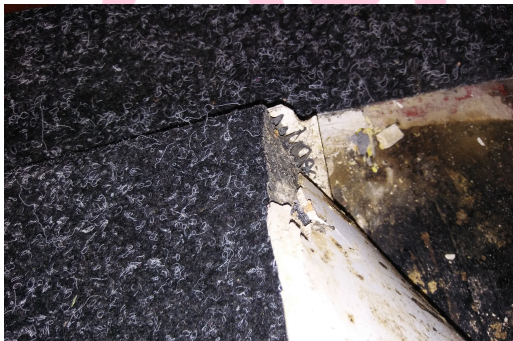
Item 18 – As 345159-7

The subfloor in the corridor (Room 010) does not contain asbestos.

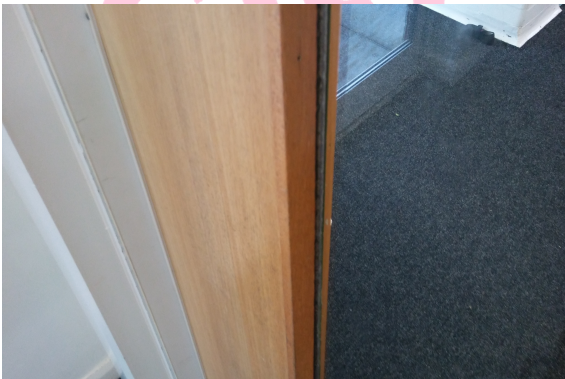
Item 21 – As 345159-1

The grey sealant to glazed panes within the door in the corridor (Room 023) does not contain asbestos.

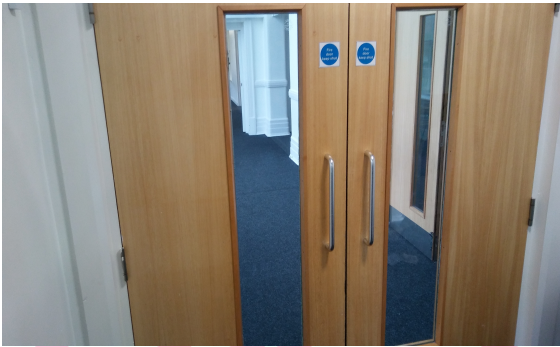
Item 23 – As 345159-1

The grey sealant to glazed panes within the door in the corridor (Room 029) does not contain asbestos.

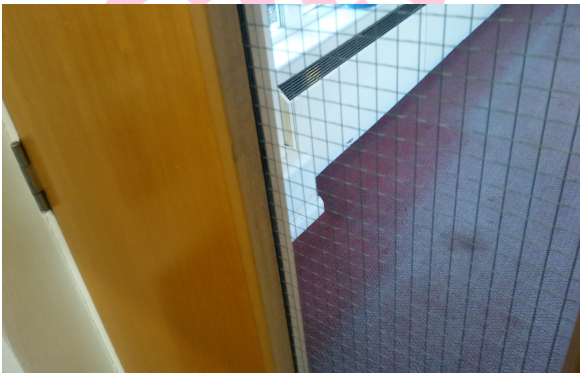
Item 24 – 345159-3

The black sealant to glazed panes within the door in the corridor (Room 029) does not contain asbestos.

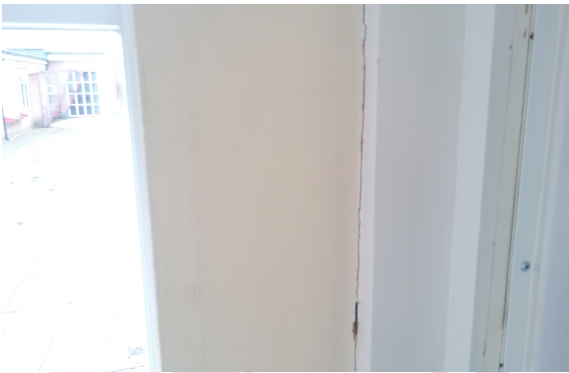
Item 26 – 345159-5

The sealant to the door frame in the corridor (Room 029) does not contain asbestos.

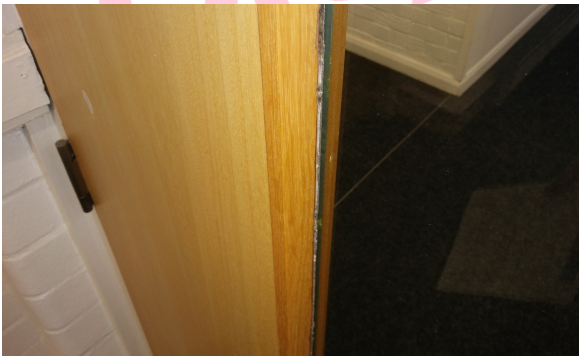
Item 27 – 345159-1

The grey sealant to glazed panes within the door in the corridor (Room 037) does not contain asbestos.

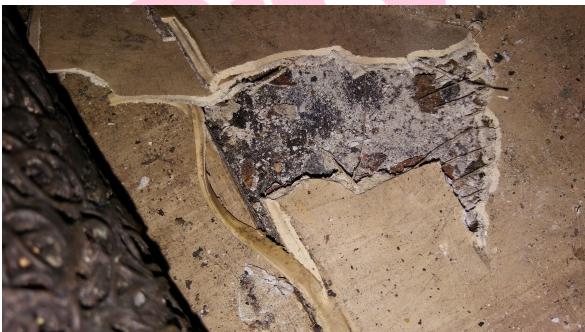
Item 30 – 345159-12

The black screed beneath modern linoleum in the link corridor (Room 047) does not contain asbestos.

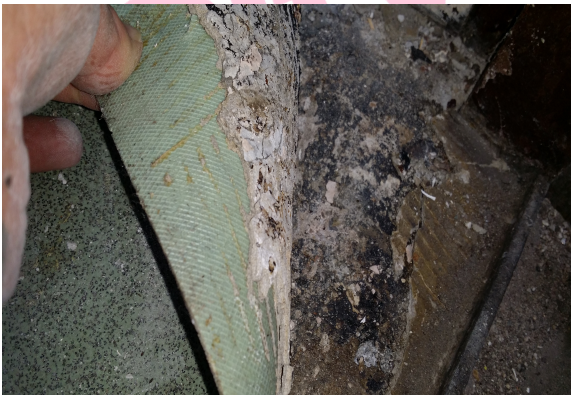
Item 33 – 118815-2

The screed to floor in the kitchen (Rm 0/05) does contain asbestos.

Any change in appearance should be reported to Property Services.

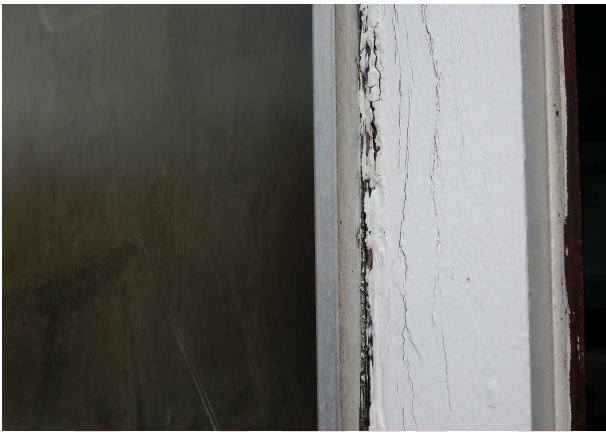
Item 35 – 118815-4

The sealant to framework (External) does not contain asbestos.

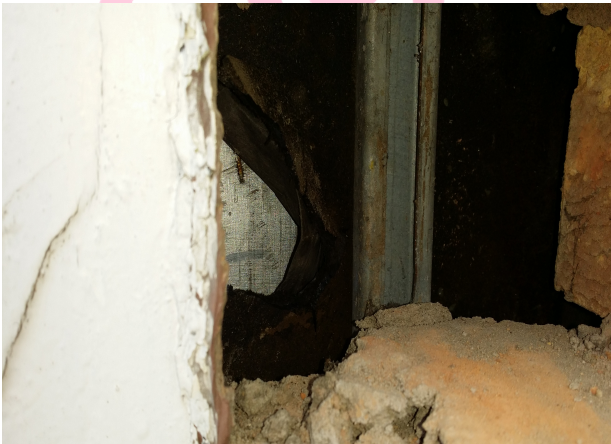
Item 36 – 118815-5

The damp proof course to wall cavity (External) does contain asbestos.

Any change in appearance should be reported to Property Services.

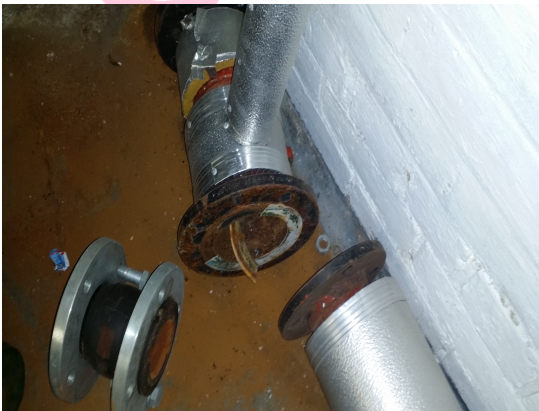
Item 39 – 106221-21

The loose lying gasket to redundant pipework (01/01 Boiler Room) does not contain asbestos.

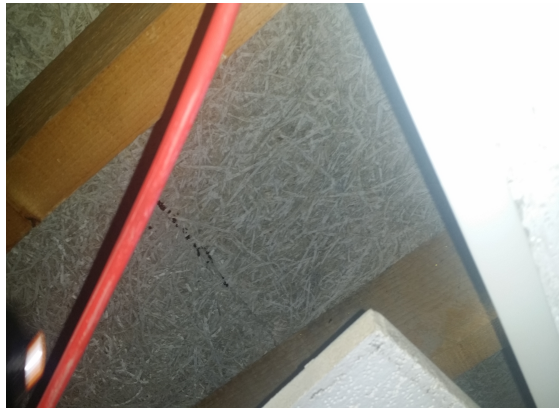
Item 40 – 106221-1

The underside of roof (0/01 Corridor – void above) does not contain asbestos.

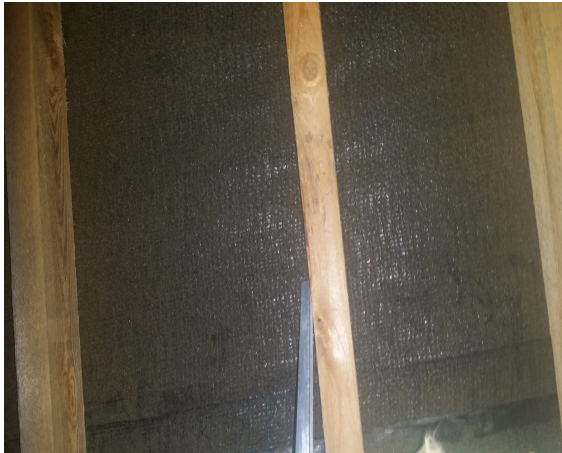
Item 41 – 106221-2

The underside of roof (0/03 Corridor – void above) does not contain asbestos.

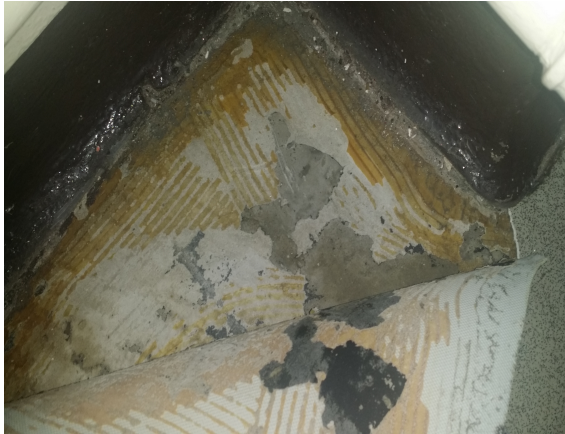
Item 43 – As 106221-3

The adhesive backing to linoleum (0/06 Toilets) does contain asbestos.

This was removed 2018

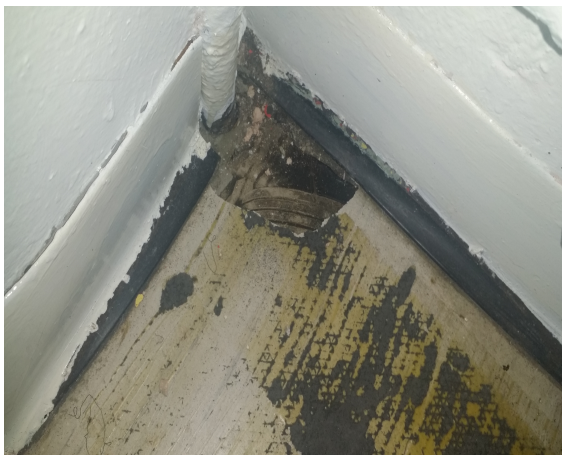
Item 45 – 106221-5

The adhesive backing to floor tiles (0/10 Corridor) does not contain asbestos.

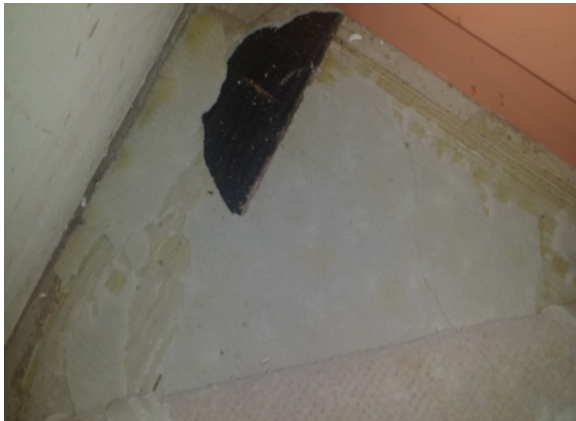
Item 46 – 106221-6

The subfloor (0/11 Female Toilets) does contain asbestos.

Any change in appearance should be reported to Property Services.

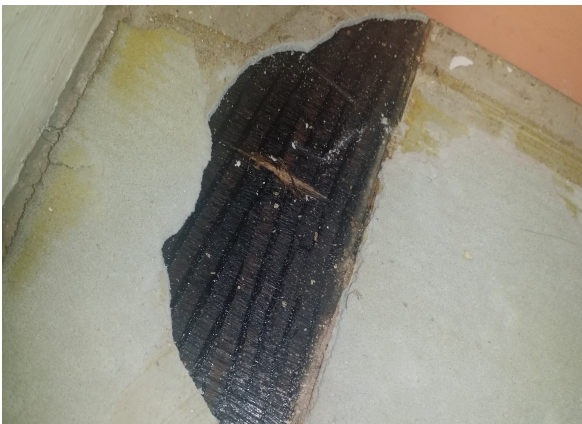
Item 47 – 106221-7

The adhesive backing to floor tiles (0/11 Female Toilets) does contain asbestos.

Any change in appearance should be reported to Property Services.

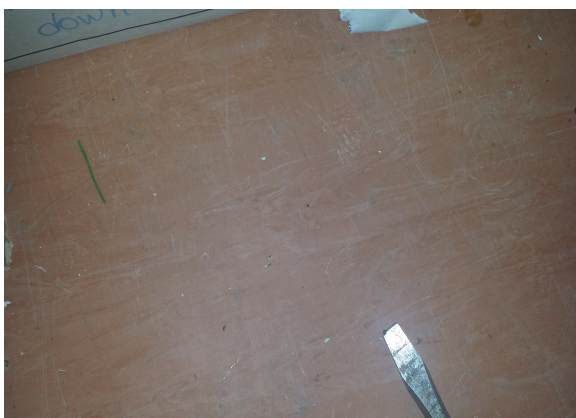
Item 48 – 106221-8

The floor covering (0/12 Store) does not contain asbestos.

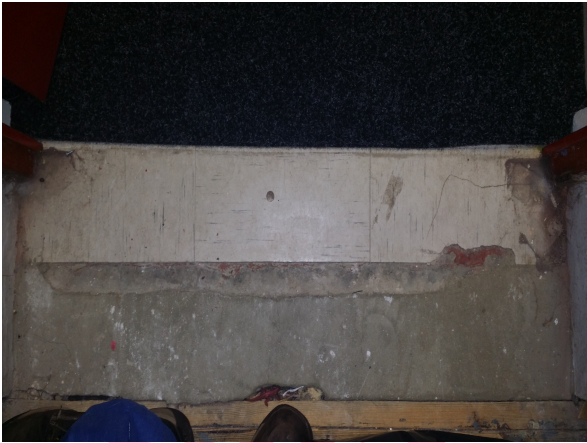
Item 50 – As 106221-6

The floor covering (0/13 Store) does contain asbestos.

Any change in appearance should be reported to Property Services.

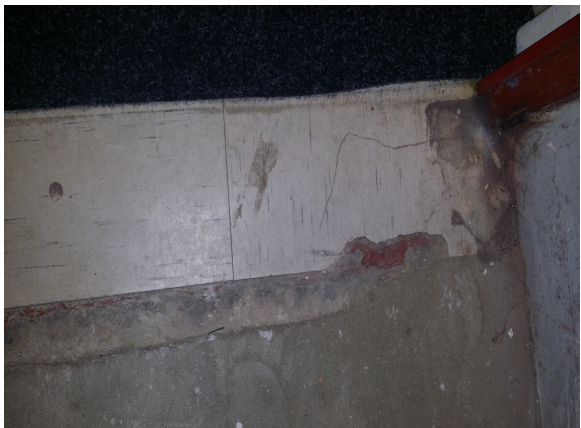
Item 51 – As 106221-9

The adhesive backing to linoleum (0/13 Store) does not contain asbestos.

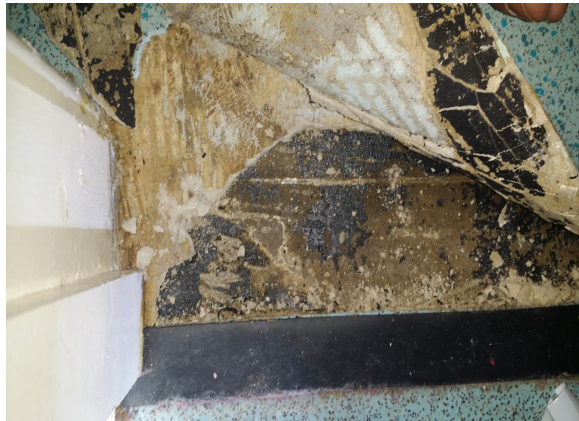
Item 52 – 106221-19

The subfloor (0/17 Disabled Toilet) does contain asbestos.

Any change in appearance should be reported to Property Services.

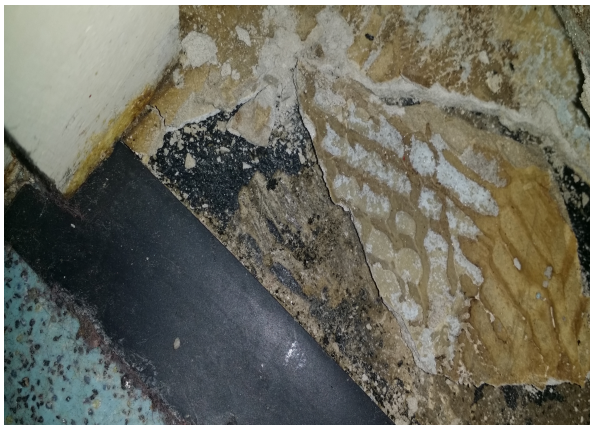
Item 53 – 106221-20

The adhesive backing to floor tiles (0/17 Disabled Toilet) does not contain asbestos.

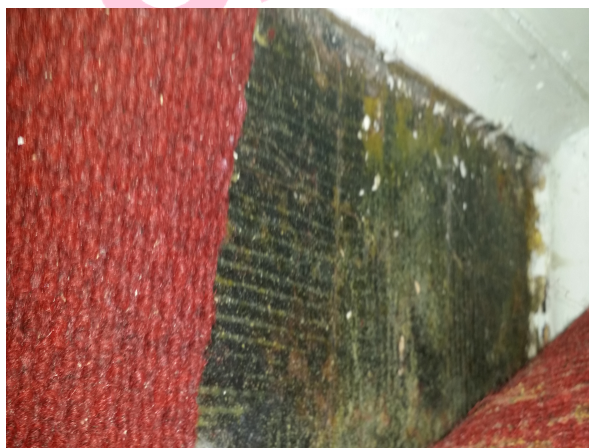
Item 54 – 106221-18

The adhesive backing to floor covering (0/21 Office) does not contain asbestos.

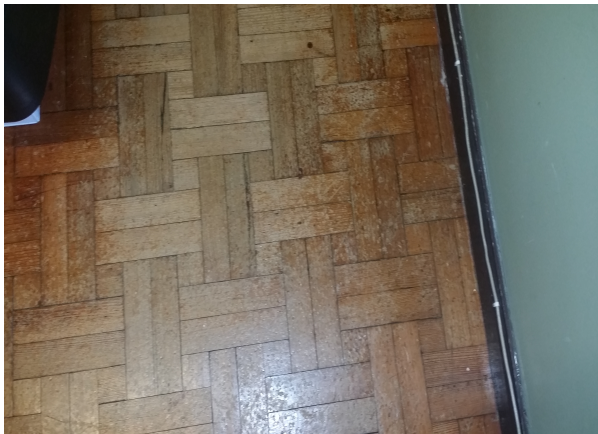
Item 56 – As 106221-17

The adhesive backing to parquet floor (0/27 Photocopy Room) does not contain asbestos.

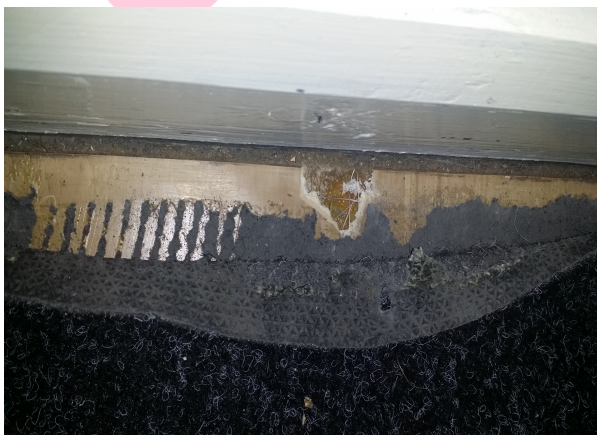
Item 57 – 106221-15

The subfloor (0/29 Corridor) does not contain asbestos.

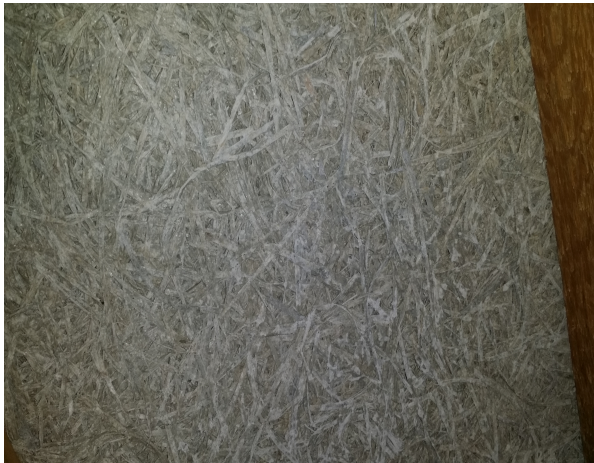
Item 58 – As 106221-1

The underside of roof (0/29 Corridor – void above) does not contain asbestos.

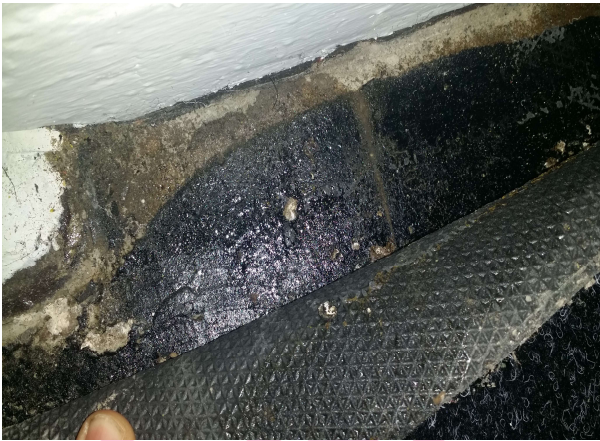
Item 59 – As 106221-16

The remnant adhesive backing to floor covering (0/32 Toilets) does contain asbestos.

Any change in appearance should be reported to Property Services.

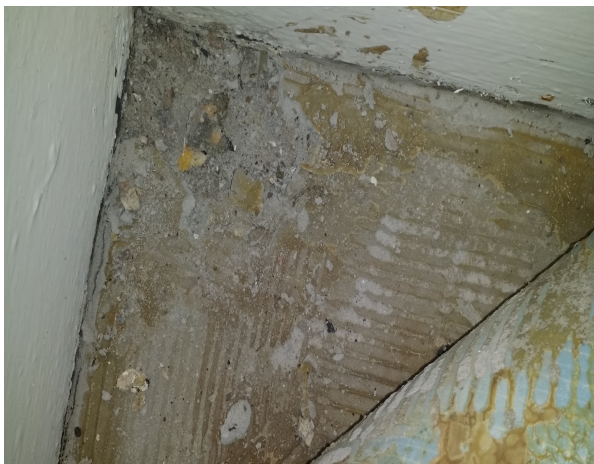
Item 60 – As 106221-16

The remnant adhesive backing to floor covering (0/35 Toilet lobby) does contain asbestos.

Any change in appearance should be reported to Property Services.

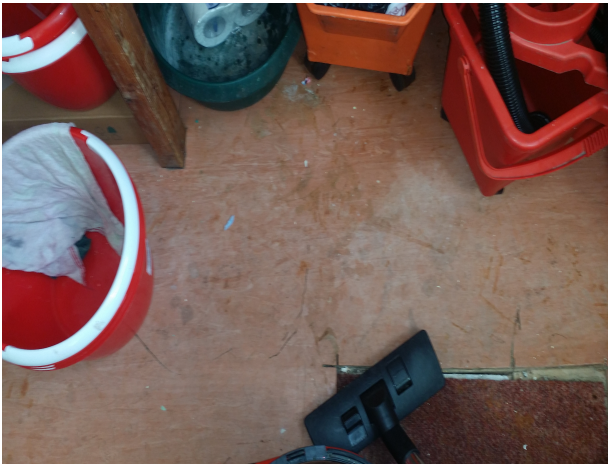
Item 65 – As 106221-8

The floor covering (0/40 Store) does not contain asbestos.

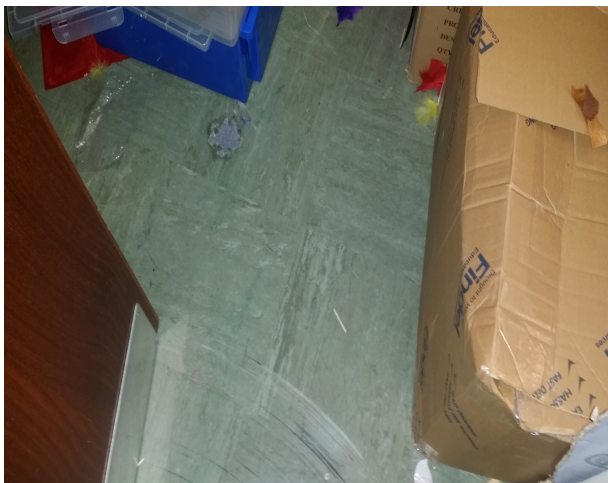
Item 66 – 106221-12

The floor covering (0/41 Store) does not contain asbestos.
