ASBESTOS SURVEY REPORT FOR NEWBOTTLE PRIMARY ACADEMY AND NURSERY SCHOOL HOUGHTON ROAD, HOUGHTON

Asbestos Register for

NEWBOTTLE ACADEMY AND NURSERY SCHOOL

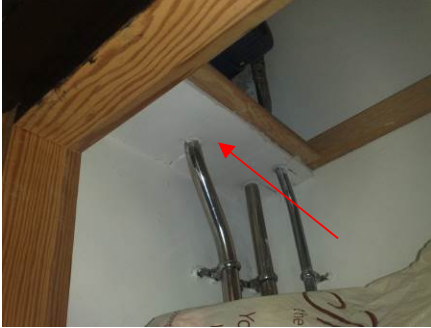
Item 1 Ref: IC09/1437

The board to the ceiling in the small cupboard (Area 2) does not contain asbestos.

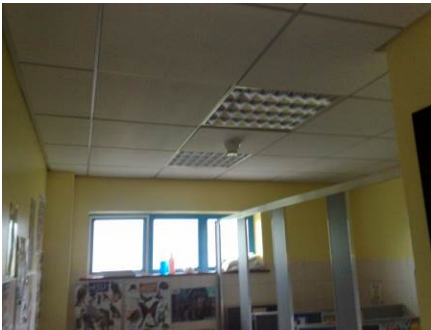
Various - Ref: IC09/1438

The suspended ceiling tiles in area 3 do not contain asbestos.

Similar ceiling tiles are located in area 7, area 9 and corridors throughout.

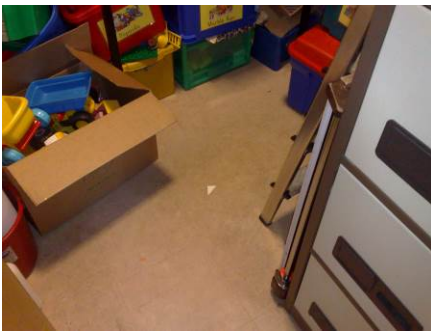
Various - Ref: IC09/1439

The floor tiles in area 6 do not contain asbestos.

Similar floor tiles are located in area 32, area 34, area 36, area 38, area 41, area 46, area 50, area 55, area 57, area 59, area 61, area 64, area 65, area 67, area 74 and area 75.

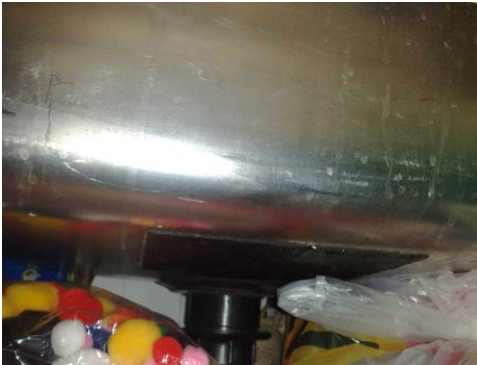
Item 5 - Ref: IC09/1440

Sink pad in area 7 does not contain asbestos.

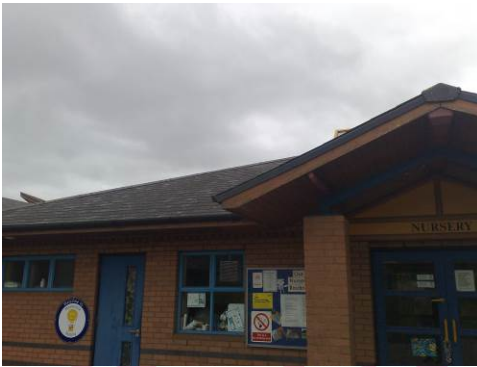
Item 7 - Ref: IC09/1441

The roof tiles on the external nursery do not contain asbestos.

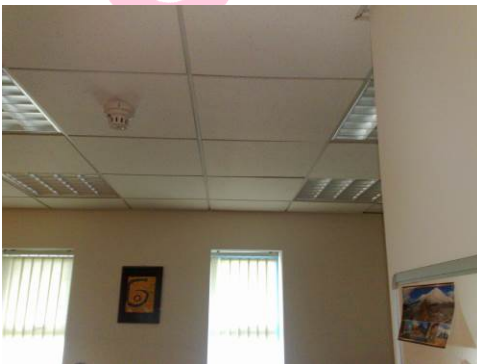
Various – Ref: IC09/1442

The suspended ceiling tiles in area 10 do not contain asbestos.

Similar ceiling tiles can be located in area 11, area 13, area 22, area 33, area 35, area 37, area 39, area 42, area 43, area 44, area 45, area 53, area 54, area 56, area 58, area 60, area 66 and area 72.

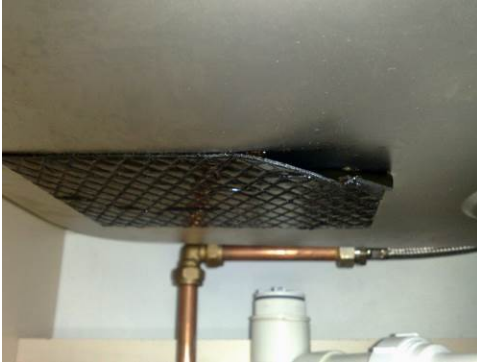
Item 11 – Ref: IC09/1443

The sink pad in area 13 does not contain asbestos.

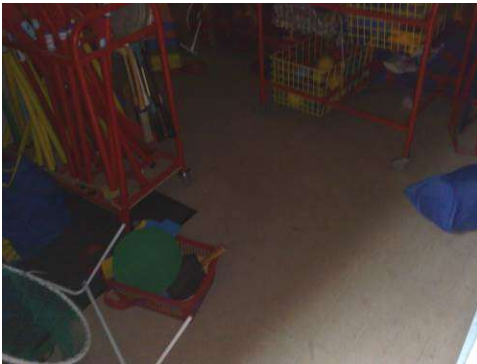
Various – Ref: IC09/1444

The floor tiles in area 16 do not contain asbestos.

Similar floor tiles can be located in area 17 and area 23.

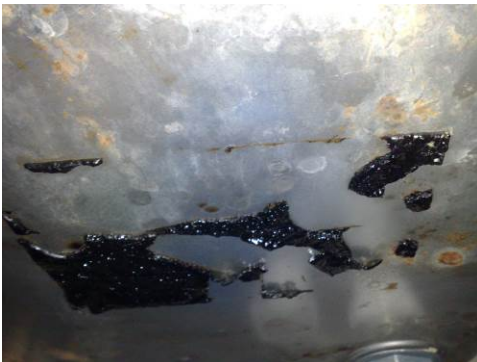
Item 14 – Ref: IC09/1445

The sink pad in area 19 does not contain asbestos.

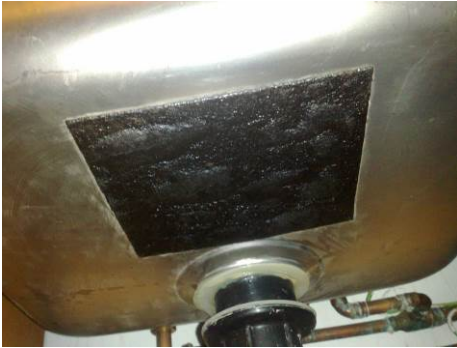
Item 15 – Ref: IC09/1446

The sink pad in area 21 does not contain asbestos.

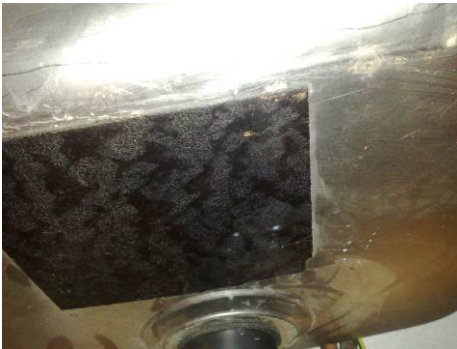
Item 26 – Ref: IC09/1447

The sink pad in area 39 does not contain asbestos.

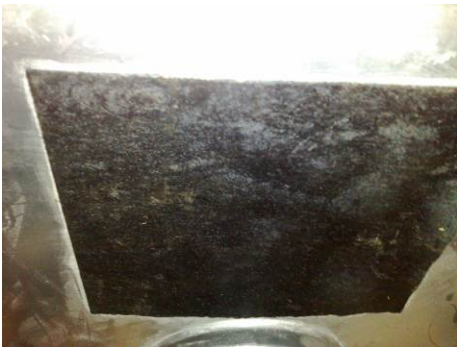
Item 38 – Ref: IC09/1449

The sink pad in area 53 does not contain asbestos.

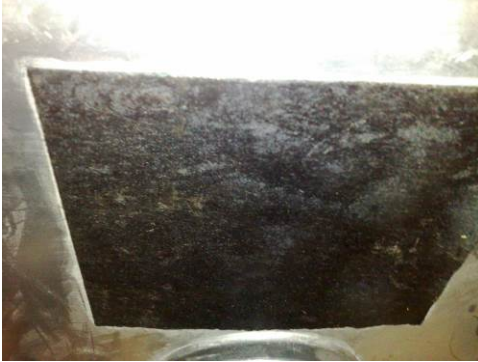
Item 39 - Ref: IC09/1450

The sink pad in area 53 does not contain asbestos.

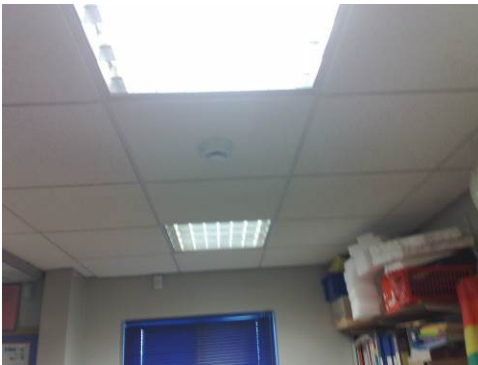
Item 56 - Ref: IC09/1451

The suspended ceiling tiles in area 73 do not contain asbestos.

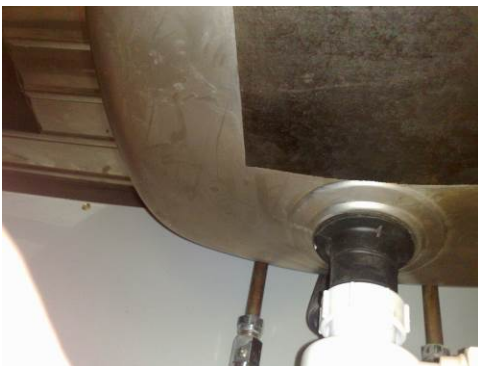
Item 57 - Ref: IC09/1452

The sink pad in area 76 does not contain asbestos.

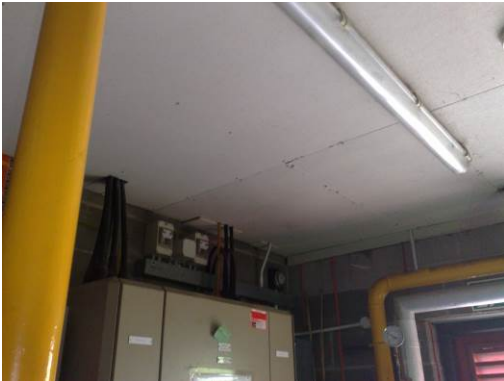
Item 58 – Ref: IC09/1453

The ceiling board in area 77 (plant room) does not contain asbestos.

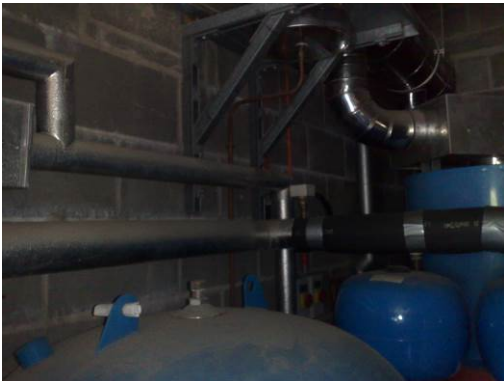
Item 59 - Ref: IC09/1454

The pipe lagging in area 77 (plant room) had limited access due to metal covering on pipes but does not contain asbestos.

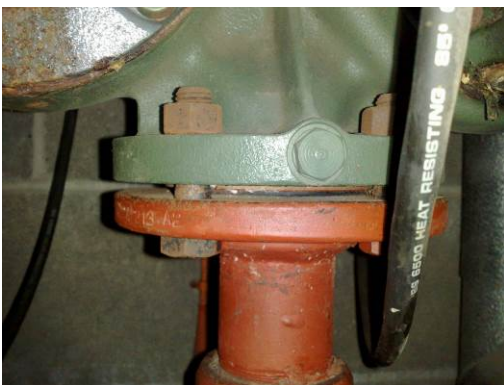
Item 60 – Ref: IC09/1455

The gasket material in area 77 (plant room) contains asbestos.

Item 56	No asbestos	Is present		
Item 57	No asbestos	Is present		
Item 58	No asbestos	Is present		
Item 59	No asbestos	Is present		
Item 60	Gasket – Area 77	Low	REMOVED	OCT 2025

REMOVED OCT 2025

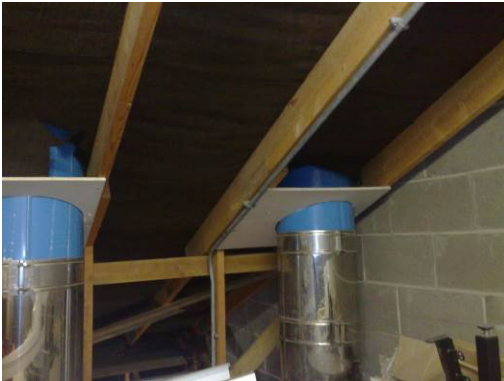
Item 61 – Ref: IC09/1456

The sarking felt in area 77 (plant room) does not contain asbestos.

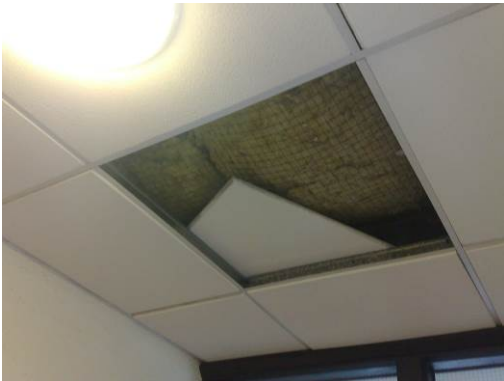
Item 63 – Ref: IC09/1457

The ceiling void throughout contains fibreglass insulation suspended in mesh but does not contain asbestos.

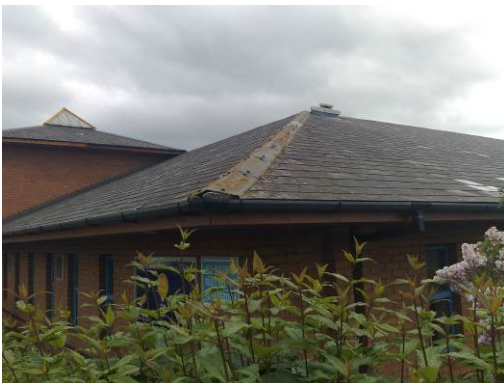
Item 64 – Ref: IC09/1459

The ridge tiles in the external area of the main school do not contain asbestos.

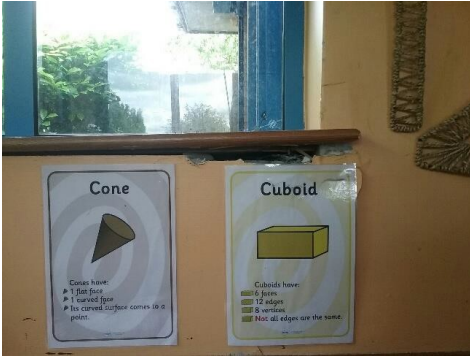
Item 66 – 16-24614-1

The packers beneath the wood window sill in the Nursery do not contain asbestos.

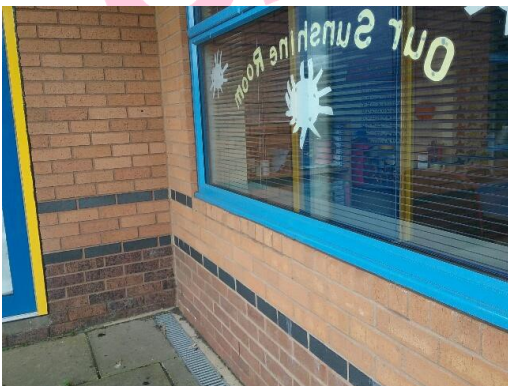
Item 67 – 16-24614-2

The mastic to the external windows does not contain asbestos.

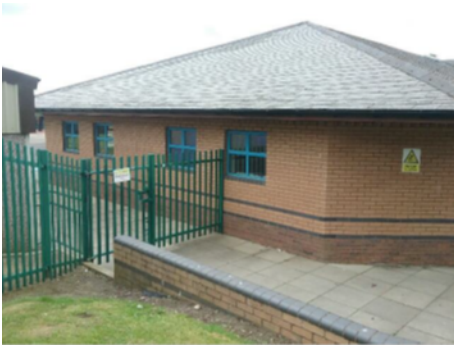
Item 68 – 16-24614-3

The putty to the external windows does not contain asbestos.

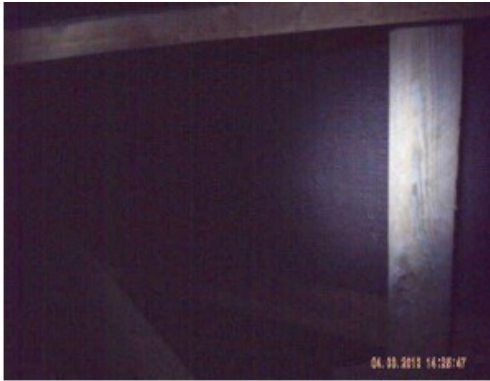
Item 69 – BB000381

The roof felt in the Infant Entrance ceiling void does not contain asbestos.

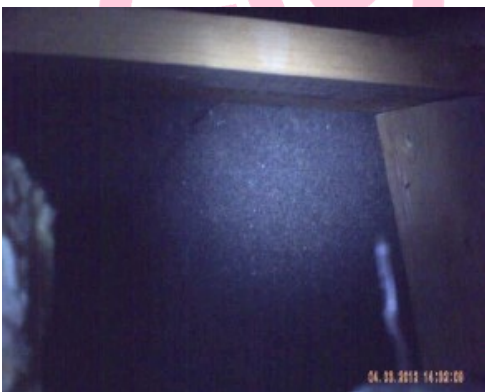
Item 70 – As BB000381

The roof felt in the Nursery Entrance ceiling void does not contain asbestos.

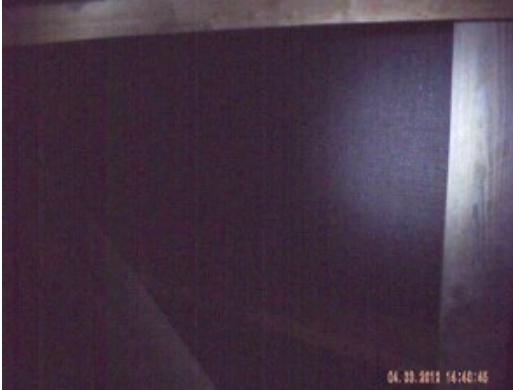
Item 71 – As BB000381

The roof felt in the External area between Infants & Nursery - ceiling void does not contain asbestos.

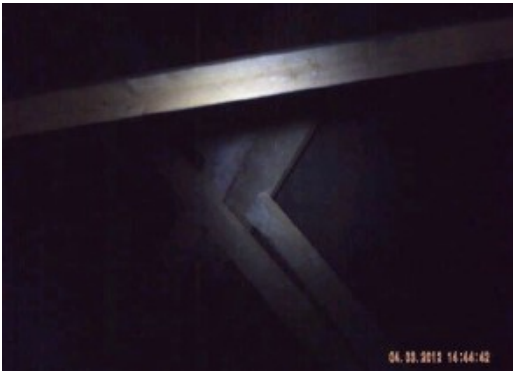
Item 72 – As BB000381

The roof felt above all soffits in the External area between Infants & Nursery does not contain asbestos.
