ASBESTOS SURVEY REPORT FOR DERWENT HILL OUTDOOR EDUCATION AND TRAINING CENTRE, PORTINSCALE, KESWICK, CUMBRIA, CA12 5RD.

Derwent Hill Outdoor Education and Training Centre

Date: 07 April 2026

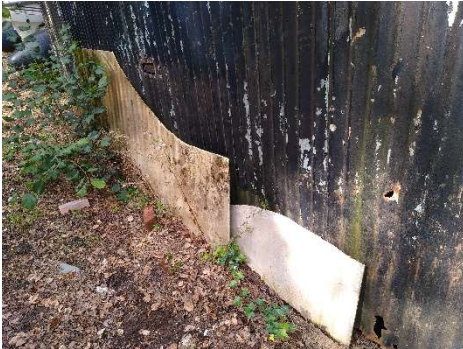
Item 1 Ref: 418920-7

The loose panel to rear of garages (External) contains asbestos.

Removed

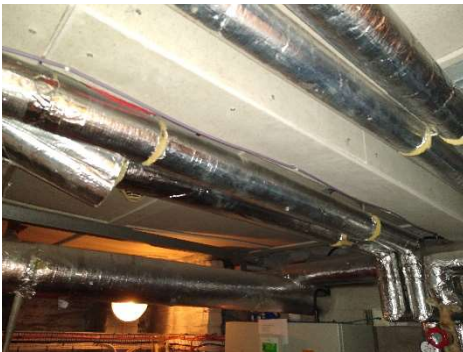
Item 5 Ref: 418920-16

The ceiling and beam cladding in Boiler Room/-1/002 does not contain asbestos.

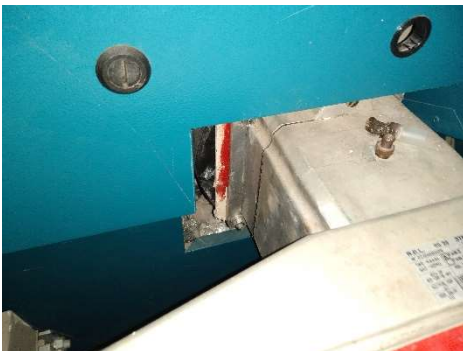
Item 6 Ref: 418920-17

The gasket to boiler front in Boiler Room/-1/002 does not contain asbestos.

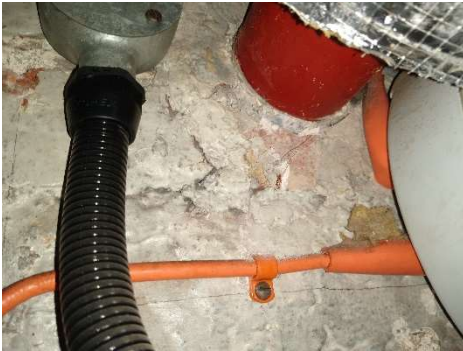
Item 8 Ref: 418920-19

The debris to wall pipe penetration in Boiler Room/-1/002 contains asbestos.

Removed and Encapsulated November 2020

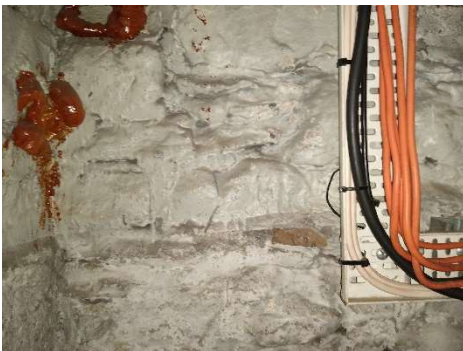
Item 9 Ref: 418920-20

The debris to walls in Boiler Room/-1/002 contains asbestos.

Removed and Encapsulated November 2020

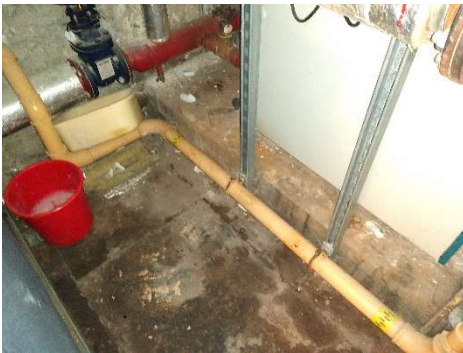
Item 11 Ref: 418920-22

The debris to floor in Boiler Room/-1/ does not contain asbestos.

Removed November 2020

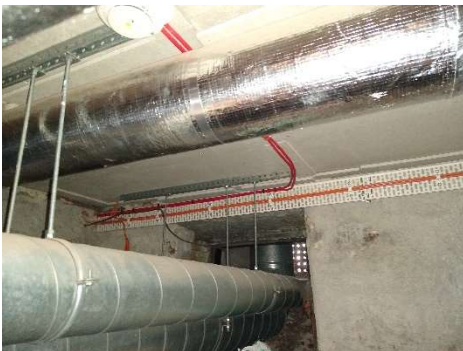
Item 12 Ref: As 418920-16

The ceiling in Store/-1/003 does not contain asbestos.

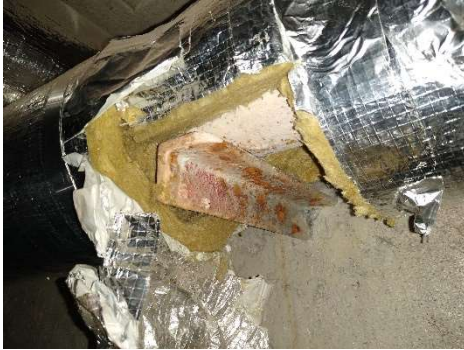
Item 13 Ref: 418920-23

The debris to pipework and bracket in Store/-1/003 contains asbestos.

Removed November 2020

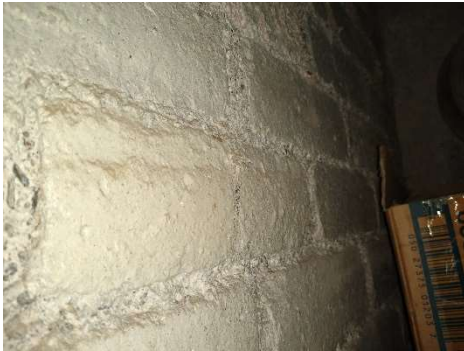
Item 14 Ref: 418920-24

The debris to walls in Store/-1/003 does not contain asbestos.

Removed November 2020

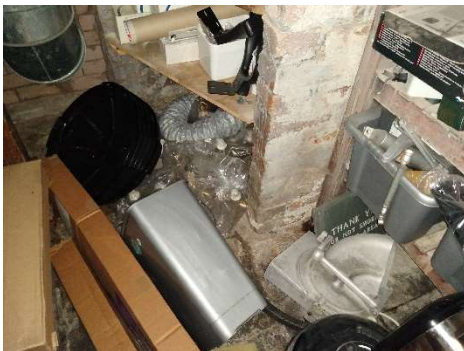
Item 15 Ref: 418920-25

The general debris to floor in Store/-1/003 contains asbestos.

Removed November 2020

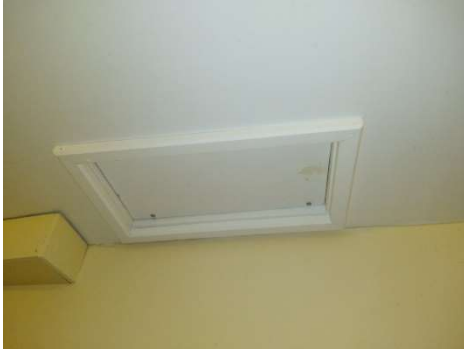
Item 16 Ref: 418920-30

The panel to loft hatch in Staff drying room/0/005 does not contain asbestos.

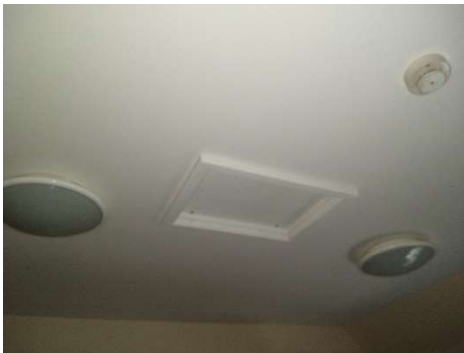
Item 17 Ref: As 418920-30

The panel to loft hatch in Staff office/0/006 does not contain asbestos.

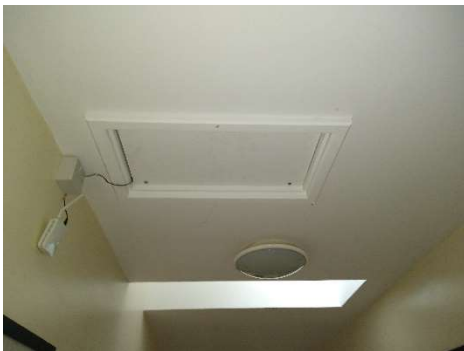
Item 18 Ref: As 418920-30

The panels to loft hatches in Corridor/0/012 do not contain asbestos.

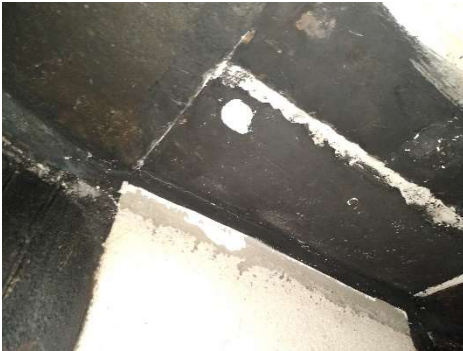
Item 20 Ref: 418920-31

The blanking panel to chimney in Dining Room/0/023 contains asbestos.

Any change in its appearance should be recorded and passed to Property Services.

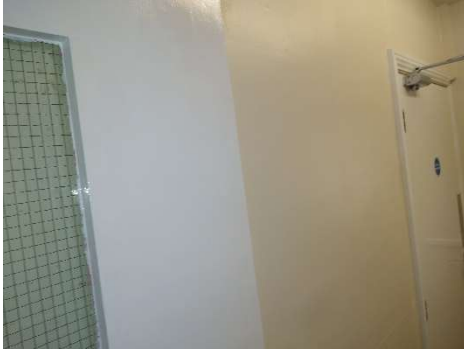
Item 22 Ref: As 418920-26

The partition wall to staff stairwell in Corridor/1/014 does not contain asbestos.

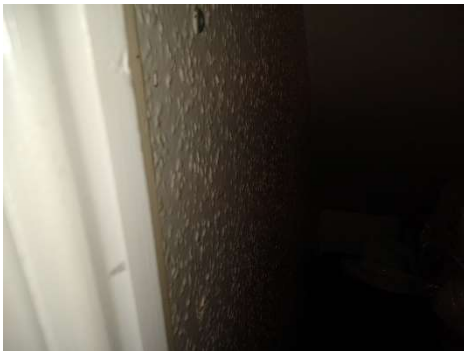
Item 23 Ref: As 418920-26

The partition wall in Corridor under stair cupboard /1/014 does not contain asbestos.

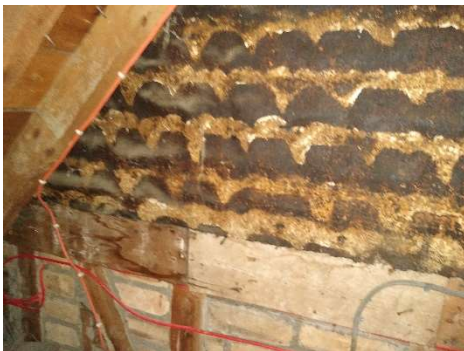
Item 24 Ref: 418920-29

The sarking to wall in Ennerdale loft above room and extension/0/018 does not contain asbestos.

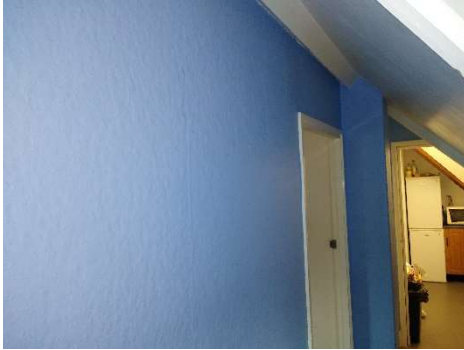
Item 25 Ref: 418920-26

The partition wall to rooms 2/003 & 004 in Corridor 2/001 does not contain asbestos.

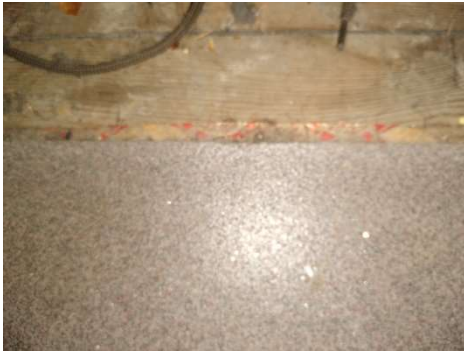
Item 26 Ref: 418920-27

The floor covering below plyboard in Corridor 2/001 contains asbestos.

Any change in its appearance should be recorded and passed to Property Services.

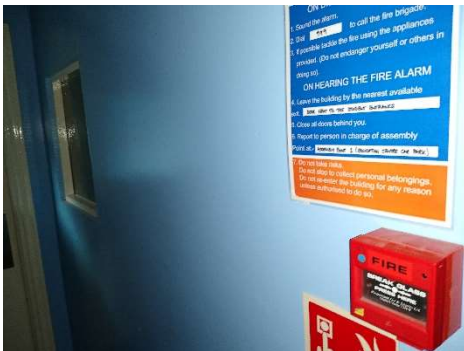
Item 27 Ref: As 418920-26

The partition wall to stairwell in Landing and Stairwell/2/007 does not contain asbestos.

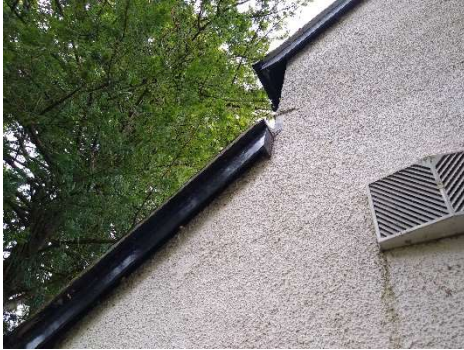
Item 28 Ref: 418920-32

The fillet to extension (External) does not contain asbestos.

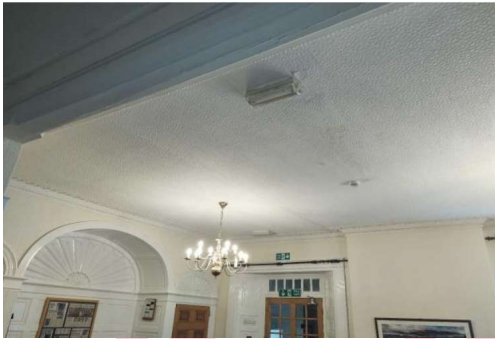
Item 64 Ref: 22-63253-1

The textured coated ceiling in the lounge (Area 1) contains asbestos.

Any change in its appearance should be recorded and passed to Property Services.

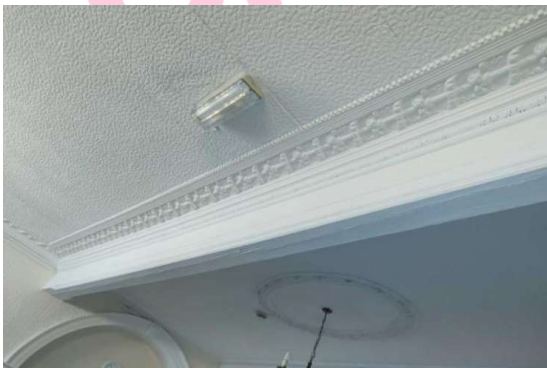
Item 65 Ref: 22-63253-1

The textured coated ceiling in the lounge (Area 1) contains asbestos.

Any change in its appearance should be recorded and passed to Property Services.

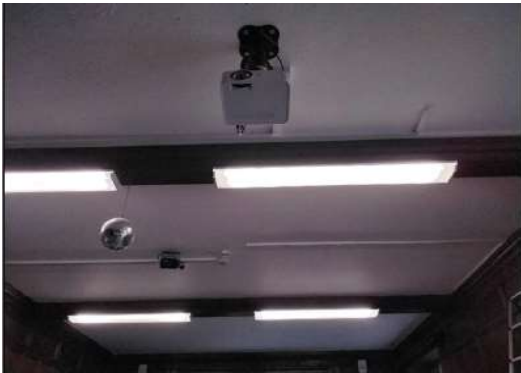
Item 66 Ref: KX001961

The ceiling papered with woodchip paper in the Common Room (G/001) does not contain asbestos.

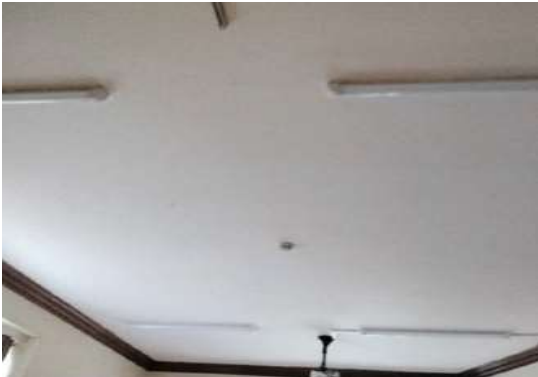
Item 67 Ref: KX001962

The ceiling papered with woodchip paper in the Living Room/Lounge (G/002) does not contain asbestos.

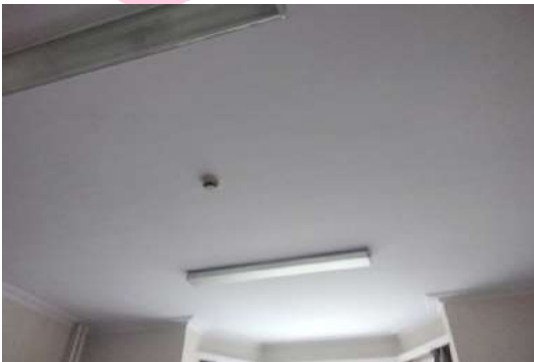
Item 68 Ref: KX001963

The ceiling in the Dales Dining Room (Room G/003) does not contain asbestos.

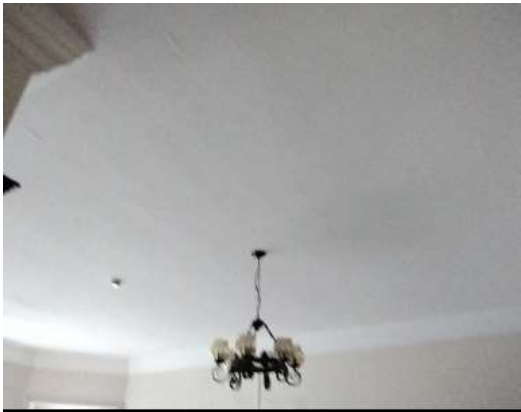
Item 69 Ref: KX001961

The papered ceiling in the Fells Dining Room (Room G/004) does not contain asbestos.

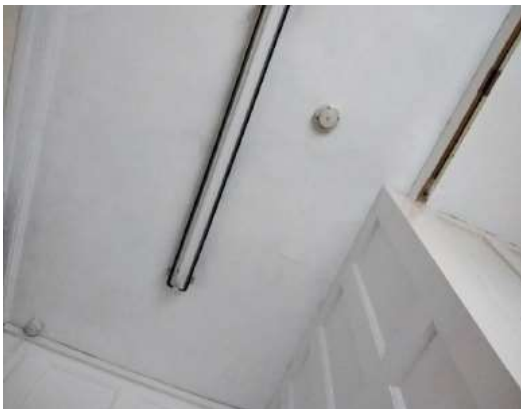
Item 70 Ref: KX001965

The ceiling in the Store Room Shop (G/005) does not contain asbestos.

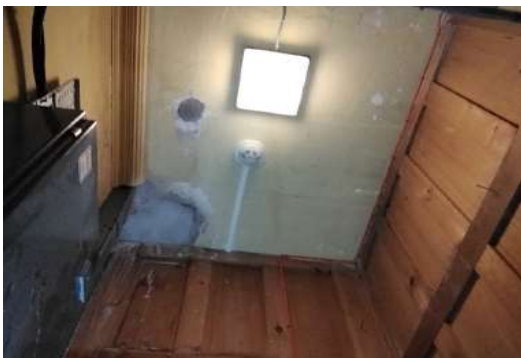
Item 71 Ref: KX001966

The ceiling in the Electrical cupboard in the shop (Room G/00) does not contain asbestos.

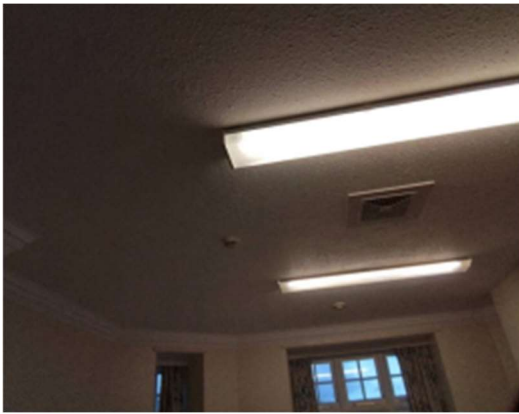
Item 72 Ref: QK000867

The ceiling wallpapered (Bedroom Borrowdale Dormitory Rm1/001) does not contain asbestos.

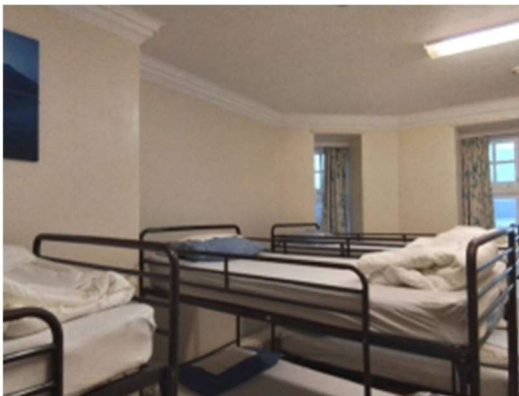
Item 73 Ref: QK000868

The wall (Borrowdale (Bedroom Dormitory Rm1/001) does not contain asbestos.

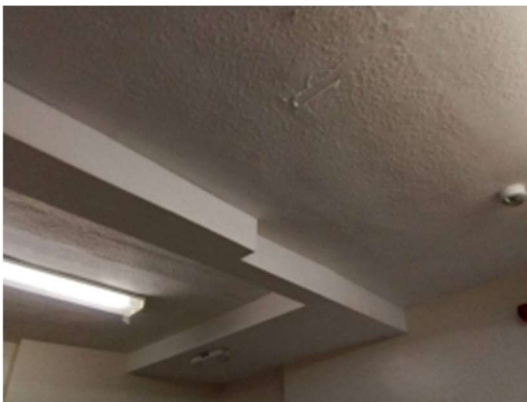
Item 74 Ref: QK000869

The ceiling wallpapered (Bedroom Scarfell Dormitory Rm 1/002) does not contain asbestos.

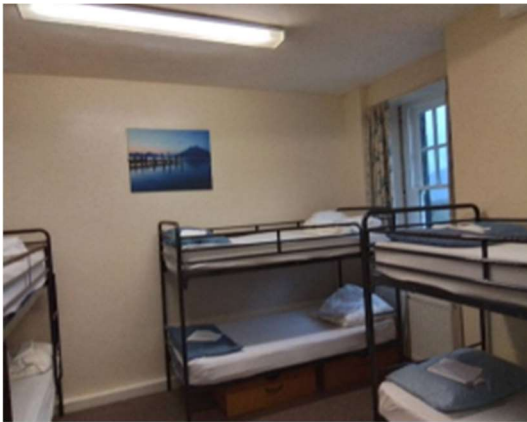
Item 75 Ref: QK000870

The wall (Bedroom Scarfell Dormitory Rm 1/002) does not contain asbestos.

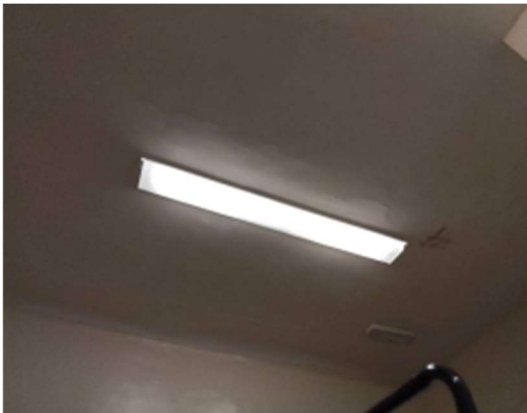
Item 76 Ref: QK000871

The ceiling (Bedroom Latrigg Dormitory Rm 1/003) does not contain asbestos.

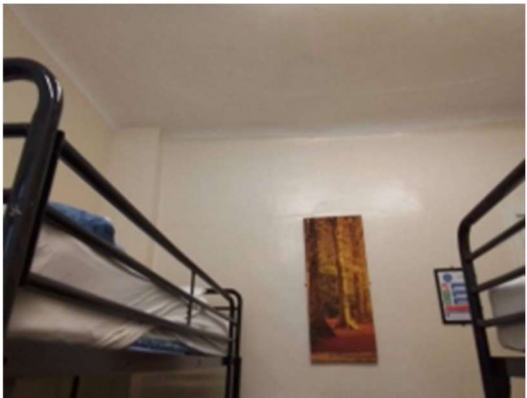
Item 77 Ref: QK000872

The wall (Bedroom Latrigg Dormitory Rm 1/003) does not contain asbestos.

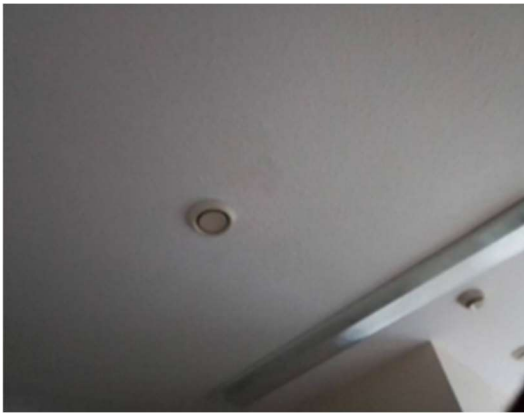
Item 78 Ref: QK000873

The ceiling (Bedroom Littleman Dormitory Rm 1/004) does not contain asbestos.

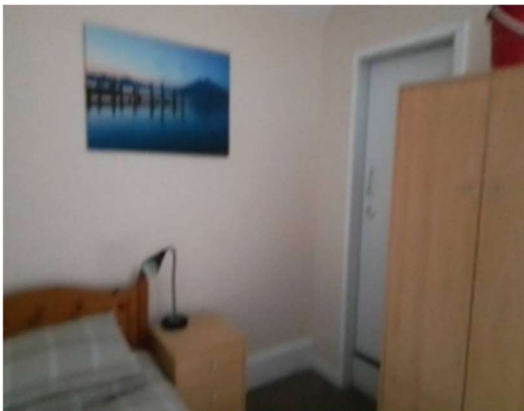
Item 79 Ref: QK000874

The wall (Bedroom Littleman Dormitory Rm 1/004) does not contain asbestos.

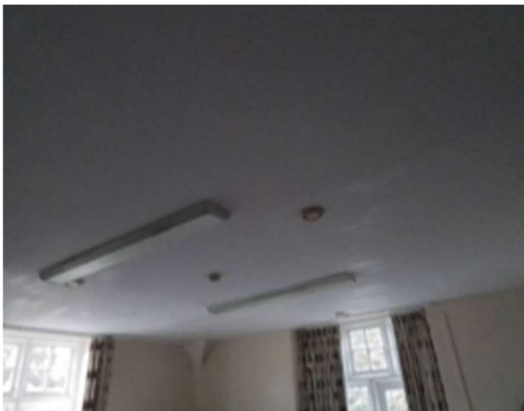
Item 80 Ref: QK000875

The ceiling (Bedroom Skiddaw Dormitory Rm 1/005) does not contain asbestos.

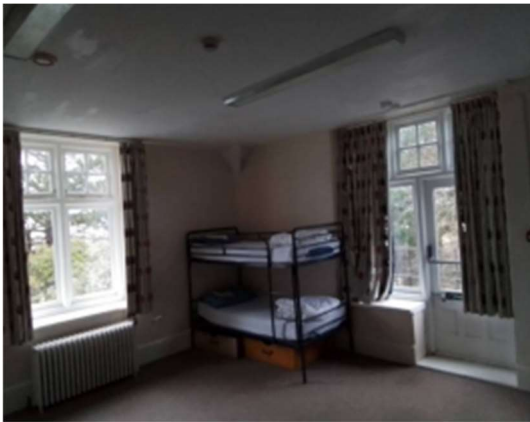
Item 81 Ref: QK000876

The wall (Bedroom Skiddaw Dormitory Rm 1/005) does not contain asbestos.

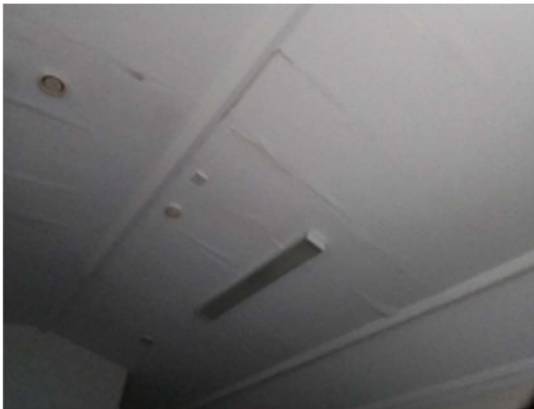
Item 82 Ref: QK000877

The ceiling (Bedroom Blencathra Dormitory Rm 1/006) does not contain asbestos.

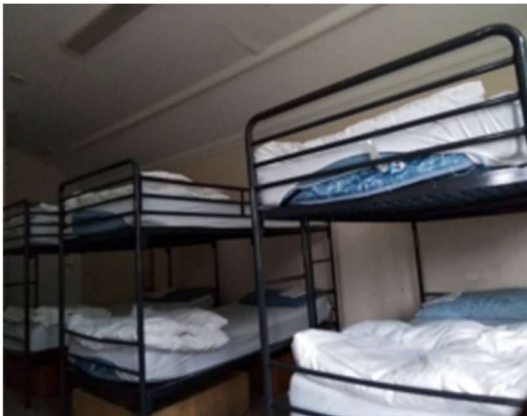
Item 83 Ref: QK000878

The wall (Bedroom Blencathra Dormitory Rm 1/006) does not contain asbestos.

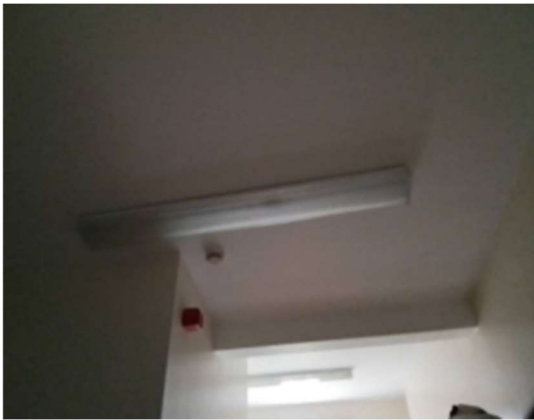
Item 84 Ref: QK000879

The ceiling (Bedroom Helvellyn Dormitory Rm 1/007) does not contain asbestos.

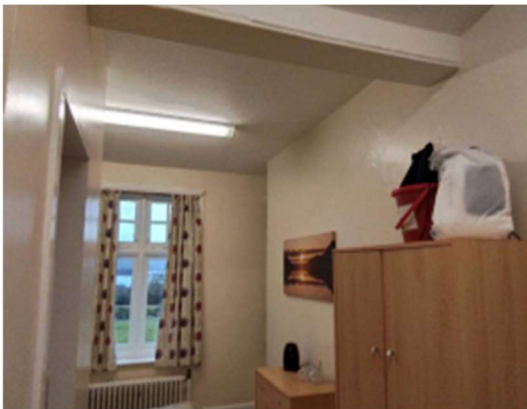
Item 85 Ref: QK000880

The wall (Bedroom Helvellyn Dormitory Rm 1/007) does not contain asbestos.

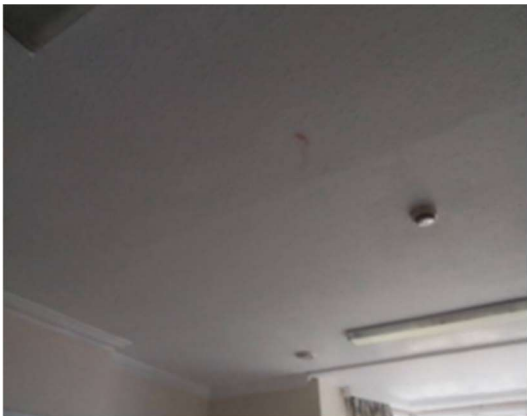
Item 86 Ref: QK000881

The ceiling (Bedroom Catbells Dormitory Rm 1/008) does not contain asbestos.

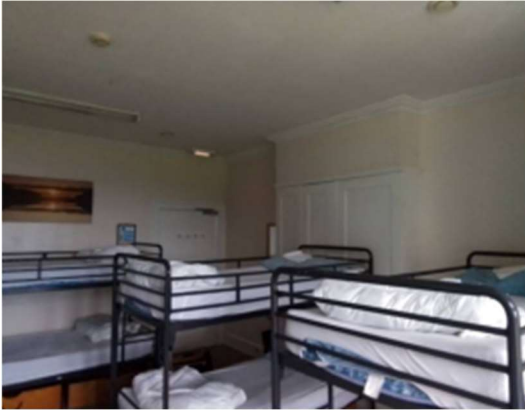
Item 87 Ref: QK000882

The wall (Bedroom Catbells Dormitory Rm 1/008) does not contain asbestos.

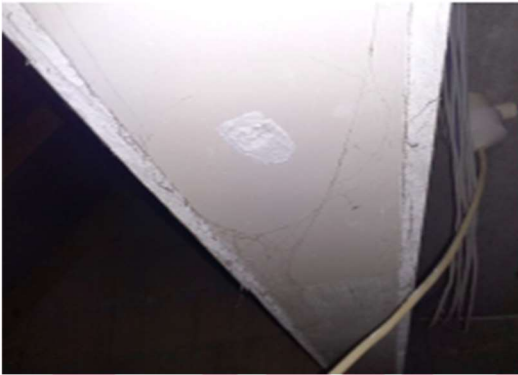
Item 88 Ref: EV006952

The insulating board – steel beams within ceiling voids in the Reception Area (G/02) does not contain asbestos.

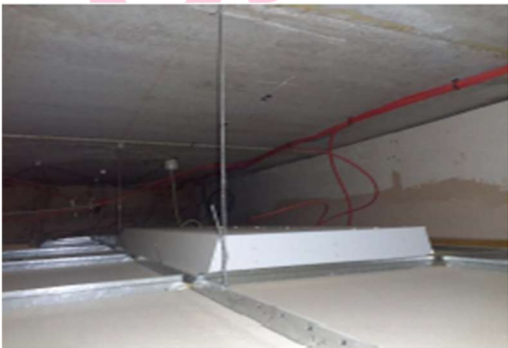
Item 89 Ref: As EV006952

The insulating board – steel beams within ceiling voids in the Office (G/03) does not contain asbestos.

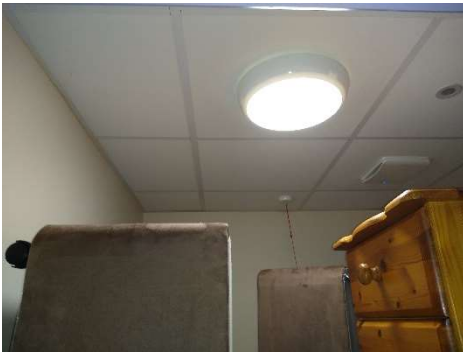
Item 29 Ref: As 418920-12

The suspended ceiling in Bedroom 15 ensuite bathroom/0/001 does not contain asbestos.

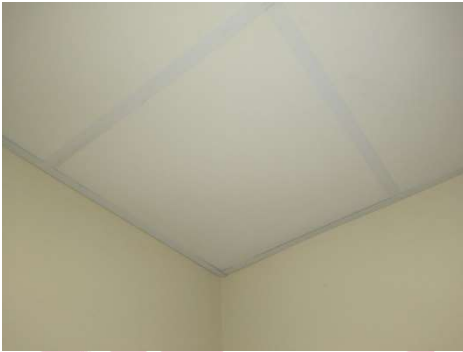
Item 30 Ref: 418920-12

The suspended ceiling in Bedroom 16 ensuite bathroom/0/002 does not contain asbestos.

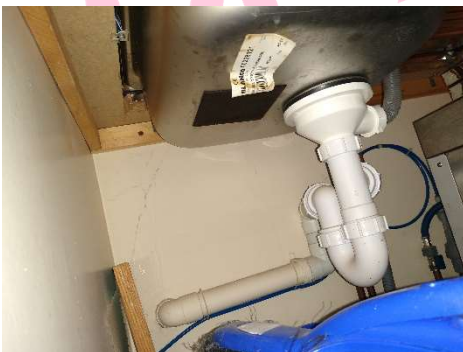
Item 31 Ref: 418920-13

The sink pad in Bar area/0/025 does not contain asbestos.

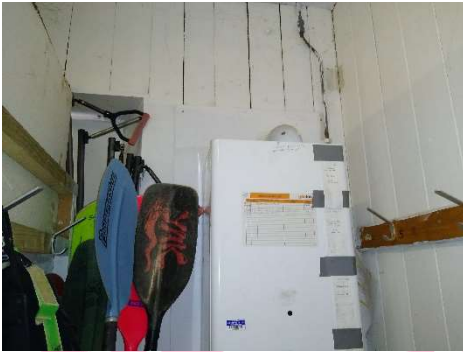
Item 34 Ref: 418920-11

The mounting board to boiler in Watersports store/0/002 does not contain asbestos.

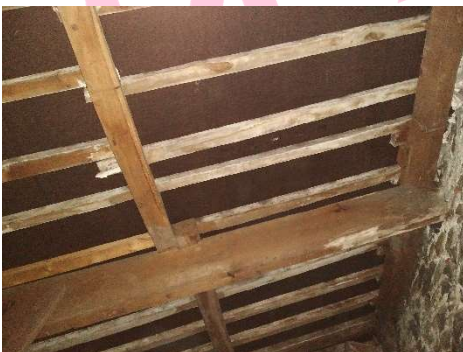
Item 35 Ref: As 418920-8

The sarking in Watersports store loft above/0/002 does not contain asbestos.

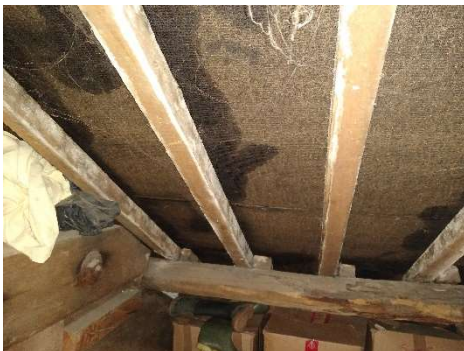
Item 37 Ref: 418920-8

The sarking in First floor/1/001 does not contain asbestos.

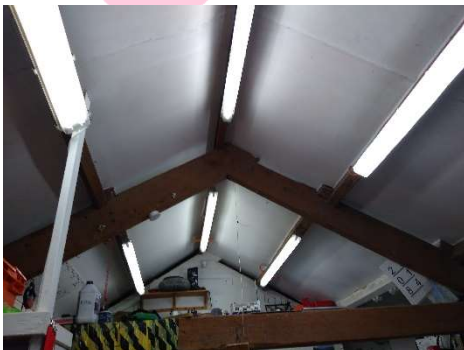
Item 38 Ref: 418920-9

The paper lining to ceiling panels in First floor/1/001 does not contain asbestos.

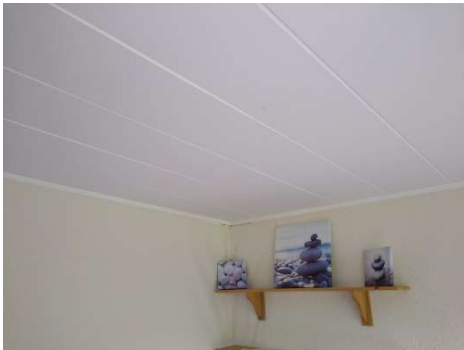
Item 39 Ref: As 418920-1

The ceiling in Bedroom/0/001 contains asbestos.

Any change in its appearance should be recorded and passed to Property Services.

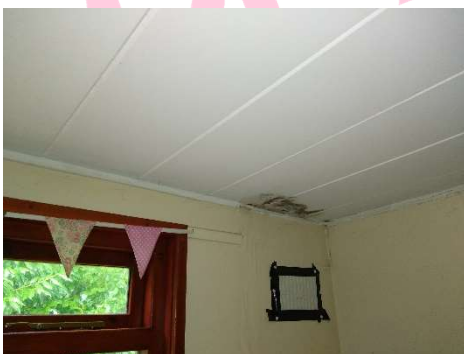
Item 41 Ref: As 418920-1

The ceiling in Kitchen/0/002 contains asbestos.

Any change in its appearance should be recorded and passed to Property Services.

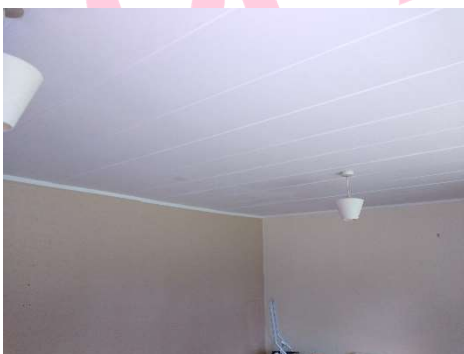
Item 44 Ref: As 418920-1

The ceiling in Living Room 0/003 contains asbestos.

Any change in its appearance should be recorded and passed to Property Services.

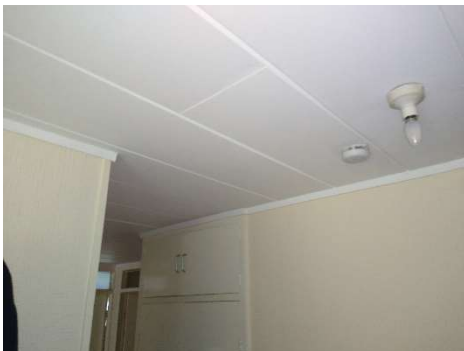
Item 46 Ref: As 418920-1

The ceiling in Hallway 0/004 contains asbestos.

Any change in its appearance should be recorded and passed to Property Services.

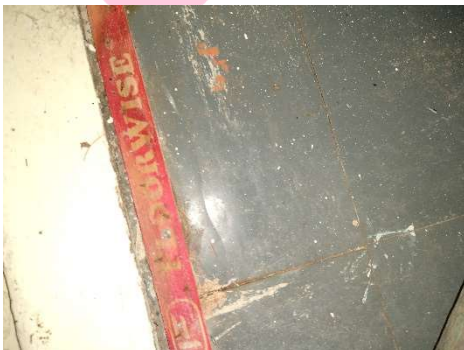
Item 47 Ref: As 418920-2

The sub floor covering in Hallway 0/004 contains asbestos.

Any change in its appearance should be recorded and passed to Property Services.

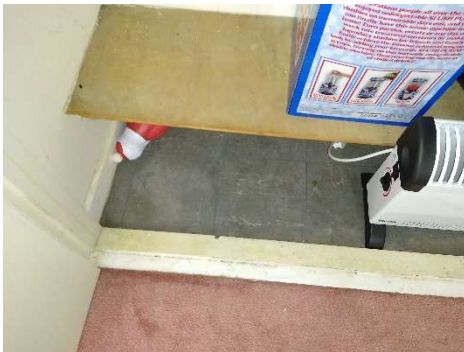
Item 49 Ref: As 418920-2

The sub floor covering in Bedroom 0/005 contains asbestos.

Any change in its appearance should be recorded and passed to Property Services.

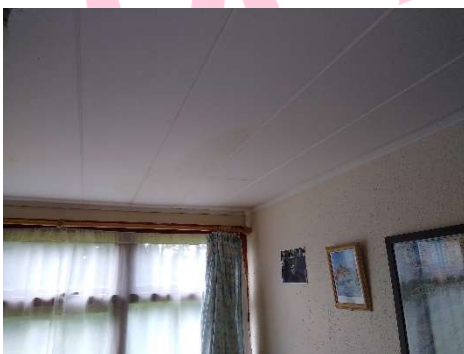
Item 50 Ref: As 418920-1

The ceiling in Bedroom 0/006 contains asbestos.

Any change in its appearance should be recorded and passed to Property Services.

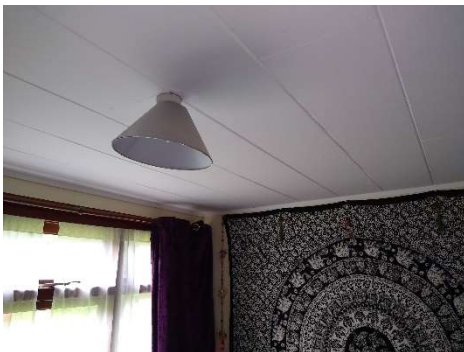
Item 52 Ref: As 418920-1

The ceiling in Bedroom 0/007 contains asbestos.

Any change in its appearance should be recorded and passed to Property Services.

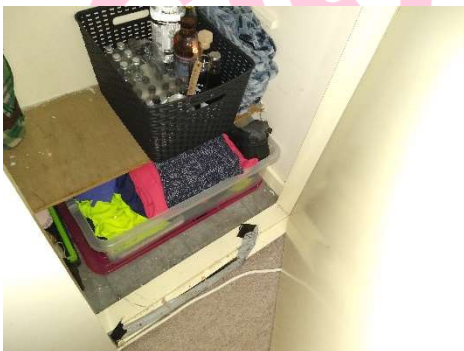
Item 53 Ref: As 418920-2

The sub floor covering in Bedroom 0/007 contains asbestos.

Any change in its appearance should be recorded and passed to Property Services.

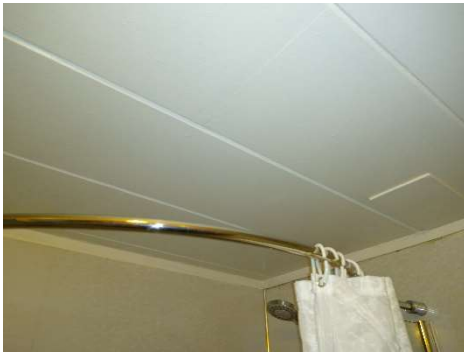
Item 55 Ref: As 418920-1

The ceiling in Shower Room 0/009 contains asbestos.

Any change in its appearance should be recorded and passed to Property Services.

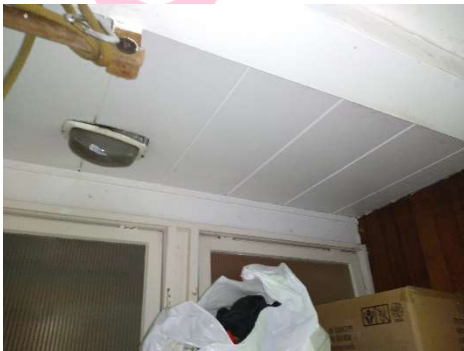
Item 56 Ref: As 418920-1

The ceiling in Rear porch 0/010 contains asbestos.

Any change in its appearance should be recorded and passed to Property Services.

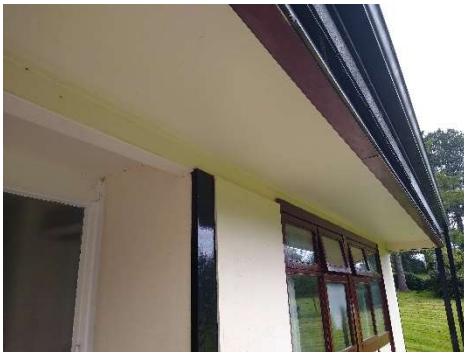
Item 58 Ref: 418920-5

The canopy and boxing to front porch and above lounge window (External) contains asbestos.

Any change in its appearance should be recorded and passed to Property Services.

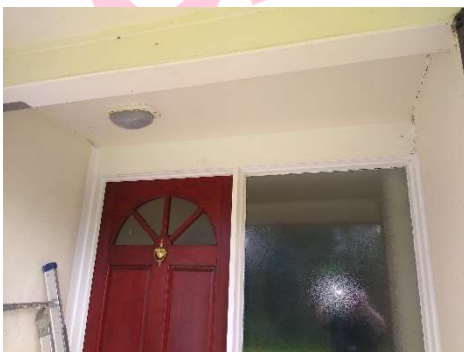
Item 59 Ref: As 418920-5

The panel above door (External) contains asbestos.

Any change in its appearance should be recorded and passed to Property Services.

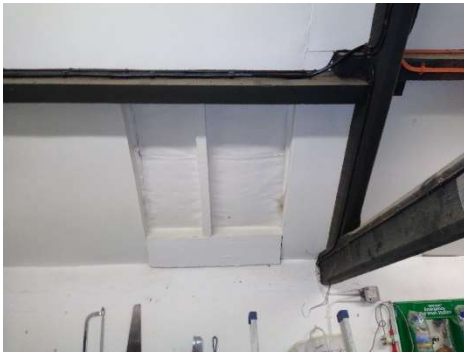
Item 60 Ref: 418920-6

The sarking over roof lights in Workshop 0/003 does not contain asbestos.
