ASBESTOS SURVEY REPORT FOR WASHINGTON MILLENIUM CENTRE LIBRARY/THE OVAL, WASHINGTON, NE37 2QD.

**Washington Millennium Centre, Washington, NE37 2QD**

**Date: 02 June 2026**

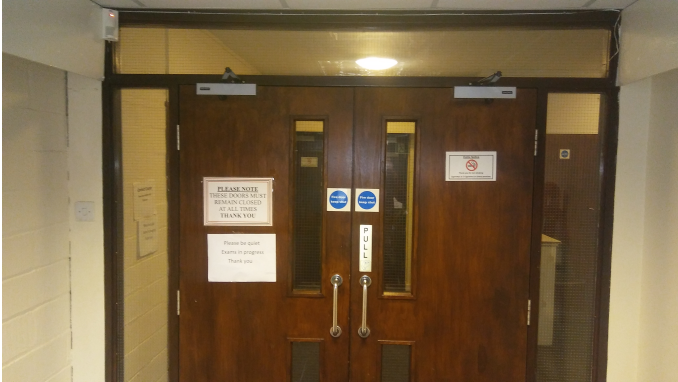
### **Item 1 Ref: 406601-1**

The sealant to internal door frame adjacent 003 in 001/Entrance lobby does not contain asbestos.

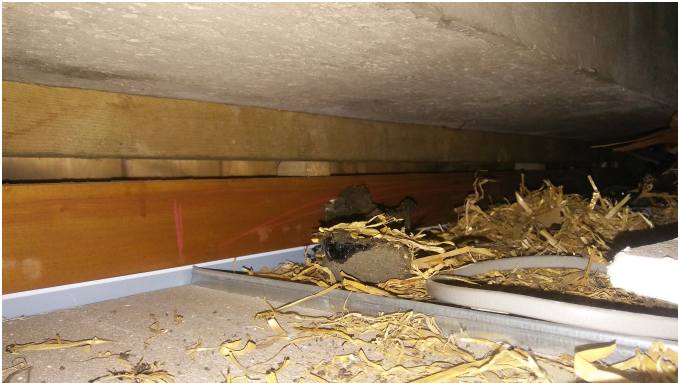
### **Item 2 Ref: 406601-2**

The debris above doors leading to 003 in 001/Entrance lobby void above contains asbestos.

Any change in its appearance should be recorded and passed to Property Services.

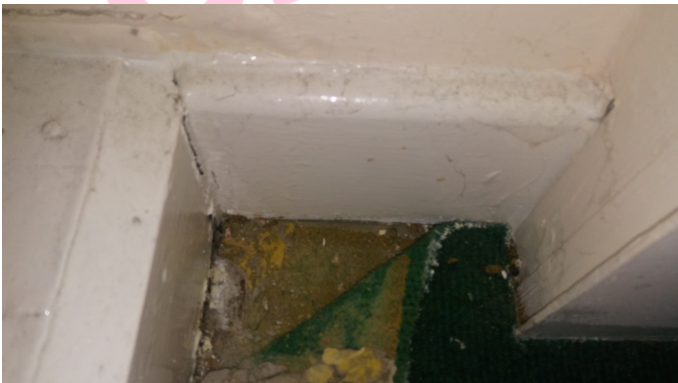
### **Item 3 Ref: 406601-11**

The sub floor covering in 002/Trust room contains asbestos.

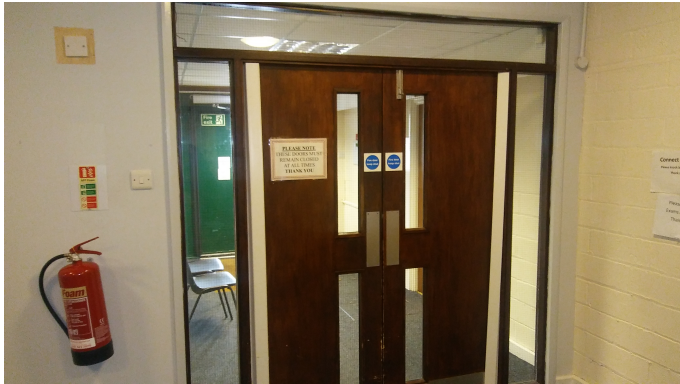
### **Item 4 Ref: As 406601-1**

The sealant to door frame adjacent 001 in 003/Lobby does not contain asbestos.

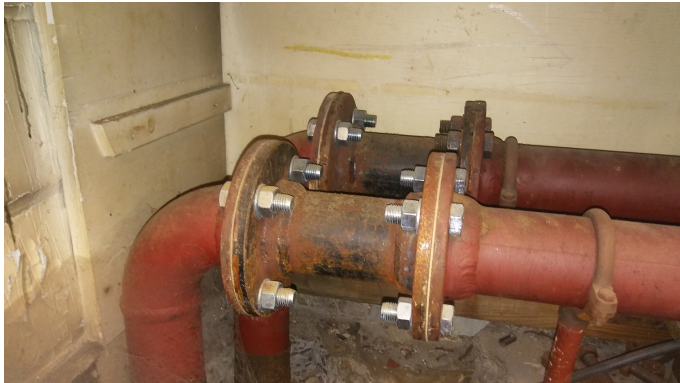
### **Item 5 Ref: 406601-4**

The pipework flange gasket in 009/Training room does not contain asbestos.

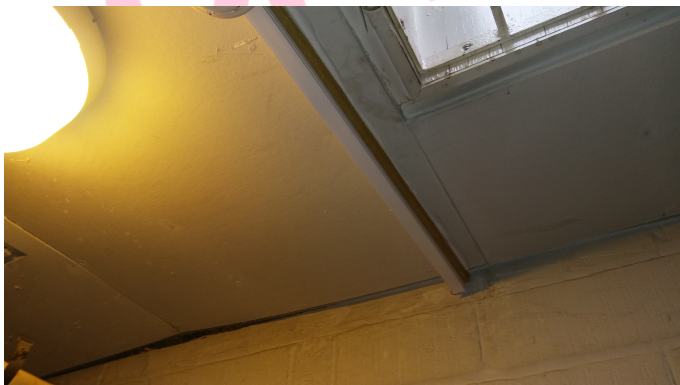
### **Item 6 Ref: As 406601-3**

The fixed suspended ceiling in 010/Store contains asbestos.

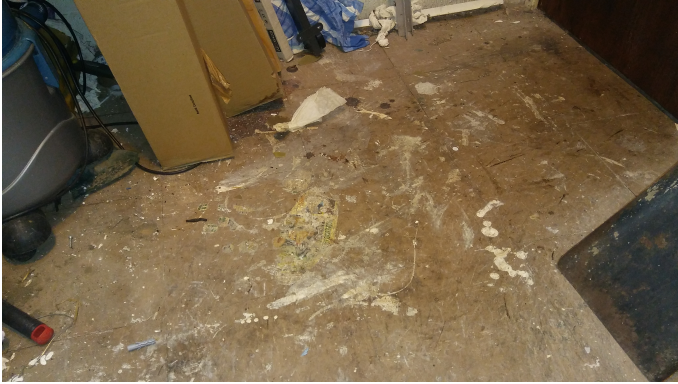
### **Item 7 Ref: 406601-12**

The floor covering in 010/Store contains asbestos.

Any change in its appearance should be recorded and passed to Property Services.

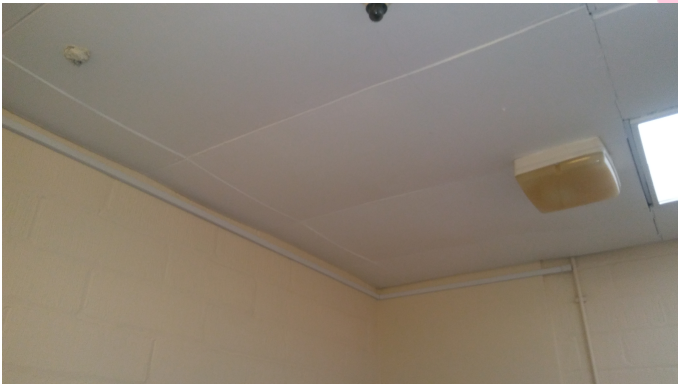
### **Item 8 Ref: As 406601-3**

The fixed suspended ceiling in 011/Female WC contains asbestos.

*Removed July 2021*

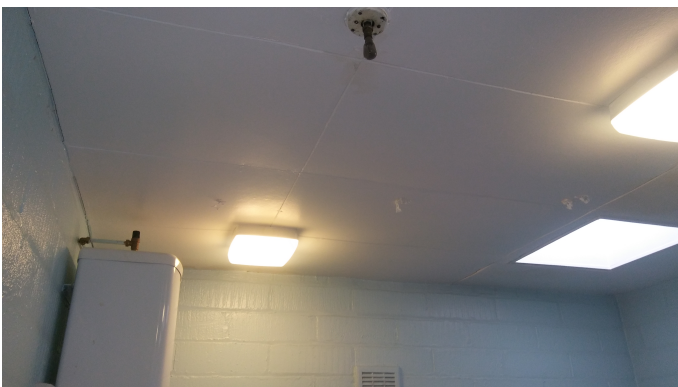
### **Item 9 Ref: As 406601-3**

The fixed suspended ceiling in 012/Male WC contains asbestos.

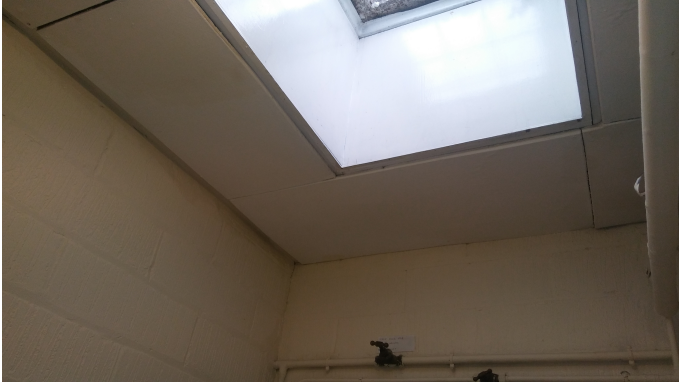
### **Item 10 Ref: 406601-3**

The fixed suspended ceiling in 013/Accessible WC contains asbestos.

Any change in its appearance should be recorded and passed to Property Services.

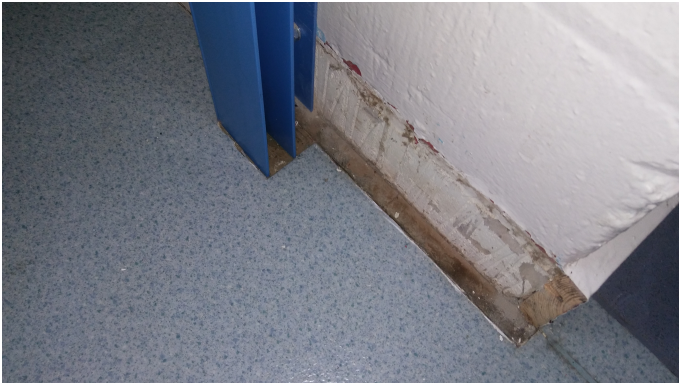
### **Item 11 Ref: As 406601-15**

The subfloor in 014/Activity room does not contain asbestos.

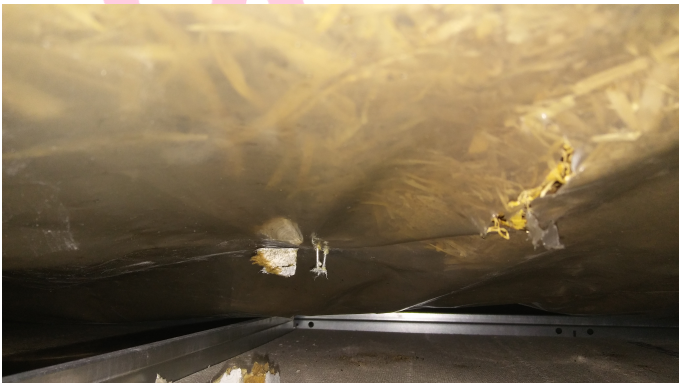
### **Item 12 Ref: 406601-6**

The remnant ceiling tiles in 014/Activity room void above contains asbestos.

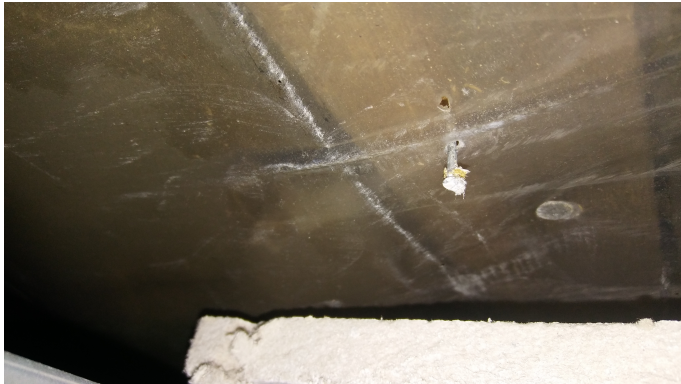
### **Item 13 Ref: 406601-7**

The debris to nails from previous fibreboard ceiling in 014/Activity room void above contains asbestos.

Any change in its appearance should be recorded and passed to Property Services.

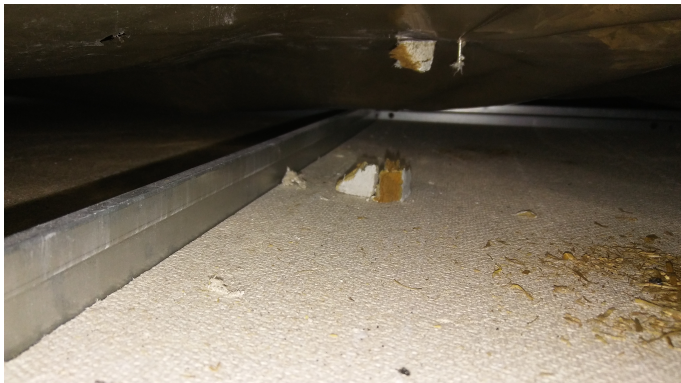
### **Item 14 Ref: 406601-8**

The debris to topside of suspended ceiling tiles below in 014/Activity room void above contains asbestos.

Any change in its appearance should be recorded and passed to Property Services.

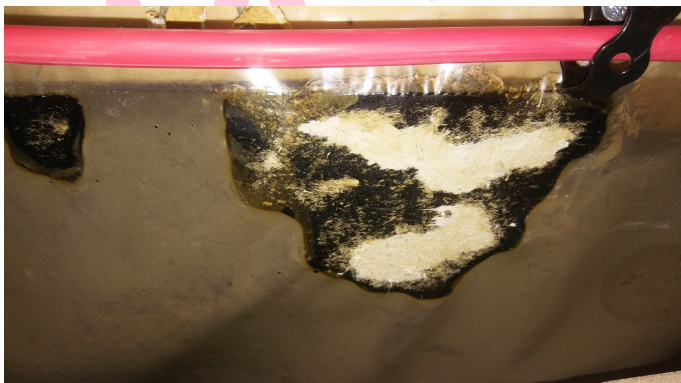
### **Item 15 Ref: 406601-10**

The debris to bitumen on polythene sheeting in 014/Activity room void above contains asbestos.

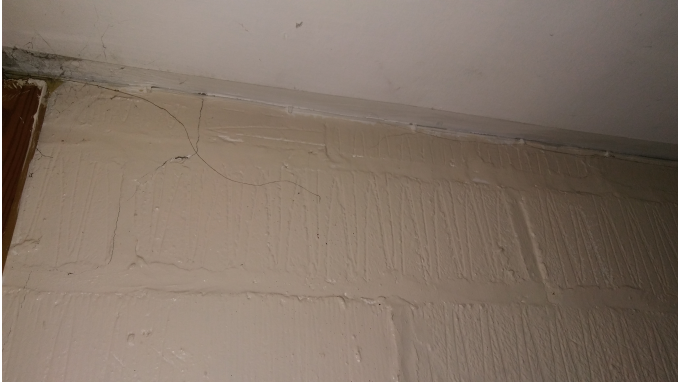
### **Item 16 Ref: 406601-13**

The ceiling in 014a/Cupboard contains asbestos.

Any change in its appearance should be recorded and passed to Property Services.

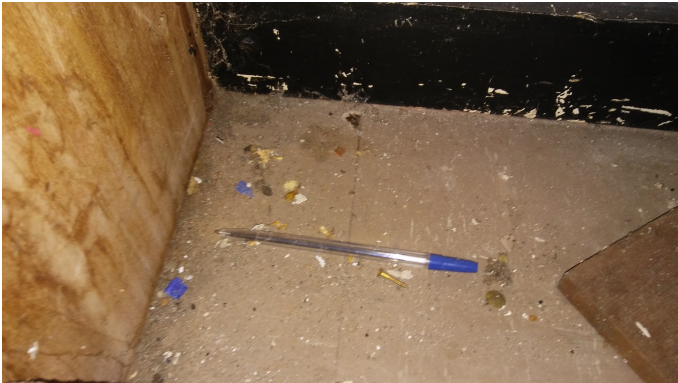
### **Item 17 Ref: 406601-16**

The floor covering in 014a/Cupboard contains asbestos.

Any change in its appearance should be recorded and passed to Property Services.

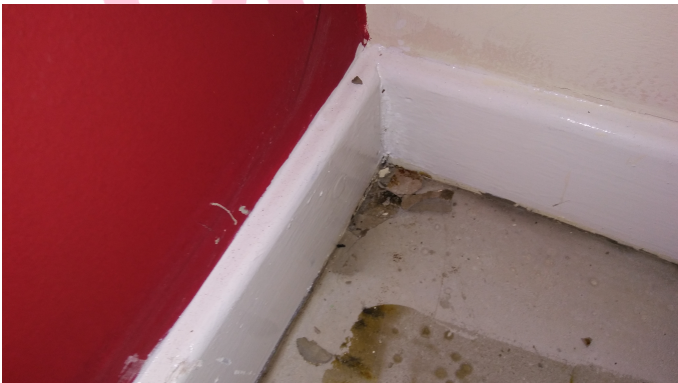
### **Item 18 Ref: As 406601-14**

The subfloor in 015/Classroom contains asbestos.

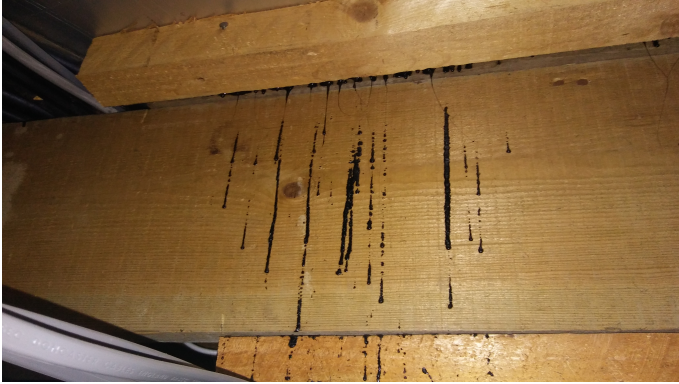
**Item 19 Ref: 406601-5**

The remnant roof sealant to wood beams in 015/Classroom void above does not contain asbestos.

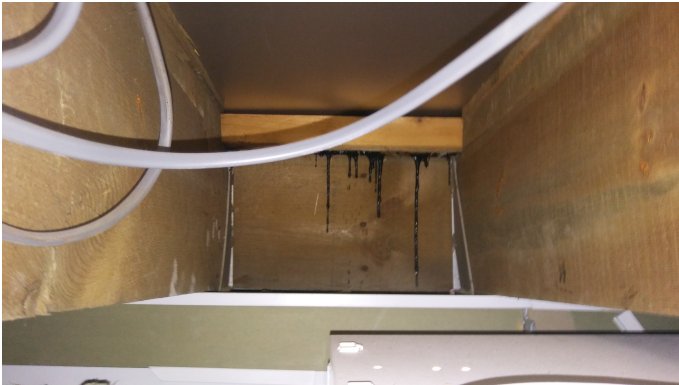
**Item 20 Ref: As 406601-5**

The remnant roof sealant to wood beams in 015a/ Classroom void above does not contain asbestos.

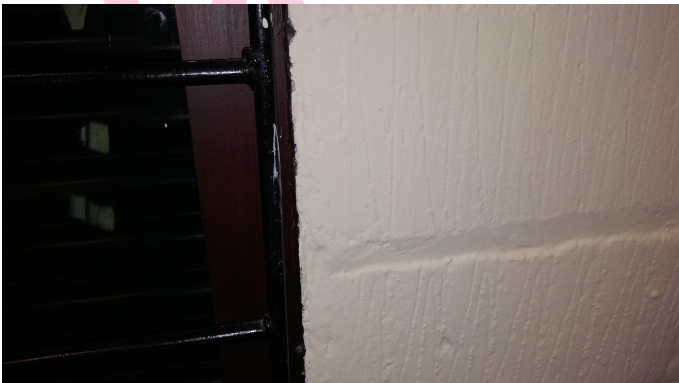
**Item 21 Ref: 406601-9**

The sealant to external door frame in 016/Side entrance does not contain asbestos.

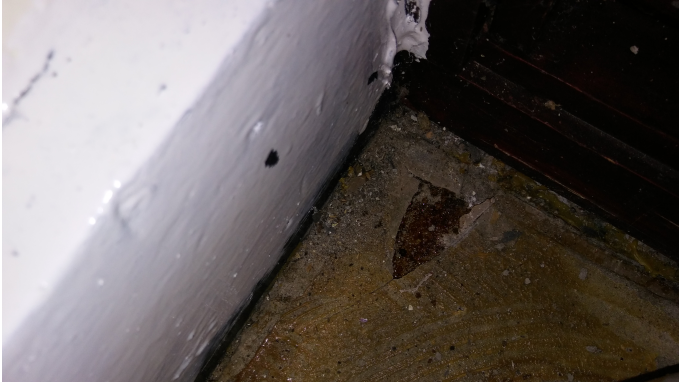
### **Item 22 Ref: 406601-17**

The floor beneath modern linoleum subfloor in 016/side entrance contains asbestos.

Any change in its appearance should be recorded and passed to Property Services.

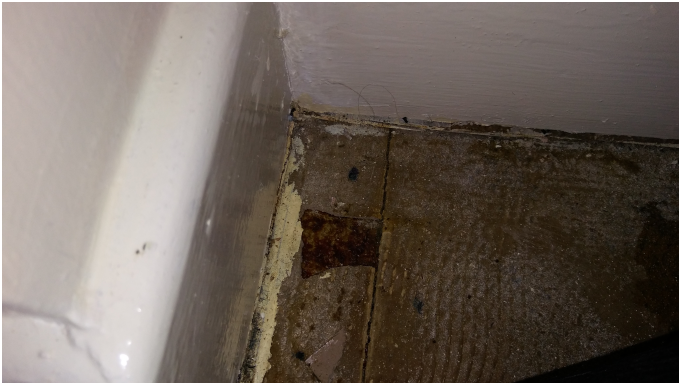
### **Item 23 Ref: As 406601-17**

The subfloor in 017/Store contains asbestos.

Any change in its appearance should be recorded and passed to Property Services.

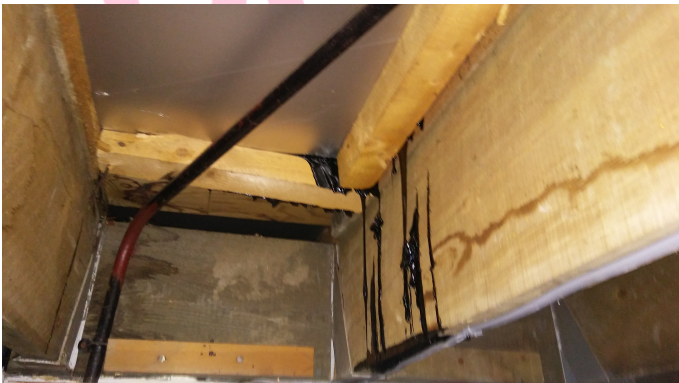
### **Item 24 Ref: As 406601-5**

The remnant roof sealant to wood beams in 017/Store void above does not contain asbestos.

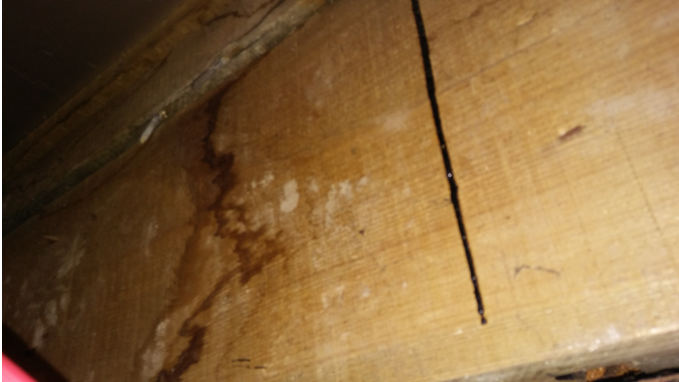
### **Item 25 Ref: As 406601-5**

The remnant roof sealant to wood beams in 018/Kitchen void above does not contain asbestos.

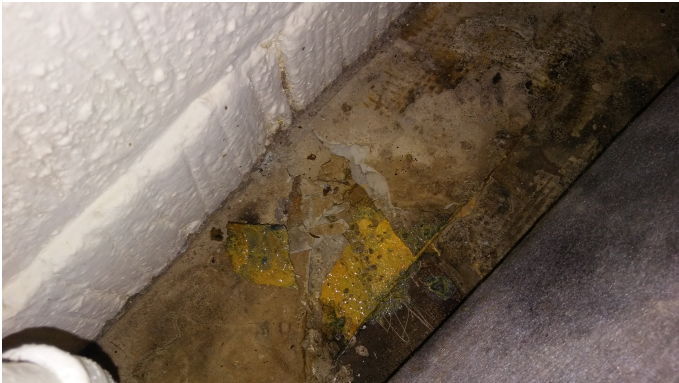
### **Item 26 Ref: 406601-14**

The subfloor in 019/WC contains asbestos.

Any change in its appearance should be recorded and passed to Property Services.

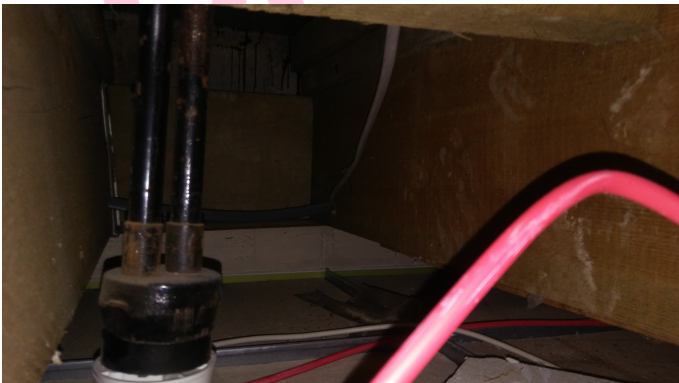
### **Item 27 Ref: As 406601-5**

The remnant roof sealant to wood beams in 019/WC void above does not contain asbestos.

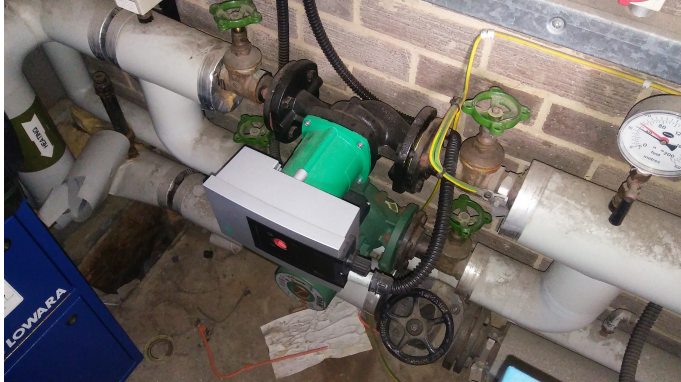
### **Item 28 Ref: 406601-15**

The pipework flange gasket in 020/Boiler Room does not contain asbestos.

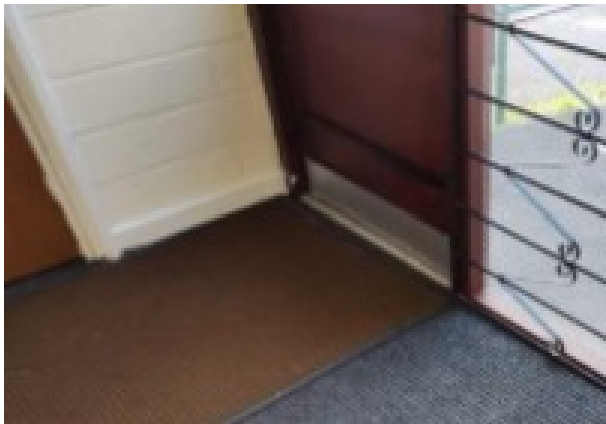
### **Item 29 Ref: 20-28493-1**

The tiles under the screed in the Entrance Hall does contain asbestos.

Any change in appearance should be reported to Property Services.

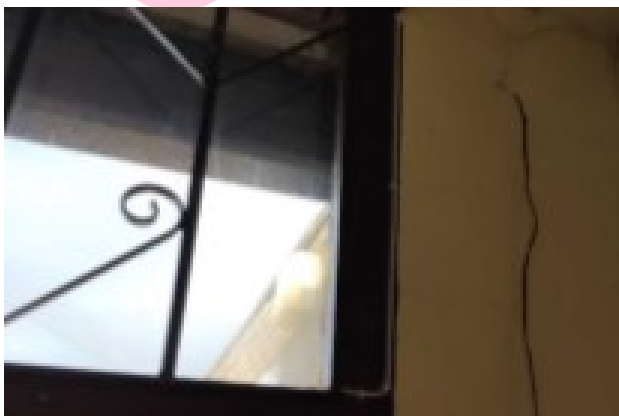
### **Item 30 Ref: 20-28493-2**

The putty sealant to the door frame in the Entrance Hall does not contain asbestos.

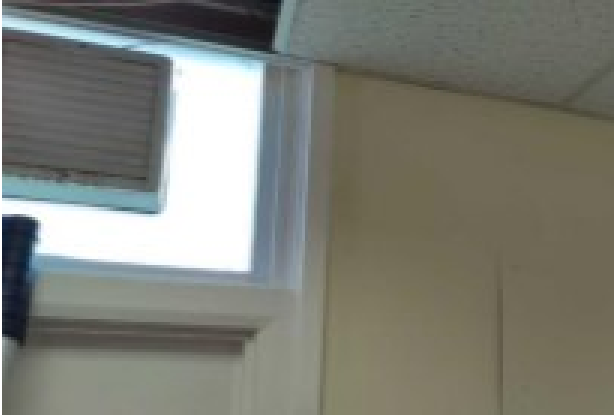
### **Item 31 Ref: 20-28493-3**

The backing paper to fibreboard behind plasterboard in the Annexe (fire exit) does not contain asbestos.

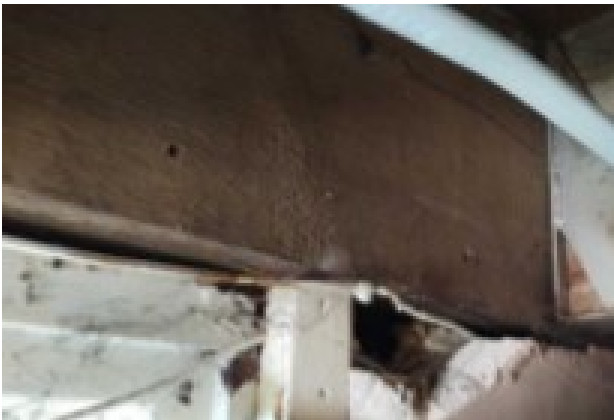
### **Item 32 Ref: As 20-28493-3**

The backing paper to fibreboard behind plasterboard in the Annexe (fire exit) does not contain asbestos.

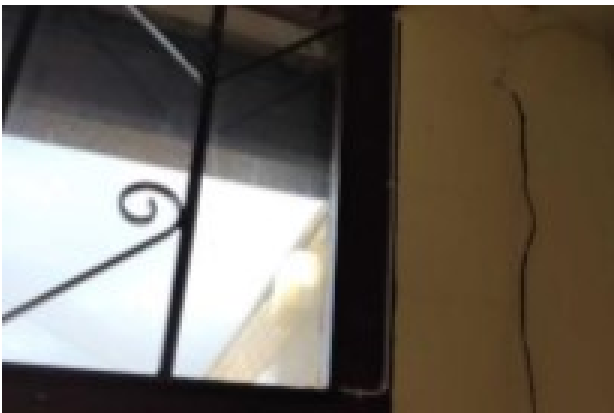
### **Item 33 Ref: 20-28493-4**

The putty sealant to the frame (externally) does not contain asbestos.

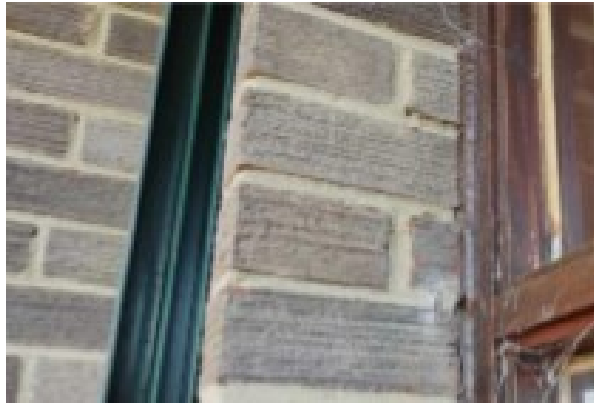
**Item 34 Ref: As 20-28493-4**

The residual putty sealant to the brickwork (Externally) does not contain asbestos.

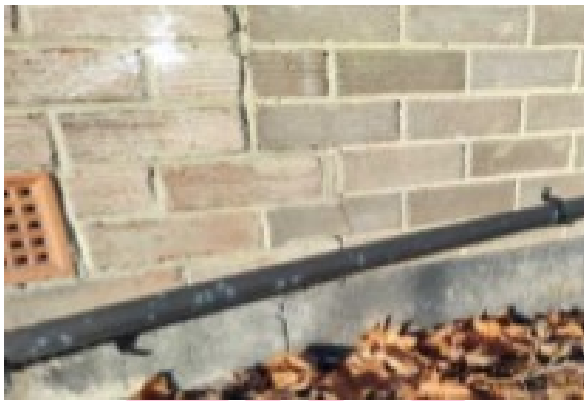
**Item 35 Ref: 20-28493-5**

The bitumen paint as low level walls (Externally) does not contain asbestos.

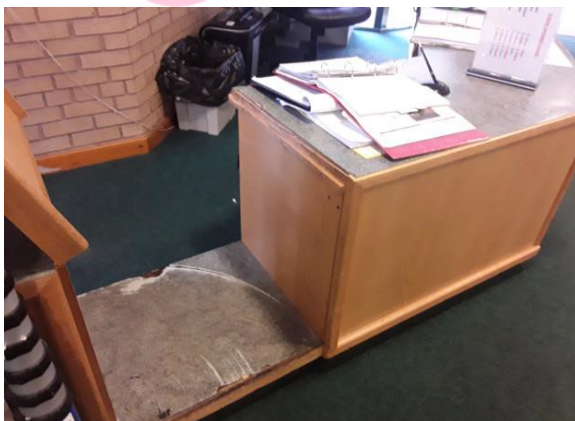
**Item 36 Ref: 21-35078-2**

The covering to main reception desk (Area 6/Reception area) does not contain asbestos.

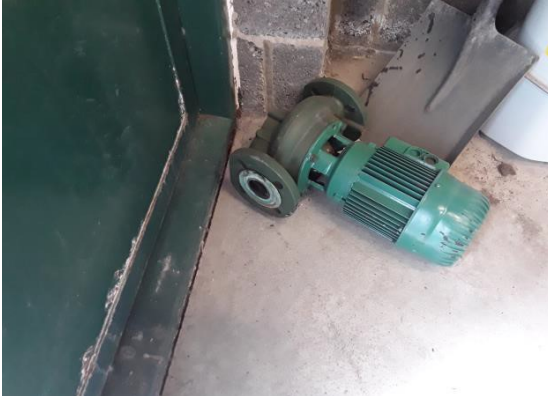
**Item 40 Ref: 21-35078-11**

The redundant pump flange gasket to floor (Area 36/Boiler Room) does not contain asbestos.

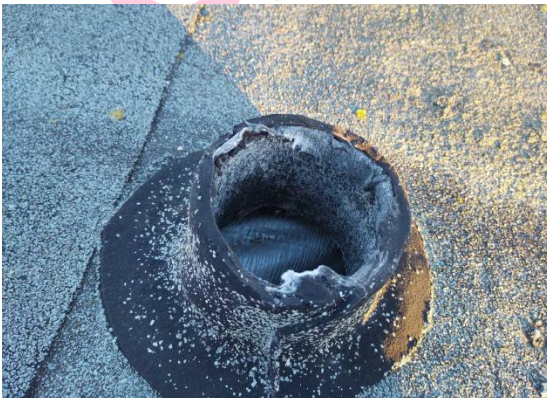
**Item 48 Ref: 22-41633-1**

The flue (Area: 1 Roof 1) contains asbestos.

Any change in appearance should be reported to Property Services.

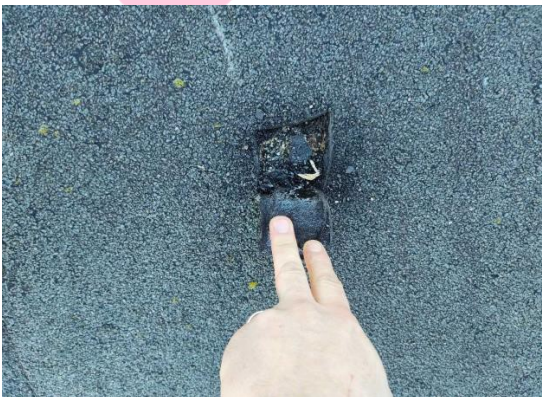
**Item 51 Ref: 22-41633-4**

The floor - felt roof (Bitumen)  
(Area: 1 Roof 1) does not  
contain asbestos.

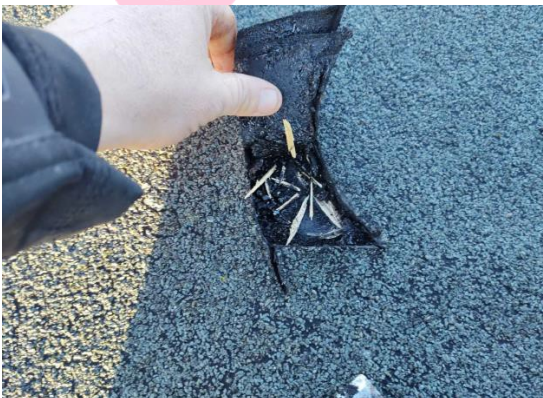
**Item 54 Ref: 22-41633-7**

The floor - felt roof (Bitumen)  
(Area: 1 Roof 1) does not  
contain asbestos.

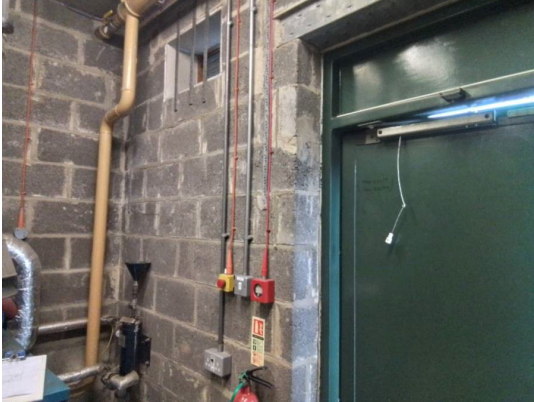
### Item 67 Ref: PZ000780

The wall panel around venting (Boiler Room E/001) does not contain asbestos.

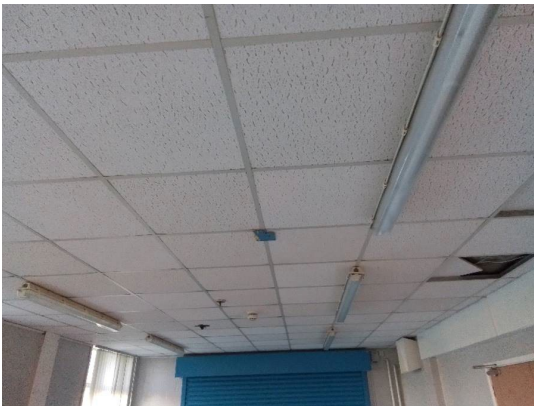
**Item 71 Ref: As PZ000781**

The debris adhesive to woodwool block (Room G/004) (Older Building – The Oval) does not contain asbestos.

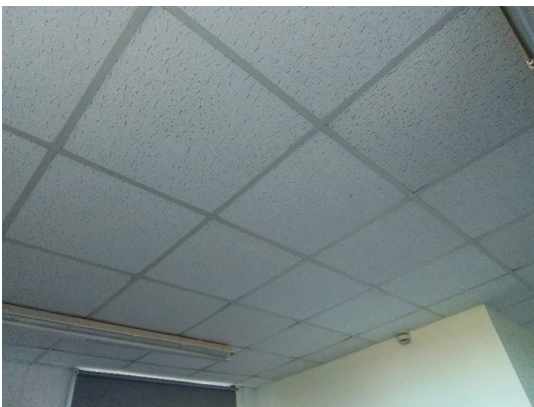
**Item 72 Ref: As PZ000781**

The debris adhesive to woodwool block (Kitchen G/005) (Older Building – The Oval) does not contain asbestos.

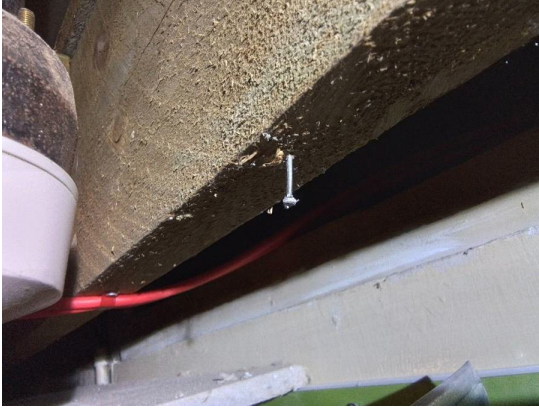
**Item 76 Ref: PZ000785**

The debris within nail holes (Kitchen G/010) (Older Building – The Oval) contains asbestos.

Any change in appearance should be reported to Property Services.

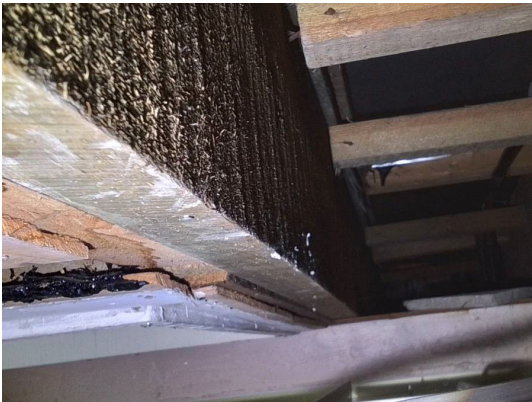
**Item 77 Ref: As PZ000785**

The debris within nail holes (Toilets G/011) (Older Building – The Oval) contains asbestos.

Any change in appearance should be reported to Property Services.

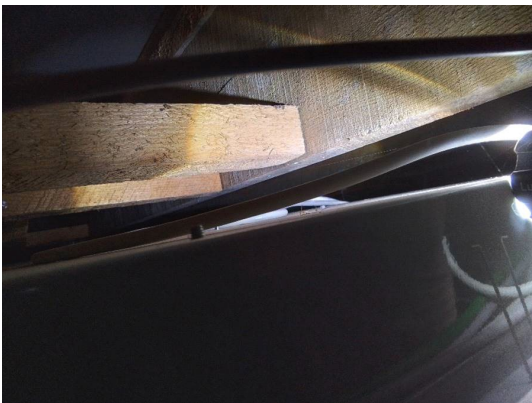
**Item 78 Ref: As PZ000785**

The debris within nail holes (Room Large G/012) (Older Building – The Oval) contains asbestos.

Any change in appearance should be reported to Property Services.

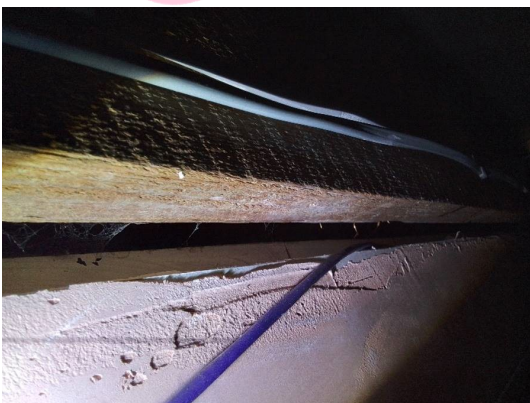
### Item 81 Ref: As PZ000785

The debris within nail holes (Room Small G/013) (Older Building – The Oval) contains asbestos.

Any change in appearance should be reported to Property Services.

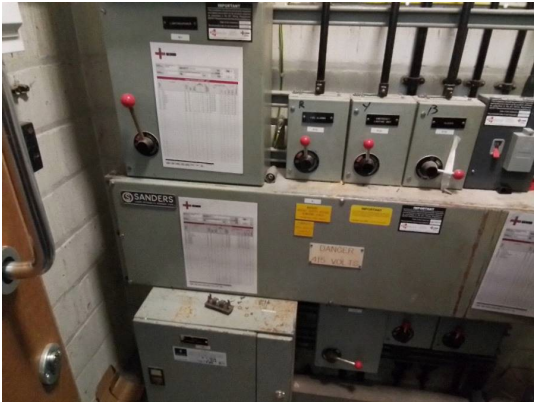
### **Item 83 Ref: PZ000786**

The electrical services (Cupboard Electrical G/015) (Older Building – The Oval) contains asbestos.

Any change in appearance should be reported to Property Services.

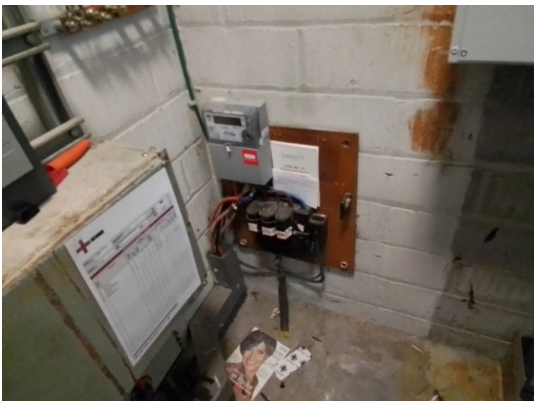
### **Item 84 Ref: Presumed**

The cable braiding/insulation (Cupboard Electrical G/015) (Older Building – The Oval) contains asbestos.

Any change in appearance should be reported to Property Services.

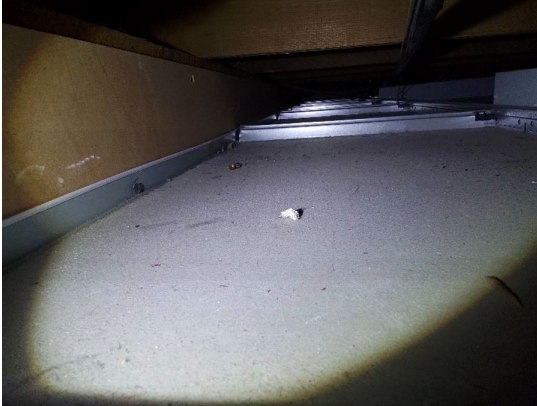
### Item 85 Ref: As PZ000787

The debris to beams nail holes and lying on tiles (Office G/016) (Older Building – The Oval) contains asbestos.

Any change in appearance should be reported to Property Services.

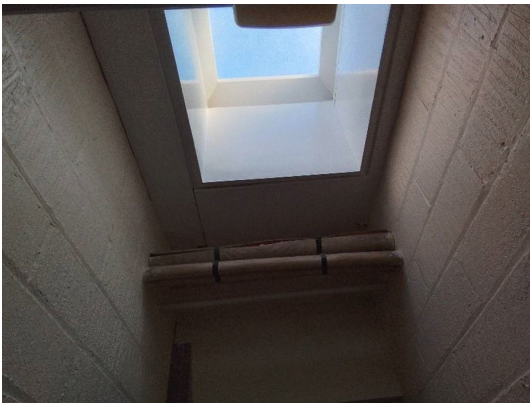
**Item 89 Ref: As PZ000788**

The ceiling (Female Toilets G/019) (Older Building – The Oval) contains asbestos.

Any change in appearance should be reported to Property Services.

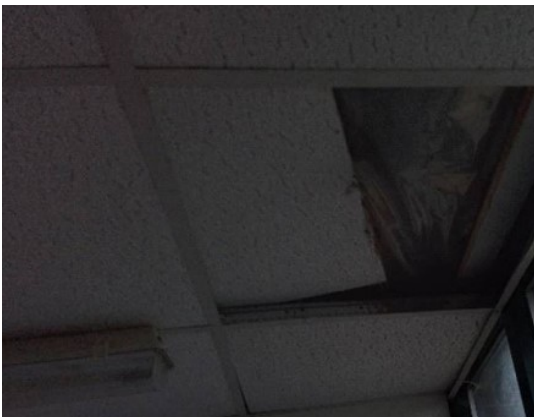
**Item 93 Ref: RN000224**

The Debris (Kitchen G/001) (Active Families Hub) does not contain asbestos.

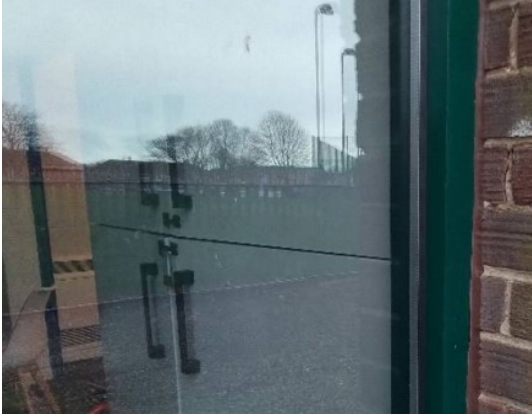
**Item 94 Ref: PZ000789**

The door seal/gasket (Kitchen G/001) (Active Families Hub) does not contain asbestos.

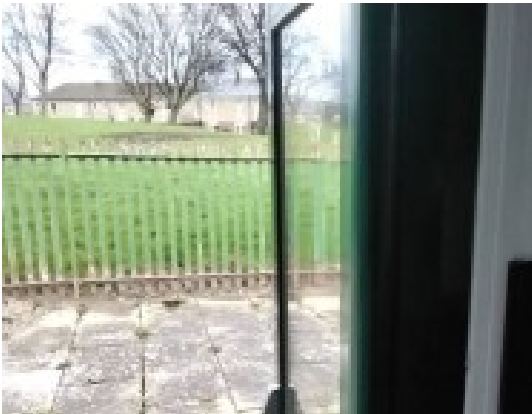
**Item 95 Ref: AW005449**

The door frame sealant (Activities Room G/001) (Active Families Hub) does not contain asbestos.

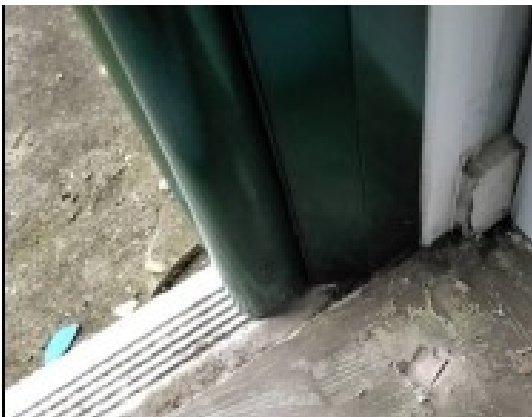
**Item 96 Ref: AW005451**

The floor tile with adhesive (Activities Room G/001) (Active Families Hub) does not contain asbestos.

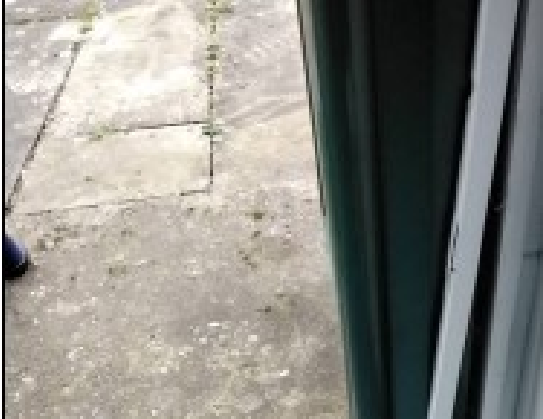
**Item 97 Ref: AW005455**

The wall – void/cavity damp proof course (Activities Room G/001) (Active Families Hub) does not contain asbestos.

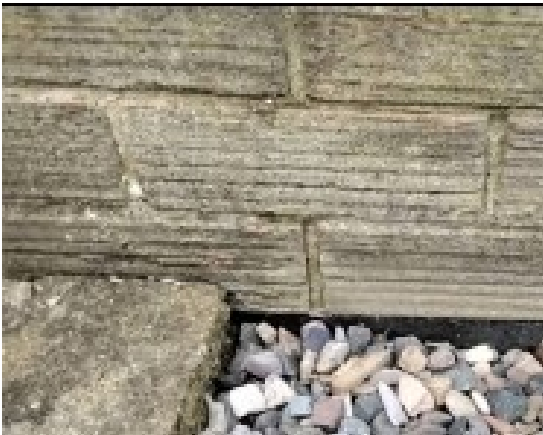
**Item 98 Ref: AW005452**

The damp proof course (External) (Active Families Hub) does not contain asbestos.

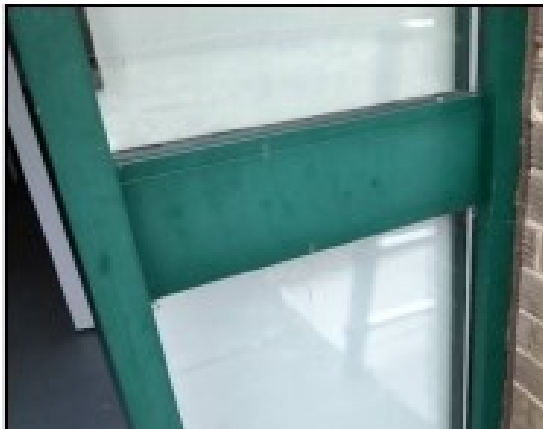
**Item 99 Ref: AW005453**

The door frame sealant (External) (Active Families Hub) does not contain asbestos.

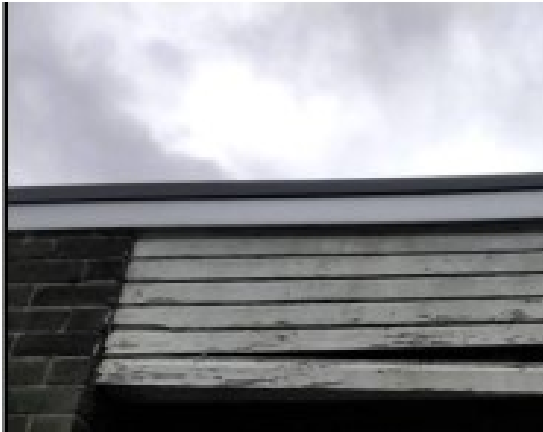
### **Item 100 Ref: AW005454**

The door vapour barrier within heading boxing (External) (Active Families Hub) does not contain asbestos.

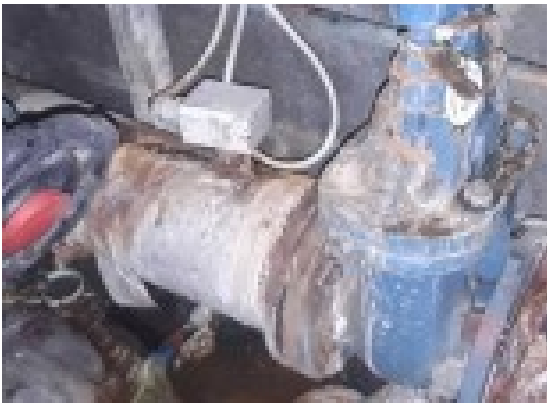
### **Item 101 Ref: NZ001264**

The pipework gasket to bottom pipework V28 left side (Boiler Room G/001 – The Oval) does contain asbestos.

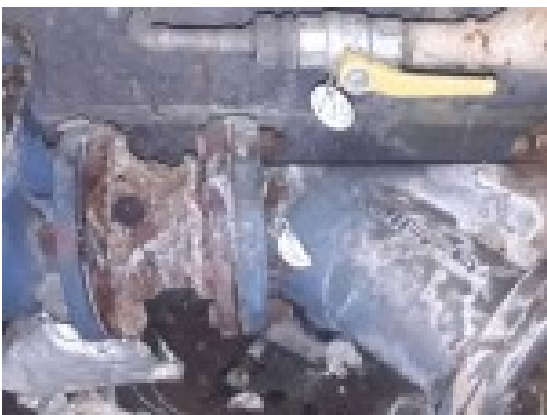
### **Item 102 Ref: NZ001265**

The pipework gasket to bottom pipework V28 right side (Boiler Room G/001 – The Oval) does contain asbestos.

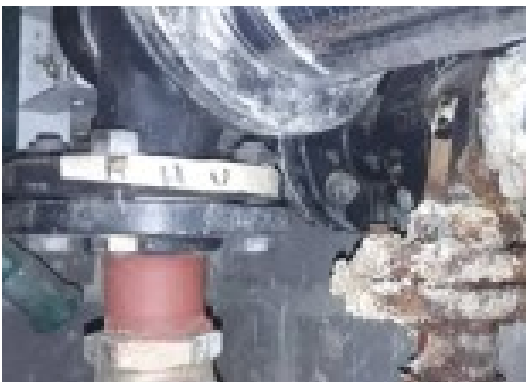
**Item 111 Ref: NZ001274**

- (Item 111) Ref: NZ001274 – Pipework Gasket to pipework right of V21 rusting black pipework (Boiler Room G/001 The Oval Building) – Removed May 2024
- (Item 112) Ref: NZ001275 – Debris/Residue to floor discarded gaskets within water and insulation (Boiler Room G/001 The Oval Building) – Low Risk

The pipework gasket to pipework right of V21 rusting lack pipework (Boiler Room G/001 – The Oval) does contain asbestos.

*Removed May 2024*

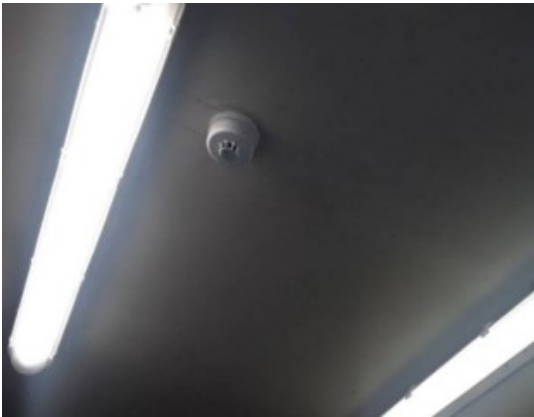
### **Item 113 Ref: NZ001276**

The ceiling (Boiler Room G/001 – The Oval) does not contain asbestos.

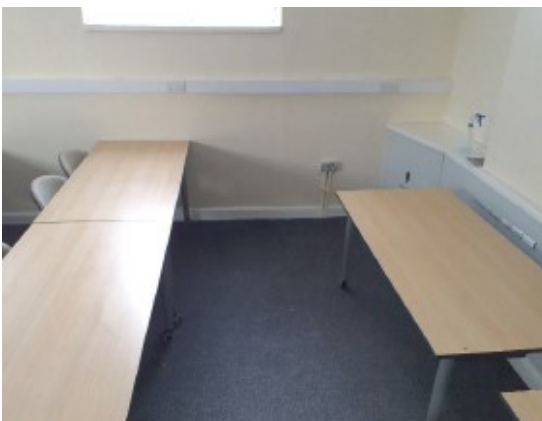
### **Item 114 Ref: RT000202**

The Beige vinyl floor tiles to floor below carpet and modern screed (Training Room G/01 The Oval Building) does contain asbestos.

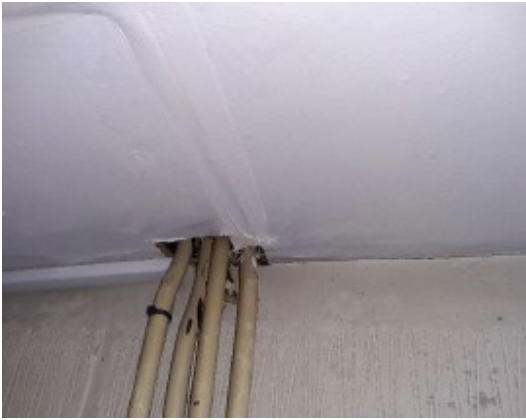
### **Item 115 Ref: RT000203**

The Paper lined fibreboard ceiling panels (Store G/02 The Oval Building) does contain asbestos.

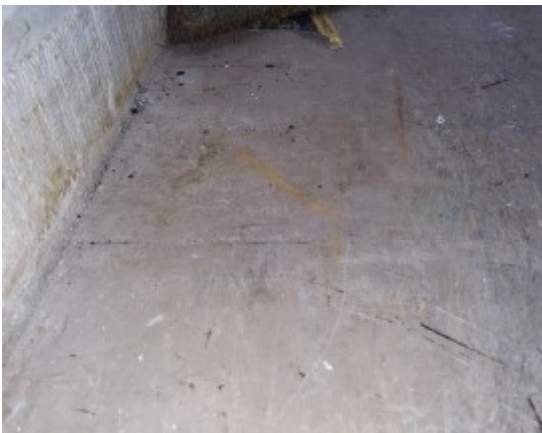
### **Item 116 Ref: As RT000202**

The Beige vinyl tiles to floor (Store G/02 The Oval Building) does contain asbestos.

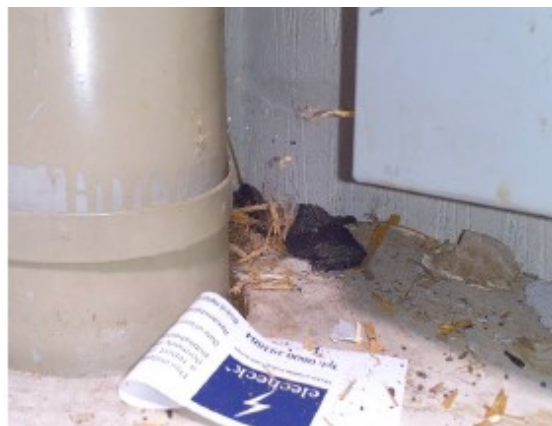
### **Item 117 Ref: RT000204**

The Felt/bitumen debris to shelf around waste pipe (Store G/02 The Oval Building) does contain asbestos.

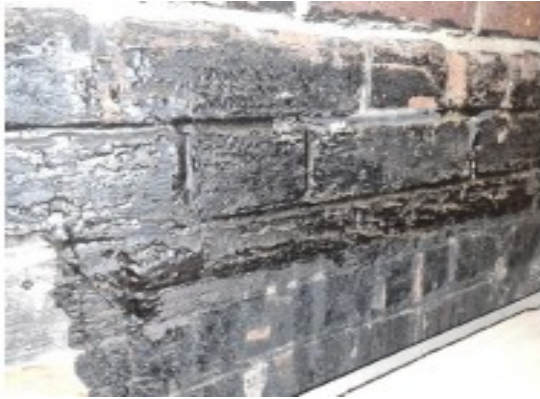
**Item 118 Ref: RT000803**

The bitumen adhesive to wall in void in Store 1 (G/01) does not contain asbestos.
