### **ASBESTOS SURVEY REPORT FOR WASHINGTON MILLENIUM CENTRE LIBRARY/THE OVAL, WASHINGTON, NE37 2QD.**

## **Asbestos Register for Washington Millennium Centre, Washington, NE37 2QD**

**Date: 23 July 2025**

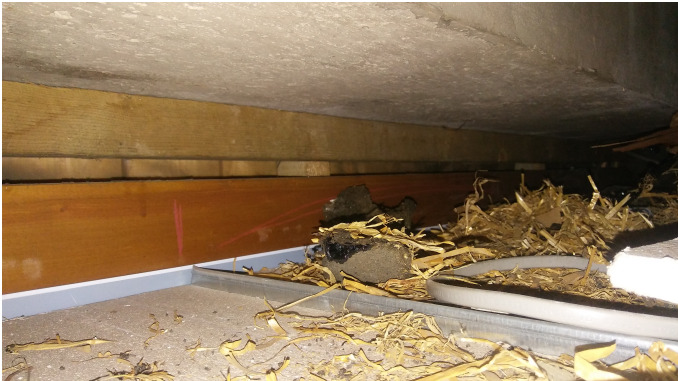
### **Item 2 Ref: 406601-2**

The debris above doors leading to 003 in 001/Entrance lobby void above contains asbestos.

Any change in its appearance should be recorded and passed to Property Services.

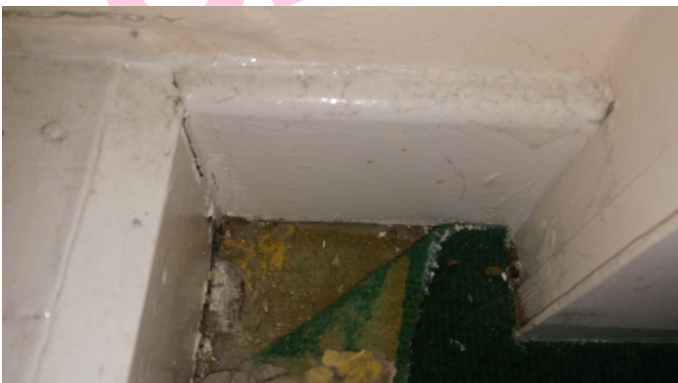
### **Item 3 Ref: 406601-11**

The sub floor covering in 002/Trust room contains asbestos.

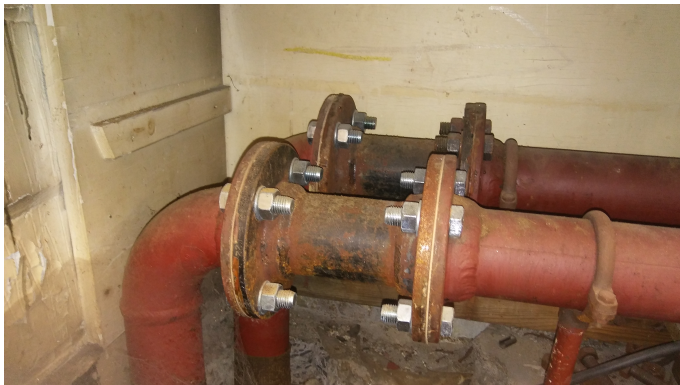
### **Item 5 Ref: 406601-4**

The pipework flange gasket in 009/Training room does not contain asbestos.

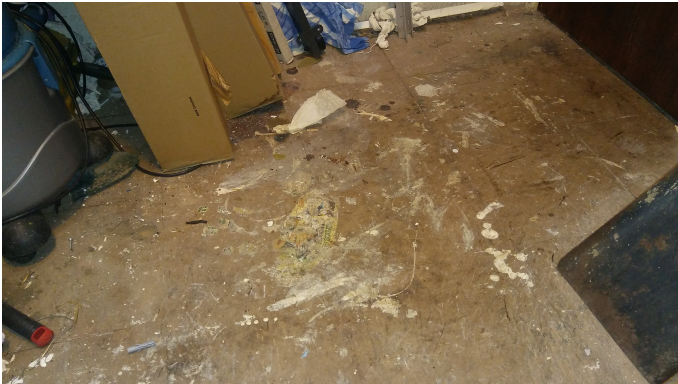
### **Item 7 Ref: 406601-12**

The floor covering in 010/Store contains asbestos.

Any change in its appearance should be recorded and passed to Property Services.

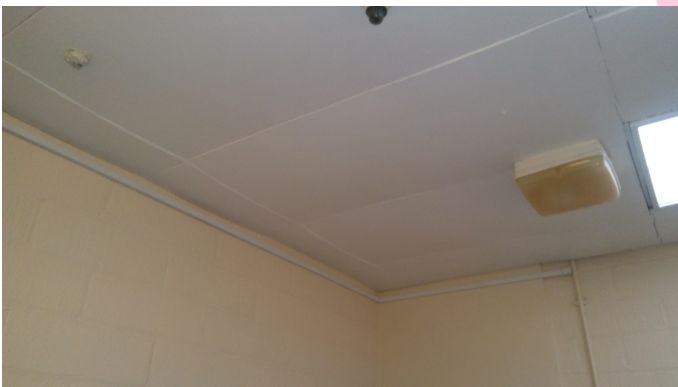
### **Item 8 Ref: As 406601-3**

The fixed suspended ceiling in 011/Female WC contains asbestos.

*Removed July 2021*

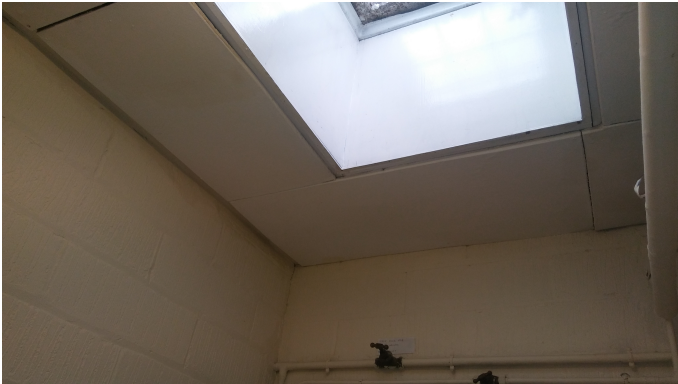
### **Item 10 Ref: 406601-3**

The fixed suspended ceiling in 013/Accessible WC contains asbestos.

Any change in its appearance should be recorded and passed to Property Services.

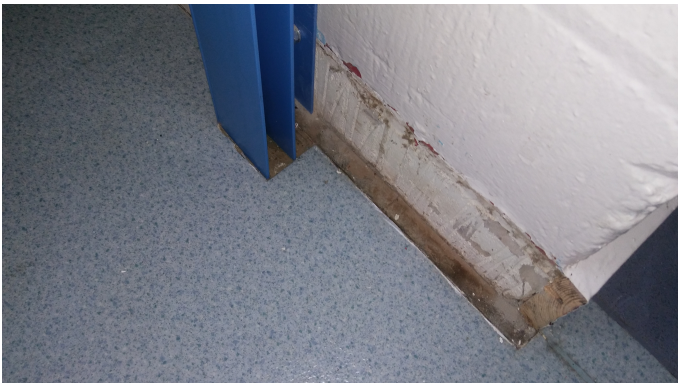
### **Item 11 Ref: As 406601-15**

The subfloor in 014/Activity room does not contain asbestos.

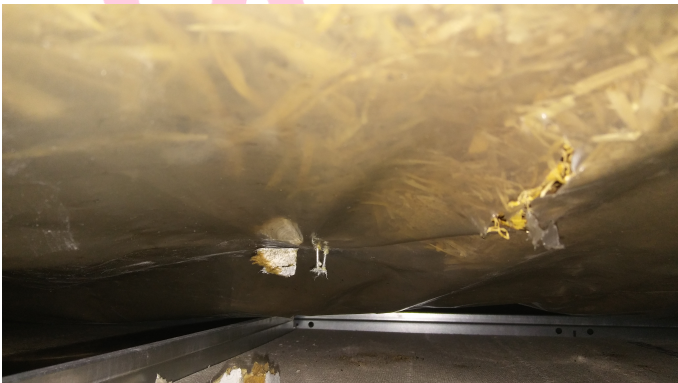
### **Item 12 Ref: 406601-6**

The remnant ceiling tiles in 014/Activity room void above contains asbestos.

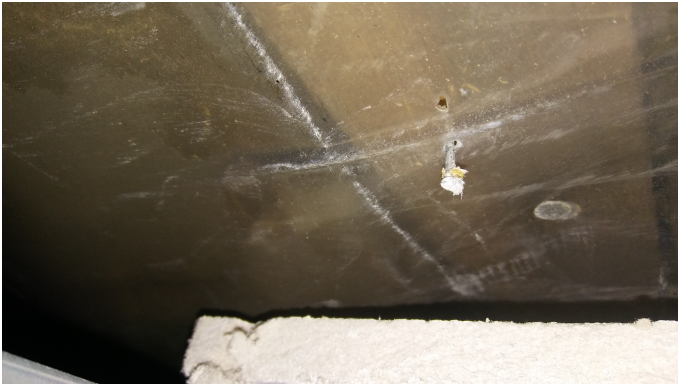
### **Item 13 Ref: 406601-7**

The debris to nails from previous fibreboard ceiling in 014/Activity room void above contains asbestos.

Any change in its appearance should be recorded and passed to Property Services.

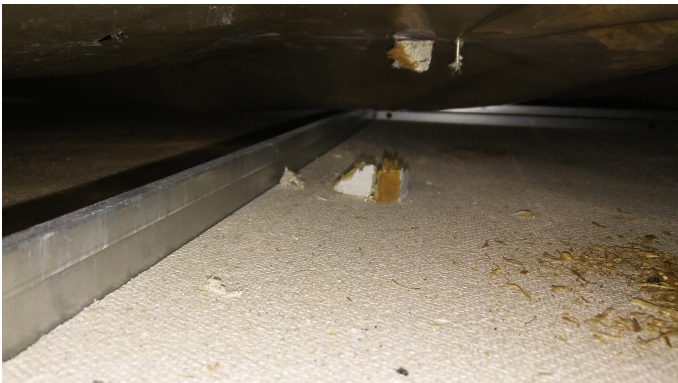
### **Item 14 Ref: 406601-8**

The debris to topside of suspended ceiling tiles below in 014/Activity room void above contains asbestos.

Any change in its appearance should be recorded and passed to Property Services.

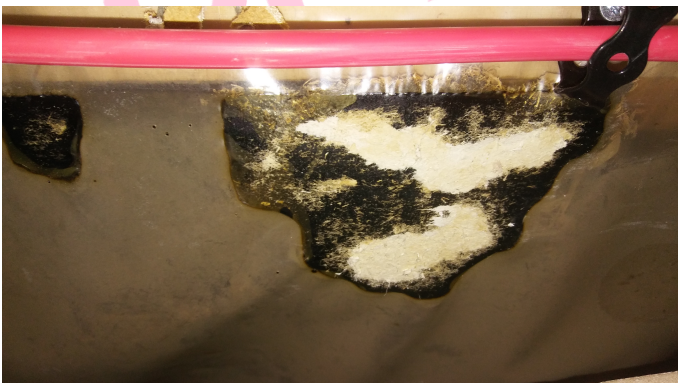
### **Item 15 Ref: 406601-10**

The debris to bitumen on polythene sheeting in 014/Activity room void above contains asbestos.

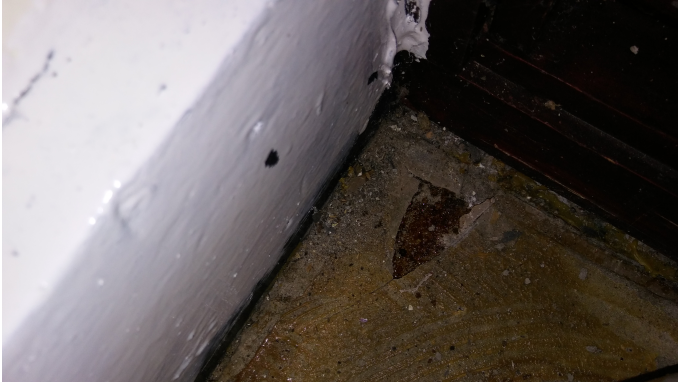
#### **Item 22 Ref: 406601-17**

The floor beneath modern linoleum subfloor in 016/side entrance contains asbestos.

Any change in its appearance should be recorded and passed to Property Services.

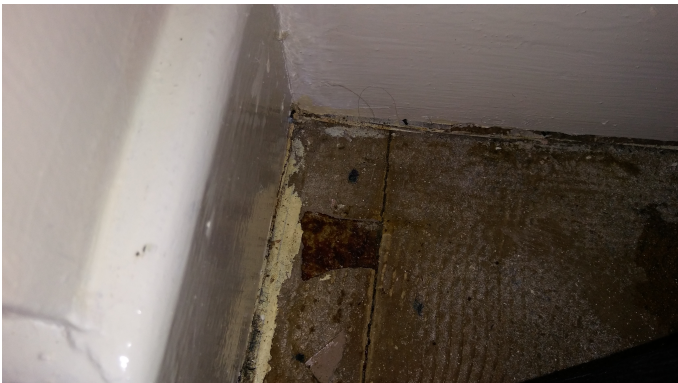
#### **Item 23 Ref: As 406601-17**

The subfloor in 017/Store contains asbestos.

Any change in its appearance should be recorded and passed to Property Services.

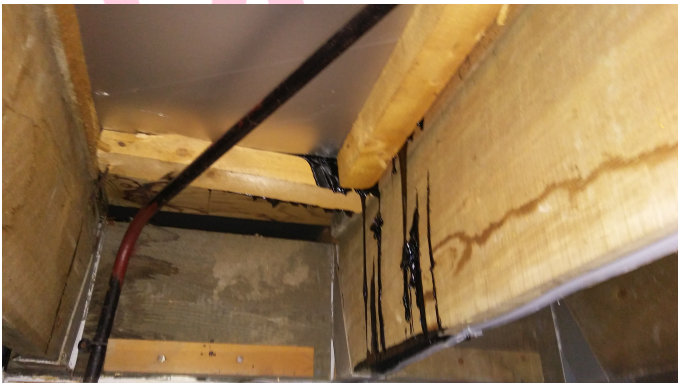
#### **Item 24 Ref: As 406601-5**

The remnant roof sealant to wood beams in 017/Store void above does not contain asbestos.

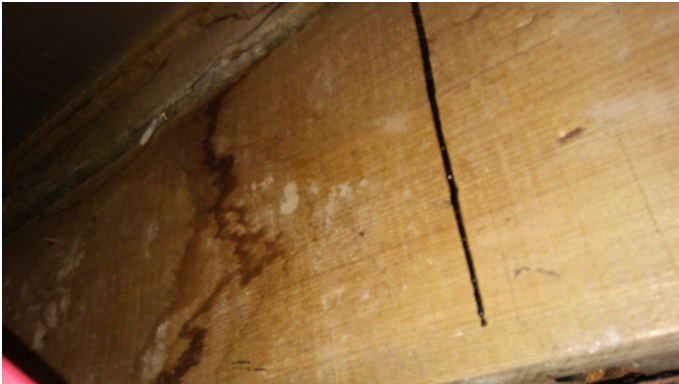
#### **Item 25 Ref: As 406601-5**

The remnant roof sealant to wood beams in 018/Kitchen void above does not contain asbestos.

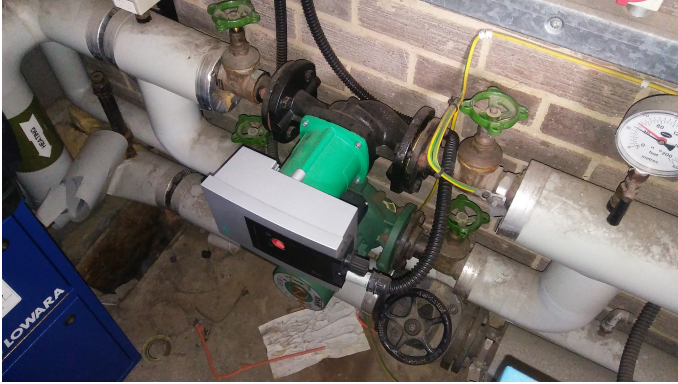
### **Item 28 Ref: 406601-15**

The pipework flange gasket in 020/Boiler Room does not contain asbestos.

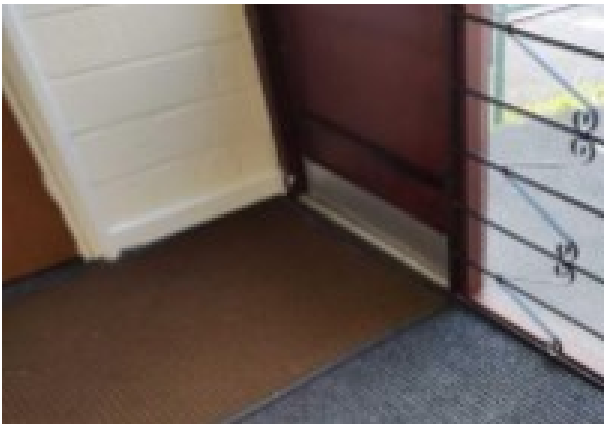
### **Item 29 Ref: 20-28493-1**

The tiles under the screed in the Entrance Hall does contain asbestos.

Any change in appearance should be reported to Property Services.

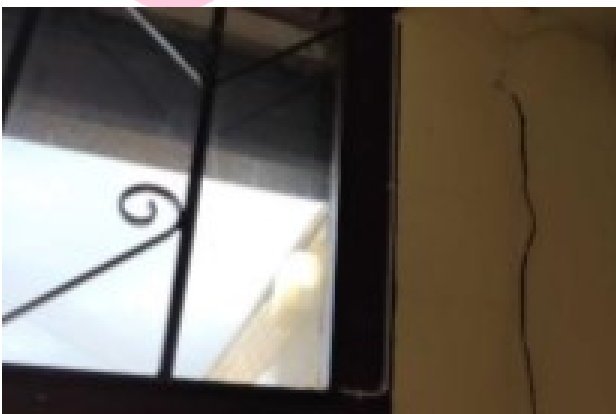
### **Item 30 Ref: 20-28493-2**

The putty sealant to the door frame in the Entrance Hall does not contain asbestos.

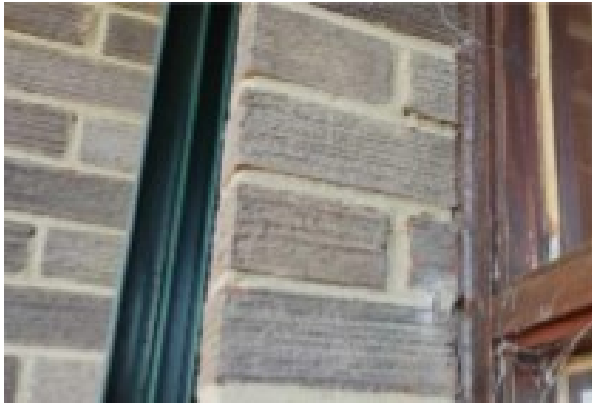
**Item 34 Ref: As 20-28493-4**

The residual putty sealant to the brickwork (Externally) does not contain asbestos.

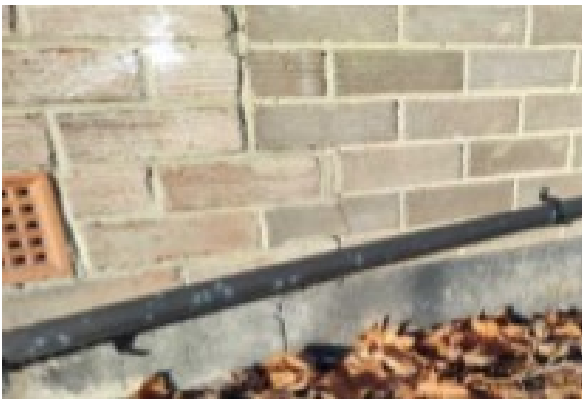
**Item 35 Ref: 20-28493-5**

The bitumen paint as low level walls (Externally) does not contain asbestos.

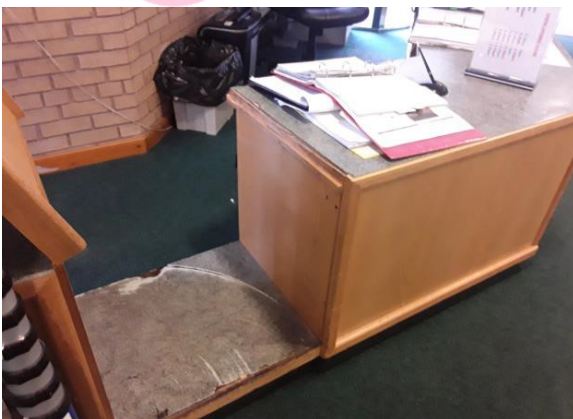
**Item 36 Ref: 21-35078-2**

The covering to main reception desk (Area 6/Reception area) does not contain asbestos.

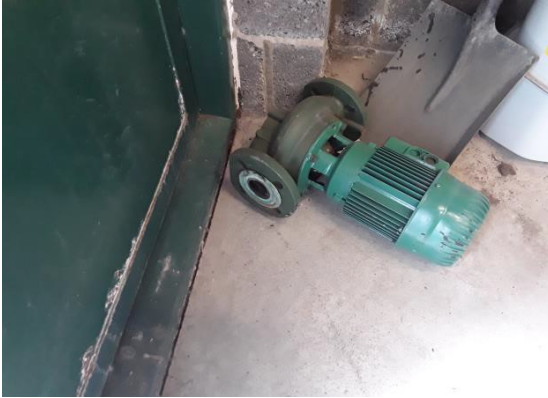
### **Item 40 Ref: 21-35078-11**

The redundant pump flange gasket to floor (Area 36/Boiler Room) does not contain asbestos.

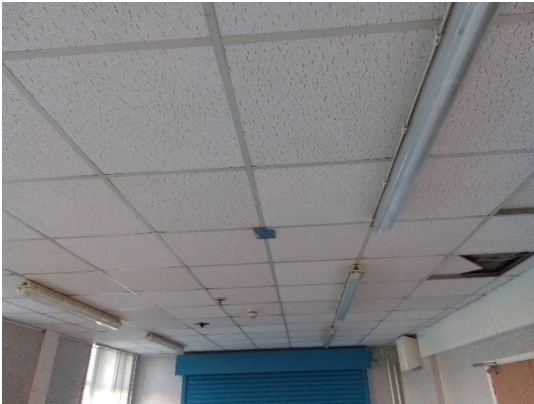
### **Item 71 Ref: As PZ000781**

The debris adhesive to woodwool block (Room G/004) (Older Building – The Oval) does not contain asbestos.

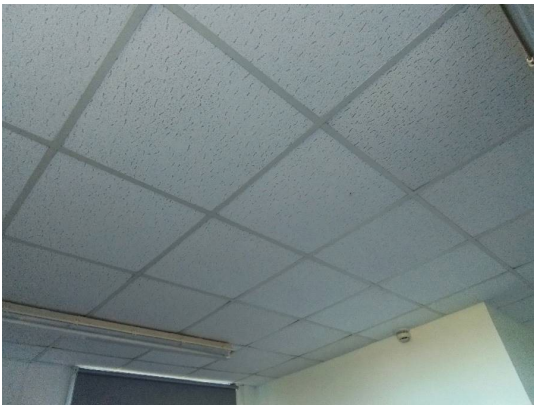
### **Item 72 Ref: As PZ000781**

The debris adhesive to woodwool block (Kitchen G/005) (Older Building – The Oval) does not contain asbestos.

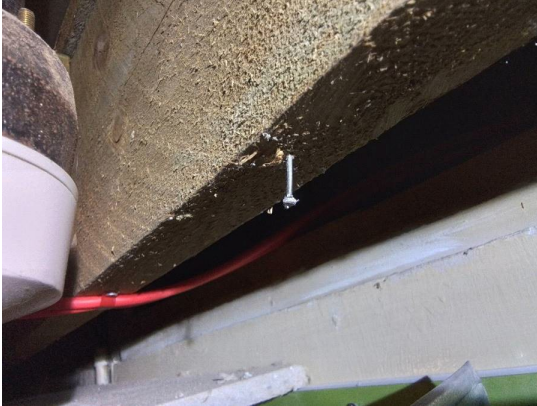
### **Item 76 Ref: PZ000785**

The debris within nail holes (Kitchen G/010) (Older Building – The Oval) contains asbestos.

Any change in appearance should be reported to Property Services.

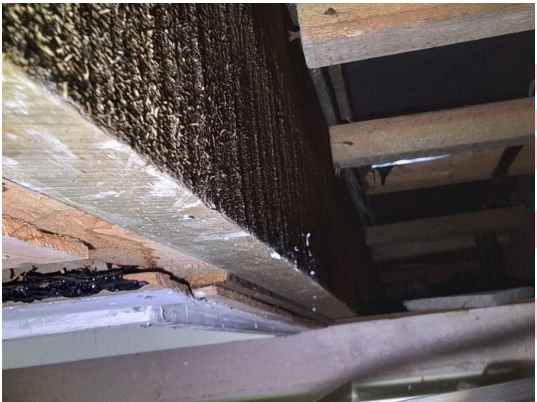
### **Item 77 Ref: As PZ000785**

The debris within nail holes (Toilets G/011) (Older Building – The Oval) contains asbestos.

Any change in appearance should be reported to Property Services.

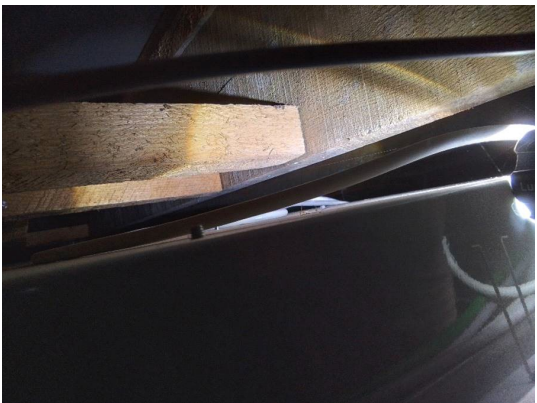
### **Item 78 Ref: As PZ000785**

The debris within nail holes (Room Large G/012) (Older Building – The Oval) contains asbestos.

Any change in appearance should be reported to Property Services.

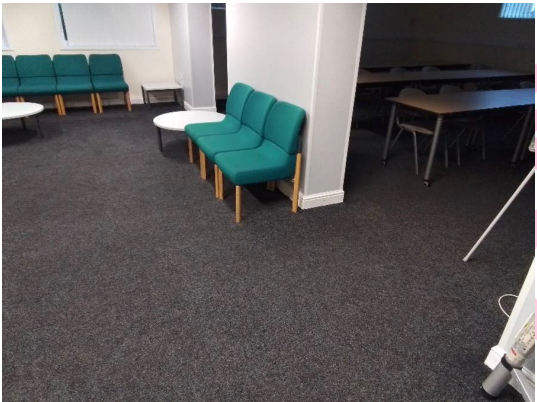
### **Item 86 Ref: As PZ000782**

The floor adhesive (Room Large G/017) (Older Building – The Oval) contains asbestos.

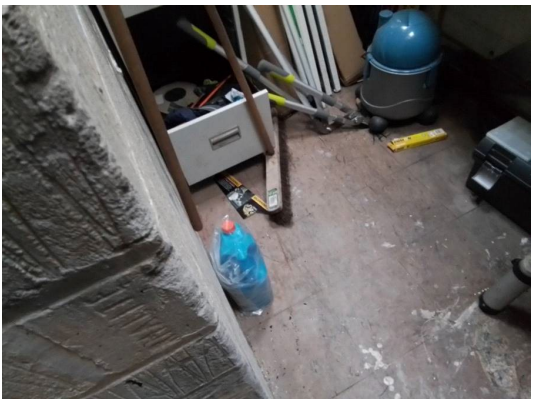
### **Item 87 Ref: As PZ000784**

The floor tile with adhesive (Beige) (Cupboard Electrical G/018) (Older Building – The Oval) does not contain asbestos.

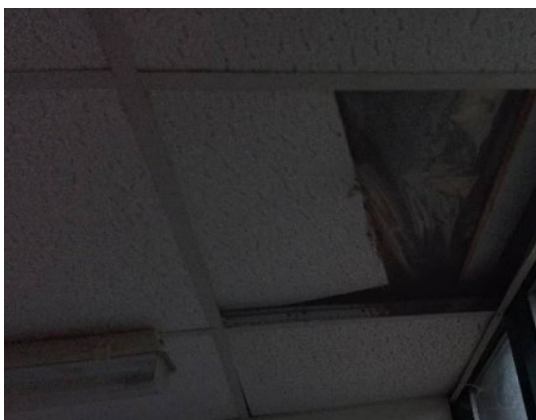
### **Item 93 Ref: RN000224**

The Debris (Kitchen G/001) (Active Families Hub) does not contain asbestos.

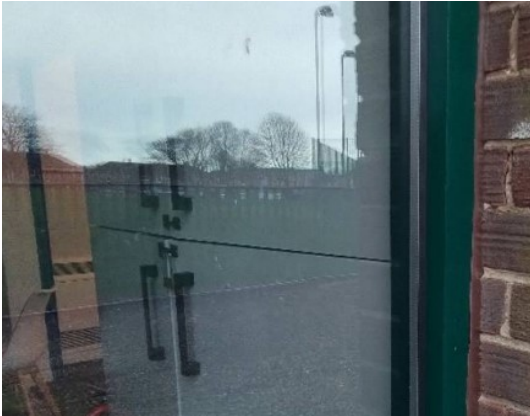
### **Item 94 Ref: PZ000789**

The door seal/gasket (Kitchen G/001) (Active Families Hub) does not contain asbestos.

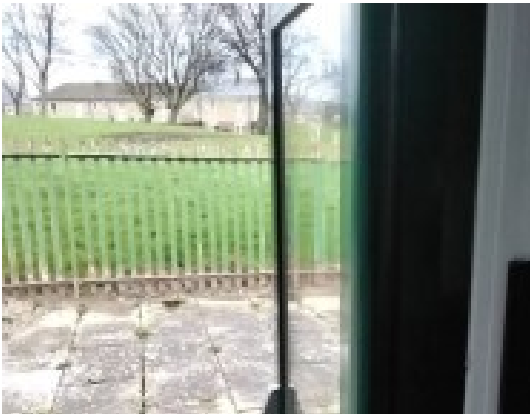
### **Item 95 Ref: AW005449**

The door frame sealant (Activities Room G/001) (Active Families Hub) does not contain asbestos.

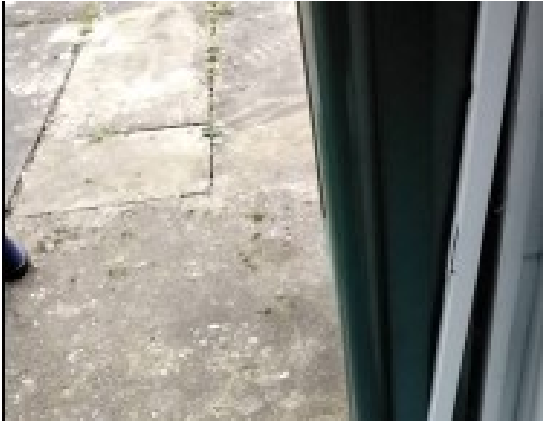
### **Item 97 Ref: AW005455**

The wall – void/cavity damp proof course (Activities Room G/001) (Active Families Hub) does not contain asbestos.

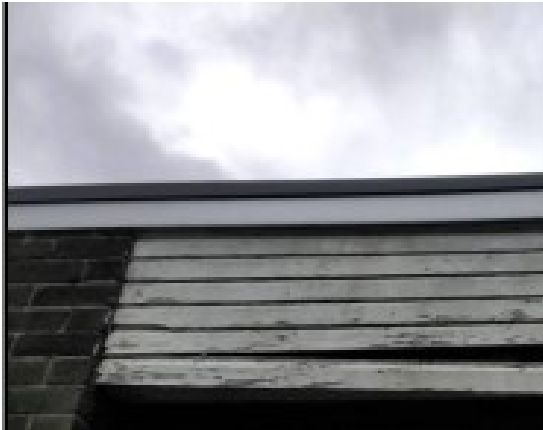
### **Item 100 Ref: AW005454**

The door vapour barrier within heading boxing (External) (Active Families Hub) does not contain asbestos.

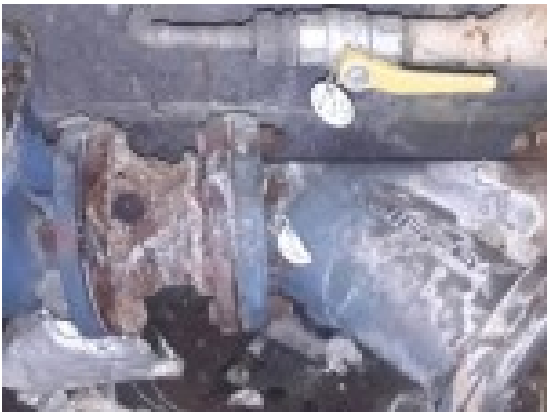
### **Item 102 Ref: NZ001265**

The pipework gasket to bottom pipework V28 right side (Boiler Room G/001 – The Oval) does contain asbestos.

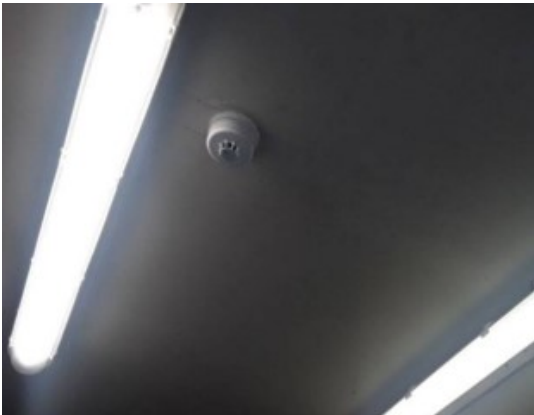
### **Item 113 Ref: NZ001276**

The ceiling (Boiler Room  
G/001 – The Oval) does not  
contain asbestos.

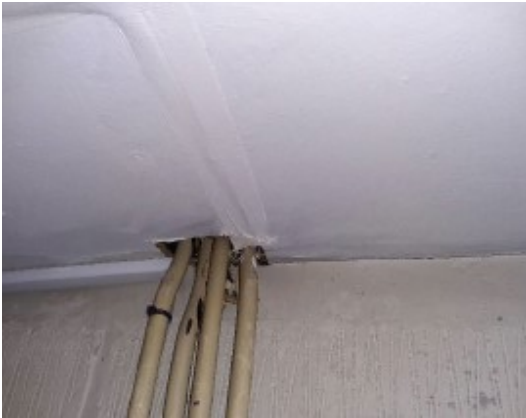
### **Item 115 Ref: RT000203**

The Paper lined fibreboard ceiling panels (Store G/02 The Oval Building) does contain asbestos.

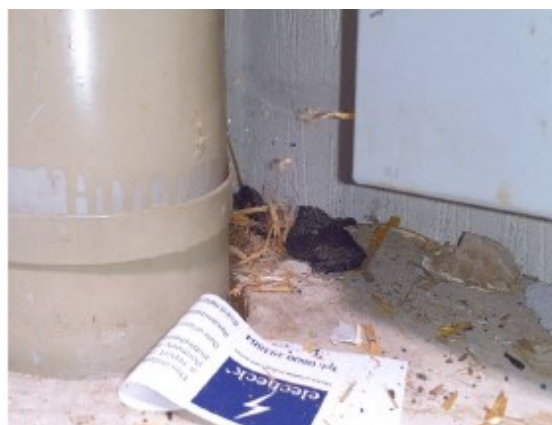
### **Item 117 Ref: RT000204**

The Felt/bitumen debris to shelf around waste pipe (Store G/02 The Oval Building) does contain asbestos.
