ASBESTOS SURVEY REPORT FOR WASHINGTON MILLENIUM CENTRE LIBRARY/THE OVAL, WASHINGTON, NE37 2QD.

Asbestos Register for

Washington Millennium Centre, Washington, NE37 2QD

Date: 19 June 2025

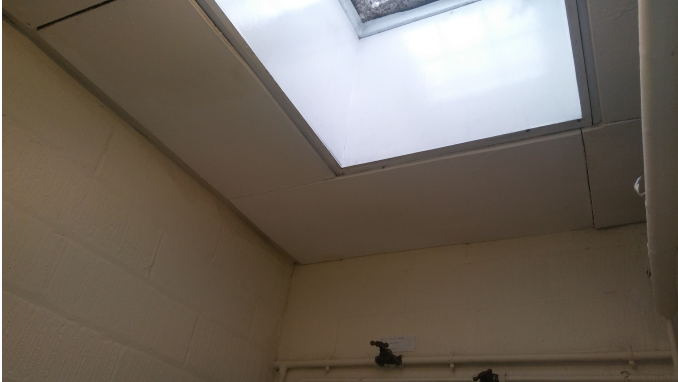
Item 10 Ref: 406601-3

The fixed suspended ceiling in 013/Accessible WC contains asbestos.

Any change in its appearance should be recorded and passed to Property Services.

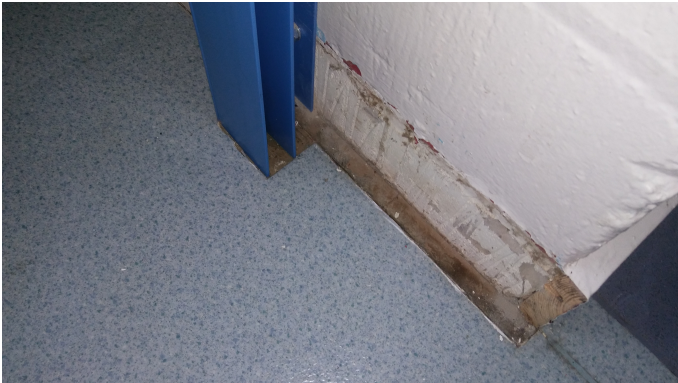
Item 11 Ref: As 406601-15

The subfloor in 014/Activity room does not contain asbestos.

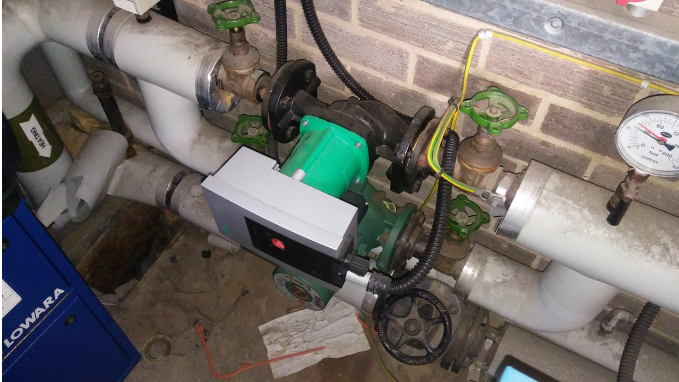
Item 28 Ref: 406601-15

The pipework flange gasket in 020/Boiler Room does not contain asbestos.

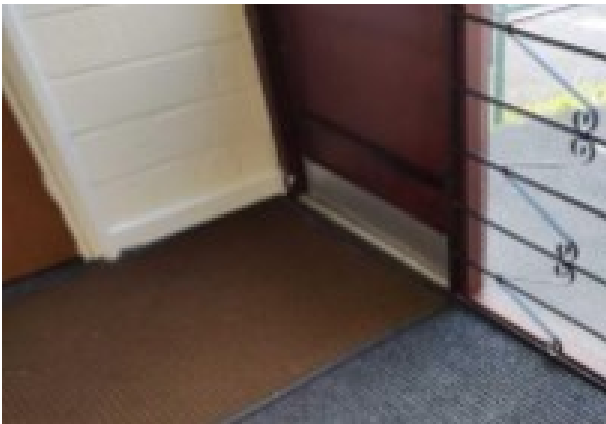
Item 29 Ref: 20-28493-1

The tiles under the screed in the Entrance Hall does contain asbestos.

Any change in appearance should be reported to Property Services.

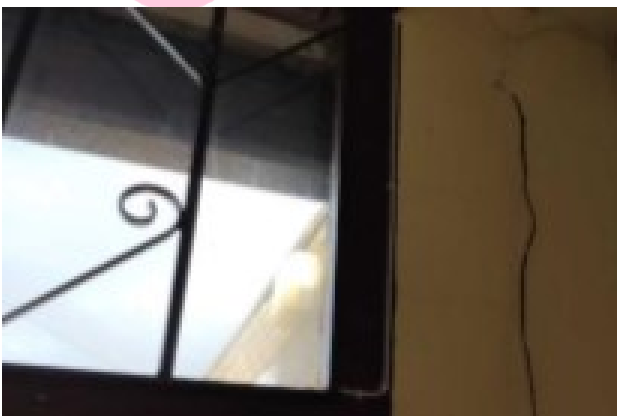
Item 30 Ref: 20-28493-2

The putty sealant to the door frame in the Entrance Hall does not contain asbestos.

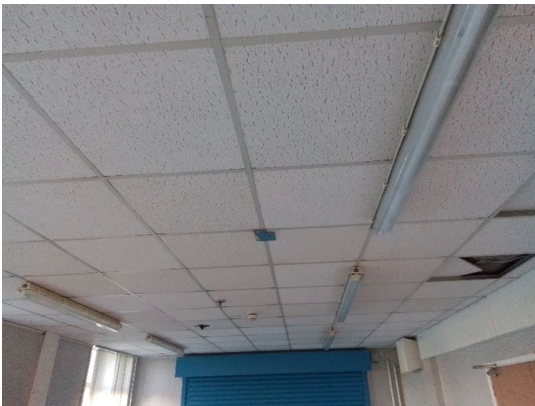
Item 71 Ref: As PZ000781

The debris adhesive to woodwool block (Room G/004) (Older Building – The Oval) does not contain asbestos.

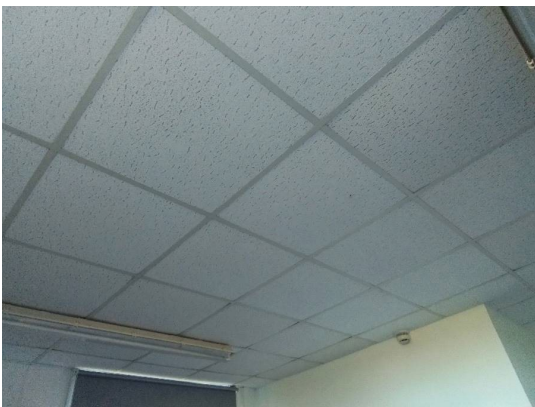
Item 72 Ref: As PZ000781

The debris adhesive to woodwool block (Kitchen G/005) (Older Building – The Oval) does not contain asbestos.

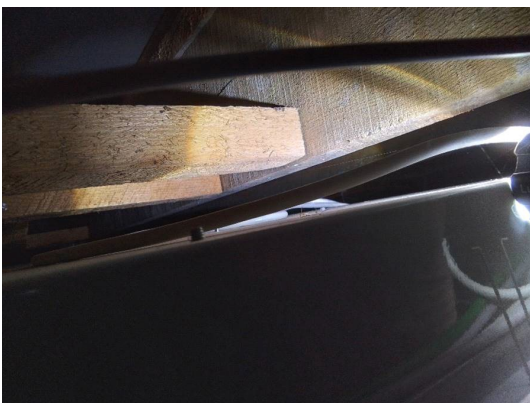
Item 78 Ref: As PZ000785

The debris within nail holes (Room Large G/012) (Older Building – The Oval) contains asbestos.

Any change in appearance should be reported to Property Services.

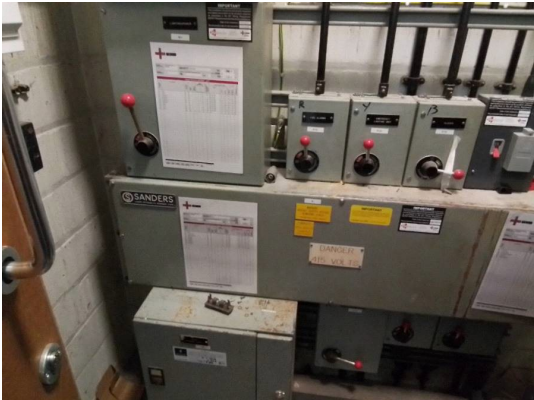
Item 83 Ref: PZ000786

The electrical services (Cupboard Electrical G/015) (Older Building – The Oval) contains asbestos.

Any change in appearance should be reported to Property Services.

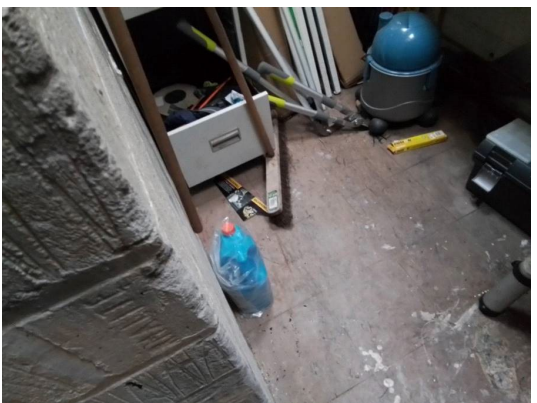
Item 87 Ref: As PZ000784

The floor tile with adhesive (Beige) (Cupboard Electrical G/018) (Older Building – The Oval) does not contain asbestos.

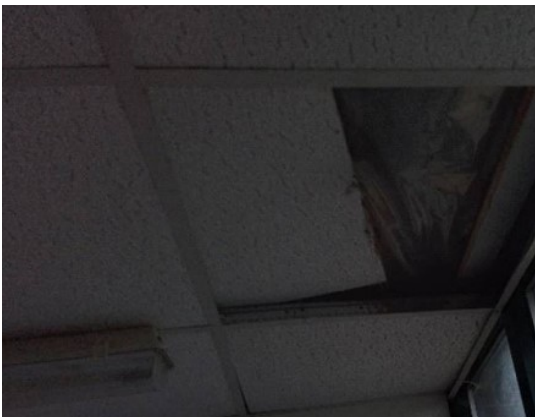
Item 93 Ref: RN000224

The Debris (Kitchen G/001) (Active Families Hub) does not contain asbestos.

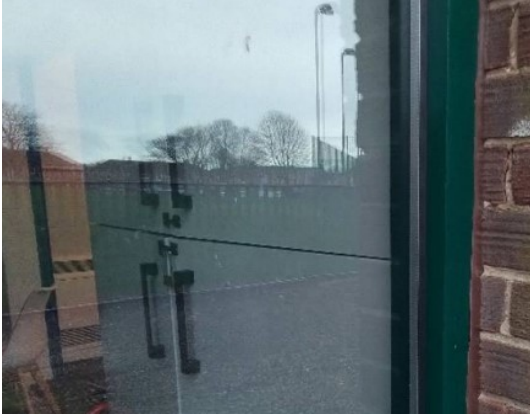
Item 94 Ref: PZ000789

The door seal/gasket (Kitchen G/001) (Active Families Hub) does not contain asbestos.
