ASBESTOS SURVEY REPORT FOR SOUTH HYLTON HOUSE, SOUTH HYLTON BANK, SR4 0JL.

**South Hylton House, South Hylton Bank, SR4 0JL**

**Date: 24 March 2026**

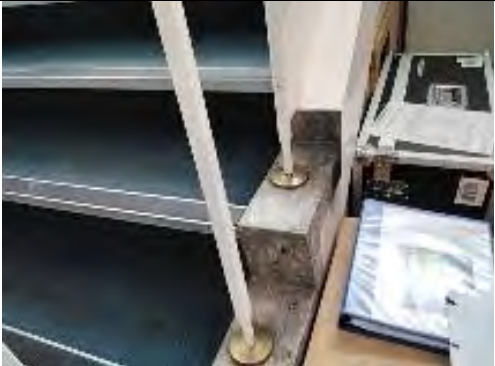
1.	KX000892	Floor screed to stairs	Block 1, Ground Floor, Reception/Entrance Hall (Room G/002)	Contains asbestos - Any change in its appearance should be recorded and passed to Property Services.

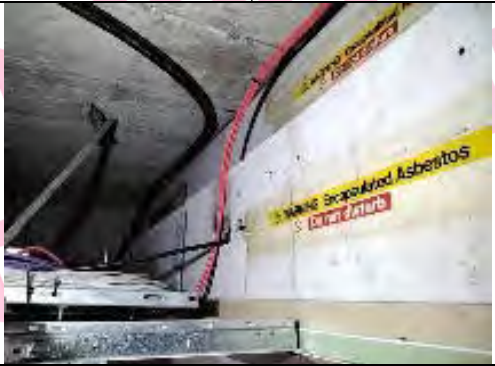
2.	KX000893	Ceiling Void Window Header Panel	Block 1, Ground Floor, Reception/Entrance Hall (Room G/002)	Contains asbestos - Any change in its appearance should be recorded and passed to Property Services.

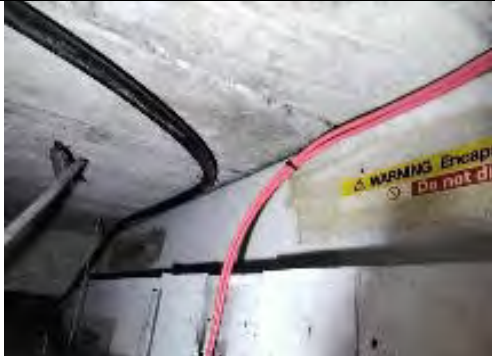
3.	KX000894	Ceiling Void Beam Cladding	Block 1, Ground Floor, Reception/Entrance Hall (Room G/002)	Contains asbestos - Any change in its appearance should be recorded and passed to Property Services.

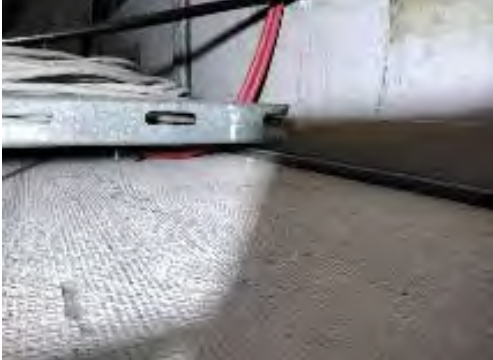
4.	As KX000893	Ceiling void debris on tiles adjacent window header panel	Block 1, Ground Floor, Reception/Entrance Hall (Room G/002)	Contains asbestos - Any change in its appearance should be recorded and passed to Property Services.

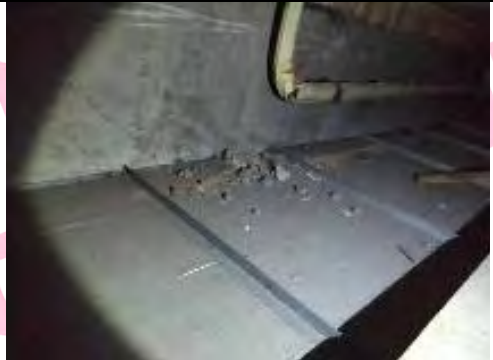
5.	KX000895	Ceiling void external canopy topside	Block 1, Ground Floor, Reception/Entrance Hall (Room G/002)	Contains asbestos - Any change in its appearance should be recorded and passed to Property Services.

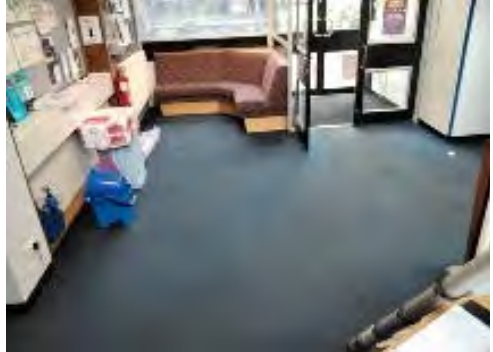
6.	KX000904	Floor under floor covering	Block 1, Ground Floor, Reception/Entrance Hall (Room G/002)	Contains asbestos - Any change in its appearance should be recorded and passed to Property Services.

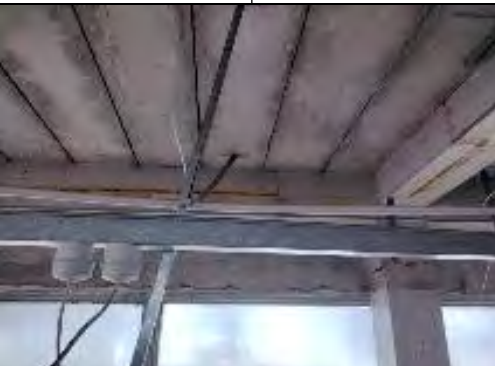
12.	As KX000894	Ceiling Void Beam cladding	Block 1, Ground Floor, Store Room (Room G/006)	Contains asbestos - Any change in its appearance should be recorded and passed to Property Services.

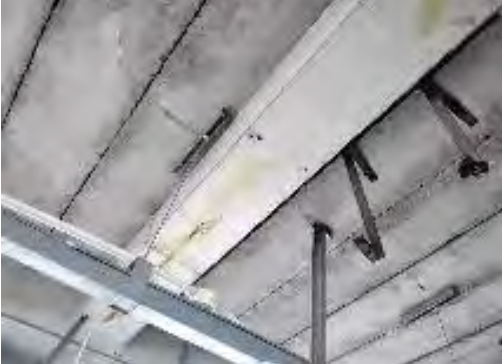
16.	As KX000894	Ceiling Void Beam cladding	Block 1, Ground Floor, Store Room (Room G/007)	Contains asbestos - Any change in its appearance should be recorded and passed to Property Services.

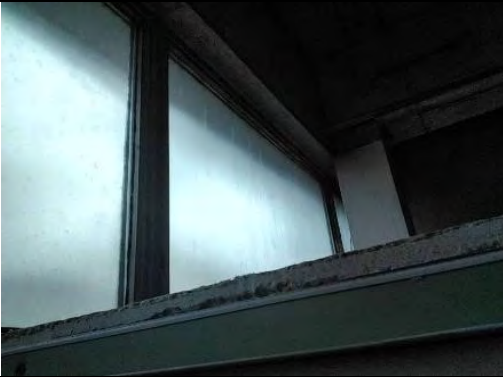
25.	As KX000898	Window Putty seal	Block 1, Ground Floor, Cupboard (Room G/009)	Does not contain asbestos.

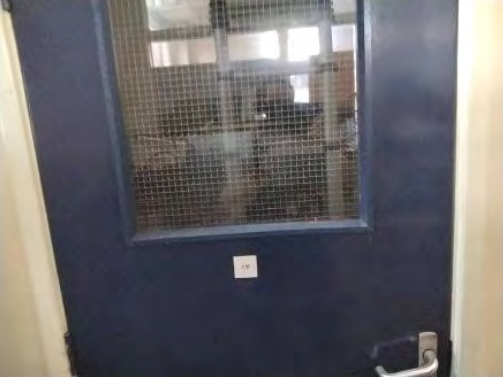
26.	As KX000900	Door window beading	Block 1, Ground Floor, Cupboard (Room G/009)	Does not contain asbestos.

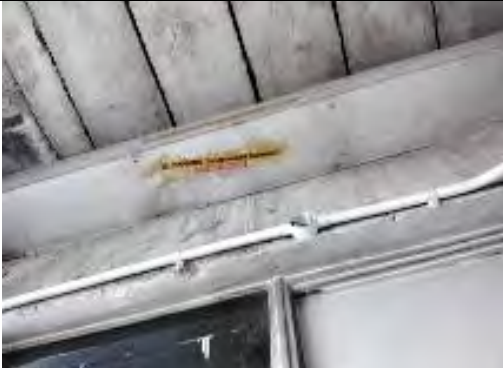
27.	As KX000894	Ceiling Void Beam cladding	Block 1, Ground Floor, Kitchen (Room G/010)	Contains asbestos - Any change in its appearance should be recorded and passed to Property Services.

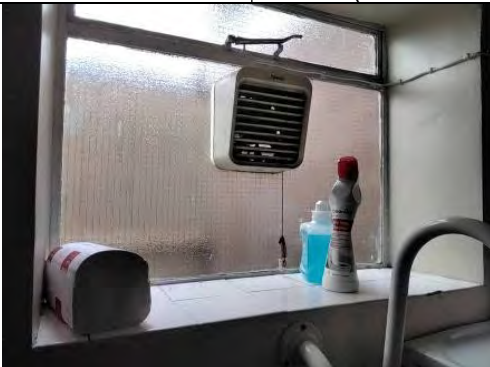
34.	As KX000903	Window Putty seal	Block 1, Ground Floor, Toilets (Room G/014)	Does not contain asbestos.

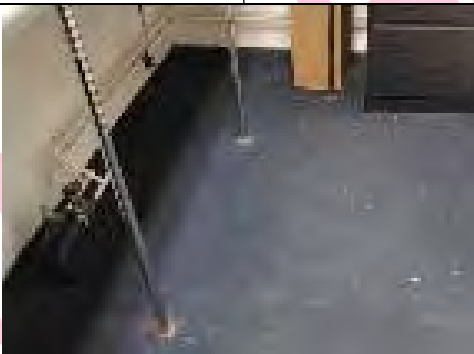
35.	KX000904	Floor under floor covering	Block 1, Ground Floor, Small Office (Room G/016)	Contains asbestos - Any change in its appearance should be recorded and passed to Property Services.

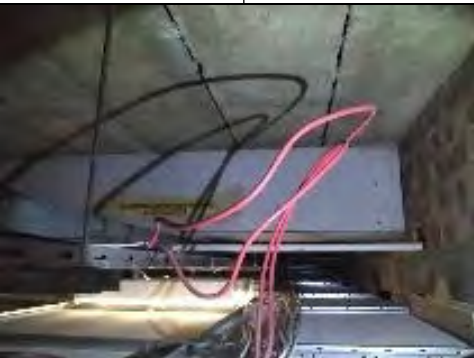
36.	As KX000894	Ceiling Void Beam cladding x 4	Block 1, Ground Floor, Corridor (Room G/017)	Contains asbestos - Any change in its appearance should be recorded and passed to Property Services.

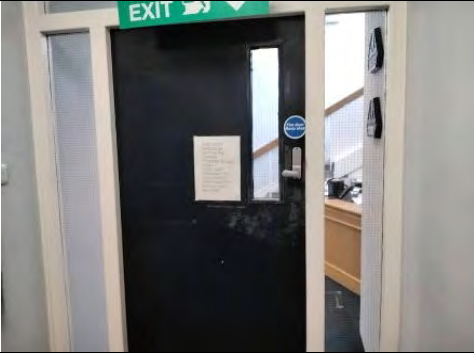
37.	KX000905	Door window beading	Block 1, Ground Floor, Corridor (Room G/017)	Does not contain asbestos.

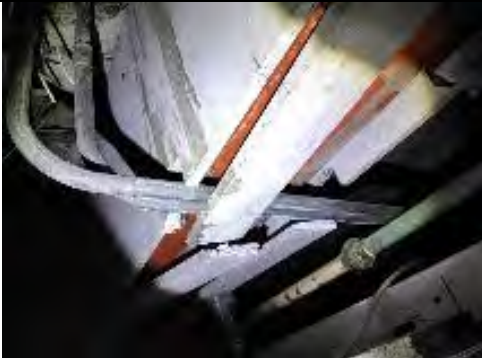
43.	As KX000894	Ceiling Void Beam cladding	Block 1, Ground Floor, Office (Room G/019)	Contains asbestos - Any change in its appearance should be recorded and passed to Property Services.

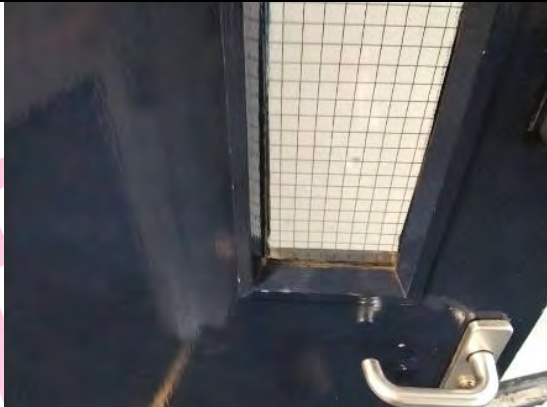
44.	KX000905	Door window beading	Block 1, Ground Floor, Office (Room G/019)	Does not contain asbestos.

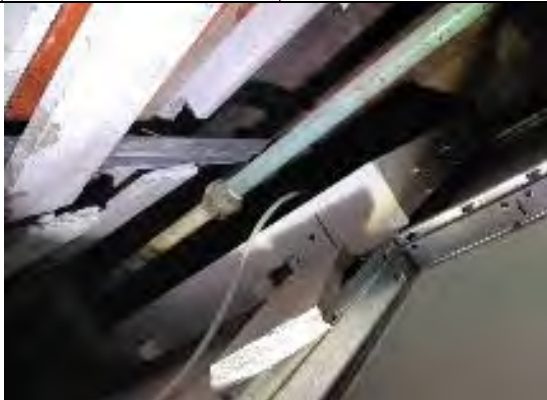
45.	As KX000894	Ceiling void debris to stench pipe penetration	Block 1, Ground Floor, Office (Room G/019)	Contains asbestos - Any change in its appearance should be recorded and passed to Property Services.

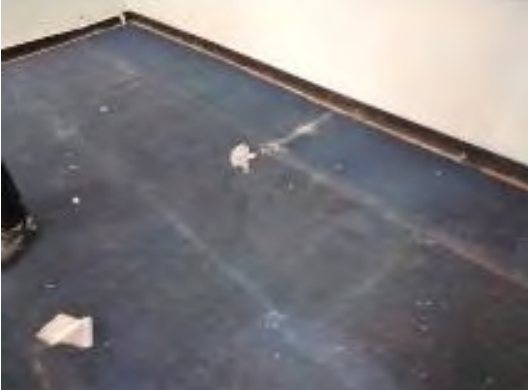
46.	KX000907	Floor adhesive residue under floor covering	Block 1, Ground Floor, Office (Room G/019)	Contains asbestos - Any change in its appearance should be recorded and passed to Property Services.

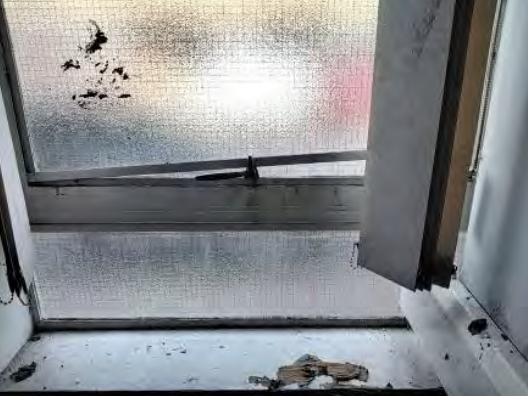
47.	As KX000898	Window Putty seal	Block 1, Ground Floor, Office (Room G/019)	Does not contain asbestos.

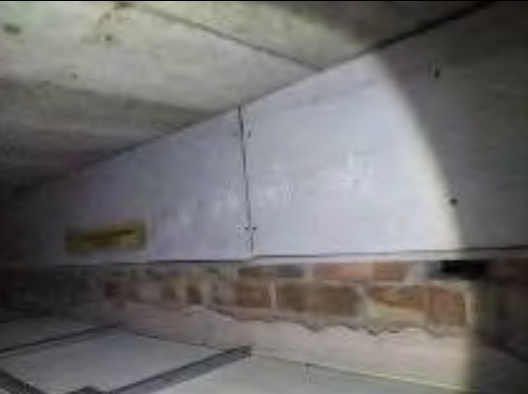
48.	As KX000894	Ceiling void beam cladding	Block 1, Ground Floor, Office (Room G/020)	Contains asbestos - Any change in its appearance should be recorded and passed to Property Services.

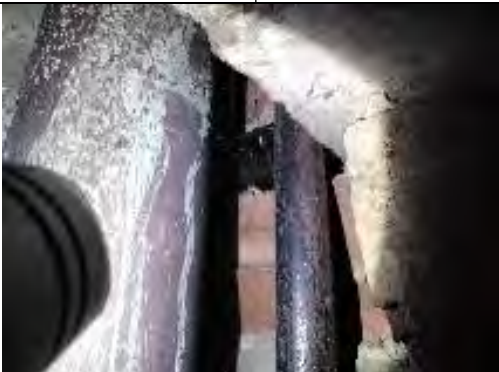
52.	As KX000906	Ceiling void debris to stench pipe penetration	Block 1, Ground Floor, Office (Room G/020)	Contains asbestos - Any change in its appearance should be recorded and passed to Property Services.

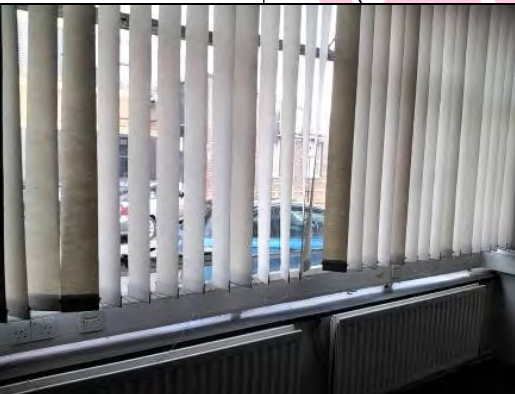
53.	As KX000898	Window Putty seal	Block 1, Ground Floor, Office (Room G/020)	Does not contain asbestos.

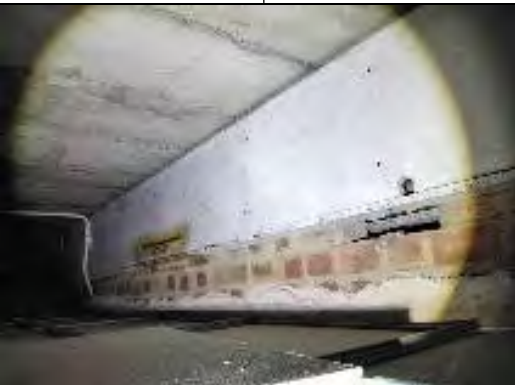
54.	As KX000894	Ceiling void beam cladding	Block 1, Ground Floor, Office (Room G/021)	Contains asbestos - Any change in its appearance should be recorded and passed to Property Services.

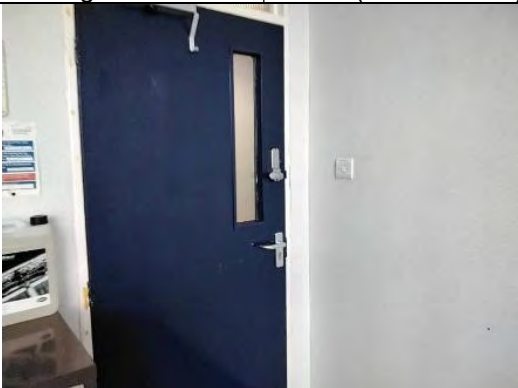
55.	As KX000905	Door window beading	Block 1, Ground Floor, Office (Room G/021)	Does not contain asbestos.

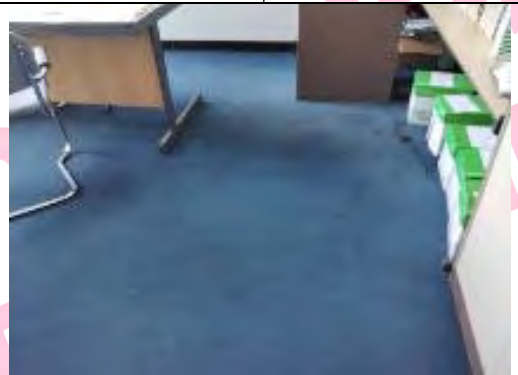
56.	As KX000907	Floor adhesive residue under floor covering	Block 1, Ground Floor, Office (Room G/021)	Contains asbestos - Any change in its appearance should be recorded and passed to Property Services.

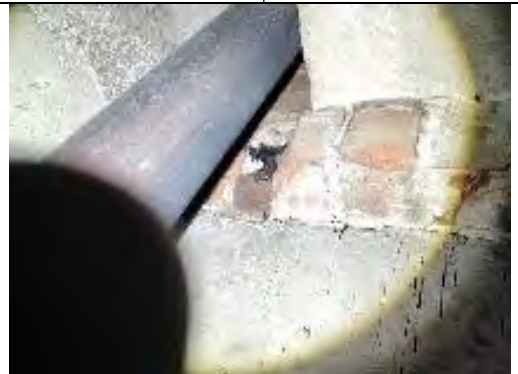
57.	As KX000906	Ceiling void debris to stench pipe penetration	Block 1, Ground Floor, Office (Room G/021)	Contains asbestos - Any change in its appearance should be recorded and passed to Property Services.

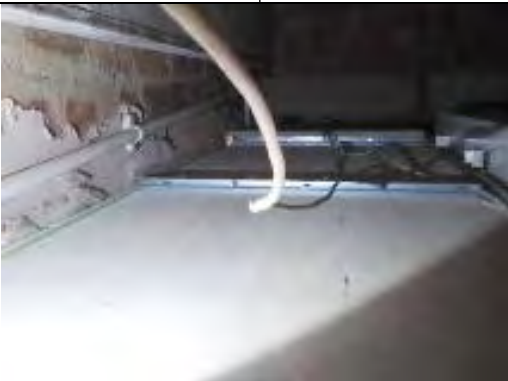
61.	As KX000894	Ceiling void debris hanging off damaged beams	Block 1, Ground Floor, Office (Room G/022)	Contains asbestos - Any change in its appearance should be recorded and passed to Property Services.

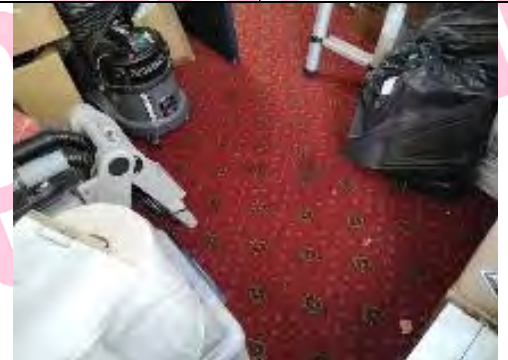
62.	As KX000907	Floor adhesive residue under floor covering	Block 1, Ground Floor, Office (Room G/022)	Contains asbestos - Any change in its appearance should be recorded and passed to Property Services.

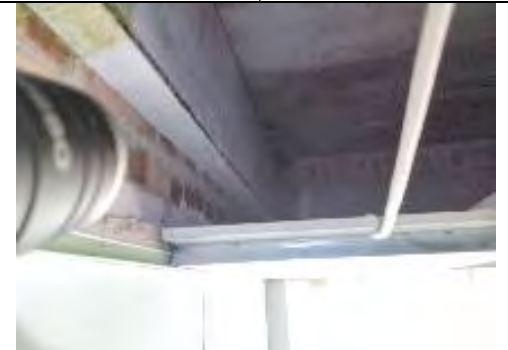
63.	As KX000906	Ceiling void debris to stench pipe penetration	Block 1, Ground Floor, Office (Room G/022)	Contains asbestos - Any change in its appearance should be recorded and passed to Property Services.

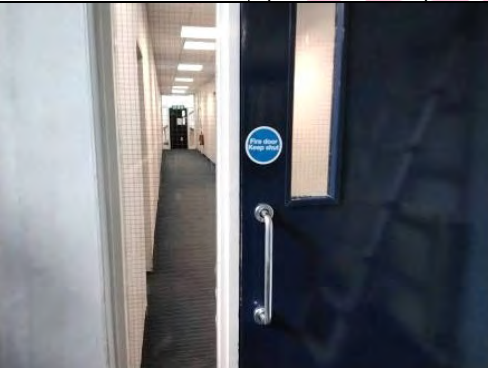
80.	As KX000900	Door window beading	Block 1, Ground Floor, Staircase/Stairwell (Room G/026)	Does not contain asbestos.

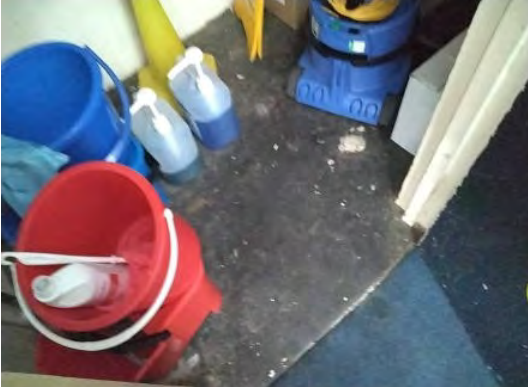
81.	KX000909	Floor tile	Block 1, Ground Floor, Cupboard understairs (Room G/027)	Does not contain asbestos.

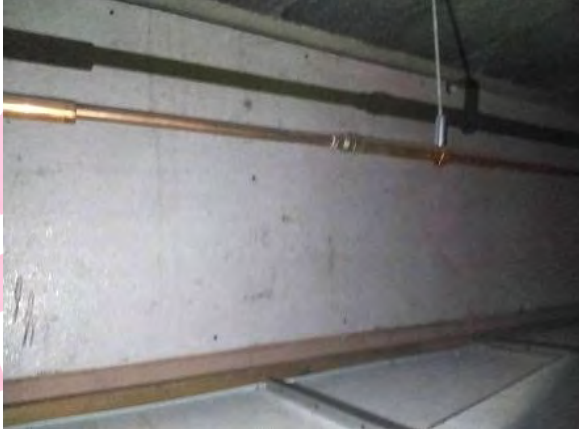
86.	KX000913	Ceiling void fire breaks	Block 1, Ground Floor, Corridor (Room G/028)	Does not contain asbestos.

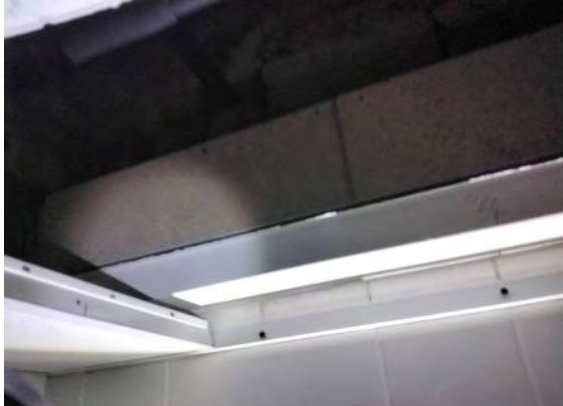
87.	As KX000912	Ceiling void beam cladding	Block 1, Ground Floor, Hallway/Passageway (Room G/029)	Does not contain asbestos.

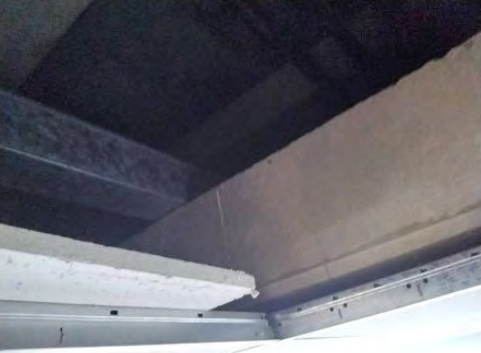
90.	As KX000912	Ceiling void beam cladding	Block 1, Ground Floor, Corridor (Room G/031)	Does not contain asbestos.

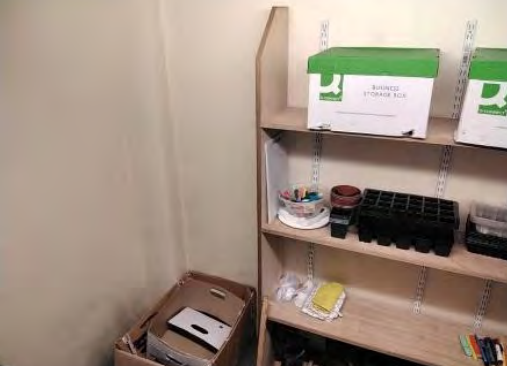
129.	KX000904	Boxing vertical adhesive residue under floor covering	Block 1, Ground Floor, Storage Area (Room G/042)	Does not contain asbestos.

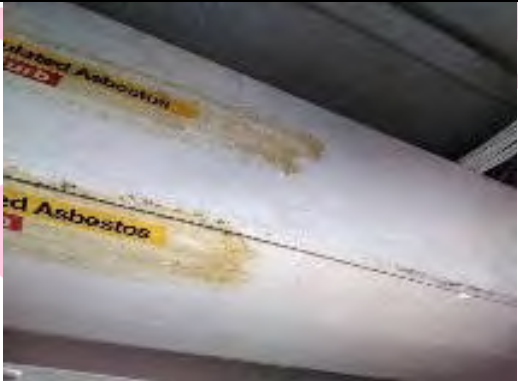
131.	KX000928	Ceiling void beam cladding	Block 1, First Floor, Landing within Stairwell (Room 1/001)	Contains asbestos - Any change in its appearance should be recorded and passed to Property Services.

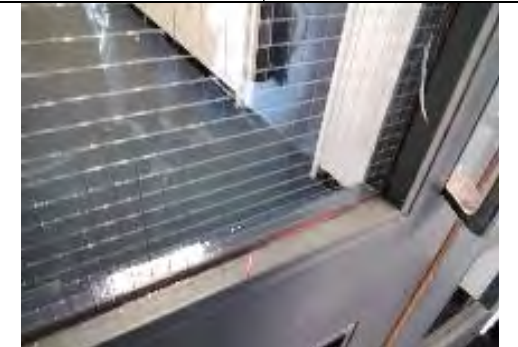
132.	KX000929	Door window beading including to header	Block 1, First Floor, Landing within Stairwell (Room 1/001)	Contains asbestos - Any change in its appearance should be recorded and passed to Property Services.

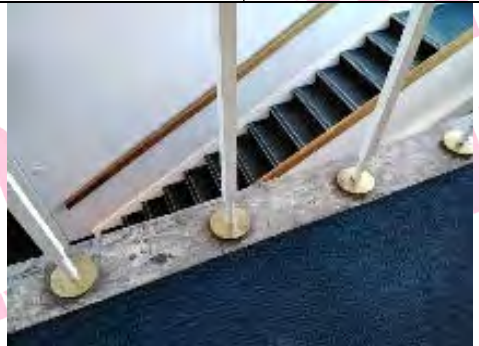
134.	As KX000892	Floor screed to stairs	Block 1, First Floor, Landing within Stairwell (Room 1/001)	Contains asbestos - Any change in its appearance should be recorded and passed to Property Services.

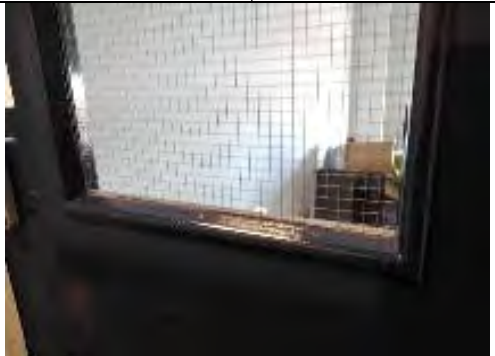
153.	As KX000929	Door window beading including to header	Block 1, First Floor, Office ceiling void from adjacent room (Room 1/008)	Contains asbestos - Any change in its appearance should be recorded and passed to Property Services.

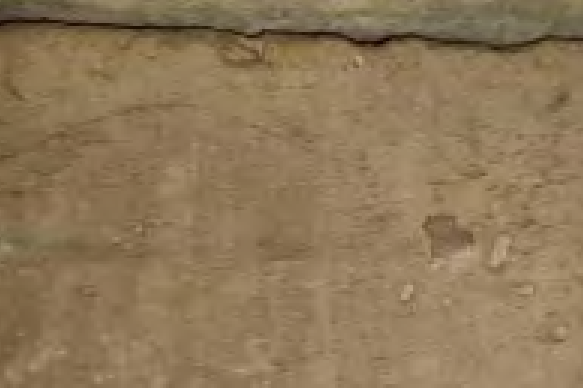
329	24-71128-4	Walls - Piece of insulation found on wall inside pipe run - Insulation	Area 001 (Internal pipe run)	Does not contain asbestos
