ASBESTOS SURVEY REPORT FOR MARKET PLACE DEPOT, HOUGHTON LE SPRING,

Asbestos Register for Market Place Depot, Houghton le Spring

UPRN: - 344426

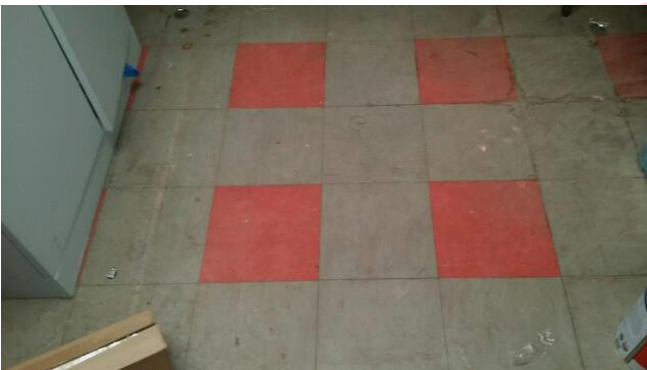
Item 8 Ref: As 02

The floor tiles in the Store Room (Rm 0/14) do not contain asbestos.

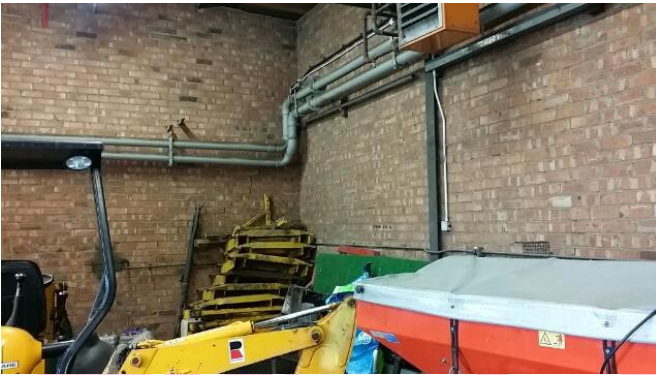
Item 14 Ref: Presumed

The pipework gaskets in the Garage (Rm 0/33) are presumed to contain asbestos.

Any changes in the appearance should be recorded and passed to Property Services.

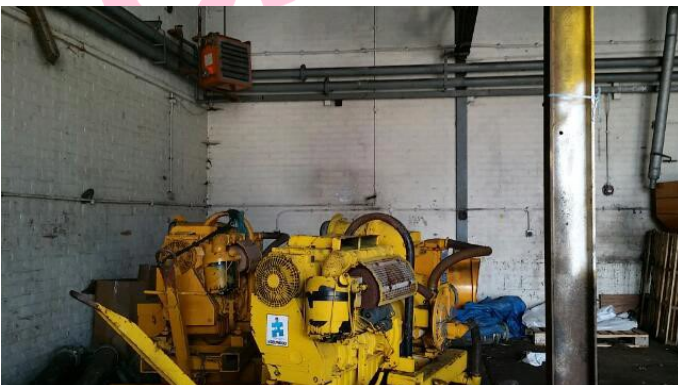
Item 15 Ref: Presumed

The pipework gaskets in the Garage (Rm 0/34) are presumed to contain asbestos.

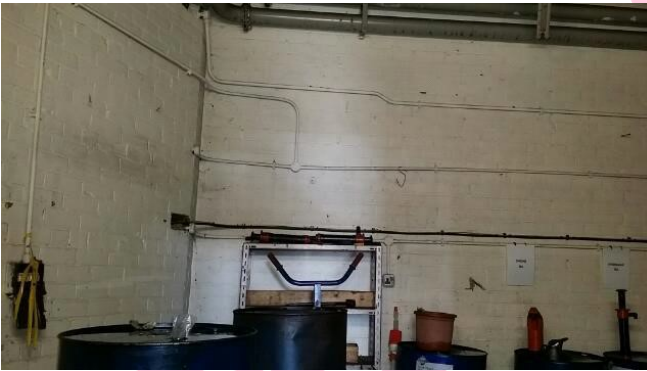
Item 17 Ref: Presumed

The pipework gaskets in the Garage (Rm 0/34) are presumed to contain asbestos.

Any changes in the appearance should be recorded and passed to Property Services.

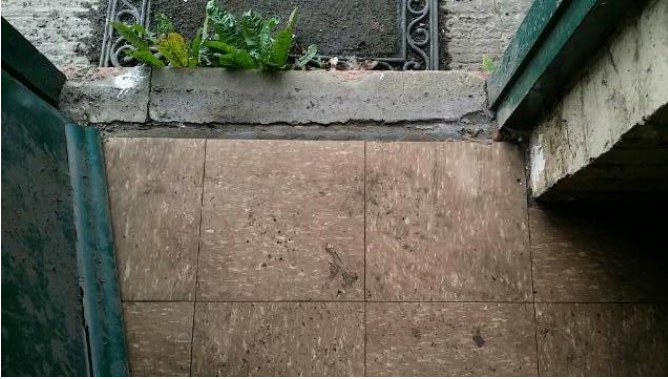
Item 19 Ref: As 07

The floor tiles in the Rest Room (Rm 0/36) contain asbestos.

Any change in the appearance should be recorded and passed to Property Services.

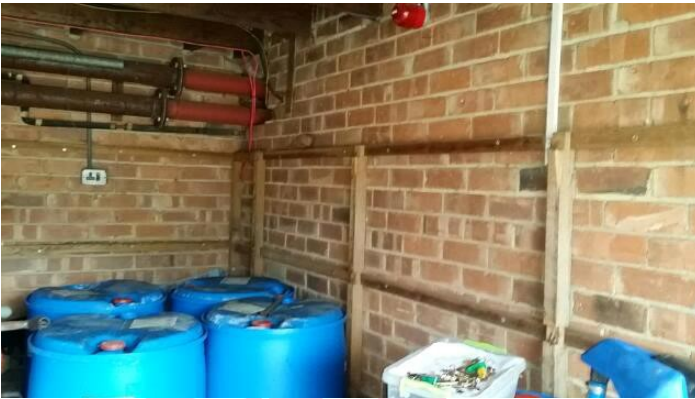
Item 20 Ref: Presumed

The pipework gaskets in the Shed (Rm 0/39) are presumed to contain asbestos.

Removed 2023

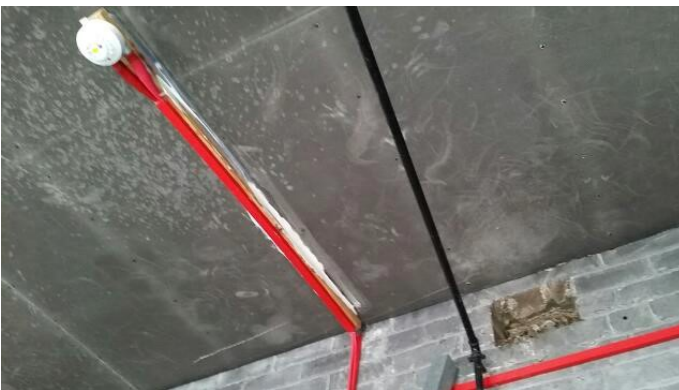
Item 21 Ref: 16

The ceiling in the Boiler Room (Rm 0/40) contained asbestos.

An Environmental clean was carried out in the Boiler Room in October 2016. This has now been removed.

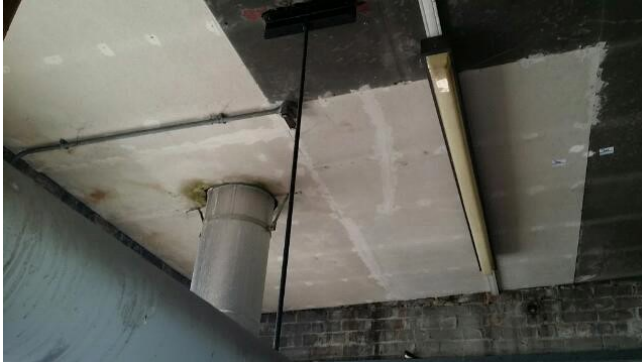
Item 22 Ref: 17

The repair board to ceiling in the Boiler Room (Rm 0/40) do not contain asbestos.

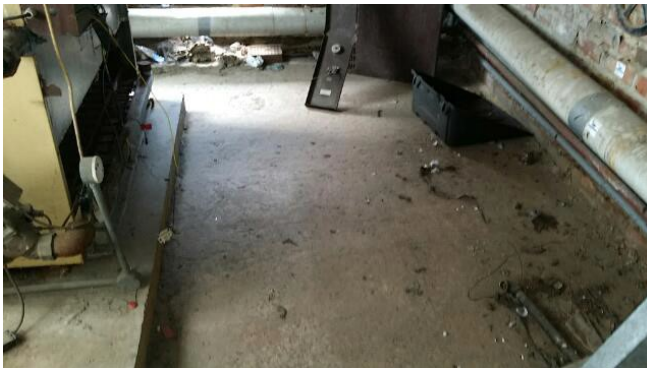
Item 23 Ref: 18

The debris to floor in the Boiler Room (Rm 0/40) contained asbestos.

An Environmental clean was carried out in the Boiler Room in October 2016. This has now been removed.

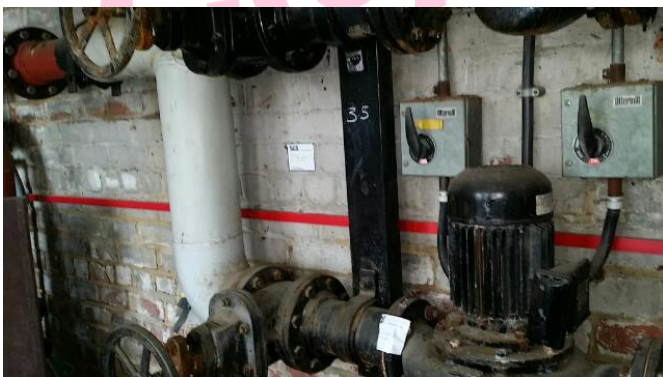
Item 24 Ref: 10

The debris to wall in the Boiler Room (Rm 0/40) contained asbestos.

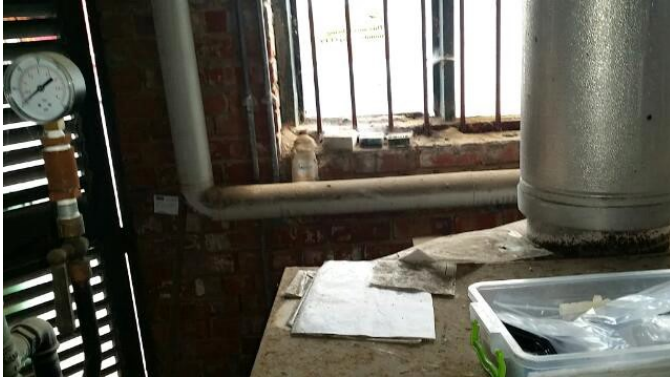
Item 28 Ref: 14

The debris to wall rear of boiler in the Boiler Room (Rm 0/40) does not contain asbestos.

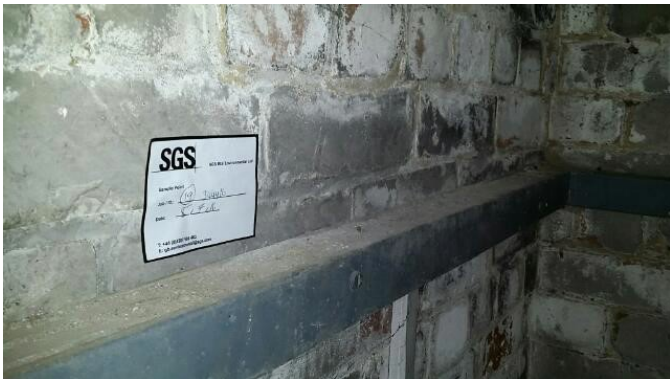
Item 29 Ref: 19

The debris to cable housing in the Boiler Room (Rm 0/40) contained asbestos.

An Environmental clean was carried out in the Boiler Room in October 2016. This has now been removed.

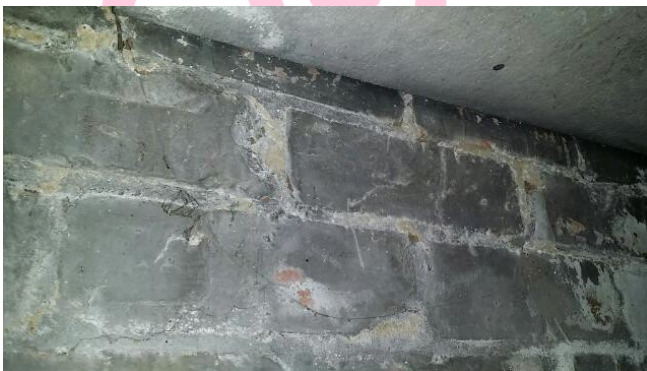
Item 30 Ref: As 19

The debris to cobwebs in the Boiler Room (Rm 0/40) contained asbestos.

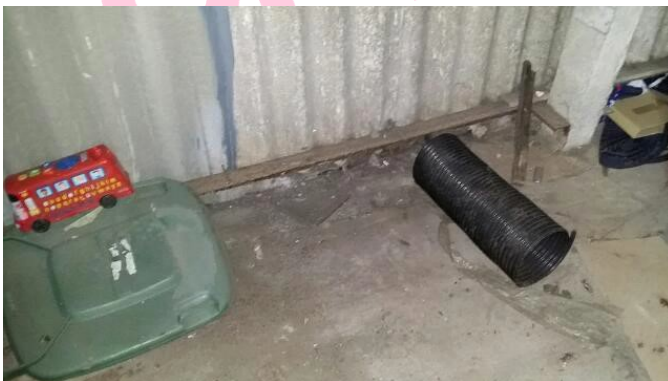
Item 33 Ref: 20

The debris from damaged wall cladding in the Shed (Rm 0/43) contain asbestos.

Removed Jan 2025

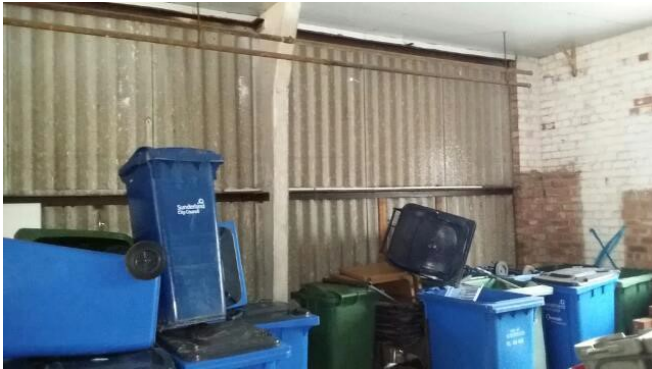
Item 34 Ref: As 20

The sheet cladding to wall in the Shed (Rm 0/43) contains asbestos.

Removed 2023

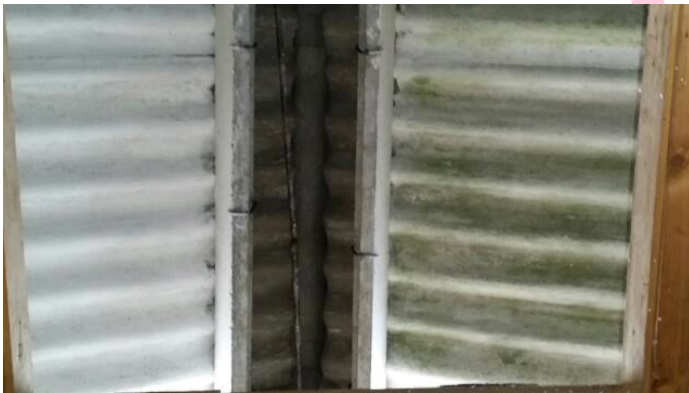
Item 35 Ref: As 21

The sheet cladding to roof in the Shed (Rm 0/43) contains asbestos.

Removed Jan 2025

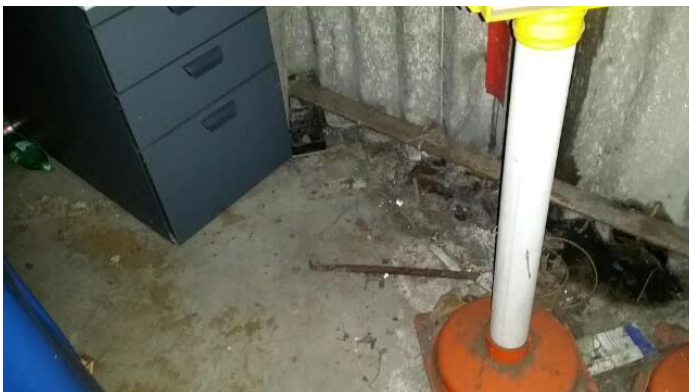
Item 36 Ref: As 20

The debris from wall cladding in Salt Shed (Rm 0/44) contains asbestos.

Removed Jan 2025

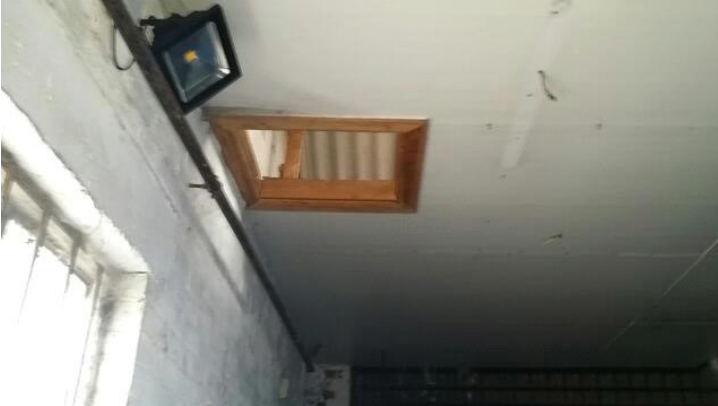
Item 37 Ref: As 21

The roof sheeting in the Salt Shed (Rm 0/44) contains asbestos.

Removed Jan 2025

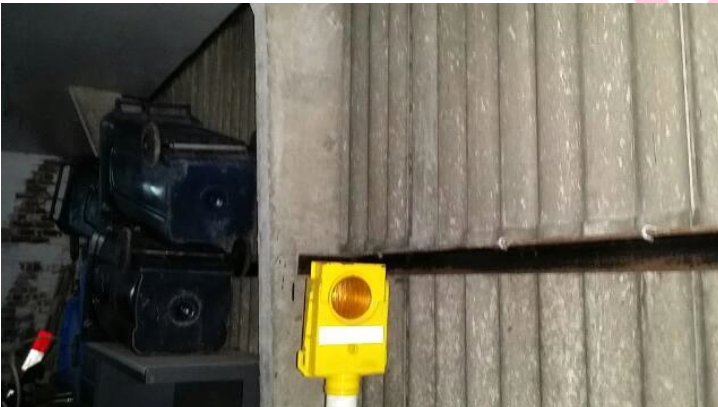
Item 38 Ref: As 20

The wall cladding in the Salt Shed (Rm 0/44) contains asbestos.

Removed Jan 2025

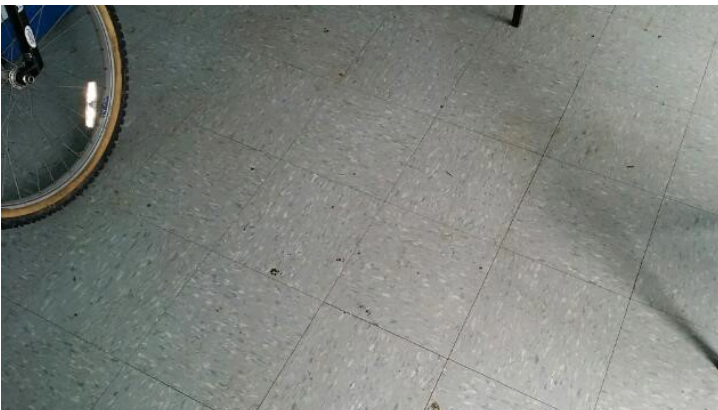
Item 39 Ref: 22

The floor tiles in the Shower Room (Rm 0/46) do not contain asbestos.

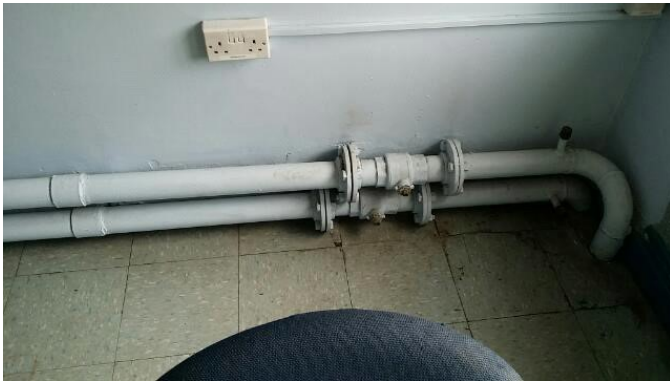
Item 40 Ref: Presumed

The pipework gaskets in the Shower Room (Rm 0/46) contains asbestos.

Removed Jan 2025

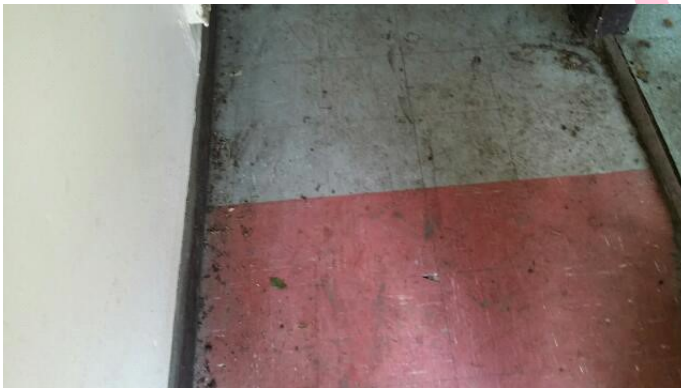
Item 41 Ref: 23

The floor tiles in the Hallway (Rm 0/49) contains asbestos.

Removed Jan 2025

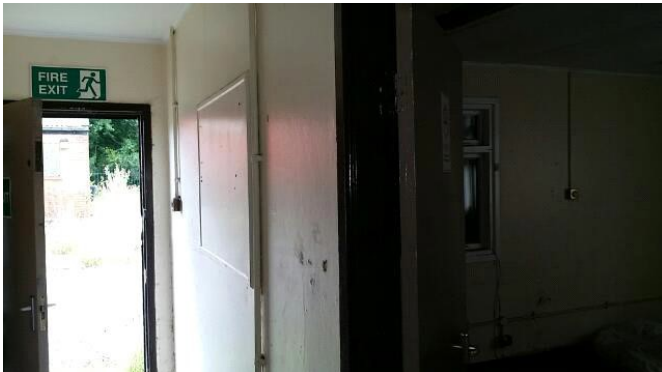
Item 42 Ref: 24

The wall in the Hallway (Rm 0/49) contains asbestos.

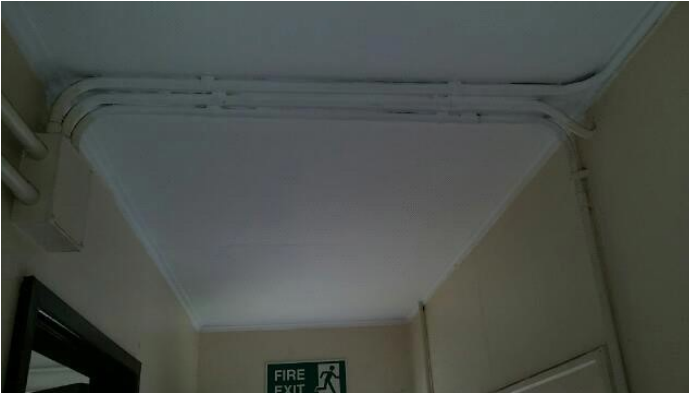
Item 43 Ref: 25

The ceiling in the Hallway (Rm 0/49) contains asbestos.

Any change in its appearance should be recorded and passed to Property Services.

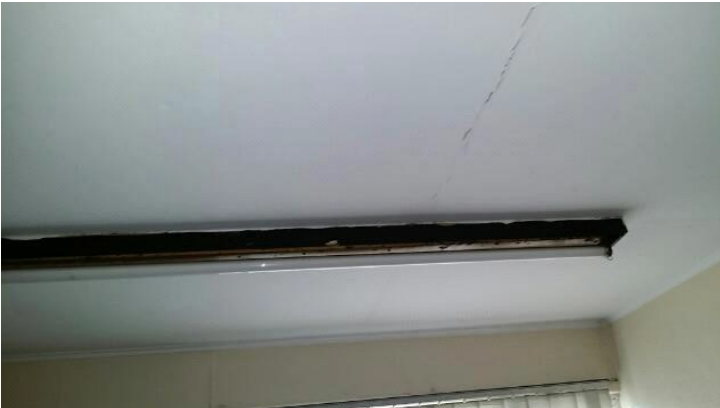
Item 44 Ref: As 25

The ceiling in the Office (Rm 0/50) contains asbestos.

Any change in its appearance should be recorded and passed to Property Services.

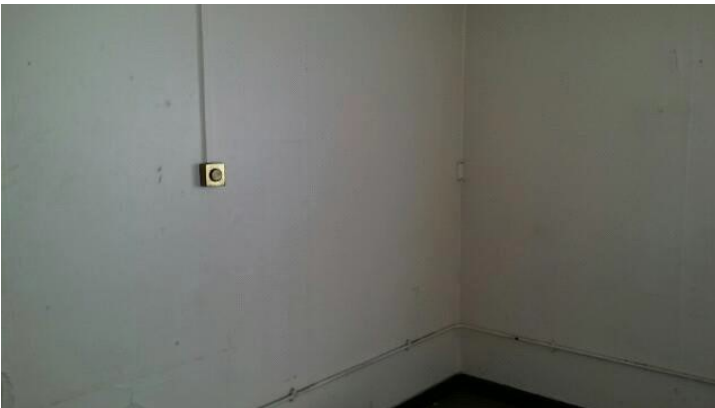
Item 45 Ref: As 24

The wall in the Office (Rm 0/50) contains asbestos.

Any change in its appearance should be recorded and passed to Property Services.

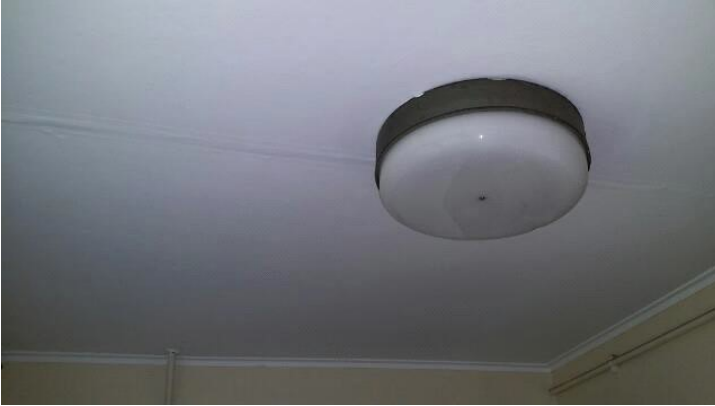
Item 46 Ref: As 25

The ceiling in the Toilets (Rm 0/51) contains asbestos.

Any change in its appearance should be recorded and passed to Property Services.

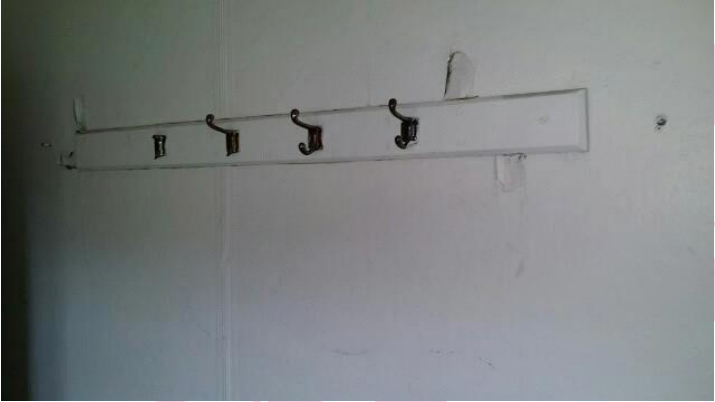
Item 47 Ref: As 24

The wall in the Toilets (Rm 0/51) contains asbestos.

Any change in its appearance should be recorded and passed to Property Services.

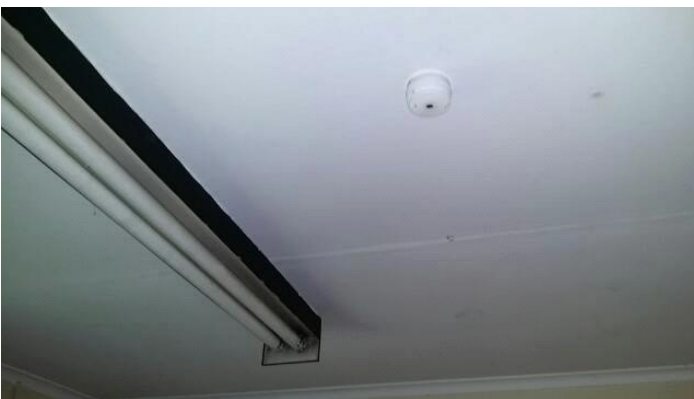
Item 48 Ref: As 25

The ceiling in the Office (Rm 0/52) contains asbestos.

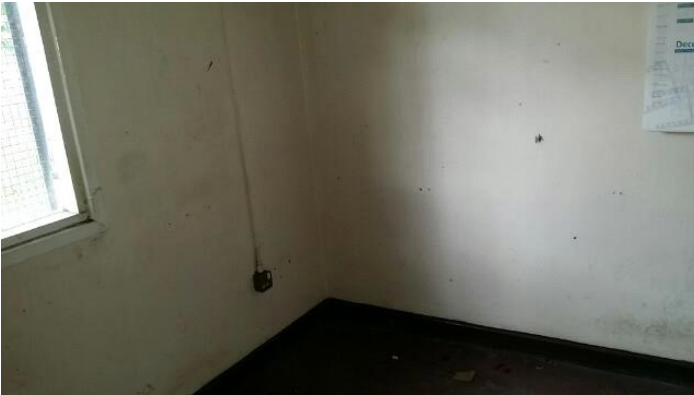
Item 49 Ref: As 24

The wall in the Office (Rm 0/52) contains asbestos.

Any change in its appearance should be recorded and passed to Property Services.

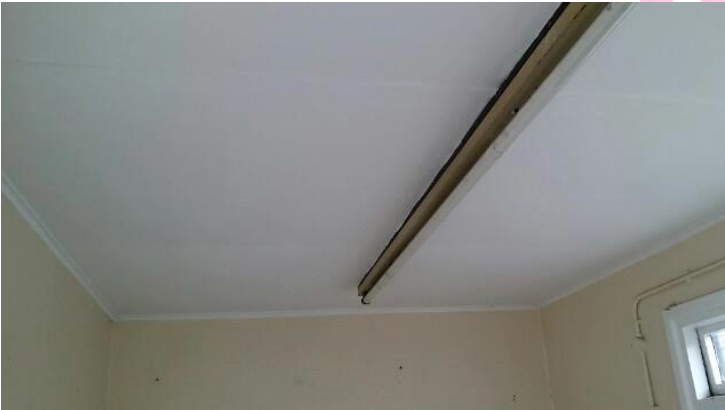
Item 50 Ref: As 25

The ceiling in the Office (Rm 0/53) contains asbestos.

Any change in its appearance should be recorded and passed to Property Services.

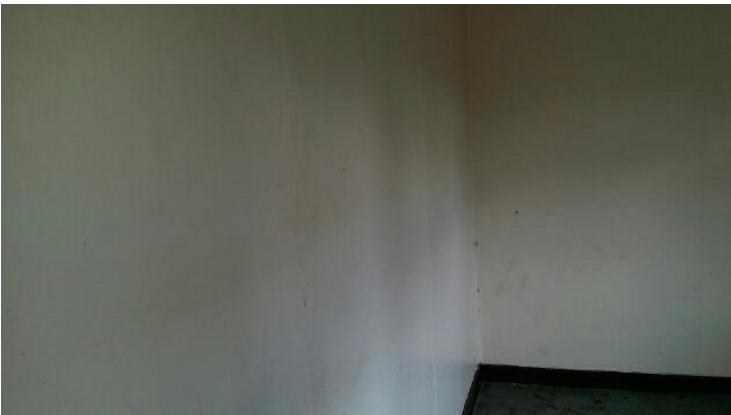
Item 51 Ref: As 24

The wall in the Office (Rm 0/53) contains asbestos.

Any change in its appearance should be recorded and passed to Property Services.

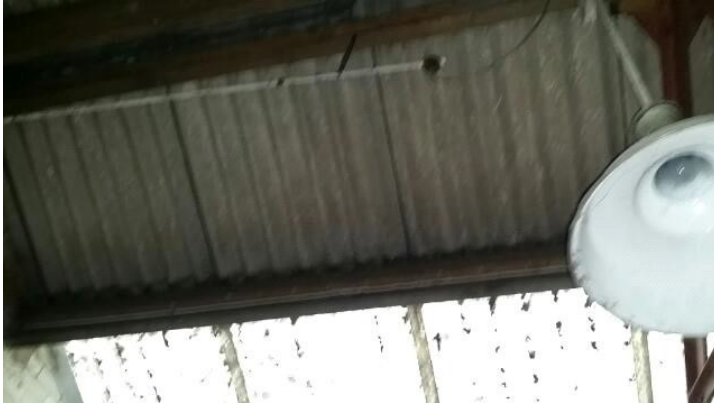
Item 52 Ref: 26

The ceiling in the Shed (Rm 0/54) contains asbestos.

Any change in its appearance should be recorded and passed to Property Services.

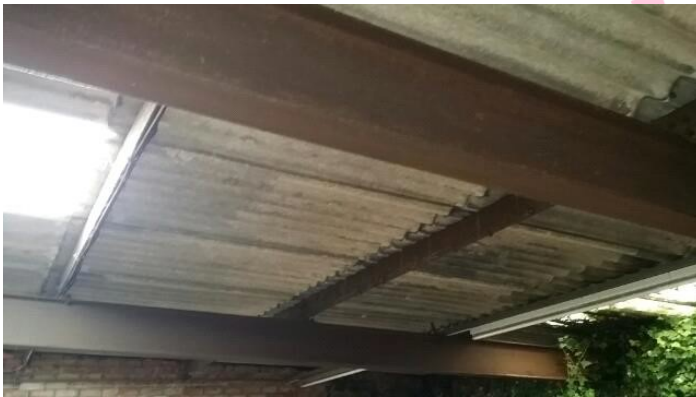
Item 53 Ref: As 26

The ceiling in the Garage (Rm 0/56) contains asbestos.

Any change in its appearance should be recorded and passed to Property Services.

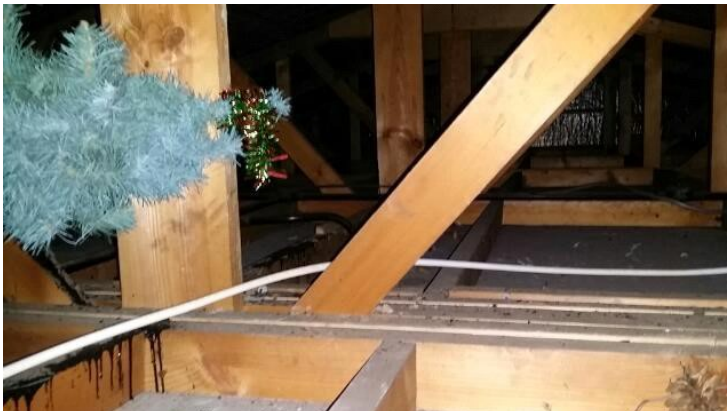
Item 54 Ref: As 25

The ceiling in the Loft Space (Rm L0/5) contains asbestos.

Any change in its appearance should be recorded and passed to Property Services.

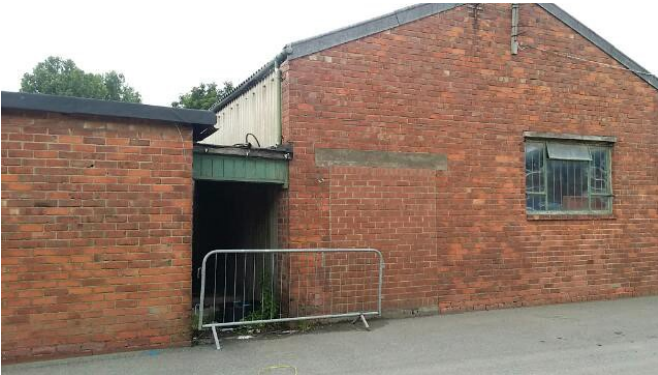
Item 55 Ref: As 20

The wall (External) contains asbestos.

Removed 2023

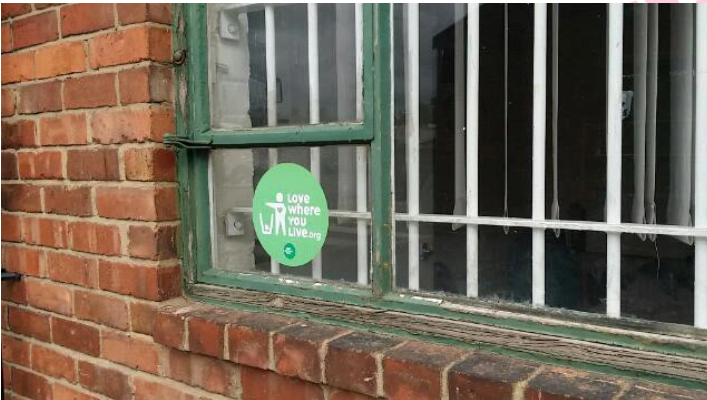
Item 56 Ref: 27

The window putty to the glass (External) does not contain asbestos.

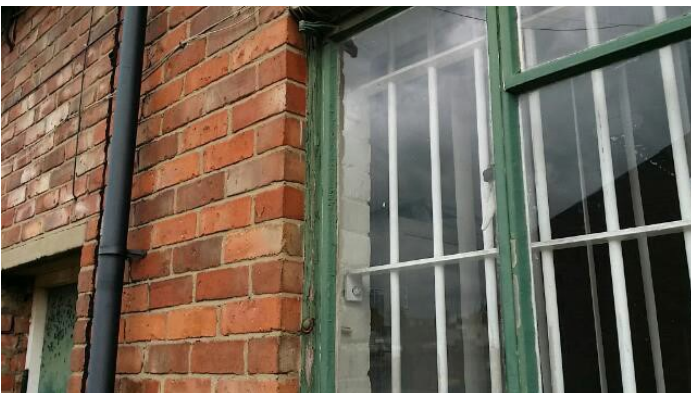
Item 57 Ref: 28

The window putty to the frame (External) contains asbestos.

Removed 2023

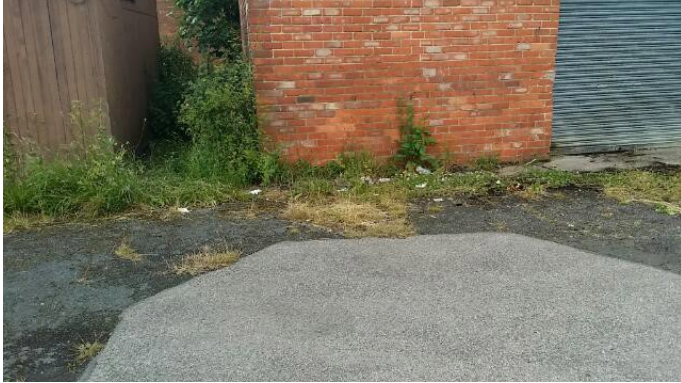
Item 58 Ref: Presumed

The damp proof course (External) contains asbestos.

Removed 2023

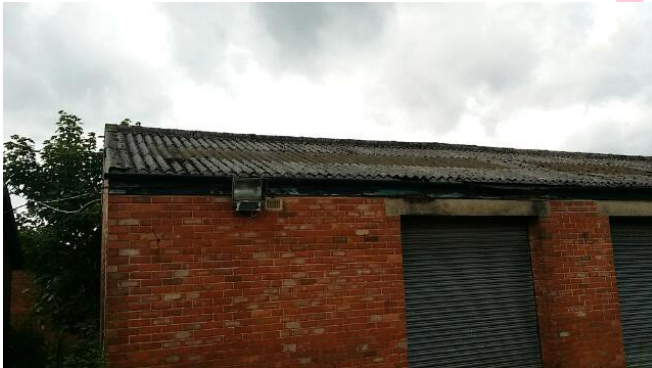
Item 59 Ref: As 26

The roof sheeting (External) contains asbestos.

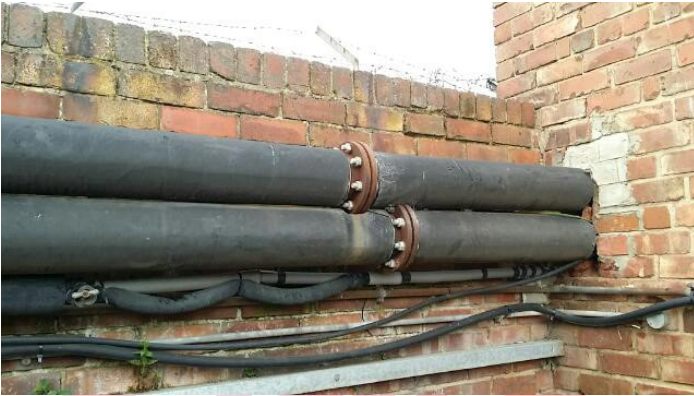
Item 62 Ref: 31

The pipework gaskets
(External) do not contain
asbestos.

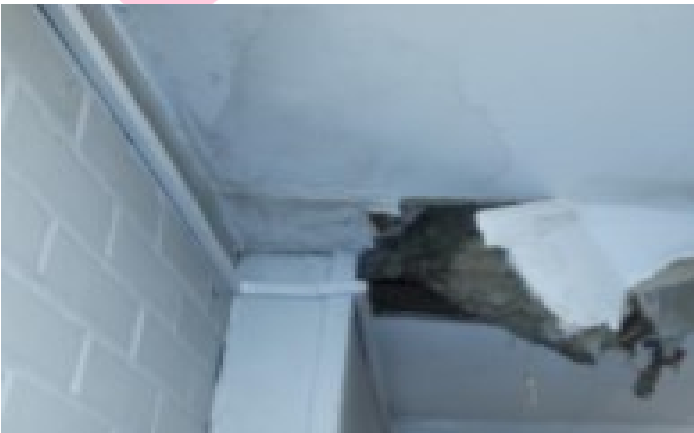
Item 63 Ref: 21-30435-1

The ceiling board in the
corridor adjacent to Debra's
office does not contain
asbestos.

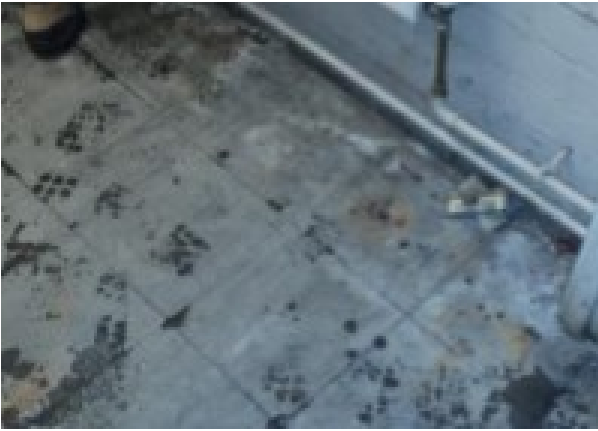
Item 64 Ref: 21-30435-2

The floor tiles and adhesive in the corridor adjacent to Debra's office does not contain asbestos.

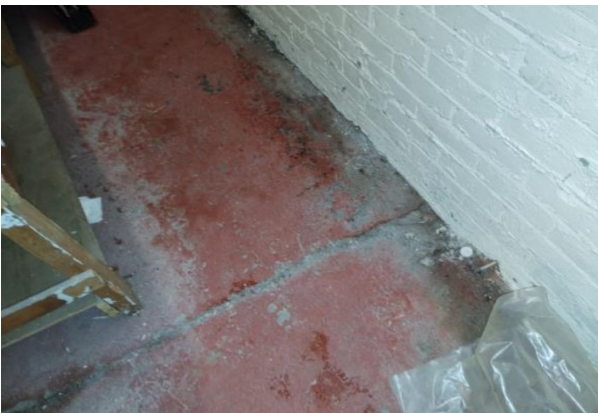
Item 65 Ref: 21-30764-1

The putty to joints in floor in Area 1/Store Room does not contain asbestos.

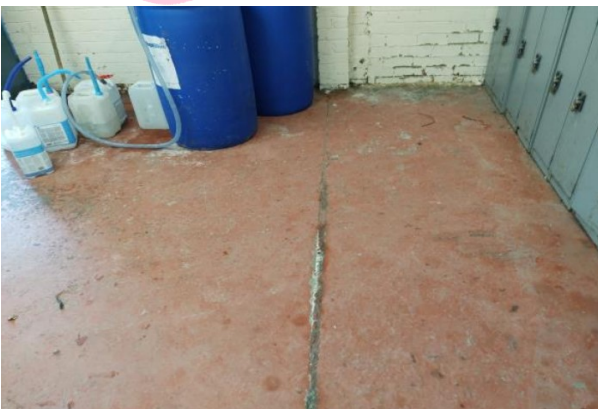
Item 66 Ref: 21-30764-1

The putty on floor in Area 2/Locker Room does not contain asbestos.

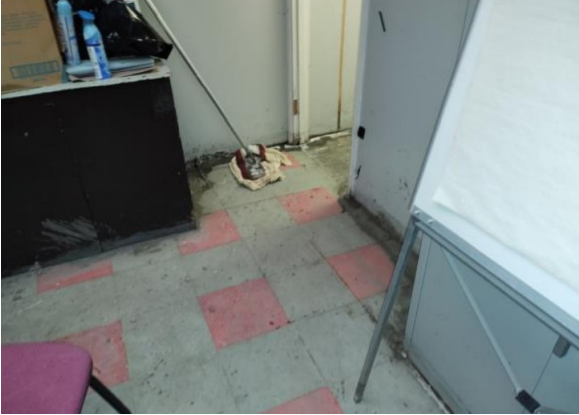
Item 73 Ref: 21-30764-11

The floor tiles and adhesive in Area 14/Mess Room does not contain asbestos.

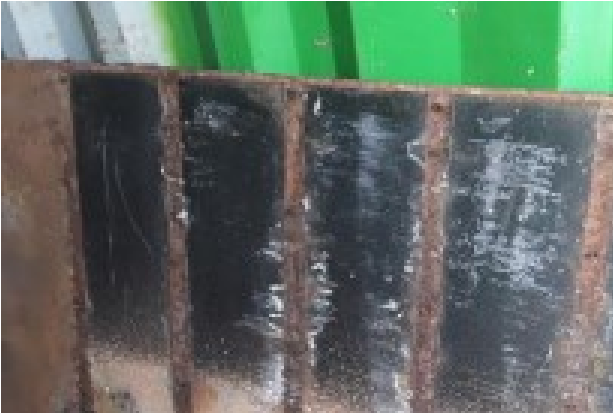
Item 76 Ref: 21-32018-1

The bitumen to the underside of the wood flooring in Container 3 does contain asbestos.

Removed 2023

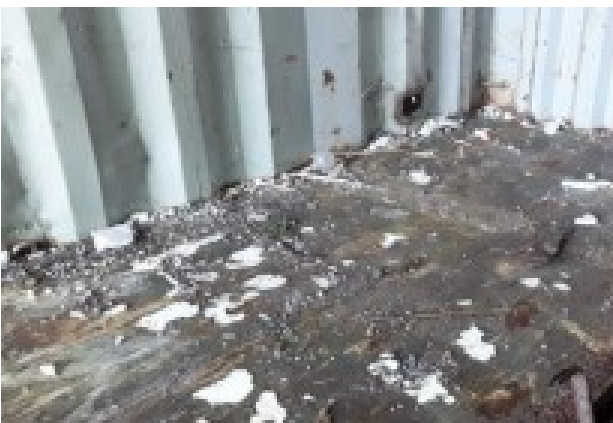
Item 78 Ref: 21-32018-1

The bitumen to the underside of the wood flooring in Container 6 does contain asbestos.

Removed 2023

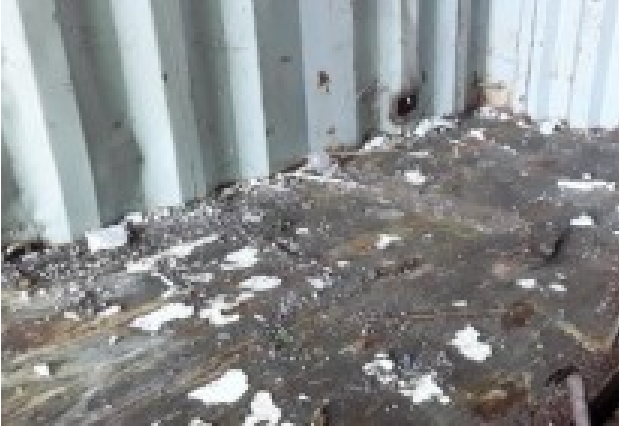
Item 79 Ref: 21-32018-1

The bitumen to the underside of the wood flooring in Container 8 does contain asbestos.

Removed 2023

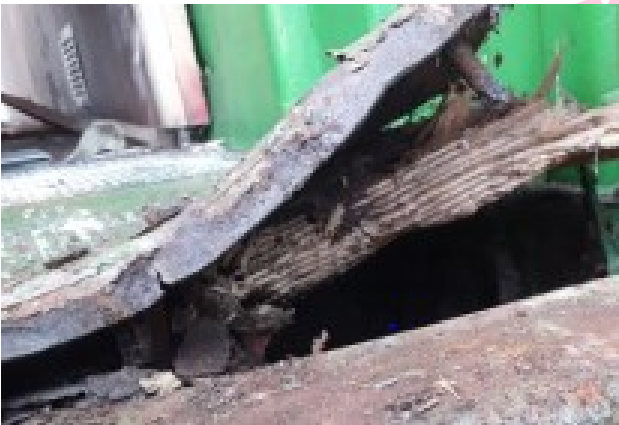
Item 80 Ref: 21-32018-1

The bitumen to the underside of the wood flooring in Container 9 does contain asbestos.

Removed 2023

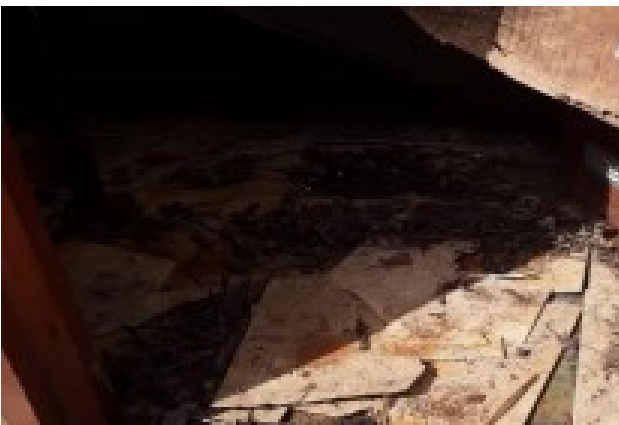
Item 81 Ref: 21-32018-2

The floor tiles in Container 17 do not contain asbestos.

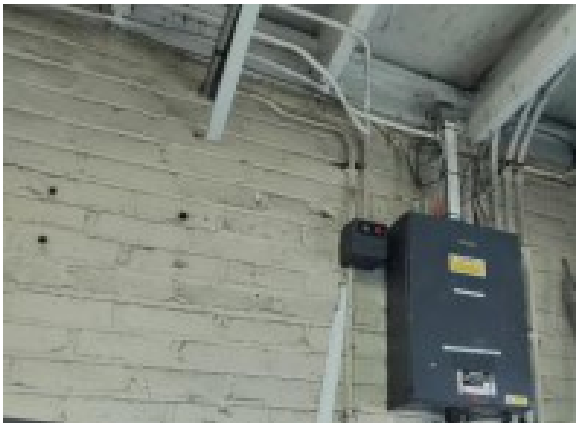
Item 83 Ref: Presumed

The flash guards within live equipment (Tractor Store Wall around DBPL1 and fuse board) is presumed to contain asbestos.

Removed 2023

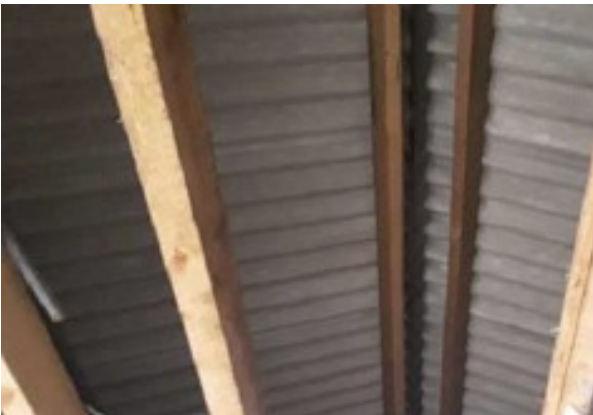
Item 87 Ref: 22-46862-10

The cement ceiling in Warehouse 1 contains asbestos.

Removed 2023

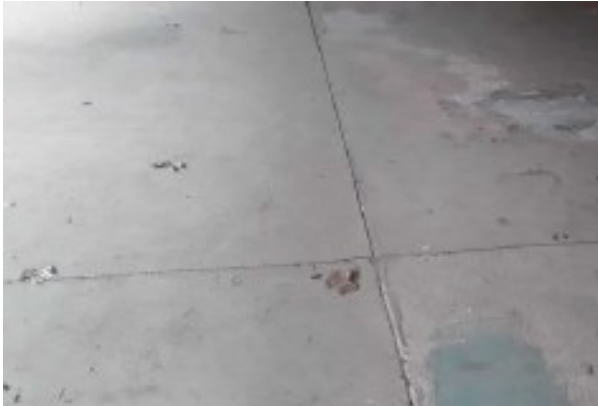
Item 88 Ref: 22-46862-11

The expansion joints to concrete floor slabs in Warehouse 1 contains asbestos.

Removed 2023

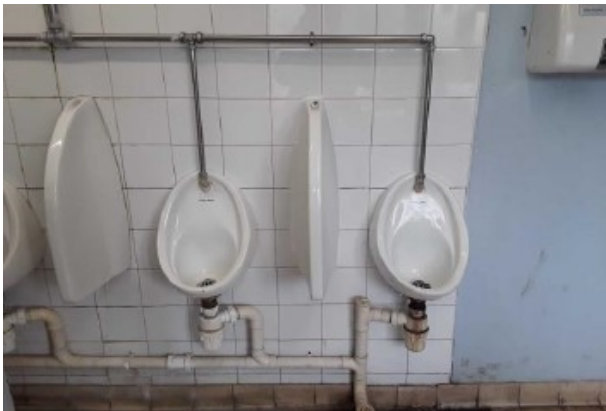
Item 89 Ref: 22-46862-12

The ceramic tile adhesive to walls in Area 4 – Men's Toilets does not contain asbestos.

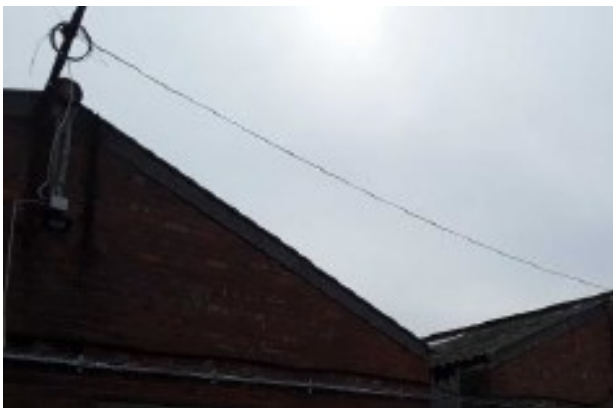
Item 90 Ref: 22-46862-14

The roof cement (External) contains asbestos.

Removed 2023

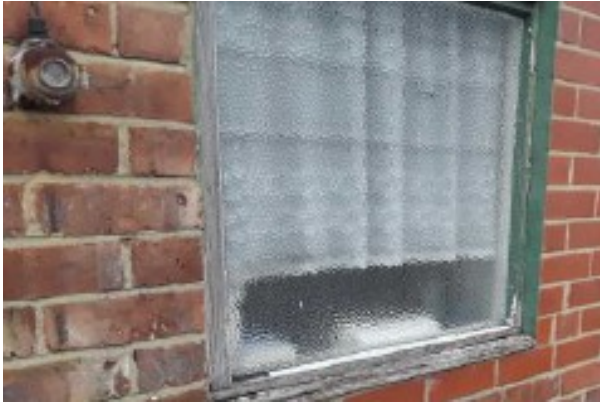
Item 91 Ref: 22-46862-15

The window putty (External) does not contain asbestos.

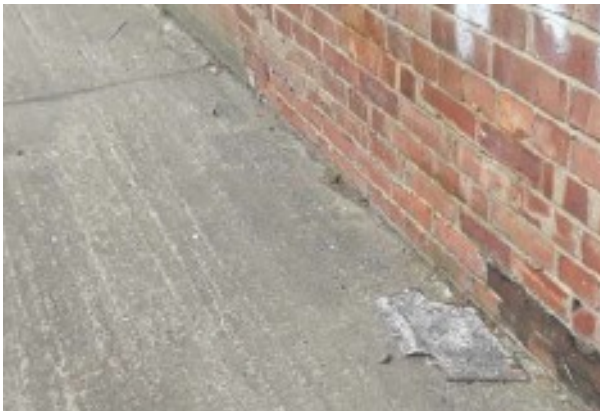
Item 92 Ref: 22-46862-16

The cement debris to floor (External) contains asbestos.

Removed 2023

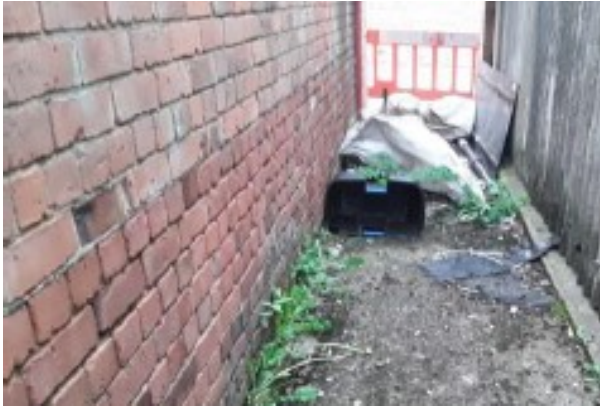
Item 94 Ref: 22-46862-18

The roof felt debris between warehouses (External) contains asbestos.

Removed 2023

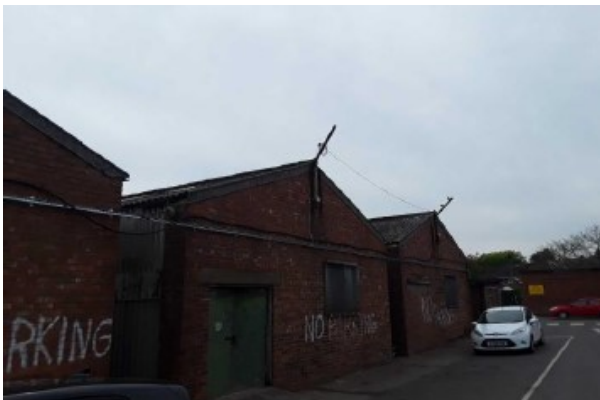
Item 96 Ref: 22-46862-20

The cement roof edging (External) contains asbestos.

Removed 2023

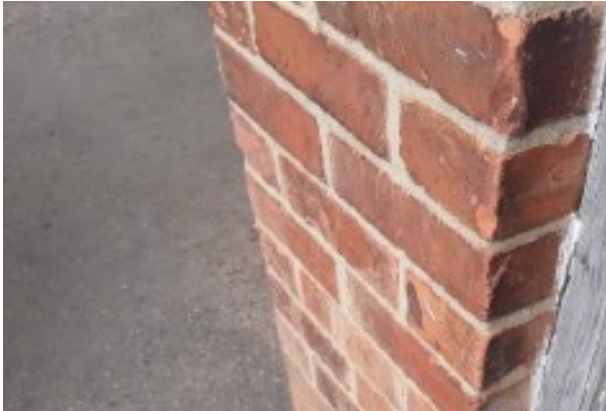
Item 97 Ref: 22-46862-21

The frame sealant to brickwork (External) does not contain asbestos.

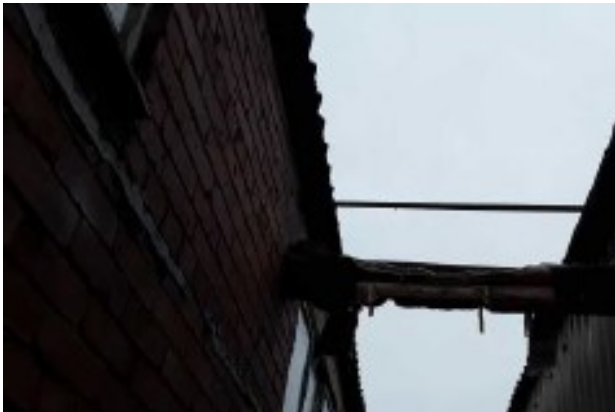
Item 98 Ref: 22-46862-26

The wrap to external pipes (External) contains asbestos.

Removed 2023

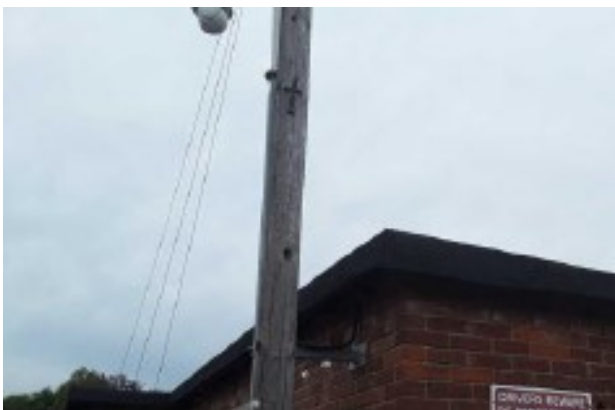
Item 99 Ref: 22-46862-27

The bitumen roof felt (External) does not contain asbestos.

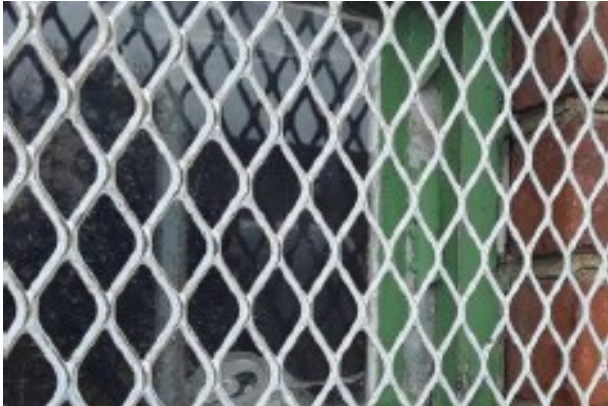
Item 100 Ref: 22-46862-28

The window frame sealant (External) contains asbestos.

Removed 2023

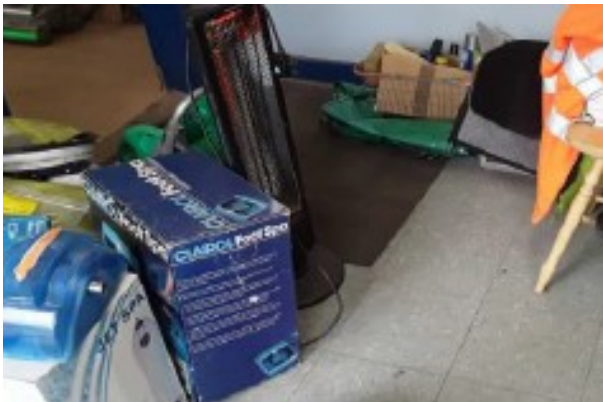
Item 101 Ref: 22-46862-23

The floor tiles & adhesive in Area 7 – Store Room does not contain asbestos.

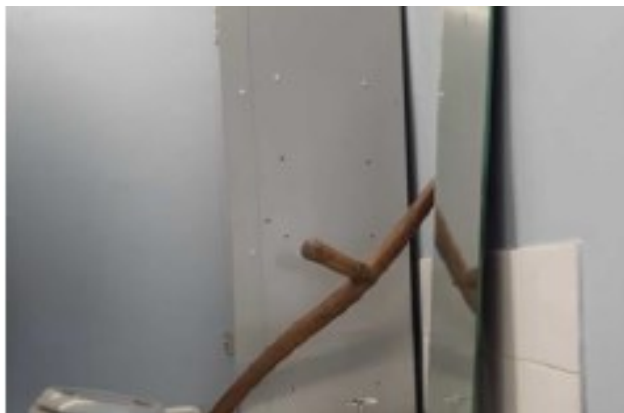
Item 102 Ref: 22-46862-24

The ceramic tile adhesive to walls in Area 8 – Shower Room does not contain asbestos.

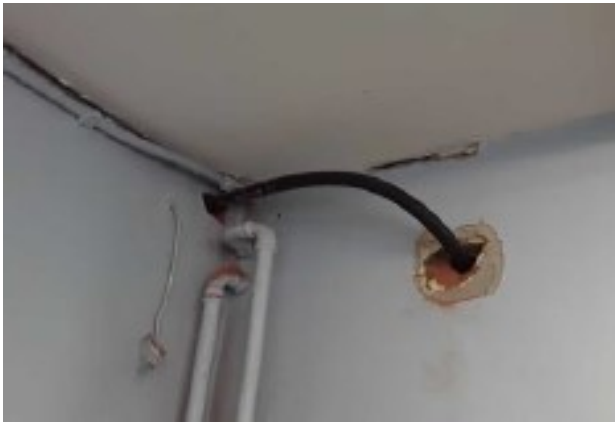
Item 103 Ref: 22-46862-25

The textured coating to walls in Area 8 – Shower Room does not contain asbestos.
