*Control of Asbestos
Regulations 2012*

Asbestos Register for

Easington Lane Access Point

Date: 22 October 2025

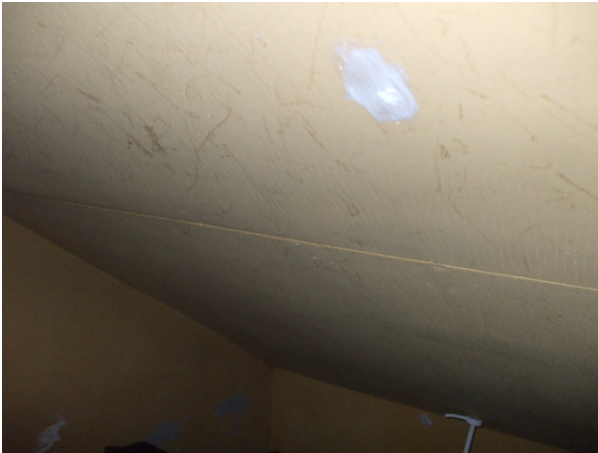
Item 1 Ref: 20915126-003

20915126-003 – Panel under stairs (Rm 0/005) (Item 1) Very Low Risk

The panel to under stairs in 0/005 reception hall cleaners cupboard contains asbestos. Any change in appearance should be recorded and passed to property services.

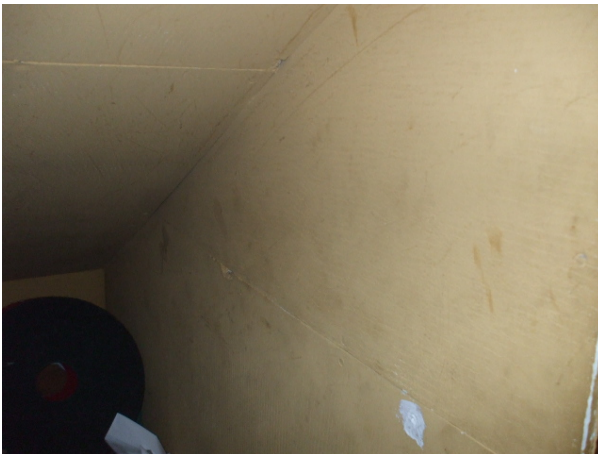
Item 2 Ref: 20915126-004

20915126-004 – Panel to Walls (Rm 0/005) (Item 2) Very Low Risk

The panels to the walls under stairs in 0/005 reception hall cleaners cupboard contains asbestos. Any change in appearance should be recorded and passed to property services.

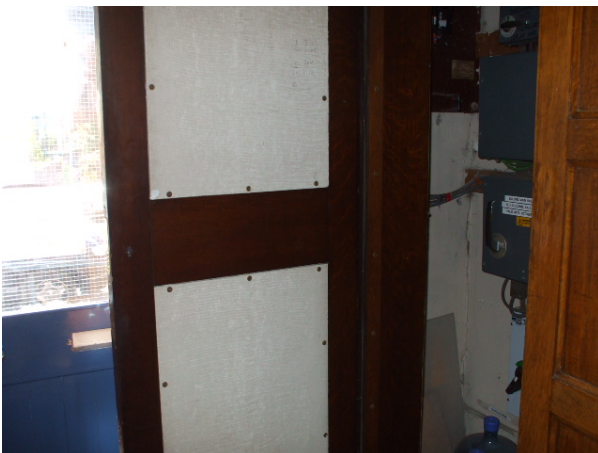
Item 3 Ref: 20915126-001

20915126-001 – Panel above Doors (Rm 0/005) (Item 3) Very Low Risk

The panels above the doors to 0/005 reception hall electric cupboard contain asbestos. Any change in appearance should be recorded and passed to property services.

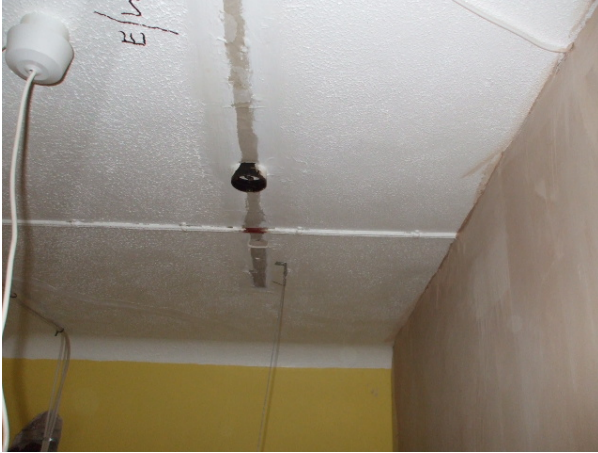
Item 4&5 Ref: 20915126-002

20915126-002 – Textured Coating to Ceiling (Rm 0/008) (Item 4) No Risk

As 20915126-002 – Textured Coating to Ceiling (Rm 0/010) (Item 5) No Risk

The textured coating to the ceiling above the suspended ceiling in 0/008 does not contain asbestos. Similar coating can be found in 0/010 female W.C.

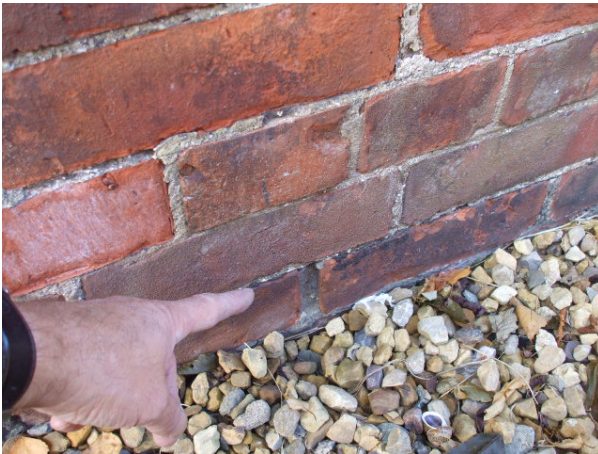
Item 6 Ref: 20915126-007

20915126-007 – Damp proof Course (Externals) (Item 6) No Risk

The Damp Proof Course to externals does not contain asbestos.

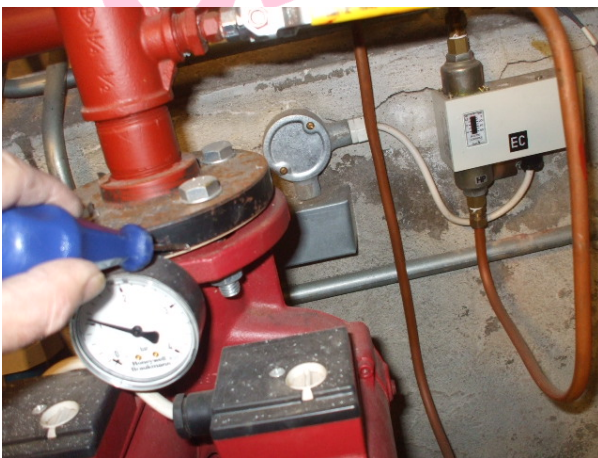
Item 7 Ref: 20915126-005

20915126-005 – Flange Gaskets (Externals Boiler Room) (Item 7) No Risk

The Flange Gaskets to the externals Boiler Room does not contain asbestos.

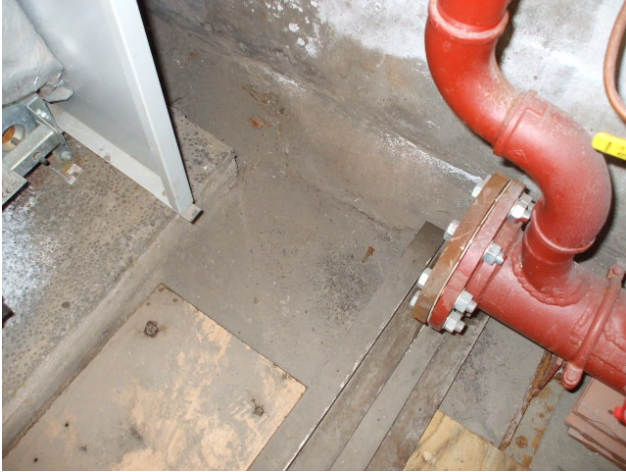
Item 8 Ref: 20915126-006

20915126-005 – Debris (Externals Boiler Room) (Item 8) No Risk

The debris to the floor in 9/999 externals Boiler Room does not contain asbestos.

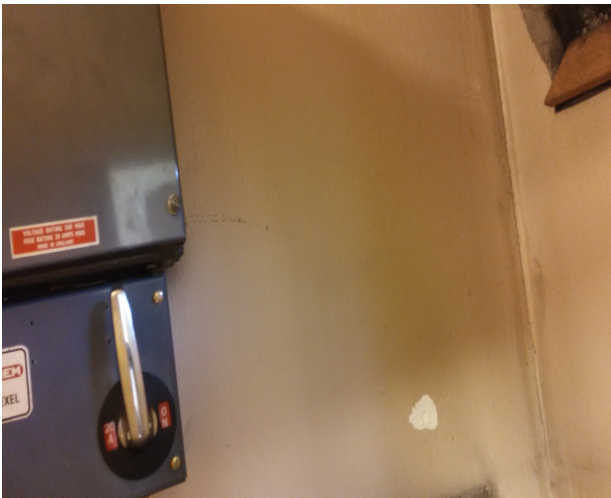
Item 9 Ref: 223226-1

223226-1 – Wall Boards and door header (Rm10 Cupboard) (Item 9) Low Risk

The panels to the walls and door header in the cupboard (Rm10) do contain asbestos.

Any change in appearance should be recorded and passed to property services.

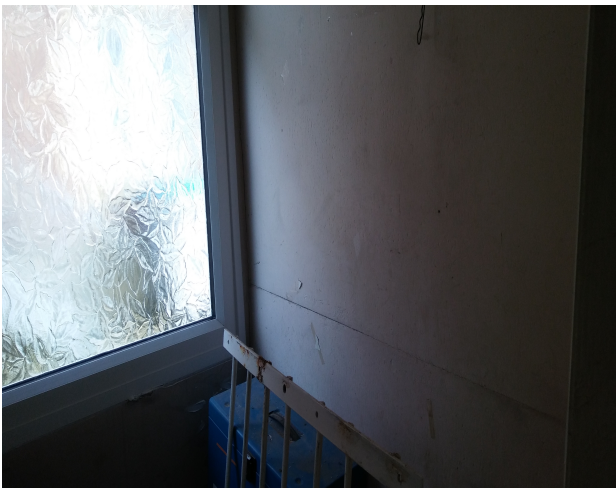
Item 10 Ref: As 223226-1

As 223226-1 - Wall Boards and door header (Rm12 Cupboard) (Item 10) Low Risk

The panels to the walls and door header in the cupboard (Rm12) do contain asbestos.

Any change in appearance should be recorded and passed to property services.

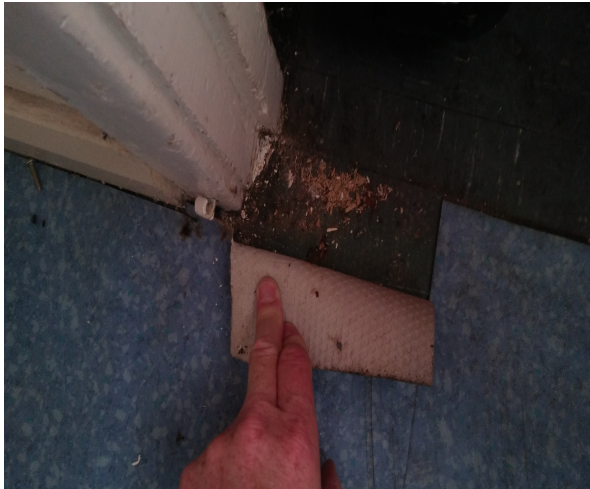
Item 11 Ref: 223226-2

223226-2 – Floor tile & bitumen adhesive (Kitchen) (Item 11) - Removed 2017

The floor tiles & bitumen adhesive in the kitchen (Rm14) do contain asbestos.

Removed November 2017.

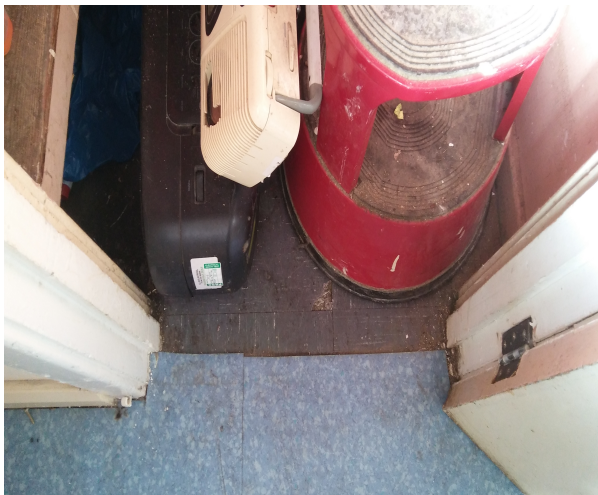
Item 12 Ref: As 223226-2

As 223226-2 – Floor tile & bitumen adhesive (Tank cupboard) (Item 12) - Removed 2017

The floor tiles & bitumen adhesive in the tank cupboard (Rm15) do contain asbestos.

Removed November 2017.

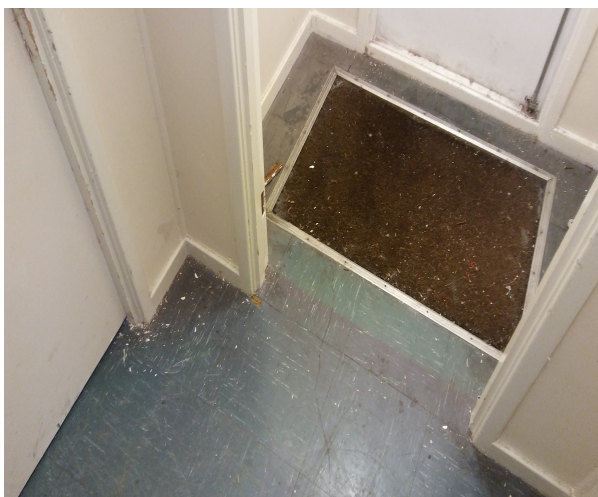
Item 13 Ref: 223226-3

223226-3 – Floor tile & bitumen adhesive (Rear Fire Exit Lobby) (Item 13) Very low Risk

The floor tiles & bitumen adhesive in the rear fire exit lobby (Rm18) do contain asbestos.

Any change in appearance should be recorded and passed to property services.

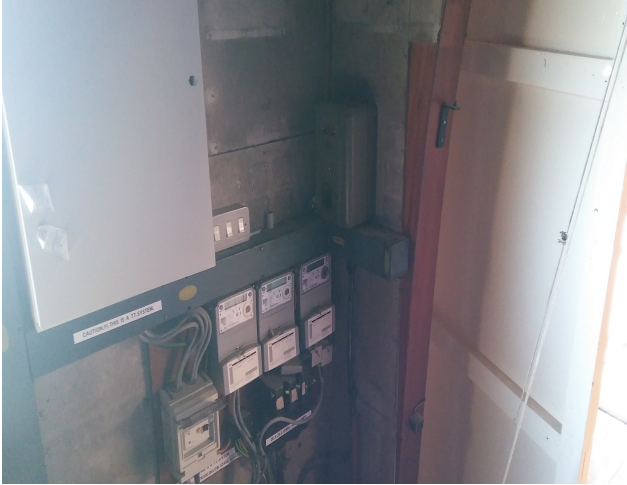
Item 14 Ref: 223226-4

223226-4 – Panels around electrics (Stage Area) (Item 14) Very Low Risk

The panels around the electrics in the stage area (Rm19) do contain asbestos.

Any change in appearance should be recorded and passed to property services.

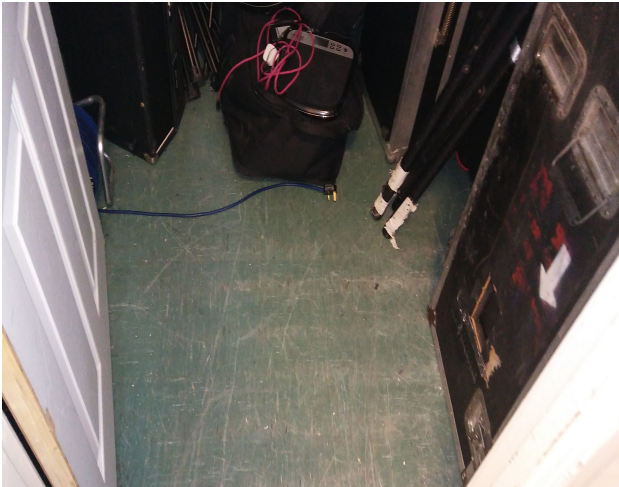
Item 15 Ref: As 223226-3

As 223226-3 - Floor tile & bitumen adhesive (Rm21 Rear Store) (Item 15) Very Low Risk

The floor tiles & bitumen adhesive in the rear store (Rm21) do contain asbestos.

Any change in appearance should be recorded and passed to property services.

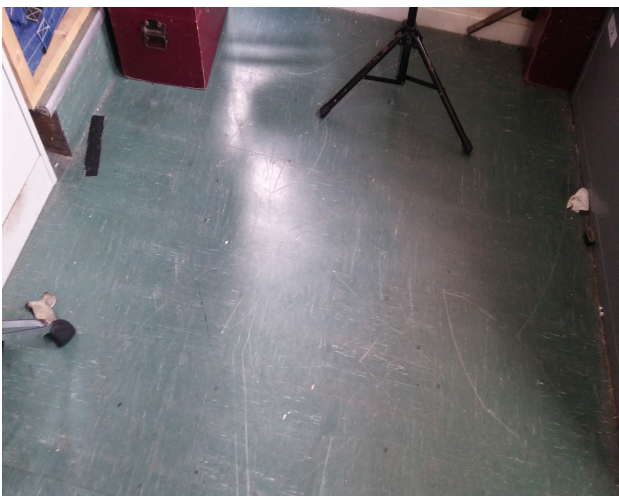
Item 16 Ref: As 223226-3

As 223226-3 - Floor tile & bitumen adhesive (Rm 22 Rear Store) (Item 16) Very Low Risk

The floor tiles & bitumen adhesive in the rear store (Rm22) do contain asbestos.

Any change in appearance should be recorded and passed to property services.

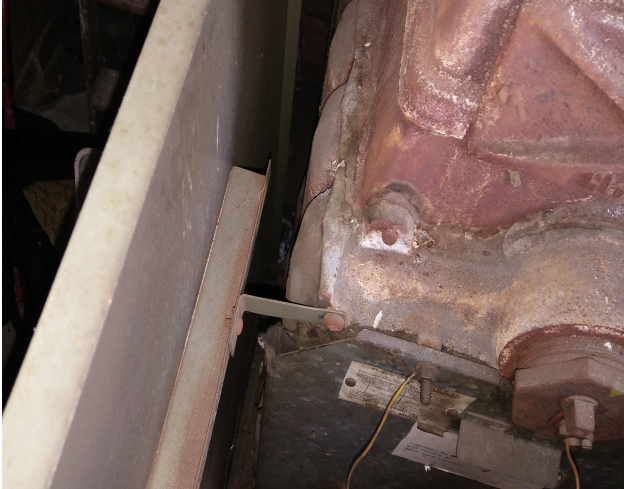
Item 17 Ref: 223226-5

223226-5 – Ropes (Boiler room) (Item 17) Removed November 2019

The ropes to the boiler sections in the boiler room (Rm23) do contain asbestos.

Removed November 2019.

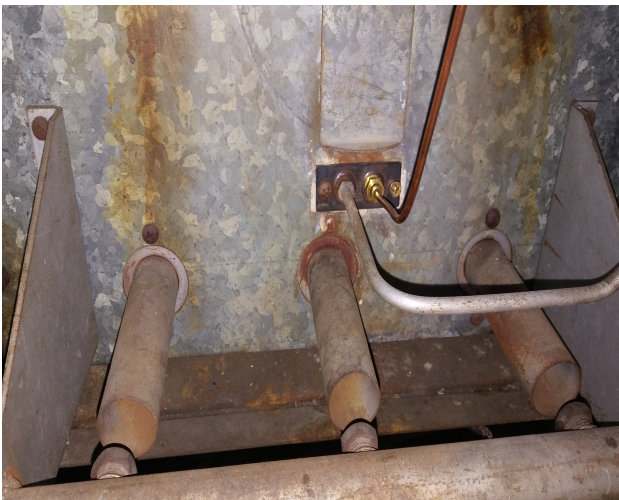
Item 18 Ref: 223226-6

226226-6 – Gasket to boilers (Boiler room) (Item 18) Removed November 2019

The gaskets to pipe inlets in the boiler room (Rm23) do contain asbestos.

Removed November 2019.

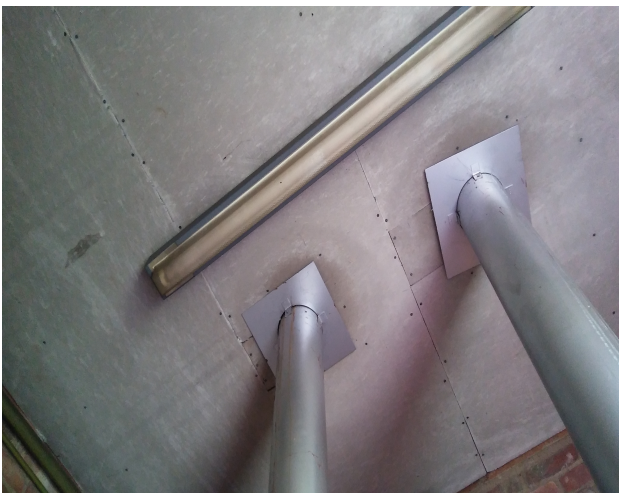
Item 19 Ref: 223226-7

223226-7 – Ceiling Panels (Boiler room) (Item 19) Very Low Risk

The ceiling panels in the boiler room (Rm23) do contain asbestos.

Any change in appearance should be recorded and passed to property services.

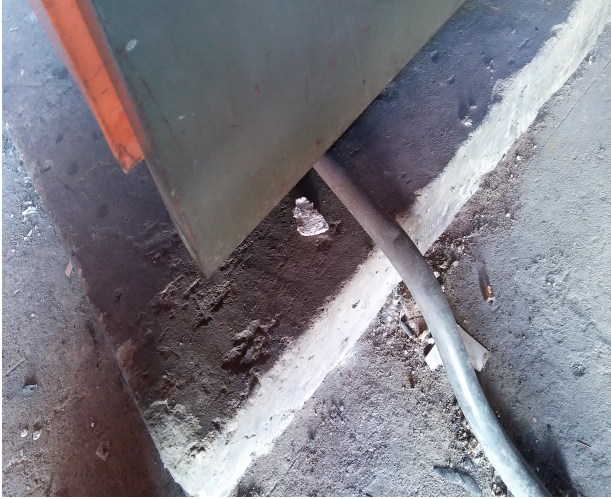
Item 20 Ref: 223226-8

223226-8 – Debris (Boiler room) (Item 20) No Risk

The debris in the boiler room (Rm23) does not contain asbestos.

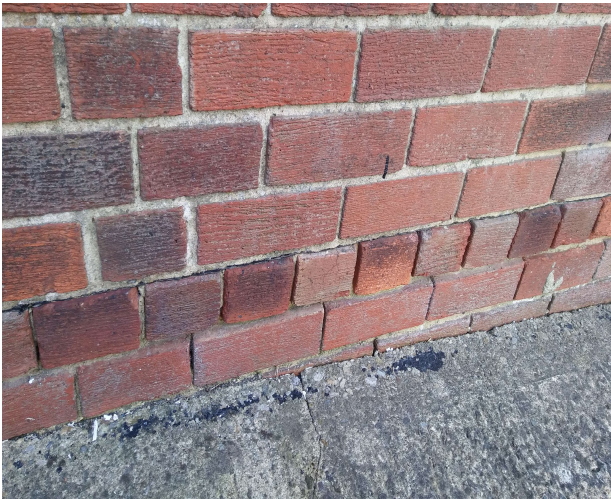
Item 21 Ref: 223226-9

223226-9 – Damp Proof Course (Externals) (Item 21) No Risk

The damp proof course to the externals does not contain asbestos.

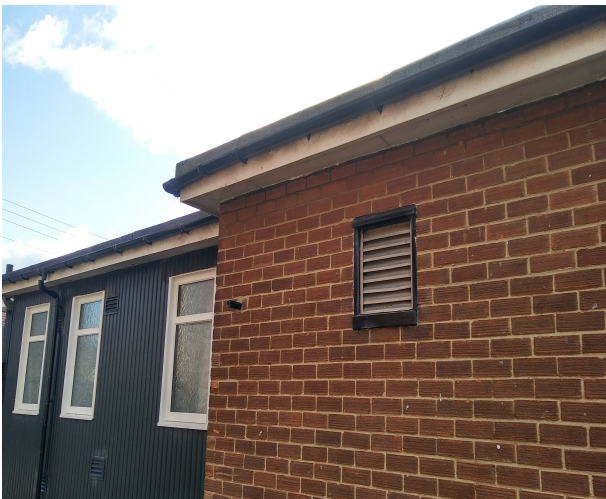
Item 22 Ref: 223226-10

223226-10 – Soffit (Externals) (Item 22) Very Low Risk

The soffit to the externals does contain asbestos.

Any change in appearance should be recorded and passed to property services.

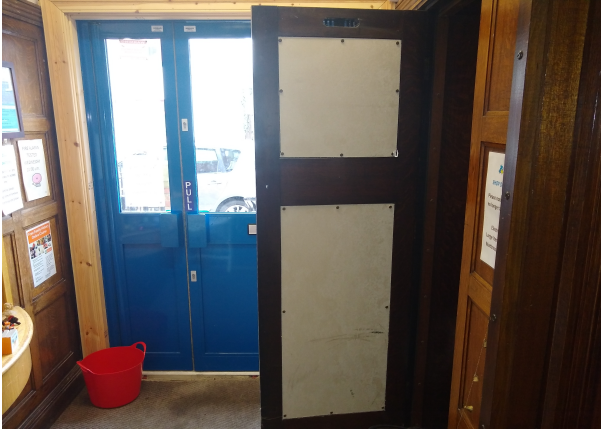
Item 23 Ref: 349822-2

349822-2 – Panel to rear of electrical cupboard doors (Room 0/005) (Item 23) No Risk

The panel to the rear of the electrical cupboard doors in the reception (Room 0/005) does not contain asbestos.

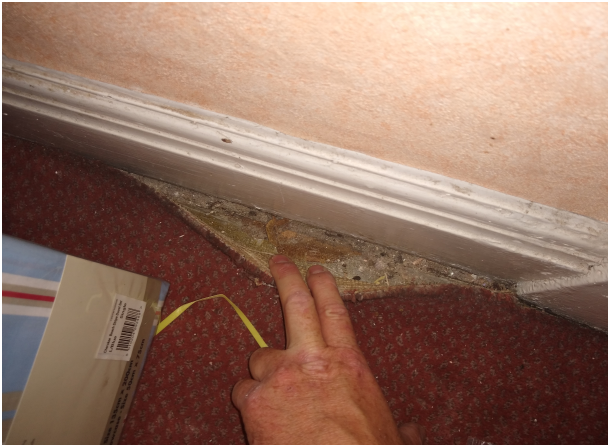
Item 24 Ref: 349822-1

349822-1 – Floor covering (Room 0/007) (Item 24) No Risk

The floor covering in the office (Room 0/07) does not contain asbestos.
