### **ASBESTOS SURVEY REPORT FOR ST MARYS CAR PARK, ST MARYS WAY, SUNDERLAND**

### **St Marys Car Park, St Marys Way, Sunderland**

**Date: 3<sup>rd</sup> July 2025**

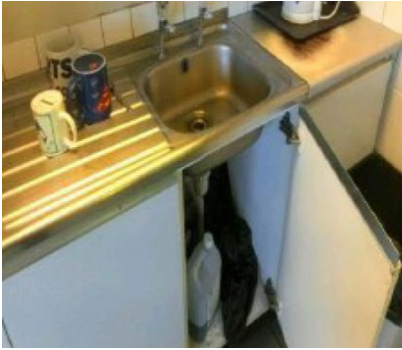
### **Item 1 – EC002219**

The sink pad in the canteen (Room 7) on the Ground Floor does not contain asbestos.

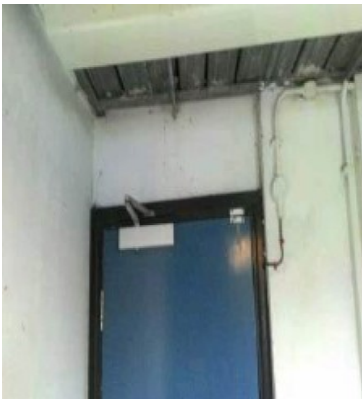
### **Item 2 – As EC002218**

The firebreak above the doors to the car park on ground floor emergency stairwell 1 (Room 15) does not contain asbestos.

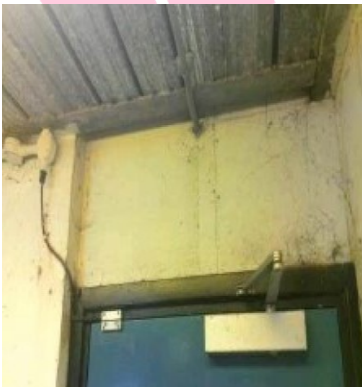
### **Item 3 – As EC002218**

The firebreak above the doors to the car park on ground floor emergency stairwell 2 (Room 16) does not contain asbestos.

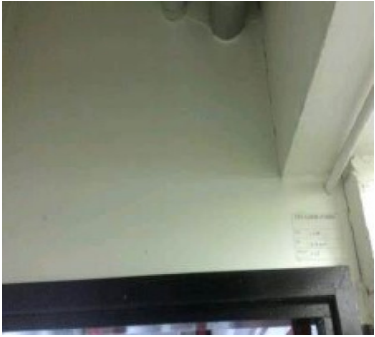
#### **Item 4 – As EC002218**

Insulating board to the wall in the electrical cupboard on the 1st floor (Room 1) does not contain asbestos.

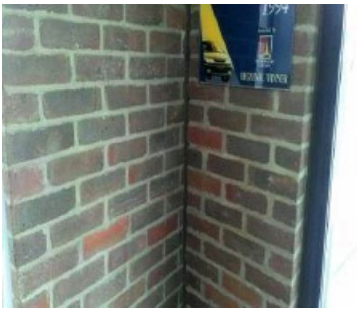
#### **Item 5 – EC002217**

The sealant to the wall in the 2<sup>nd</sup> Floor lobby (Room 7) does not contain asbestos.

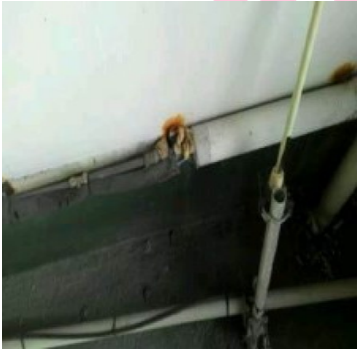
#### **Item 6 – EC002214**

The pipe lagging in the 3<sup>rd</sup> floor parking area (Room 1) does not contain asbestos.

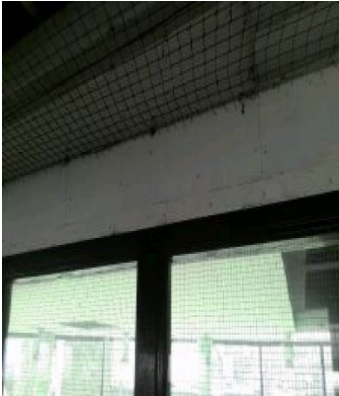
### **Item 7 – EC002215**

The cement panel above the windows in the 3<sup>rd</sup> floor parking area (Room 1) do not contain asbestos.

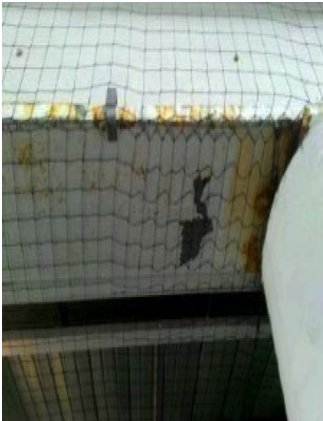
### **Item 8 – EC002216**

The coating to the steel beam in the 3<sup>rd</sup> floor parking area (Room 1) does not contain asbestos.

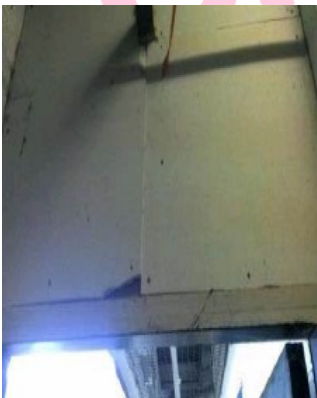
### **Item 9 – EC002218**

The insulation board to the 3<sup>rd</sup> floor electrical cupboard (Room 4) does not contain asbestos.

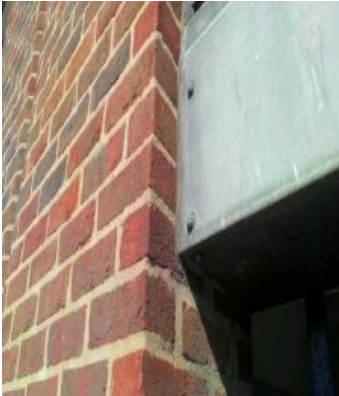
**Item 10 – EC002220**

The wall sealant to the external does not contain asbestos.
