ASBESTOS SURVEY REPORT FOR ST MARYS CAR PARK, ST MARYS WAY, SUNDERLAND

Asbestos Register for

St Marys Car Park, St Marys Way, Sunderland

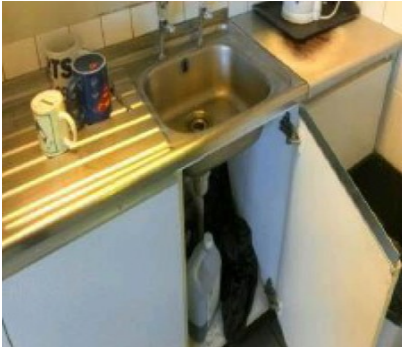
Item 1 – EC002219

The sink pad in the canteen (Room 7) on the Ground Floor does not contain asbestos.

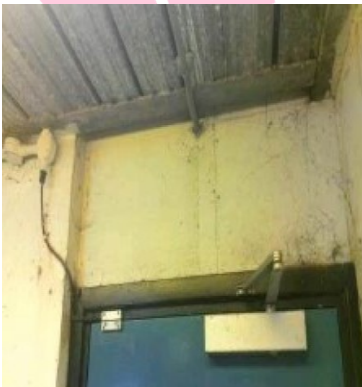
Item 3 – As EC002218

The firebreak above the doors to the car park on ground floor emergency stairwell 2 (Room 16) does not contain asbestos.

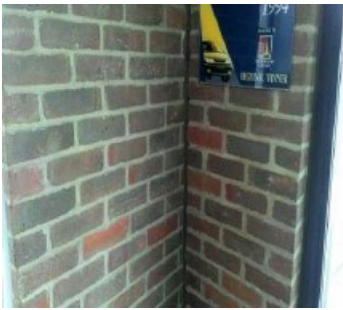
Item 5 – EC002217

The sealant to the wall in the 2nd Floor lobby (Room 7) does not contain asbestos.

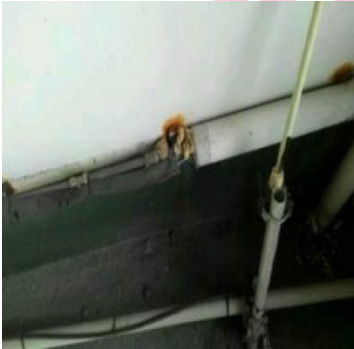
Item 6 – EC002214

The pipe lagging in the 3rd floor parking area (Room 1) does not contain asbestos.

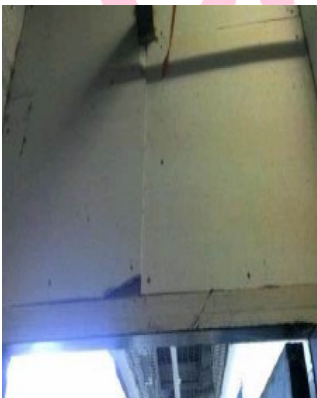
Item 9 – EC002218

The insulation board to the 3rd floor electrical cupboard (Room 4) does not contain asbestos.
