ASBESTOS SURVEY REPORT FOR SILKSWORTH RECREATION PARK,  
BLIND LANE, SUNDERLAND, SR3 1AU.

## **Asbestos Register for**

**Silksworth Recreation Park, Blind Lane,  
Sunderland, SR3 1AU.**

**Date: 05 February 2026**

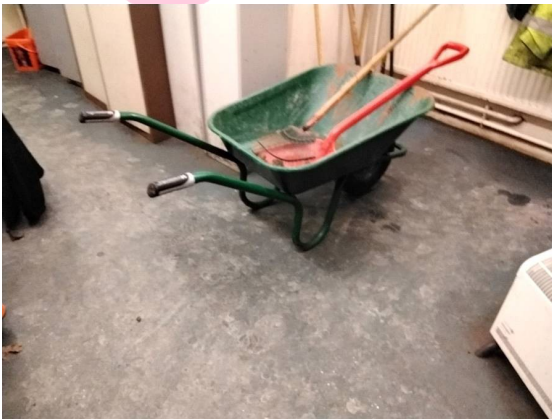
### **Item 3 Ref: KX000470**

The Floor – Covering - Vinyl Tile, Vinyl/Lino in Boiler House/Changing Rooms G/001 Staff Room does not contain asbestos.

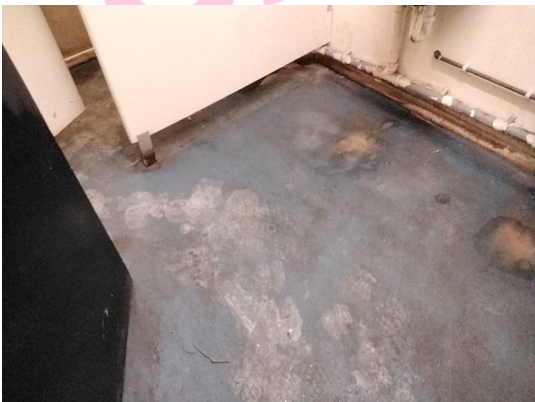
**Item 6 Ref:** As KX000470

The Floor – Covering - Vinyl Tile, Vinyl/Lino in Boiler House/Changing Rooms G/003 Toilets does not contain asbestos.

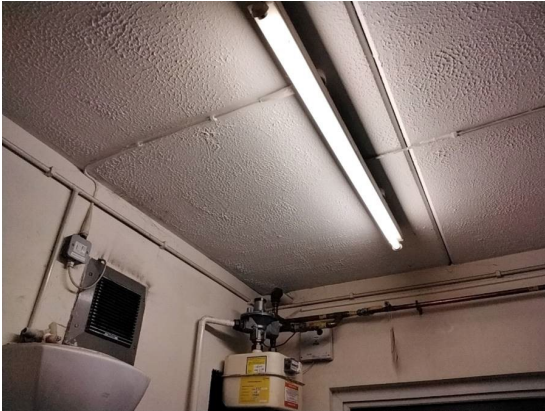
**Item 7 Ref:** As KX000469

The Ceiling – Coating – decorative finish in Boiler House/Changing Rooms G/003 Toilets does not contain asbestos.

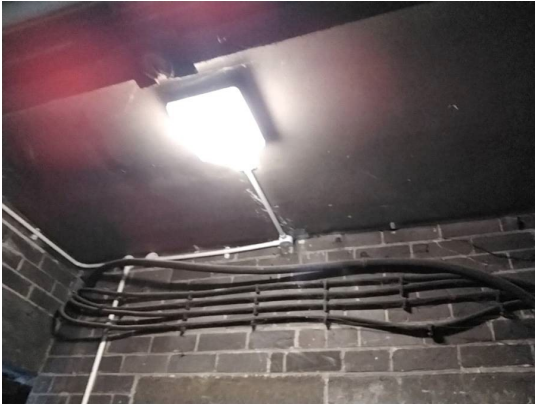
**Item 8 Ref:** KX000471

8.	KX000471	Ceiling - Insulating Board	Boiler House/Changing Rooms G/004 Boiler Room	Low
9.	KX000472	Debris/Residue - to floor	Boiler House/Changing Rooms G/004 Boiler Room	No Risk

The Ceiling - Insulating Board in Boiler House/Changing Rooms G/004 Boiler Room contains asbestos.

Any change in its appearance should be recorded and passed to Property Services.

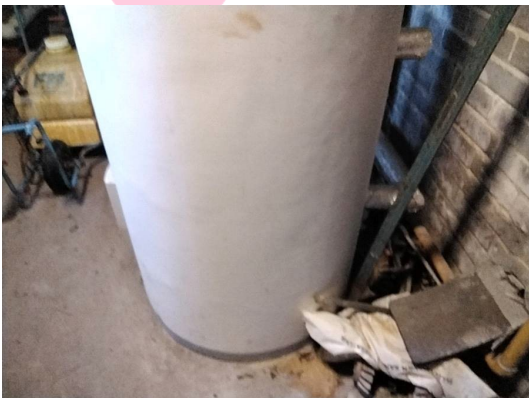
**Item 9 Ref:** KX000472

The Debris/Residue - to floor in Boiler House/Changing Rooms G/004 Boiler Room does not contain asbestos.

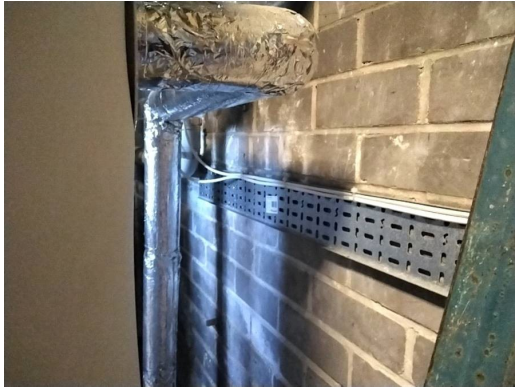
**Item 10 Ref: KX000473**

The Debris/Residue - to walls behind calorifiers - Thermal Insulation Lagging in Boiler House/Changing Rooms G/004 Boiler Room does not contain asbestos.

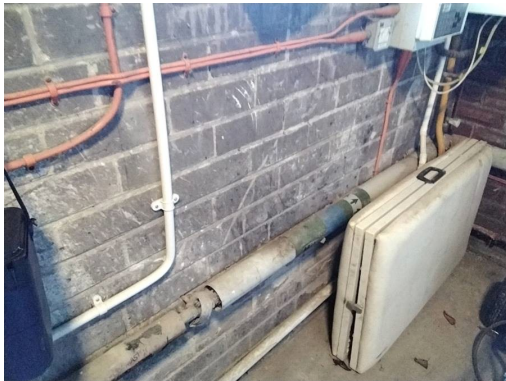
**Item 11 Ref: KX000474**

The Debris/Residue - to walls under window - Thermal Insulation Lagging in Boiler House/Changing Rooms G/004 Boiler Room does not contain asbestos.

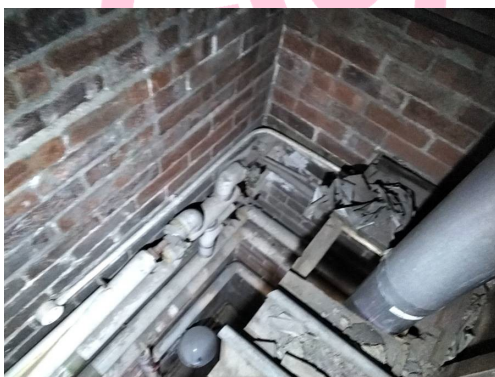
**Item 12 Ref: KX000476**

The Debris/Residue - to pipe penetrations - Thermal Insulation Lagging in Boiler House/Changing Rooms G/004 Boiler Room does not contain asbestos.

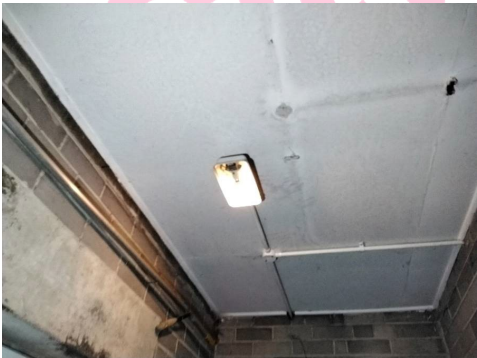
### **Item 15 Ref: KX000476**

The Ceiling - Insulating Board in Boiler House/Changing Rooms G/007 Cupboard-Store contains asbestos.

Any change in its appearance should be recorded and passed to Property Services.

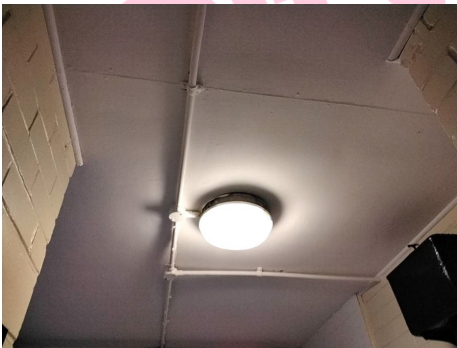
### **Item 18 Ref: As KX000477**

The Ceiling - Insulating Board in Boiler House/Changing Rooms G/012 Shower Room contains asbestos.

Any change in its appearance should be recorded and passed to Property Services.

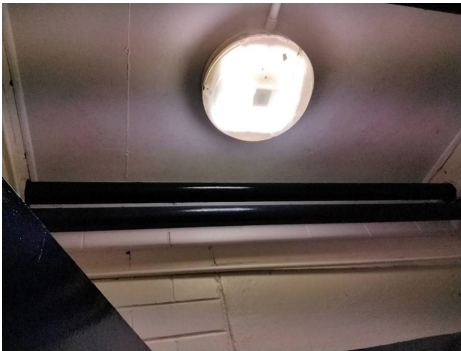
### **Item 20 Ref: As KX000477**

The Ceiling - Insulating Board in Boiler House/Changing Rooms G/017 Toilets contains asbestos.

Any change in its appearance should be recorded and passed to Property Services.

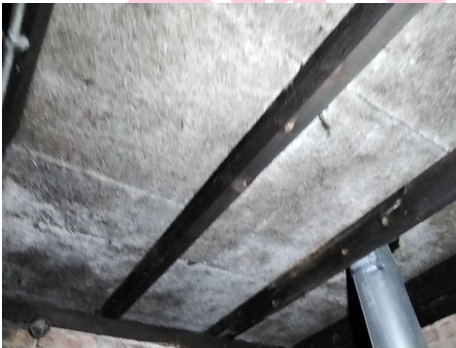
### **Item 21 Ref: KX000475**

The Ceiling in Boiler House/ Changing Rooms 1<sup>st</sup> Floor 1/001 Tank Room does not contain asbestos.

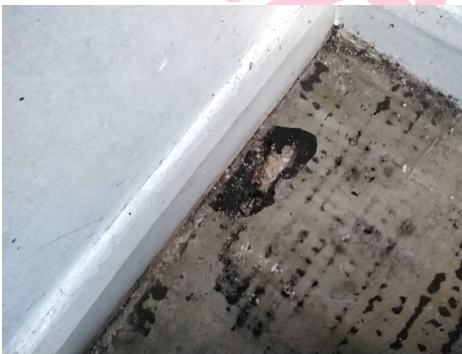
**Item 24 Ref:** KX000479

The Floor - adhesive residue – bitumen in Tea Rooms G/001 Entrance Hall contains asbestos.

Any change in its appearance should be recorded and passed to Property Services.

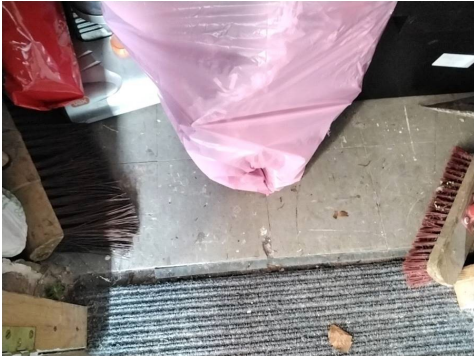
### **Item 25 Ref: KX000480**

The Floor - Tile – green - Composite Vinyl Tile, Vinyl/Lino with adhesive in Tea Rooms G/002 Storeroom (Limited inspection within due to storage) contains asbestos.

Any change in its appearance should be recorded and passed to Property Services.

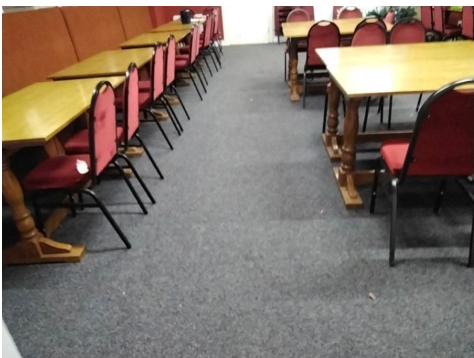
### **Item 26 Ref: As KX000479**

The Floor - adhesive residue – bitumen in Tea Rooms G/003 Dining Hall contains asbestos.

Any change in its appearance should be recorded and passed to Property Services.

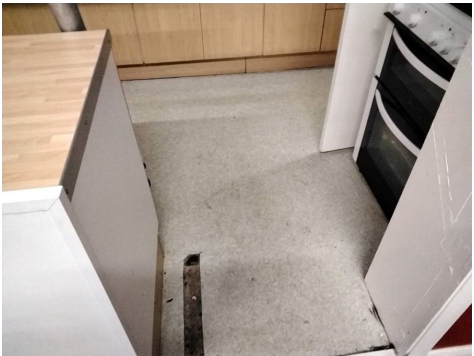
### **Item 27 Ref: As KX000479**

The Floor - adhesive residue – bitumen in Tea Rooms G/004 Kitchen contains asbestos.

Any change in its appearance should be recorded and passed to Property Services.

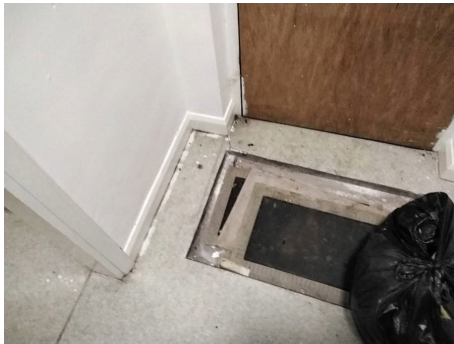
**Item 29 Ref: As KX000479**

The Floor - adhesive residue – bitumen in Tea Rooms G/006  
Passageway contains asbestos.

Any change in its appearance should be recorded and passed to Property Services.

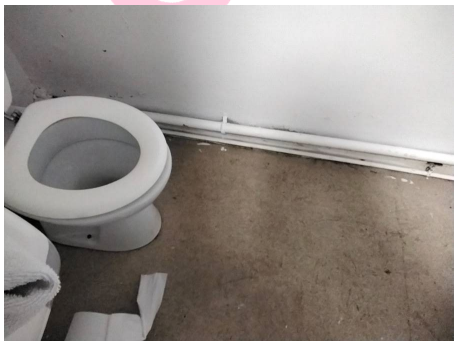
**Item 30 Ref: As KX000479**

The Floor - adhesive residue – bitumen in Tea Rooms G/007  
Toilets contains asbestos.

Any change in its appearance should be recorded and passed to Property Services.

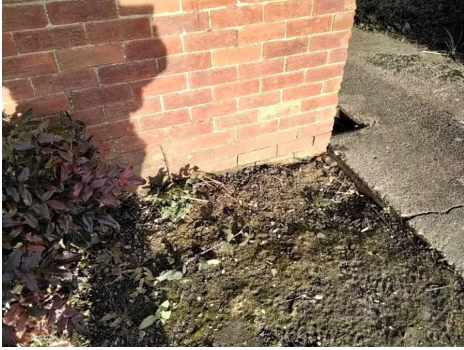
**Item 31 Ref: KX000481**

The Damp Proof Course External Tea Rooms does not contain asbestos.
