ASBESTOS SURVEY REPORT FOR 18 REVELSTOKE ROAD, SUNDERLAND

Asbestos Register for

18 REVELSTOKE ROAD, SUNDERLAND

Site/Area: 18 Revelstoke Road, Redhouse, Sunderland, SR5 5EP

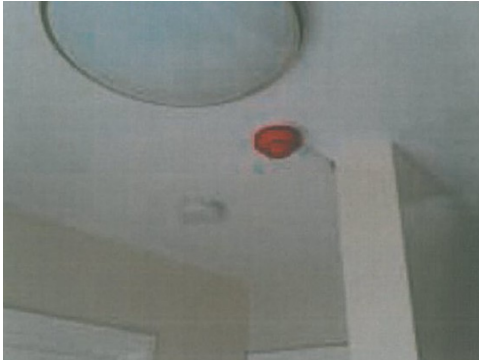
Item 1 Ref: IC10/1643

IC10/1643 – Textured coating (Room 1 Rear Foyer) (Item 1) – Very Low Risk

The textured coating to the ceiling in the foyer and stairs (Room 1) contains asbestos.

Any changes in its appearance should be noted and passed to Property Services.

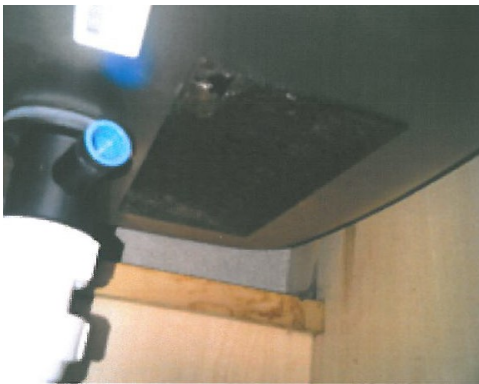
Item 2 - Ref: IC10/1644

The sink pad in the kitchen (Room 3) does not contain asbestos.

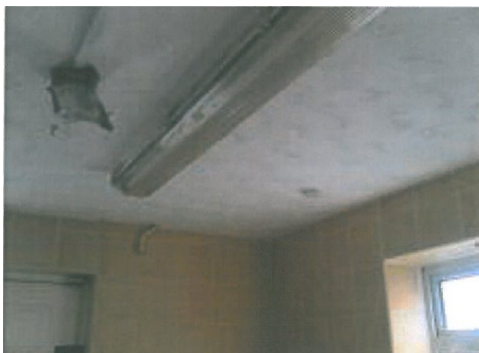
Item 3 - Ref: IC10/1645

The textured coating to the ceiling in the kitchen (Room 6) does not contain asbestos.

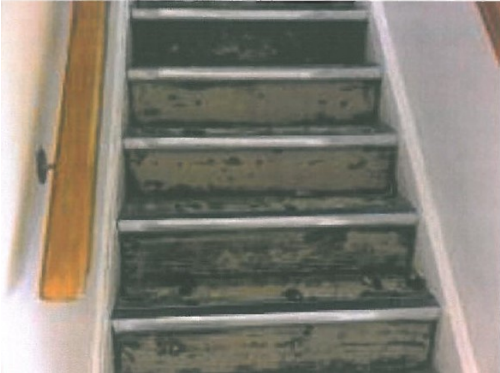
Item 4 Ref: IC10/1648

The stair nosing to the hall and stairs (Room 7) does not contain asbestos.

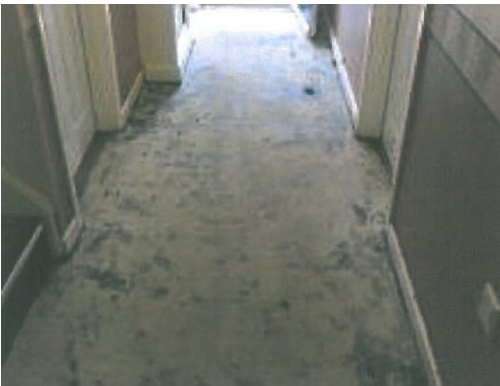
Item 5 - Ref: IC10/1647

IC10/1647 – Floor tiles (Room 7 Front Hall & Stairs) (Item 5) – Very Low Risk

The floor tiles to the hall and stairs (Room 7) contain asbestos. Any changes in its appearance should be noted and passed to Property Services.

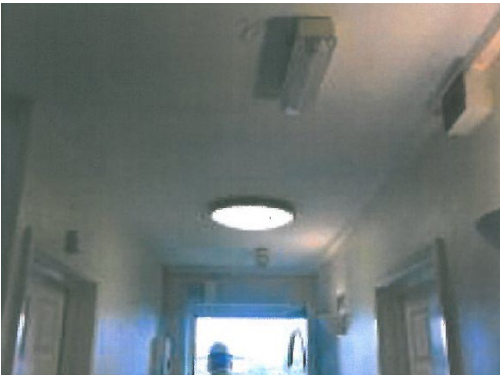
Item 6 - As IC10/1643

The textured coating to the ceiling in the hall and stairs (Room 7) contains asbestos. Any changes in its appearance should be noted and passed to Property Services.

This has been removed and resampled. See Item 24 for evidence.

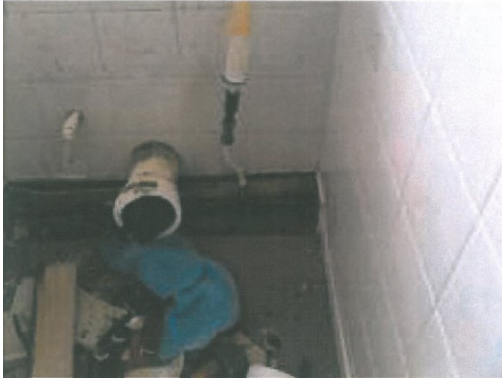
Item 7 Ref: IC10/1649

IC10/1649 – Floor tiles and adhesive (Room 12 WC 2) (Item 7) - Low Risk

The floor tiles and adhesive to WC 2 (Room 12) contain asbestos. Any changes in its appearance should be noted and passed to Property Services.

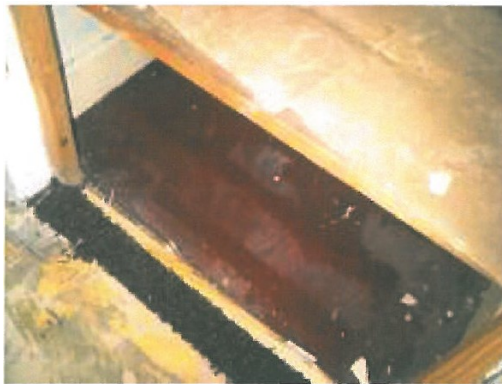
Item 8 - Ref: IC10/1650

The flooring to the landing – Cupboard A (Room 14) does not contain asbestos.

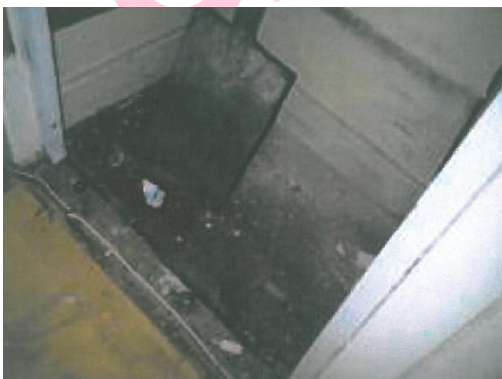
Item 9 - As IC10/1650

The flooring to Landing Cupboard B (Room 15) does not contain asbestos.

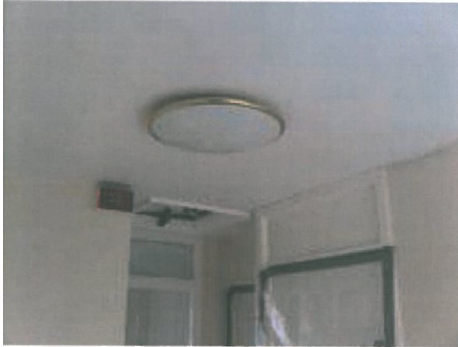
Item 10 As IC10/1643

As IC10/1643 – Textured coating to ceiling (Room 18 Rear Landing) (Item 10) – Very Low Risk

The textured coating to the ceiling in the rear landing (Room 18) contains asbestos. Any changes in its appearance should be noted and passed to Property Services.

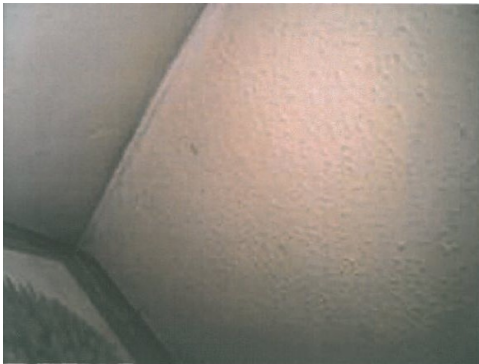
Item 11 – As IC10/1643

As IC10/1643 – Textured coating to ceiling (Room 19 Rear Landing Cupboard) (Item 11) – Very Low Risk

The textured coating to the ceiling in the rear landing cupboard (Room 19) contains asbestos. Any changes in its appearance should be noted and passed to Property Services.

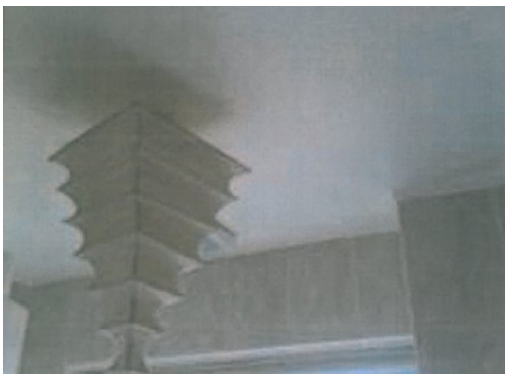
Item 12 - As IC10/1643

As IC10/1643 – Textured coating to ceiling (Room 20 Bathroom 2) (Item 12) – Low Risk

The textured coating to the ceiling in bathroom 2 (Room 20) contains asbestos.

Any changes in its appearance should be noted and passed to Property Services.

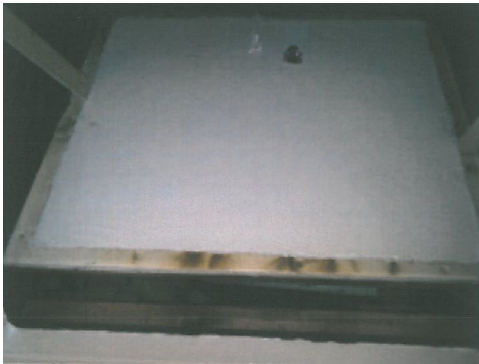
Item 14 – Ref: IC10/1651

The loft hatch board does not contain asbestos.

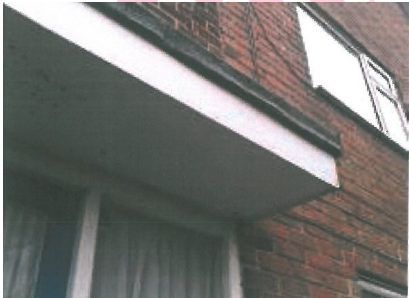
Item 15 Ref: IC10/1653

The canopy to the rear door does not contain asbestos.

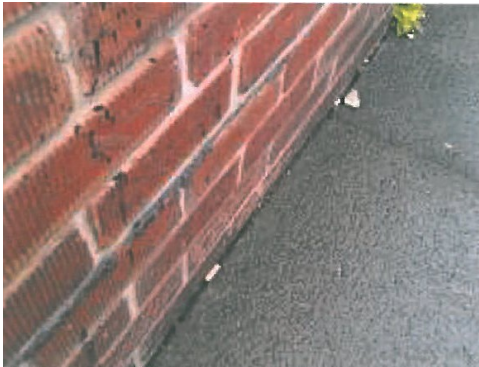
Item 16 Ref: IC10/1654

The damp proof course to the external does not contain asbestos.

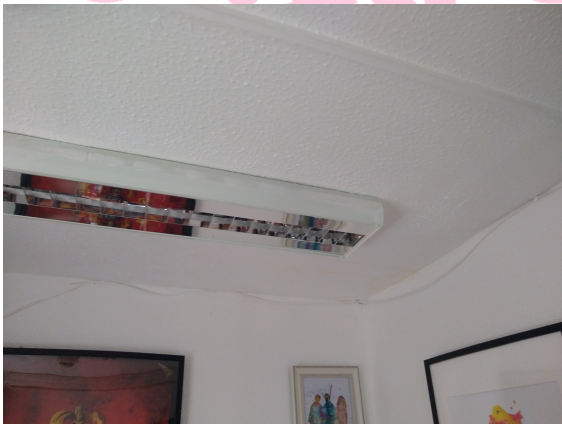
Item 21 Ref: As 340701-2

As 340701-2 – Textured coating to ceiling (Rm 006/ Rear office) (Item 21) – Very Low Risk

The Textured coating to ceiling in Room 006/office contains asbestos.

Any change in appearance should be reported to Property Services.

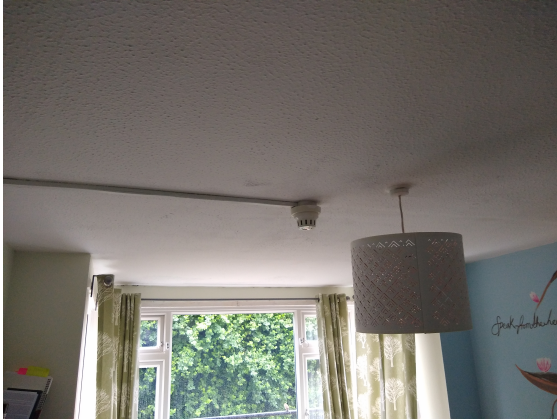
Item 22 Ref: 340701-2

340701-2 – Textured coating to ceiling (Rm 007/ Rear office) (Item 22) – Very Low Risk

The Textured coating to ceiling in Room 007/office contains asbestos.

Any change in appearance should be reported to Property Services.

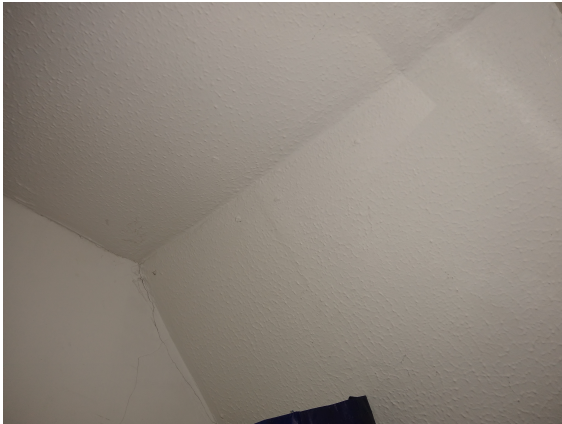
Item 23 Ref: As 340701-2

As 340701-2 – Textured coating to ceiling (Rm 008/Rear under stairs cupboard) (Item 23) – Very Low Risk

The Textured coating to ceiling in Room 008/under stairs cupboard contains asbestos.

Any change in appearance should be reported to Property Services.

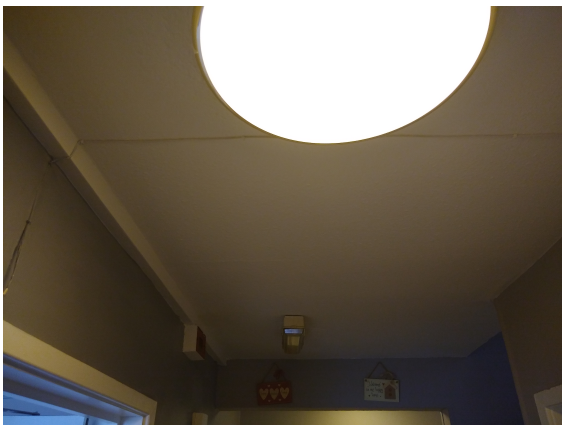
Item 24 Ref: 340701-3/ 22- 53444-1

The Textured coating to ceiling in Room 010/corridor does not contain asbestos.

Resampled by Pattinsons 2022 – confirmed no asbestos present.

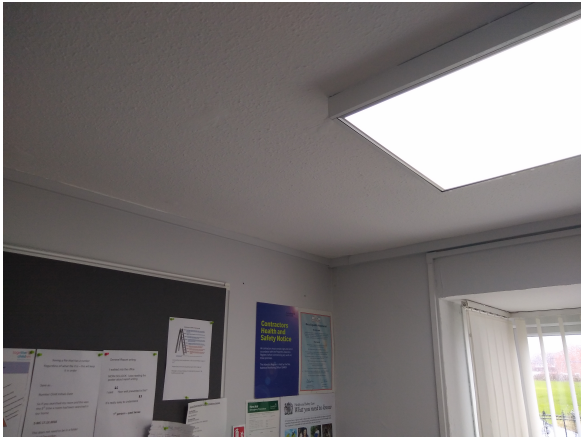
Item 25 Ref: 340701-7/ 22-53444-2

The Textured coating to ceiling in Room 012/office does not contain asbestos.

Resampled by Pattinsons 2022 – confirmed no asbestos present.

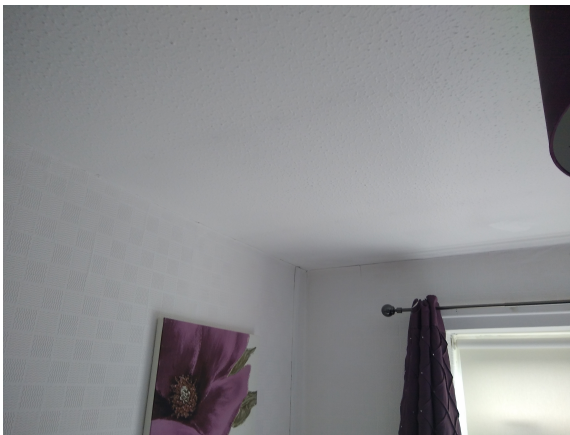
Item 26 Ref: 340701-5

340701-5 – Textured coating to ceiling (Rm 1/004/Rear staff bedroom) (Item 26) – Very Low Risk

The Textured coating to ceiling in Room 004/staff bedroom contains asbestos.

Any change in appearance should be reported to Property Services.

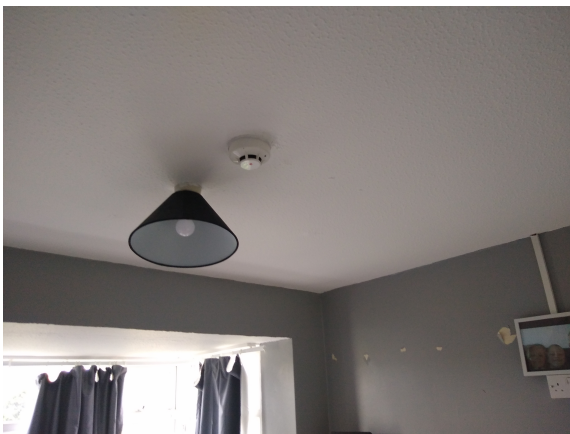
Item 27 Ref: As 340701-5

As 340701-5 – Textured coating to ceiling (Rm 1/005/bedroom 2) (Item 27) – Very Low Risk

The Textured coating to ceiling in Room 005/bedroom 2 contains asbestos.

Any change in appearance should be reported to Property Services.

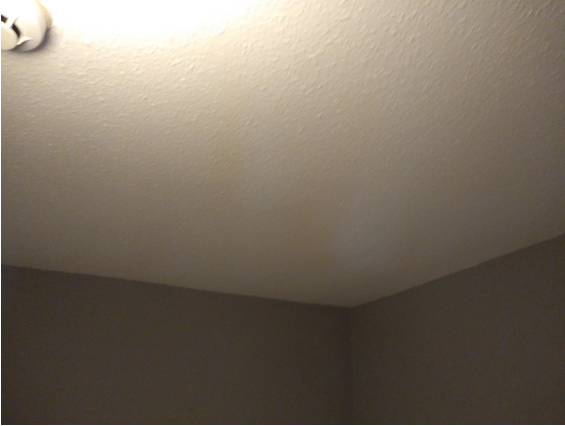
Item 28 Ref: 340701-6

The Textured coating to ceiling in Room 009/bedroom 6 does not contain asbestos.

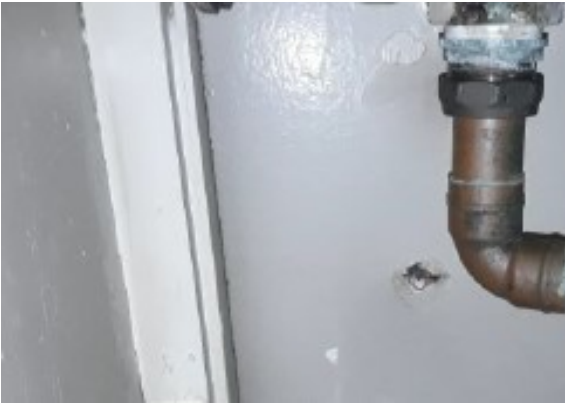
Item 29 Ref: 21-36178-1

The ceiling in the boiler/heating cupboard does not contain asbestos.

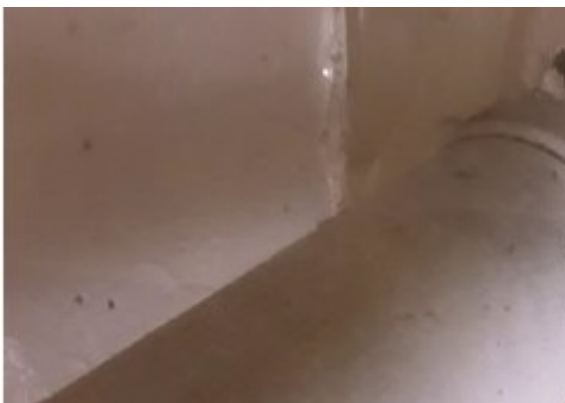
Item 30 Ref: 21-36178-2

The walls in the boiler/heating cupboard does not contain asbestos.

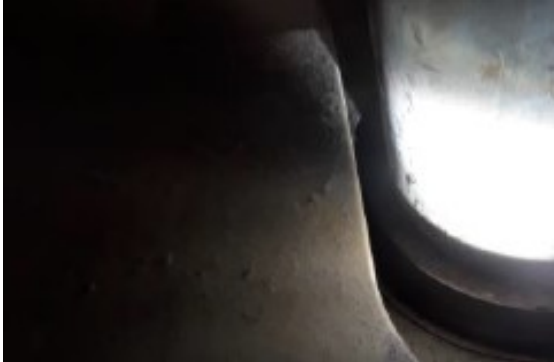
Item 31 Ref: 21-36178-3

The seal to the boiler from the flue in the boiler/heating cupboard does not contain asbestos.

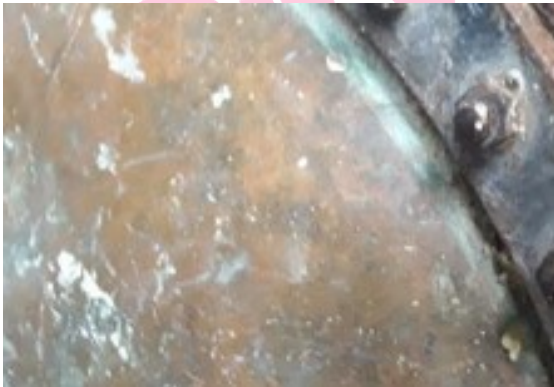
Item 33 Ref: 21-36330-1

The gasket to redundant water tank (External) does not contain asbestos.

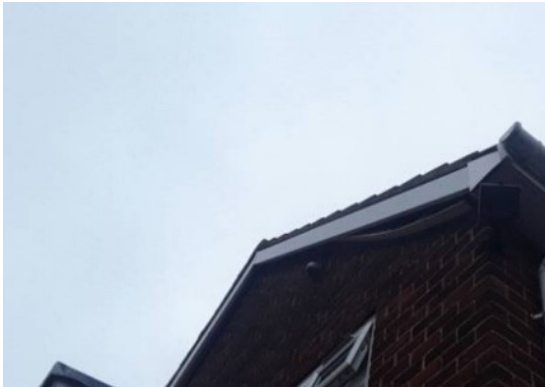
Item 34 Ref: NZ001241

The roof lining (External) does not contain asbestos.

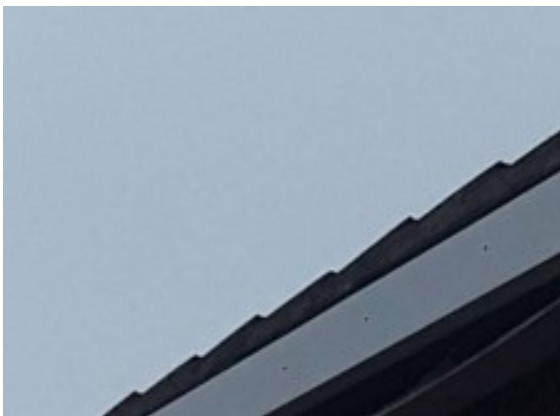
Item 35 Ref: NZ001242

NZ001242 – Undercloak to left hand rear extension (External) (Item 35) – Very Low Risk

The undercloak to left hand rear extension (External) does contain asbestos.

Any changes in appearance should be reported to Property Services.

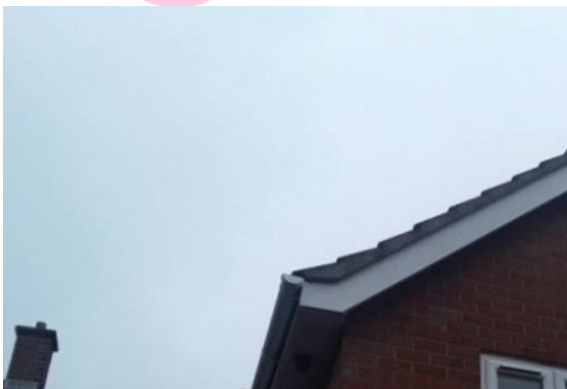
Item 36 Ref: NZ001244

The soffits to right hand rear extension (External) does not contain asbestos.

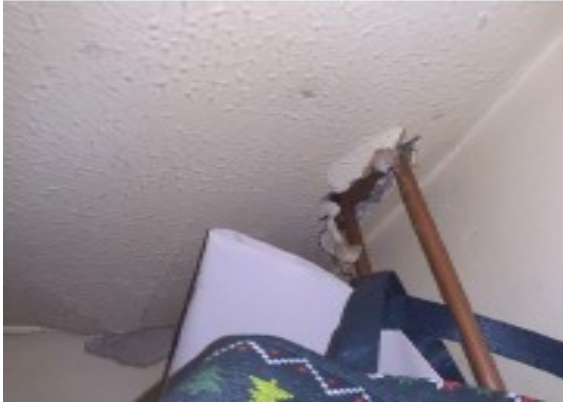
Item 37 Ref: As KG001276

The Textured coating to ceiling (Cupboard 1/01) does not contain asbestos.

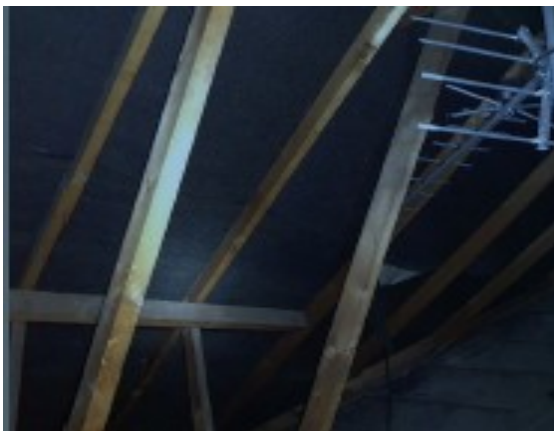
Item 38 Ref: KG001274

The Sarking to roof (Loft R/01) does not contain asbestos.

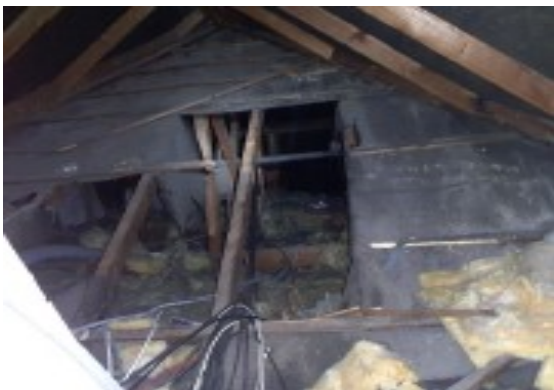
Item 39 Ref: KG001275

The Sarking lower sloping roof (Loft R/01) does not contain asbestos.

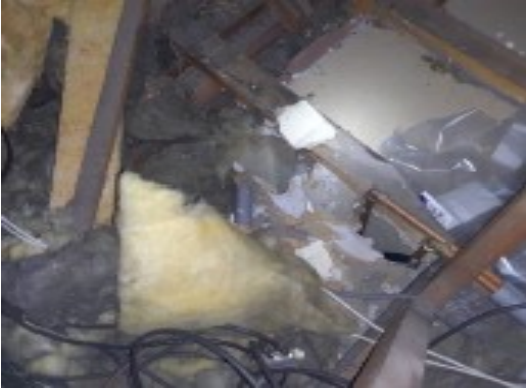
Item 40 Ref: KG001276

The Textured coating debris (Loft R/01) does not contain asbestos.

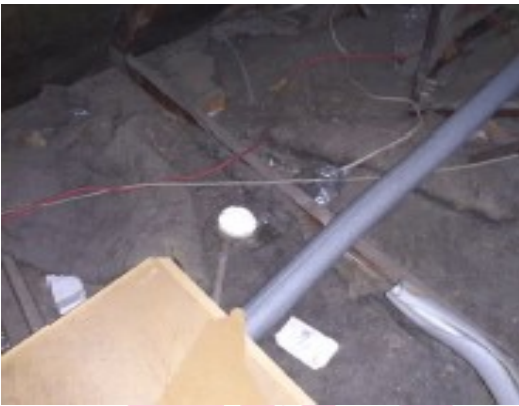
Item 41 Ref: As KG001276

The Textured coating debris (Loft R/01) does not contain asbestos.

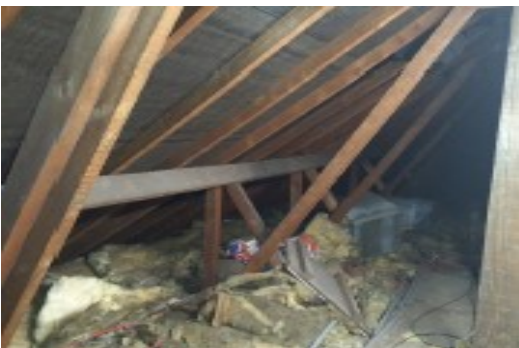
Item 42 Ref: KG001277

The Sarking to roof (Loft R/01) does not contain asbestos.
