ASBESTOS SURVEY REPORT FOR SOUTHWICK COMMUNITY CENTRE,
SOUTHWICK ROAD, SUNDERLAND, SR5 2AB

Asbestos Register for Southwick Community Centre

Date: 28 April 2025

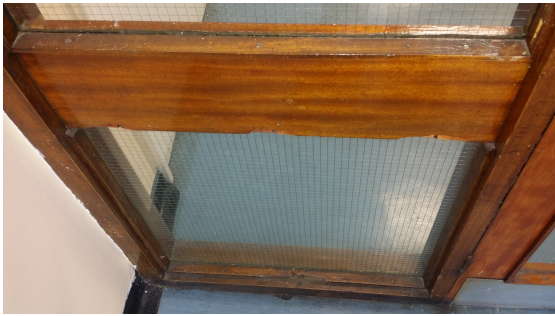
Item 1 Ref: As 292432-3

The sealant to frames in the lobby corridor (Room 001) does not contain asbestos.

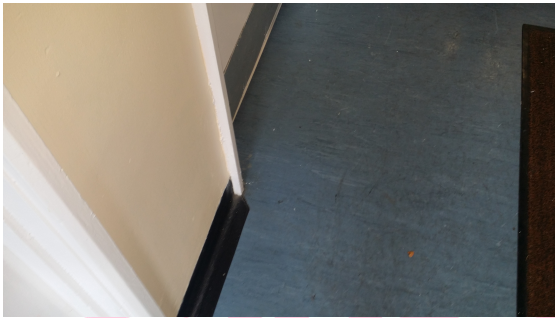
Item 2 Ref: As 292432-4

The remnant adhesive backing to floor in the lobby corridor (Room 001) does not contain asbestos.

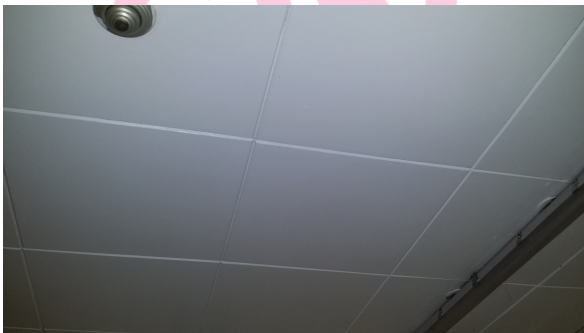
Item 3 Ref: 292432-1

The ceiling in the kitchen (Room 002) contains asbestos.

Any change in appearance should be reported to Property Services.

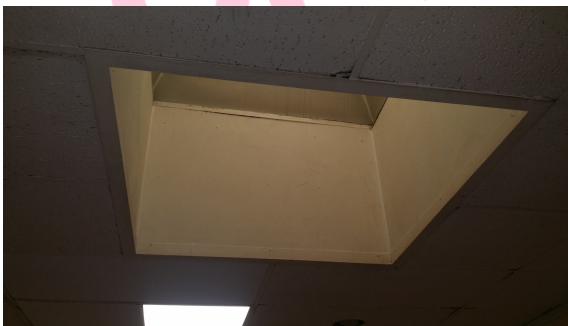
Item 6 Ref: As 292432-2

The skylight surrounds in the corridor (Room 004) contains asbestos.

Any change in appearance should be reported to Property Services.

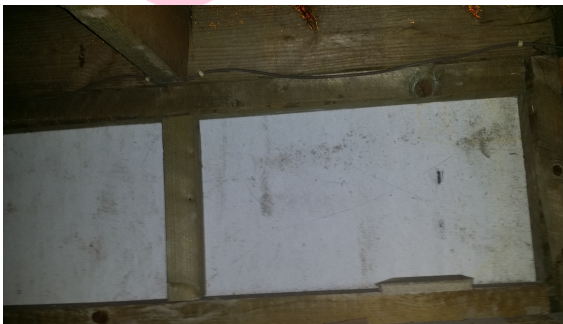
Item 9 Ref: As 292432-2

The skylight in the corridor – void above (Room 004) contains asbestos.

Any change in appearance should be reported to Property Services.

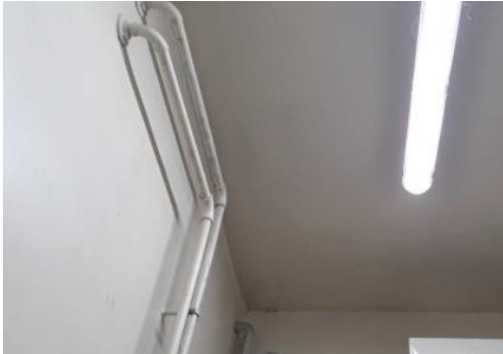
Item 10 Ref: 22-48075-2

The ceiling in the cleaners store (Room 006) does contain asbestos.

Any change in appearance should be reported to Property Services.

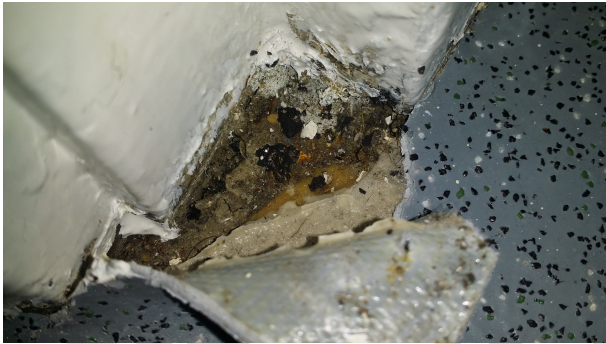
Item 14 Ref: As 292432-4

The remnant adhesive backing to the floor in the disabled toilet (Room 007) does not contain asbestos.

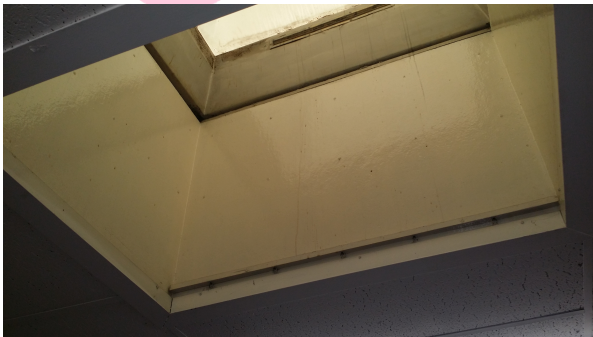
Item 15 Ref: As 292432-2

The skylight surrounds in the office (Room 008) contains asbestos.

Removed 2023

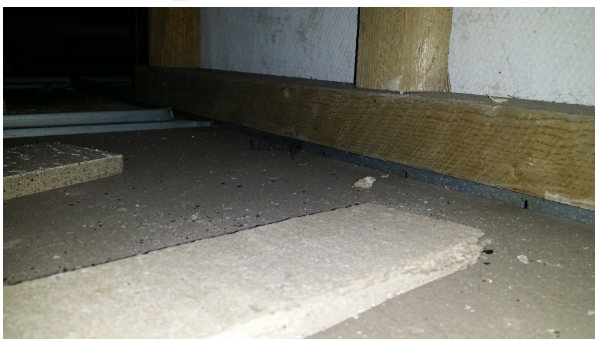
Item 18 Ref: 292432-7

The debris to the top of the ceiling tile in the office ceiling void (Room 008) contains asbestos.

Removed 2023

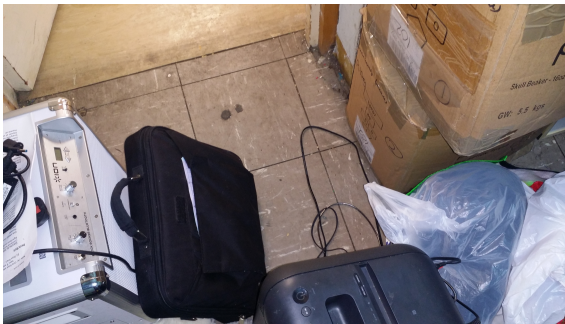
Item 20 Ref: As 292432-6

The floor covering in the cleaners store (Room 009) does not contain asbestos.

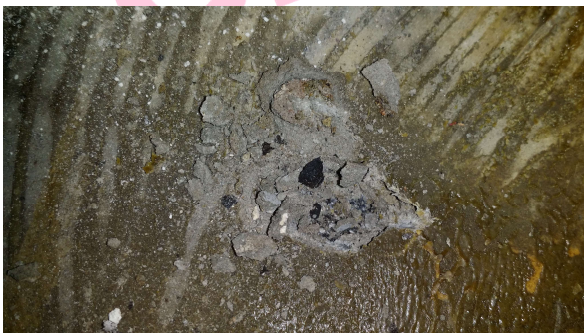
Item 21 Ref: As 292432-4

The remnant adhesive backing to the floor in the community room (Room 010) does not contain asbestos.

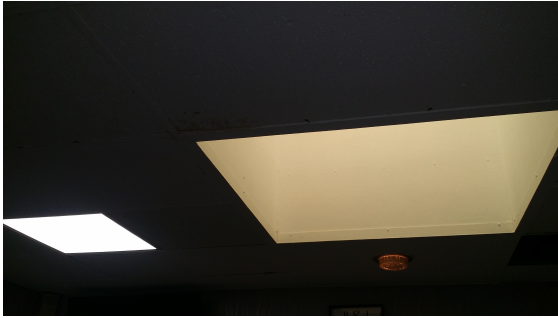
Item 22 Ref: As 292432-2

The skylight surrounds in the community room ceiling void (Room 0110) contains asbestos.

Removed 2023

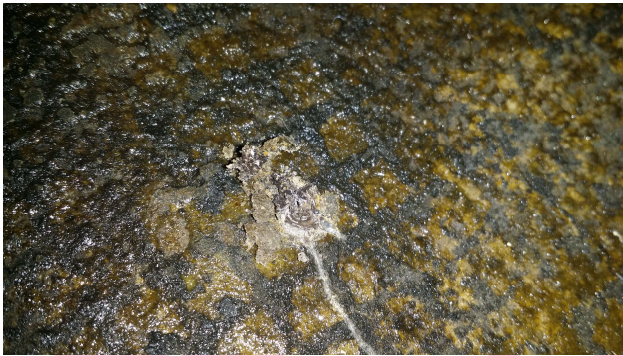
Item 23 Ref: As 292432-6

The remnant adhesive backing to the floor in the bar lounge (Room 011) does not contain asbestos.

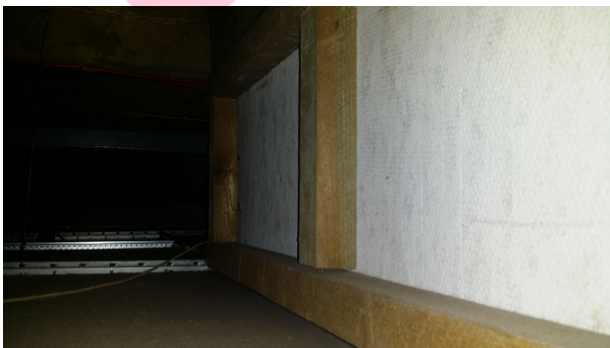
Item 24 Ref: As 292432-2

The skylight in the bar lounge ceiling void (Room 011) contains asbestos.

Removed 2023

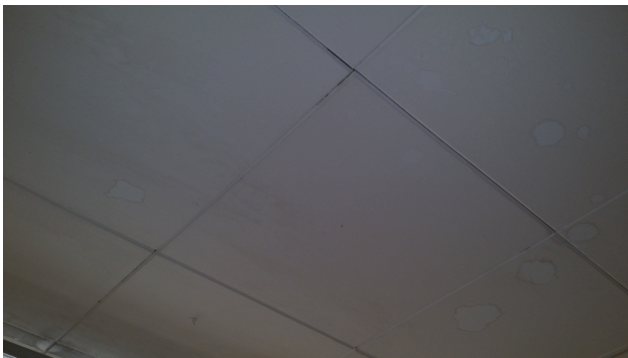
Item 27 Ref: As 292432-8

The ceiling in the female toilets (Room 013) contains asbestos.

Any change in appearance should be reported to Property Services.

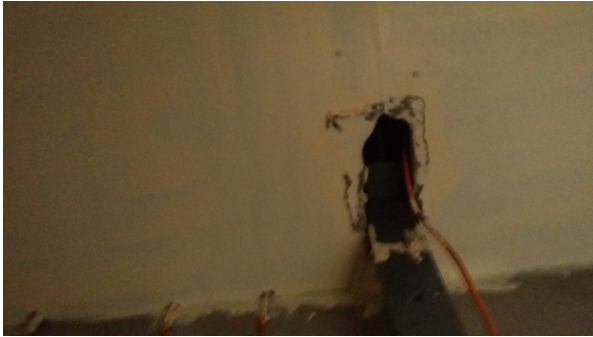
Item 28 Ref: 292432-9

The ceiling in the electrics store (Room 014) contains asbestos.

Any change in appearance should be reported to Property Services.

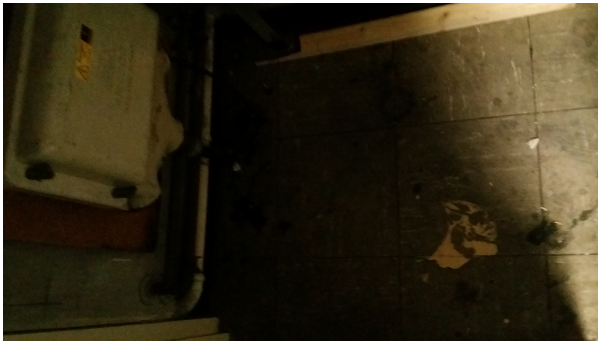
Item 29 Ref: 292432-8

The remnant adhesive backing to the floor in the bar lounge (Room 011) does not contain asbestos.

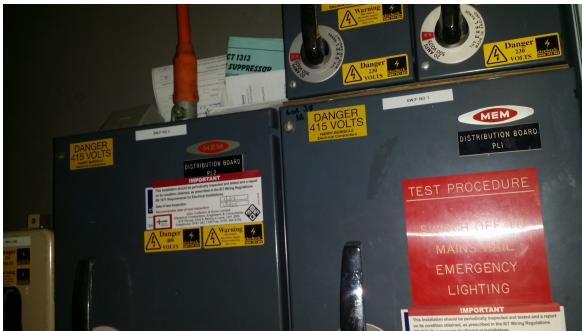
Item 30 Ref: Presumed

The electrics in the electric store (Room 014) are presumed to contain asbestos.

Any works planned should have further investigation before proceeding.

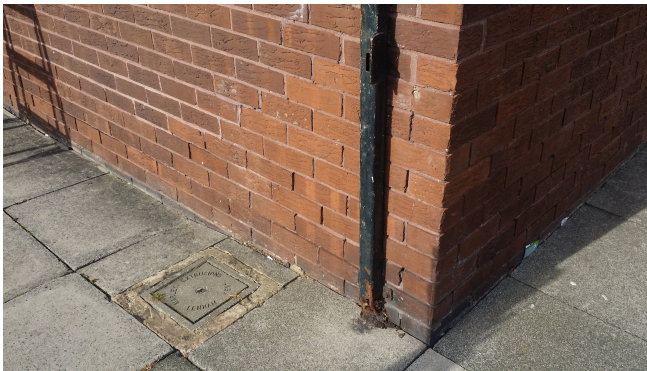
Item 35 Ref: 292432-12

The damp proof course (External) does not contain asbestos.

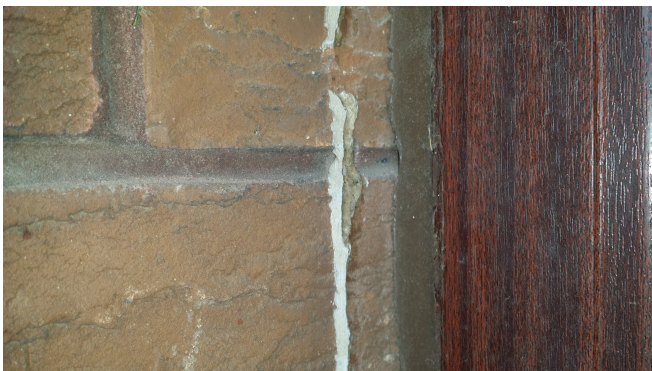
Item 36 Ref: 292432-13

The remnant mastic to wall at entrance doors (External) contains asbestos.

Any change in appearance should be reported to Property Services.

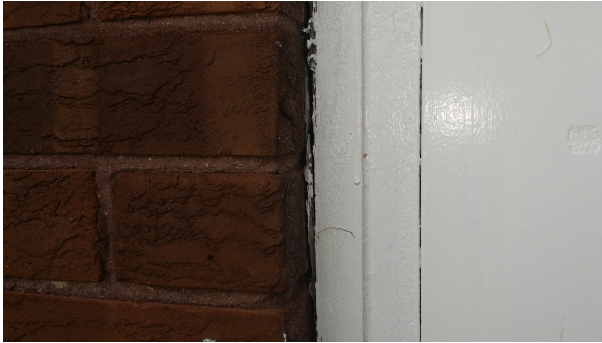
Item 37 Ref: 292432-14

The mastic to hall doors
(External) contains asbestos.

Any change in appearance
should be reported to Property
Services.

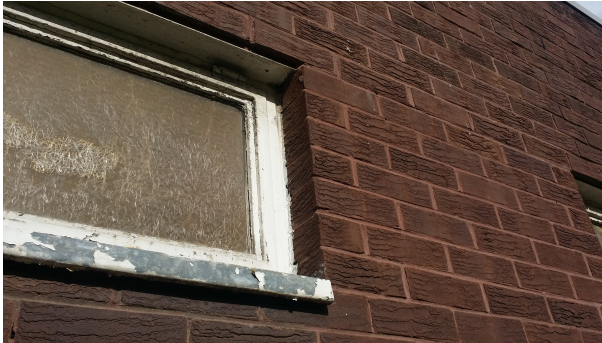
Item 38 Ref: As 292432-14

The mastic to window frames
(External) contains asbestos.

Any change in appearance
should be reported to Property
Services.

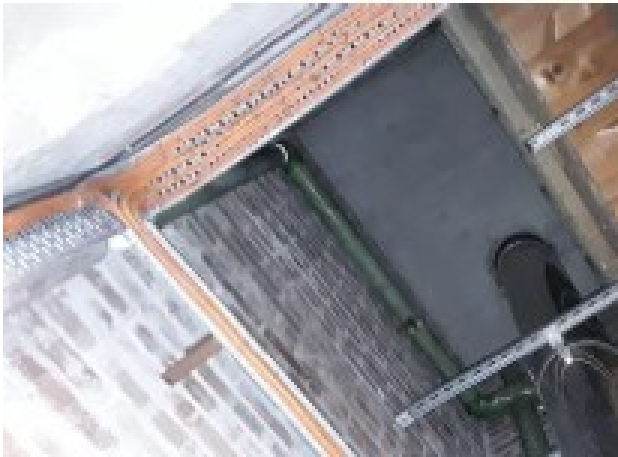
Item 41 Ref: 21-34052-10

The pipe insulation to the External Boiler House does not contain asbestos.

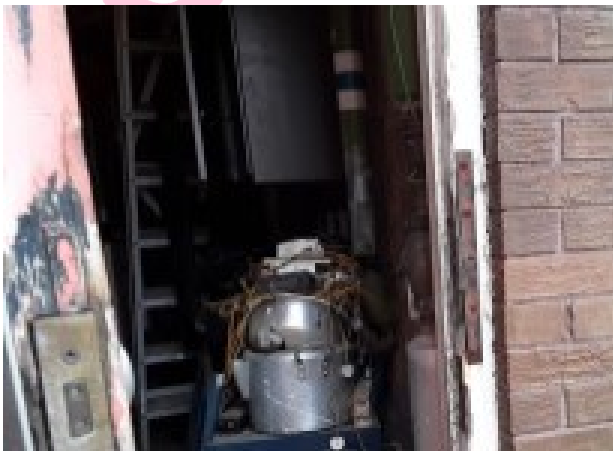
Item 42 Ref: 21-34052-11

The door frame sealant to the External Boiler House does contain asbestos.

Any change in appearance should be reported to Property Services.

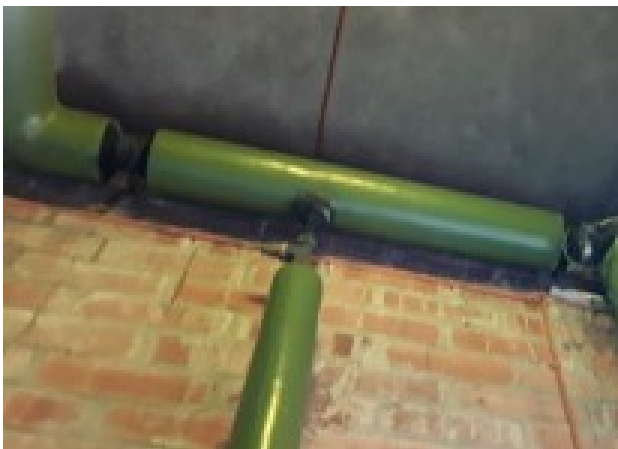
Item 44 Ref: 21-34052-3

The pipe insulation to the External Boiler House does not contain asbestos.

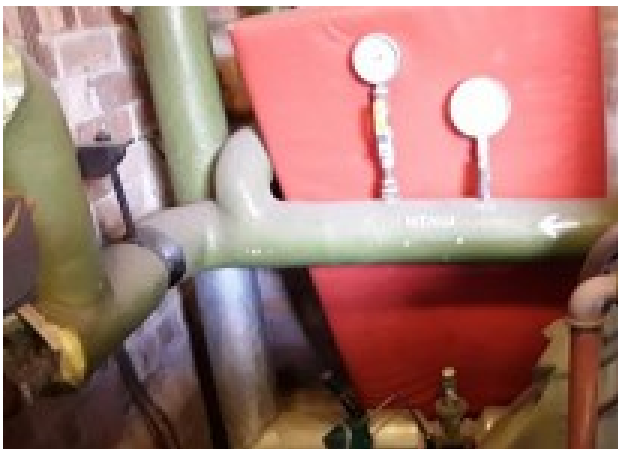
Item 45 Ref: 21-34052-4

The pipe insulation to the External Boiler House does not contain asbestos.

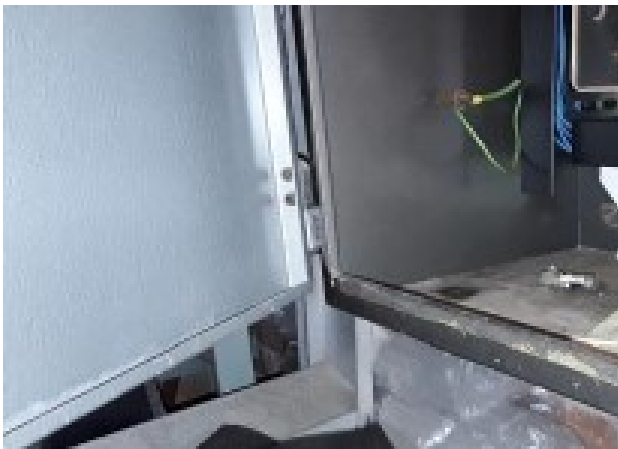
Item 48 Ref: 21-34052-7

The redundant barrel fuses to the floor in the External Boiler House do not contain asbestos.

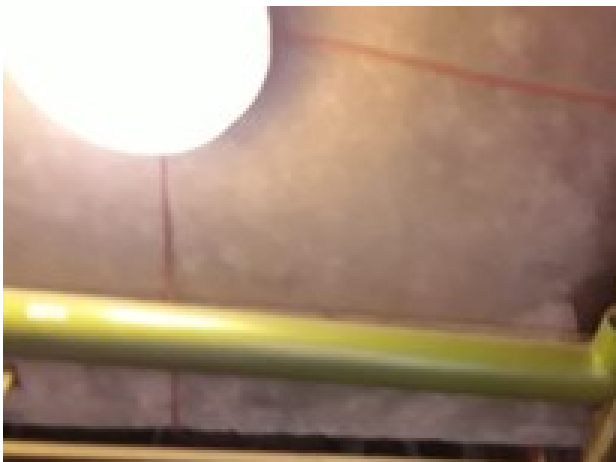
Item 50 Ref: 21-34052-9

The pipes insulation to the External Boiler House do not contain asbestos.

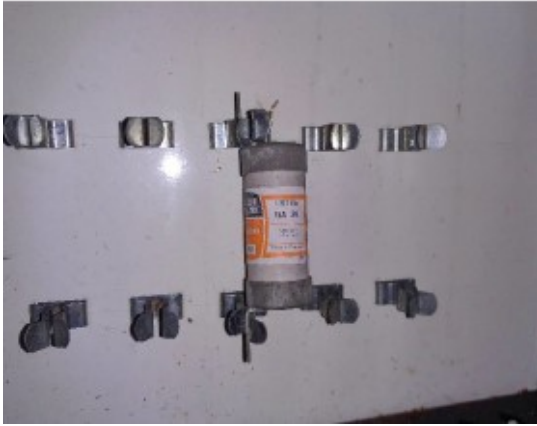
Item 52 Ref: KG000565

The paper lined fuses dated 1967/1975 (Boiler House G/01) contains asbestos.

Any change in appearance should be reported to Property Services.

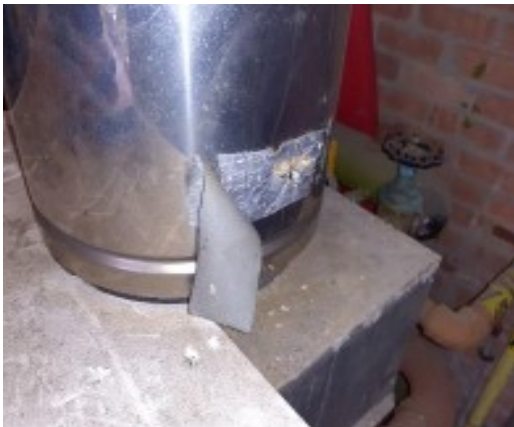
Item 54 Ref: KG000564

The insulation flue pipe lining (Boiler House G/01) does not contain asbestos.

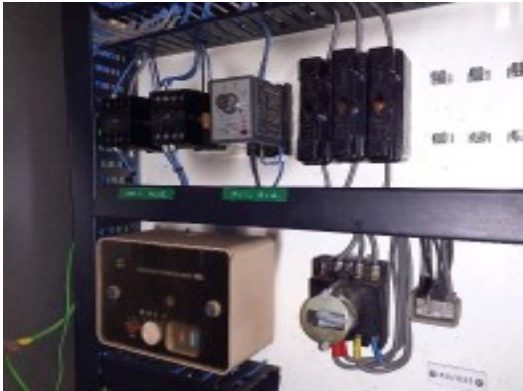
Item 56 Ref: KG000567

The Bakerlite black electrical components and fuse carriers (Boiler House G/01) does not contain asbestos.

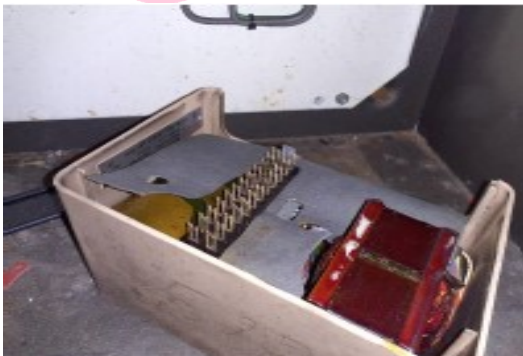
Item 57 Ref: KG000568

The Paperlining Satchwell control box (Boiler House G/01) does not contain asbestos.

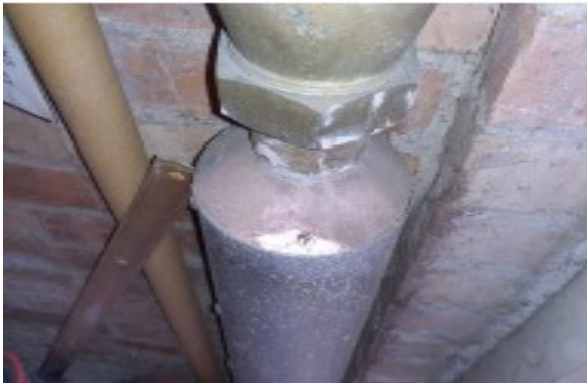
Item 58 Ref: KG000569

The insulation vertical pipework near door (Boiler House G/01) does not contain asbestos.

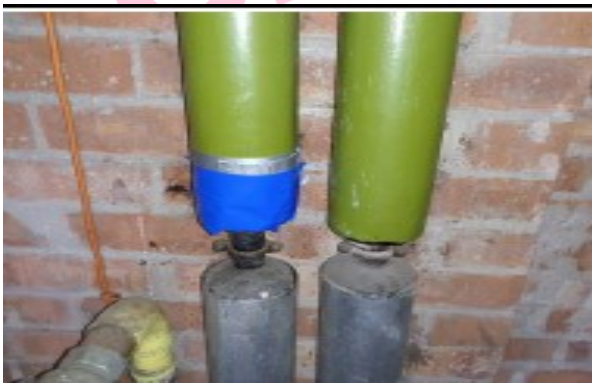
Item 60 Ref: KG000570

The insulation vertical pipework rear wall 2 pipes (Boiler House G/01) does not contain asbestos.

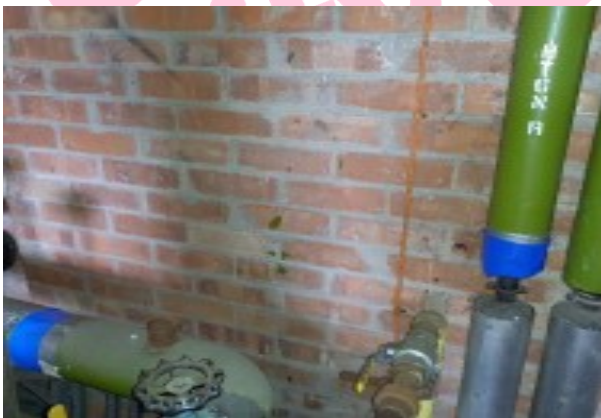
Item 63 Ref: KG000575

The residue rear wall (Boiler House G/01) does not contain asbestos.

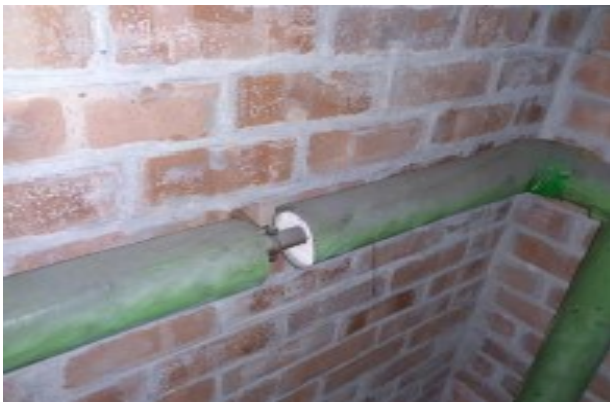
Item 65 Ref: KG000577

The insulation pipework (Tank Room 1/01) does not contain asbestos.
