ASBESTOS SURVEY REPORT FOR SOUTHWICK COMMUNITY CENTRE,
SOUTHWICK ROAD, SUNDERLAND, SR5 2AB

Asbestos Register for Southwick Community Centre

UPRN: - 292432

Date: 18 February 2026

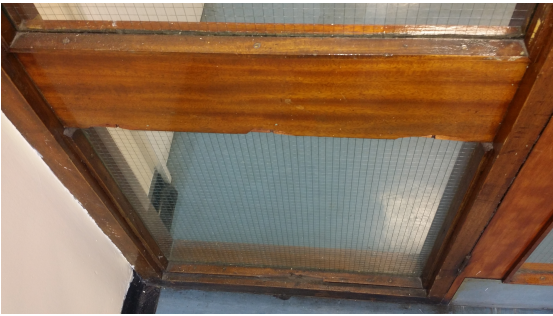
Item 1 Ref: As 292432-3

The sealant to frames in the lobby corridor (Room 001) does not contain asbestos.

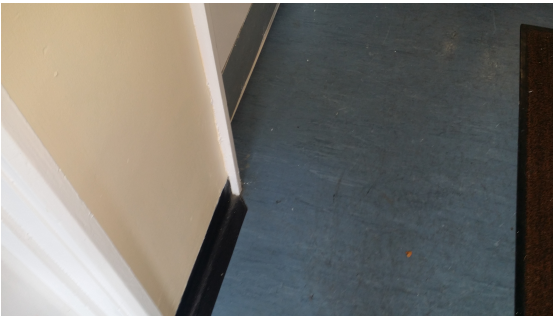
Item 2 Ref: As 292432-4

The remnant adhesive backing to floor in the lobby corridor (Room 001) does not contain asbestos.

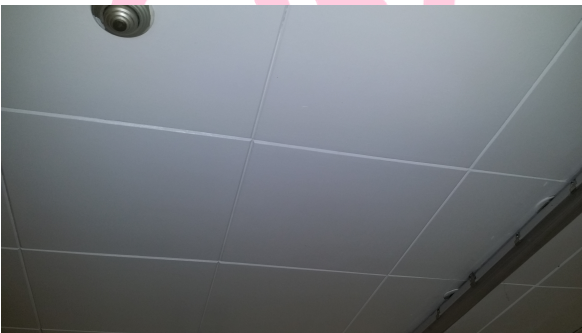
Item 3 Ref: 292432-1

The ceiling in the kitchen (Room 002) contains asbestos.

Any change in appearance should be reported to Property Services.

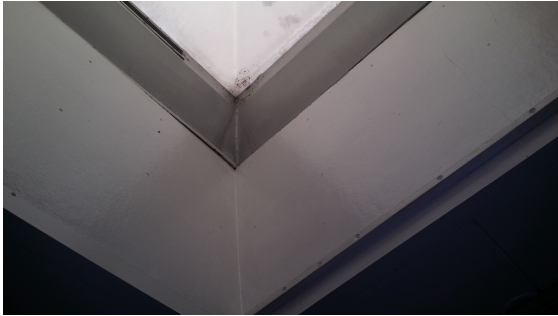
Item 4 Ref: As 292432-2

The skylight surrounds in the kitchen (Room 002) contains asbestos.

Any change in appearance should be reported to Property Services.

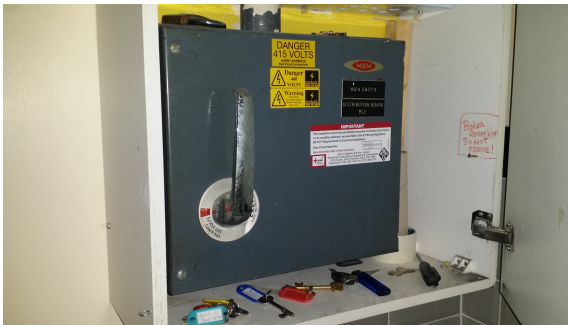
Item 5 Ref: Presumed

The Electrics MEM box in the kitchen (Room 002) is presumed to contain asbestos.

Any further investigation and change in appearance should be reported to Property Services.

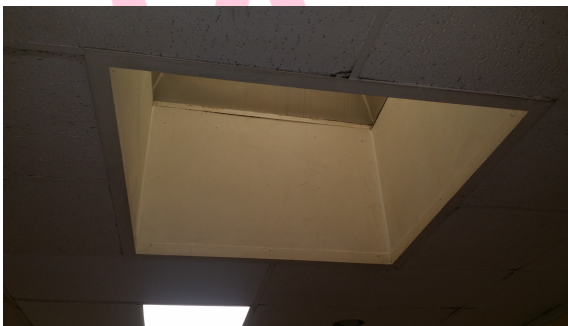
Item 6 Ref: As 292432-2

The skylight surrounds in the corridor (Room 004) contains asbestos.

Any change in appearance should be reported to Property Services.

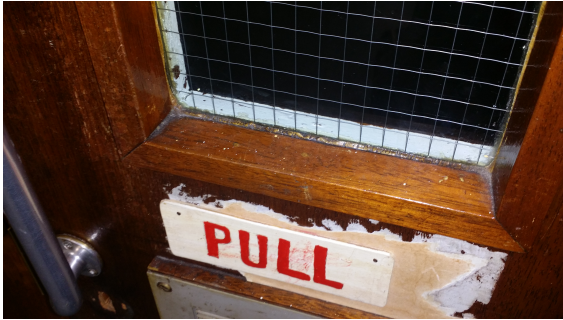
Item 7 Ref: 292432-3

The sealant to glazing at doors in the corridor (Room 004) does not contain asbestos.

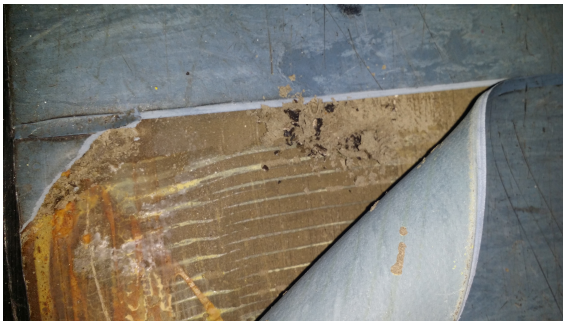
Item 8 Ref: 292432-4

The remnant adhesive backing to the floor in the corridor (Room 004) does not contain asbestos.

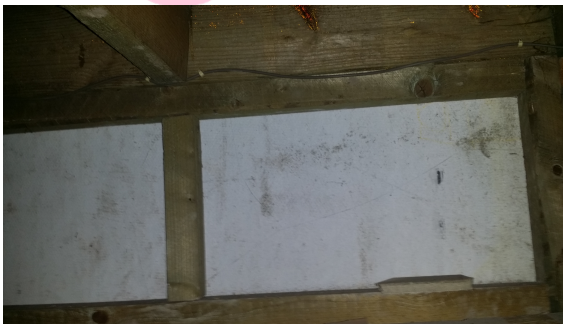
Item 9 Ref: As 292432-2

The skylight in the corridor – void above (Room 004) contains asbestos.

Any change in appearance should be reported to Property Services.

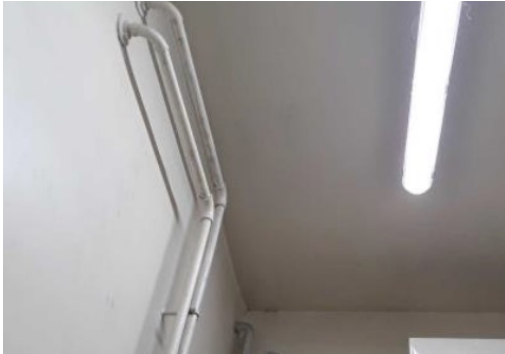
Item 10 Ref: 22-48075-2

The ceiling in the cleaners store (Room 006) does contain asbestos.

Any change in appearance should be reported to Property Services.

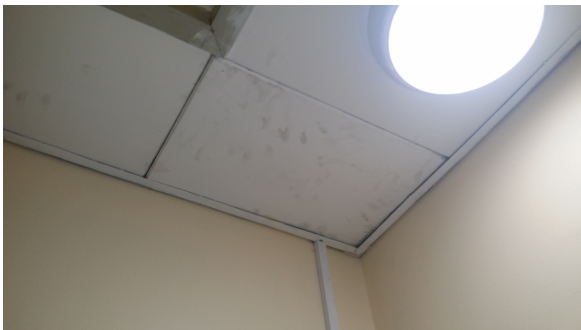
Item 12 Ref: As 292432-1

The ceiling in the disabled WC (Room 007) contains asbestos.

Any change in appearance should be reported to Property Services.

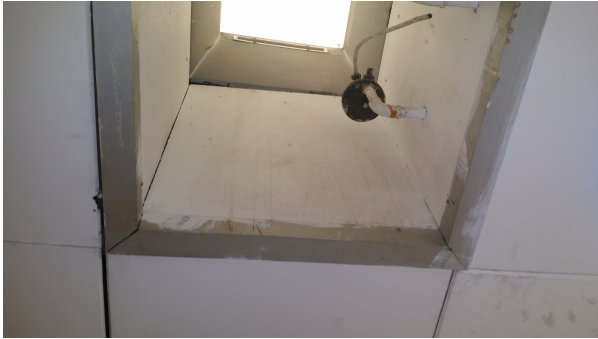
Item 13 Ref: As 292432-2

The skylight surrounds in the Disabled WC (Room 007) contains asbestos.

Any change in appearance should be reported to Property Services.

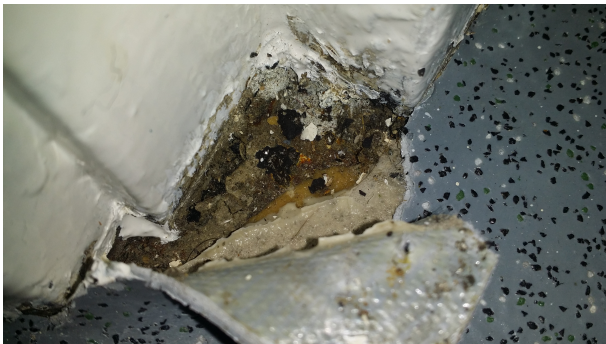
Item 14 Ref: As 292432-4

The remnant adhesive backing to the floor in the disabled toilet (Room 007) does not contain asbestos.

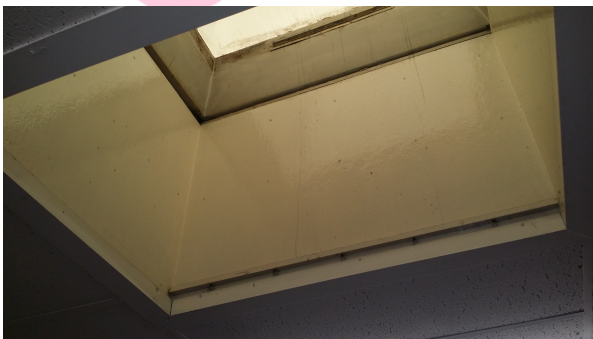
Item 15 Ref: As 292432-2

The skylight surrounds in the office (Room 008) contains asbestos.

Removed 2023

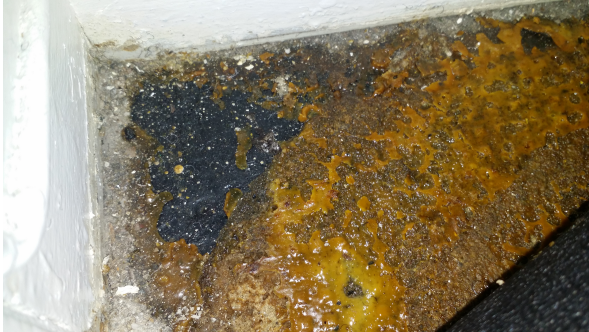
Item 16 Ref: As 292432-4

The remnant adhesive backing to the floor in the office (Room 006) does not contain asbestos.

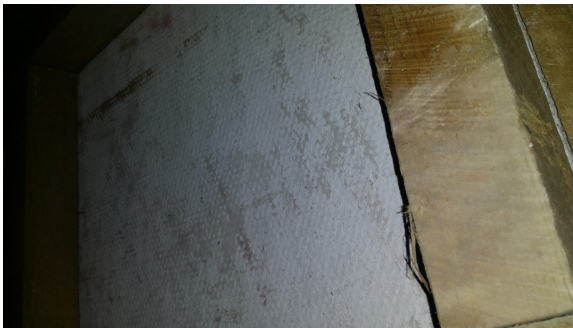
Item 17 Ref: As 292432-2

The skylight surrounds in the office ceiling void (Room 008) contains asbestos.

Removed 2023

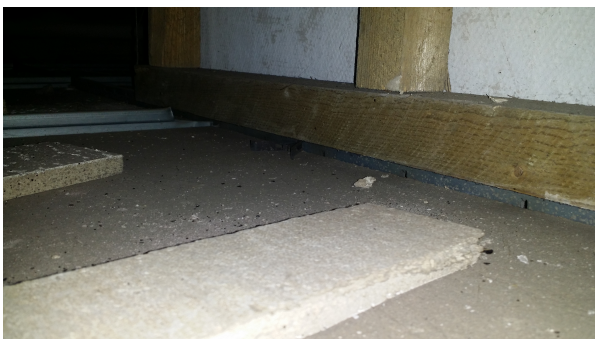
Item 18 Ref: 292432-7

The debris to the top of the ceiling tile in the office ceiling void (Room 008) contains asbestos.

Removed 2023

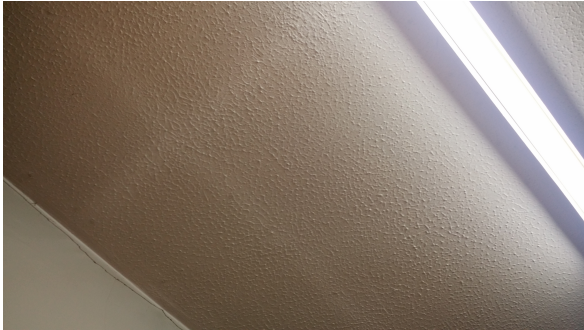
Item 19 Ref: As 292432-5

The ceiling in the cleaners store (Room 009) does not contain asbestos.

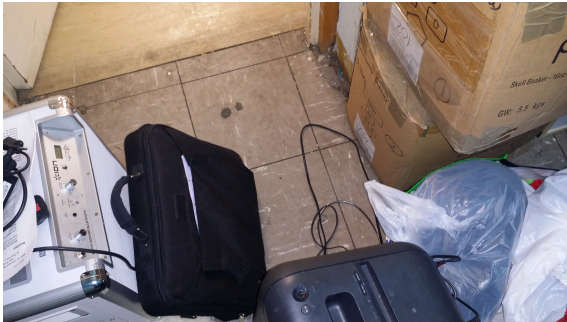
Item 20 Ref: As 292432-6

The floor covering in the cleaners store (Room 009) does not contain asbestos.

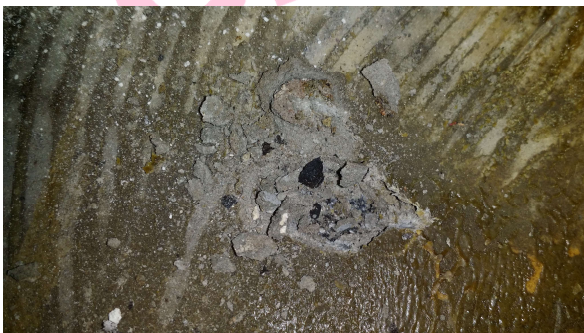
Item 21 Ref: As 292432-4

The remnant adhesive backing to the floor in the community room (Room 010) does not contain asbestos.

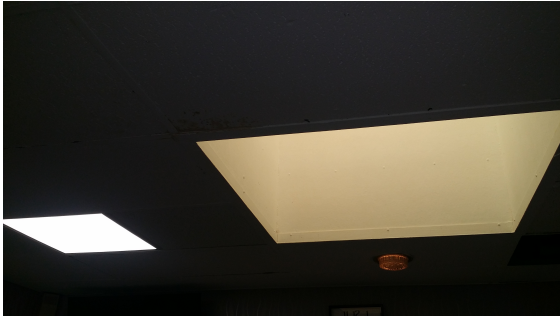
Item 22 Ref: As 292432-2

The skylight surrounds in the community room ceiling void (Room 0110) contains asbestos.

Removed 2023

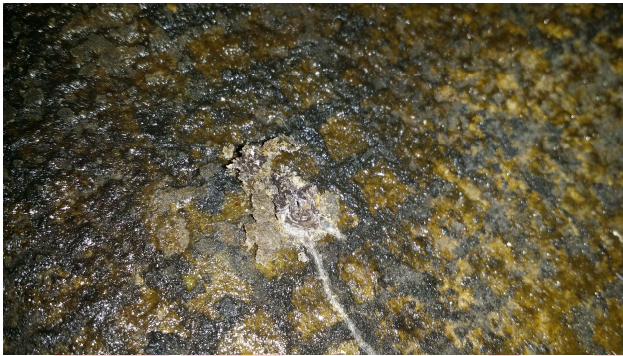
Item 23 Ref: As 292432-6

The remnant adhesive backing to the floor in the bar lounge (Room 011) does not contain asbestos.

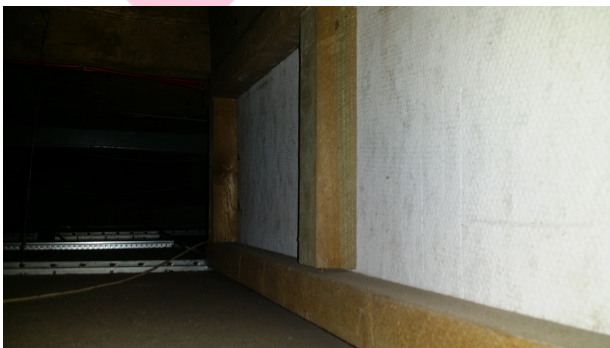
Item 24 Ref: As 292432-2

The skylight in the bar lounge ceiling void (Room 011) contains asbestos.

Removed 2023

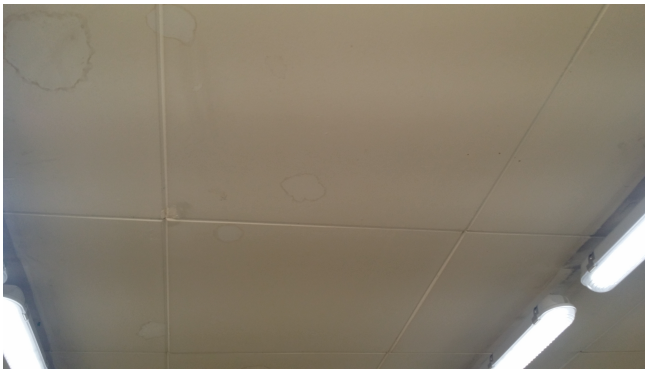
Item 26 Ref: 292432-8

The ceiling in the male toilets (Room 012) contains asbestos.

Any change in appearance should be reported to Property Services.

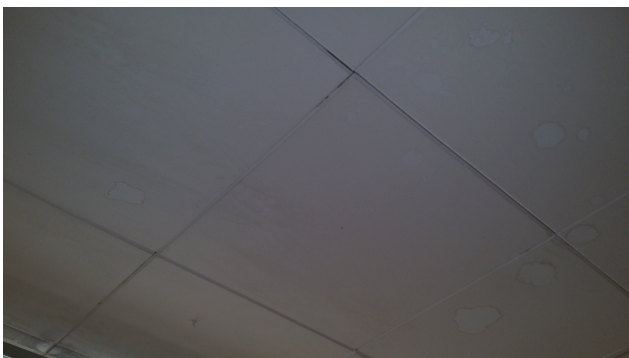
Item 27 Ref: As 292432-8

The ceiling in the female toilets (Room 013) contains asbestos.

Any change in appearance should be reported to Property Services.

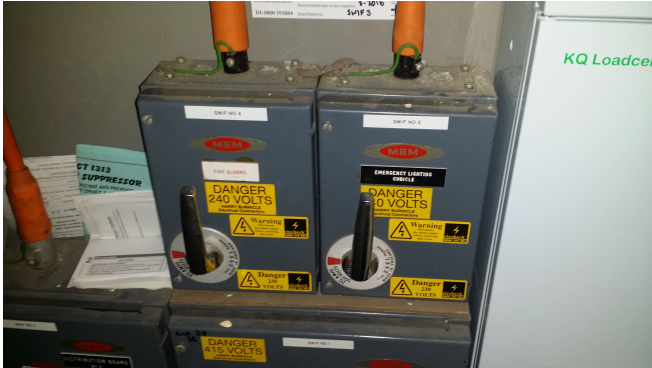
Item 31 Ref: 292432-10

The debris to tops of electrics in the electric store (Room 014) contains asbestos.

Any change in appearance should be reported to Property Services.

Removed 15 November 2018

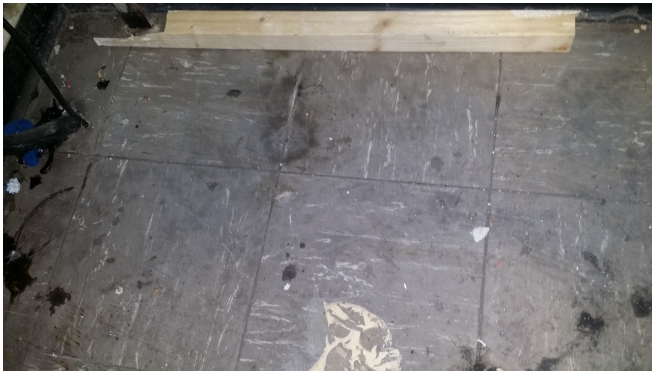
Item 32 Ref: 292432-11

The debris to floor in the electric store (Room 014) contains asbestos.

Any change in appearance should be reported to Property Services.

Removed 15 November 2018

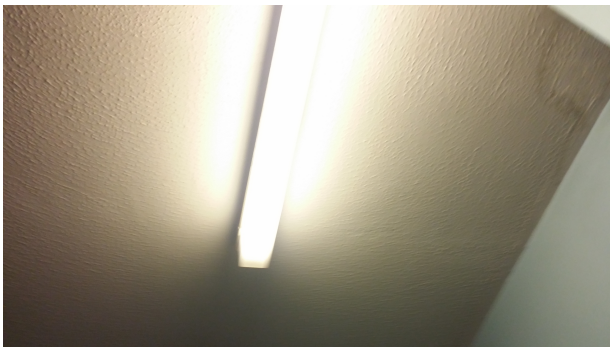
Item 33 Ref: As 292432-5

The ceiling in the store (Room 015) does not contain asbestos.

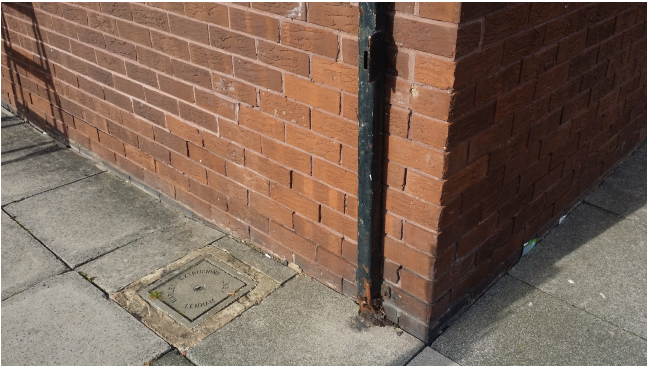
Item 35 Ref: 292432-12

The damp proof course (External) does not contain asbestos.

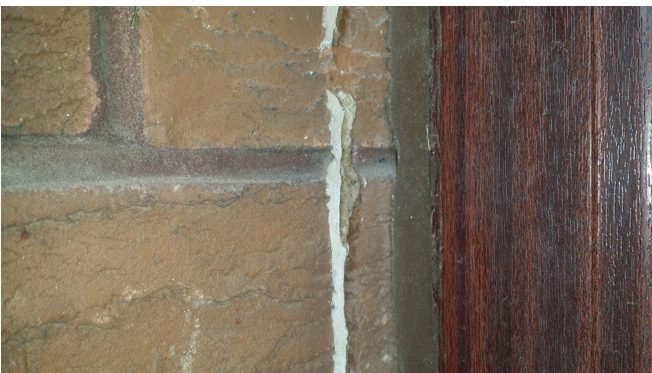
Item 36 Ref: 292432-13

The remnant mastic to wall at entrance doors (External) contains asbestos.

Any change in appearance should be reported to Property Services.

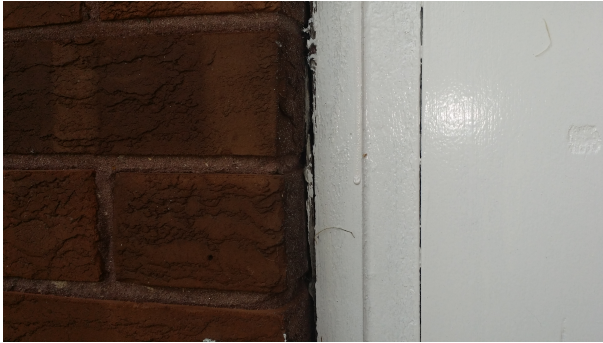
Item 37 Ref: 292432-14

The mastic to hall doors
(External) contains asbestos.

Any change in appearance
should be reported to Property
Services.

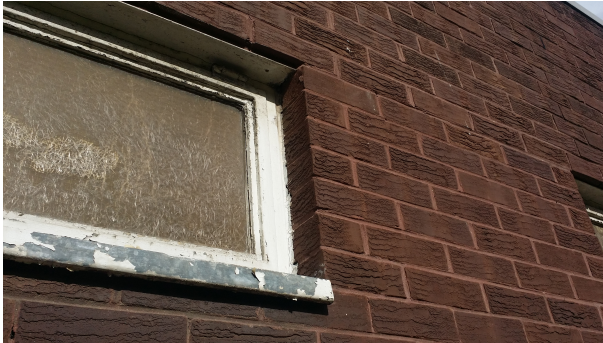
Item 38 Ref: As 292432-14

The mastic to window frames
(External) contains asbestos.

Any change in appearance
should be reported to Property
Services.

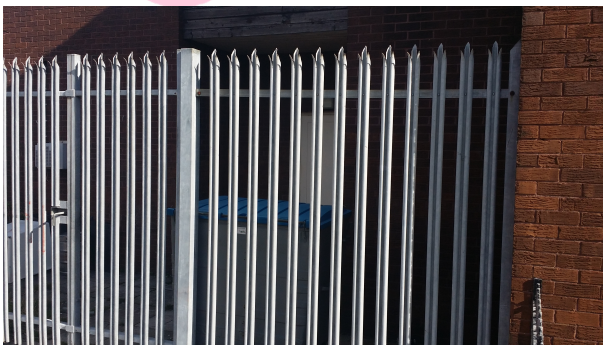
Item 39 Ref: As 292432-13

The sealant to door frame at
kitchen (External) contains
asbestos.

Any change in appearance
should be reported to Property
Services.

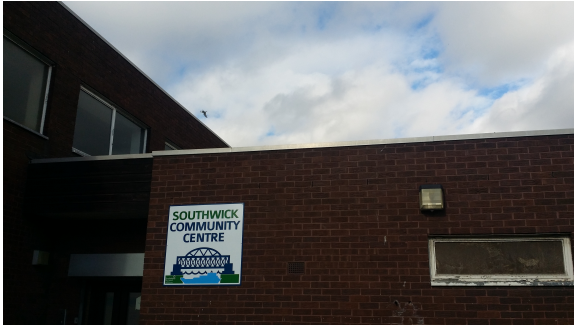
Item 40 Ref: 292432-15

The roof covering to lower roof (External) does not contain asbestos.

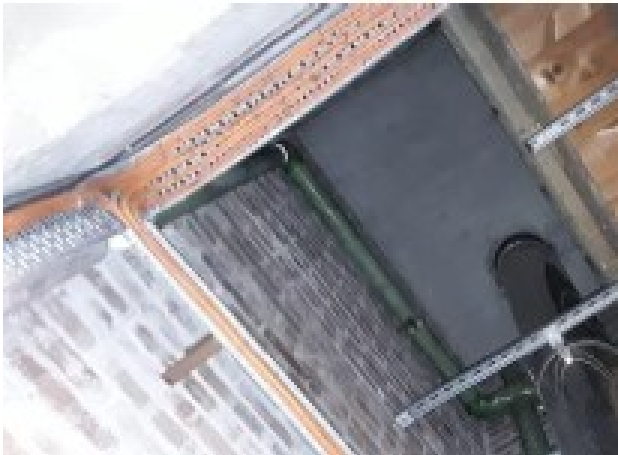
Item 41 Ref: 21-34052-10

The pipe insulation to the External Boiler House does not contain asbestos.

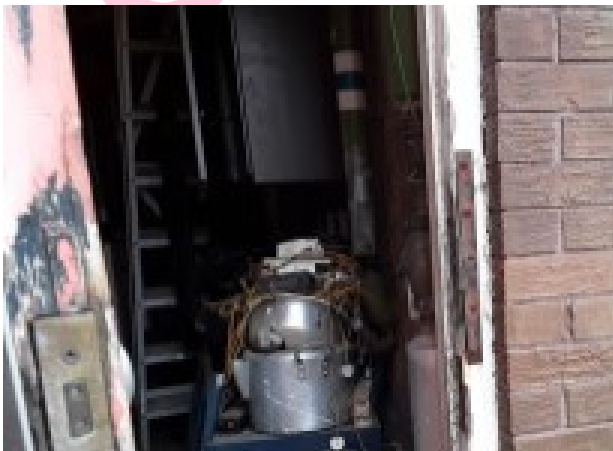
Item 42 Ref: 21-34052-11

The door frame sealant to the External Boiler House does contain asbestos.

Any change in appearance should be reported to Property Services.

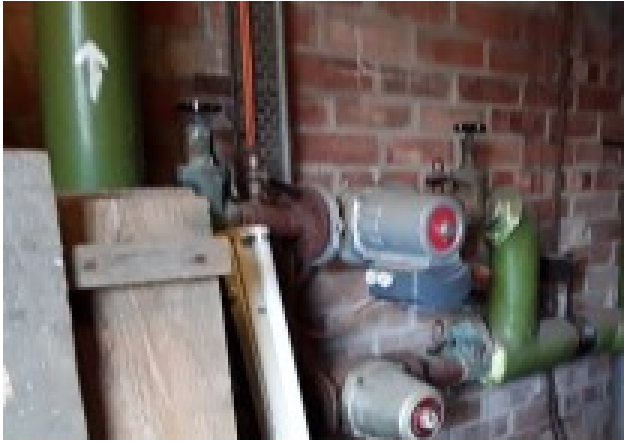
Item 43 Ref: 21-34052-2

The pipe insulation to the External Boiler House does not contain asbestos.

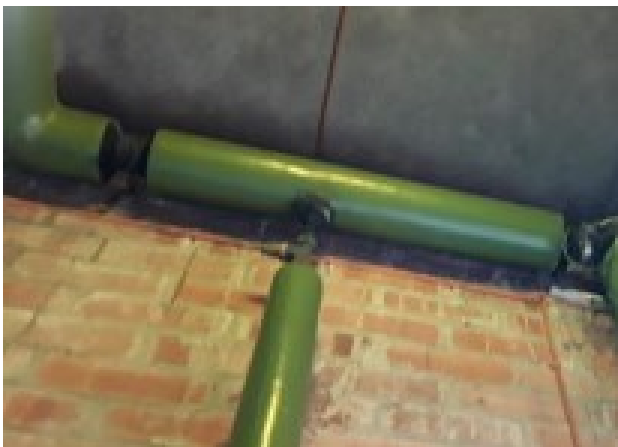
Item 44 Ref: 21-34052-3

The pipe insulation to the External Boiler House does not contain asbestos.

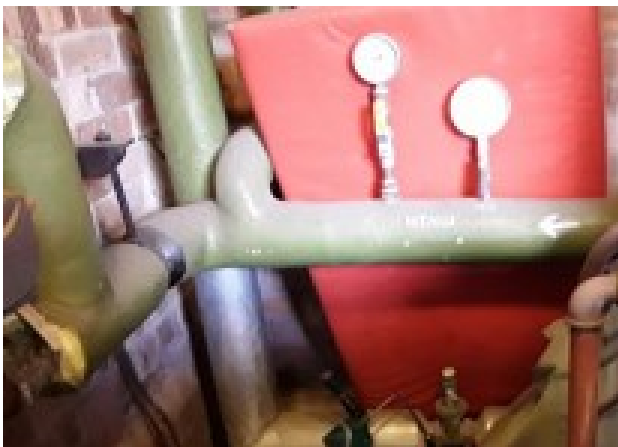
Item 45 Ref: 21-34052-4

The pipe insulation to the External Boiler House does not contain asbestos.

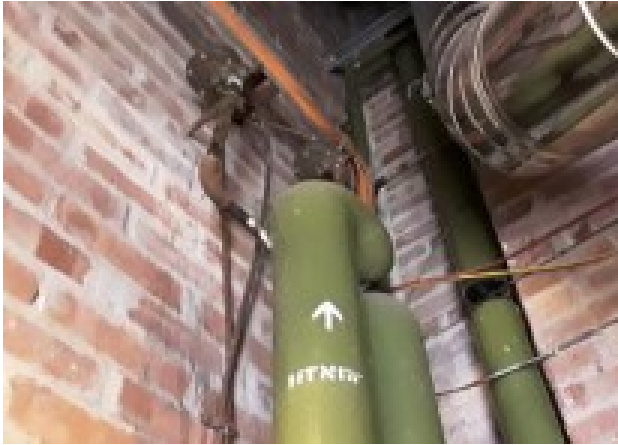
Item 46 Ref: 21-34052-5

The pipe insulation to the External Boiler House does not contain asbestos.

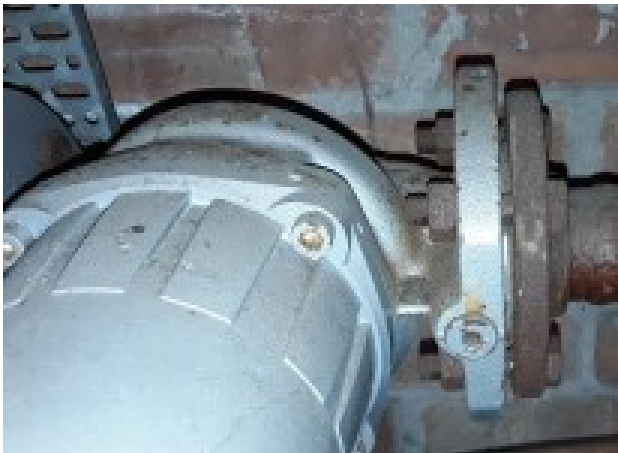
Item 47 Ref: 21-34052-6

The pipes (flange gaskets) in the External Boiler House do not contain asbestos.

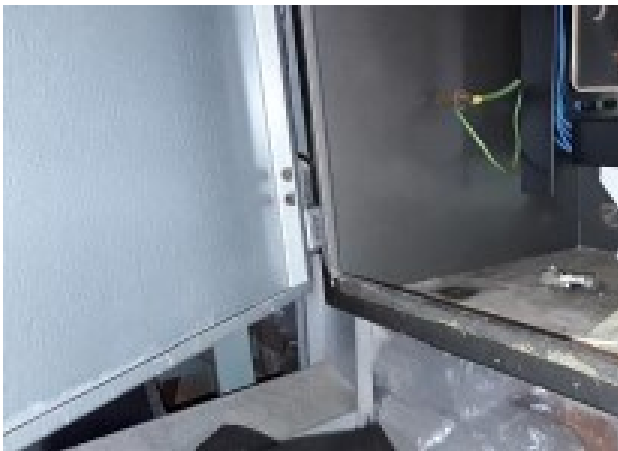
Item 48 Ref: 21-34052-7

The redundant barrel fuses to the floor in the External Boiler House do not contain asbestos.

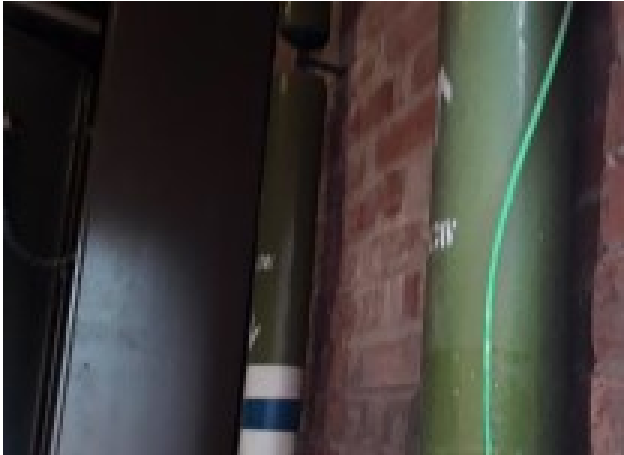
Item 49 Ref: 21-34052-8

The pipe insulation to the External Boiler House does not contain asbestos.

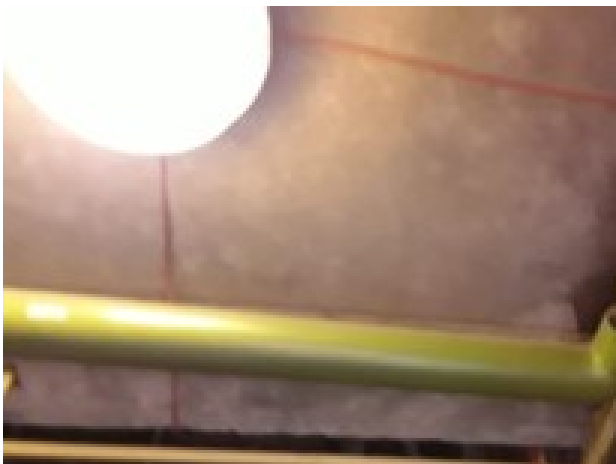
Item 50 Ref: 21-34052-9

The pipes insulation to the External Boiler House do not contain asbestos.

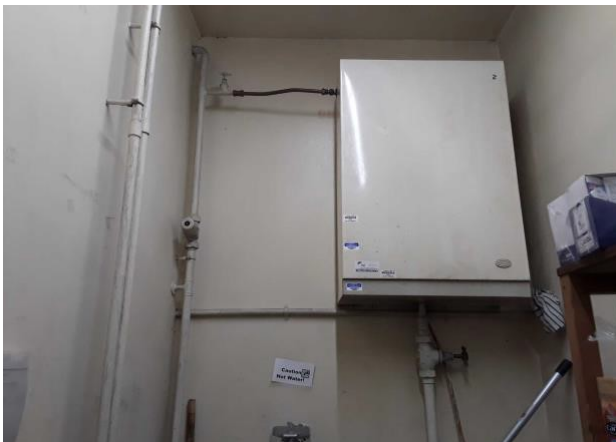
Item 51 Ref: Presumed

The stop tap gaskets (Cleaners Cupboard Rm 006/Area 1) are presumed to contain asbestos.

(No WCN's – removed 2025)

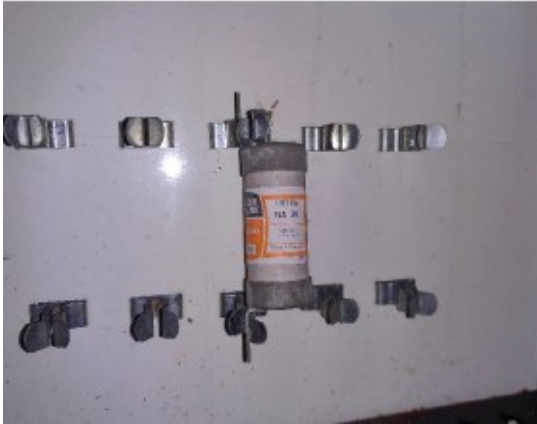
Item 52 Ref: KG000565

The paper lined fuses dated 1967/1975 (Boiler House G/01) contains asbestos.

(No WCN's – removed 2025)

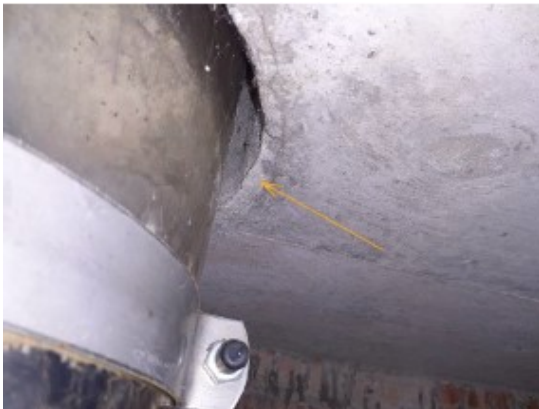
Item 53 Ref: KG000578

The flue pipe outside metal flue (Boiler House G01) contains asbestos.

Any change in appearance should be reported to Property Services.

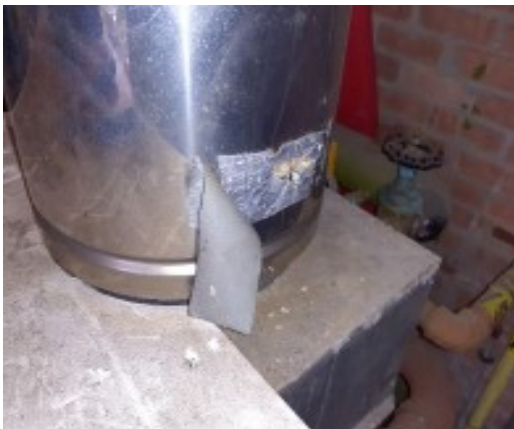
Item 54 Ref: KG000564

The insulation flue pipe lining (Boiler House G/01) does not contain asbestos.

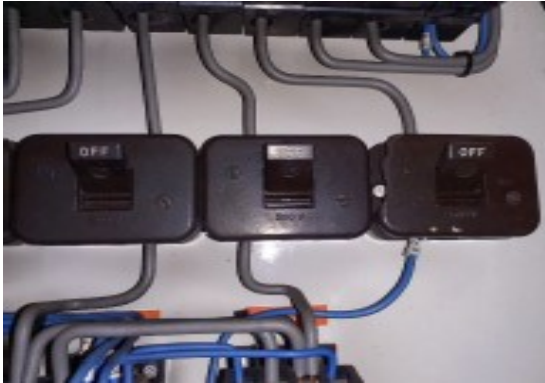
Item 55 Ref: KG000566

The Bakerlite switches (Boiler House G/01) does not contain asbestos.

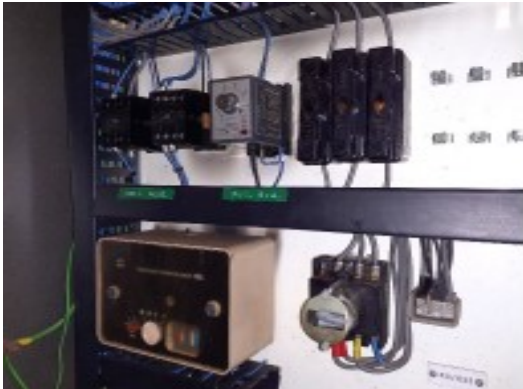
Item 56 Ref: KG000567

The Bakerlite black electrical components and fuse carriers (Boiler House G/01) does not contain asbestos.

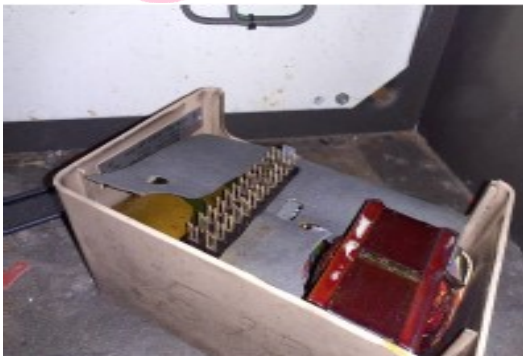
Item 57 Ref: KG000568

The Paperlining Satchwell control box (Boiler House G/01) does not contain asbestos.

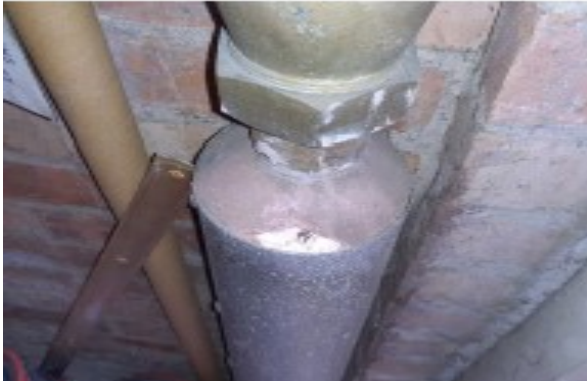
Item 58 Ref: KG000569

The insulation vertical pipework near door (Boiler House G/01) does not contain asbestos.

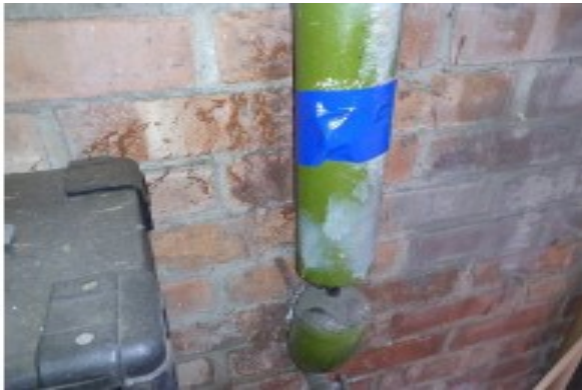
Item 59 Ref: As KG000569

The insulation vertical pipework near electric box (Boiler House G/01) does not contain asbestos.

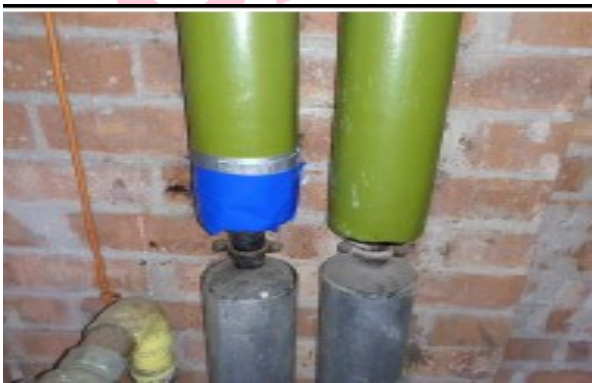
Item 60 Ref: KG000570

The insulation vertical pipework rear wall 2 pipes (Boiler House G/01) does not contain asbestos.

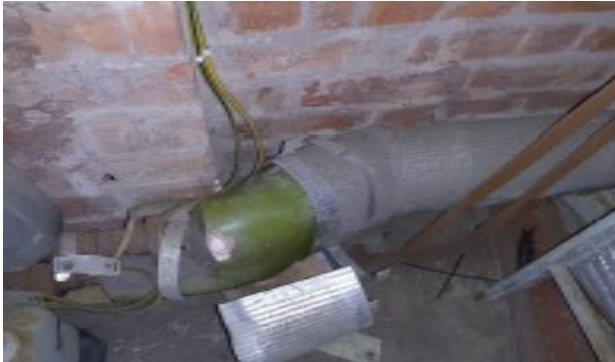
Item 61 Ref: As KG000570

The insulation low level pipework rear wall (Boiler House G/01) does not contain.

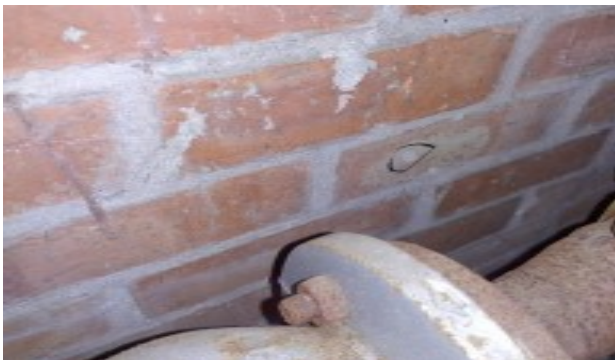
Item 62 Ref: KG000574

The residue to wall lhs boiler (Boiler House G/01) does not contain asbestos.

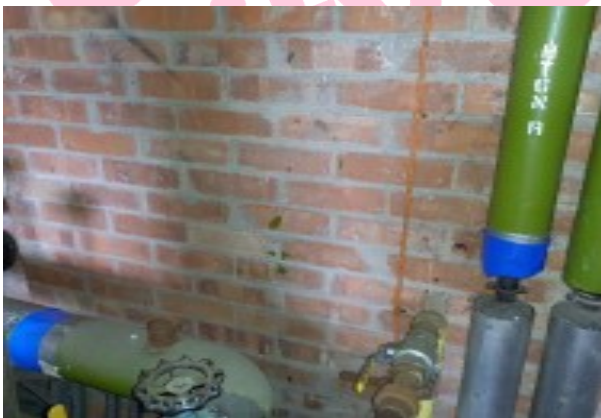
Item 63 Ref: KG000575

The residue rear wall (Boiler House G/01) does not contain asbestos.

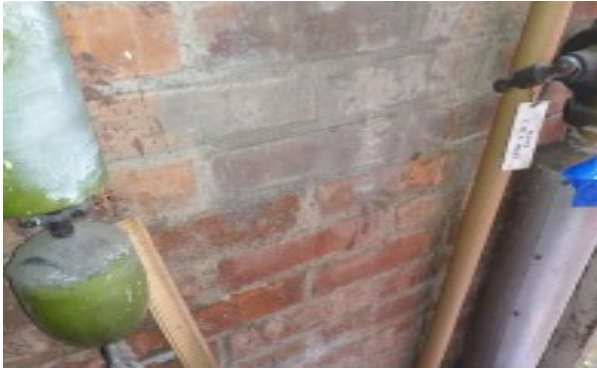
Item 64 Ref: KG000576

The residue electric box wall (Boiler House G/01) does not contain asbestos.

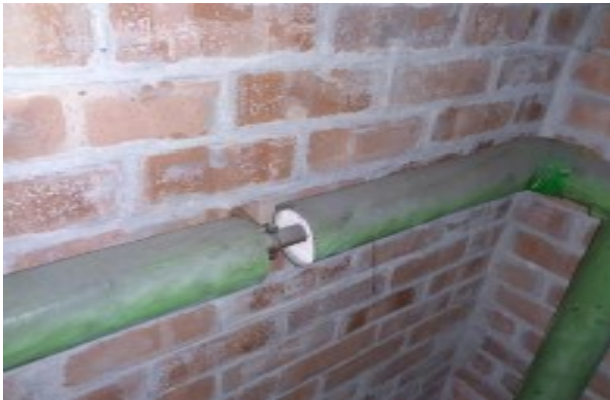
Item 65 Ref: KG000577

The insulation pipework (Tank Room 1/01) does not contain asbestos.
