ASBESTOS SURVEY REPORT FOR JACK CRAWFORD HOUSE,
COMMERCIAL ROAD, SUNDERLAND, SR2 8QR.

Jack Crawford House, Commercial Road, SR2 8QR

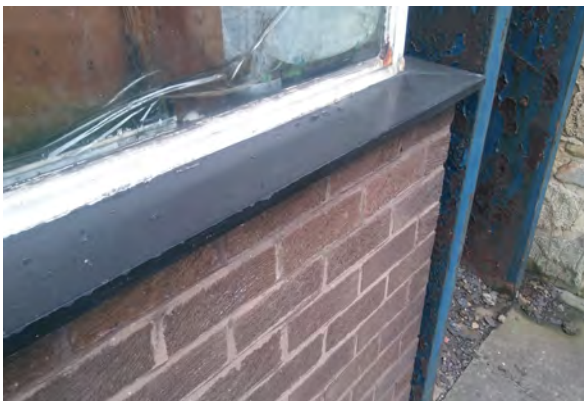
Item 5 Ref: 406299-80

The window sill to the gatehouse (External) does not contain asbestos.

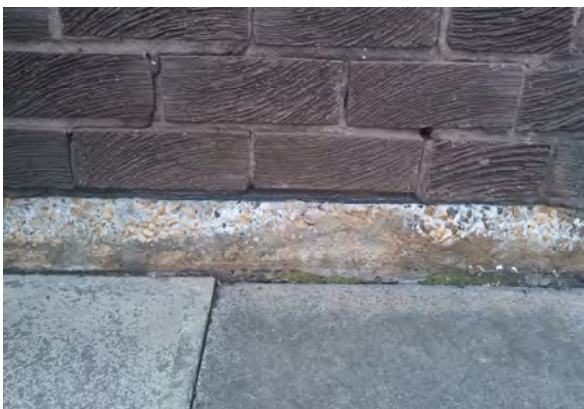
Item 6 Ref: 406299-81

The damp proof course of the gatehouse (External) contains asbestos.

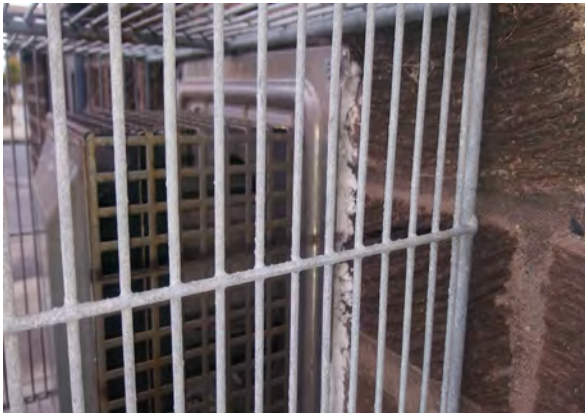
Item 8 Ref: 406299-83

The mastic seal to vent to the gatehouse (External) does not contain asbestos.

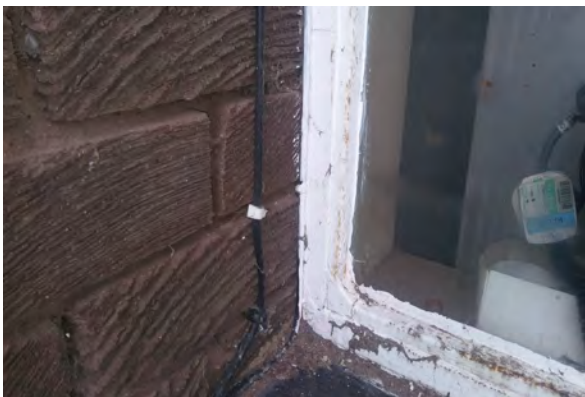
Item 9 Ref: 406299-84

The sealant to window frame to the gatehouse (External) does not contain asbestos.

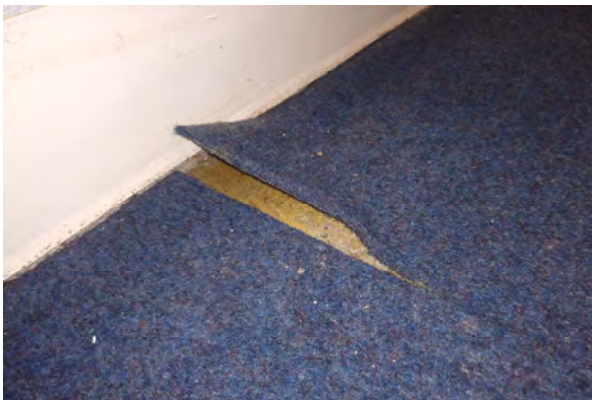
Item 12 Ref: 406299-24

The remnant adhesive to floor beneath carpet in the Jaques Restaurant – computer training room T1 (Rm 0/60a) contains asbestos.

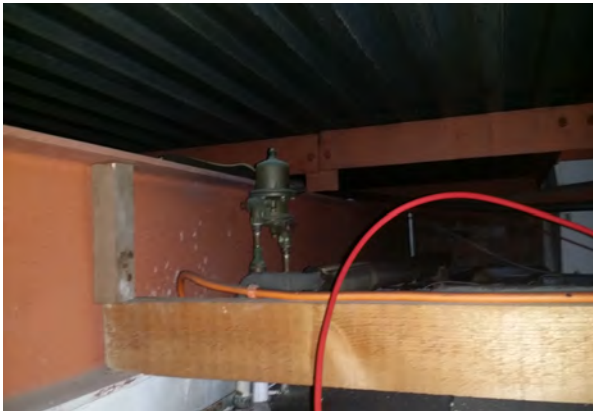
Item 15 Ref: Presumed

The gasket to pipework in the Jacques Restaurant – store – void above (Rm 0/60) contains asbestos.

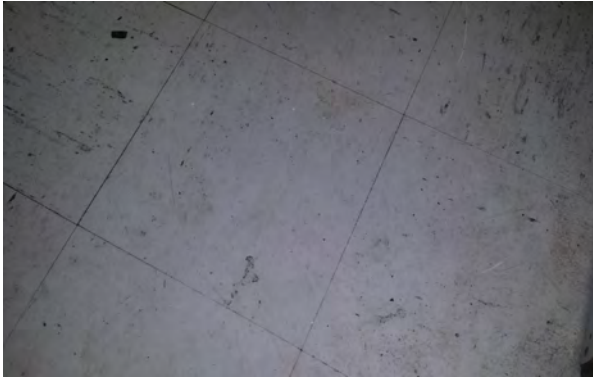
Item 17 Ref: As406299-38

The floor covering in Jaques Restaurant – office (Rm 0/61) does not contain asbestos.

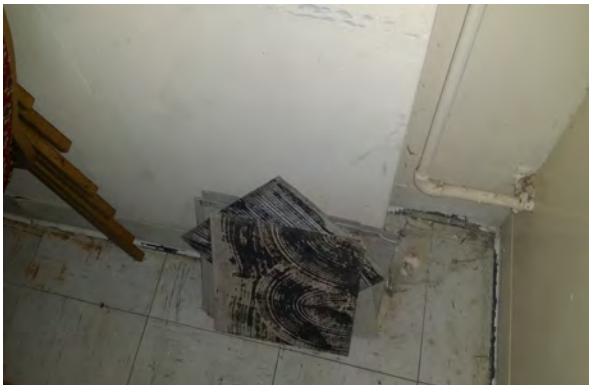
Item 21 Ref: 406299-25

The loose lying tiles in the Jaques Restaurant – store (Rm 0/63) contains asbestos.

Removed May 2020

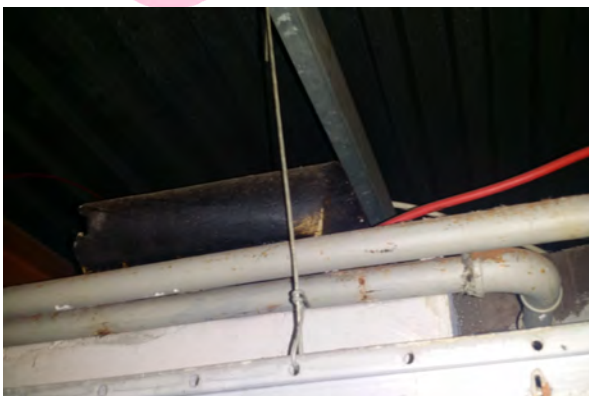
Item 22 Ref: 406299-26

The loose lying felt in the Jaques Restaurant – store – void above (Rm 0/63) contains asbestos.

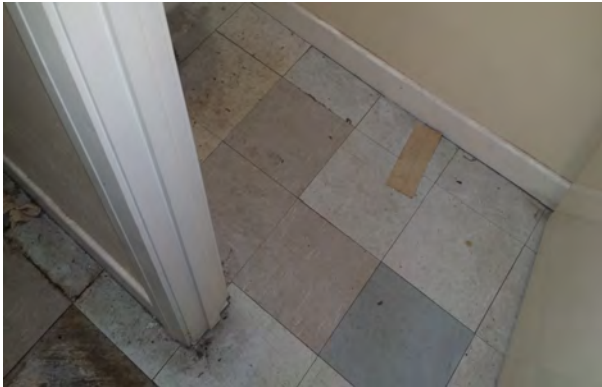
Item 24 Ref: 406299-27

The floor covering in Jacques Restaurant – toilet (Rm 0/65) does not contain asbestos.

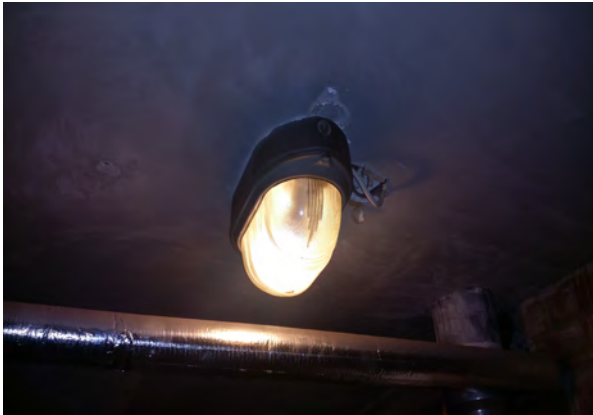
Item 26 Ref: 406299-28

The mastic to bulkhead light in the Jaques Restaurant – boiler room (Rm 0/68) contains asbestos.

Any change in its appearance should be recorded and passed to Property Services.

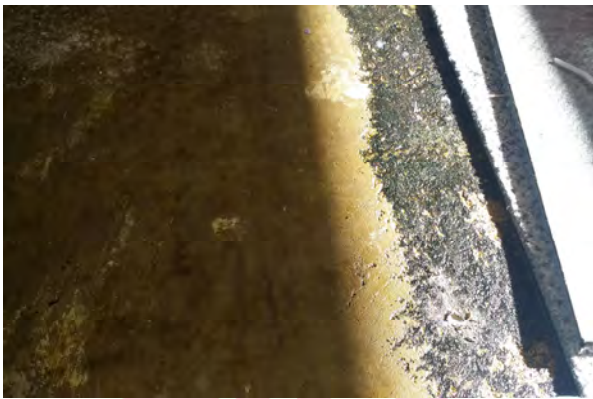
Item 27 Ref: As406299-29

The adhesive backing to floor in the Jaques Restaurant – store (Rm 0/71) contains asbestos.

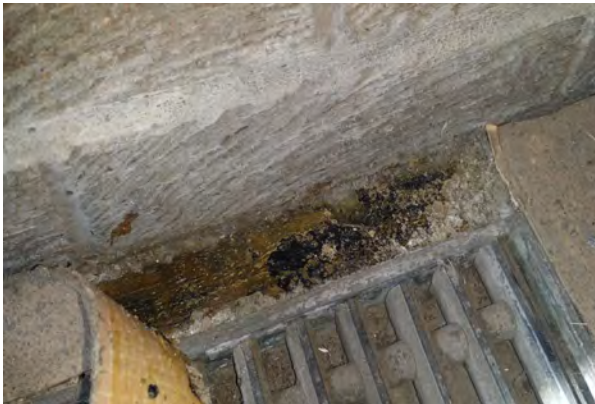
Item 30 Ref: 406299-29

The remnant adhesive backing to floor in the Jaques Restaurant – lobby (Rm 0/71a) contains asbestos.

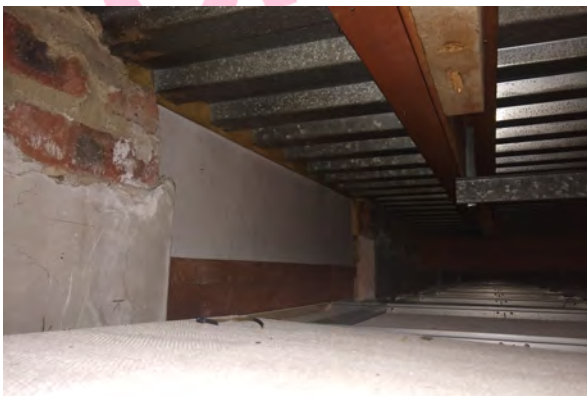
Item 41 Ref: 406299-2

The panels above windows in the office – void above (Rm 0/02) contains asbestos.

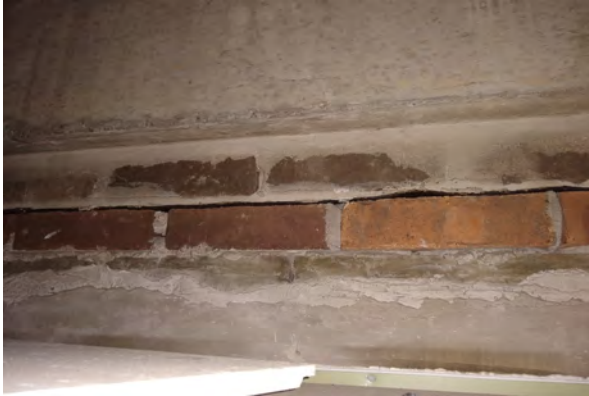
Item 45 Ref: 406299-6

The membrane to brick wall in the meeting room – void above (Rm 0/05) does not contain asbestos.

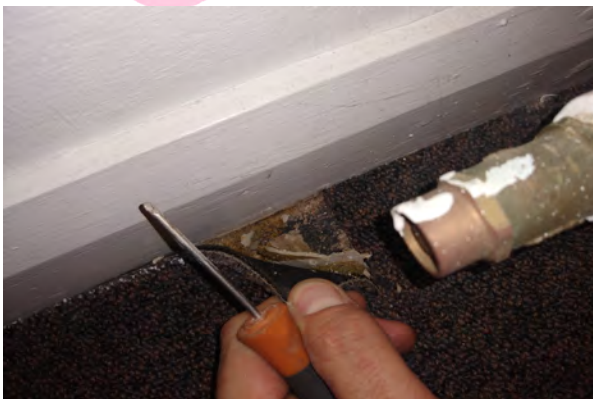
Item 50 Ref: As 406299-9

The remnant adhesive to floor beneath carpet & screed in the board room (Rm 0/10a) contains asbestos.

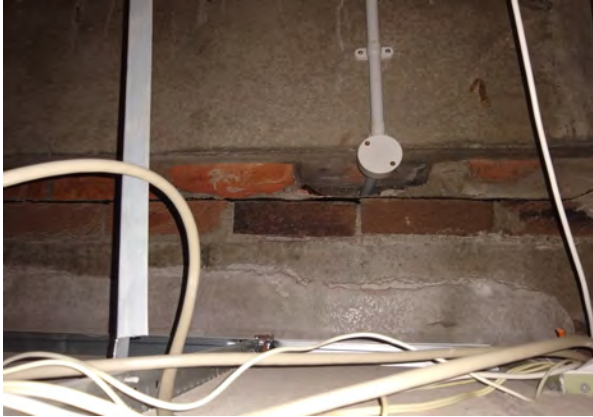
Item 51 Ref: As 406299-6

The membrane to brick wall in the board room – void above (Rm 0/10a) does not contain asbestos.

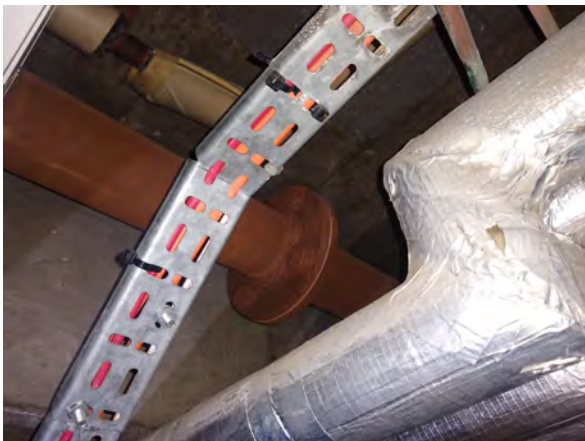
Item 52 Ref: As406299-22

The pipework flange gasket in the corridor – void above (Rm 0/10b) contains asbestos.

Any change in its appearance should be recorded and passed to Property Services.

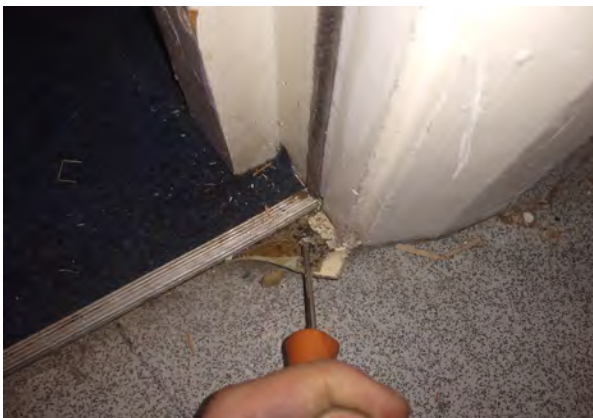
Item 53 Ref: As 406299-9

The remnant adhesive to floor beneath linoleum & screed in the evidence store (Rm 0/11) contains asbestos.

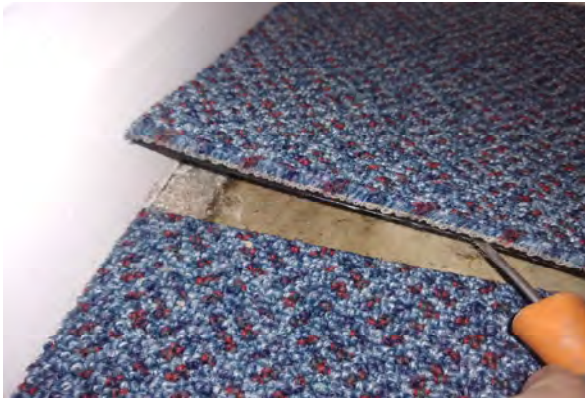
Item 58 Ref: As 406299-9

The remnant adhesive to floor in the office (Rm 0/15) contains asbestos.

Any change in its appearance should be recorded and passed to Property Services.

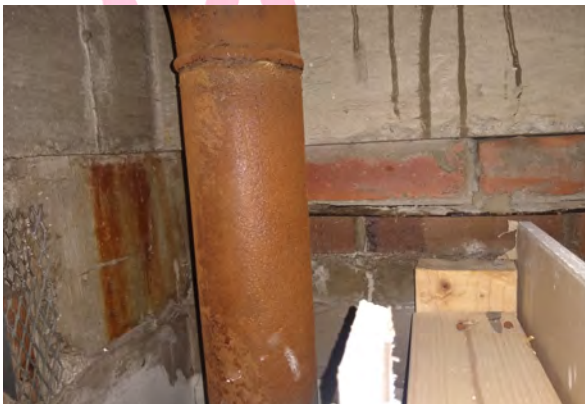
Item 59 Ref: As 406299-6

The membrane to brick wall in the office – void above (Rm 0/15) does not contain asbestos.

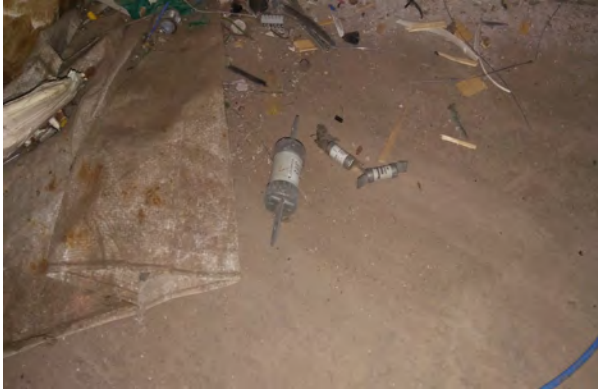
Item 63 Ref: Presumed

The loose lying fuse end caps in the switchroom (Rm 0/17) contains asbestos.

Removed May 2020

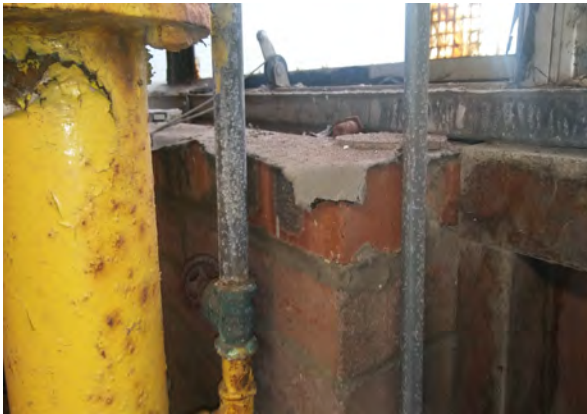
Item 64 Ref: 406299-75

The damp proof membrane to window sills in the boiler house (Rm 0/18) contains asbestos.

Any change in its appearance should be recorded and passed to Property Services.

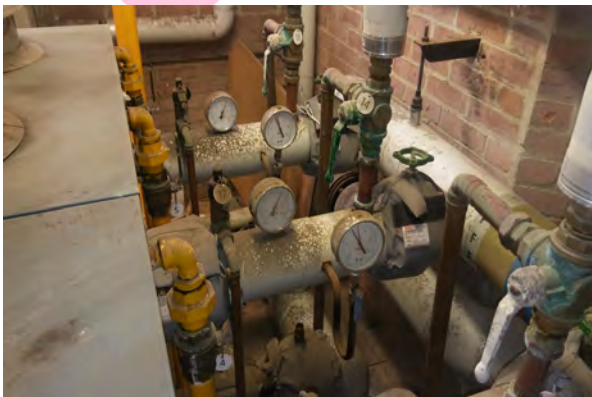
Item 65 Ref: 406299-76

The pipework flange gasket in the boiler house – void above (Rm 0/15) contains asbestos.

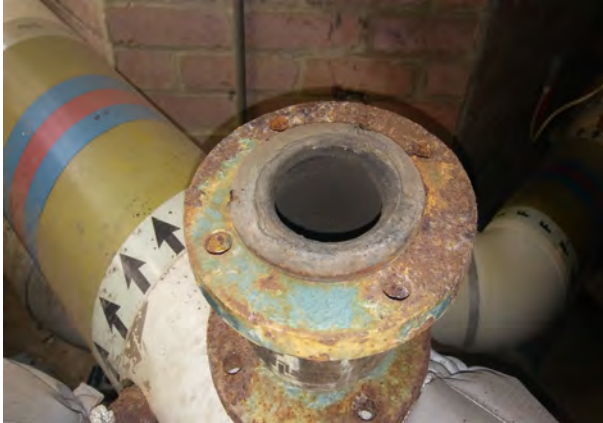
Item 66 Ref: 406299-77

The loose lying pipework flange gasket behind boilers in the boiler house (Rm 0/18) does not contain asbestos.

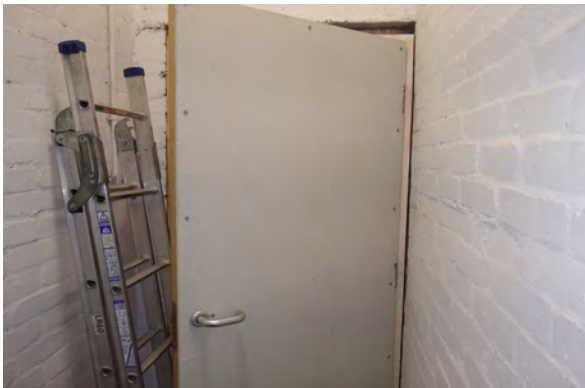
Item 67 Ref: 406299-21

The panel to door in the service riser (Rm 0/19) does not contain asbestos.

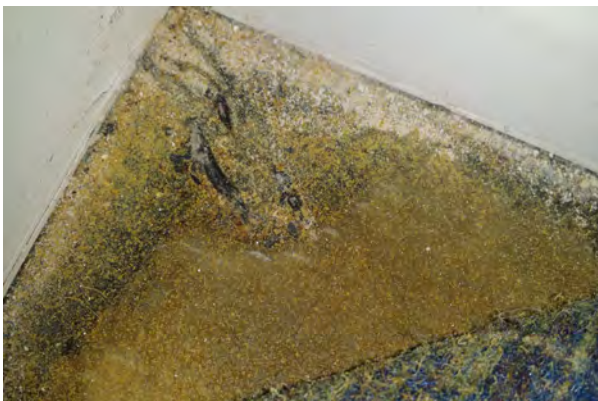
Item 77 Ref: 406299-14

The adhesive backing to floor in the store (Rm 1/103) contains asbestos.

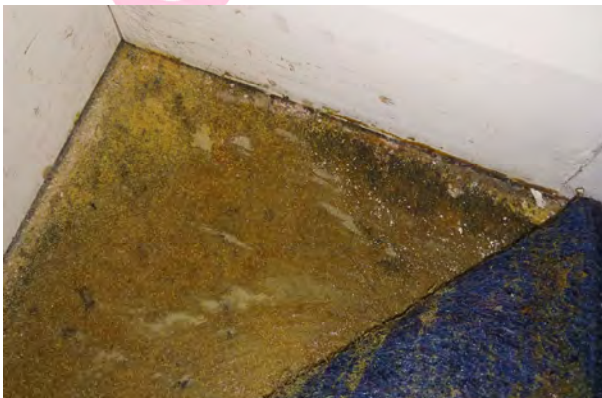
Item 80 Ref: 406299-63

The remnant adhesive to floor in the open plan office (Rm 1/108) contains asbestos.

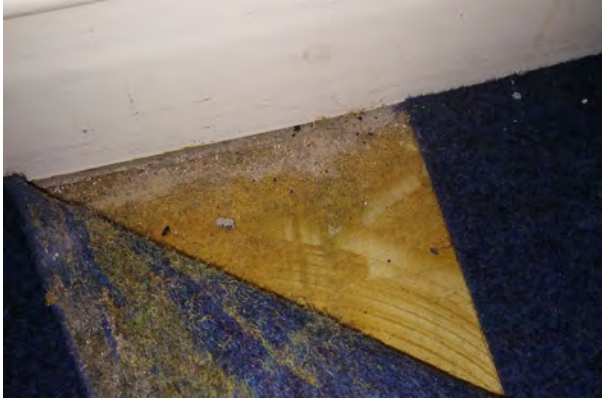
Item 81 Ref: As406299-63

The remnant adhesive to floor beneath screed in the office (Rm 1/111) contains asbestos.

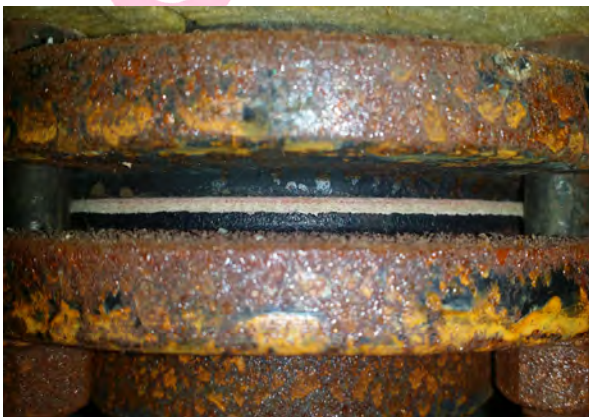
Item 83 Ref: 406299-12

The gasket to pipework in the riser cupboard (Rm 1/112) contains asbestos.

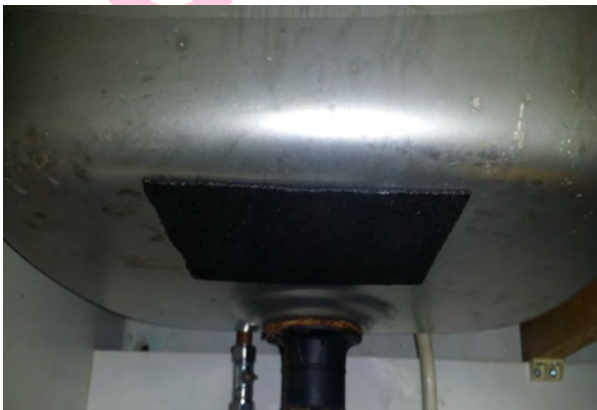
Item 92 Ref: 406299-17

The sink pad in the canteen (Rm 2/06a) does not contain asbestos.

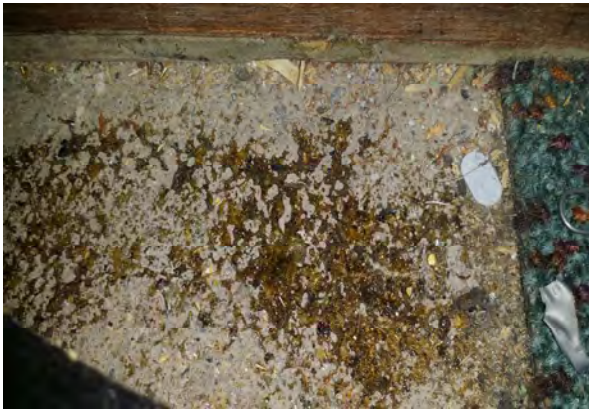
Item 97 Ref: As406299-15

The remnant adhesive backing to floor in the store (Rm 2/210a) contains asbestos.

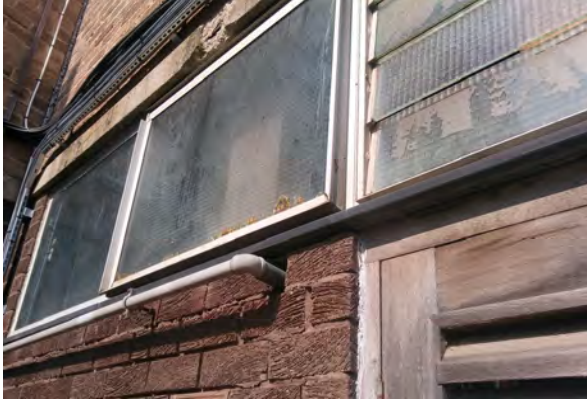
Item 99 Ref: 406299-70

The window sill to the main building (External) does not contain asbestos.

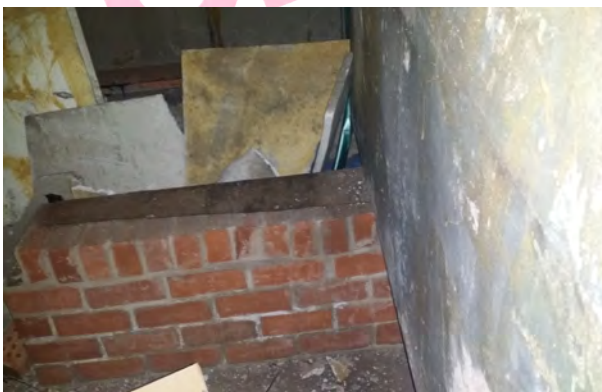
Item 104 Ref: 406299-33

The damp proof course to tank plinths to the tank room (Rm 3/001) contains asbestos.

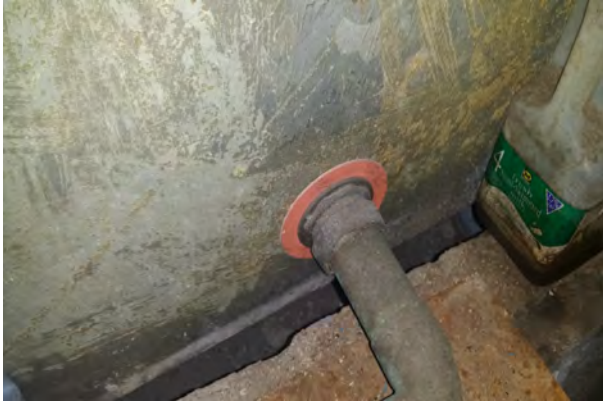
Item 105 Ref: 406299-34

The gasket to water tank in the tank room (Rm 3/001) contains asbestos.

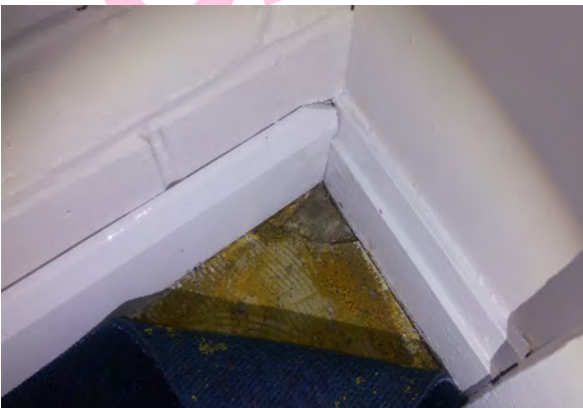
Item 112 Ref: As 406299-41

The subfloor in the Depot – open office (Rm 0/142) does not contain asbestos.

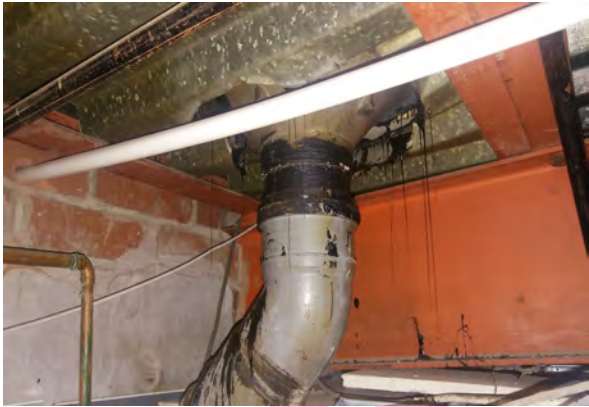
Item 114 Ref: 406299-42

The bitumen coating to downpipe in the Depot canteen – void above suspended ceiling (Rm 0/144) contains asbestos.

Any change in its appearance should be recorded and passed to Property Services

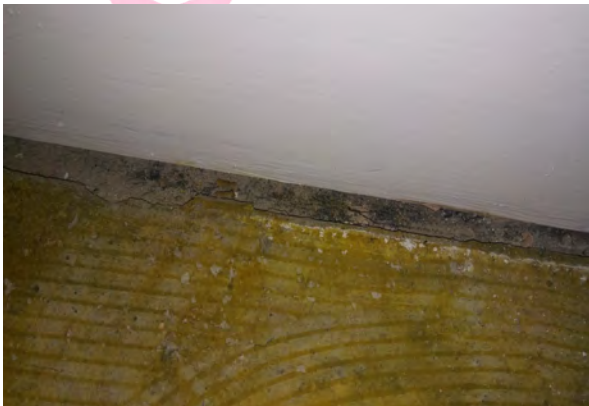
Item 115 Ref: 406299-43

The remnant adhesive to floor beneath screed in the Depot office (Rm 0/147) contains asbestos.

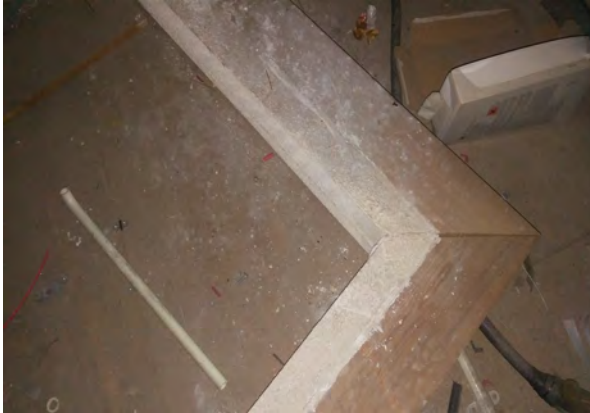
Item 134 Ref: 406299-47

The textured coating to loose lying timber frames in the Depot circulation – plant room above (Rm 1/170) does not contain asbestos.

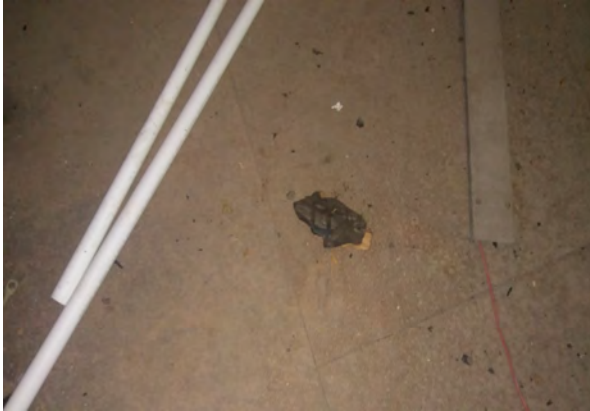
Item 137 Ref: 406299-50

The debris to floor in the Depot circulation – plant room above (Rm 1/170) does not contain asbestos.

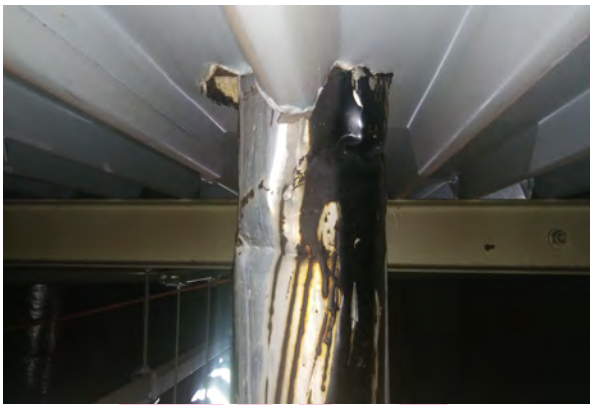
Item 138 Ref: 406299-51

The bitumen coating to boiler flue to floor in the Depot circulation – plant room above (Rm 1/170) does not contain asbestos.

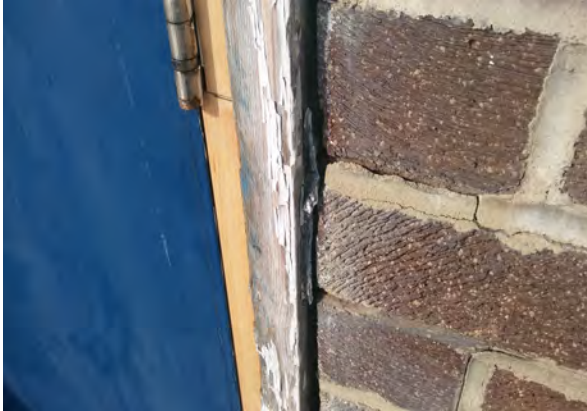
Item 143 Ref: 406299-61

The sealant to south elevation door frames to the Depot (External) does not contain asbestos.

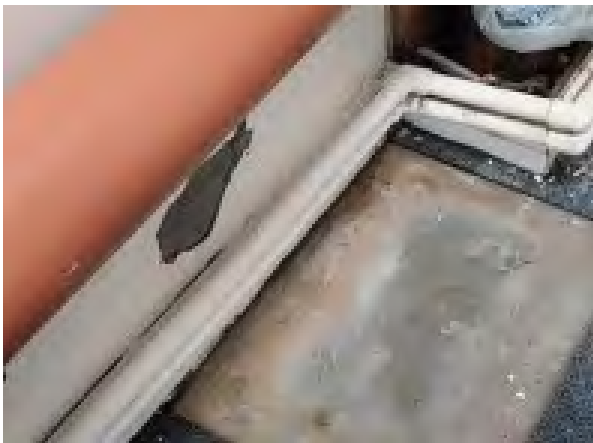
Item 144 Ref: 21-33672-1

The screed below carpet tiles in Refuse Supervisors Office does not contain asbestos.

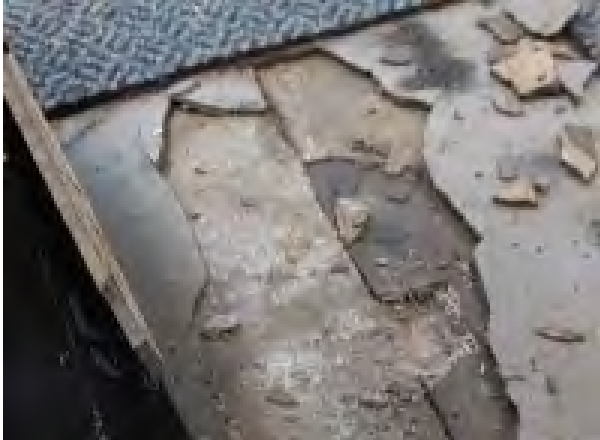
Item 146 Ref: 21-33672-3

The tiles and adhesive below 2 x layers of screed in the Refuse Supervisors Office does not contain asbestos.

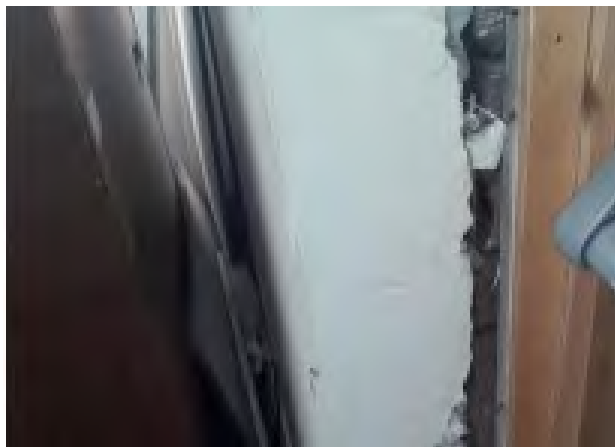
Item 150 Ref: 21-33925-4

The damp proof course inside wall cavity (Area 1/External access door to offices, toiler and canteen) does not contain asbestos.

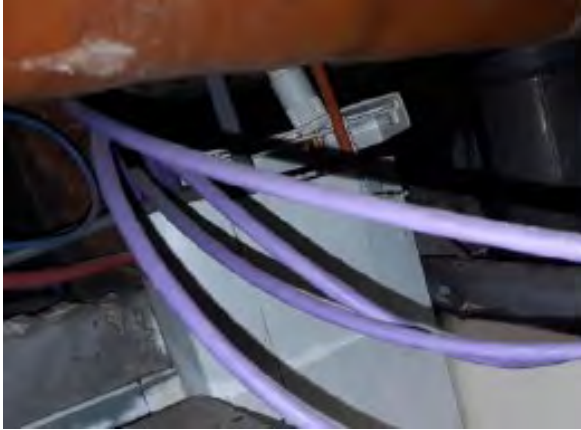
Item 152 Ref: 21-33618-1

The felt debris around downpipes penetration to Area 1 (Ceiling void above office, refuse team) does not contain asbestos.

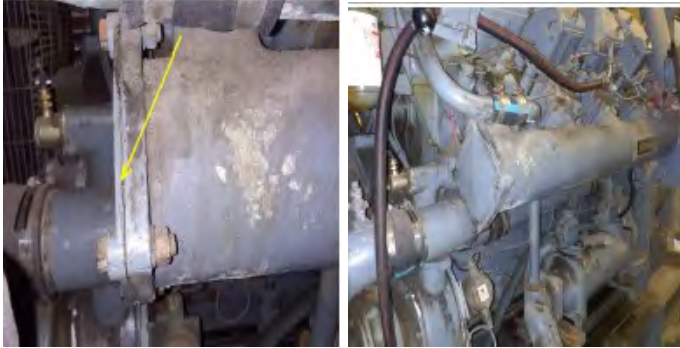
Item 173 Ref: NM001198

The gasket flange in the Pump House (G/01) does not contain asbestos.

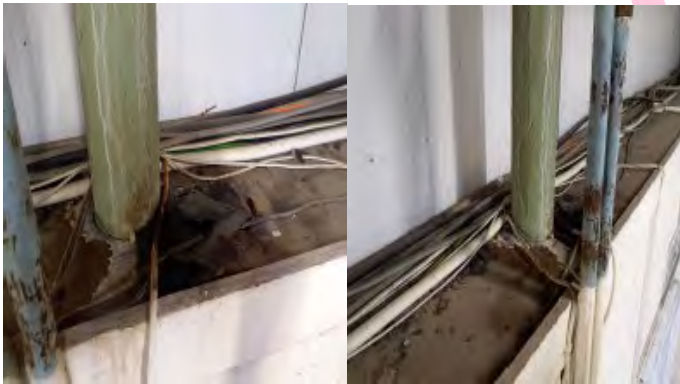
Item 174 Ref: RO001392

The bitumen debris on the ledge in the circulation 185 area does not contain asbestos.

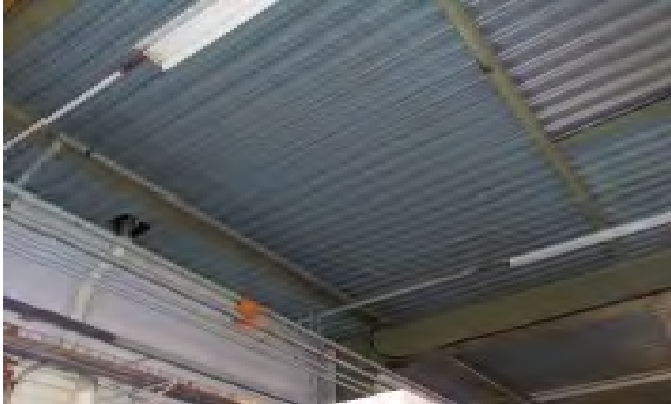
Item 179 Ref: As HD001081

The galbestos ceiling in the Highways store (G/04) does not contain asbestos.
