ASBESTOS SURVEY REPORT FOR SUNDERLAND EMPIRE THEATRE, 4-5 HIGH STREET WEST, SUNDERLAND, SR1 3EX

## *Control of Asbestos Regulations 2012*

**Sunderland Empire Theatre, 4-5 High Street West,  
Sunderland, SR1 3EX**

**Date: 19 January 2026**

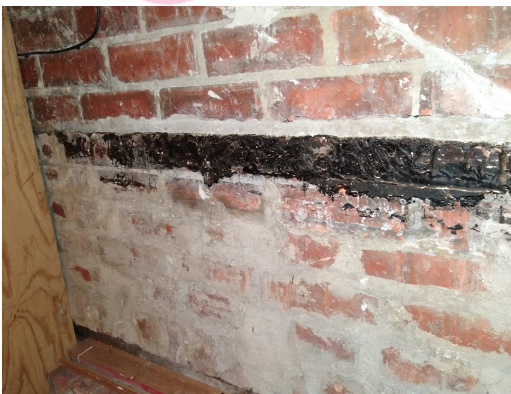
**Item 6 Ref: 405964-46**

The walls – bituminous product (1/018/storage area) do not contain asbestos.

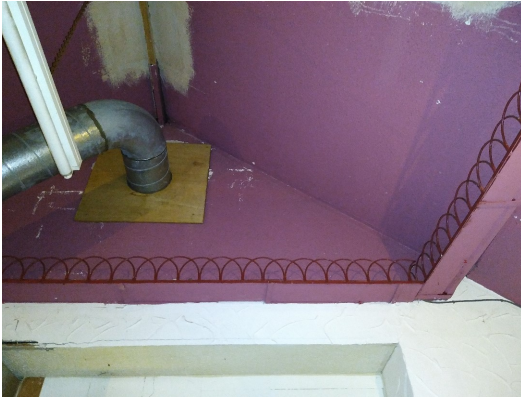
**Item 7 Ref: As 405964-44**

The ceiling - textured coating (1/019/store area mezzanine) does not contain asbestos.

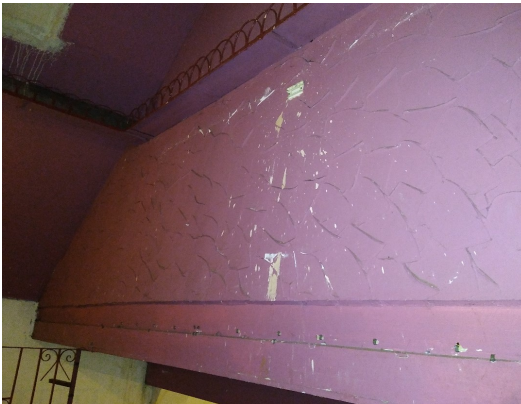
**Item 8 Ref: As 405964-45**

The wall – textured coating (1/019/store area mezzanine) does not contain asbestos.

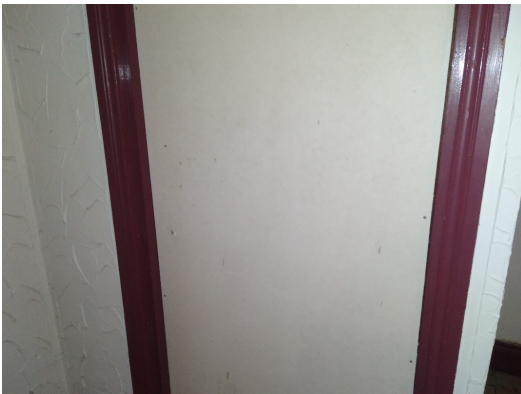
**Item 9 Ref: 405964-47**

The panel to door – insulating board (1/019/store area mezzanine) does not contain asbestos.

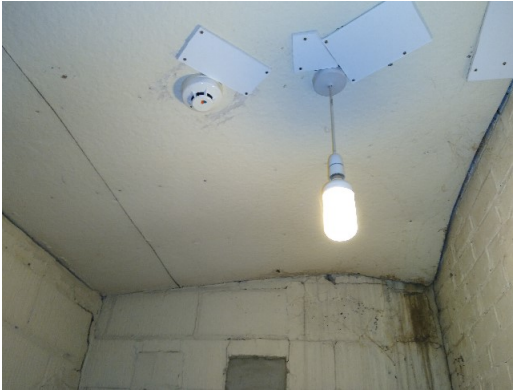
**Item 16 Ref: As 405964-41**

The ceiling – fibreboard (2/010/boiler room) does not contain asbestos.

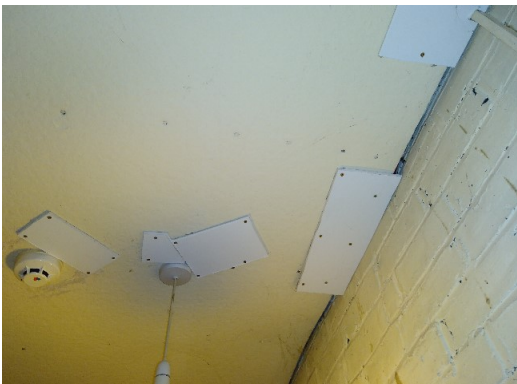
**Item 17 Ref: As 405964-40**

The panel – insulating board (2/010/boiler room) does not contain asbestos.

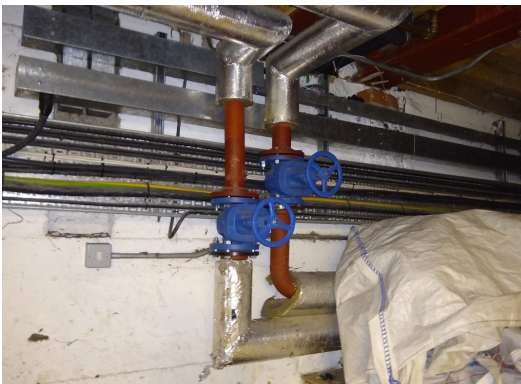
**Item 18 Ref: 405964-35**

The pipework flange gaskets (0/002/under stage store) do not contain asbestos.

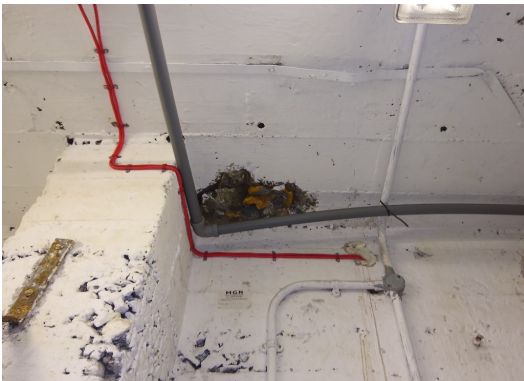
**Item 20 Ref: 405964-36**

The debris to former pipe penetration to underside of floor above – insulation (0/009/battery inverter room) does not contain asbestos.

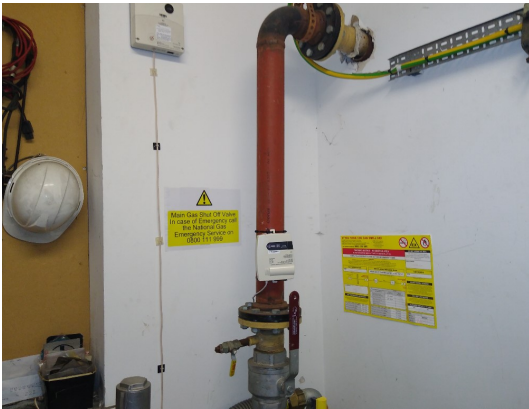
### **Item 29 Ref: 405964-32**

The pipework flange gasket (1/012/Store) does not contain asbestos.

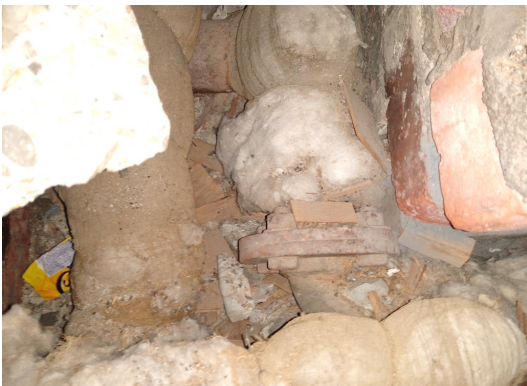
### **Item 30 Ref: Presumed**

The pipework flange gasket (1/020/stalls seating area – floor duct) is presumed to contain asbestos.

Any change in appearance should be recorded and passed to Property Services.

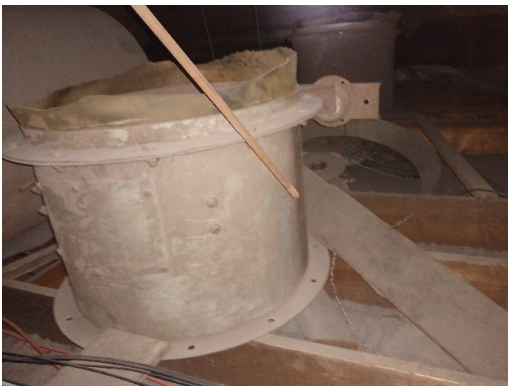
**Item 32 Ref: As 405964-85**

- (Item 31) Ref: 405964-85 – Ductwork flange gaskets (1/020/stalls seating area-void above) – Very Low Risk
- (Item 32) Ref: As 405964-85 – Flange gaskets to loose lying ductwork sections (1/020/stalls seating area-void above) – Very Low Risk

The flange gaskets to loose lying ductwork sections (1/020/stalls seating area-void above) contain asbestos.

Any change in appearance should be recorded and passed to Property Services.

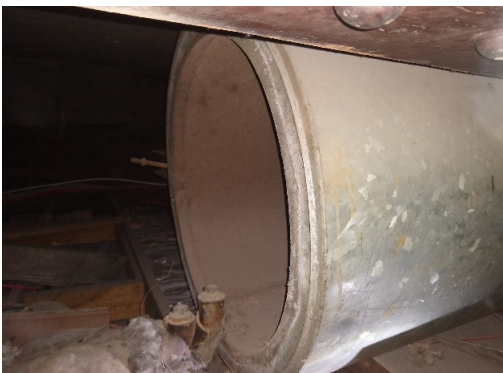
**Item 33 Ref: 405964-86**

- (Item 33) Ref: 405964-86 - Debris to open flange of loose lying ductwork section (1/020/stalls seating area-void above) – *Removed April 2022*
- (Item 34) Ref: 405964-31 – Remnant bitumen adhesive below carpet (1/024A/corridor lobby) – No Risk

The debris to open flange of loose lying ductwork section (/020/stalls seating area-void above) contains asbestos.

Removed April 2022

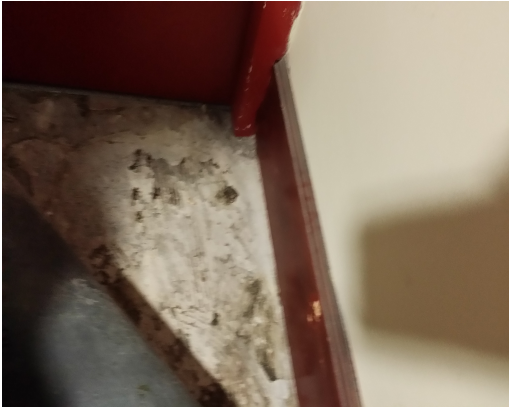
### **Item 34 Ref: 405964-31**

The remnant bitumen adhesive below carpet (1/024A/corridor lobby) does not contain asbestos.

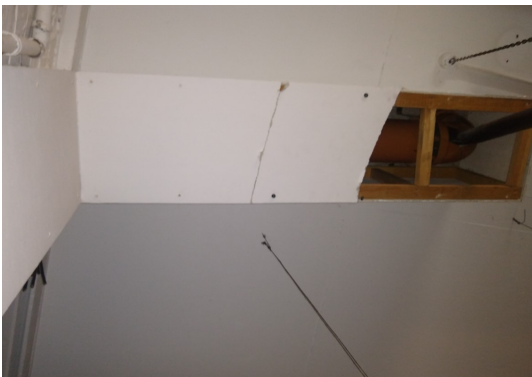
### **Item 36 Ref: 405964-39**

The boxing above suspended ceiling (1/030/cellar) does not contain asbestos.

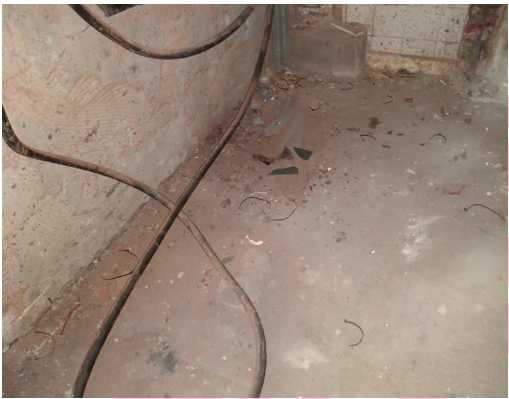
### **Item 44 Ref: 405964-27**

The floor covering (tile with bitumen adhesive) (1/043/lobby & corridor-void below stairs) does not contain asbestos.

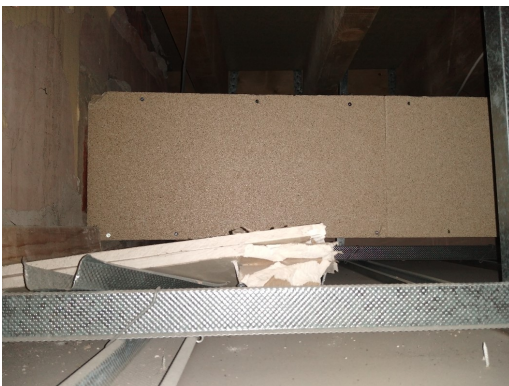
### **Item 45 Ref: 405964-30**

The firebreak panels to beams (1/045/lobby & stairwell to contact centre-void above) do not contain asbestos.

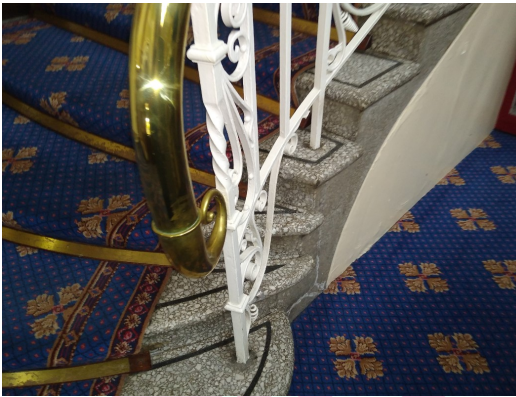
### **Item 47 Ref: 405964-29**

The floor covering to stairs (1/047/stairwell lobby) does not contain asbestos.

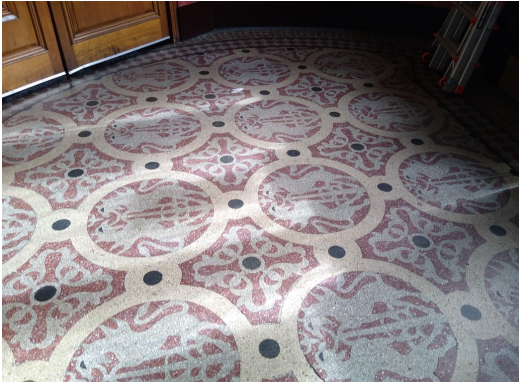
### **Item 49 Ref: 405964-28**

The floor covering (1/048/tower entrance lobby) does not contain asbestos.

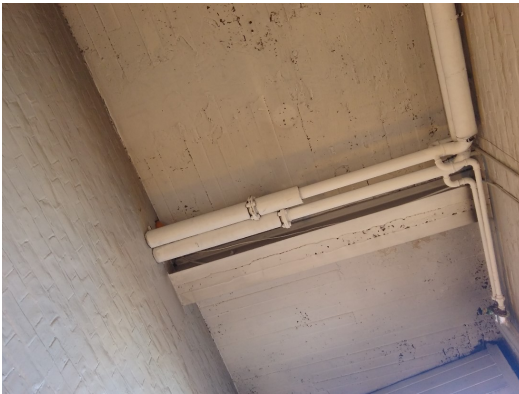
### **Item 50 Ref: PRESUMED**

The pipework flange gaskets (1/052/ice cream store) are presumed to contain asbestos.

Any change in appearance should be recorded and passed to Property Services.

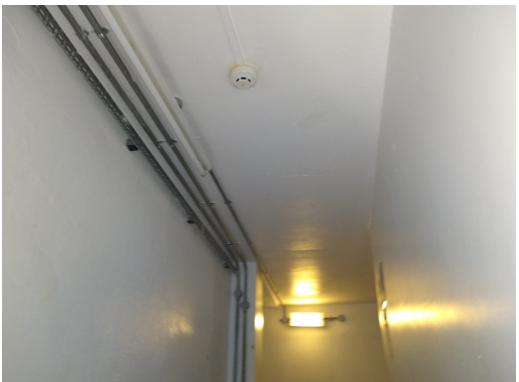
### **Item 51 Ref: 405964-33**

The decorative finish to underside of floor above (1/053/corridor & stairs) does not contain asbestos.

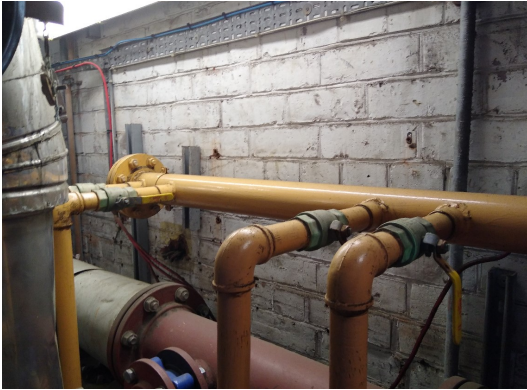
### **Item 52 Ref: 405964-87**

The debris to walls – insulation (1/054/boiler room) does not contain asbestos.

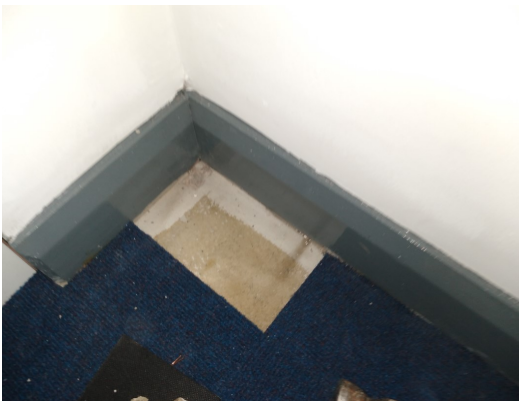
### **Item 54 Ref: 405964-19**

The remnant bitumen adhesive below carpet (2/003/dressing room 1 – Block A) does not contain asbestos.

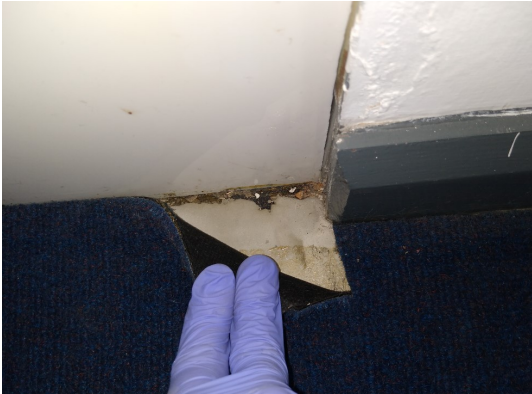
**Item 55 Ref: As 405964-19**

The remnant bitumen adhesive below carpet (2/004/dressing room 2 – Block A) does not contain asbestos.

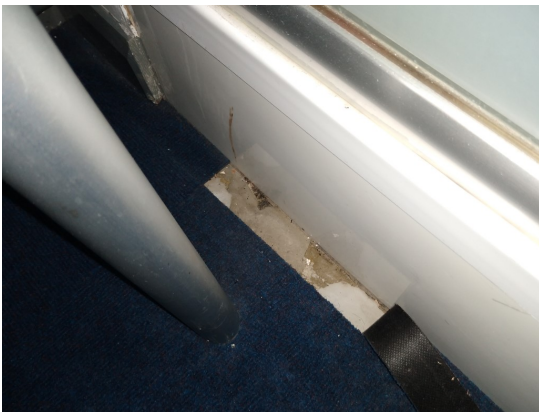
**Item 56 Ref: As 405964-19**

The remnant bitumen adhesive below carpet (2/005/dressing room 3 – Block A) does not contain asbestos.

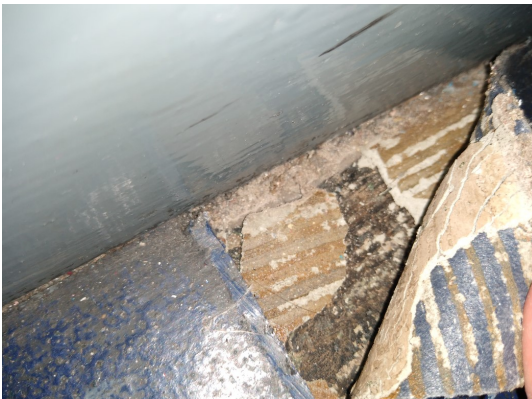
**Item 57 Ref: As 405964-19**

The remnant bitumen adhesive below modern lino (2/006A/corridor & stairwell – Block A) does not contain asbestos.

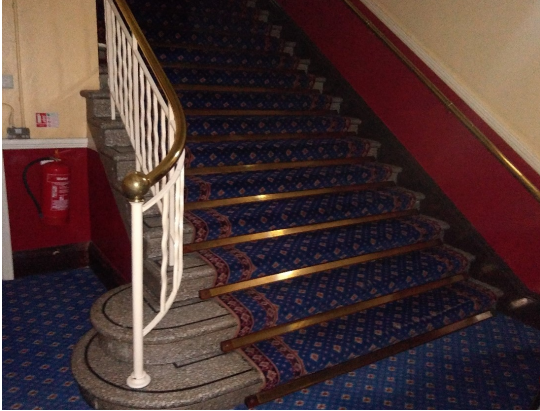
### **Item 58 Ref: 405964-52**

The stairs (2/011/stairwell) does not contain asbestos.

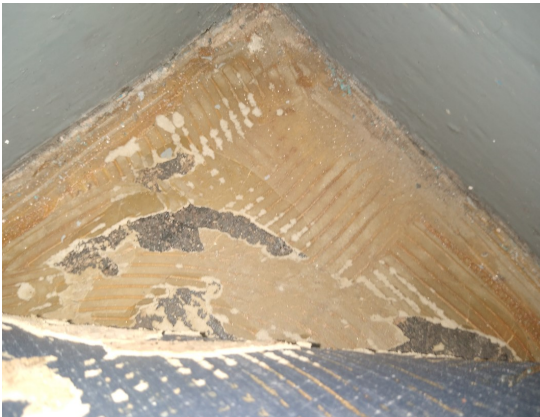
### **Item 59 Ref: As 405964-18**

The remnant bitumen adhesive below modern linoleum (3/003/corridor – Block A) contains asbestos.

Any change in appearance should be recorded and passed to Property Services.

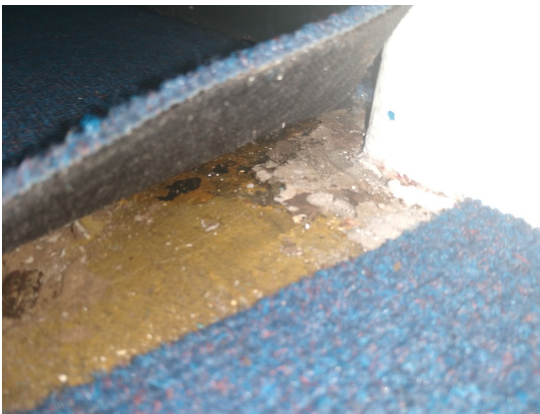
### **Item 60 Ref: As 405964-17**

The remnant bitumen adhesive below modern linoleum (3/003A/stairwell & landing – Block A) contains asbestos.

Any change in appearance should be recorded and passed to Property Services.

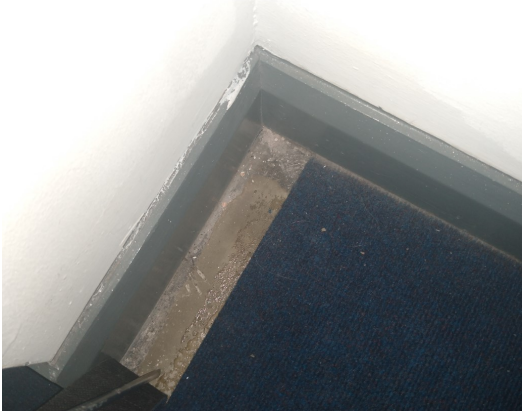
**Item 61 Ref: As 405964-18**

The remnant bitumen adhesive below carpet (3/004/dressing room 4 – Block A) contains asbestos.

Any change in appearance should be recorded and passed to Property Services.

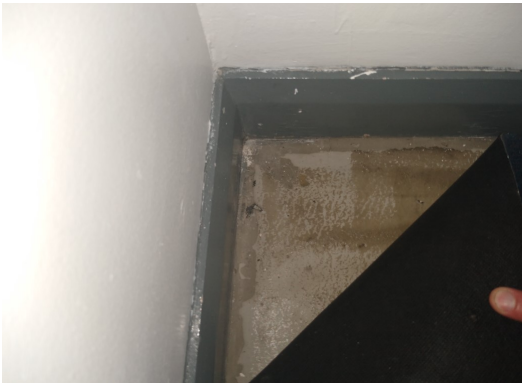
**Item 62 Ref: As 405964-17**

The remnant bitumen adhesive below carpet (3/005/dressing room 5 – Block A) contains asbestos.

Any change in appearance should be recorded and passed to Property Services.

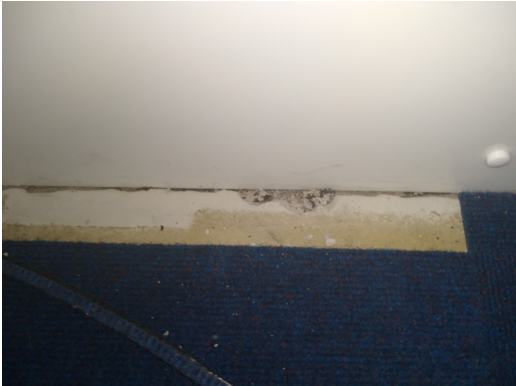
**Item 64 Ref: As 405964-17**

The remnant bitumen adhesive below carpet (3/008/dressing room 6 – Block A) contains asbestos.

Any change in appearance should be recorded and passed to Property Services.

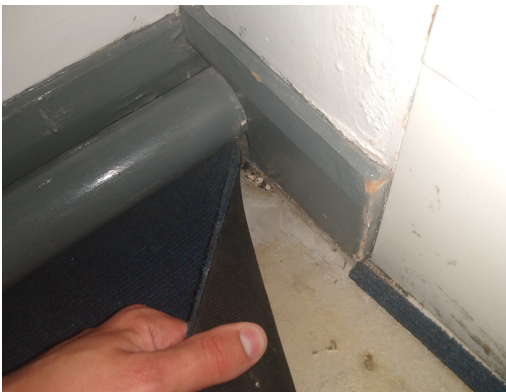
**Item 66 Ref: As 405964-17**

The remnant bitumen adhesive below carpet (3/010/dressing room 8 – Block A) contains asbestos.

Any change in appearance should be recorded and passed to Property Services.

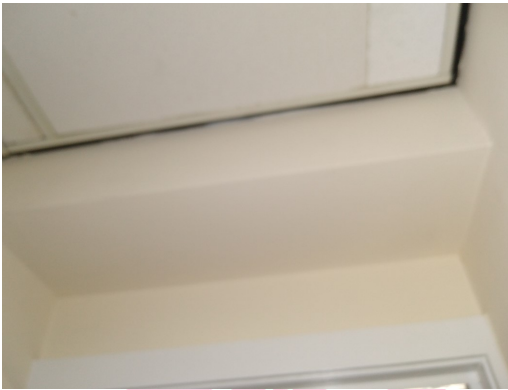
**Item 71 Ref: As 405964-4**

The boxing in corridor (3/013/managers office - Block B) does not contain asbestos.

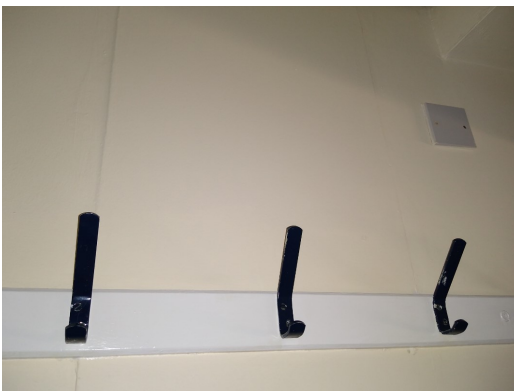
**Item 72 Ref: As 405964-3**

The panel to riser – insulating board (3/013/managers office - Block B) does not contain asbestos.

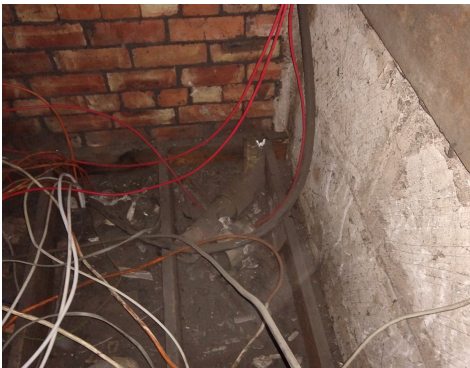
### Item 113 Ref: 405964-67

- (Item 113) *Ref: 405964-67 – Loose lying flue sections adjacent hatch (3/029/female toilets – void above) – Removed April 2022*
- (Item 114) Ref: 405964-62 – Subfloor – linoleum (3/031/corridor) – No Risk

The loose lying flue sections adjacent hatch (3/029/female toilets – void above) contains asbestos.

Item 111	No asbestos	Is present		
<b>Item 112</b>	<b>415kv DB board (3/029 Female toilets)</b>	<b>Very Low Risk</b>	<b>12 monthly</b>	<b>14/01/2027</b>
Item 113	Loose lying flue sections (3/029 Female toilets-void above)	Very Low Risk	12 monthly	Removed April 2022

Removed April 2022

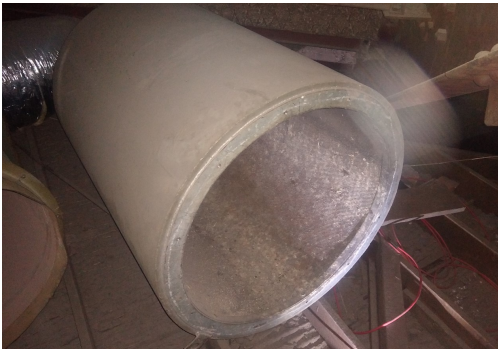
### **Item 125 Ref: 405964-58**

- (Item 125) Ref: 405964-58 – Residue to loose lying ductwork flange southwest (3/040/dress circle – void above) – Removed April 2022
- (Item 126) Ref: 405964-59 – Flange gasket to loose lying ductwork southwest (3/040/dress circle – void above) – Low Risk

The residue to loose lying ductwork flange southwest (3/040/dress circle – void above) contains asbestos.

Item 123	No asbestos	Is present		
Item 124	No asbestos	Is present		
Item 125	Residue to loose lying ductwork (3/040 Dress circle-void above)	Low Risk	6 monthly	Removed April 2022

Removed April 2022

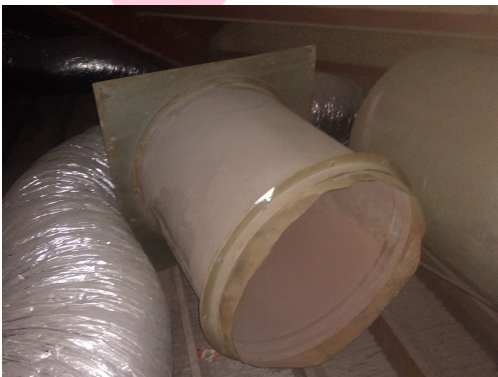
### **Item 126 Ref: 405964-59**

The flange gasket to loose lying ductwork southwest (3/040/dress circle – void above) contains asbestos.

Any change in appearance should be recorded and passed to Property Services.

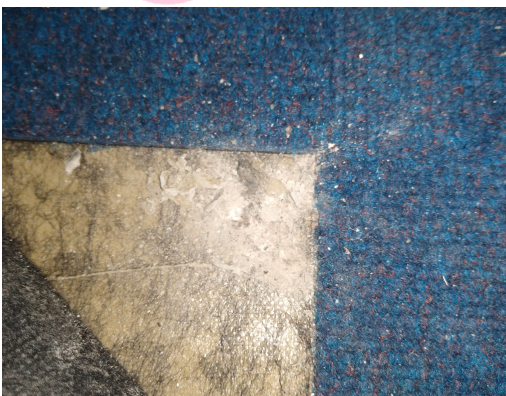
### **Item 135 Ref: As 405964-15**

The remnant bitumen adhesive below carpet (4/007/dressing room 11 – Block A) contains asbestos.

Any change in appearance should be recorded and passed to Property Services.

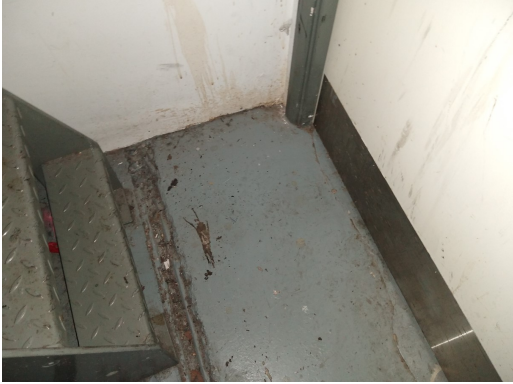
### **Item 136 Ref: As 405964-16**

The bitumen adhesive to floor (4/008/stairs to operating gallery – Block A) contains asbestos.

Any change in appearance should be recorded and passed to Property Services.

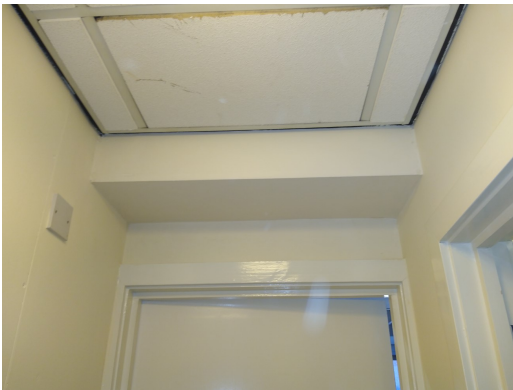
### **Item 138 Ref: As 405964-12**

The boxing to beams below plasterboard (4/012/dressing room 10 – Block B) does not contain asbestos.

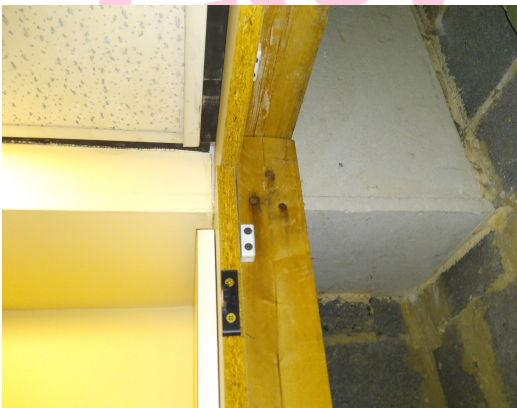
**Item 141 Ref: As 405964-11**

The boxing to beam below  
plasterboard (4/012A/shower  
room – Block B) does not  
contain asbestos.

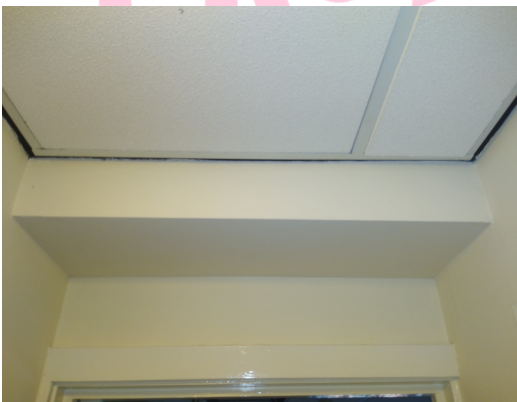
### **Item 147 Ref: As 405964-11**

The boxing to beam below plasterboard (4/014/dressing room 8 – Block B) does not contain asbestos.

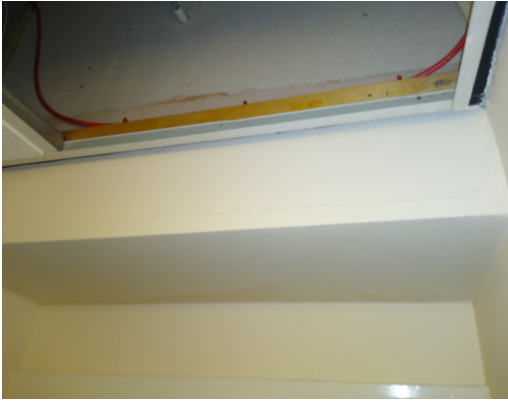
**Item 151 Ref: As 405964-11**

The boxing to beam below plasterboard (4/015/dressing room 7 – Block B) does not contain asbestos.

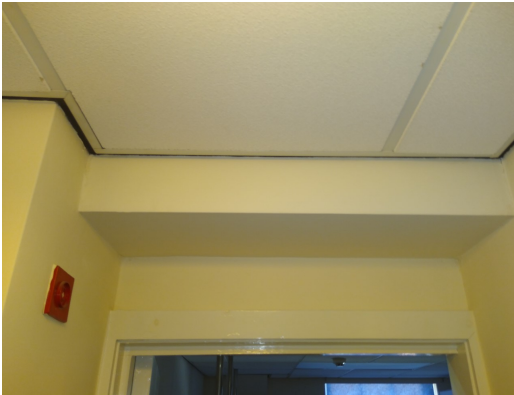
**Item 155 Ref: As 405964-11**

The boxing to beam below plasterboard (4/016/dressing room 6 – Block B) does not contain asbestos.

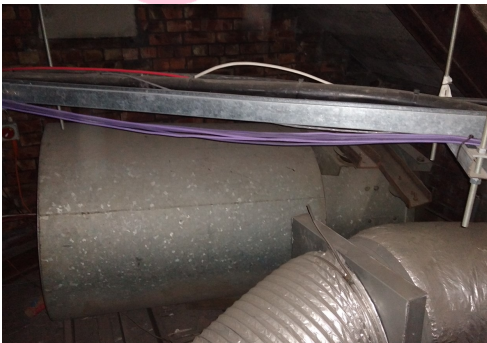
### **Item 171 Ref: As 405964-79**

- (Item 170) Ref: 405964-79 – Ductwork flange gaskets northeast (4/023/upper circle – void above) – Low Risk
- (Item 171) Ref: As 405964-79 – Flange gaskets to loose lying ductwork southwest (4/023/upper circle – void above) – Low Risk

The flange gaskets to loose lying ductwork southwest (4/023/upper circle – void above) contain asbestos.

Any change in appearance should be recorded and passed to Property Services.

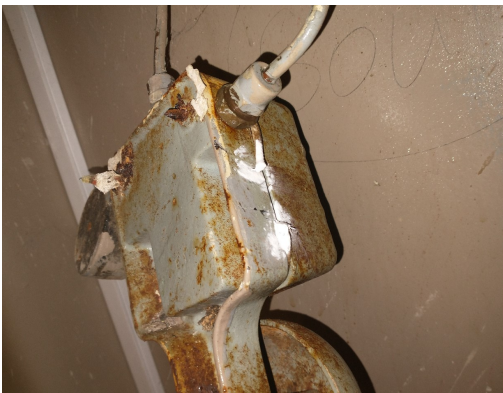
**Item 176 Ref: 405964-78**

The rope seal to redundant fire bell (4/024/old projectors room) does not contain asbestos.

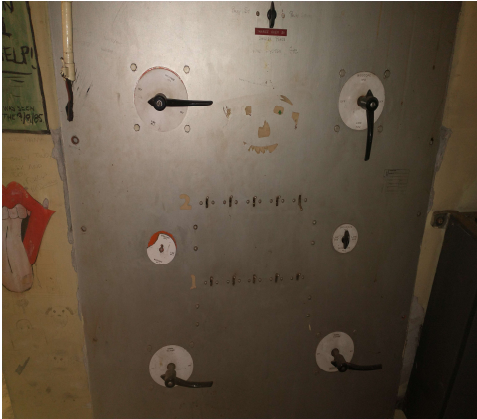
**Item 178 Ref: 405964-81**

The circular names plates to old electric panel (4/024/old projectors room) does not contain asbestos.

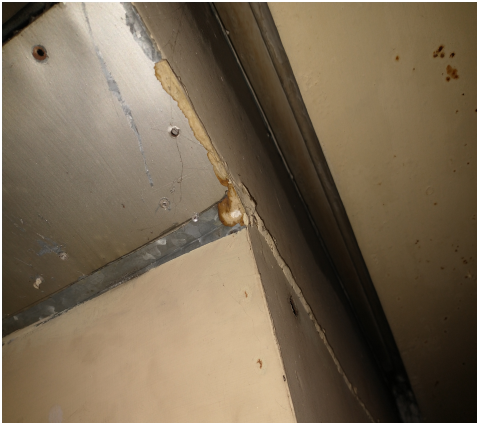
**Item 179 Ref: 405964-82**

The remnant mastic to old ductwork (4/024/old projectors room) does not contain asbestos.

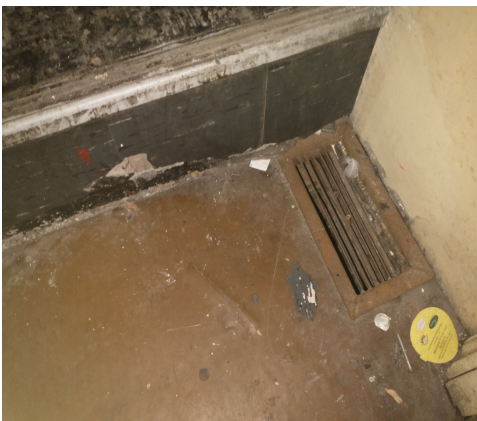
**Item 180 Ref: 405964-71**

The linoleum floor covering (4/024a/lobby) does not contain asbestos.

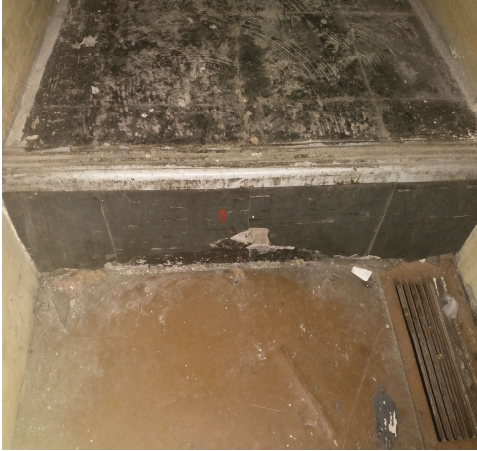
### **Item 181 Ref: 405964-72**

The floor covering to upstand of step (4/024a/lobby) contains asbestos.

Any change in appearance should be recorded and passed to Property Services.

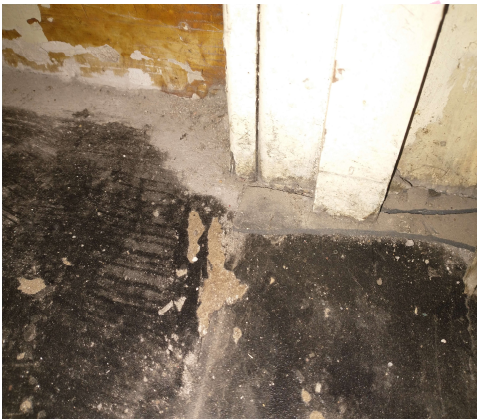
### **Item 182 Ref: 405964-73**

The remnant floor tiles & adhesive backing to floor (4/024a/lobby) contains asbestos.

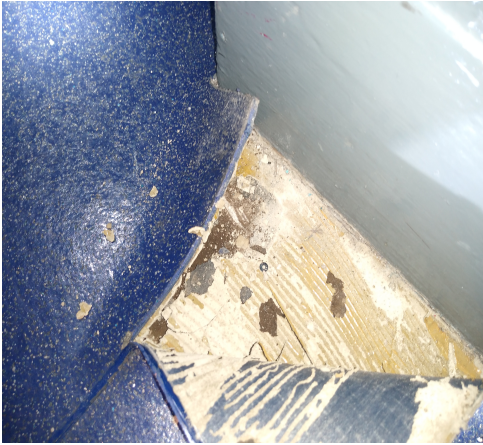
**Item 184 Ref: As 405964-15**

The remnant bitumen adhesive below carpet (4/026/corridor – Block A) contains asbestos.

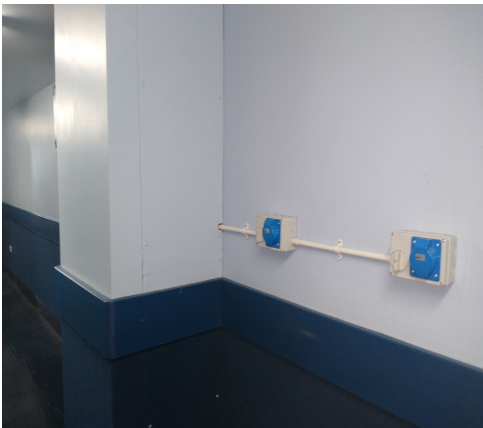
**Item 185 Ref: As 405964-5**

The panels to boxing (5/06/corridor) does not contain asbestos.

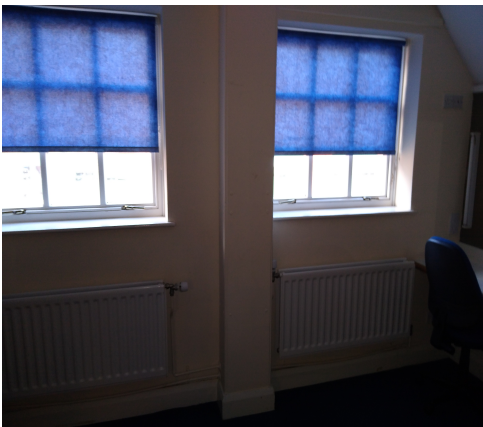
**Item 186 Ref: As 405964-2**

The boxing to pipework (5/07/dressing room 16) does not contain asbestos.

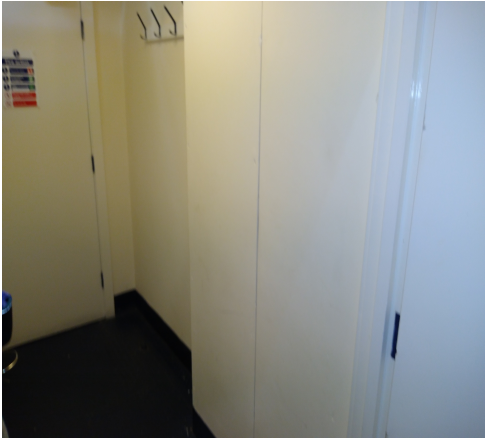
**Item 187 Ref: 405964-4**

The boxing in corridor (5/07/dressing room 16) does not contain asbestos.

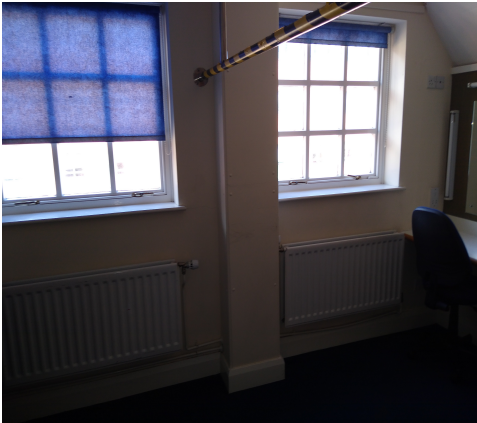
**Item 188 Ref: As 405964-2**

The boxing to pipework (5/08/dressing room 15) does not contain asbestos.

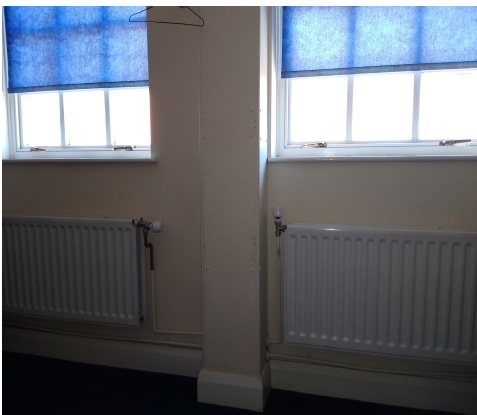
**Item 189 Ref: As 405964-2**

The boxing to pipework (5/09/dressing room 303) does not contain asbestos.

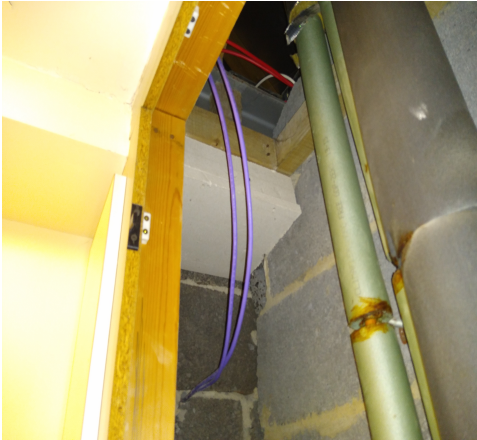
**Item 190 Ref: 405964-3**

The high level panel within void behind wood wall (5/09A/shower room 303) does not contain asbestos.

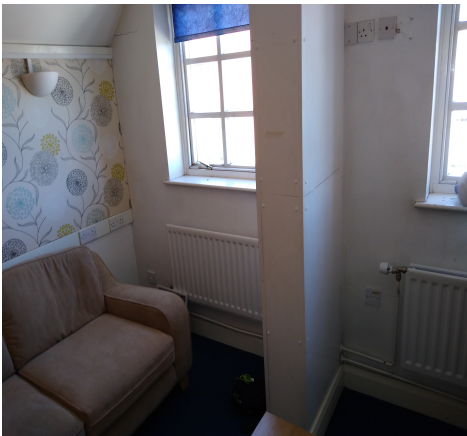
**Item 191 Ref: 405964-2**

The boxing to pipework (5/10/dressing room 304) does not contain asbestos.

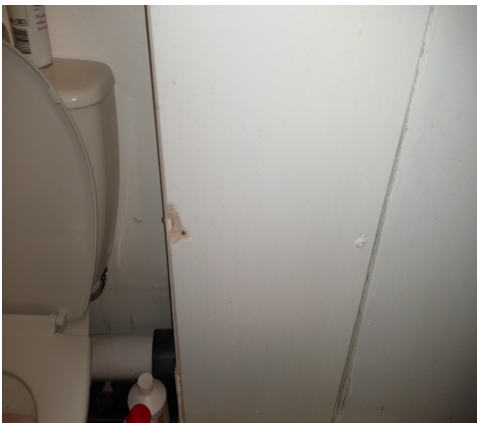
**Item 192 Ref: As 405964-2**

The boxing to pipework (5/010A/shower room 304) does not contain asbestos.

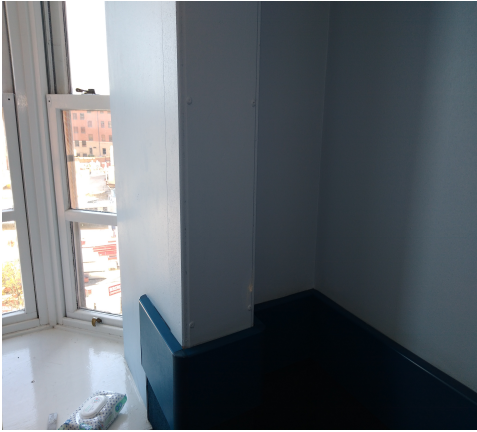
### **Item 193 Ref: 405964-1**

The boxing to pipework (5/014/stairwell) does not contain asbestos.

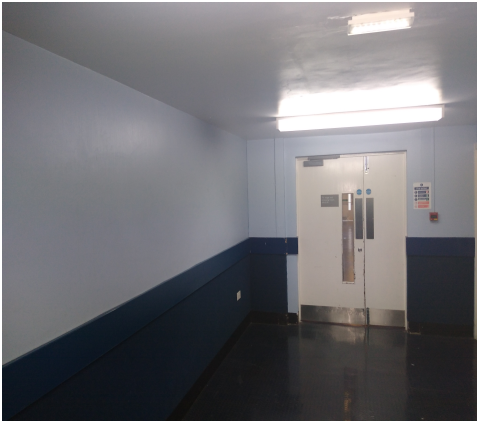
### **Item 194 Ref: 405964-5**

The panels to boxing (5/018/corridor) does not contain asbestos.

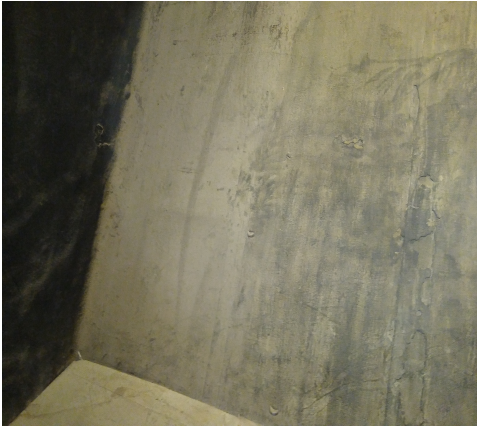
**Item 196 Ref: As 405964-6**

The redundant roof covering to old roof (6/04/loft void) does not contain asbestos.

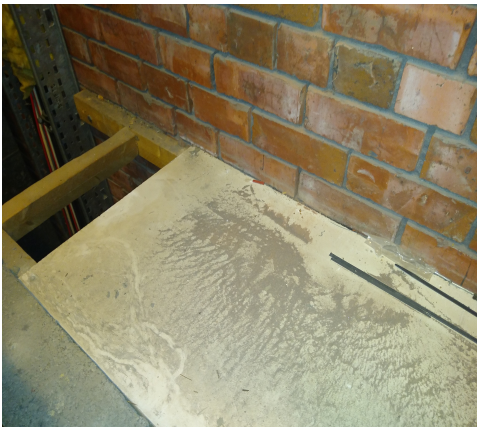
**Item 198 Ref: 405964-8**

The panel below wood walkway (6/04/loft void) does not contain asbestos.

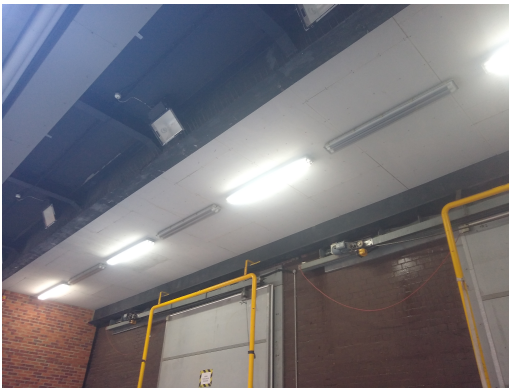
### **Item 200 Ref: 405964-90**

The soffit above stage loading bay (External) does not contain asbestos.

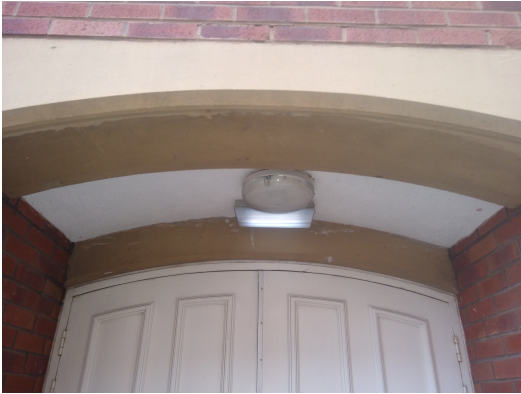
### **Item 202 Ref: 405964-91**

The textured coating to arched soffits southwest (External) does not contain asbestos.

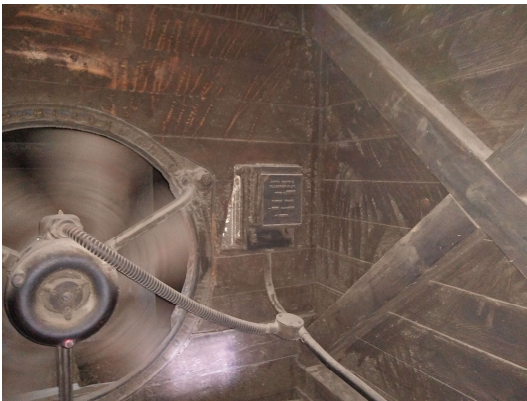
### **Item 203 Ref: 405964-89**

The backboard to transformer (External-roof top fan room) contains asbestos.

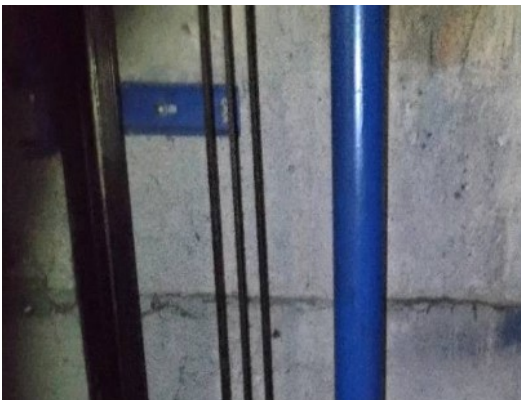
### **Item 204 Ref: DC003636**

The damp proof course in the Lift Pitt (G/001) does not contain asbestos.

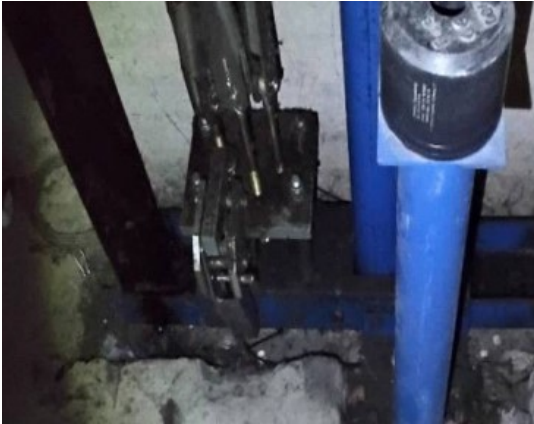
**Item 205 Ref: DC003637**

The debris/residue in the Lift Pitt (G/001) does not contain asbestos.
