ASBESTOS SURVEY REPORT FOR SUNDERLAND EMPIRE THEATRE, 4-5 HIGH STREET WEST, SUNDERLAND, SR1 3EX

Control of Asbestos Regulations 2012

Asbestos Register for

**Sunderland Empire Theatre, 4-5 High Street West,
Sunderland, SR1 3EX**

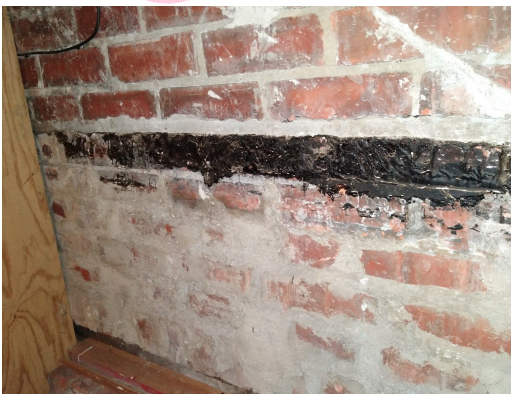
Item 6 Ref: 405964-46

The walls – bituminous product (1/018/storage area) do not contain asbestos.

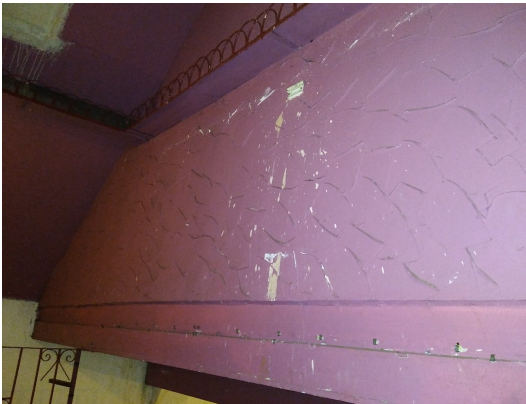
Item 8 Ref: As 405964-45

The wall – textured coating (1/019/store area mezzanine) does not contain asbestos.

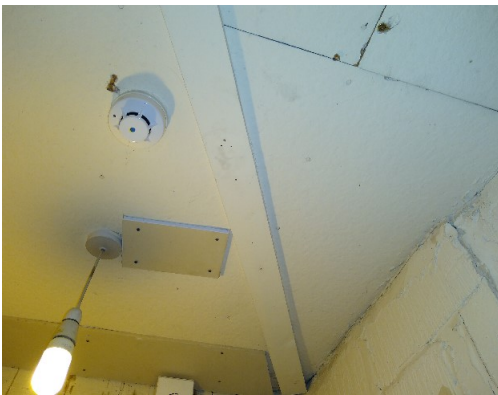
Item 11 Ref: 405964-41

The ceiling - fibreboard (2/007/landing & stairwell 3) does not contain asbestos.

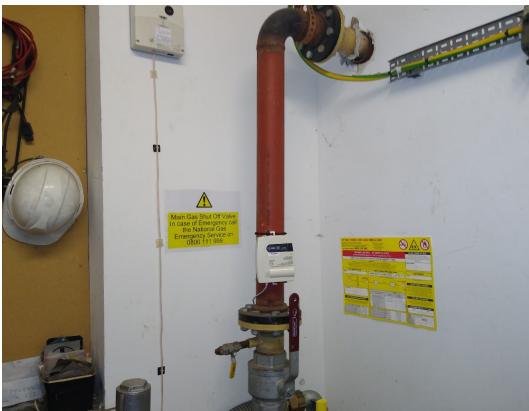
Item 29 Ref: 405964-32

The pipework flange gasket (1/012/Store) does not contain asbestos.

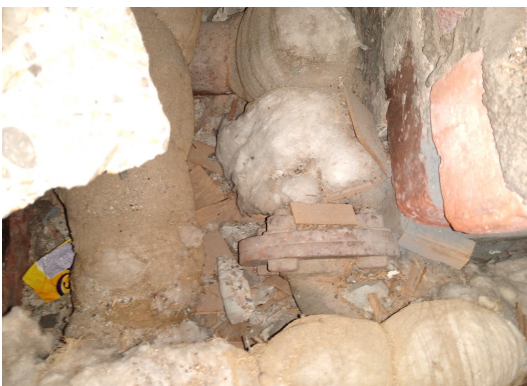
Item 30 Ref: Presumed

The pipework flange gasket (1/020/stalls seating area – floor duct) is presumed to contain asbestos.

Any change in appearance should be recorded and passed to Property Services.

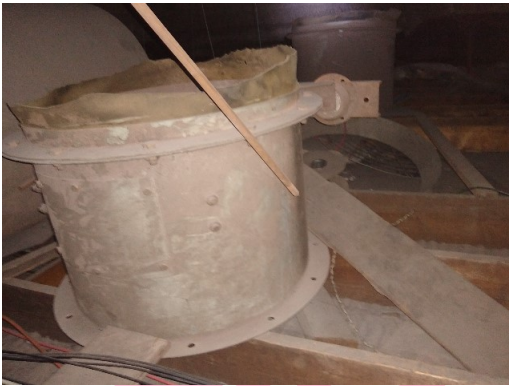
Item 32 Ref: As 405964-85

- (Item 31) Ref: 405964-85 – Ductwork flange gaskets (1/020/stalls seating area-void above) – Very Low Risk
- (Item 32) Ref: As 405964-85 – Flange gaskets to loose lying ductwork sections (1/020/stalls seating area-void above) – Very Low Risk

The flange gaskets to loose lying ductwork sections (1/020/stalls seating area-void above) contain asbestos.

Any change in appearance should be recorded and passed to Property Services.

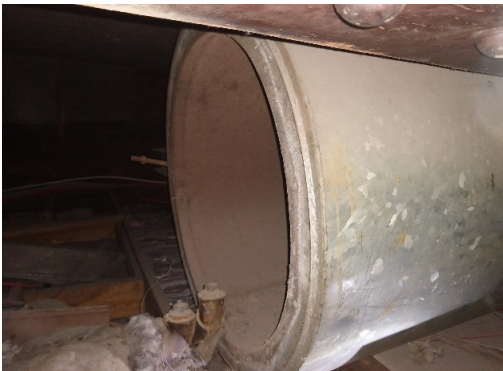
Item 33 Ref: 405964-86

The debris to open flange of loose lying ductwork section (/020/stalls seating area-void above) contains asbestos.

Removed April 2022

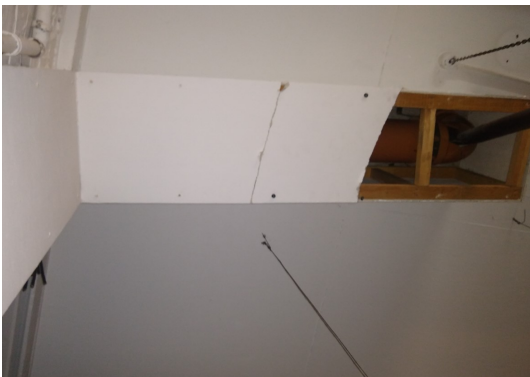
Item 36 Ref: 405964-39

The boxing above suspended ceiling (1/030/cellar) does not contain asbestos.

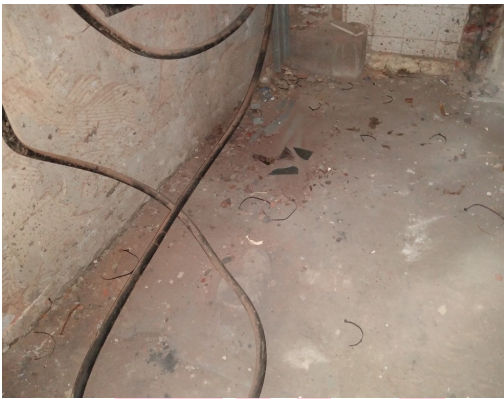
Item 44 Ref: 405964-27

The floor covering (tile with bitumen adhesive) (1/043/lobby & corridor-void below stairs) does not contain asbestos.

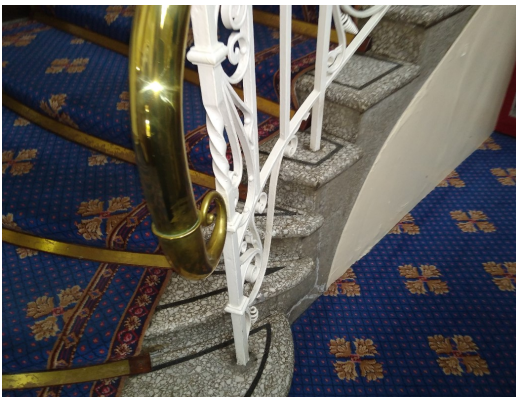
Item 47 Ref: 405964-29

The floor covering to stairs (1/047/stairwell lobby) does not contain asbestos.

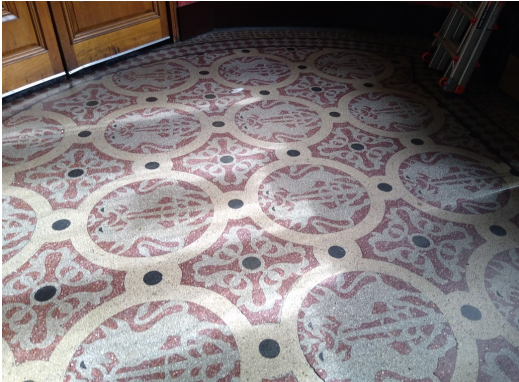
Item 49 Ref: 405964-28

The floor covering
(1/048/tower entrance lobby)
does not contain asbestos.

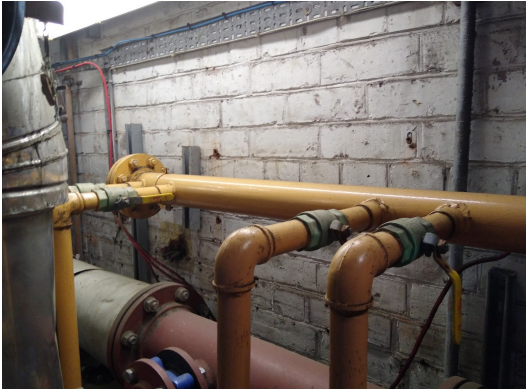
Item 52 Ref: 405964-87

The debris to walls – insulation (1/054/boiler room) does not contain asbestos.

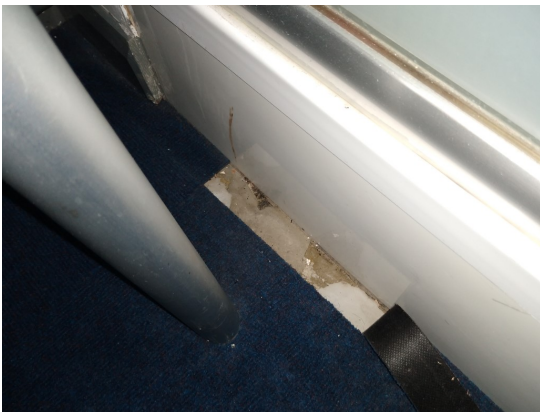
Item 56 Ref: As 405964-19

The remnant bitumen adhesive below carpet (2/005/dressing room 3 – Block A) does not contain asbestos.

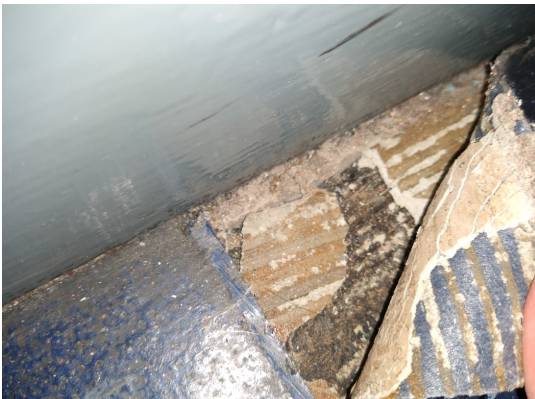
Item 57 Ref: As 405964-19

The remnant bitumen adhesive below modern lino (2/006A/corridor & stairwell – Block A) does not contain asbestos.

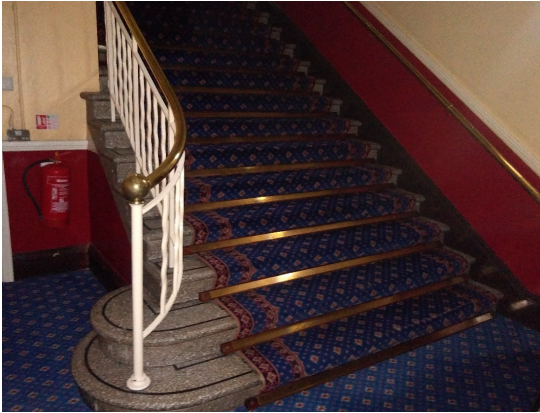
Item 58 Ref: 405964-52

The stairs (2/011/stairwell) does not contain asbestos.

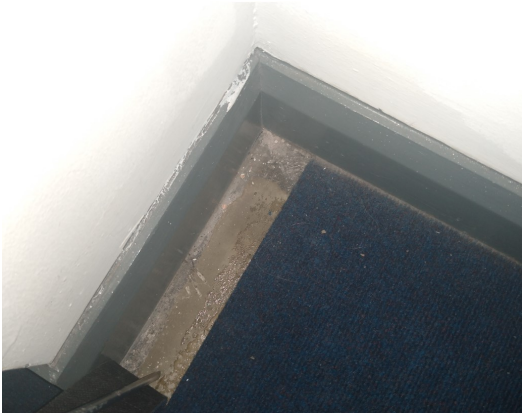
Item 61 Ref: As 405964-18

The remnant bitumen adhesive below carpet (3/004/dressing room 4 – Block A) contains asbestos.

Any change in appearance should be recorded and passed to Property Services.

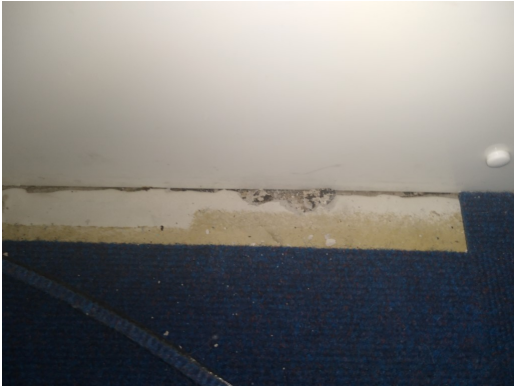
Item 64 Ref: As 405964-17

The remnant bitumen adhesive below carpet (3/008/dressing room 6 – Block A) contains asbestos.

Any change in appearance should be recorded and passed to Property Services.

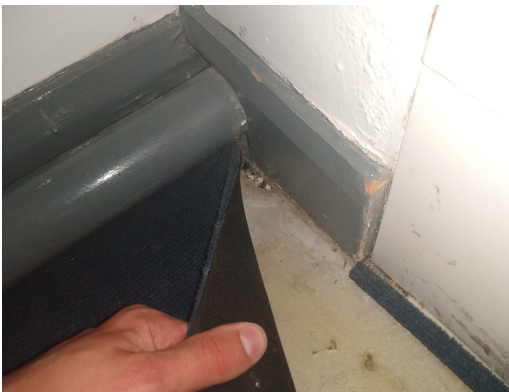
Item 66 Ref: As 405964-17

The remnant bitumen adhesive below carpet (3/010/dressing room 8 – Block A) contains asbestos.

Any change in appearance should be recorded and passed to Property Services.

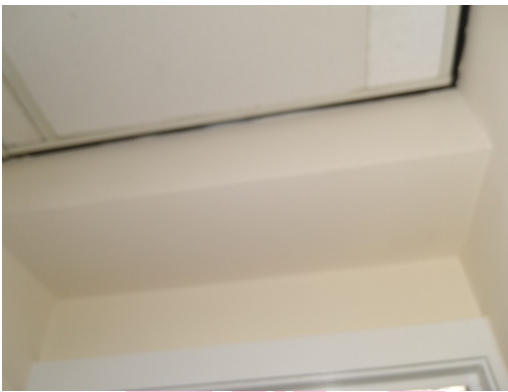
Item 71 Ref: As 405964-4

The boxing in corridor (3/013/managers office - Block B) does not contain asbestos.

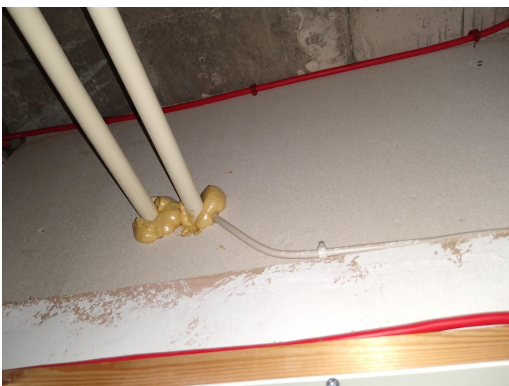
Item 78 Ref: As 405964-21

The bulkhead above corridor – insulating board (3/014/dressing room 1 – Block B ceiling void) does not contain asbestos.

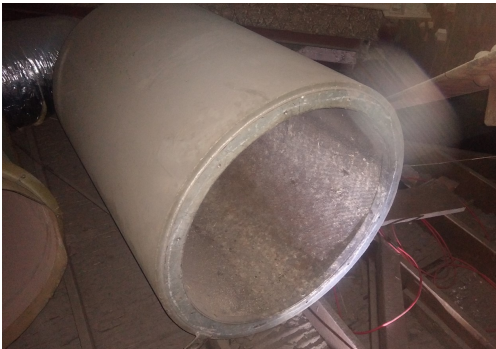
Item 125 Ref: 405964-58

- (Item 125) Ref: 405964-58 – Residue to loose lying ductwork flange southwest (3/040/dress circle – void above) – Removed April 2022
- (Item 126) Ref: 405964-59 – Flange gasket to loose lying ductwork southwest (3/040/dress circle – void above) – Low Risk

The residue to loose lying
ductwork flange southwest
(3/040/dress circle – void
above) contains asbestos.

Item 125	Residue to loose lying ductwork (3/040 Dress circle-void above)	Low Risk	6 monthly	Removed April 2022

Removed April 2022

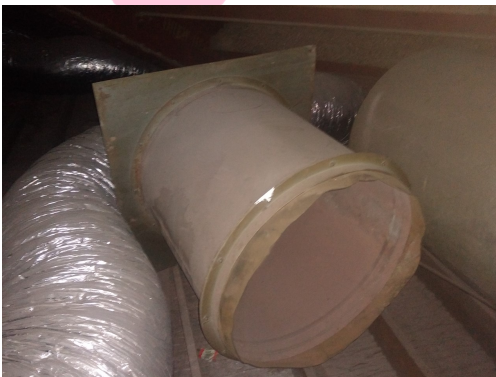
Item 126 Ref: 405964-59

The flange gasket to loose
lying ductwork southwest
(3/040/dress circle – void
above) contains asbestos.

Any change in appearance
should be recorded and
passed to Property Services.

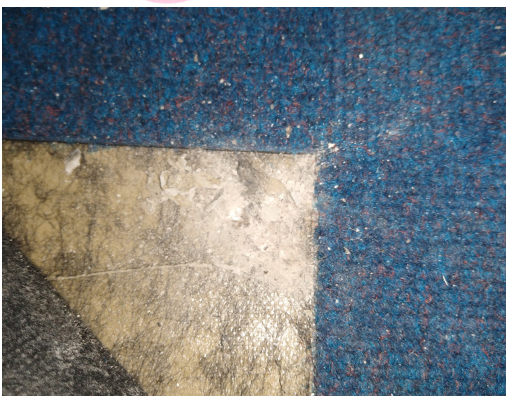
Item 135 Ref: As 405964-15

The remnant bitumen
adhesive below carpet
(4/007/dressing room 11 –
Block A) contains asbestos.

Any change in appearance
should be recorded and
passed to Property Services.

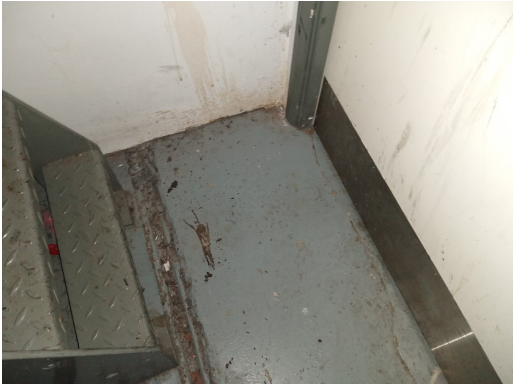
Item 136 Ref: As 405964-16

The bitumen adhesive to floor (4/008/stairs to operating gallery – Block A) contains asbestos.

Any change in appearance should be recorded and passed to Property Services.

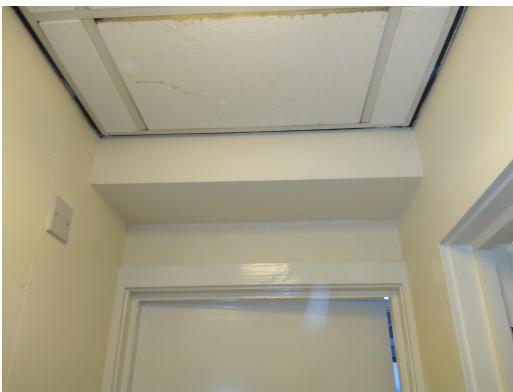
Item 138 Ref: As 405964-12

The boxing to beams below plasterboard (4/012/dressing room 10 – Block B) does not contain asbestos.

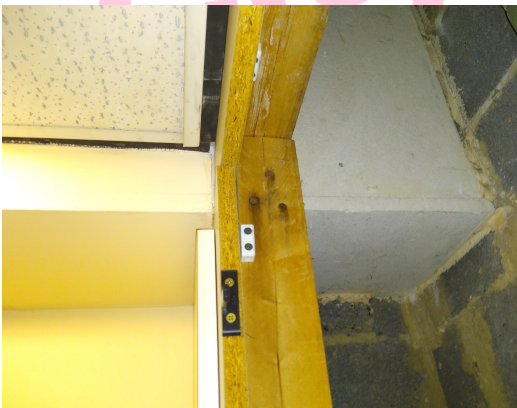
Item 141 Ref: As 405964-11

The boxing to beam below
plasterboard (4/012A/shower
room – Block B) does not
contain asbestos.

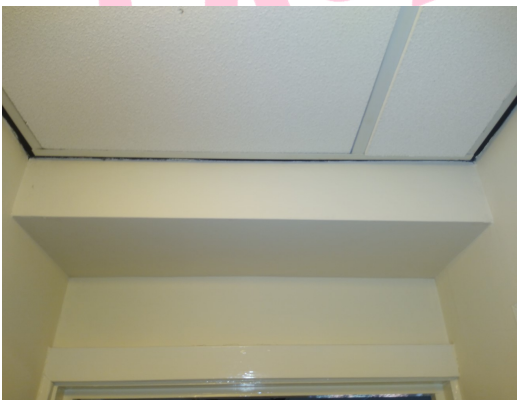
Item 147 Ref: As 405964-11

The boxing to beam below plasterboard (4/014/dressing room 8 – Block B) does not contain asbestos.

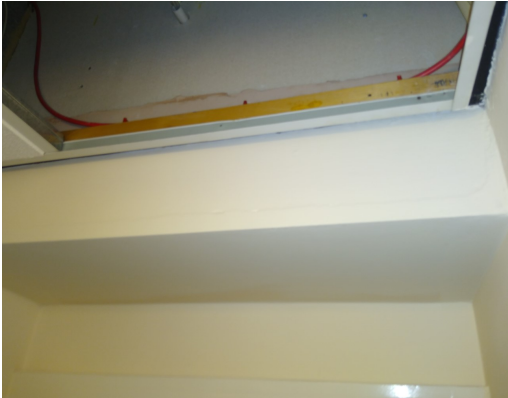
Item 151 Ref: As 405964-11

The boxing to beam below plasterboard (4/015/dressing room 7 – Block B) does not contain asbestos.

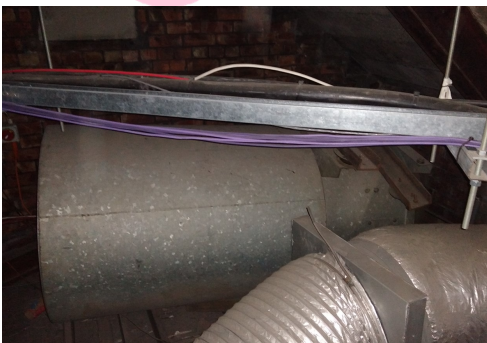
Item 171 Ref: As 405964-79

- (Item 170) Ref: 405964-79 – Ductwork flange gaskets northeast (4/023/upper circle – void above) – Low Risk
- (Item 171) Ref: As 405964-79 – Flange gaskets to loose lying ductwork southwest (4/023/upper circle – void above) – Low Risk

The flange gaskets to loose lying ductwork southwest (4/023/upper circle – void above) contain asbestos.

Any change in appearance should be recorded and passed to Property Services.

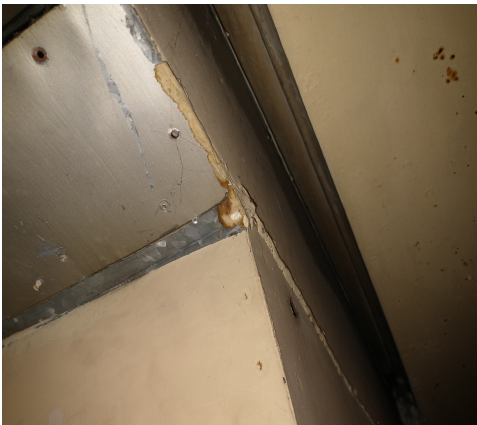
Item 179 Ref: 405964-82

The remnant mastic to old ductwork (4/024/old projectors room) does not contain asbestos.

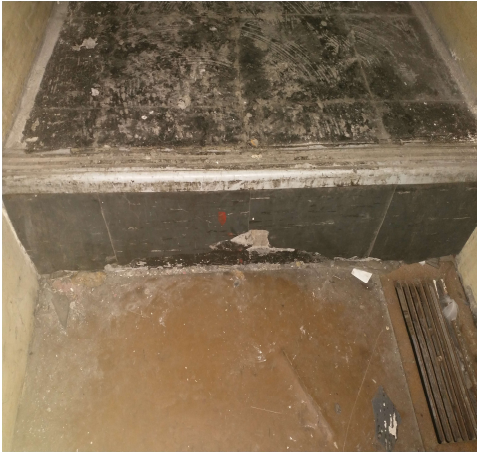
Item 181 Ref: 405964-72

The floor covering to upstand of step (4/024a/lobby) contains asbestos.

Any change in appearance should be recorded and passed to Property Services.

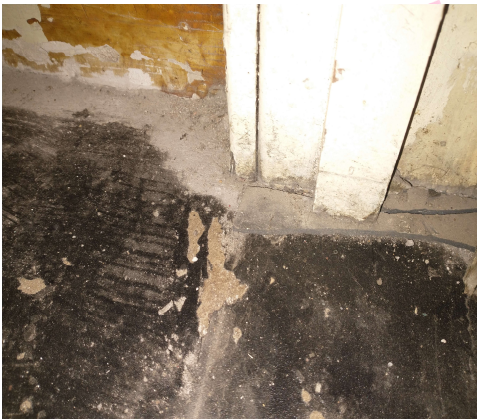
Item 182 Ref: 405964-73

The remnant floor tiles & adhesive backing to floor (4/024a/lobby) contains asbestos.

Any change in appearance should be recorded and passed to Property Services.

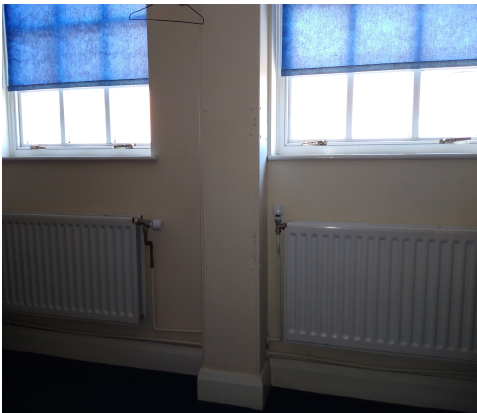
Item 189 Ref: As 405964-2

The boxing to pipework (5/09/dressing room 303) does not contain asbestos.

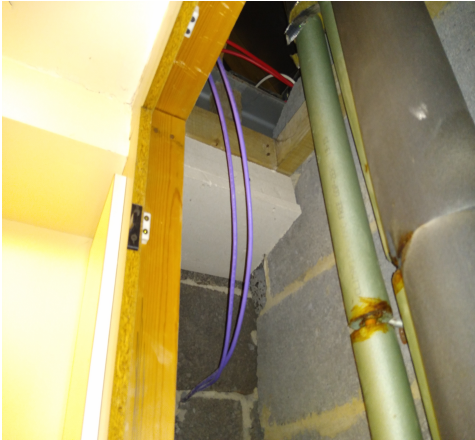
Item 190 Ref: 405964-3

The high level panel within void behind wood wall (5/09A/shower room 303) does not contain asbestos.

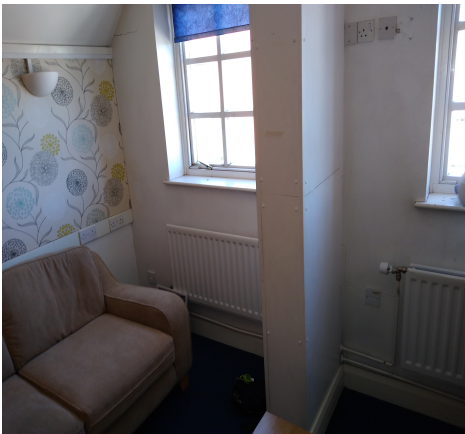
Item 191 Ref: 405964-2

The boxing to pipework (5/10/dressing room 304) does not contain asbestos.

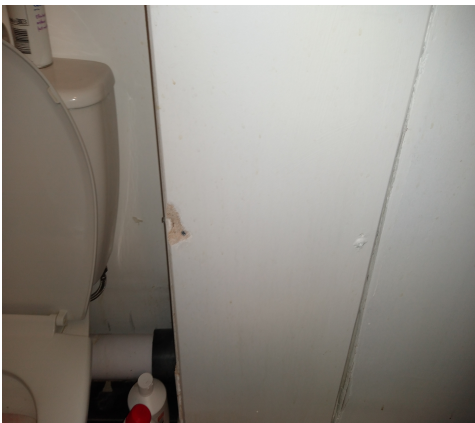
Item 192 Ref: As 405964-2

The boxing to pipework (5/010A/shower room 304) does not contain asbestos.

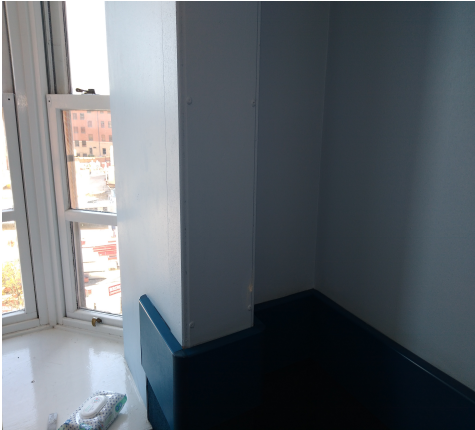
Item 193 Ref: 405964-1

The boxing to pipework (5/014/stairwell) does not contain asbestos.

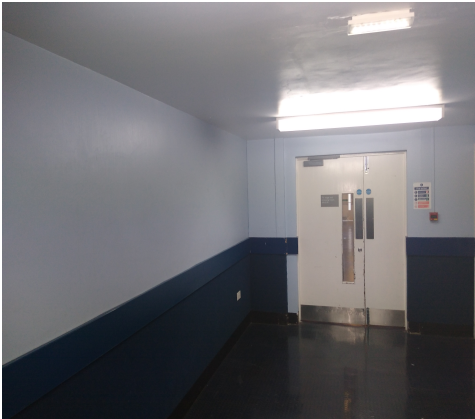
Item 194 Ref: 405964-5

The panels to boxing (5/018/corridor) does not contain asbestos.

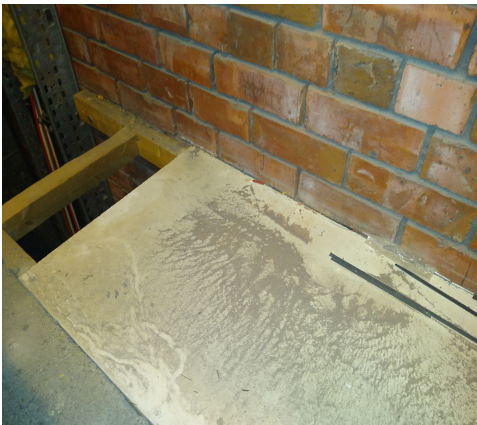
Item 198 Ref: 405964-8

The panel below wood walkway (6/04/loft void) does not contain asbestos.

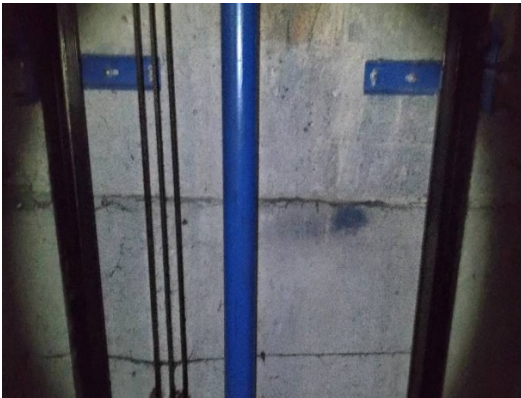
Item 204 Ref: DC003636

The damp proof course in the Lift Pitt (G/001) does not contain asbestos.

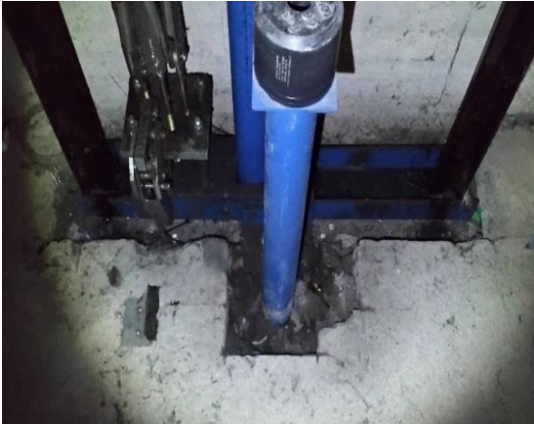
Item 205 Ref: DC003637

The debris/residue in the Lift Pitt (G/001) does not contain asbestos.
