ASBESTOS SURVEY REPORT FOR MARGARET THOMPSON PARK,
NEWCASTLE ROAD, SUNDERLAND, SR5 1LG.

**Margaret Thompson Park, Newcastle Road,
Sunderland, SR5 1LG**

Date: 30 April 2025

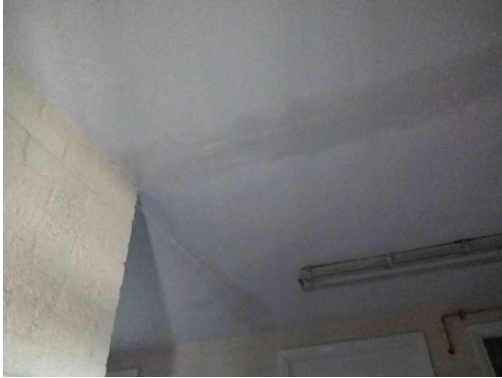
Item 4 Ref: KX000703/040

The ceiling – coating – to seams between slabs in the corridor (Football Pavilion – G/001) does not contain asbestos.

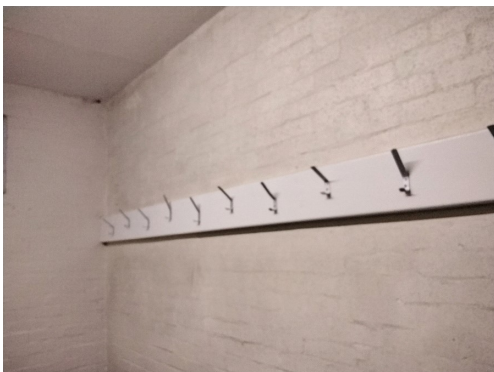
Item 9 Ref: As KX000440

The wall – coating in the changing room (Football Pavilion – G/003) does not contain asbestos.

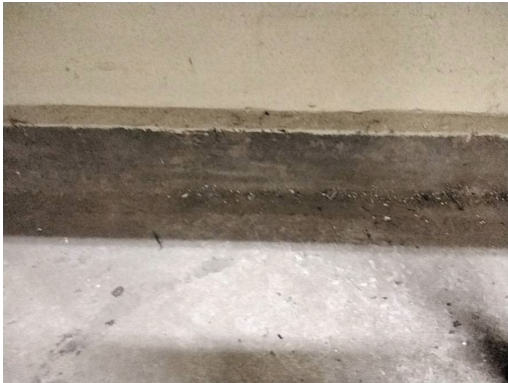
Item 10 Ref: As KX000441

The debris/residue – paint coating from deteriorating walls to floor in the changing room (Football Pavilion – G/003) does not contain asbestos.

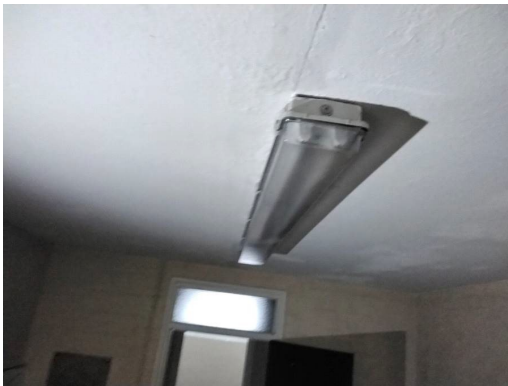
Item 11 Ref: KX000704/041

The ceiling – coating – to seams between slabs in the changing room (Football Pavilion – G/003) does not contain asbestos.

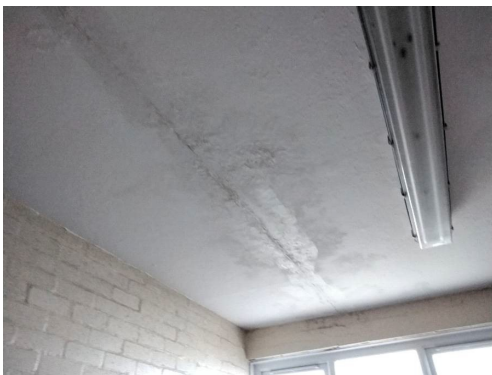
Item 12 Ref: As KX000439

The ceiling – coating in the changing room (Football Pavilion – G/004) does not contain asbestos.

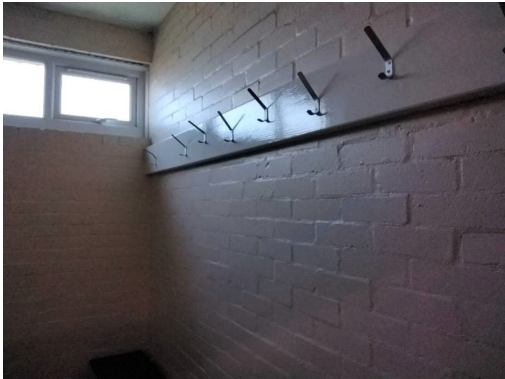
Item 16 Ref: KX000443/014

The wall – coating in the changing room (Football Pavilion – G/005) does not contain asbestos.

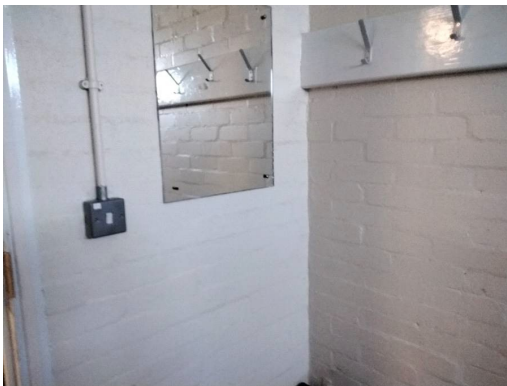
Item 23 Ref: As KX000443

The wall – coating in the changing room (Football Pavilion – G/007) does not contain asbestos.

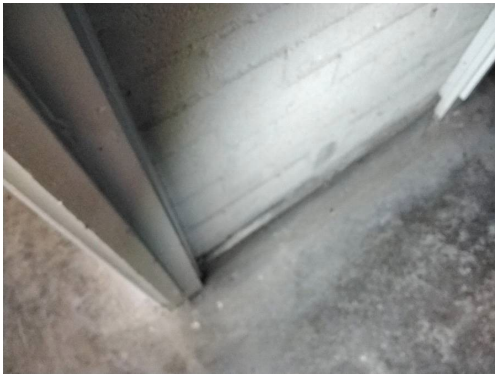
Item 29 Ref: KX000448/026

The debris/residue – from deteriorating walls in the toilets including passage (Football Pavilion – G/008) does not contain asbestos.

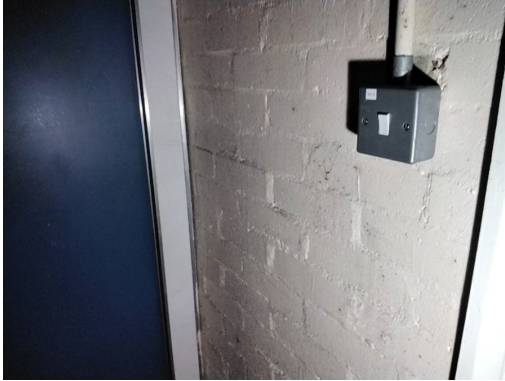
Item 31 Ref: As KX000447

The wall – coating in the toilets (Football Pavilion – G/009) does not contain asbestos.

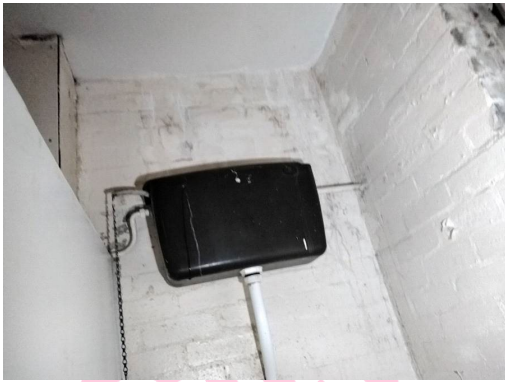
Item 32 Ref: KX000449/029

The toilet cisterns in the toilets (Football Pavilion – G/009) does not contain asbestos.

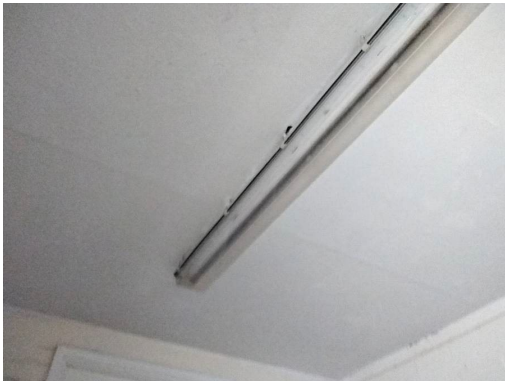
Item 33 Ref: As KX000445

The ceiling – coating in the changing room (Football Pavilion – G/010) does not contain asbestos.

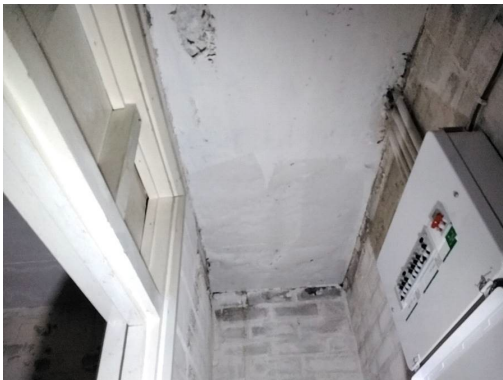
Item 36 Ref: KX000450/033

The ceiling – coating in the electrical cupboard (Football Pavilion – G/011) does not contain asbestos.

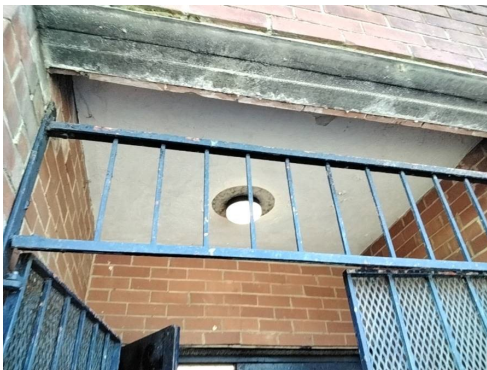
Item 39 Ref: As KX000439

The ceiling – coating (External) (Football Pavilion – E/001) does not contain asbestos.

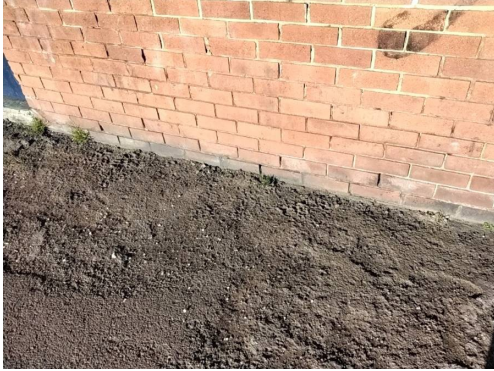
**Item 40 Ref:
KX000452/038**

The damp proof course (External) (Football Pavilion – E/001) does not contain asbestos.

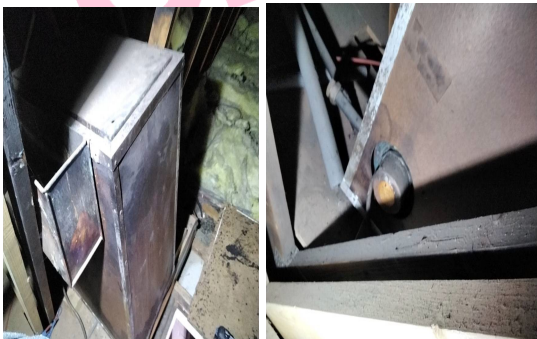
Item 42 Ref: Presumed

| 42. | Presumed | Tank – to heating coils | Guard House, Loft Space, R/001 | Very Low Risk |

The Tank – heating coils in Loft Space (Guard House – R/001) is presumed to contain asbestos.

Any change in its appearance should be recorded and passed to Property Services.

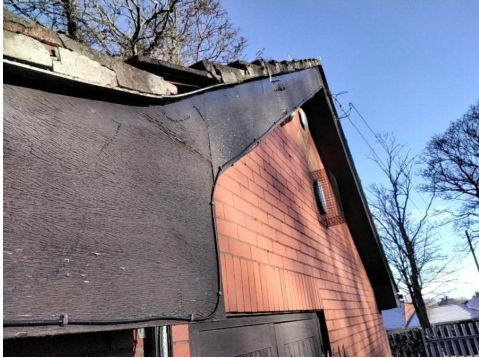
**Item 43 Ref:
KX000453/043**

The undercloak (External) (Guard House – E/001) does not contain asbestos.

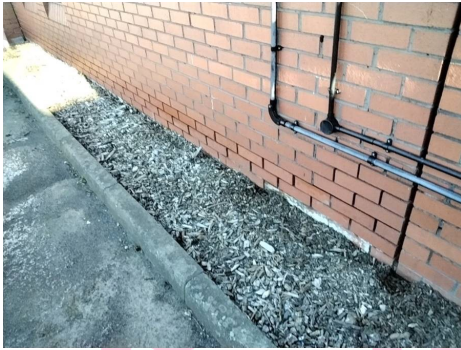
**Item 44 Ref:
KX000454/044**

The damp proof course (External) (Guard House – E/001) does not contain asbestos.

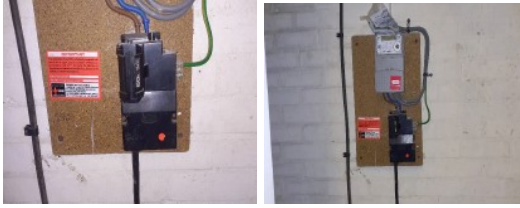
Item 49 Ref: Presumed

| 49. | Presumed | Flash Guards | Electric Cupboard G/03 | Low Risk |

The flash guards in the electric cupboard (G/03) are presumed contain asbestos.

Any change in its appearance should be recorded and passed to Property Services.

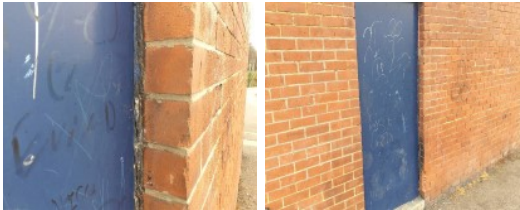
Item 50 Ref: PK001198

| 50. | PK001198 | Mastic Residue – Brick work around fire exit door | External E/01 | Very Low Risk |

The mastic residue to brick work around fire exit door (External) contains asbestos.

Any change in its appearance should be recorded and passed to Property Services.
