ASBESTOS SURVEY REPORT FOR MARGARET THOMPSON PARK,
NEWCASTLE ROAD, SUNDERLAND, SR5 1LG.

**Margaret Thompson Park, Newcastle Road,
Sunderland, SR5 1LG**

UPRN: - J152627

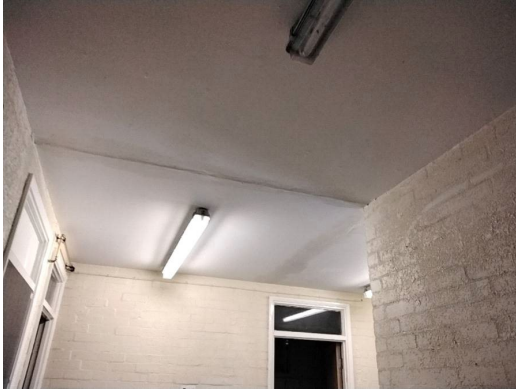
Item 1 Ref: KX000439/001

The ceiling – coating in the corridor (Football Pavilion – G/001) does not contain asbestos.

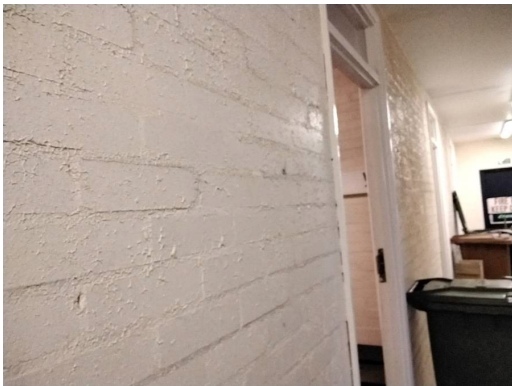
Item 2 Ref: KX000440/002

The wall – coating in the corridor (Football Pavilion – G/001) does not contain asbestos.

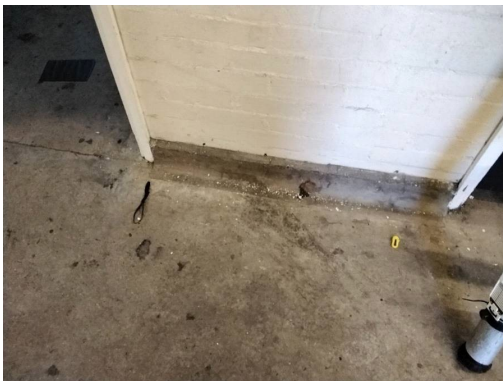
Item 3 Ref: KX000441/003

The debris/residue – paint coating from deteriorating walls to floor in the corridor (Football Pavilion – G/001) does not contain asbestos.

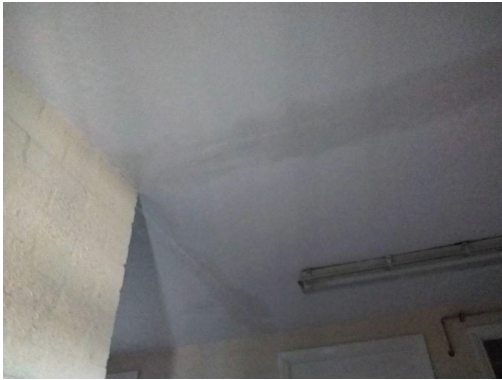
Item 4 Ref: KX000703/040

The ceiling – coating – to seams between slabs in the corridor (Football Pavilion – G/001) does not contain asbestos.

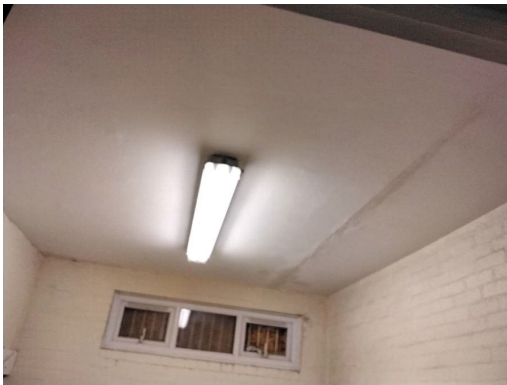
Item 5 Ref: As KX000439

The ceiling – coating in the changing room (Football Pavilion – G/002) does not contain asbestos.

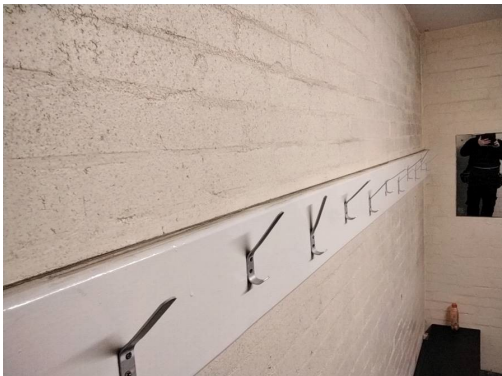
Item 6 Ref: As KX000440

The wall – coating in the changing room (Football Pavilion – G/002) does not contain asbestos.

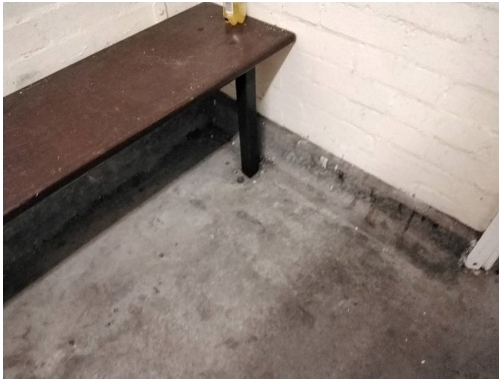
Item 7 Ref: As KX000441

The debris/residue – paint coating from deteriorating walls to floor in the changing room (Football Pavilion – G/002) does not contain asbestos.

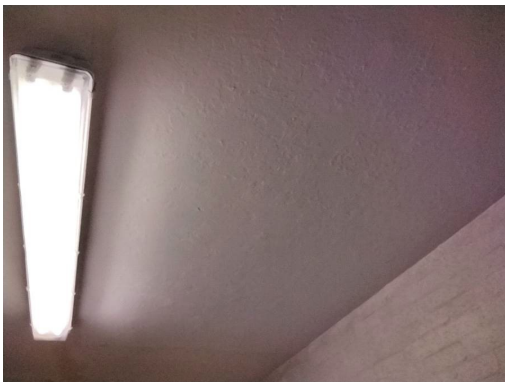
Item 8 Ref: As KX000439

The ceiling – coating in the changing room (Football Pavilion – G/003) does not contain asbestos.

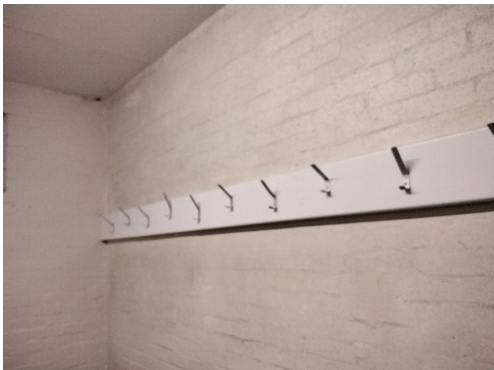
Item 9 Ref: As KX000440

The wall – coating in the changing room (Football Pavilion – G/003) does not contain asbestos.

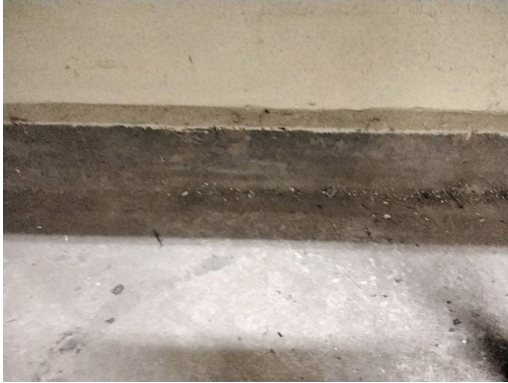
Item 10 Ref: As KX000441

The debris/residue – paint coating from deteriorating walls to floor in the changing room (Football Pavilion – G/003) does not contain asbestos.

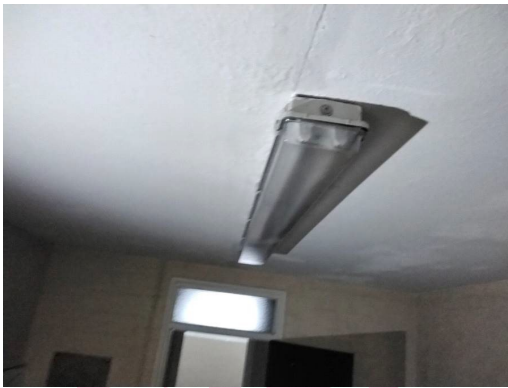
Item 11 Ref: KX000704/041

The ceiling – coating – to seams between slabs in the changing room (Football Pavilion – G/003) does not contain asbestos.

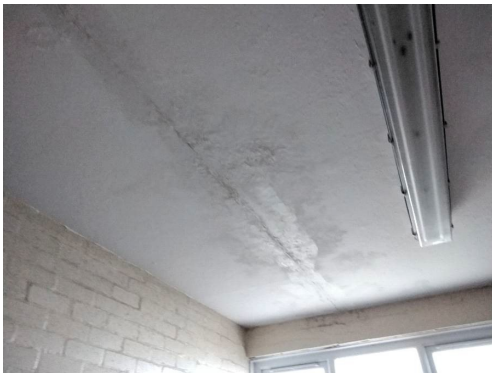
Item 12 Ref: As KX000439

The ceiling – coating in the changing room (Football Pavilion – G/004) does not contain asbestos.

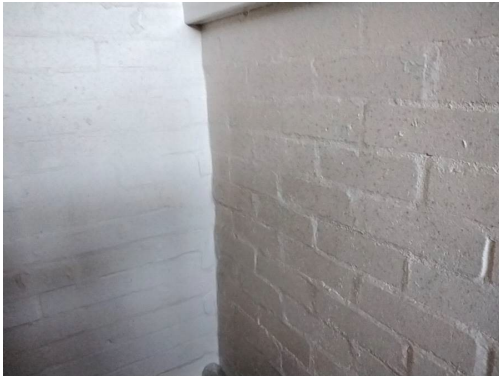
Item 13 Ref: As KX000440

The wall – coating in the changing room (Football Pavilion – G/004) does not contain asbestos.

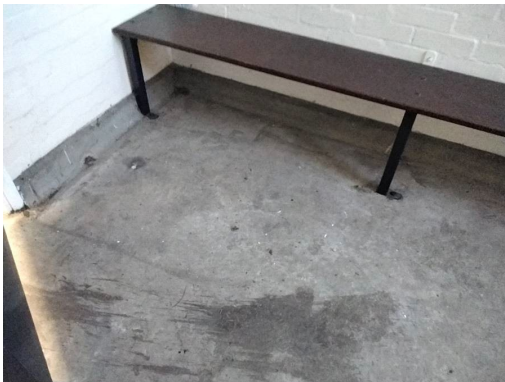
Item 14 Ref: As KX000441

The debris/residue – paint coating from deteriorating walls to floor in the changing room (Football Pavilion – G/004) does not contain asbestos.

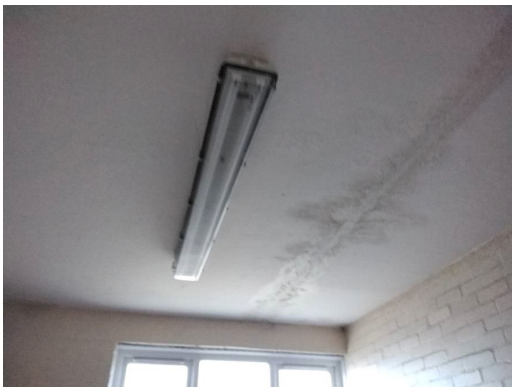
Item 15 Ref: KX000442/013

The ceiling – coating in the changing room (Football Pavilion – G/005) does not contain asbestos.

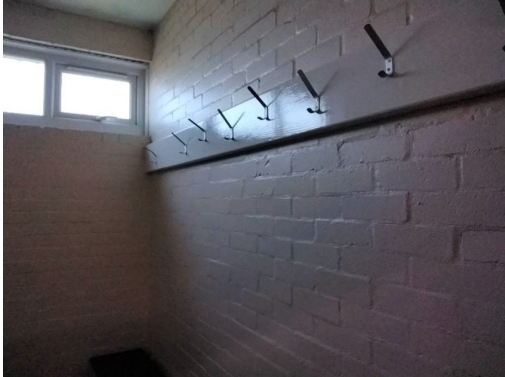
Item 16 Ref: KX000443/014

The wall – coating in the changing room (Football Pavilion – G/005) does not contain asbestos.

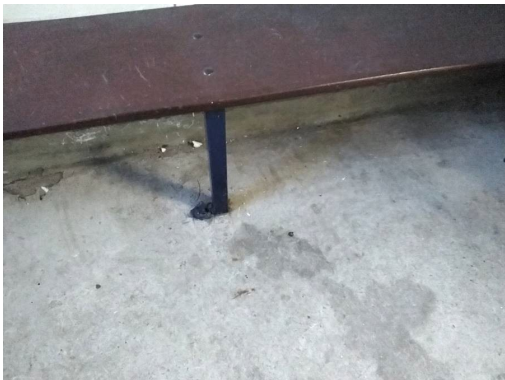
Item 17 Ref: KX000444/015

The debris/residue – paint coating from deteriorating walls to floor in the changing room (Football Pavilion – G/005) does not contain asbestos.

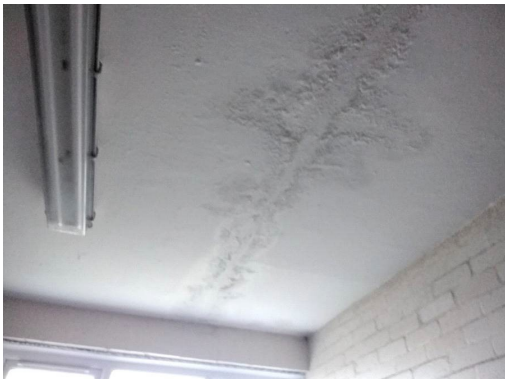
Item 18 Ref: KX000705/042

The ceiling – coating – to seams between slabs in the changing room (Football Pavilion – G/005) does not contain asbestos.

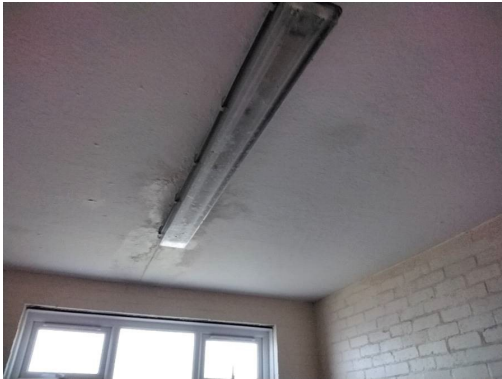
Item 19 Ref: As KX000442

The ceiling – coating in the changing room (Football Pavilion – G/006) does not contain asbestos.

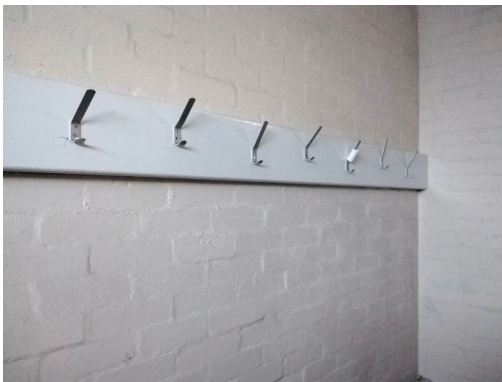
Item 20 Ref: As KX000443

The wall – coating in the changing room (Football Pavilion – G/006) does not contain asbestos.

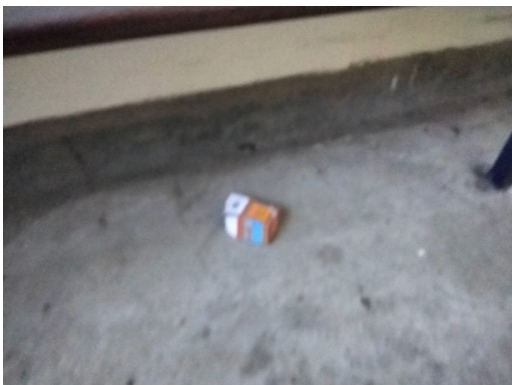
Item 21 Ref: As KX000444

The debris/residue – paint coating from deteriorating walls to floor in the changing room (Football Pavilion – G/006) does not contain asbestos.

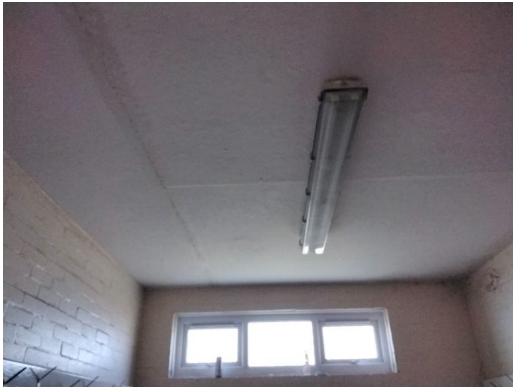
Item 22 Ref: As KX000442

The ceiling – coating in the changing room (Football Pavilion – G/007) does not contain asbestos.

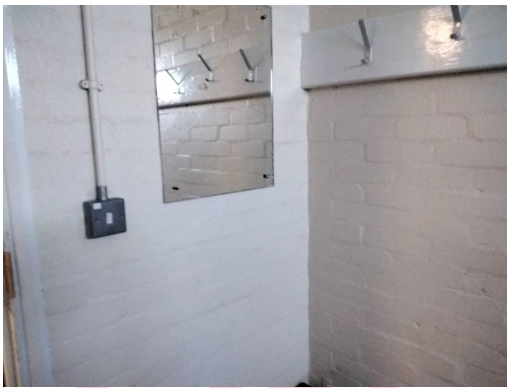
Item 23 Ref: As KX000443

The wall – coating in the changing room (Football Pavilion – G/007) does not contain asbestos.

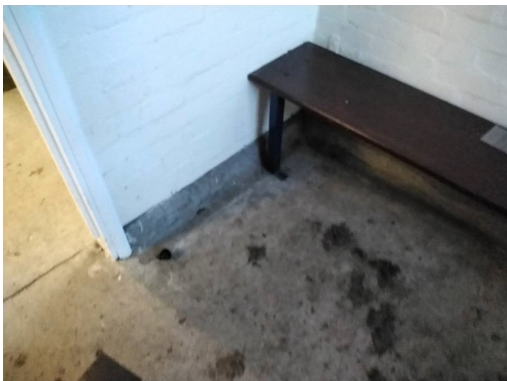
Item 24 Ref: As KX000444

The debris/residue – paint coating from deteriorating walls to floor in the changing room (Football Pavilion – G/007) does not contain asbestos.

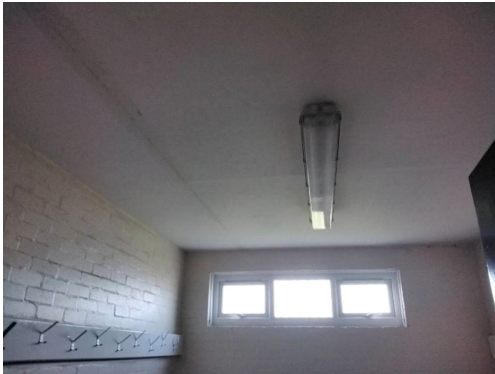
Item 25 Ref: KX000706/044

The ceiling – coating – to seams between slabs in the changing room (Football Pavilion – G/007) does not contain asbestos.

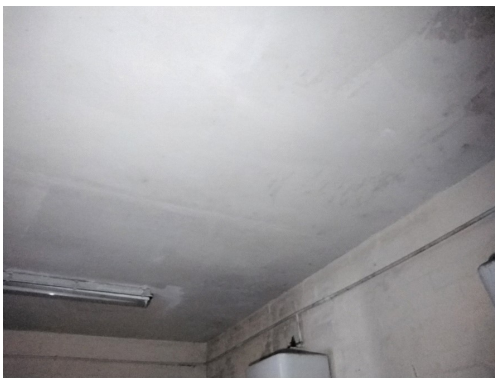
Item 26 Ref: KX000445/022

The ceiling – coating in the toilets including passage (Football Pavilion – G/008) does not contain asbestos.

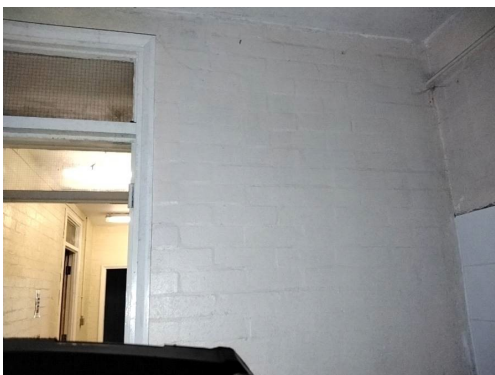
Item 27 Ref: KX000447/023

The wall – coating in the toilets including passage (Football Pavilion – G/008) does not contain asbestos.

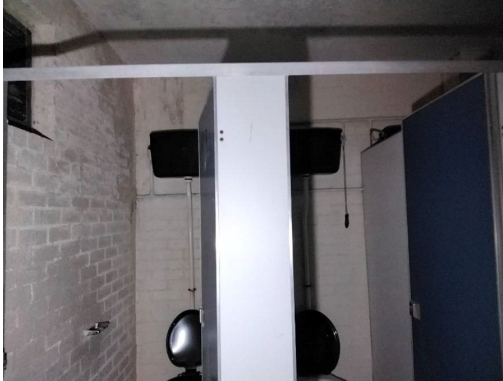
Item 28 Ref: KX000446/025

The toilet cisterns in the toilets including passage (Football Pavilion – G/008) does not contain asbestos.

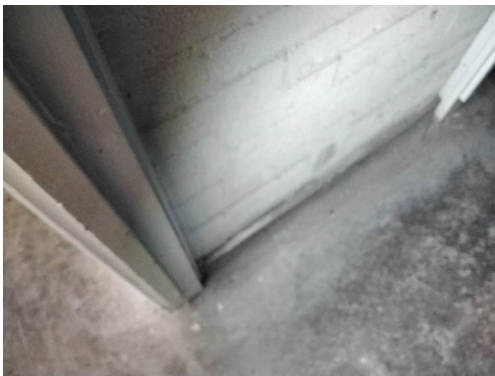
Item 29 Ref: KX000448/026

The debris/residue – from deteriorating walls in the toilets including passage (Football Pavilion – G/008) does not contain asbestos.

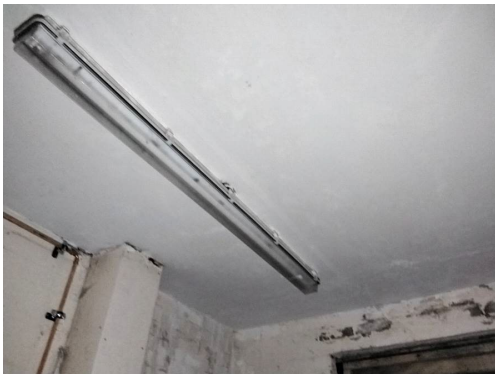
Item 30 Ref: As KX000445

The ceiling – coating in the toilets (Football Pavilion – G/009) does not contain asbestos.

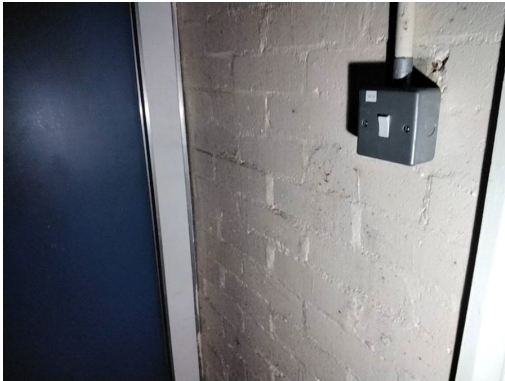
Item 31 Ref: As KX000447

The wall – coating in the toilets (Football Pavilion – G/009) does not contain asbestos.

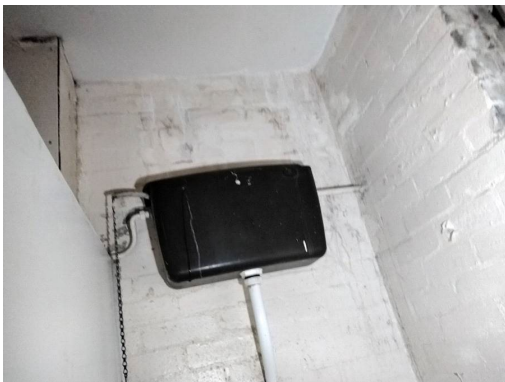
Item 32 Ref: KX000449/029

The toilet cisterns in the toilets (Football Pavilion – G/009) does not contain asbestos.

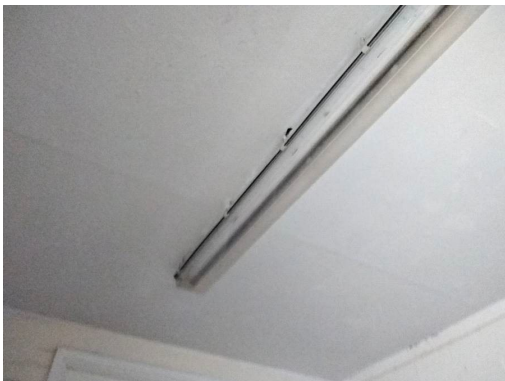
Item 33 Ref: As KX000445

The ceiling – coating in the changing room (Football Pavilion – G/010) does not contain asbestos.

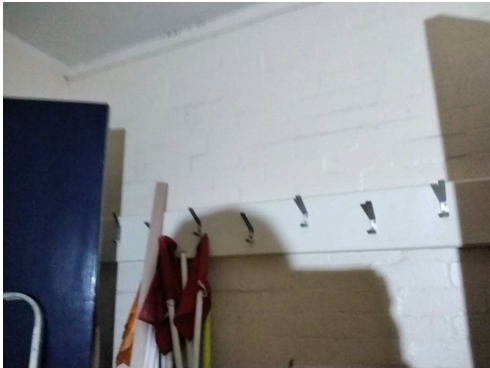
Item 34 Ref: As KX000447

The wall – coating in the changing room (Football Pavilion – G/010) does not contain asbestos.

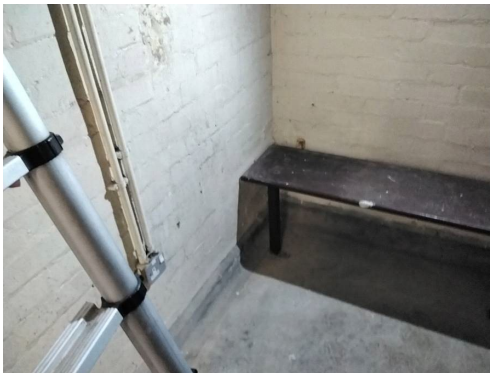
Item 35 Ref: As KX000448

The debris/residue – paint coating from deteriorating walls to floor in the changing room (Football Pavilion – G/010) does not contain asbestos.

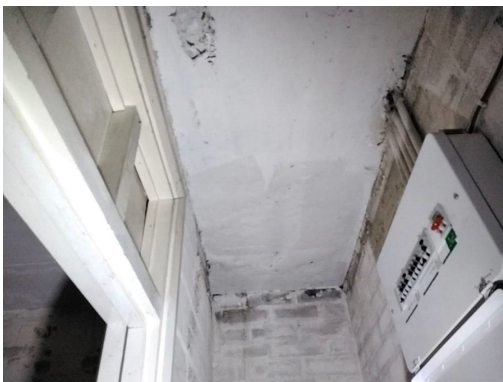
Item 36 Ref: KX000450/033

The ceiling – coating in the electrical cupboard (Football Pavilion – G/011) does not contain asbestos.

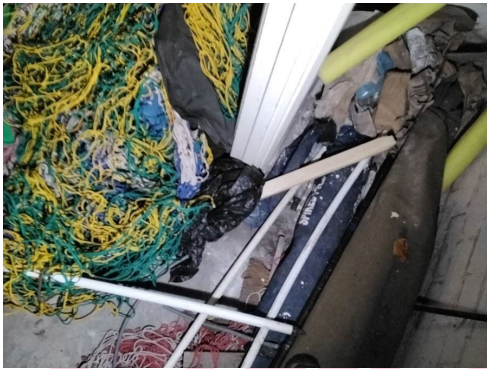
Item 38 Ref: KX000451/035

The debris – to floor from ceiling in the electrical cupboard (Football Pavilion – G/011) does not contain asbestos.

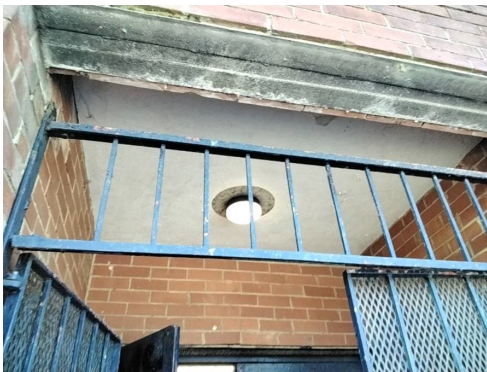
Item 39 Ref: As KX000439

The ceiling – coating (External) (Football Pavilion – E/001) does not contain asbestos.

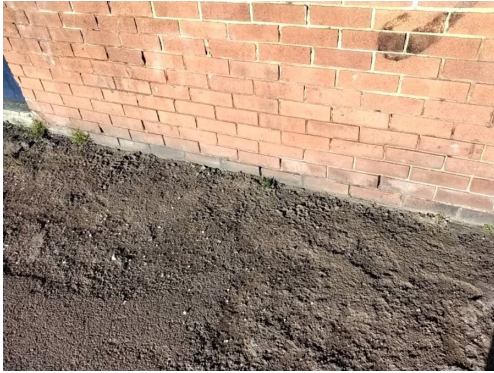
**Item 40 Ref:
KX000452/038**

The damp proof course (External) (Football Pavilion – E/001) does not contain asbestos.

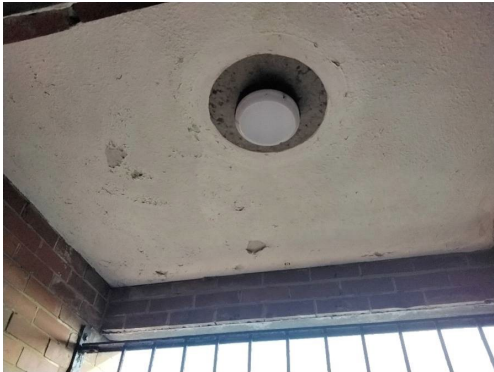
**Item 41 Ref:
KX000702/039**

The ceiling – coating to canopy (External) (Football Pavilion – E/001) does not contain asbestos.

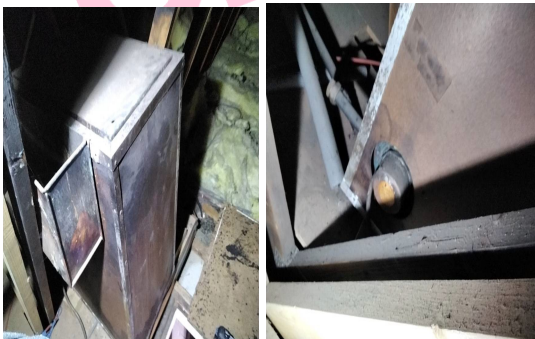
Item 42 Ref: Presumed

42.	Presumed	Tank – to heating coils	Guard House, Loft Space, R/001	Very Low Risk
43.	KX000453	Undercloak	Guard House, External E/001	No Risk
44.	KX000454	Damp Proof Course	Guard House, External E/001	No Risk

The Tank – heating coils in Loft Space (Guard House – R/001) is presumed to contain asbestos.

Any change in its appearance should be recorded and passed to Property Services.

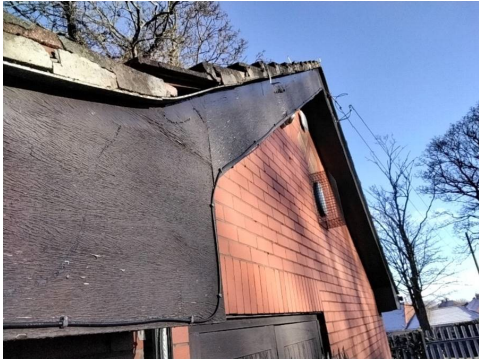
**Item 43 Ref:
KX000453/043**

The undercloak (External) (Guard House – E/001) does not contain asbestos.

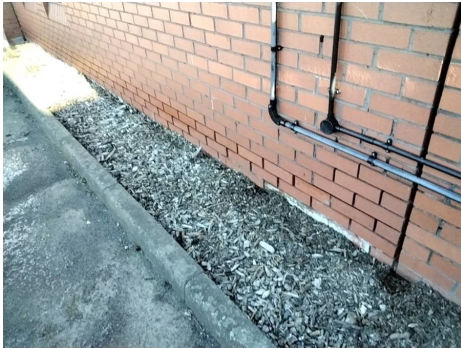
**Item 44 Ref:
KX000454/044**

The damp proof course (External) (Guard House – E/001) does not contain asbestos.

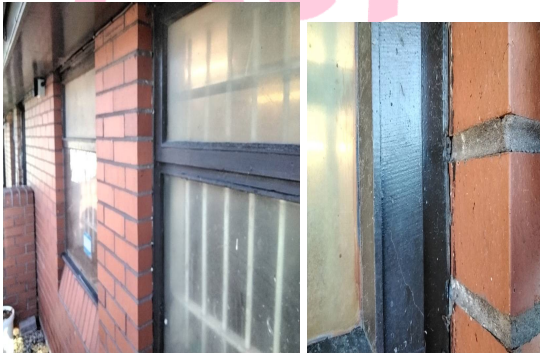
**Item 45 Ref:
KX000455/045**

45.	KX000455	Window Putty/seal frames to wall	Guard House, External E/001	Very Low Risk
46.	KX000482	Toilets – Cisterns	Bowls Pavillion, Ground Floor, Male Toilets G/005	No Risk

The window putty/seal – frames to wall (External) (Guard House – E/001) contains asbestos.

Any change in its appearance should be recorded and passed to Property Services.

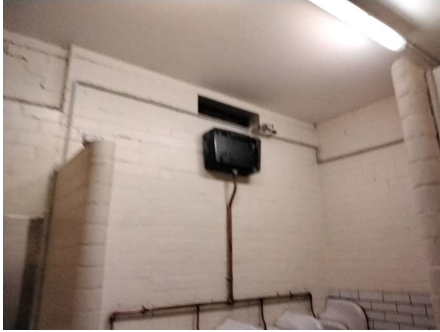
Item 46 Ref: KX000482/002

The toilet cistern – shires in the Male Toilets (Bowls Pavilion – G/005) does not contain asbestos.

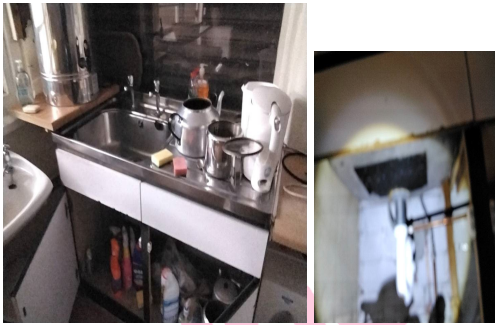
Item 47 Ref: KX000483/003

47.	KX000483	Under sink mat	Bowls Pavillion, Dining Hall Area, G/006	Very Low Risk
48.	KX000484	Damp Proof Course	Bowls Pavillion, External, E/001	No Risk

The under sink mat in the dining hall area (Bowls Pavilion – G/006) contains asbestos.

Any change in its appearance should be recorded and passed to Property Services.

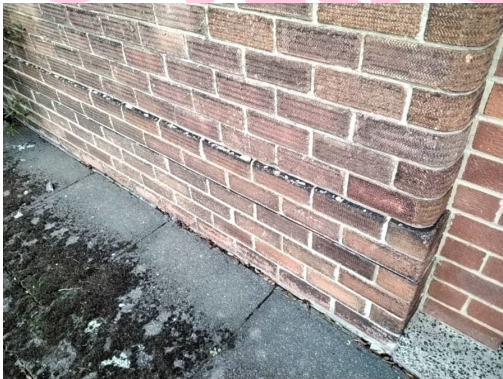
Item 48 Ref: KX000484/004

The damp proof course (External) (Bowls Pavillion – E/001) does not contain asbestos.

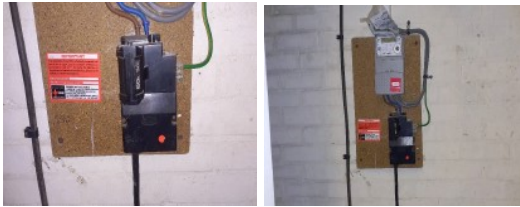
Item 49 Ref: Presumed

The flash guards in the electric cupboard (G/03) are presumed contain asbestos.

Any change in its appearance should be recorded and passed to Property Services.

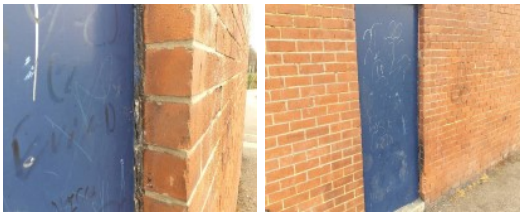
Item 50 Ref: PK001198

The mastic residue to brick work around fire exit door (External) contains asbestos.

Any change in its appearance should be recorded and passed to Property Services.

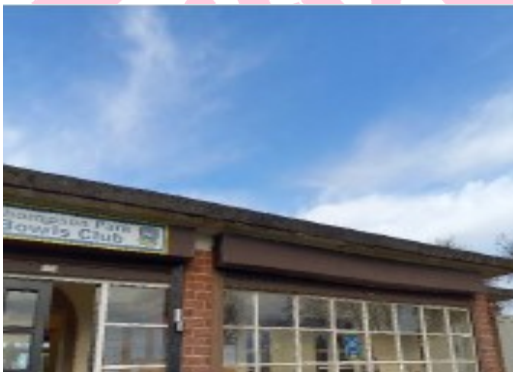
Item 51 Ref: PK003867

The roof felt (External) does not contain asbestos.

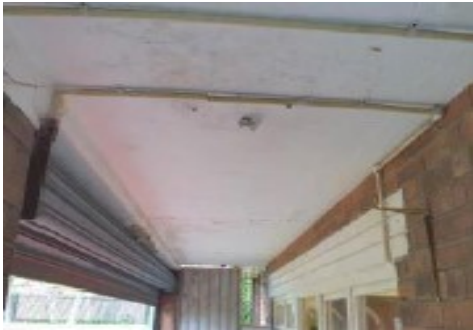
Item 52 Ref: Presumed

52.	BS067955	Concrete roof deck – Roof soffits	External E/01	No Risk

The concrete roof deck (Roof/soffits) (External) does not contain asbestos.
