ASBESTOS SURVEY REPORT FOR LEECHMERE TRAINING CENTRE (INCLUDING TELECARE HOUSE), SUNDERLAND

Asbestos Register for LEECHMERE CENTRE, SUNDERLAND

Premises Manager / Samo: - Tenant Date: 16 January 2025

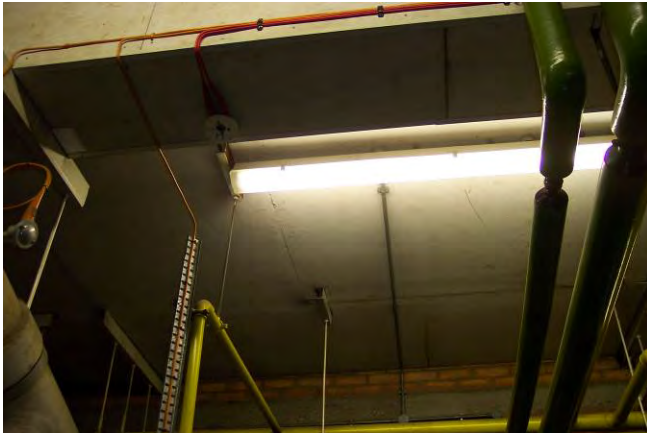
Item 1 Ref: DJC04/1426

The ceiling boards in the Boiler Room contain asbestos.

Removed Oct 2020

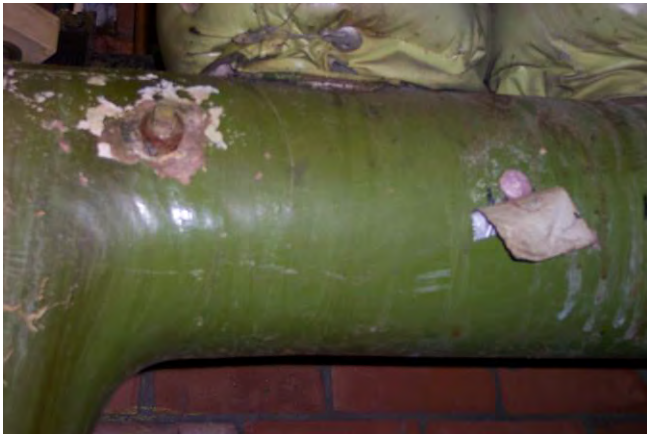
Item 2 - Ref: DJC04/1427

The pipe lagging in the boiler room does not contain asbestos.

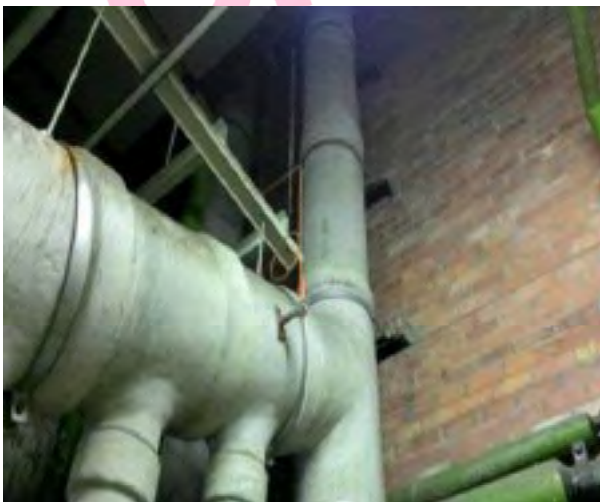
Item 3 - Ref: DJC04/1428

The Boiler flues in the Boiler Room contain asbestos.

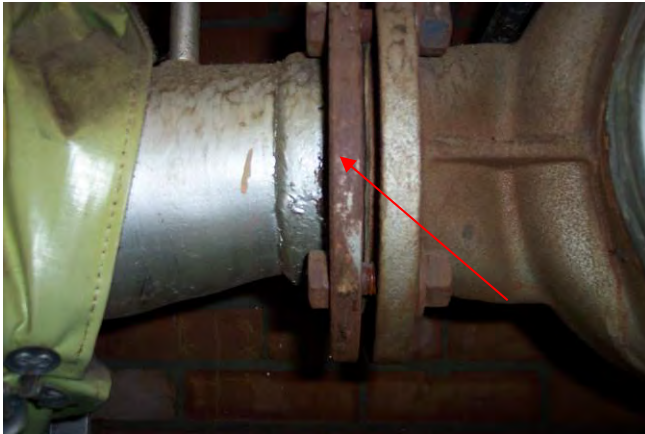
Item 4 - Ref: DJC04/1429

The gaskets in the pipework in the Boiler Room contain asbestos.

Removed Oct 2020

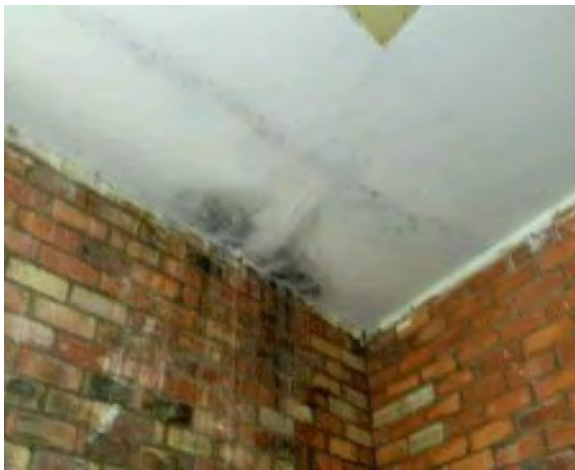
Item 5 - Ref: CB000912

The textured coating to the ceiling in the Stores external cupboard contains asbestos.

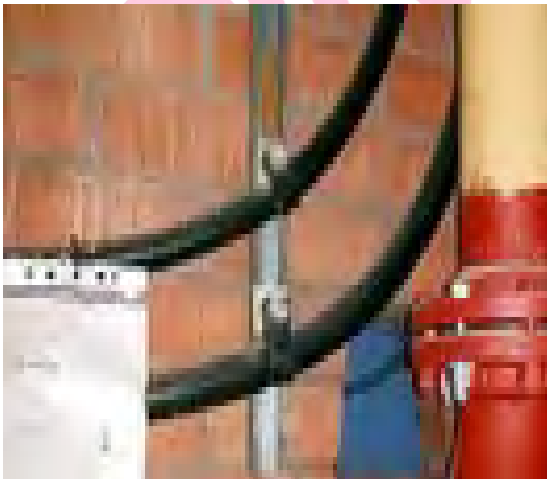
Item 32 - Ref: KG001006

The flange gasket to gas pipe the electricians intake room – void above (Rm 0/062) does not contain asbestos.

Sampled Jan 2026 and found to be non-asbestos containing (J142852) (previously presumed)

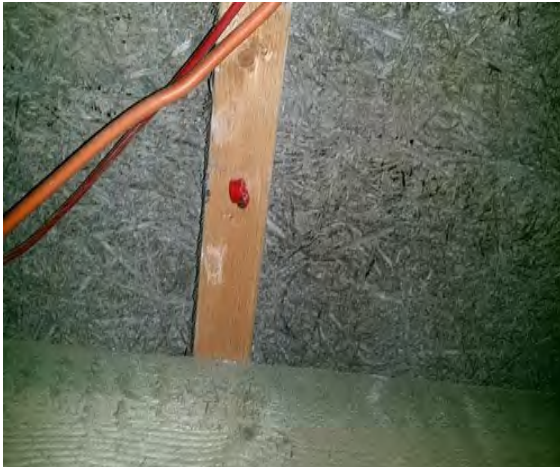
Item 33 - Ref: As 70826-1

The underside of roof in ILC reception office ceiling void (Rm 0/066) does not contain asbestos.

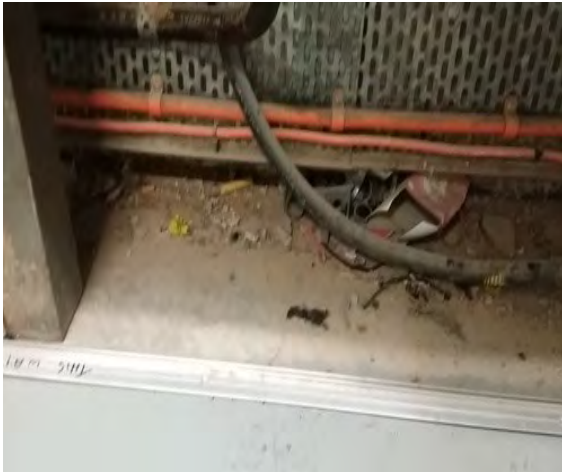
Item 36 - Ref: 70826-4

The debris to floor below electric in sub main electric intake room (Rm 0/067) contains asbestos.

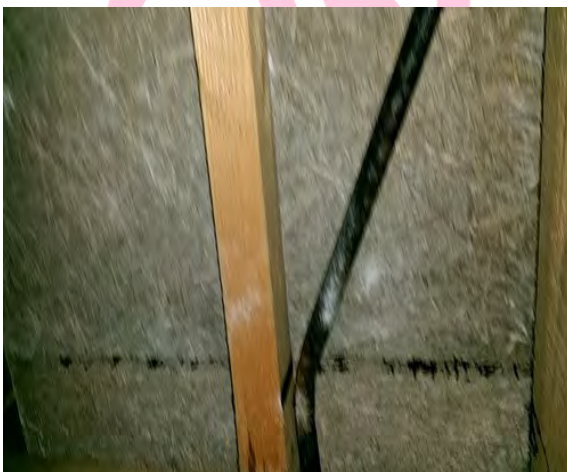
Item 38 - Ref: As 70826-1

The underside of roof in ILC reception area ceiling void (Rm 0/068) does not contain asbestos.

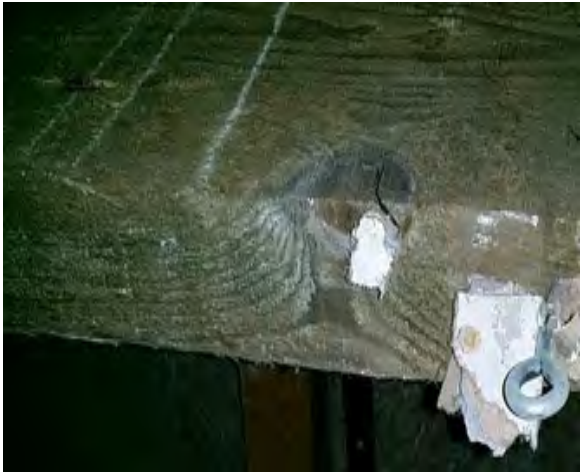
Item 39 - Ref: As 70826-3

The debris to nails in wood beams in ILC reception area ceiling void (Rm 0/068) contains asbestos.

Removed November 2019

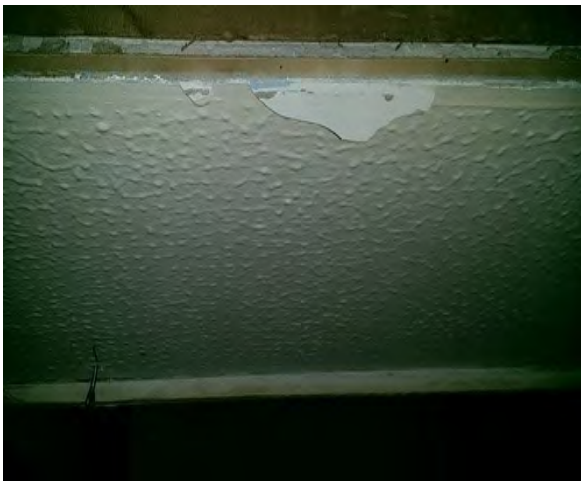
Item 40 - Ref: As 70826-2

The textured coating to former plasterboard ceiling in ILC reception area ceiling void (Rm 0/068) contains asbestos.

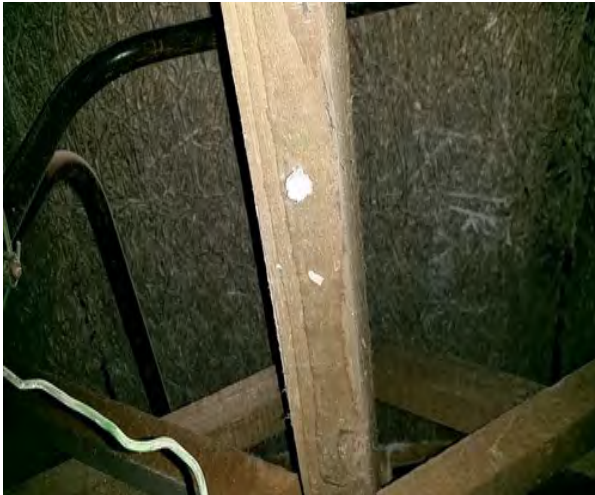
Item 42 - Ref: As 70826-3

The debris to nails in wood beams in Female Toilets & Lobby ceiling void (Rm 0/070) contains asbestos.

Any change in its appearance should be recorded and passed to Property Services.

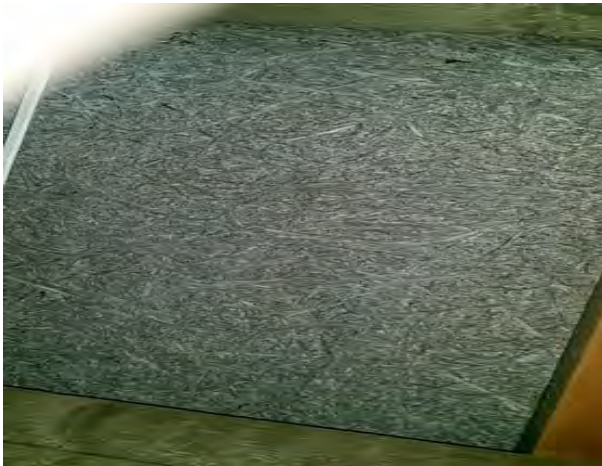
Item 43 - Ref: As 70826-1

The underside of roof in Male Toilets & Lobby ceiling void (Rm 0/071) does not contain asbestos.

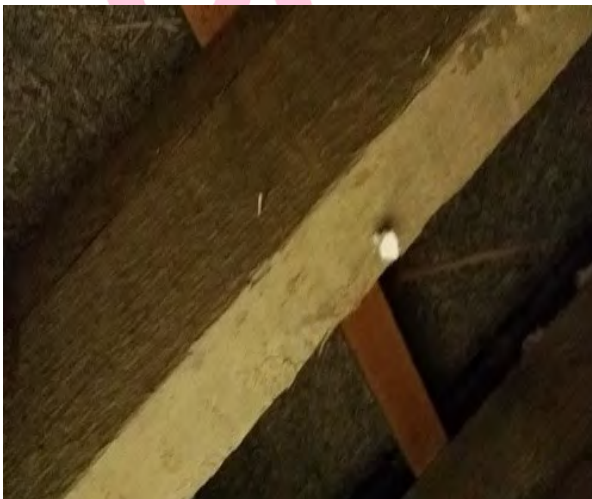
Item 44 - Ref: As 70826-3

The debris to nails in wood beams in Male Toilets & Lobby ceiling void (Rm 0/071) contains asbestos.

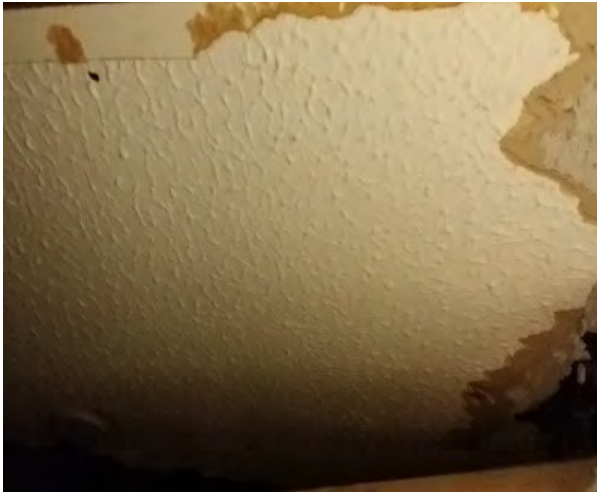
Item 45 - Ref: As 70826-2

The textured coating to former plasterboard ceiling in Male Toilets & Lobby ceiling void (Rm 0/071) contains asbestos.

Removed 21 January 2022

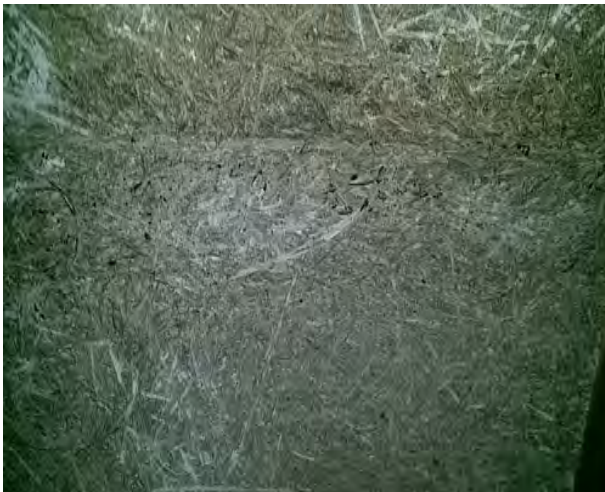
Item 46 - Ref: As 70826-1

The underside of roof in Disabled Bathroom ceiling void (Rm 0/072) does not contain asbestos.

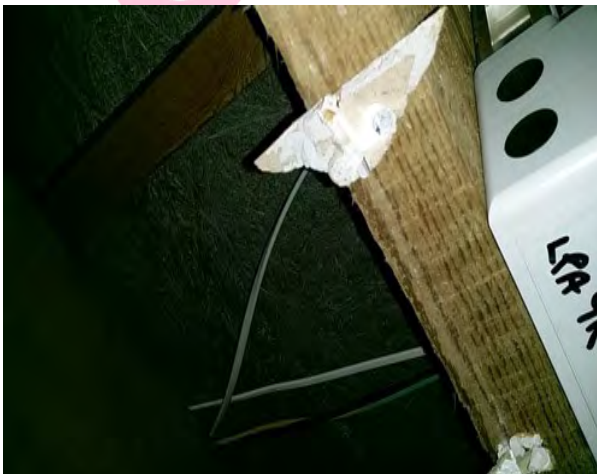
Item 47 - Ref: As 70826-3

The debris to nails in wood beams in Disabled Bathroom ceiling void (Rm 0/072) contains asbestos.

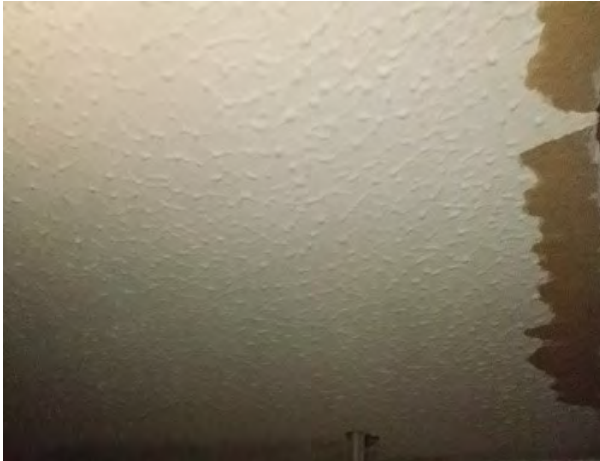
Item 48 - Ref: As 70826-2

The textured coating to former plasterboard ceiling in Disabled Bathroom ceiling void (Rm 0/072) contains asbestos.

Any change in its appearance should be recorded and passed to Property Services.

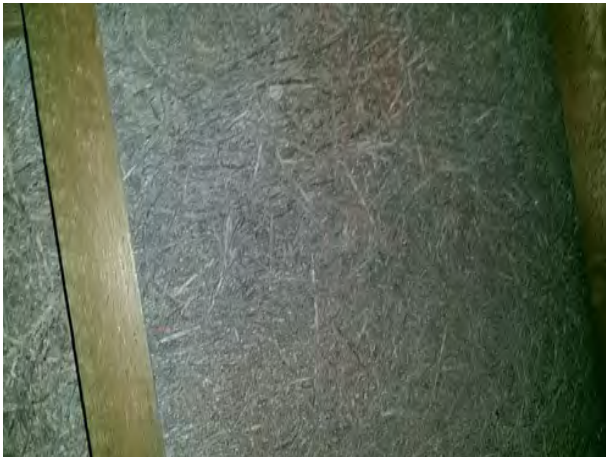
Item 49 - Ref: As 70826-1

The underside of roof in Duty Office ceiling void (Rm 0/073) does not contain asbestos.

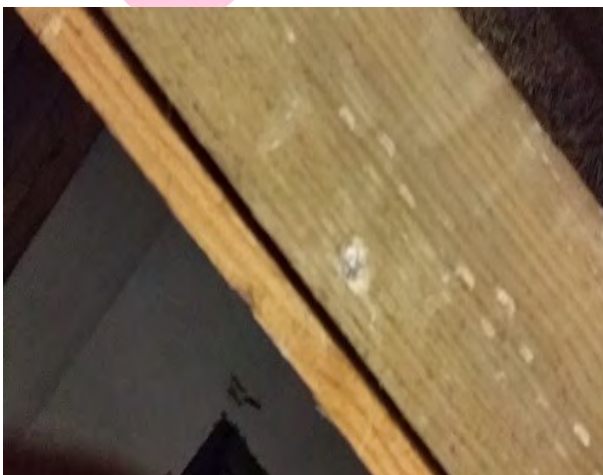
Item 50 - Ref: As 70826-3

The debris to nails in wood beams in Duty Office ceiling void (Rm 0/073) contains asbestos.

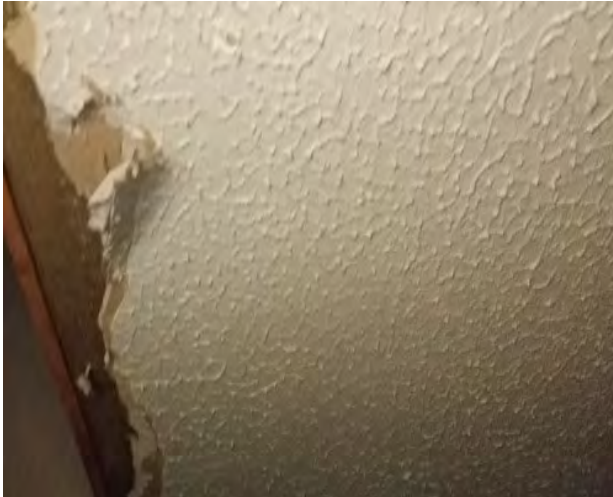
Item 51 - Ref: As 70826-2

The textured coating to former plasterboard ceiling in Duty Office ceiling void (Rm 0/073) contains asbestos.

Any change in its appearance should be recorded and passed to Property Services.

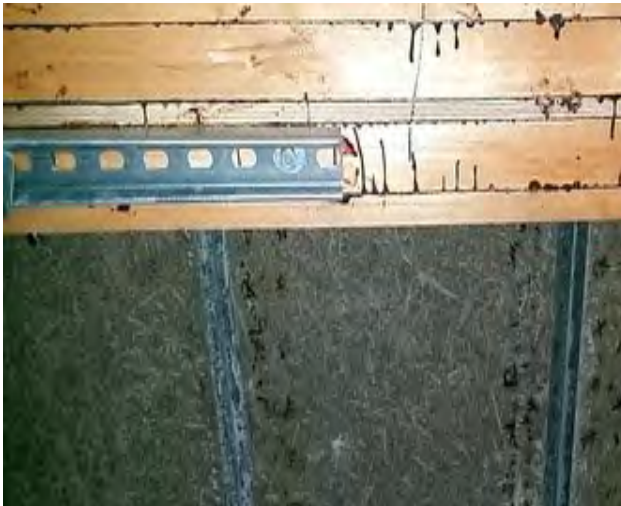
Item 52 - Ref: As 70826-1

The underside of roof in Care and Support Office ceiling void (Rm 0/074) does not contain asbestos.

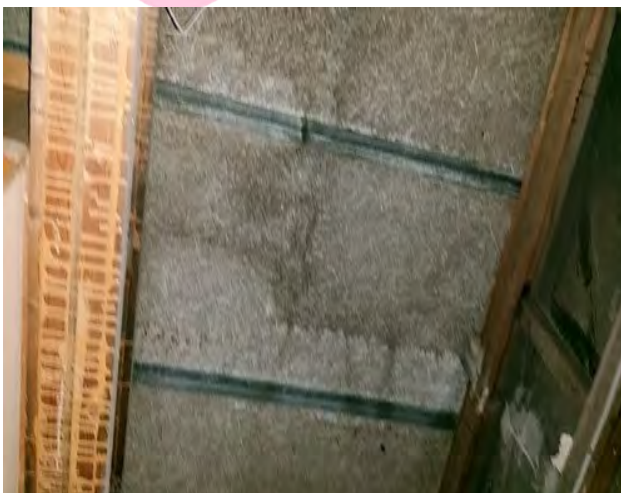
Item 53 - Ref: As 70826-1

The underside of roof in Care and Support Operation Managers Office ceiling void (Rm 0/075) does not contain asbestos.

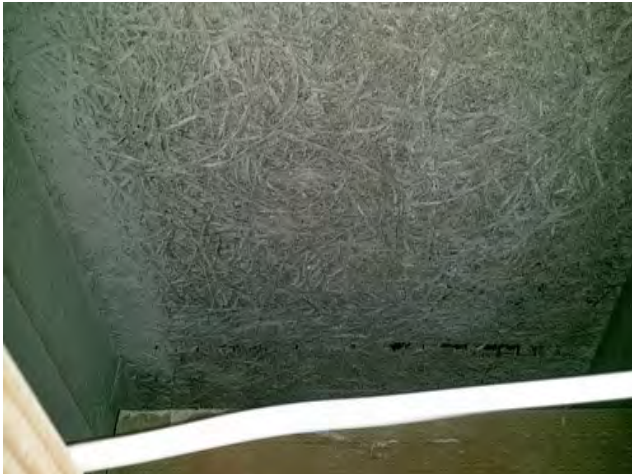
Item 54 - Ref: As 70826-1

The underside of roof in Office ceiling void (Rm 0/076) does not contain asbestos.

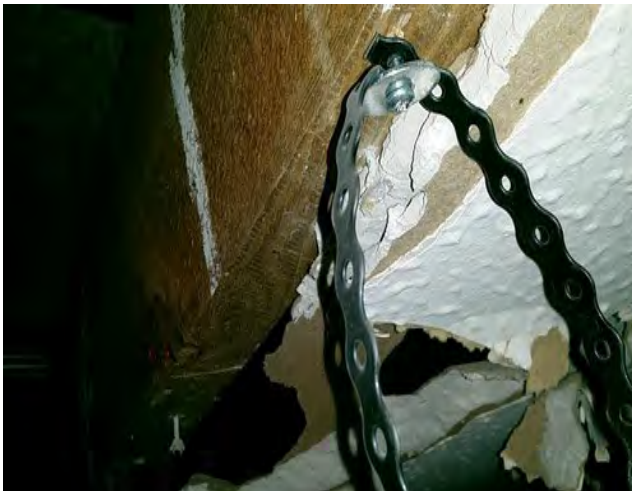
Item 55 - Ref: As 70826-3

The debris to nails in wood beams in Office ceiling void (Rm 0/076) contains asbestos.

Any change in its appearance should be recorded and passed to Property Services.

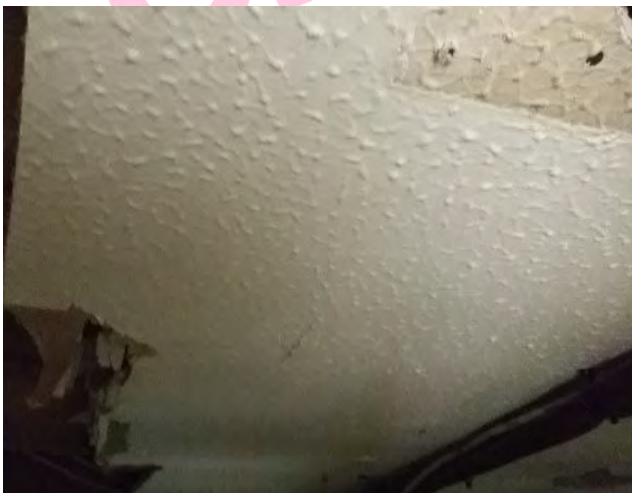
Item 56 - Ref: 70826-5

The textured coating to former plasterboard ceiling in Office ceiling void (Rm 0/076) contains asbestos.

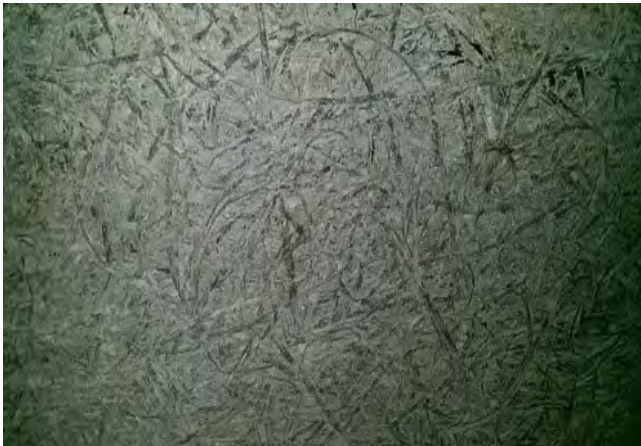
Item 57 - Ref: As 70826-1

The underside of roof in Operations Managers Office ceiling void (Rm 0/077) does not contain asbestos.

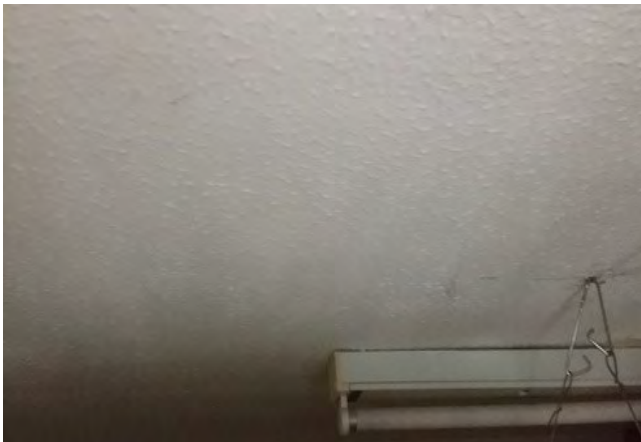
Item 58 - Ref: As 70826-5

The textured coating to former plasterboard ceiling in Operations Managers Office ceiling void (Rm 0/077) contains asbestos.

Any change in its appearance should be recorded and passed to Property Services.

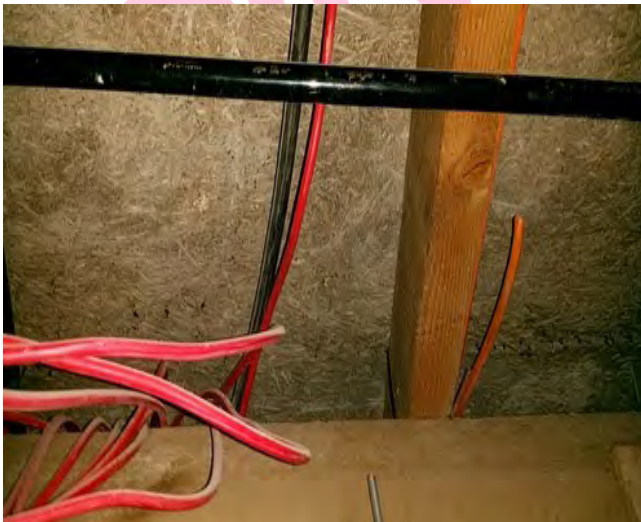
Item 59 - Ref: 70826-6

The underside of roof in Corridor ceiling void (Rm 0/078) does not contain asbestos.

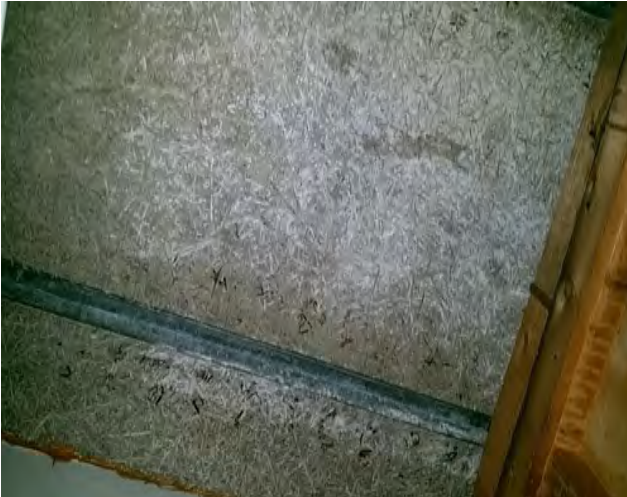
Item 60 - Ref: As 70826-6

The underside of roof in Store ceiling void (Rm 0/079) does not contain asbestos.

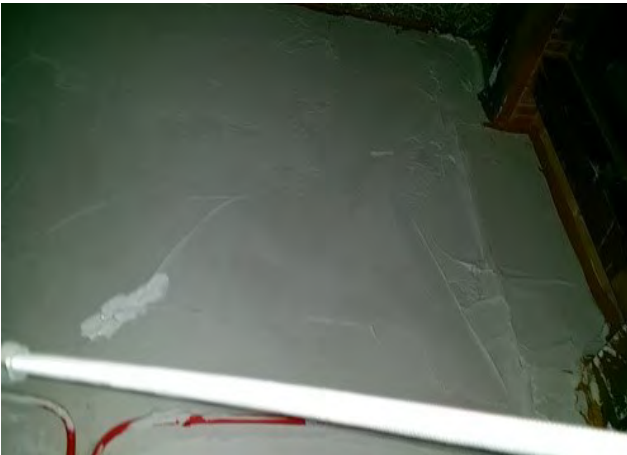
Item 61 - Ref: 70826-7

The coating to the wall in Store ceiling void (Rm 0/079) does not contain asbestos.

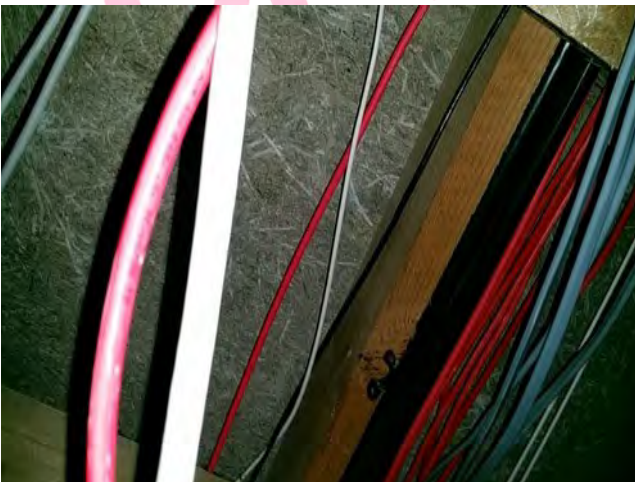
Item 62 - Ref: As 70826-6

The underside of roof in Office ceiling void (Rm 0/080) does not contain asbestos.

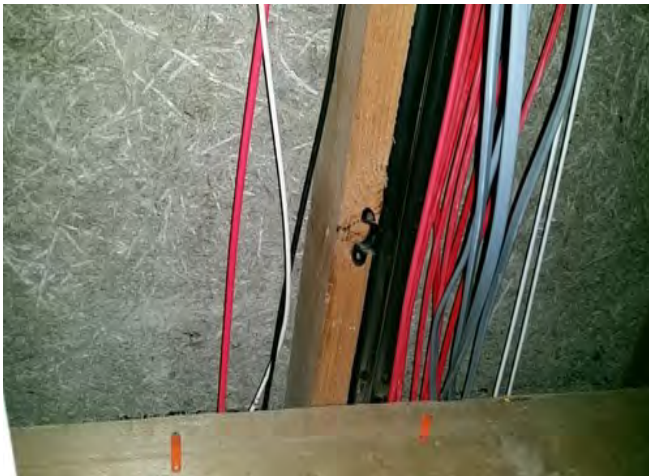
Item 63 - Ref: As 70826-6

The underside of roof in Corridor ceiling void (Rm 0/082) does not contain asbestos.

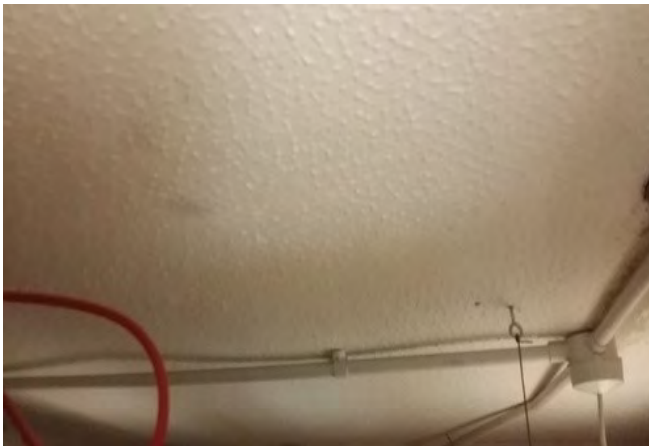
Item 64 - Ref: As 70826-5

The textured coating to plasterboard ceiling in Operations Managers Office ceiling void (Rm 0/083) contains asbestos.

Any change in its appearance should be recorded and passed to Property Services.

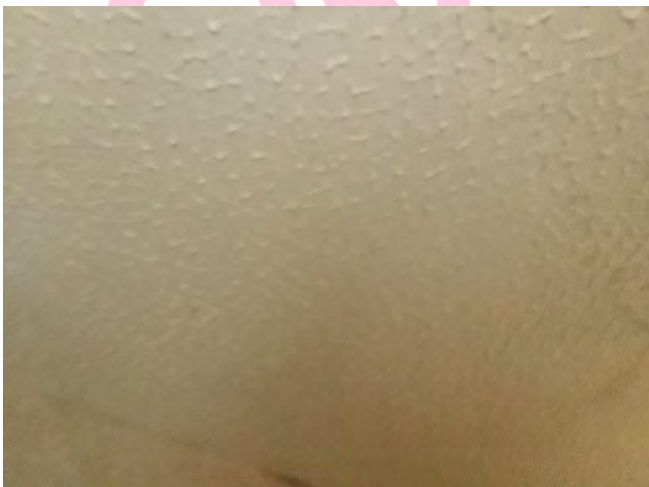
Item 65 - Ref: As 70826-5

The textured coating to plasterboard ceiling in Senior Operations Managers Office ceiling void (Rm 0/084) contains asbestos.

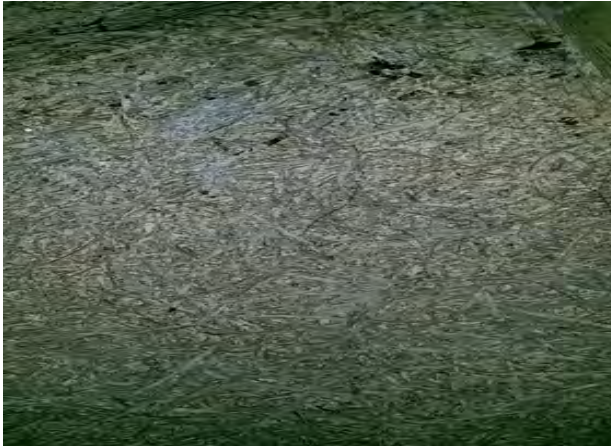
Item 66 - Ref: As 70826-6

The underside of roof in Operations Managers Office ceiling void (Rm 0/085) does not contain asbestos.

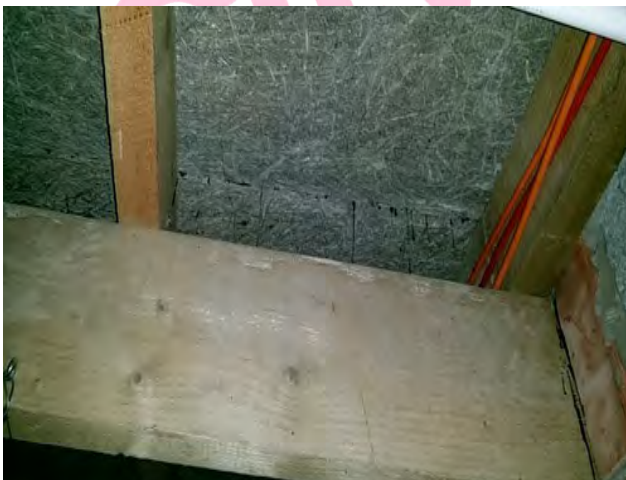
Item 68 - Ref: As 70826-6

The underside of roof in Corridor ceiling void (Rm 0/086) does not contain asbestos.

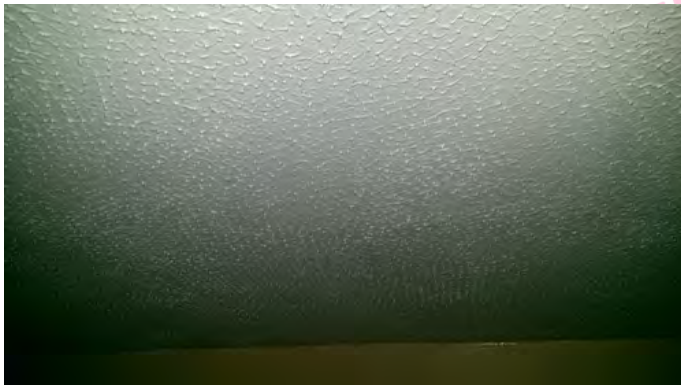
Item 85 - Ref: As 70826-9

The textured coating to ceiling in Male Toilets-void above (Rm 0/100) contains asbestos.

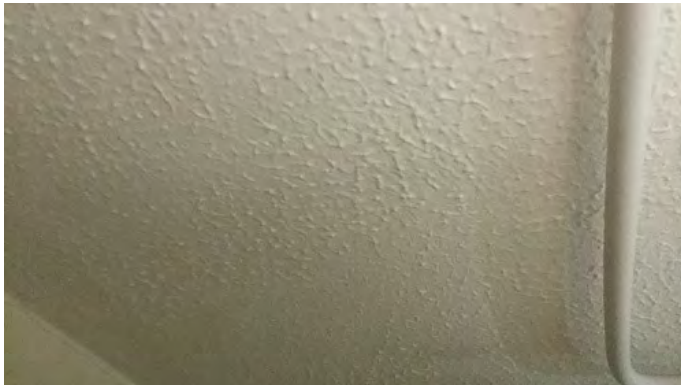
Item 88 - Ref: As 70826-9

The textured coating to ceiling in Photocopier Rm-void above (Rm 0/102) contains asbestos.

Any change in its appearance should be recorded and passed to Property Services.

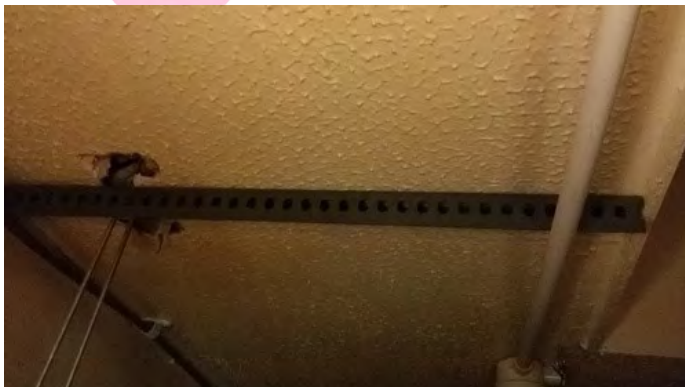
Item 89 - Ref: As 70826-9

The textured coating to ceiling in Stationary store rm-void above (Rm 0/103) contains asbestos.

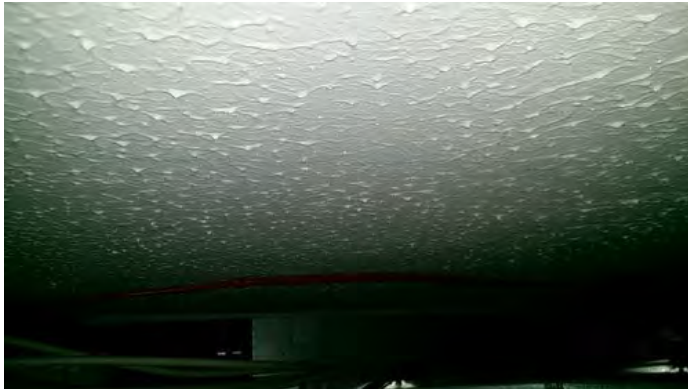
Item 93 - Ref: As 70826-14

The textured coating to ceiling in Training Rm-void above (Rm 0/106) contains asbestos.

Any change in its appearance should be recorded and passed to Property Services.

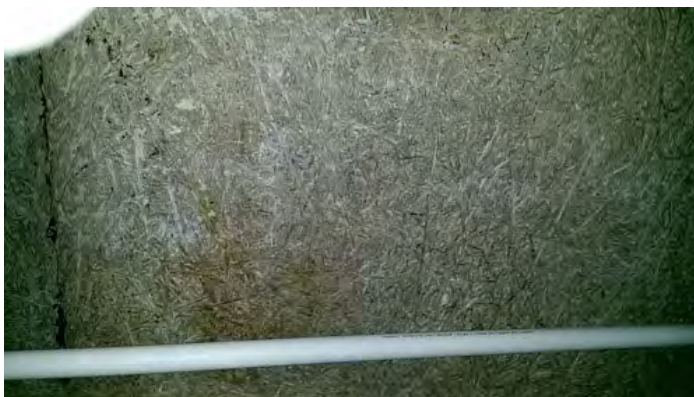
Item 94 - Ref: As 70826-12

The underside of roof in Corridor -void above (Rm 0/107) does not contain asbestos.

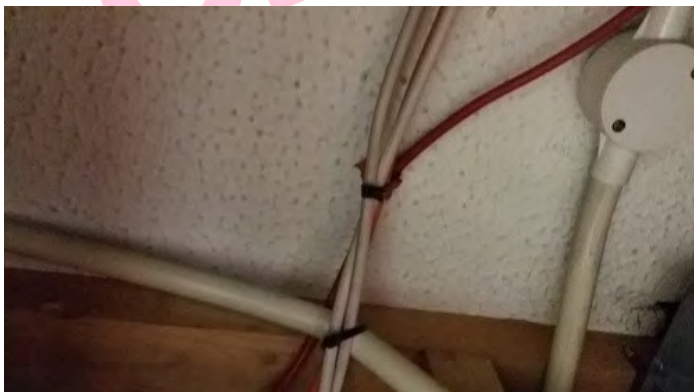
Item 95 - Ref: As 70826-14

The textured coating to ceiling in Corridor -void above (Rm 0/107) contains asbestos.

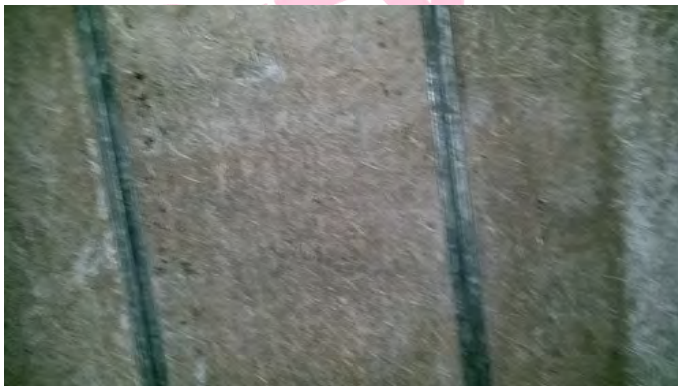
Item 101 - Ref: As 70826-12

The underside of roof in Seminar Room -void above (Rm 0/110) does not contain asbestos.

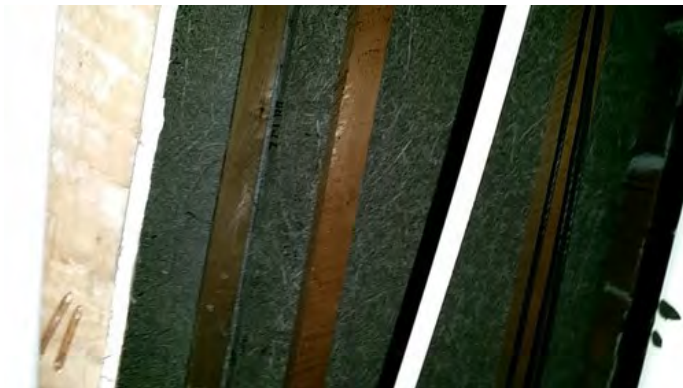
Item 109 - Ref: As 70826-12

The underside of roof in Cafeteria -void above (Rm 0/115) does not contain asbestos.

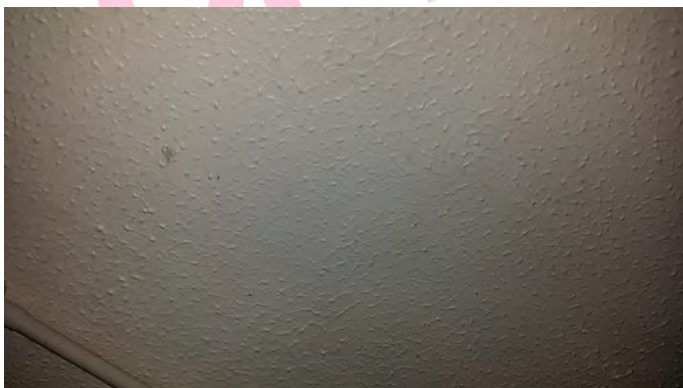
Item 110 - Ref: As 70826-14

The textured coating to ceiling in Cafeteria -void above (Rm 0/115) contains asbestos.

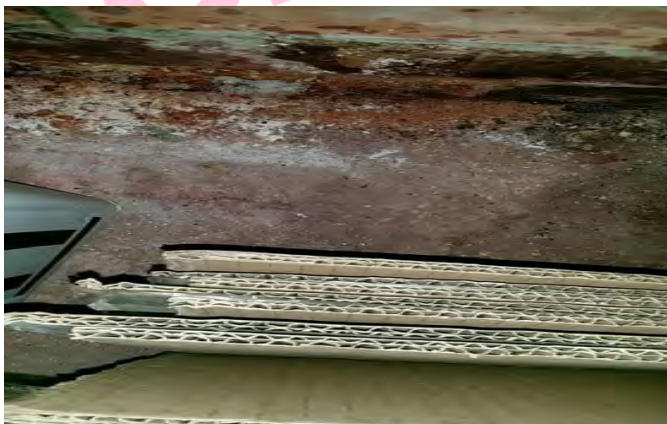
Item 131 - Ref: 70826-33

The general debris to floor in Gas cylinder Store (Rm 0/133) contains asbestos.

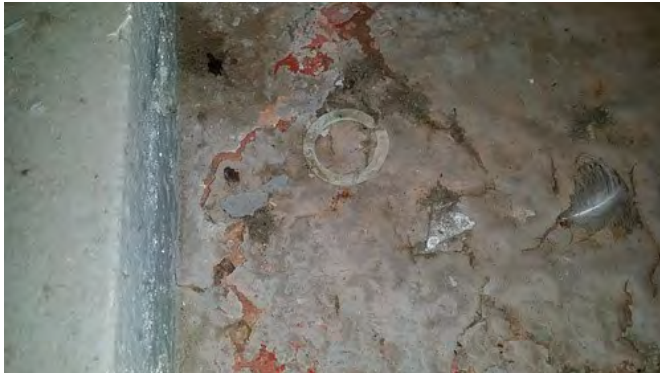
Item 138 - Ref: 70826-36

The loose lying gasket to floor in Boiler Room (Rm 0/137) does not contain asbestos.

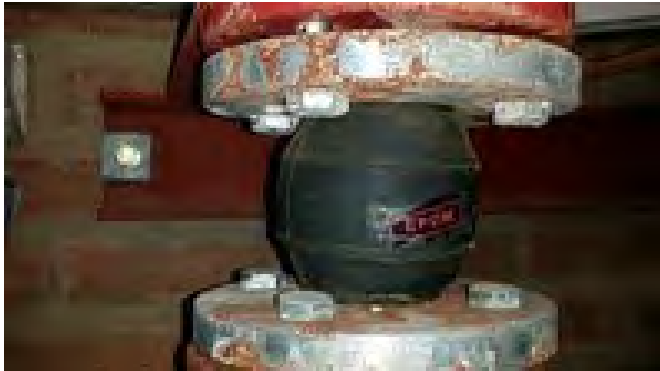
Item 139 - Ref: Presumed

The flange gaskets in Boiler Room (Rm 0/137) are presumed to contain asbestos.

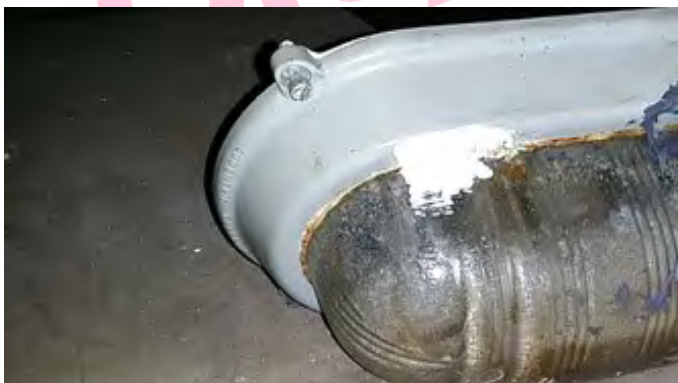
Item 143 - Ref: 70826-18

The seal to loose lying light fitting in Tank Room (Rm 1/001) contains asbestos.

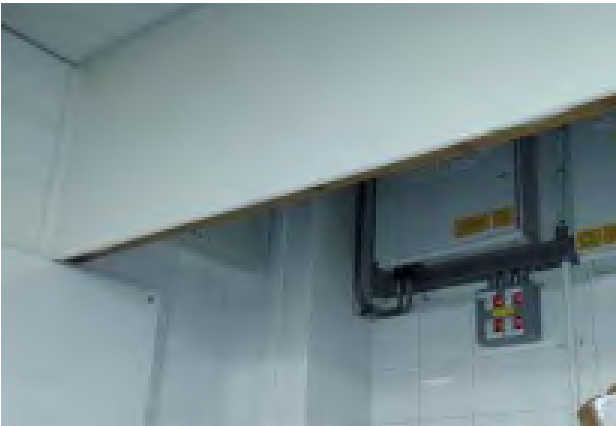
Item 183 Ref: 21-31963-2

The adhesive to the ceramic tiles to the wall in the Kitchen does not contain asbestos.

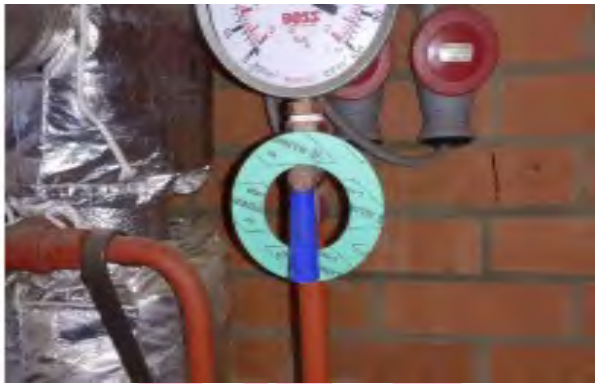
Item 204 Ref: PK000396

The loose gasket pipe in the Boiler Room (Room G/001) does not contain asbestos/

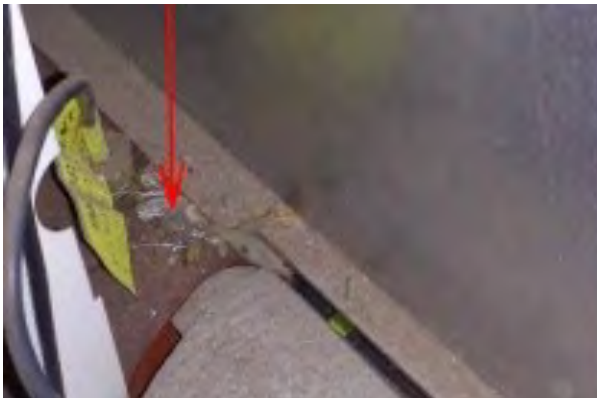
Item 205 Ref: NZ000796

The rope seal boilers in the Boiler Room (Room G/001) does not contain asbestos.

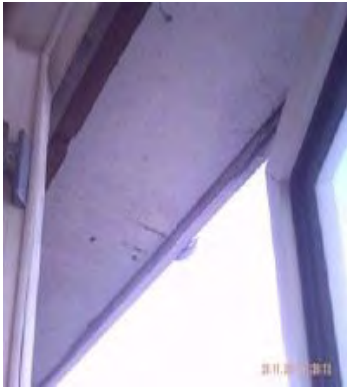
The external to the building has wooden soffits.

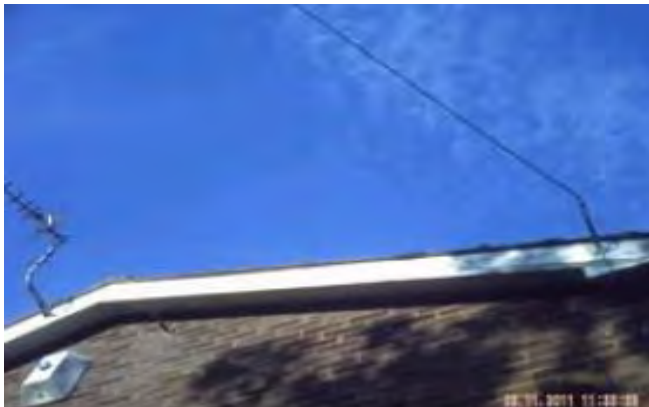
Item 148 - Ref: Presumed

The verge tiles (External) are presumed to contain asbestos.

Any change in appearance should be recorded and passed to Property Services.

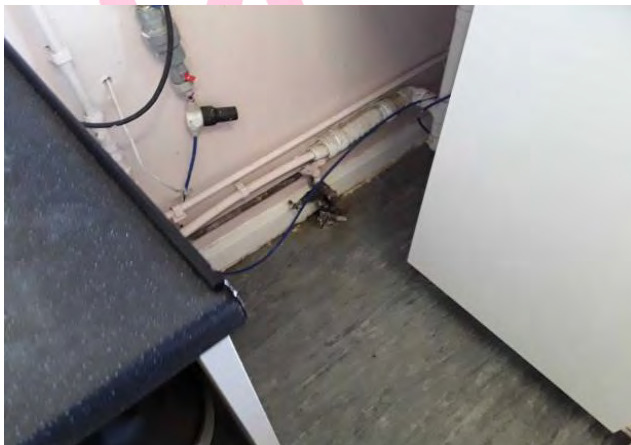
Item 187 - Ref: Presumed

The stop tap gasket (Area 5 – Kitchen) is presumed to contain asbestos.

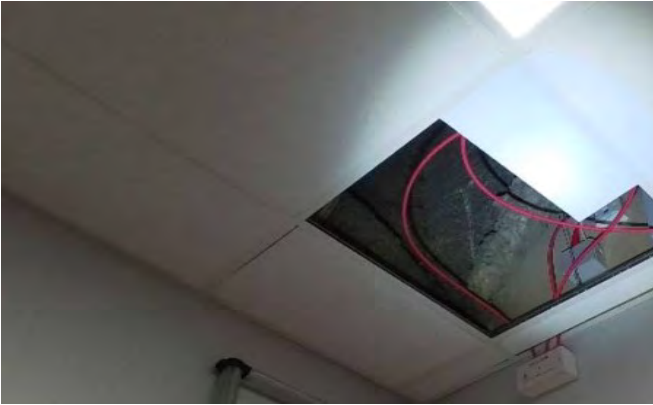
Item 199 - Ref: OQ000085

The ceiling void fire breaks in Corridor A25 (Room G/002) does not contain asbestos.

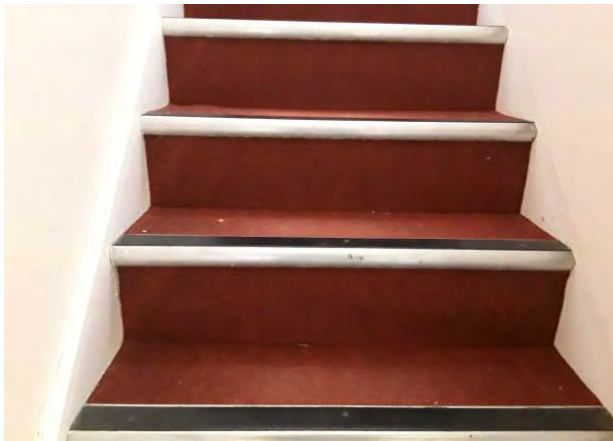
Item 188 - Ref: 22-55417-3

The stair nosing on Stairs Landing (Area 7) does not contain asbestos.

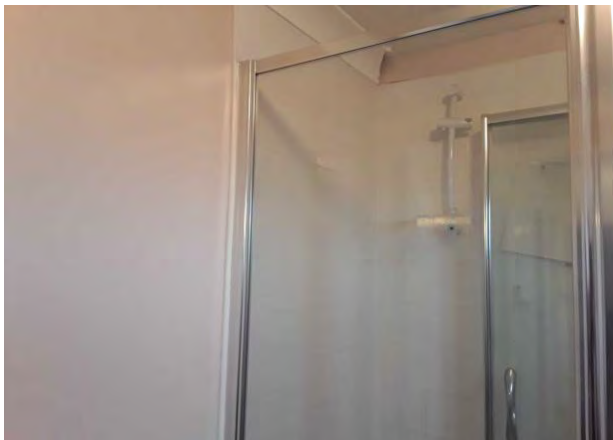
Item 189 - Ref: 22-55417-4

The ceramic tiles to walls (adhesive in the Shower Room (Area 12) does not contain asbestos.

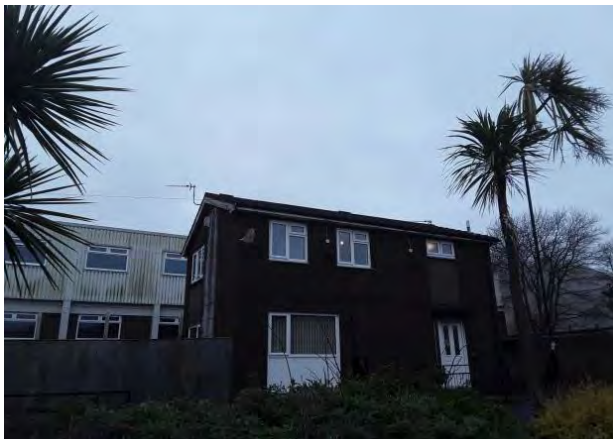
Item 190 - Ref: Presumed

The cement roof ridge vents (External) are presumed to contain asbestos.

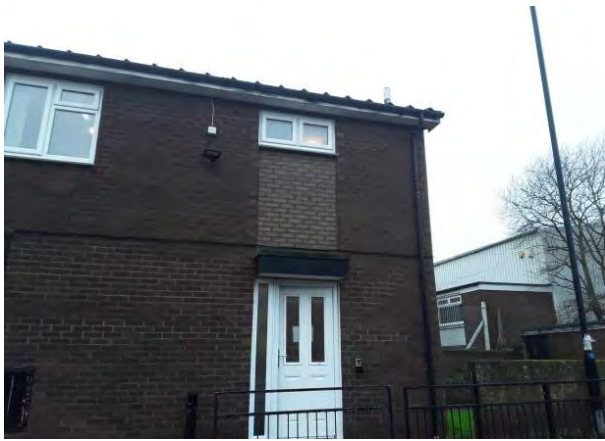
Item 191 - Ref: 22-55417-8

The front door canopy roof felt (External) contains asbestos.

Any change in appearance should be recorded and passed to Property Services.

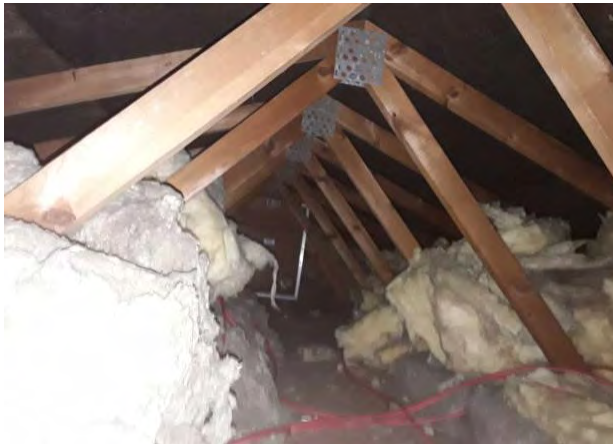
Item 192 - Ref: Presumed

The pipes/gasket to redundant elson tank in the loft (Area 16) is presumed to contain asbestos.

Any change in appearance should be recorded and passed to Property Services.
