ASBESTOS SURVEY REPORT FOR LEECHMERE TRAINING CENTRE (INCLUDING TELECARE HOUSE), SUNDERLAND

Asbestos Register for LEECHMERE CENTRE, SUNDERLAND

Date: 16 January 2025

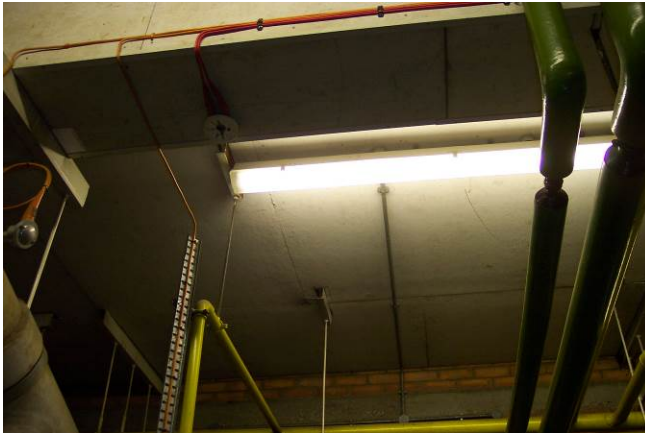
Item 1 Ref: DJC04/1426

DJC04/1426 – Ceiling Boards (Boiler room) (Item 1) – Removed Oct 2020

The ceiling boards in the Boiler Room contain asbestos.

Removed Oct 2020

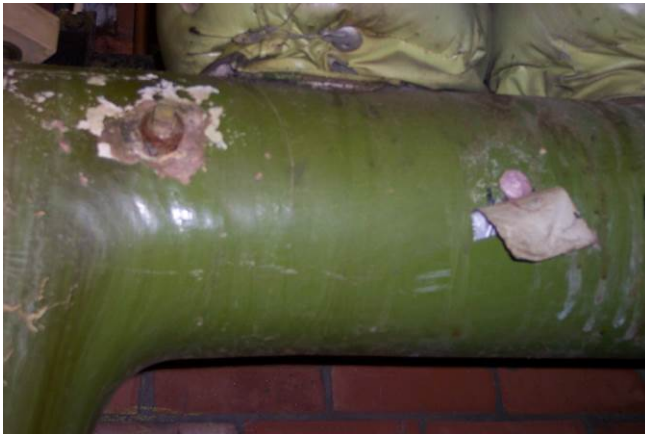
Item 2 - Ref: DJC04/1427

The pipe lagging in the boiler room does not contain asbestos.

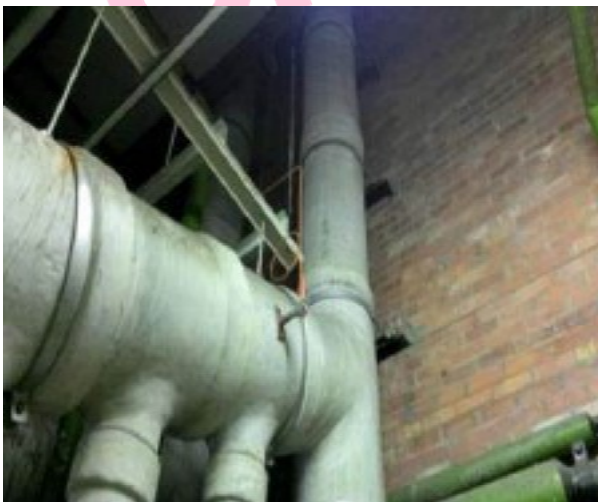
Item 3 - Ref: DJC04/1428

DJC04/1428 – Boiler Flues (Boiler Room) (Item 3) – Removed Oct 2020

The Boiler flues in the Boiler Room contain asbestos.

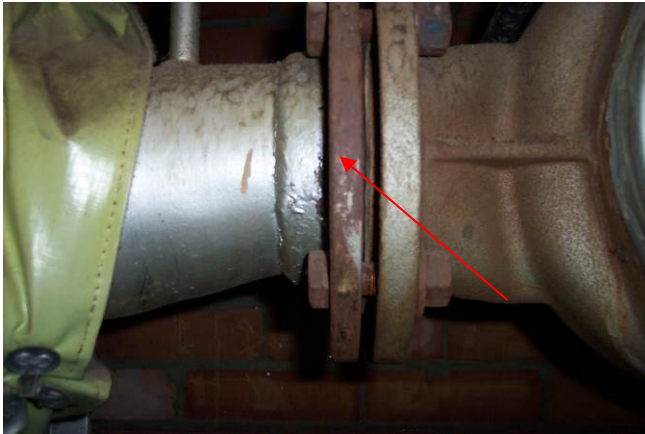
Item 4 - Ref: DJC04/1429

The gaskets in the pipework in the Boiler Room contain asbestos.

Removed Oct 2020

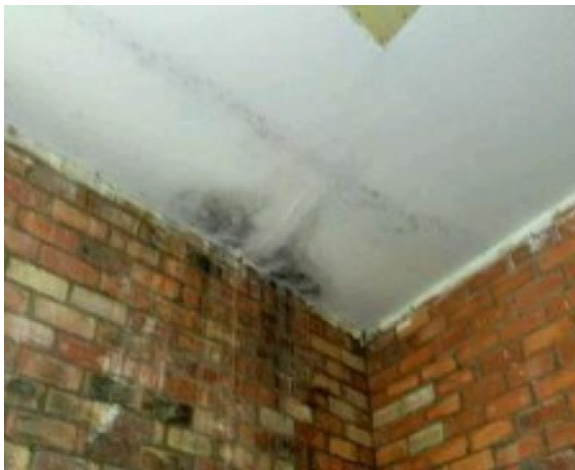
Item 5 - Ref: CB000912

CB000912 – Textured coating (External Stores Cupbd) (Item 5) – Very Low Risk

The textured coating to the ceiling in the Stores external cupboard contains asbestos.

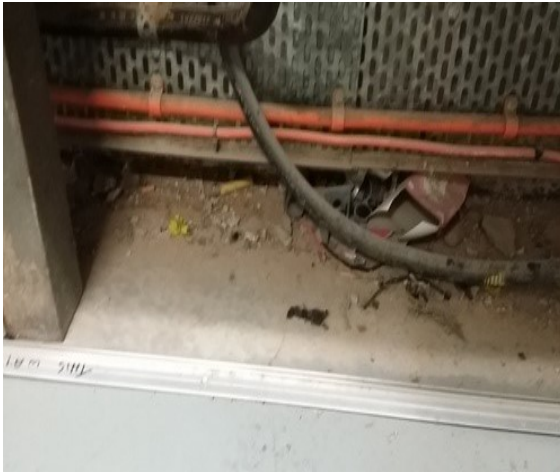
Item 36 - Ref: 70826-4

70826-4 – Debris to floor below electrics (Sub main electrics intake room 0/067) (Item 36) – Removed November 2019

The debris to floor below electric in sub main electric intake room (Rm 0/067) contains asbestos.

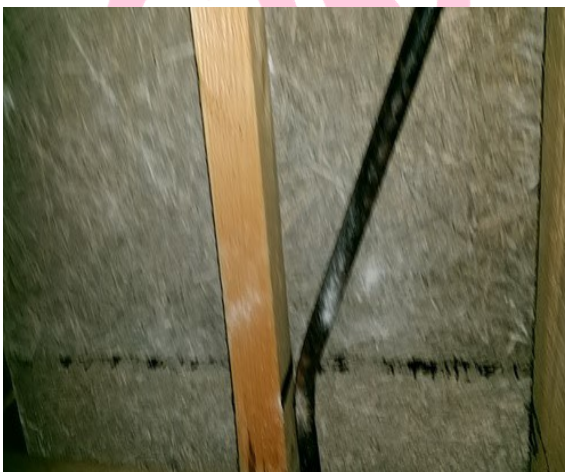
Item 38 - Ref: As 70826-1

The underside of roof in ILC reception area ceiling void (Rm 0/068) does not contain asbestos.

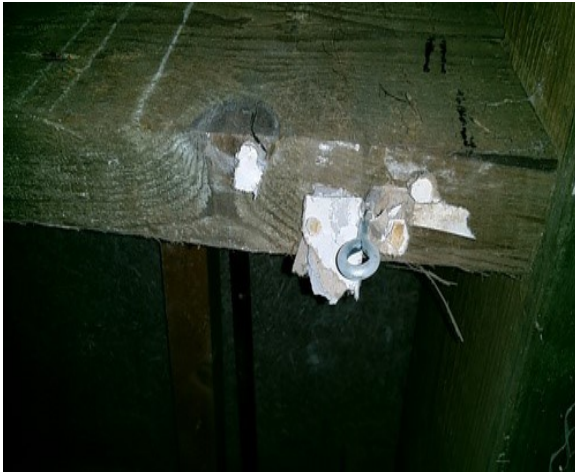
Item 39 - Ref: As 70826-3

The debris to nails in wood beams in ILC reception area ceiling void (Rm 0/068) contains asbestos.

Removed November 2019

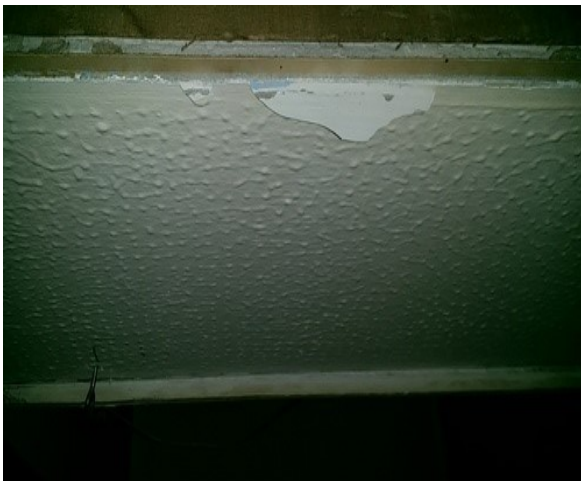
Item 40 - Ref: As 70826-2

As 70826-2 – Textured Coating to ceiling (ILC reception area-void above 0/068) (Item 40) – Very Low Risk

The textured coating to former plasterboard ceiling in ILC reception area ceiling void (Rm 0/068) contains asbestos.

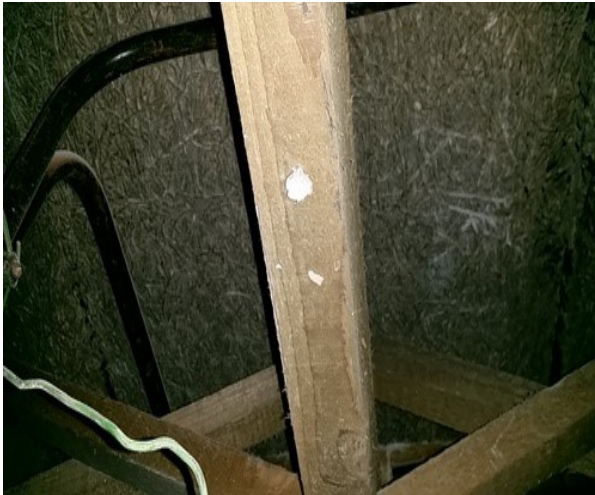
Item 42 - Ref: As 70826-3

As 70826-3 – Debris to nail in beams (Female Toilets & Lobby-void above 0/070) (Item 42) – Low Risk

The debris to nails in wood beams in Female Toilets & Lobby ceiling void (Rm 0/070) contains asbestos.

Any change in its appearance should be recorded and passed to Property Services.

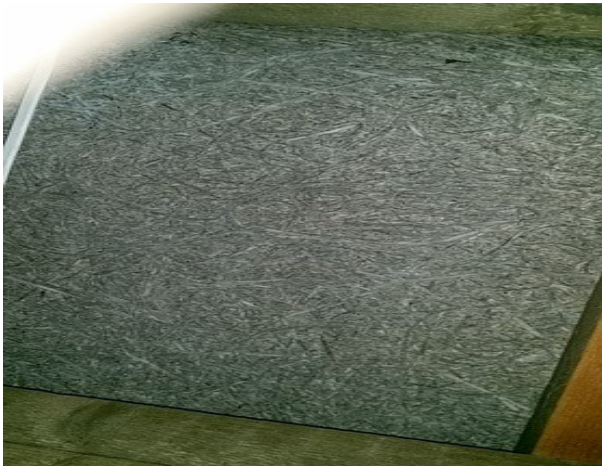
Item 43 - Ref: As 70826-1

The underside of roof in Male Toilets & Lobby ceiling void (Rm 0/071) does not contain asbestos.

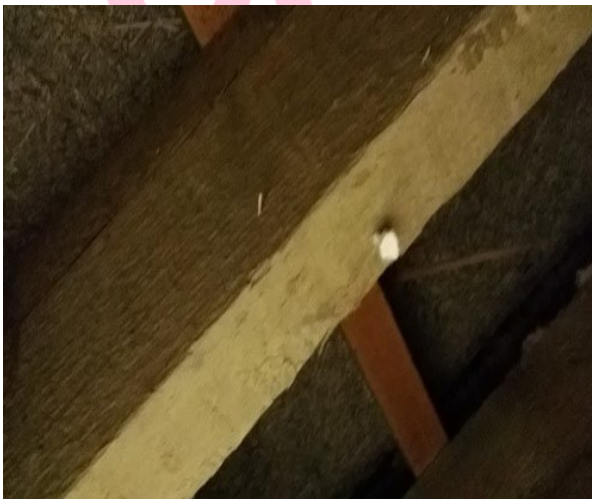
Item 44 - Ref: As 70826-3

As 70826-3 – Debris to nail in beams (Male Toilets & Lobby-void above 0/071) (Item 44) – Low Risk

The debris to nails in wood beams in Male Toilets & Lobby ceiling void (Rm 0/071) contains asbestos.

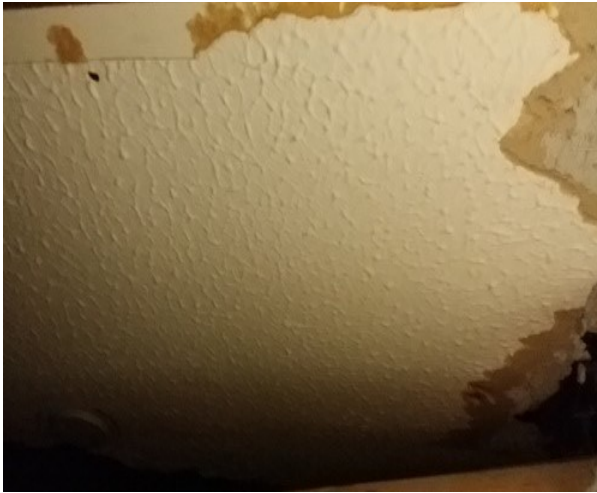
Item 45 - Ref: As 70826-2

The textured coating to former plasterboard ceiling in Male Toilets & Lobby ceiling void (Rm 0/071) contains asbestos.

Removed 21 January 2022

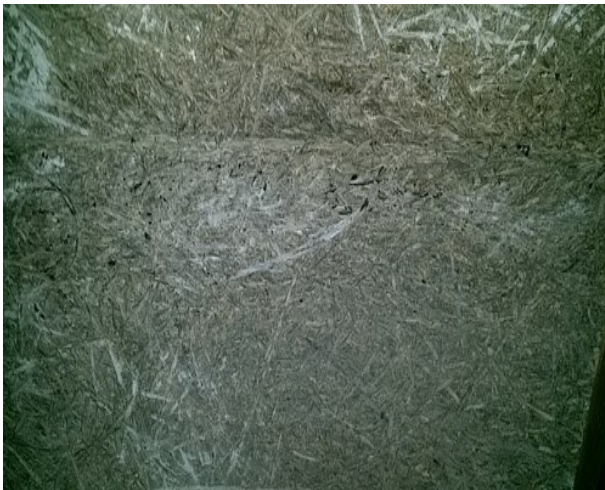
Item 46 - Ref: As 70826-1

The underside of roof in Disabled Bathroom ceiling void (Rm 0/072) does not contain asbestos.

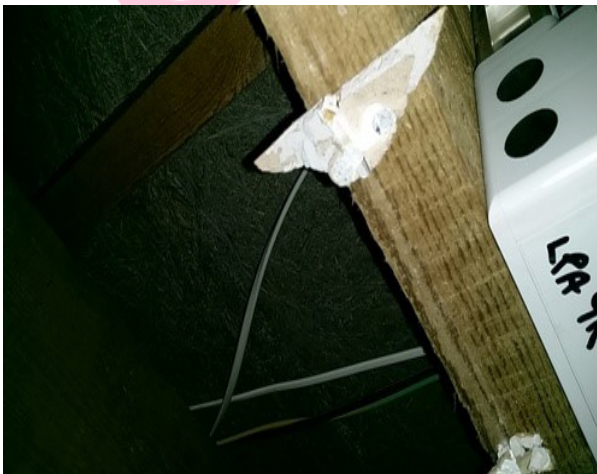
Item 47 - Ref: As 70826-3

As 70826-3 – Debris to nail in beams (Disabled Bathroom-void above 0/072) (Item 47) – Low Risk

The debris to nails in wood beams in Disabled Bathroom ceiling void (Rm 0/072) contains asbestos.

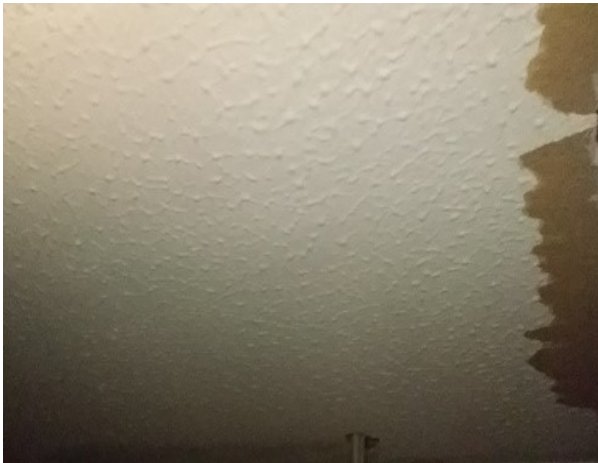
Item 48 - Ref: As 70826-2

As 70826-2 – Textured Coating to ceiling (Disabled Bathroom-void above 0/072) (Item 48) – Very Low Risk

The textured coating to former plasterboard ceiling in Disabled Bathroom ceiling void (Rm 0/072) contains asbestos.

Any change in its appearance should be recorded and passed to Property Services.

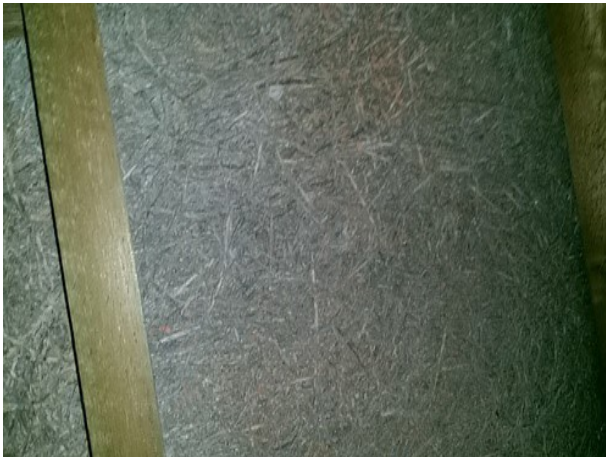
Item 49 - Ref: As 70826-1

The underside of roof in Duty Office ceiling void (Rm 0/073) does not contain asbestos.

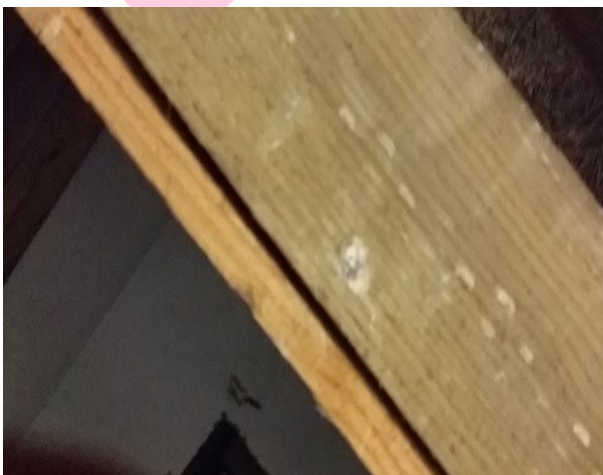
Item 50 - Ref: As 70826-3

As 70826-3 – Debris to nail in beams (Duty Office-void above 0/073) (Item 50) – Low Risk

The debris to nails in wood beams in Duty Office ceiling void (Rm 0/073) contains asbestos.

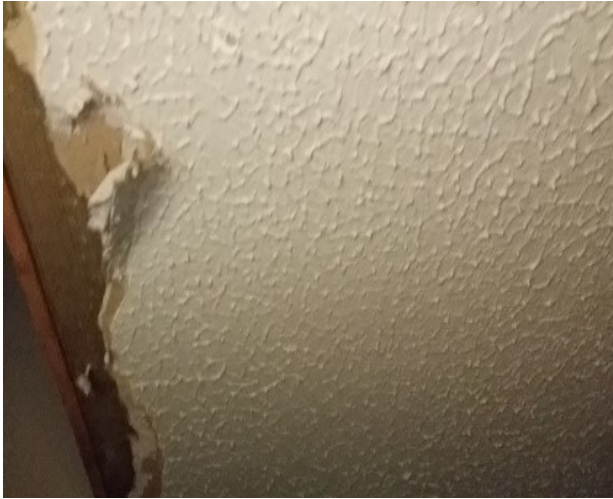
Item 51 - Ref: As 70826-2

As 70826-2 – Textured Coating to ceiling (Duty Office-void above 0/073) (Item 51) – Very Low Risk

The textured coating to former plasterboard ceiling in Duty Office ceiling void (Rm 0/073) contains asbestos.

Any change in its appearance should be recorded and passed to Property Services.

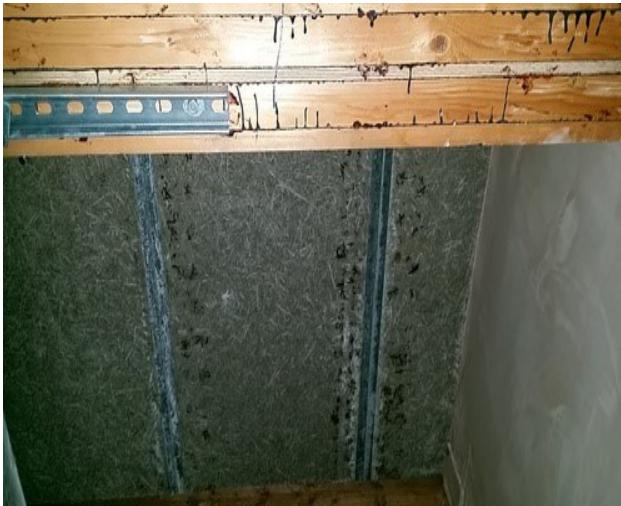
Item 52 - Ref: As 70826-1

The underside of roof in Care and Support Office ceiling void (Rm 0/074) does not contain asbestos.

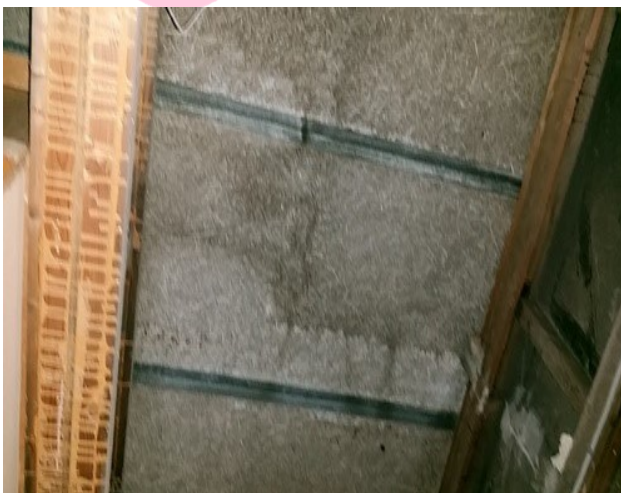
Item 53 - Ref: As 70826-1

The underside of roof in Care and Support Operation Managers Office ceiling void (Rm 0/075) does not contain asbestos.

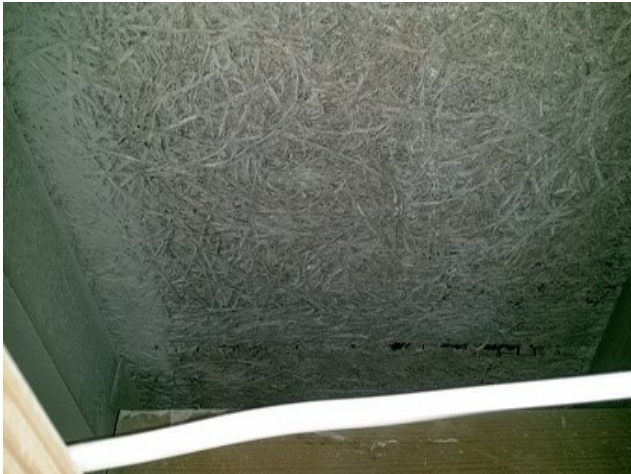
Item 54 - Ref: As 70826-1

The underside of roof in Office ceiling void (Rm 0/076) does not contain asbestos.

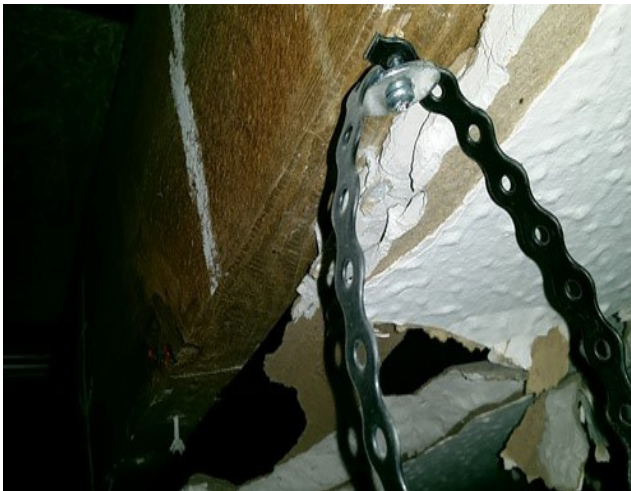
Item 55 - Ref: As 70826-3

As 70826-3 – Debris to nail in beams (Office-void above 0/076) (Item 55) – Very Low Risk

The debris to nails in wood beams in Office ceiling void (Rm 0/076) contains asbestos.

Any change in its appearance should be recorded and passed to Property Services.

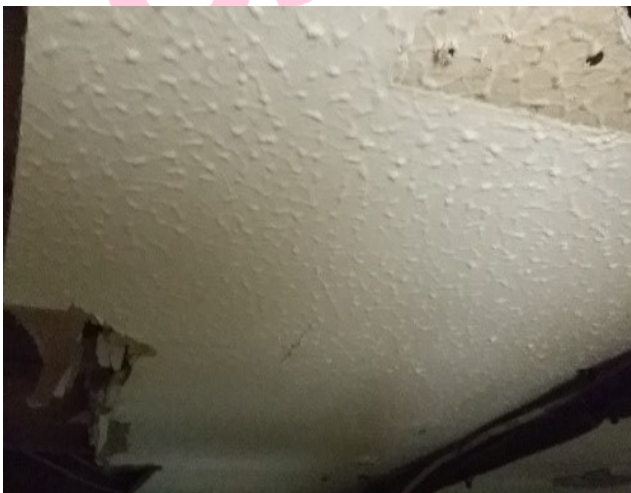
Item 56 - Ref: 70826-5

The textured coating to former plasterboard ceiling in Office ceiling void (Rm 0/076) contains asbestos.

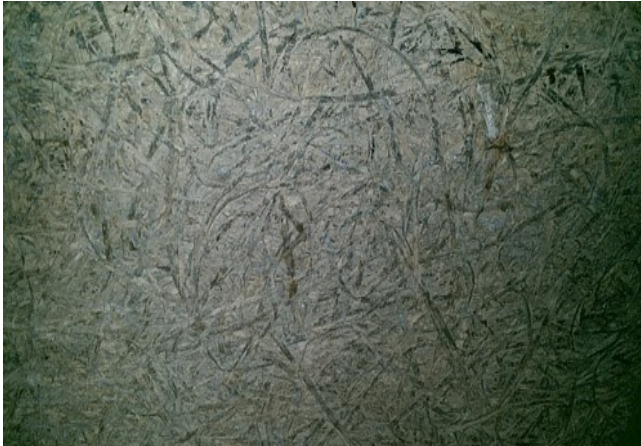
Item 57 - Ref: As 70826-1

The underside of roof in Operations Managers Office ceiling void (Rm 0/077) does not contain asbestos.

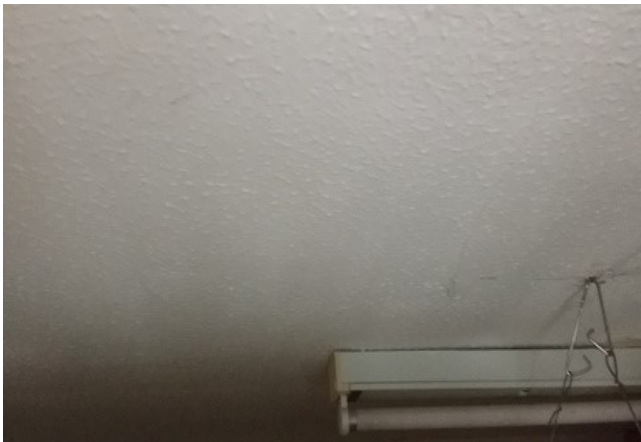
Item 58 - Ref: As 70826-5

The textured coating to former plasterboard ceiling in Operations Managers Office ceiling void (Rm 0/077) contains asbestos.

Any change in its appearance should be recorded and passed to Property Services.

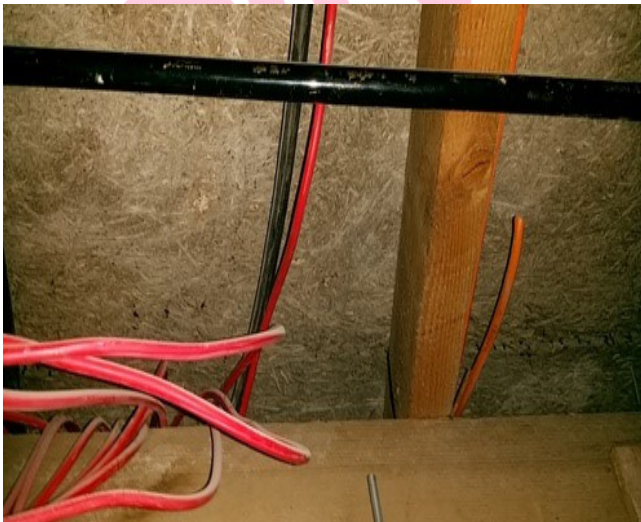
Item 59 - Ref: 70826-6

The underside of roof in Corridor ceiling void (Rm 0/078) does not contain asbestos.

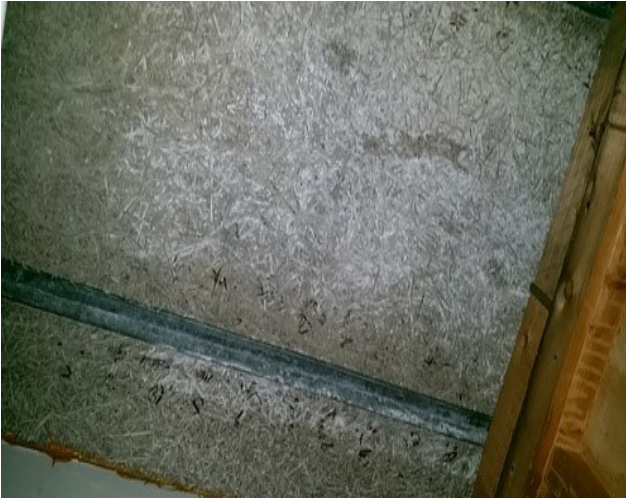
Item 60 - Ref: As 70826-6

The underside of roof in Store ceiling void (Rm 0/079) does not contain asbestos.

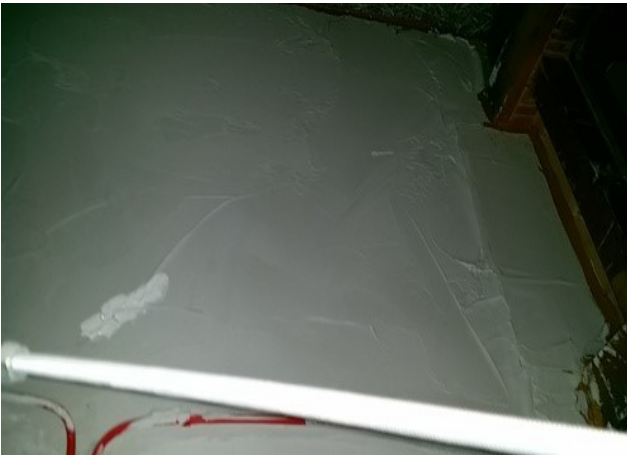
Item 61 - Ref: 70826-7

The coating to the wall in Store ceiling void (Rm 0/079) does not contain asbestos.

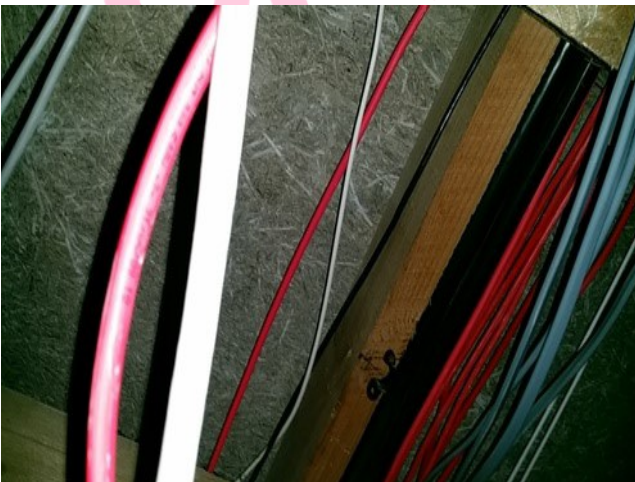
Item 62 - Ref: As 70826-6

The underside of roof in Office ceiling void (Rm 0/080) does not contain asbestos.

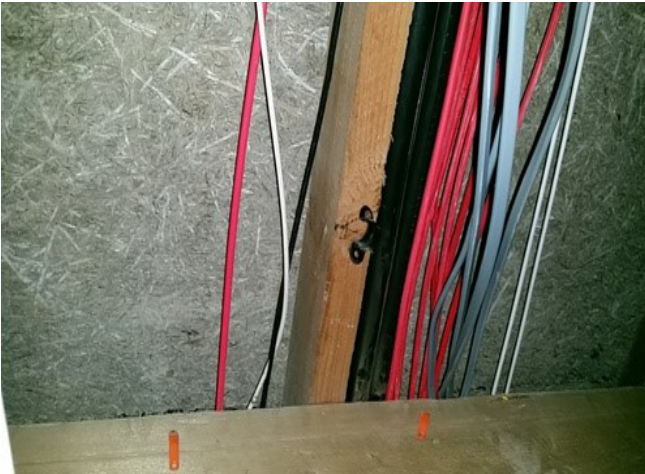
Item 63 - Ref: As 70826-6

The underside of roof in Corridor ceiling void (Rm 0/082) does not contain asbestos.

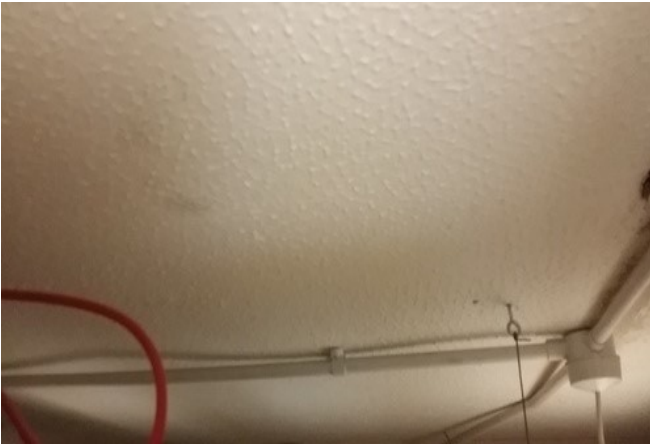
Item 64 - Ref: As 70826-5

The textured coating to plasterboard ceiling in Operations Managers Office ceiling void (Rm 0/083) contains asbestos.

Any change in its appearance should be recorded and passed to Property Services.

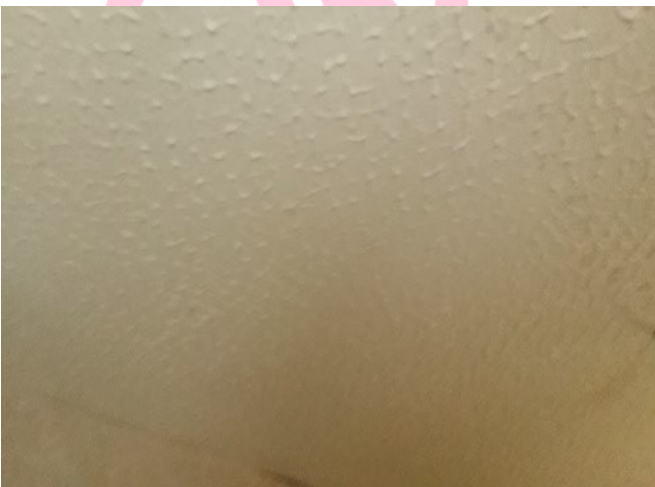
Item 65 - Ref: As 70826-5

The textured coating to plasterboard ceiling in Senior Operations Managers Office ceiling void (Rm 0/084) contains asbestos.

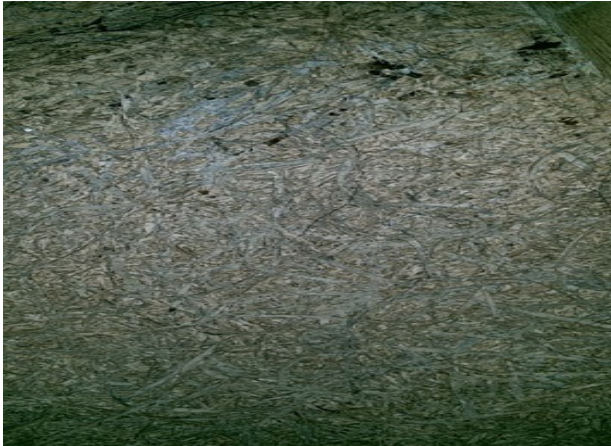
Item 66 - Ref: As 70826-6

The underside of roof in Operations Managers Office ceiling void (Rm 0/085) does not contain asbestos.

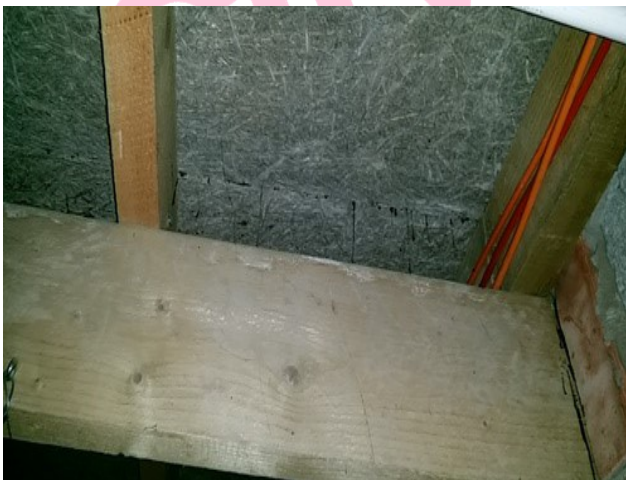
Item 68 - Ref: As 70826-6

The underside of roof in Corridor ceiling void (Rm 0/086) does not contain asbestos.

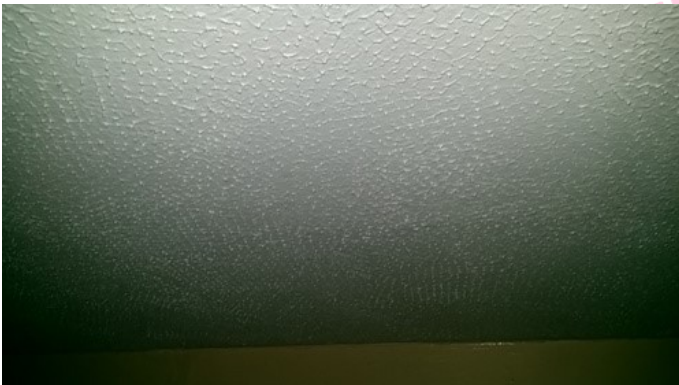
Item 85 - Ref: As 70826-9

The textured coating to ceiling in Male Toilets-void above (Rm 0/100) contains asbestos.

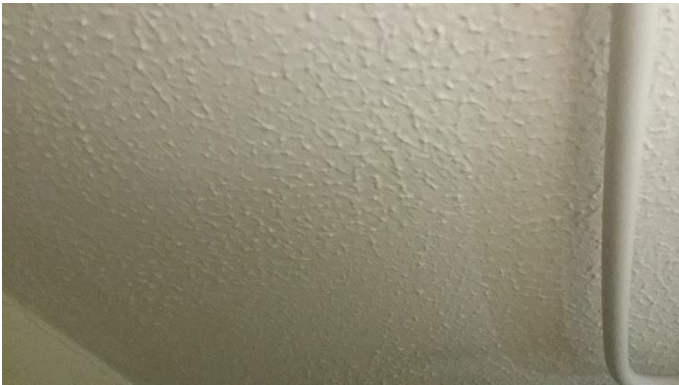
Item 88 - Ref: As 70826-9

The textured coating to ceiling in Photocopier Rm-void above (Rm 0/102) contains asbestos.

Any change in its appearance should be recorded and passed to Property Services.

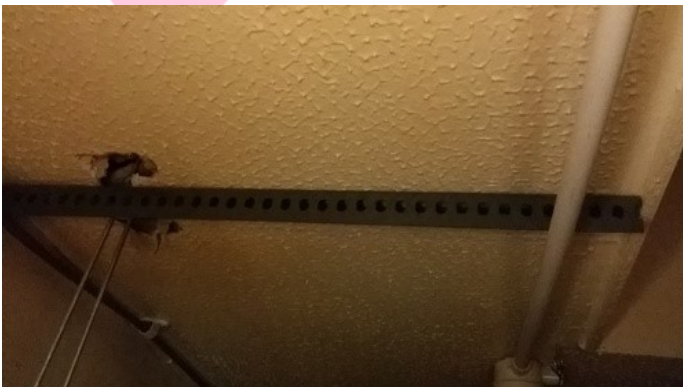
Item 89 - Ref: As 70826-9

The textured coating to ceiling in Stationary store rm-void above (Rm 0/103) contains asbestos.

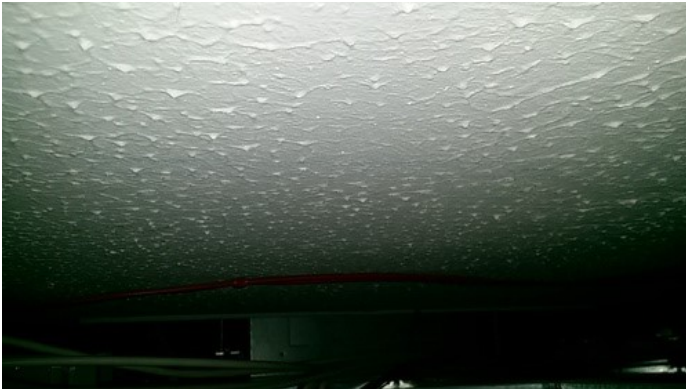
Item 93 - Ref: As 70826-14

The textured coating to ceiling in Training Rm-void above (Rm 0/106) contains asbestos.

Any change in its appearance should be recorded and passed to Property Services.

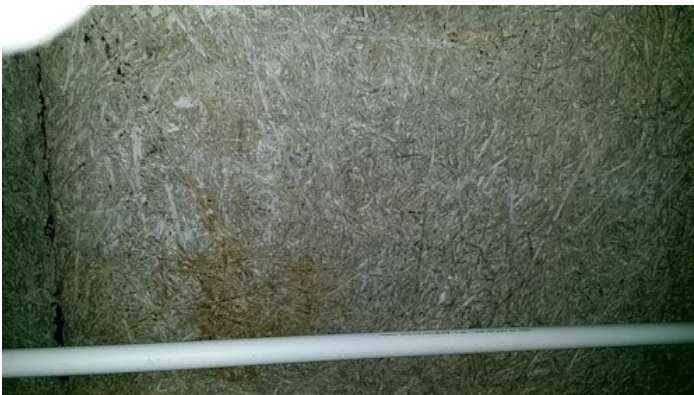
Item 94 - Ref: As 70826-12

The underside of roof in Corridor -void above (Rm 0/107) does not contain asbestos.

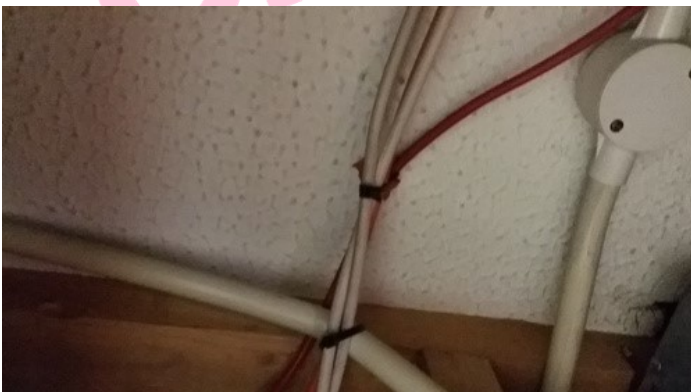
Item 95 - Ref: As 70826-14

The textured coating to ceiling in Corridor -void above (Rm 0/107) contains asbestos.

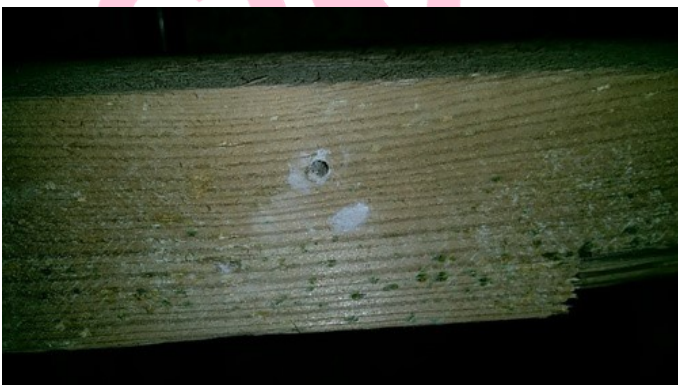
Item 98 - Ref: As 70826-13

The Debris to beams in Male toilet -void above (Rm 0/108) does not contain asbestos.

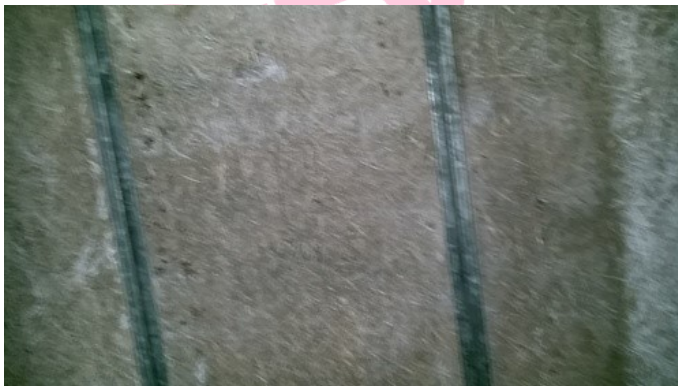
Item 101 - Ref: As 70826-12

The underside of roof in Seminar Room -void above (Rm 0/110) does not contain asbestos.

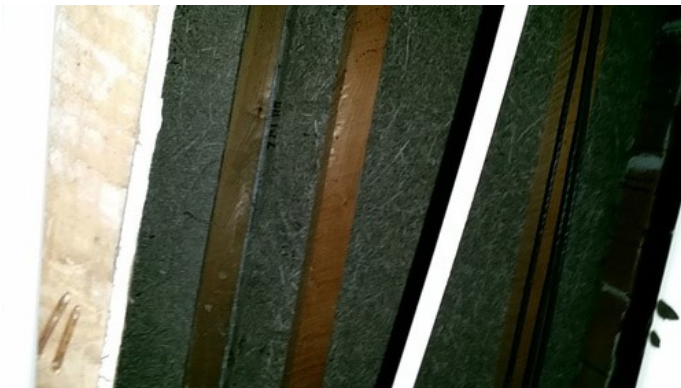
Item 109 - Ref: As 70826-12

The underside of roof in Cafeteria -void above (Rm 0/115) does not contain asbestos.

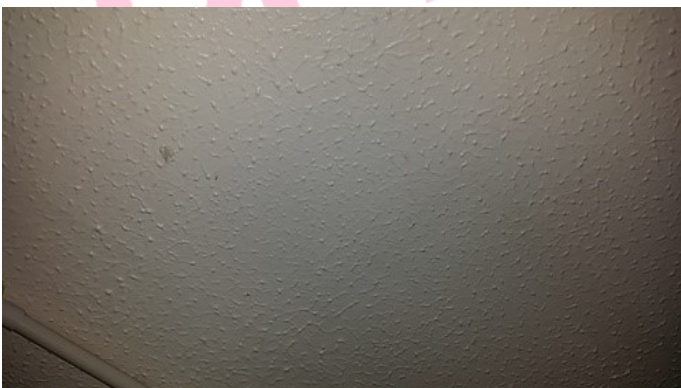
Item 110 - Ref: As 70826-14

The textured coating to ceiling in Cafeteria -void above (Rm 0/115) contains asbestos.

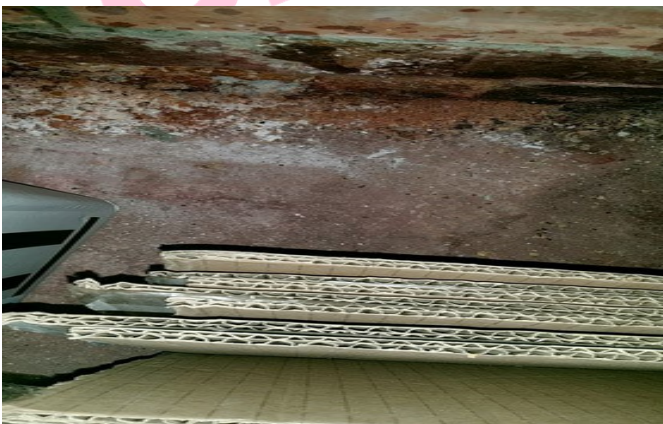
Item 131 - Ref: 70826-33

The general debris to floor in Gas cylinder Store (Rm 0/133) contains asbestos.

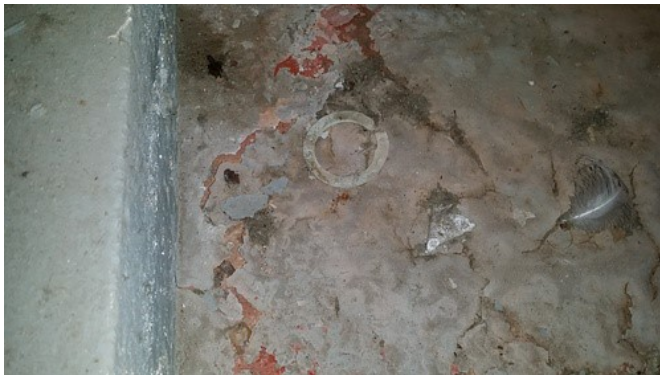
Item 138 - Ref: 70826-36

The loose lying gasket to floor in Boiler Room (Rm 0/137) does not contain asbestos.

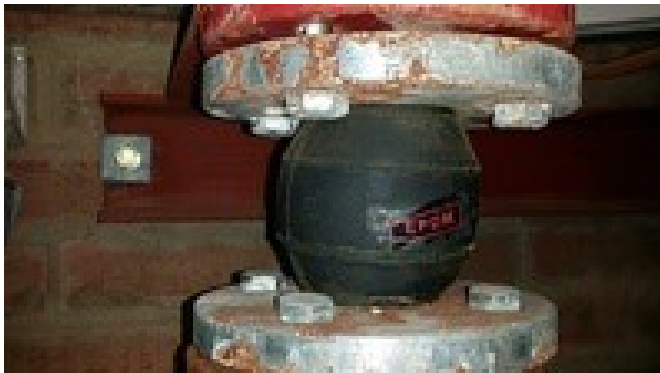
Item 139 - Ref: Presumed

The flange gaskets in Boiler Room (Rm 0/137) are presumed to contain asbestos.

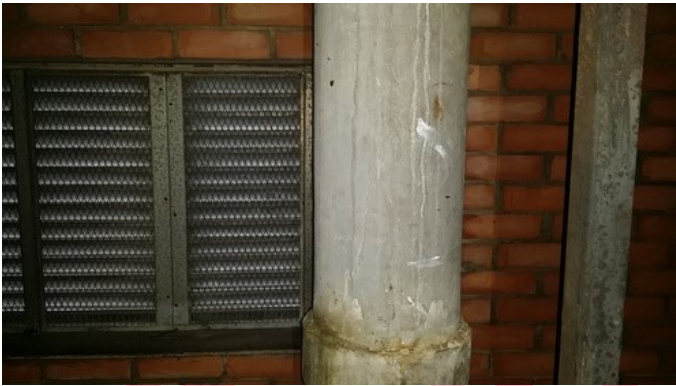
Item 142 - Ref: 70826-17

The boiler flue in Tank Room (Rm 1/001) contains asbestos.

Removed Oct 2020

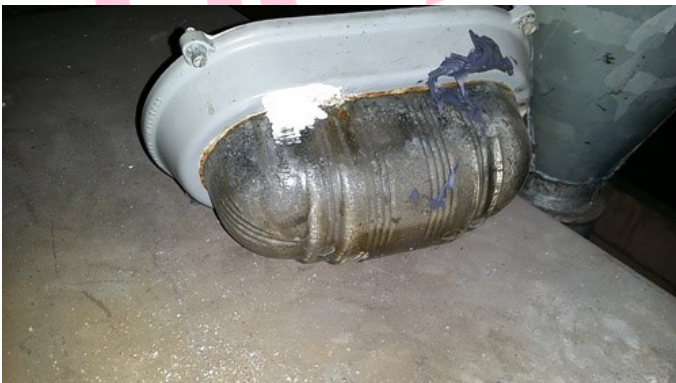
Item 143 - Ref: 70826-18

The seal to loose lying light fitting in Tank Room (Rm 1/001) contains asbestos.

| Item 143 | Seal to loose lying light fitting (Tank Room 1/001) | Very Low | | Removed November 2019 |

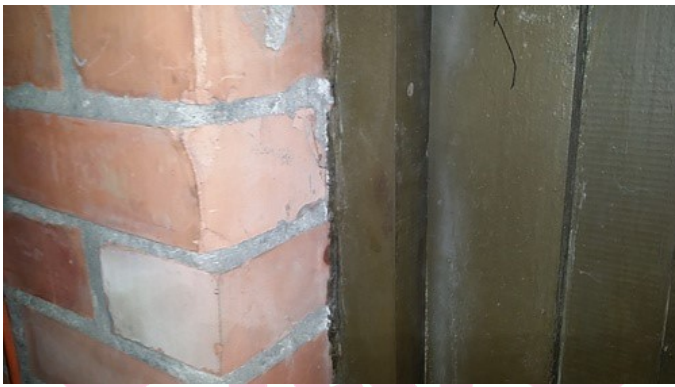
Item 145 - Ref: 70826-20

The mastic to door frame in Tank Room (Rm 1/001) contains asbestos.

Any change in its appearance should be recorded and passed to Property Services.

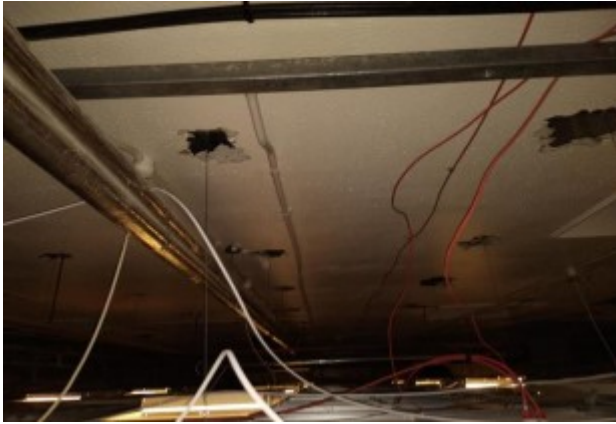
Item 182 Ref: 21-31963-1

The textured coating ceiling in the ceiling void above the canteen does contain asbestos.

Any change in appearance should be reported to Property Services.

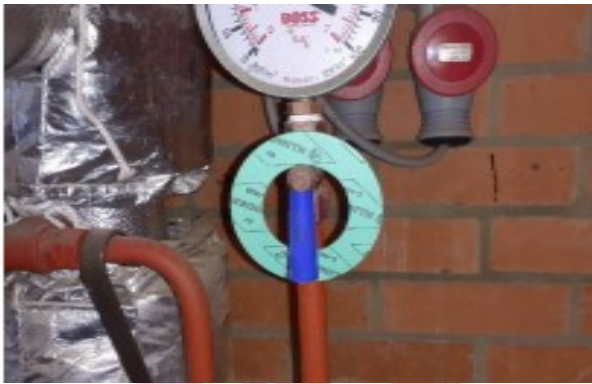
Item 204 Ref: PK000396

PK000396 – Loose gasket pipe (Boiler G/001) (Item 204) – No Risk

The loose gasket pipe in the Boiler Room (Room G/001) does not contain asbestos/

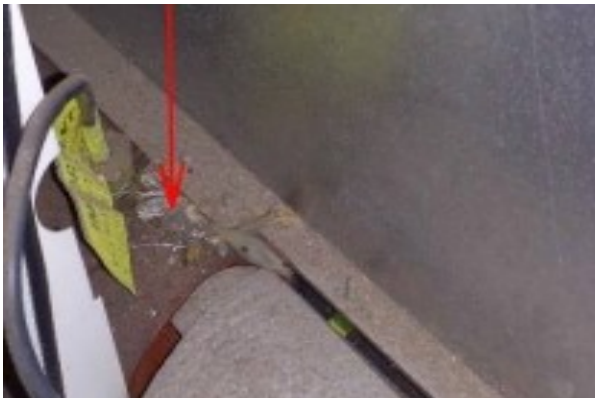
Item 205 Ref: NZ000796

The rope seal boilers in the Boiler Room (Room G/001) does not contain asbestos.

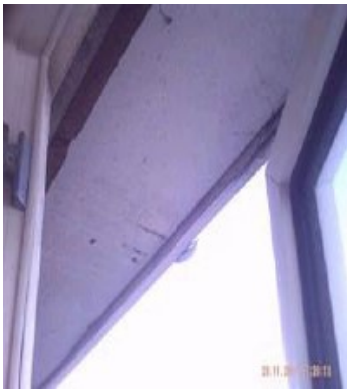
The external to the building has wooden soffits.

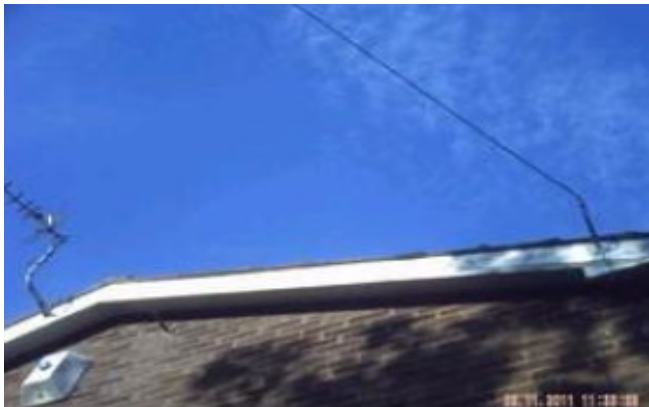
Item 148 - Ref: Presumed

The verge tiles (External) are presumed to contain asbestos.

Any change in appearance should be recorded and passed to Property Services.

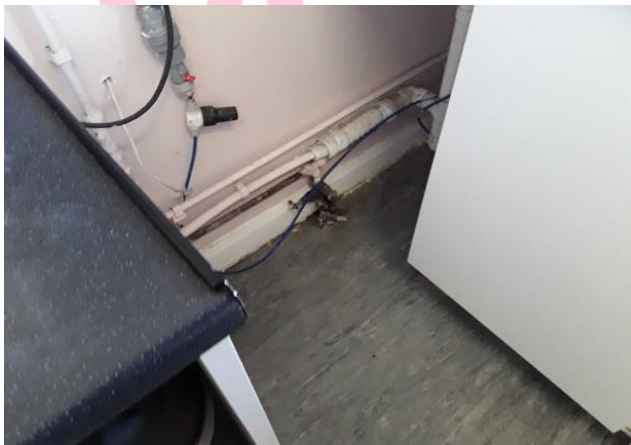
Item 187 - Ref: Presumed

The stop tap gasket (Area 5 – Kitchen) is presumed to contain asbestos.

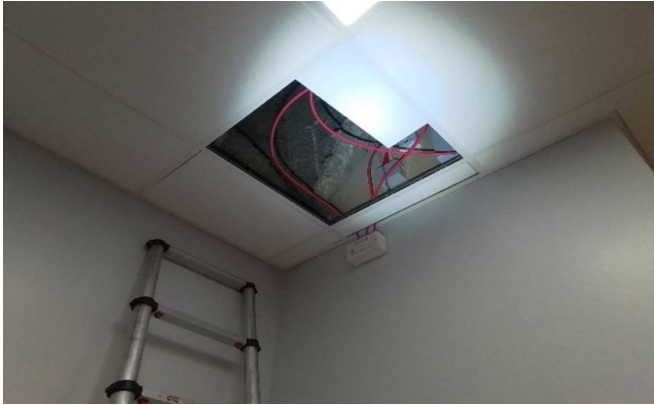
Item 199 - Ref: OQ000085

The ceiling void fire breaks in Corridor A25 (Room G/002) does not contain asbestos.

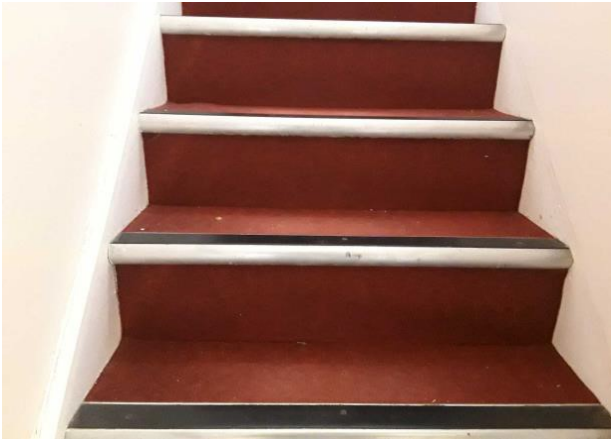
Item 188 - Ref: 22-55417-3

The stair nosing on Stairs Landing (Area 7) does not contain asbestos.

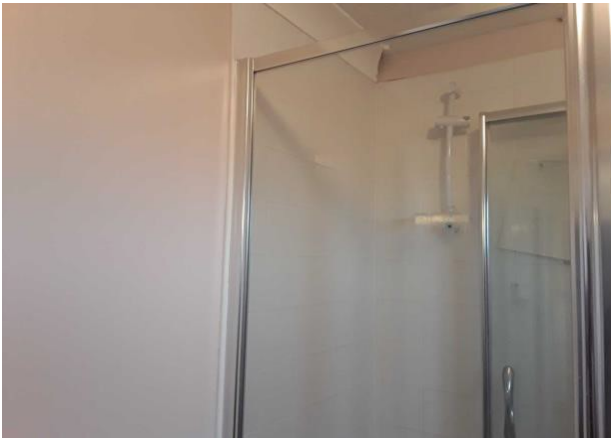
Item 189 - Ref: 22-55417-4

The ceramic tiles to walls (adhesive in the Shower Room (Area 12) does not contain asbestos.

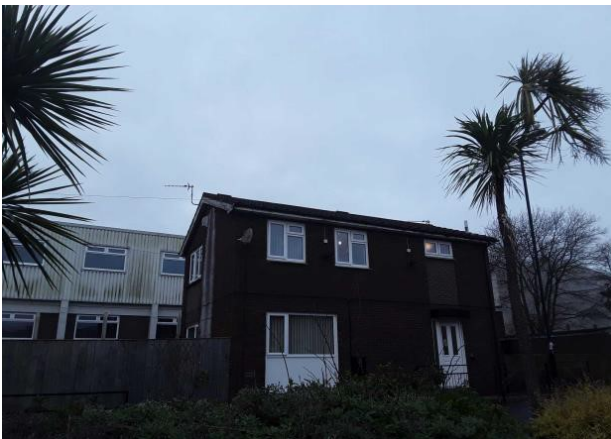
Item 190 - Ref: Presumed

The cement roof ridge vents (External) are presumed to contain asbestos.

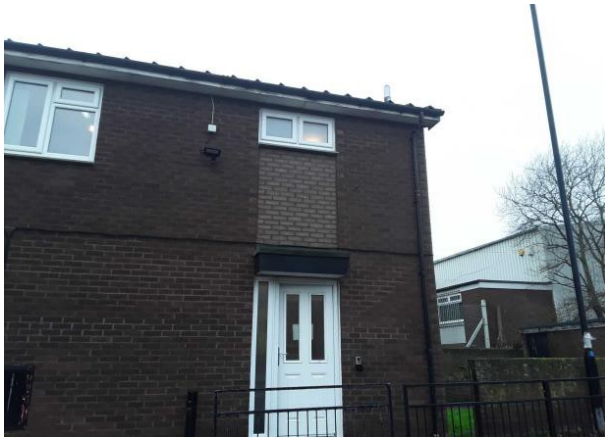
Item 191 - Ref: 22-55417-8

The front door canopy roof felt (External) contains asbestos.

Any change in appearance should be recorded and passed to Property Services.

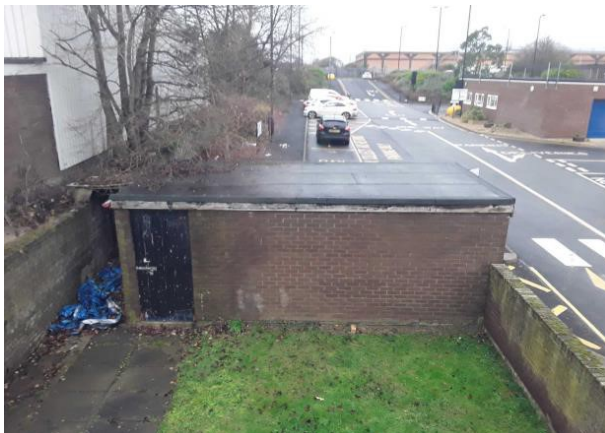
Item 193 - Ref: 22-55417-10

The roof felt to garage (External) does not contain asbestos.
