ASBESTOS SURVEY REPORT FOR CENTRAL LIBRARY, FAWCETT STREET, SUNDERLAND. SR1 1RE

Asbestos Register for

Central Library, Fawcett Street, Sunderland. SR1 1RE

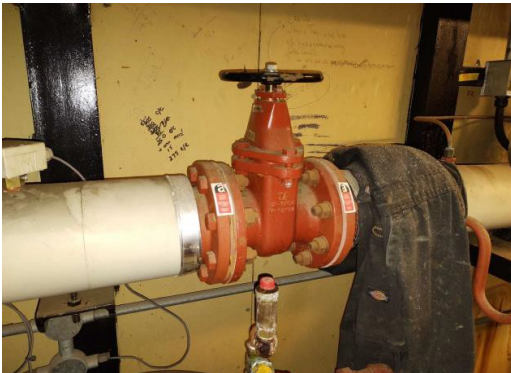
Item 1 Ref: 22-42500-22

The pipe flange gaskets (Area: 04 boiler room) contain asbestos.

Any change in its appearance should be recorded and passed to Property Services.

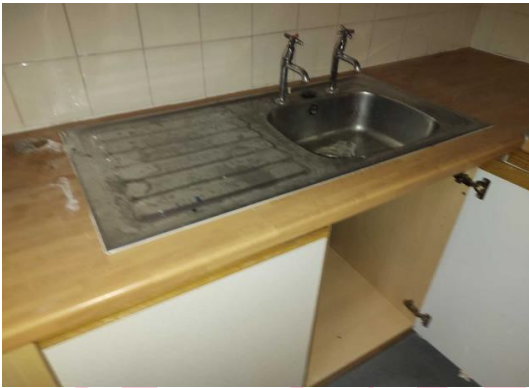
Item 2 Ref: 22-42500-10

The sink pad (Area: 3/25 staff room) does not contain asbestos.

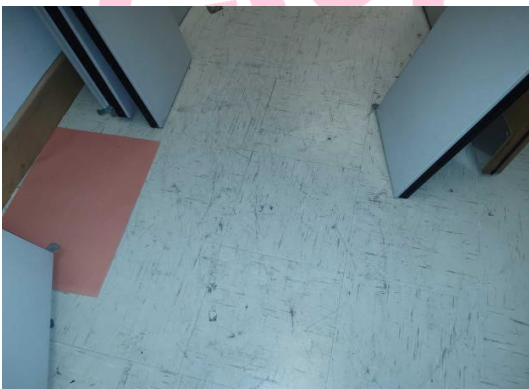
Item 3 Ref: 22-42500-8

The floor (tiles & adhesive) (Area: 3/32 cupboard) does not contain asbestos.

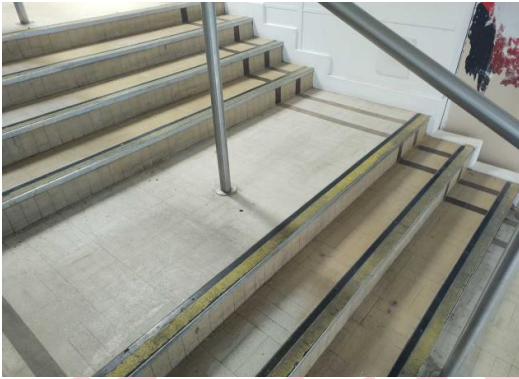
Item 5 Ref: 22-42500-4

The floor (stair nosing treads)
(Area: 3/36 foyer) does not
contain asbestos.

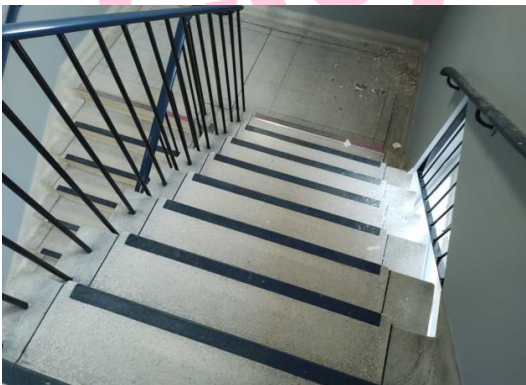
Item 6 Ref: 22-42500-5

The floor (stair nosing treads)
(Area: 3/40 stairwell) does not
contain asbestos.

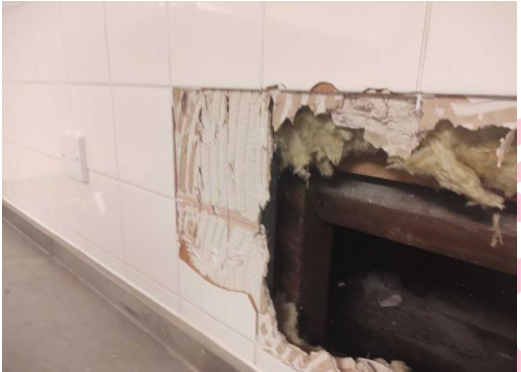
Item 8 Ref: 22-42500-2

The walls (ceramic wall tiles adhesive) (Area: 3/42 kitchen) do not contain asbestos.

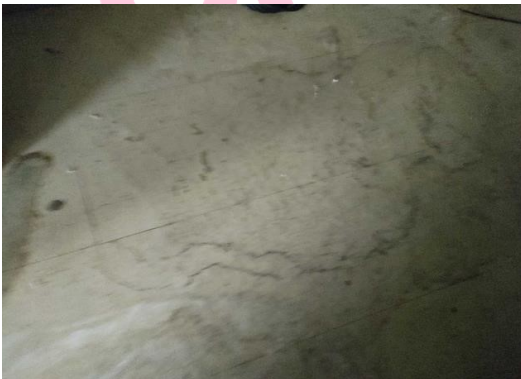
Item 9 Ref: 22-42500-3

The floor (tiles & adhesive) (Area: 3/46 electrical cupboard) does not contain asbestos.

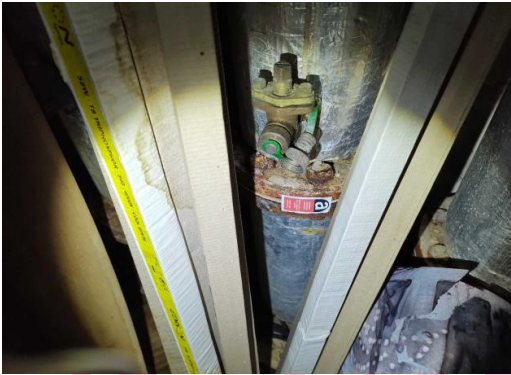
Item 11 Ref: 22-42500-7

The pipe flange gaskets (Area: 3/51 service riser) contain asbestos.

Any change in its appearance should be recorded and passed to Property Services.

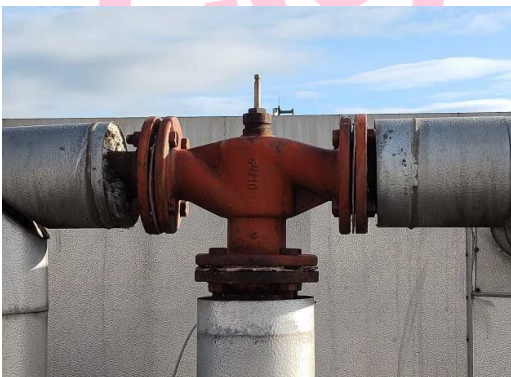
Item 12 Ref: 22-42500-22

- (Item 11) Ref: 22-42500-7 – Pipe flange gaskets (Area: 3/51 service riser) – Very Low Risk
- (Item 12) Ref: 22-42500-22 – Pipe flange gaskets (Area: 02 roof top externals) – Very Low Risk (**repair then monitor**)

The pipe flange gaskets (Area: 02 roof top externals) contain asbestos.

Any change in its appearance should be recorded and passed to Property Services.

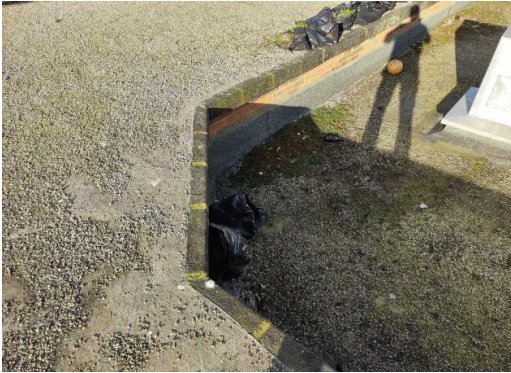
Item 13 Ref: 22-42500-23

The floor (bitumen) (Area: 02 roof top externals) does not contain asbestos.

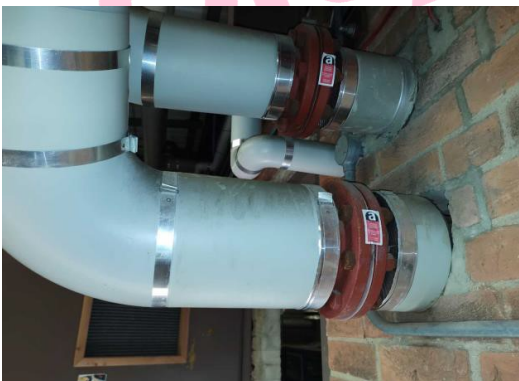
Item 15 Ref: 22-42500-22

The pipe flange gaskets (Area: 03 air handling room) contain asbestos.

Any change in its appearance should be recorded and passed to Property Services.

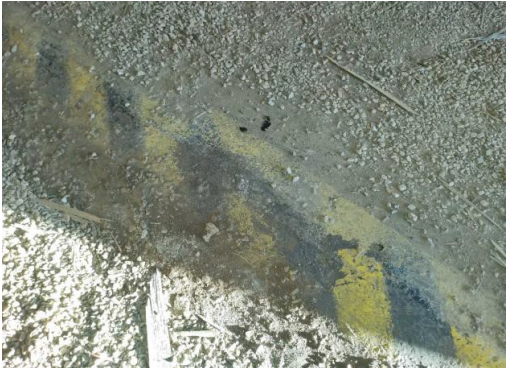
Item 16 Ref: 22-42500-23

The floor (asphalt floor) (Area: 03 air handling room) does not contain asbestos.

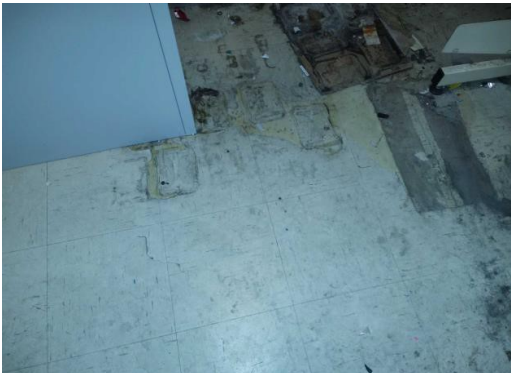
Item 17 Ref: 22-42500-27

The floor (tiles & adhesive) (Area: 1-004 switch room) does not contain asbestos.

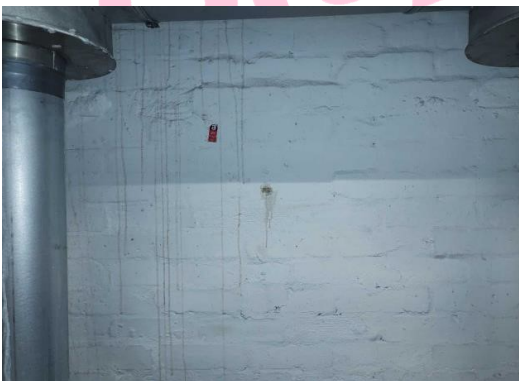
Item 18 Ref: 22-42500-13

The walls (residue to walls - insulation) (Area: 05 boiler room) contain asbestos.

Any change in its appearance should be recorded and passed to Property Services.

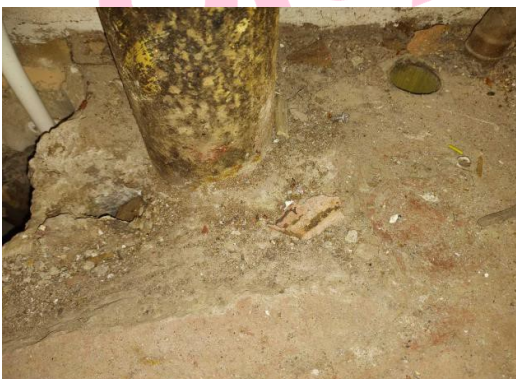
Item 21 Ref: 22-42500-16

- (Item 21) Ref: 22-42500-16 – Gasket debris to floor beneath modern fuse board & by cast iron down pipe (Area: 05 boiler room) – Low Risk (**Rhodar to remove**)

The gasket debris to floor beneath modern fuse board & by cast iron down pipe (Area: 05 boiler room) contains asbestos.

Any change in its appearance should be recorded and passed to Property Services.

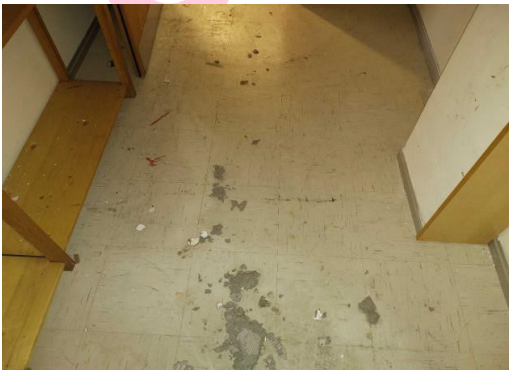
Item 24 Ref: 22-42500-27

The floor (tiles & adhesive) (Area: 2/009 store cupboard) does not contain asbestos.

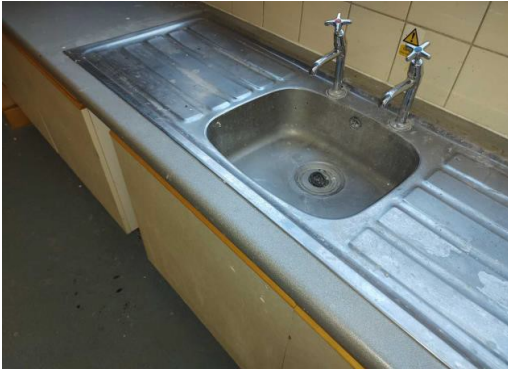
Item 25 Ref: 22-42500-28

The sink pad (Area: 2/01 staff room) does not contain asbestos.

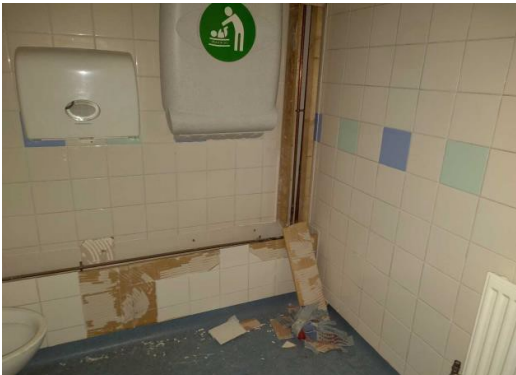
Item 26 Ref: 22-42500-26

The walls (adhesive) (Area: 2/012 baby care rom) do not contain asbestos.

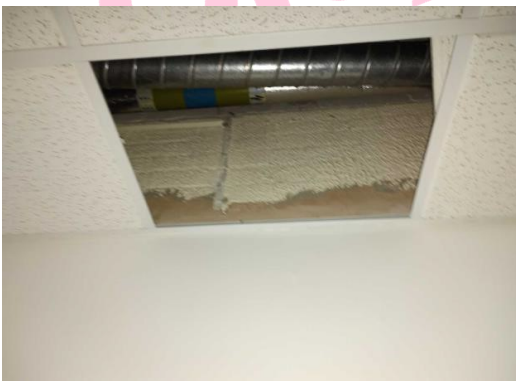
Item 27 Ref: 22-42500-29

The walls (textured coating) (Area: 2/015 office) contain asbestos.

Any change in its appearance should be recorded and passed to Property Services.

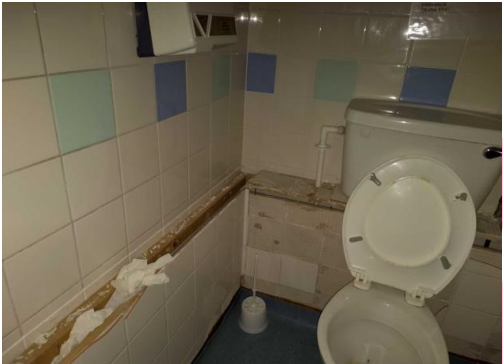
Item 29 Ref: 22-42500-26

The walls (ceramic tile adhesive) (Area: 2/02 staff wc) do not contain asbestos.

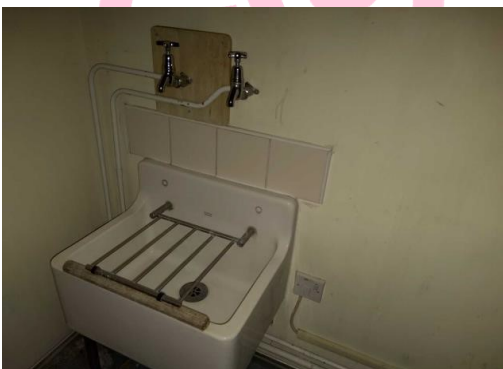
Item 30 Ref: 22-42500-26

The walls (ceramic tile adhesive) (Area: 2/021 cleaners cupboard) do not contain asbestos.

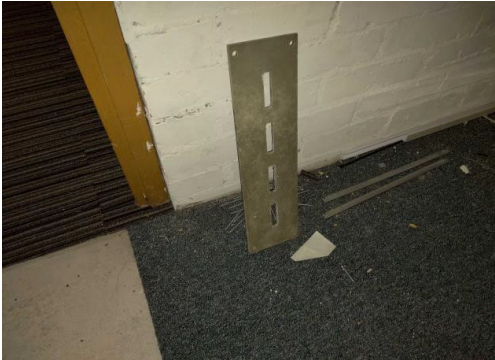
Item 31 Ref: 22-42500-30

The loose lying cement arc chute (cement) (Area: 2/022 electrical cupboard) contains asbestos.

Item 28	No asbestos	Is present		
Item 29	No asbestos	Is present		
Item 30	No asbestos	Is present		
Item 31	Loose lying cement arc chute (cement) (Area: 2/022 electrical cupboard)	Very Low Risk	12 monthly	Rhodar to remove

Any change in its appearance should be recorded and passed to Property Services.

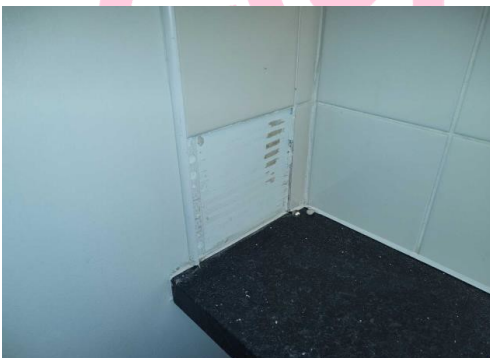
Item 33 Ref: 22-42500-26

The walls (ceramic tile adhesive) (Area: 2/027 kitchen) do not contain asbestos.

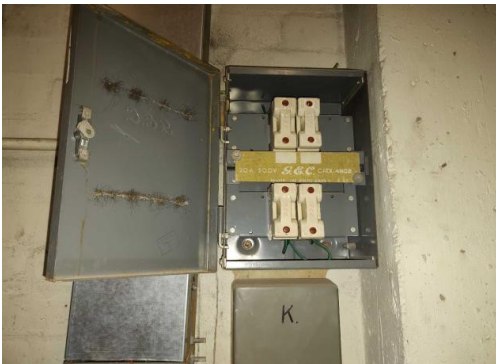
Item 35 Ref: 22-42500-12

The cement arc chute within redundant GEC electric box (Area: 3/01D electrical cupboard) contain asbestos.

Removed according to reinspection survey J133587

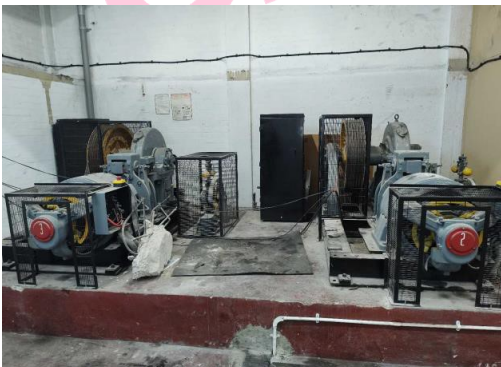
Item 36 Ref: Presumed

The brake shoes to lift machinery (cement) (Area: 04A lift motor room) are presumed to contain asbestos.

Any change in its appearance should be recorded and passed to Property Services.

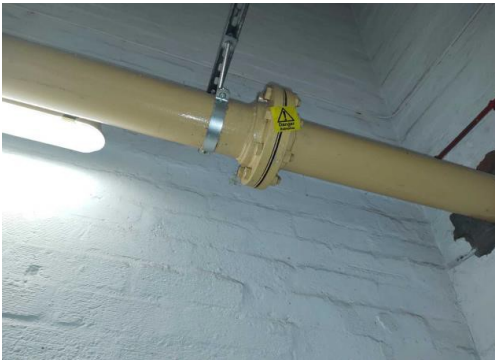
Item 38 Ref: Presumed

The pipe flange gasket (Area: 05A corridor) is presumed to contain asbestos.

Any change in its appearance should be recorded and passed to Property Services.

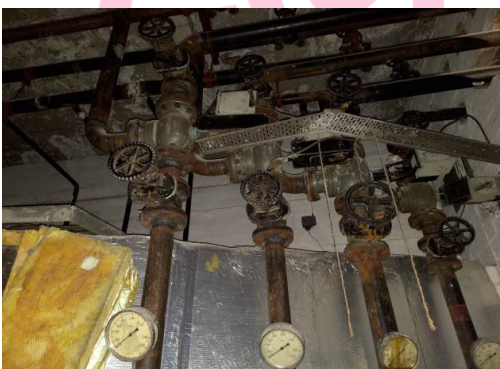
Item 39 Ref: Presumed

The pipe flange gaskets (Area: 05E ventilation rooms) are presumed to contain asbestos.

Any change in its appearance should be recorded and passed to Property Services.

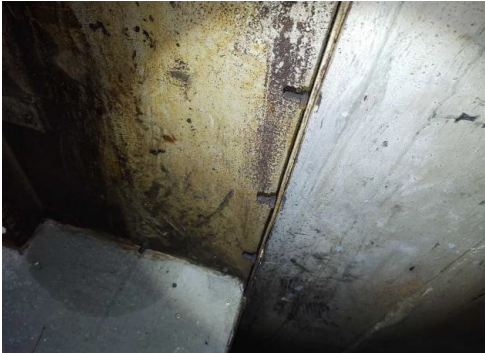
Item 40 Ref: 22-42500-19

The ductwork joint sealants (mastic) (Area: 05E ventilation rooms) do not contain asbestos.

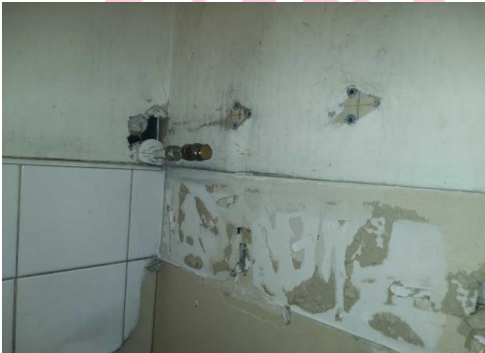
Item 42 Ref: 22-42500-26

The walls (ceramic tile adhesive) (Area: 2/04 electrical cupboard) do not contain asbestos.

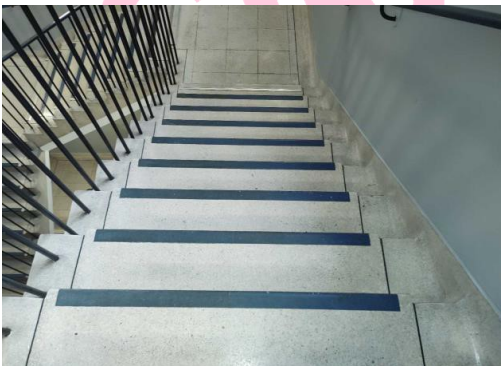
Item 45 Ref: 22-42500-5

The floor stair nosing (Area: 1/35 stairwell) does not contain asbestos.

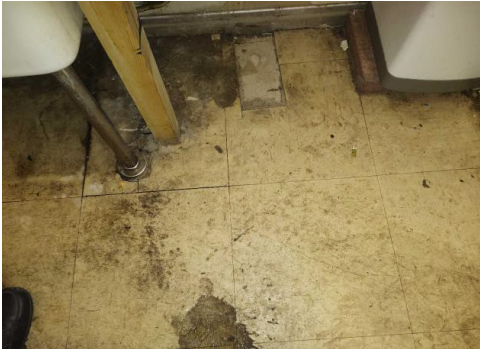
Item 46 Ref: 22-42500-27

The floor (tiles & adhesive)
(Area: 1/01 switch room) does
not contain asbestos.

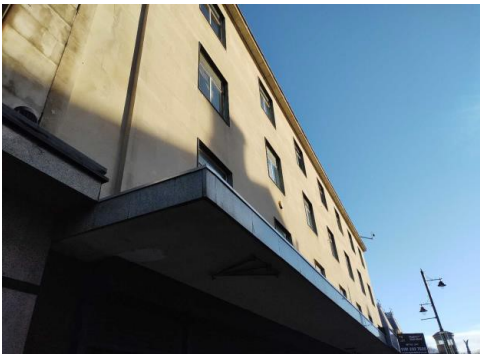
Item 47 Ref: Presumed

The felt to canopy (bitumen)
(Area: 06 building externals) is
presumed to contain
asbestos.

Any change in its appearance
should be recorded and
passed to Property Services.

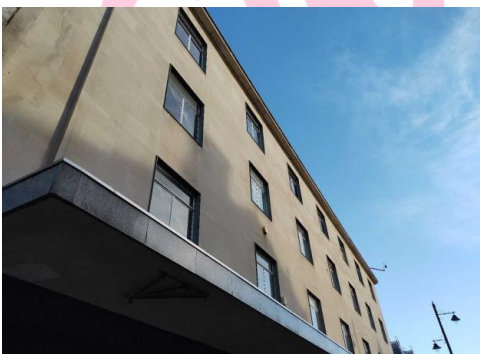
Item 48 Ref: Presumed

The window putty to front &
side elevation (putty) (Area:
06 building externals) is
presumed to contain
asbestos.

Any change in its appearance
should be recorded and
passed to Property Services.

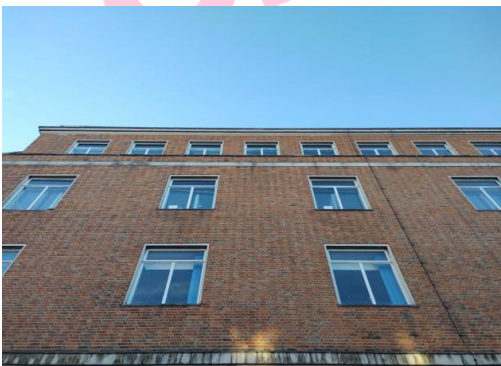
Item 51 Ref: Presumed

The windows to side elevation on John Street (putty) (Area: 06 building externals) are presumed to contain asbestos.

Any change in its appearance should be recorded and passed to Property Services.

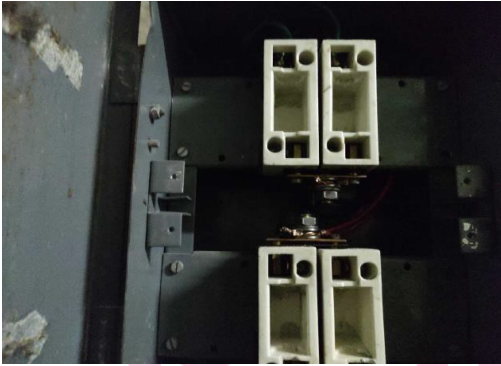
Item 53 Ref: Presumed

The flash guard residue within GEC isolation box to wall 4 no. fuses (woven) (Area: B/02 switch room) is presumed to contain asbestos.

Any change in its appearance should be recorded and passed to Property Services.

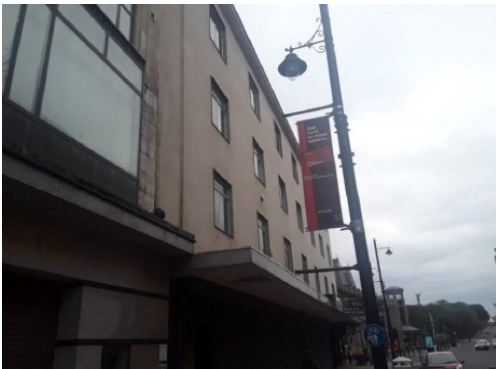
Item 54 Ref: NZ000576

The window putty/seal to glass on the third floor (External) does not contain asbestos.
