ASBESTOS SURVEY REPORT FOR SUNDERLAND MUSEUM AND WINTER GARDENS, BURDON ROAD, SUNDERLAND, SR1 1PP.

Asbestos Register for Sunderland Museum and Winter Gardens

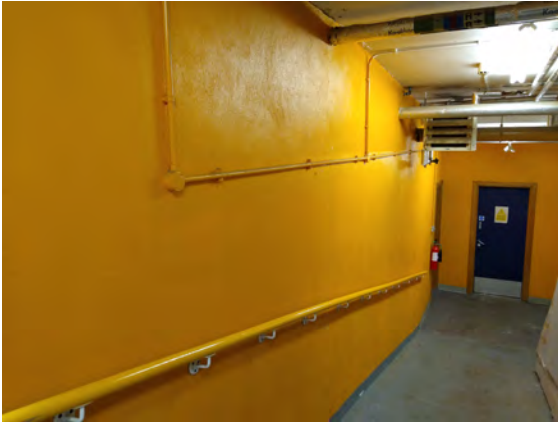
Item 1 Ref: As 402578-11

The wall coating in -1/001/Lift lobby does not contain asbestos.

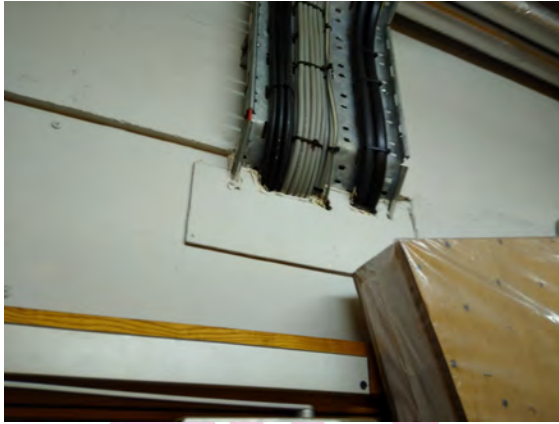
Various Ref: 402578-14

The wall panel in -1/001/Lift lobby does not contain asbestos.

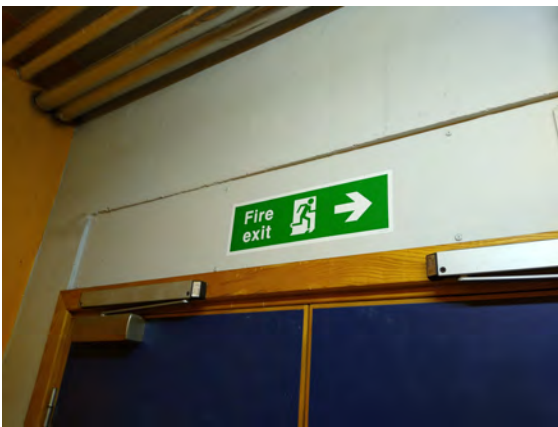
Item 3 Ref: 402578-15

The door header panel in -1/001/Lift lobby does not contain asbestos.

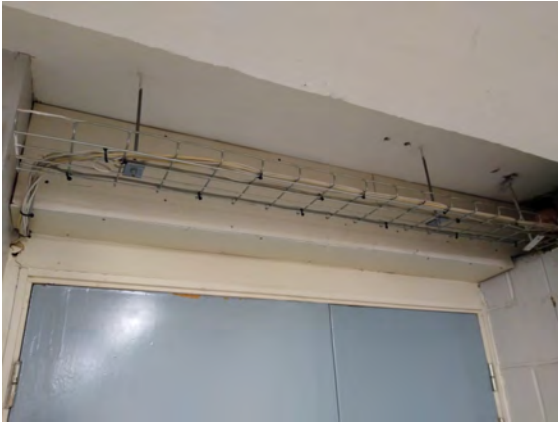
Item 4 Ref: 402578-17

The boxing in -1/001/Lift lobby does not contain asbestos.

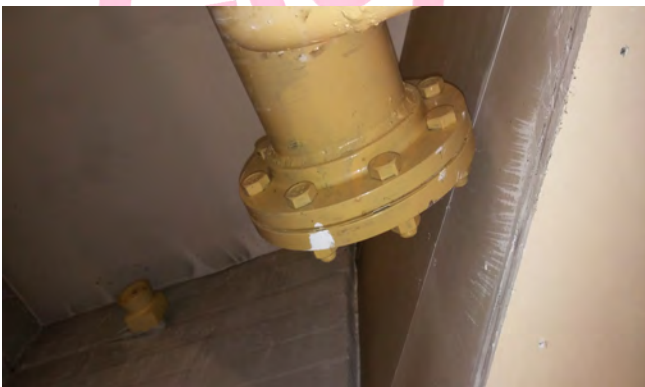
Item 6 Ref: 402578-32

The pipework flange gasket to gas pipe in -1/009/Boiler Room does not contain asbestos.

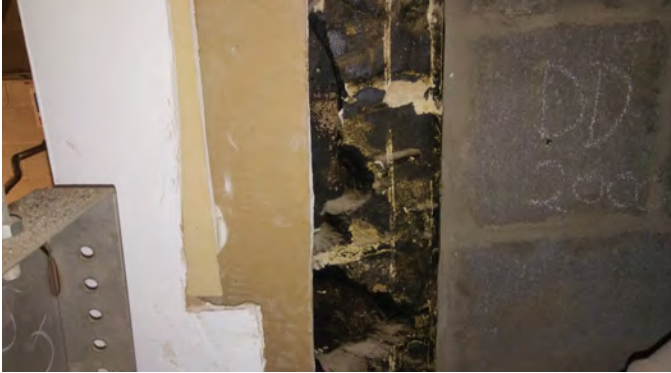
Item 7 Ref: As 402578-33

The lining within wall cavity to boiler flue duct in -1/009/Boiler Room does not contain asbestos.

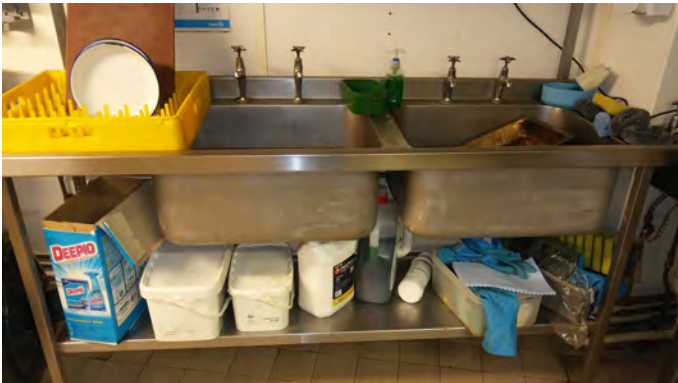
Item 8 Ref: 402578-40

The sink paint in -1/012/Kitchen does not contain asbestos.

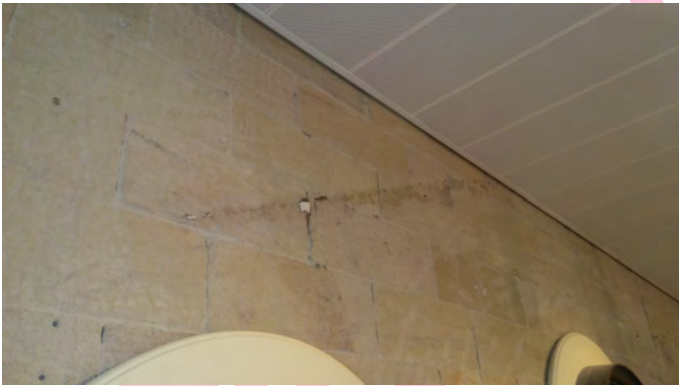
Item 14 Ref: As 402578-41

The remnant mastic to wall from former pitched roof in 0/001b/Museum Street contains asbestos.

Any change in its appearance should be recorded and passed to Property Services.

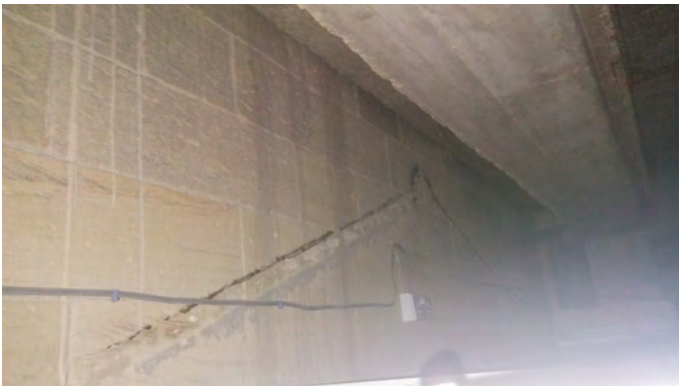
Item 15 Ref: 402578-41

The remnant mastic to wall from former pitched roof in 0/001b/Museum Street void above suspended ceiling contains asbestos.

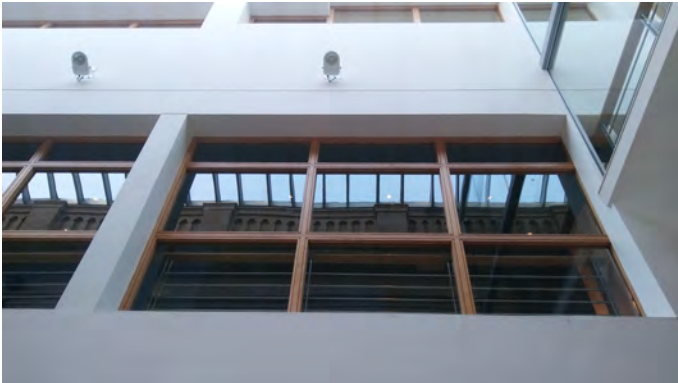
Item 17 Ref: As 402578-29

The glazing mastic in
0/013/Circulation does not
contain asbestos.

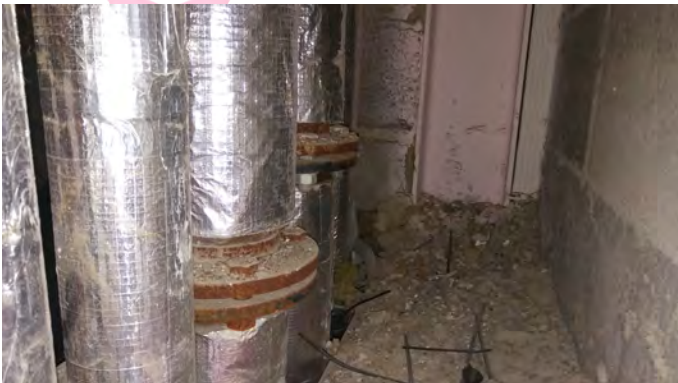
Item 21 Ref: As 402578-16

The pipework flange gasket in 0/019/Riser does not contain asbestos.

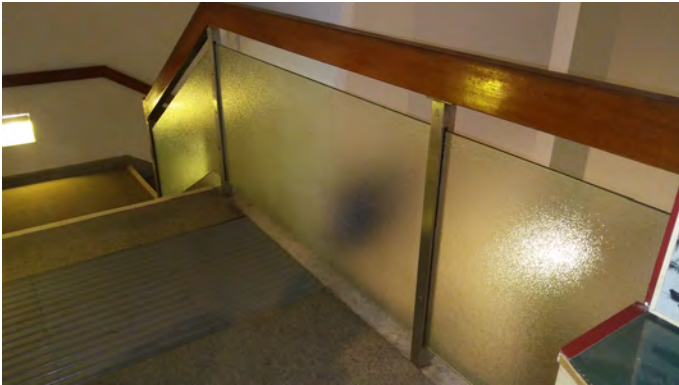
Item 26 Ref: As 402578-22

The sealant to glazed stairwell panel in 1/001/Stairwell contains asbestos.

Any change in its appearance should be recorded and passed to Property Services.

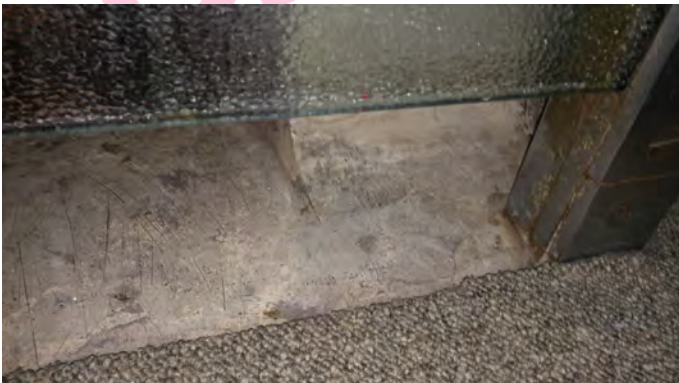
Item 27 Ref: As 402578-23

The floor in 1/001/Stairwell contains asbestos.

Any change in its appearance should be recorded and passed to Property Services.

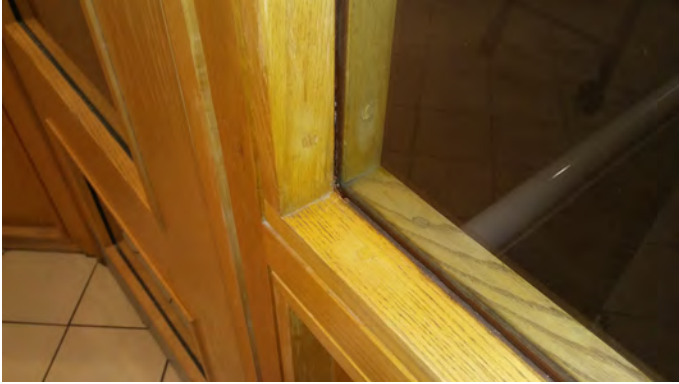
Item 28 Ref: 402578-24

The glazing mastic in 1/001a/Lift lobby does not contain asbestos.

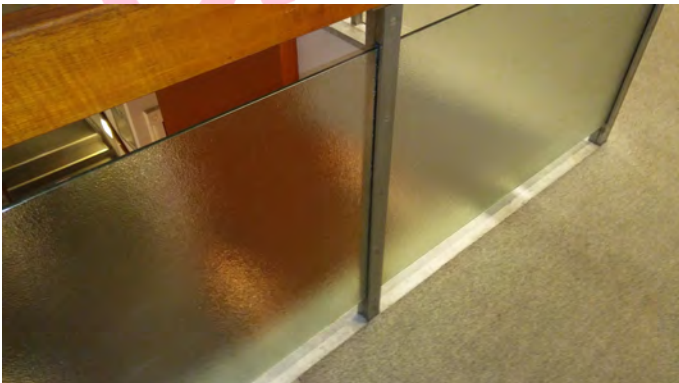
Item 30 Ref: As 402578-22

The sealant to glazed stairwell in 1/002/Stairwell landing contains asbestos.

Any change in its appearance should be recorded and passed to Property Services.

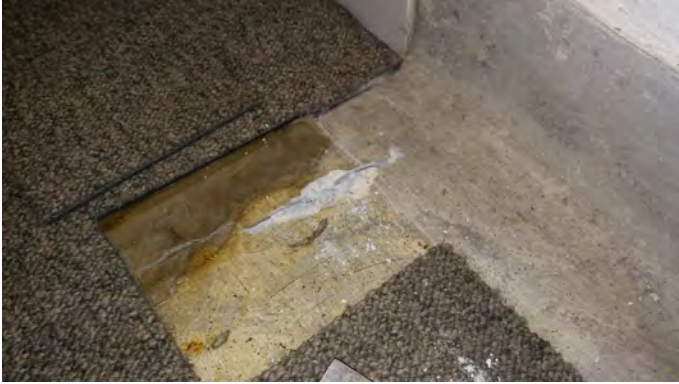
Item 31 Ref: 402578-23

The floor in 1/002/Stairwell landing contains asbestos.

Any change in its appearance should be recorded and passed to Property Services.

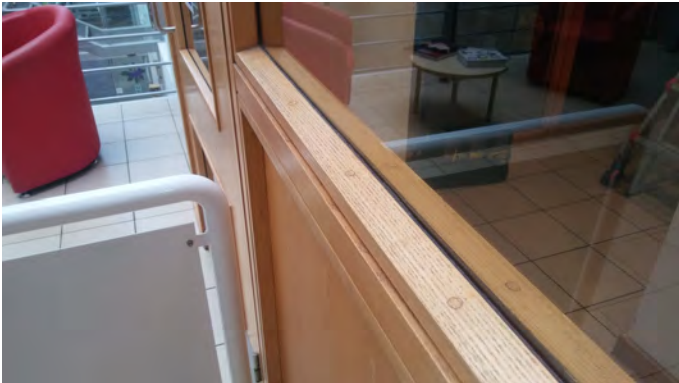
Item 32 Ref: As 402578-24

The glazing mastic in 1/005a/Lobby does not contain asbestos.

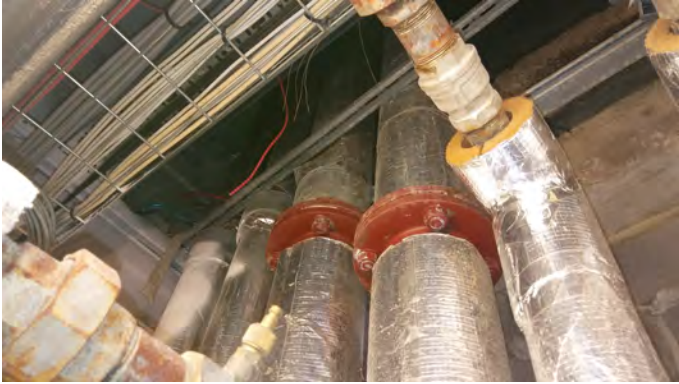
Item 34 Ref: 402578-16

The pipework flange gasket in 1/011/Riser does not contain asbestos.

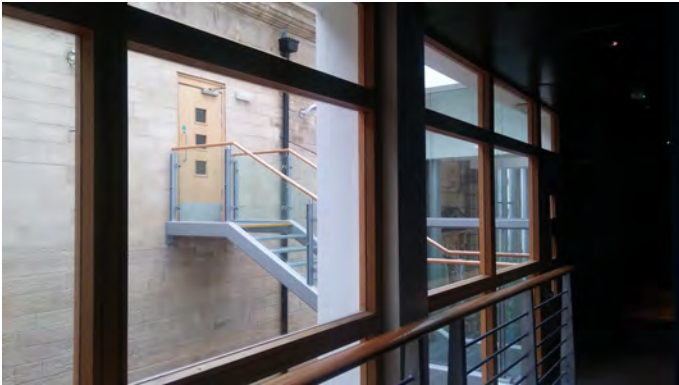
Item 35 Ref: As 402578-24

The glazing mastic in 1/014/Circulation does not contain asbestos.

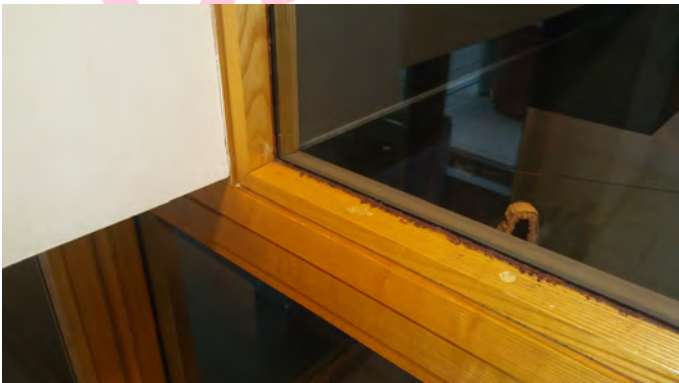
Item 36 Ref: As 402578-24

The glazing mastic in 1/014a/Lift lobby does not contain asbestos.

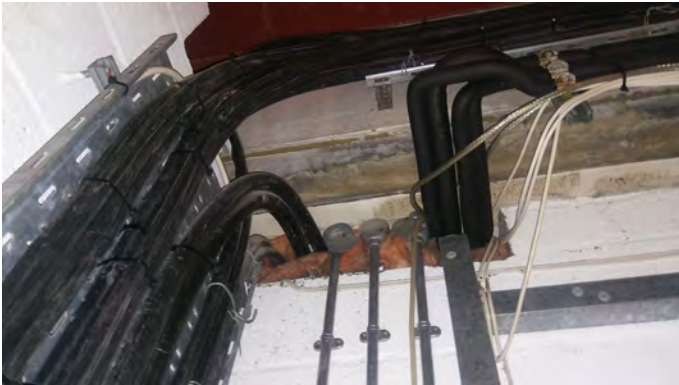
Item 38 Ref: As 402578-26

The remnant mastic to beam in 1/025/Plant room does not contain asbestos.

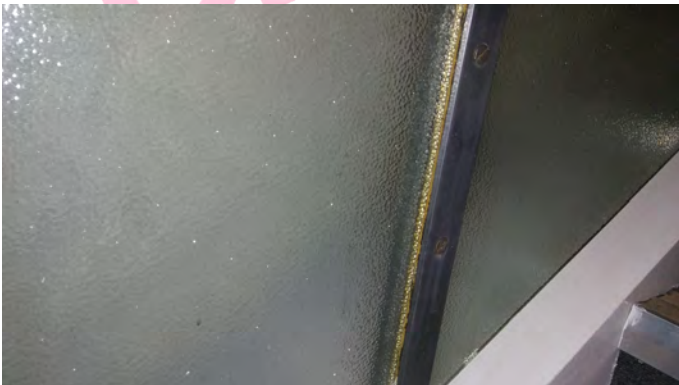
Item 39 Ref: 402578-22

The sealant to glazed stairwell panels in 2/001/Stairwell contains asbestos.

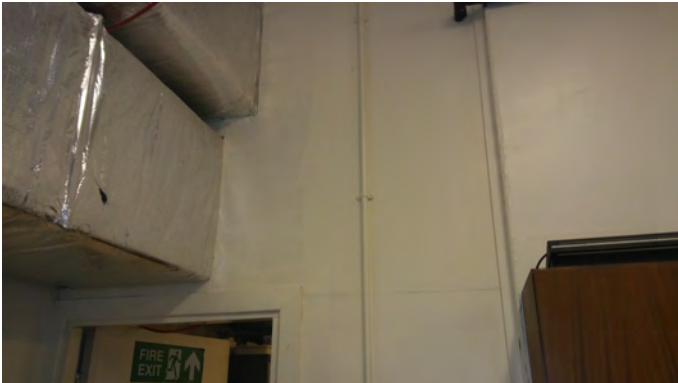
Item 44 Ref: As 402578-21

The walls in 2/021/Store do not contain asbestos.

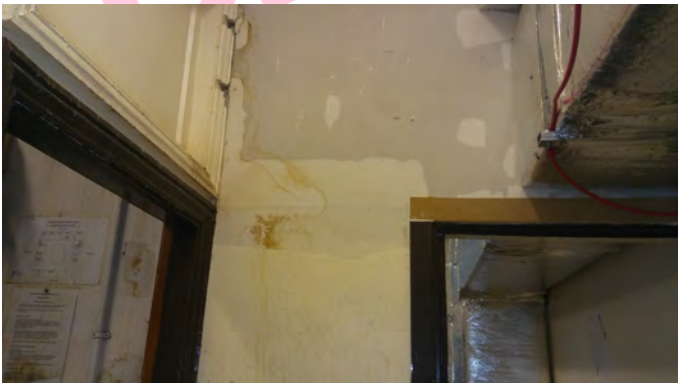
Item 45 Ref: 402578-21

The walls in 2/023/Lobby do not contain asbestos.

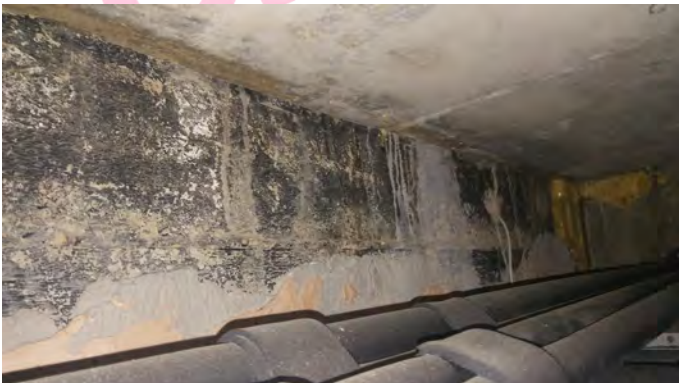
Item 48 Ref: As 402578-18

The coating to beams in 2/027/Corridor void above does not contain asbestos.

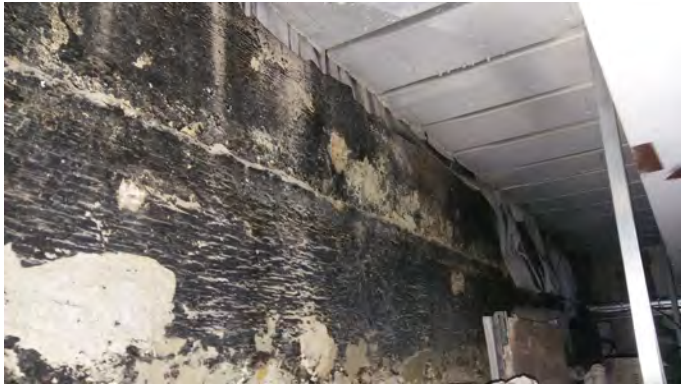
Item 49 Ref: 402578-18

The coating to beams in 2/028/Office void above does not contain asbestos.

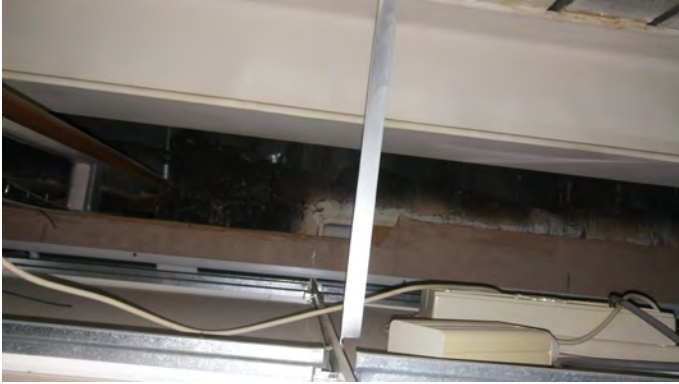
Item 58 Ref: As 402578-7

The coating to concrete beam in 3/011/Staff kitchen void above does not contain asbestos.

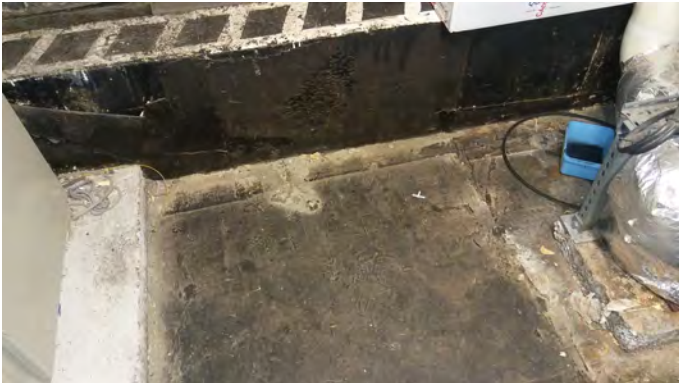
Item 59 Ref: 402578-1

The floor and low-level wall covering in 4/001/Plant room does not contain asbestos.

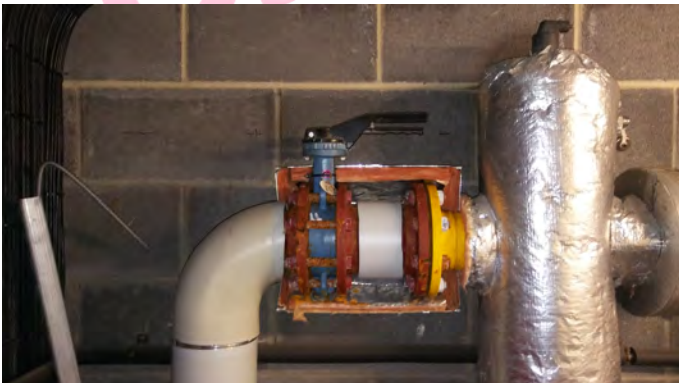
Item 60 Ref: 402578-2

The pipework flange gasket in 4/001/Plant room does not contain asbestos.

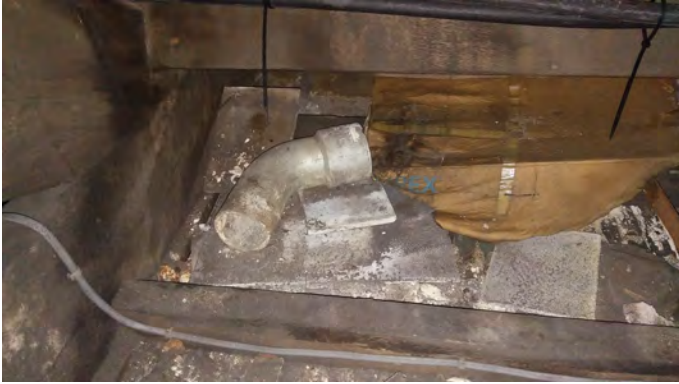
Item 61 Ref: 402578-34

The debris in 4/002/Roof void contains asbestos.

Removed April 2020.

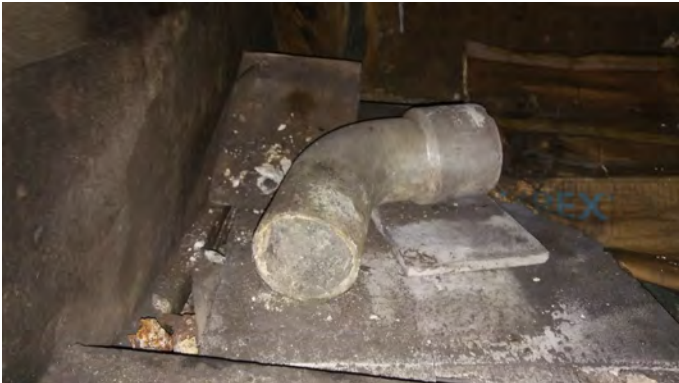
Item 62 Ref: 402578-35

The redundant flue debris in 04/002/Roof void contains asbestos.

Removed April 2020

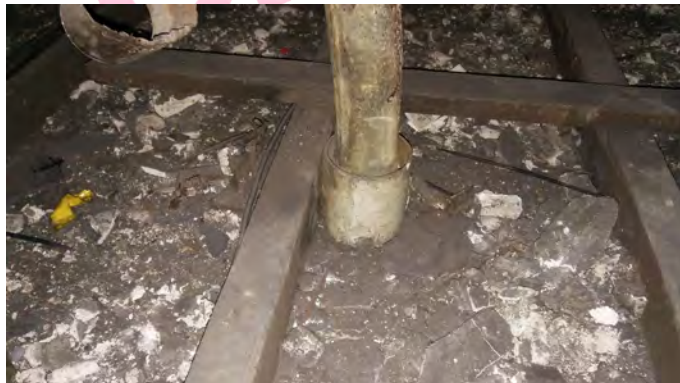
Item 63 Ref: As 402578-35

The redundant flue in 04/002/Roof void contains asbestos.

Any change in its appearance should be recorded and passed to Property Services.

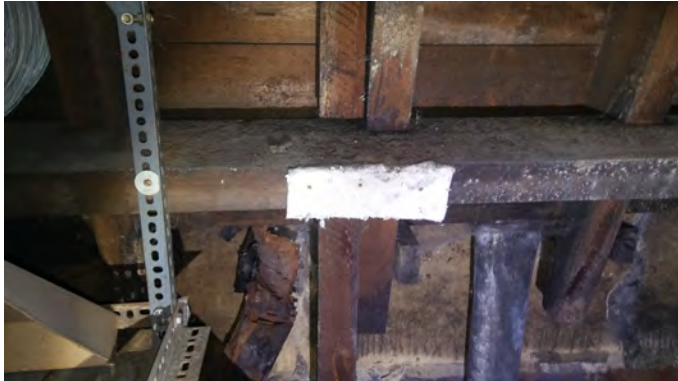
Item 64 Ref: 402578-36

The remnant board nailed to beam adjacent tank in 04/002/ Roof void contains asbestos.

Removed April 2020

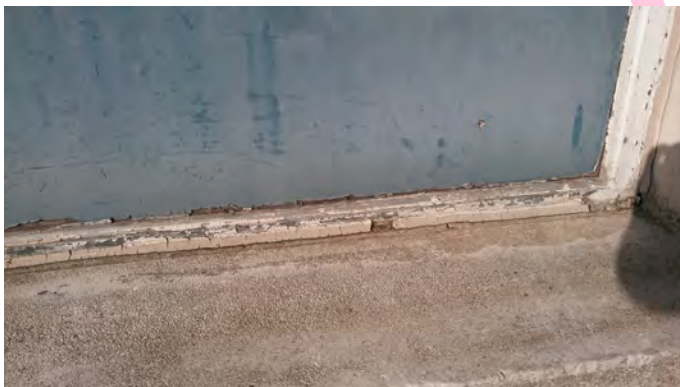
Item 65 Ref: 402578-37

The sealant to windows (External) does not contain asbestos.

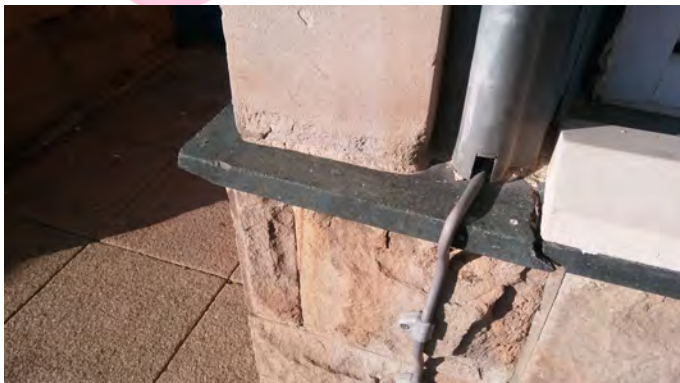
Item 66 Ref: As 402578-28

The windowsill (External) does not contain asbestos.

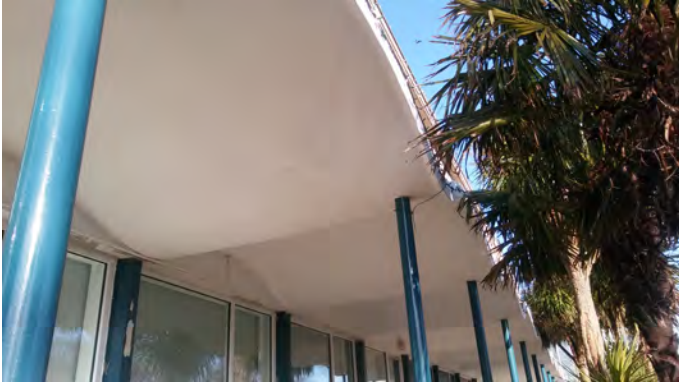
Item 67 Ref: 402578-38

The expansion joint to canopy (External) does not contain asbestos.

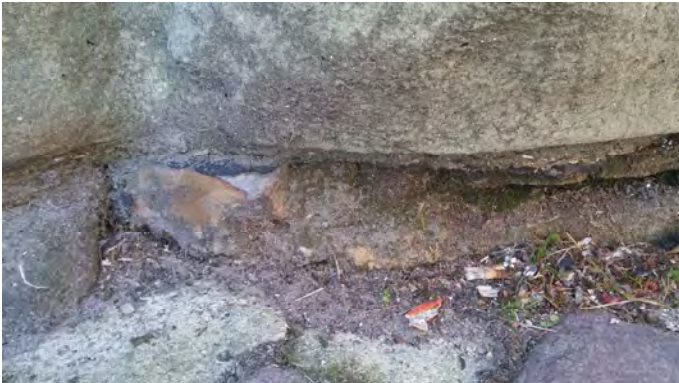
Item 68 Ref: 402578-39

The damp proof course (External) does not contain asbestos.

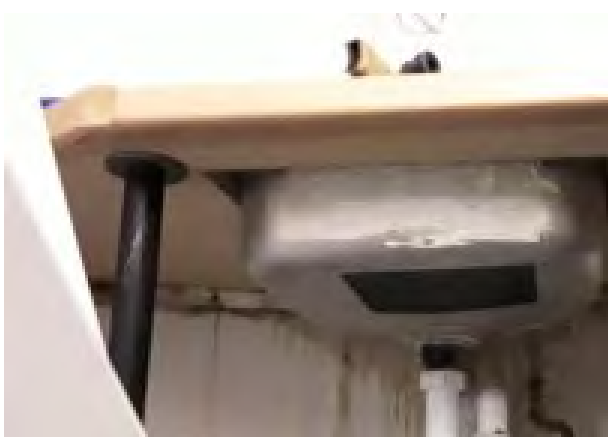
Item 75 Ref: 21-33220-1

The sink pad in the Words Alive Section does not contain asbestos.

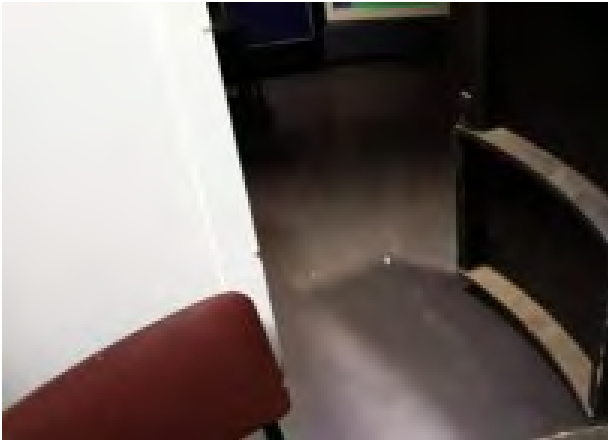
Item 76 Ref: 21-33220-2

The tiles and adhesive around aquatic tanks in the Worlds Alive Section does not contain asbestos.

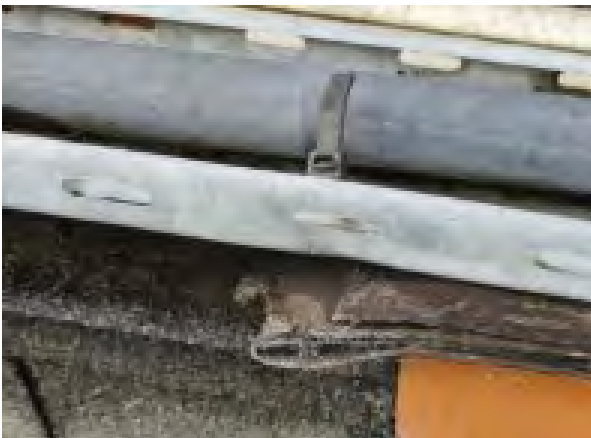
Item 77 Ref: 21-33511-4

The bitumen felt roof lining at chiller (Roof) does not contain asbestos.

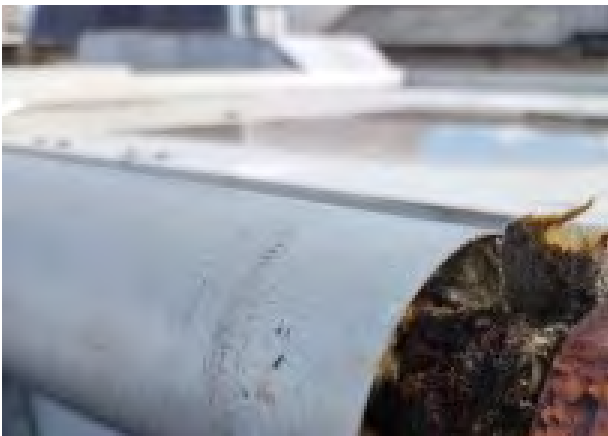
Item 78 Ref: 21-33511-5

The textile wrap to AC filter unit pipework (Roof) does not contain asbestos.

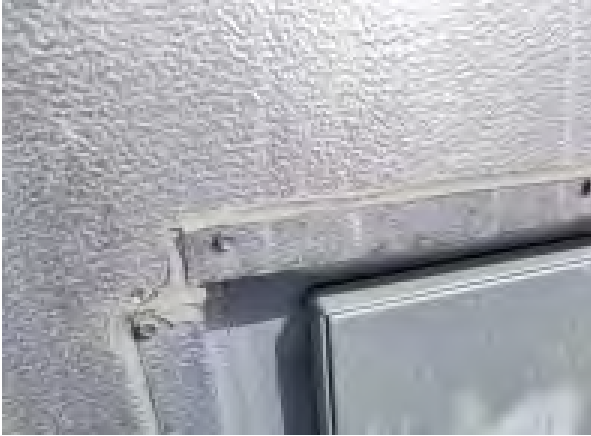
Item 79 Ref: 21-33511-6

The vessels - sealant to ducting (Roof) does not contain asbestos.

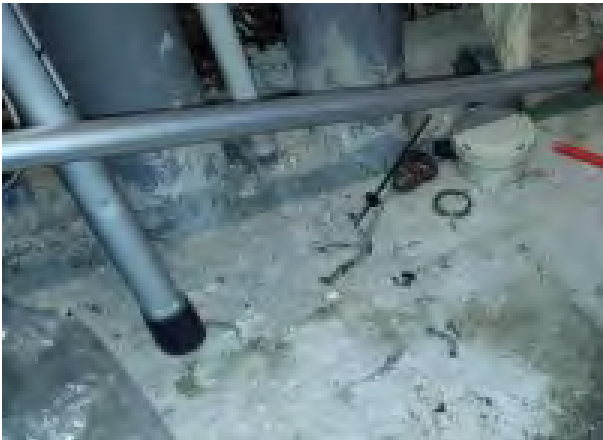
Item 80 Ref: 21-33511-7

The bitumen to the floor (Roof Plant Room) does not contain asbestos.

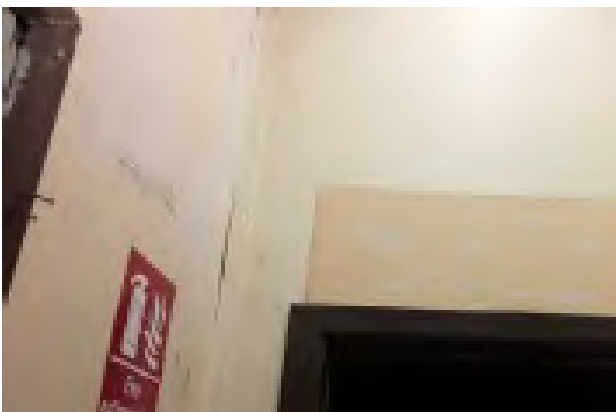
Item 81 Ref: 21-38552-1

The walls in the passage and corridor (Floor 2 Room 8) does not contain asbestos.

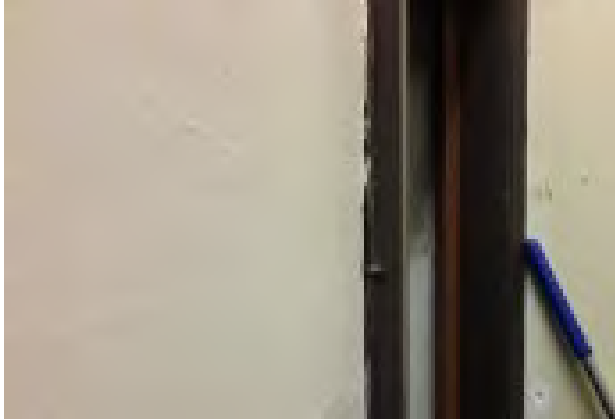
Item 82 Ref: 21-38552-1

The walls in the hall (Floor 2 Room 10) does not contain asbestos.

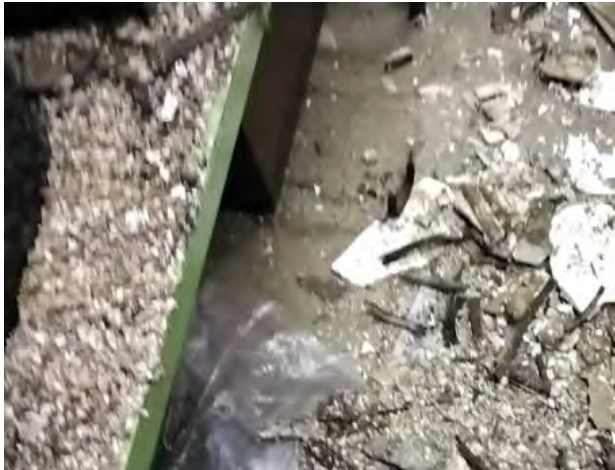
Item 83 Ref: AW004671

The lath and plaster ceiling in the laboratory (Rm 4/002) does not contain asbestos.

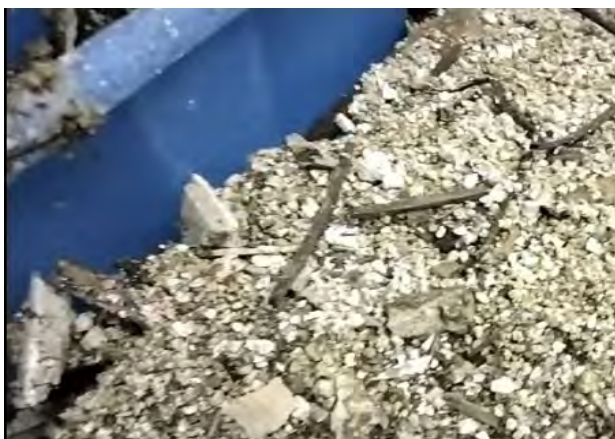
Item 84 Ref: AW004672

The insulation in the ceiling void in the laboratory (Rm 4/002) does not contain asbestos.

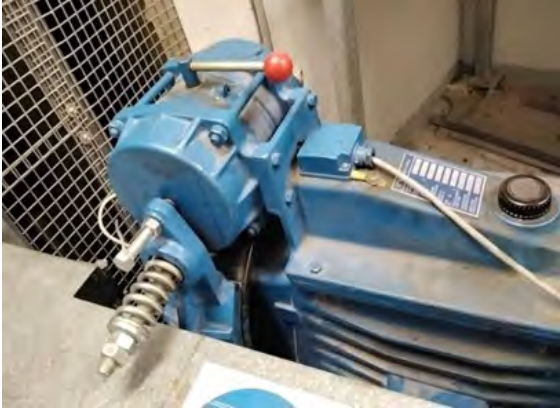
Item 85 Ref: KX000712

The lift brakes/clutch in lift machinery room for good lift (Rm Z/002) does not contain asbestos.

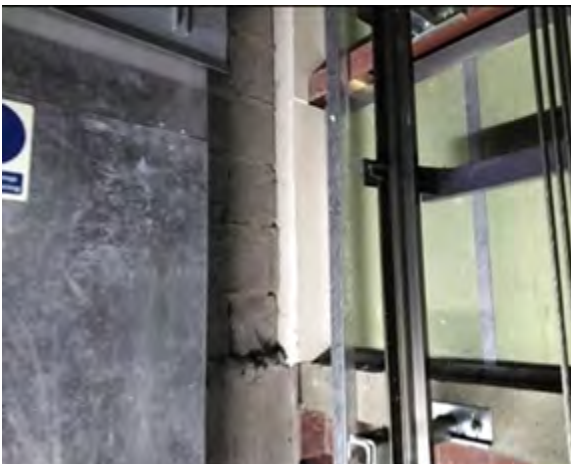
Item 86 Ref: KX000707

The column cladding to all 4 corners sampled at bottom of shaft in lift shaft main hall passenger lift (Rm G/001) does not contain asbestos.

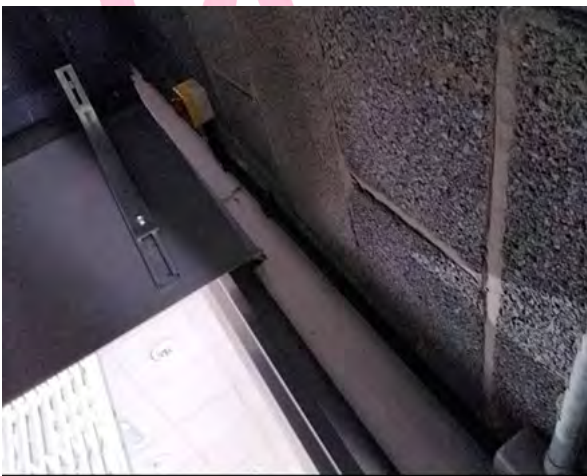
Item 87 Ref: KX000708

The door frame infill panel in lift shaft main hall passenger lift (Rm G/001) does not contain asbestos.

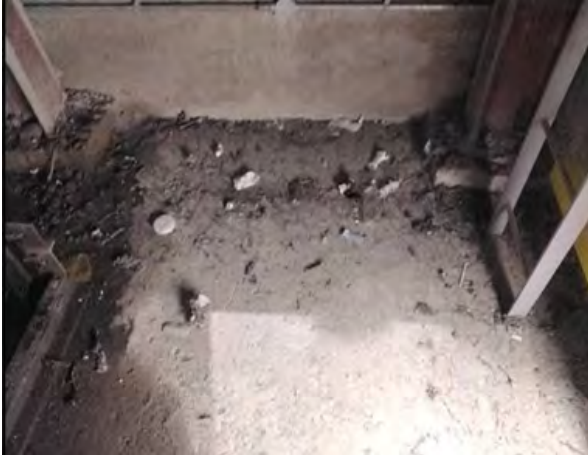
Item 88 Ref: KX000709

The debris to pit and ledges in lift shaft main hall passenger lift (Rm G/001) does not contain asbestos.

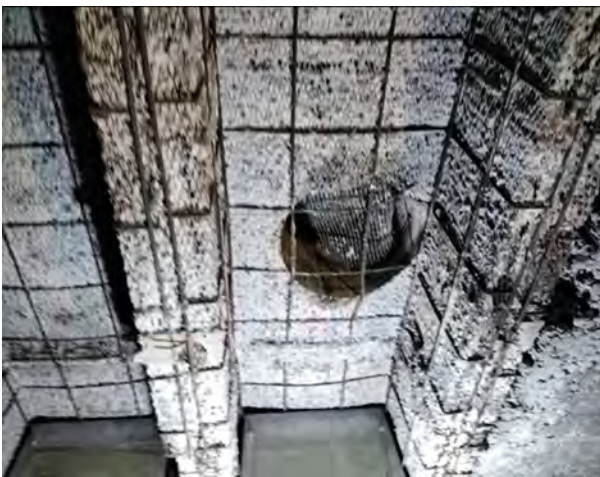
Item 89 Ref: KX000710

The debris/residue to ventilation hole in roof in lift shaft main hall passenger lift (Rm G/001) does not contain asbestos.

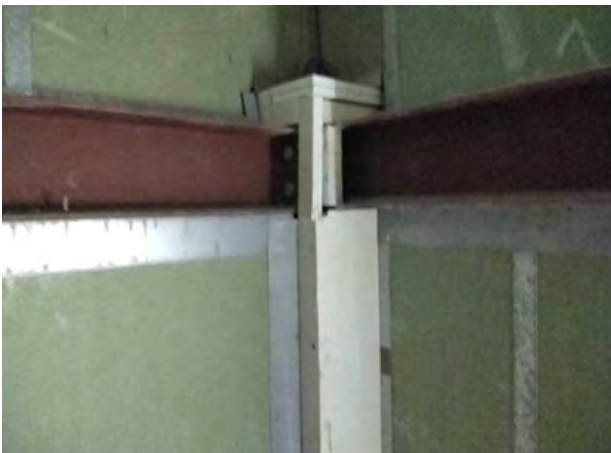
Item 90 Ref: KX000711

The column cladding to all 4 corners sampled from top of shaft in lift shaft main hall passenger lift (Rm G/001) does not contain asbestos.

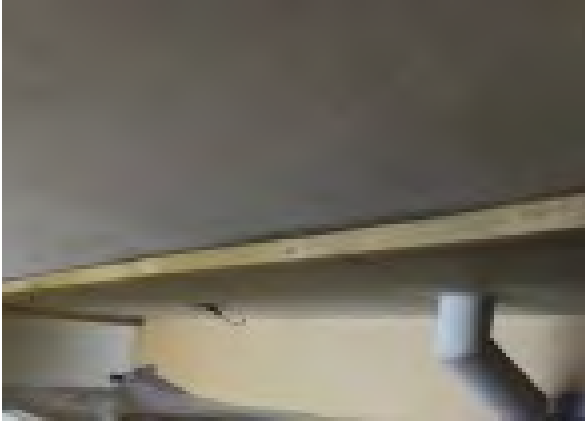
Item 91 Ref: As PZ000276

The pipework in the Herbarium room (Rm 2/001) does contain asbestos.

Any change in appearance should be reported to Property Services.

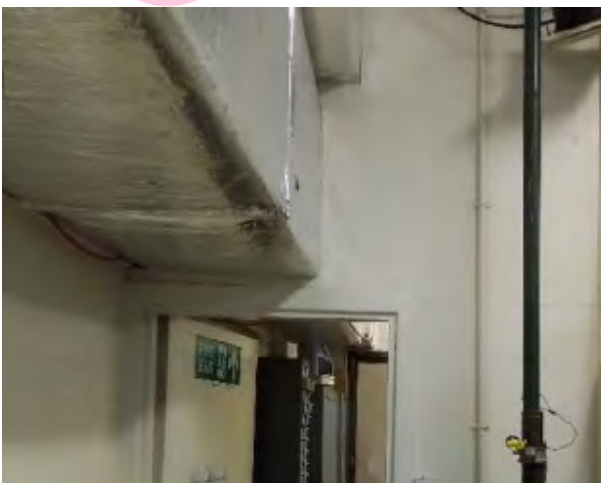
Item 93 Ref: PZ000279

The wall in the Store Room (Rm G/005) does not contain asbestos.

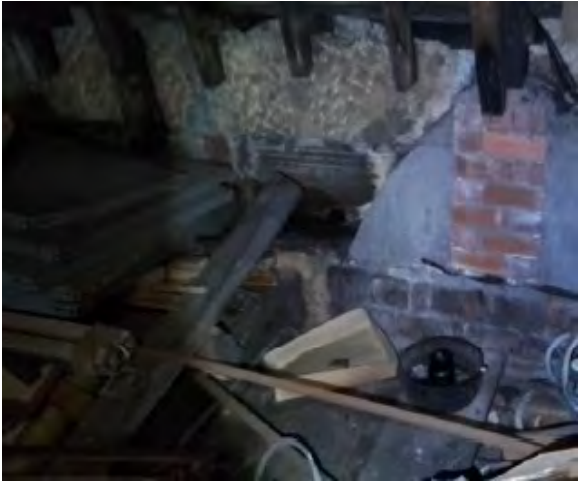
Item 94 Ref: PZ000275

The damp proof course in the loft space (Rm R/001) does not contain asbestos.

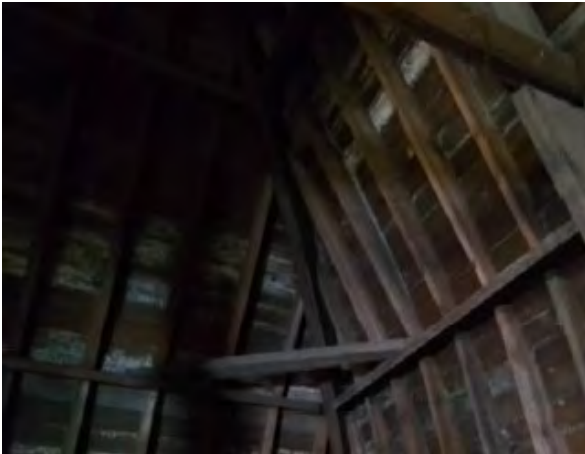
Item 95 Ref: PZ0002774

The roof lining to domed area in the loft space (Rm R/001) does not contain asbestos.

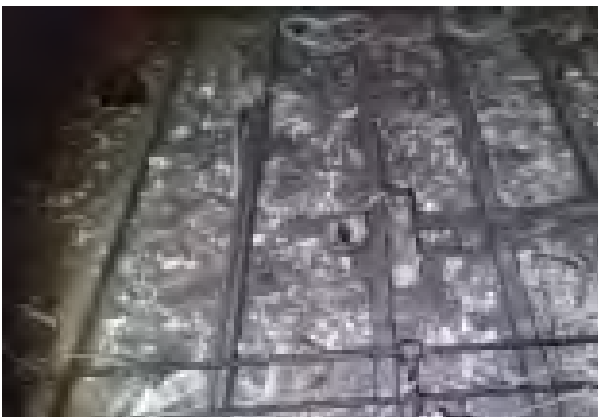
Item 96 Ref: PZ000276

The pipework in the loft space (Rm R/001) does contain asbestos.

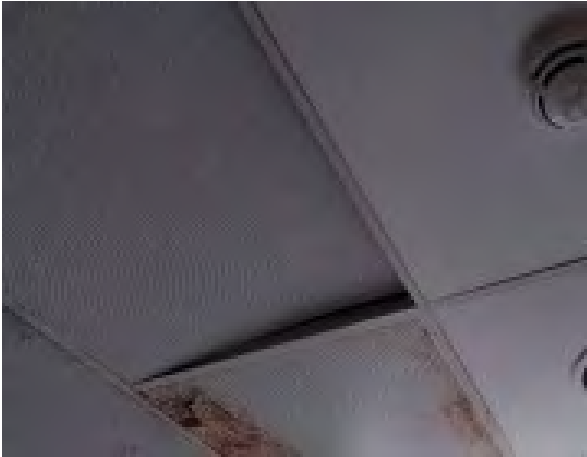
Item 97 Ref: PZ000637

The ceiling lining to ceiling tiles (Lobby to rear stairwell Rm 1/001) does not contain asbestos.

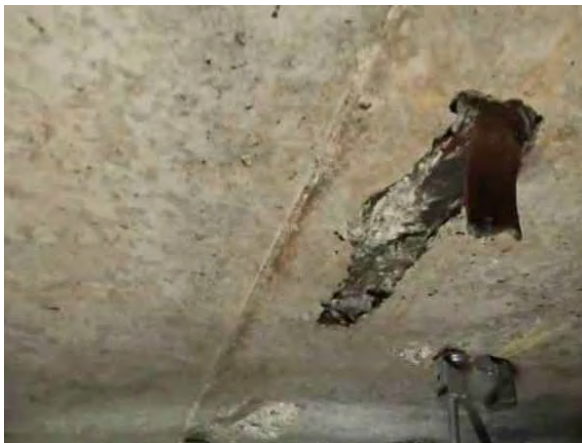
Item 98 Ref: TL000306

The ceiling void – ceiling above paper within concrete (Corridor adj Geology and Ethnography Store Rm Z1/001) does not contain asbestos.

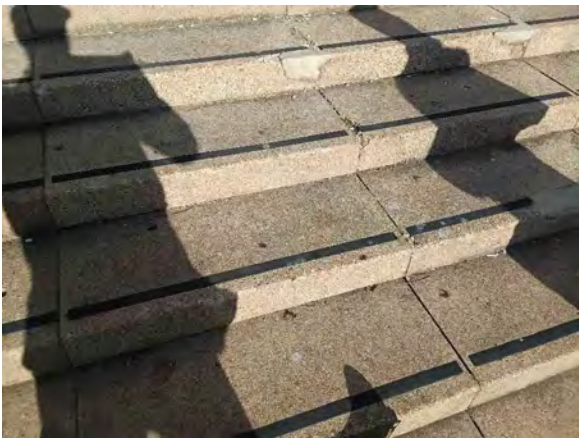
Item 99 Ref: TL000308

The floor – nosing to stairs (External Rm E/001) does not contain asbestos.

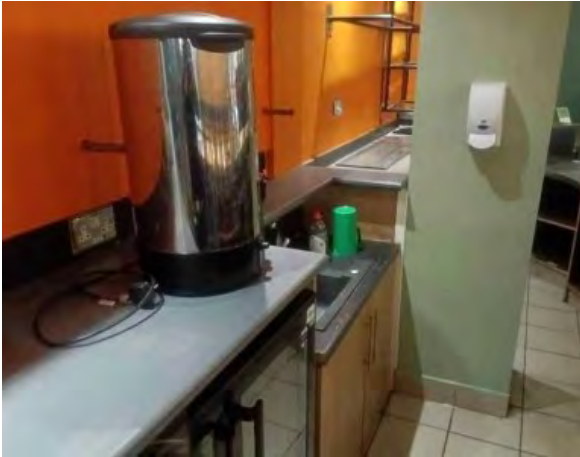
Item 100 Ref: TL000339

The wall to the servery in the Dining Hall area (G/001) does not contain asbestos.

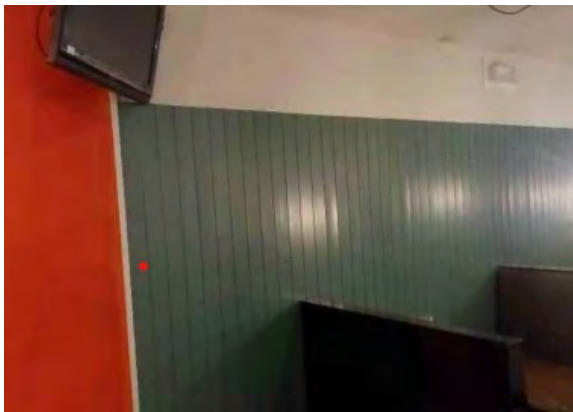
Item 101 Ref: TL000340

The wall to the seated booth area behind wooden panelling in the Dining Hall area (G/001) does not contain asbestos.

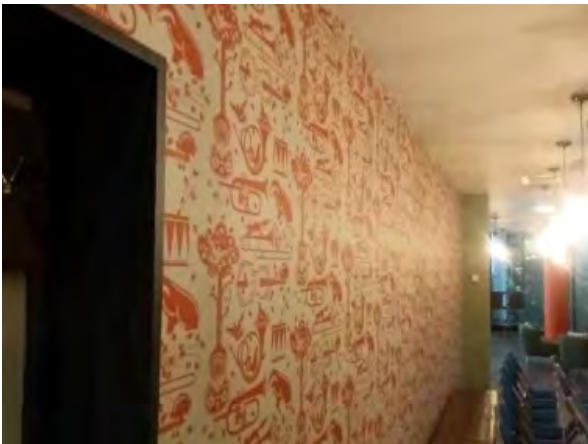
Item 102 Ref: TL000341

The wall decorated wall opposite servery in the Dining Hall area (G/001) does not contain asbestos.

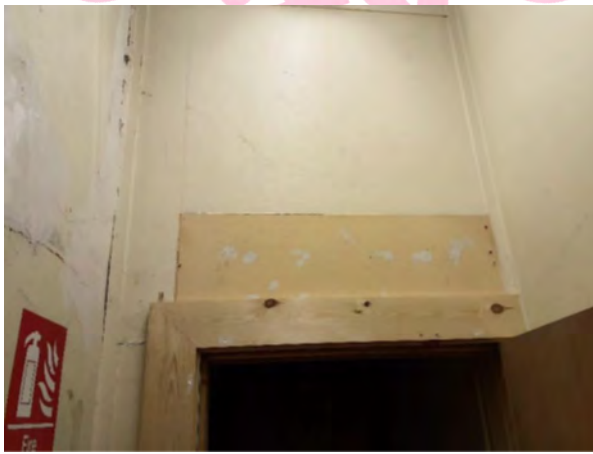
Item 108 Ref: KG000541

The header panel and side panel door to electrical cupboard (Corridor 3/001) does not contain asbestos.

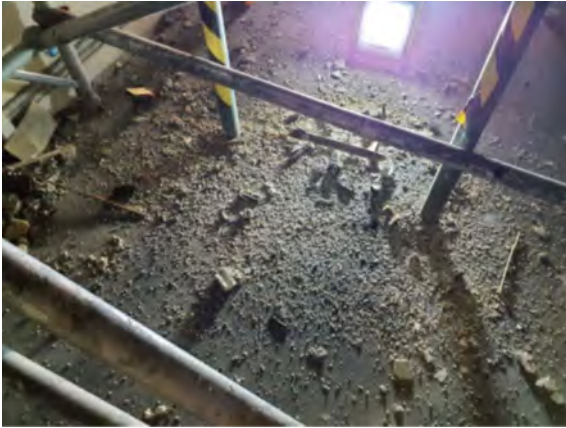
Item 109 Ref: KG000542

The vermiculite floor debris (The Lab 3/002) does not contain asbestos.
